Final Report on TREAT Tests R4 and R5;
Seven-pin, Loss-of-flow Tests with Full-length,
Unirradiated FFTF-type Fuel Pins

Reactor Analysis and Safety Division
ARGONNE NATIONAL LABORATORY
9700 S. Cass Avenue
Argonne, Illinois 60439

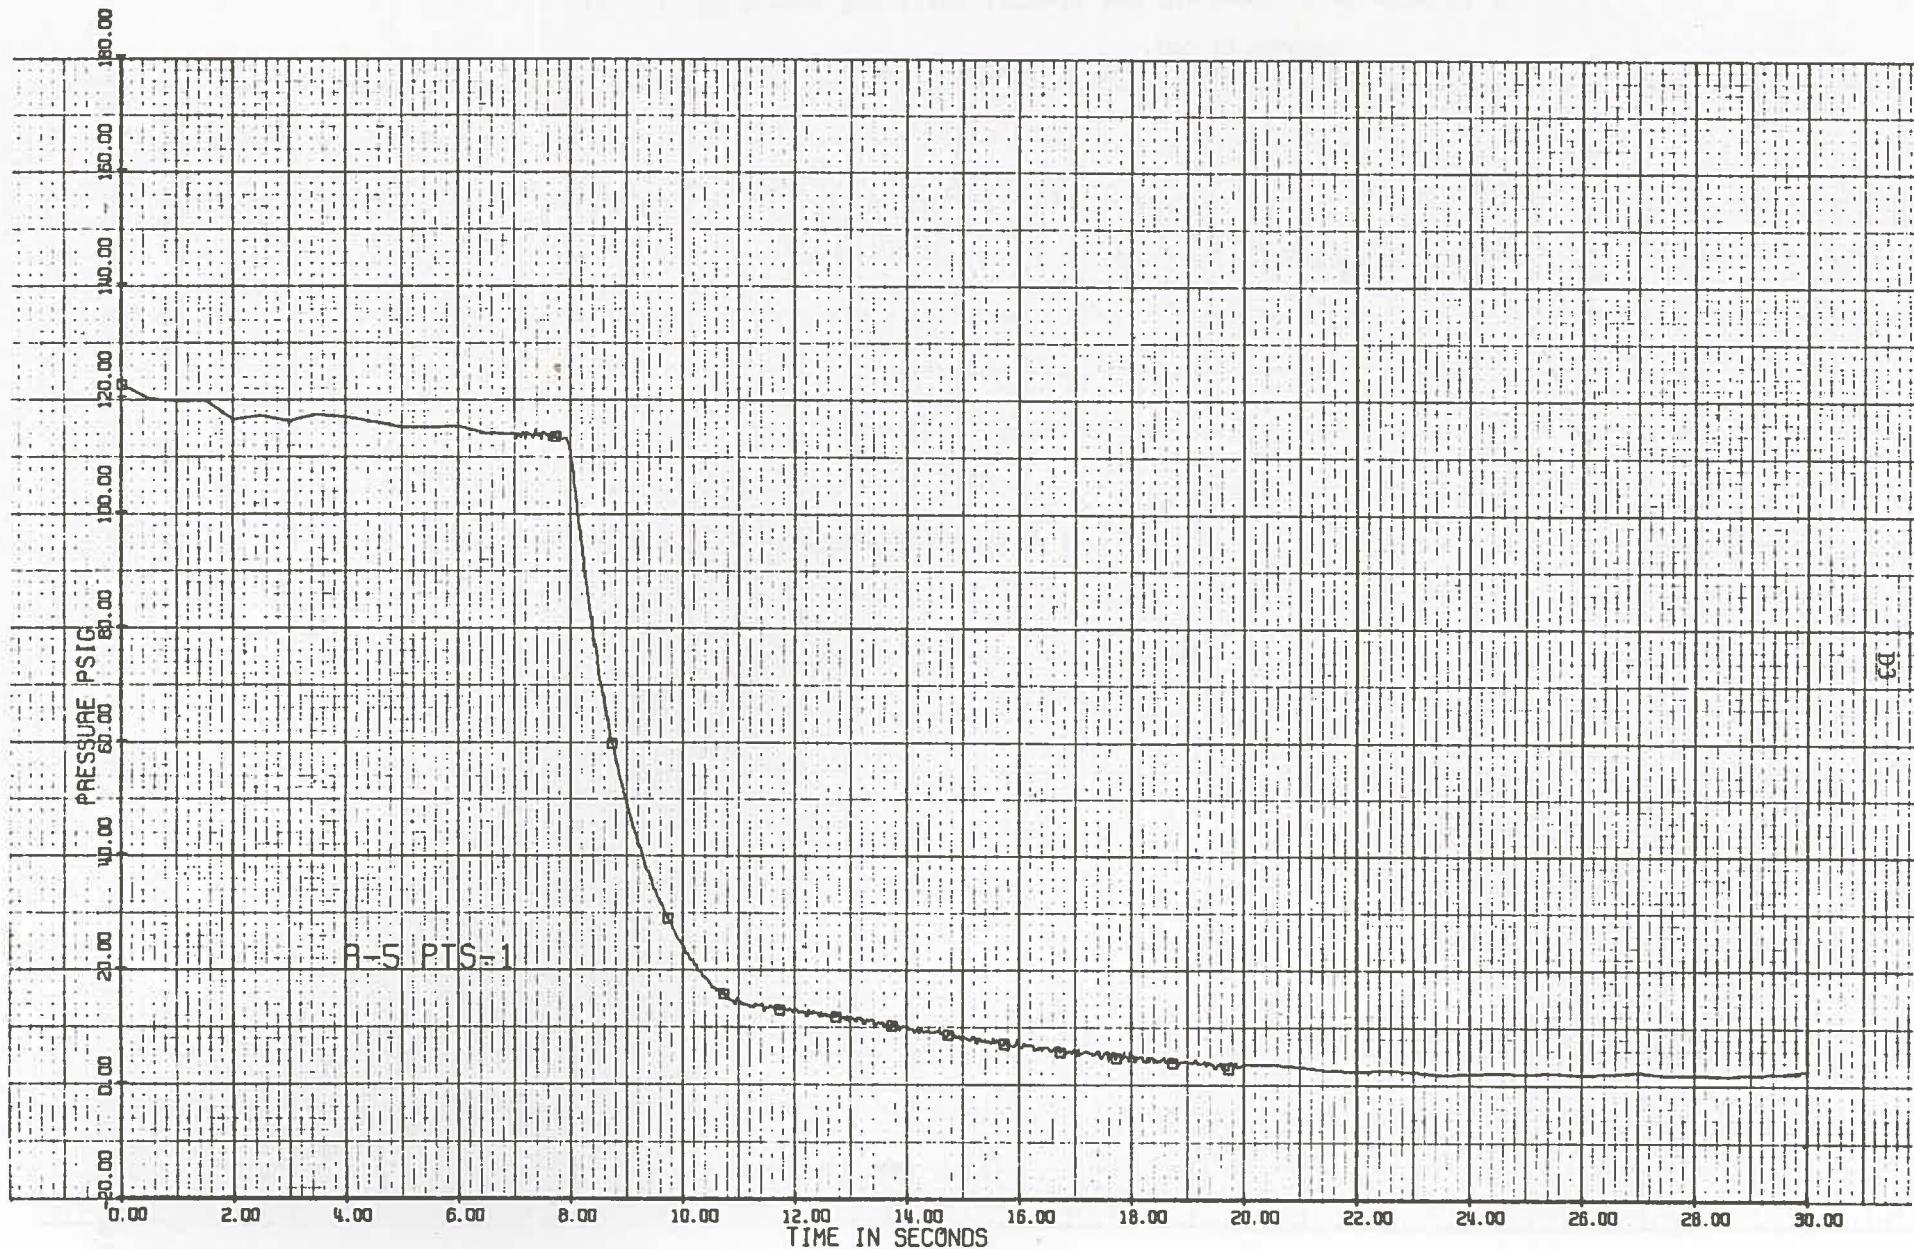
Fig. D2 R5 Supply Tank Pressure.

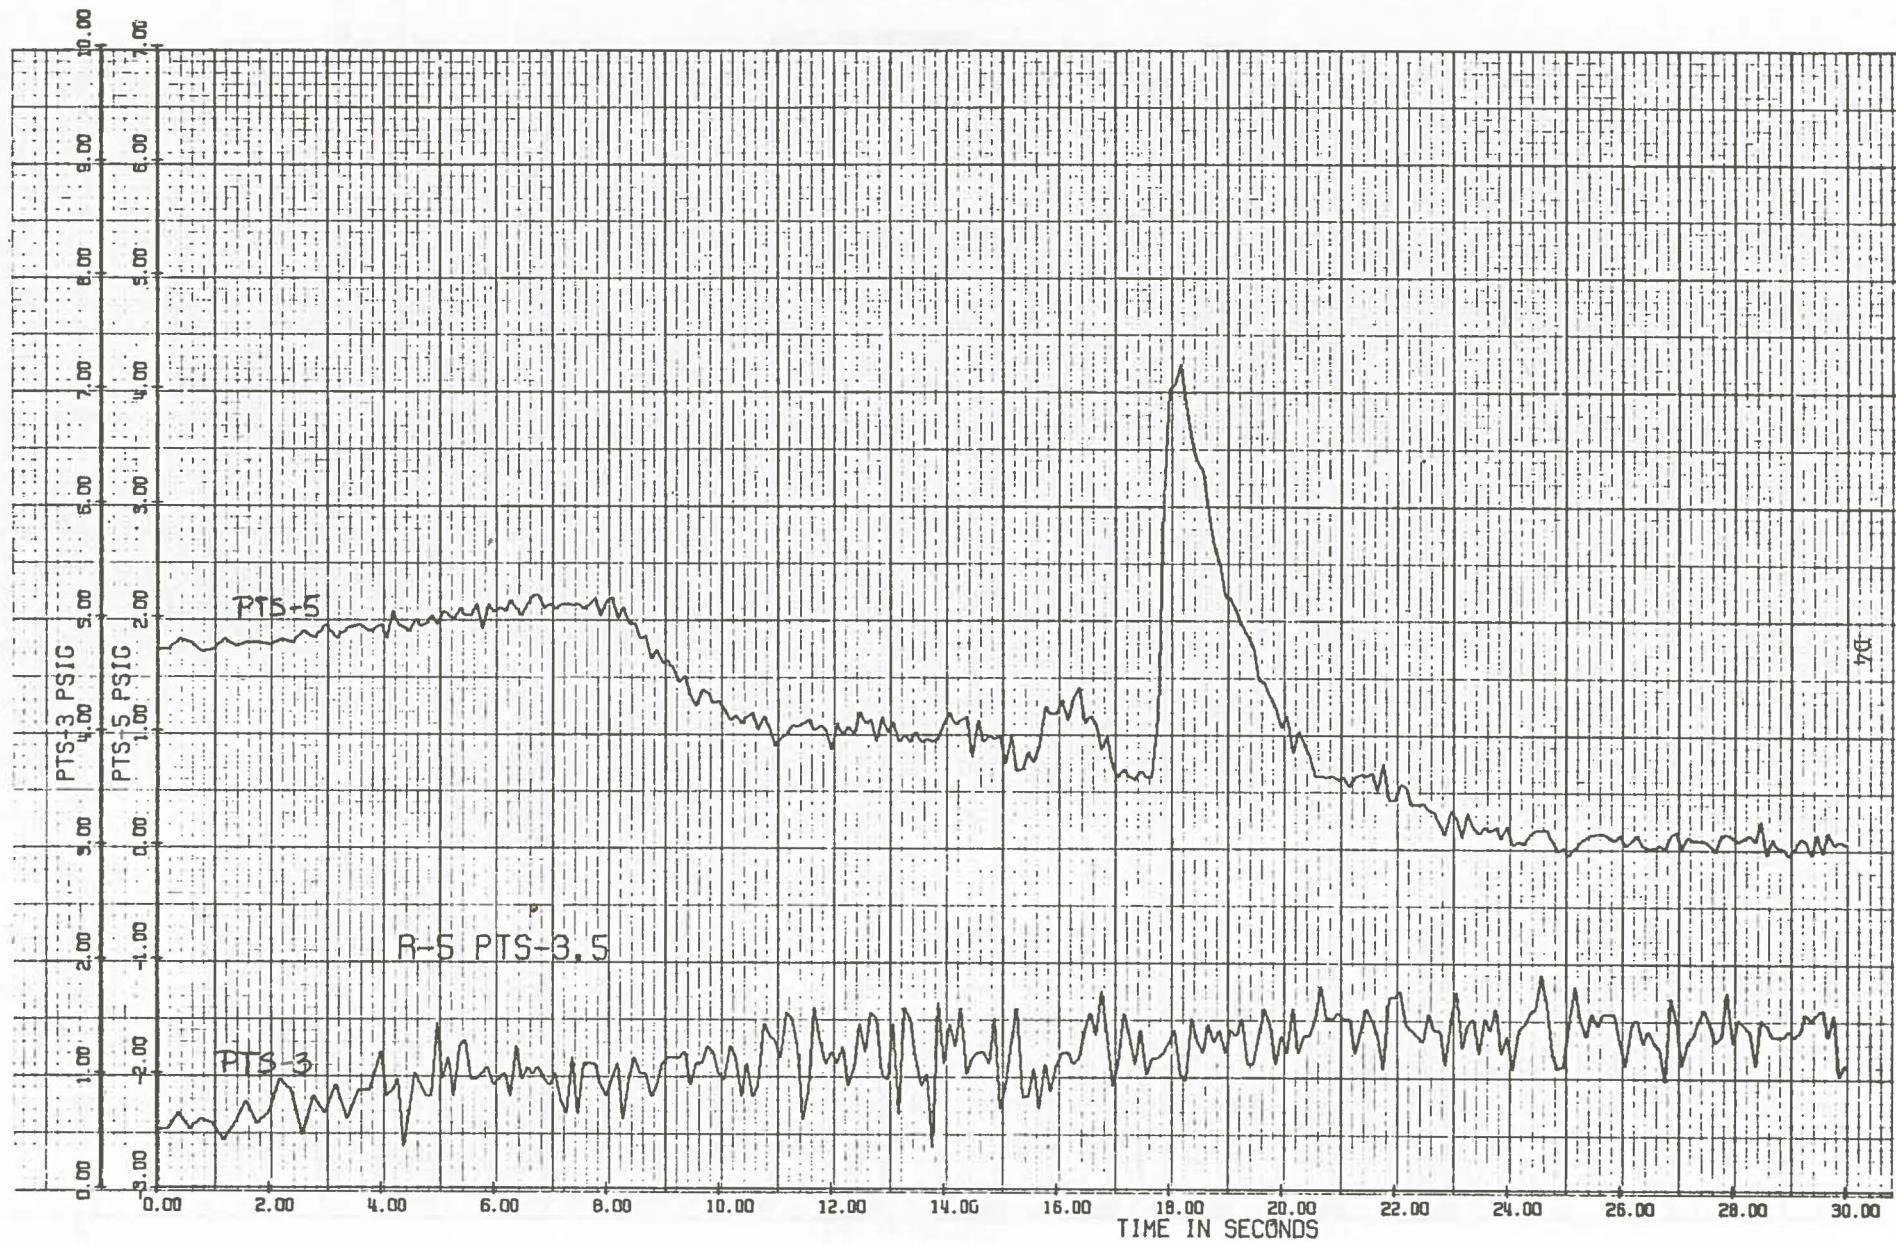
Fig. D3 R5 Plenum Simulator (PTS-5) and Discharge Tank (PTS-3) Pressure.

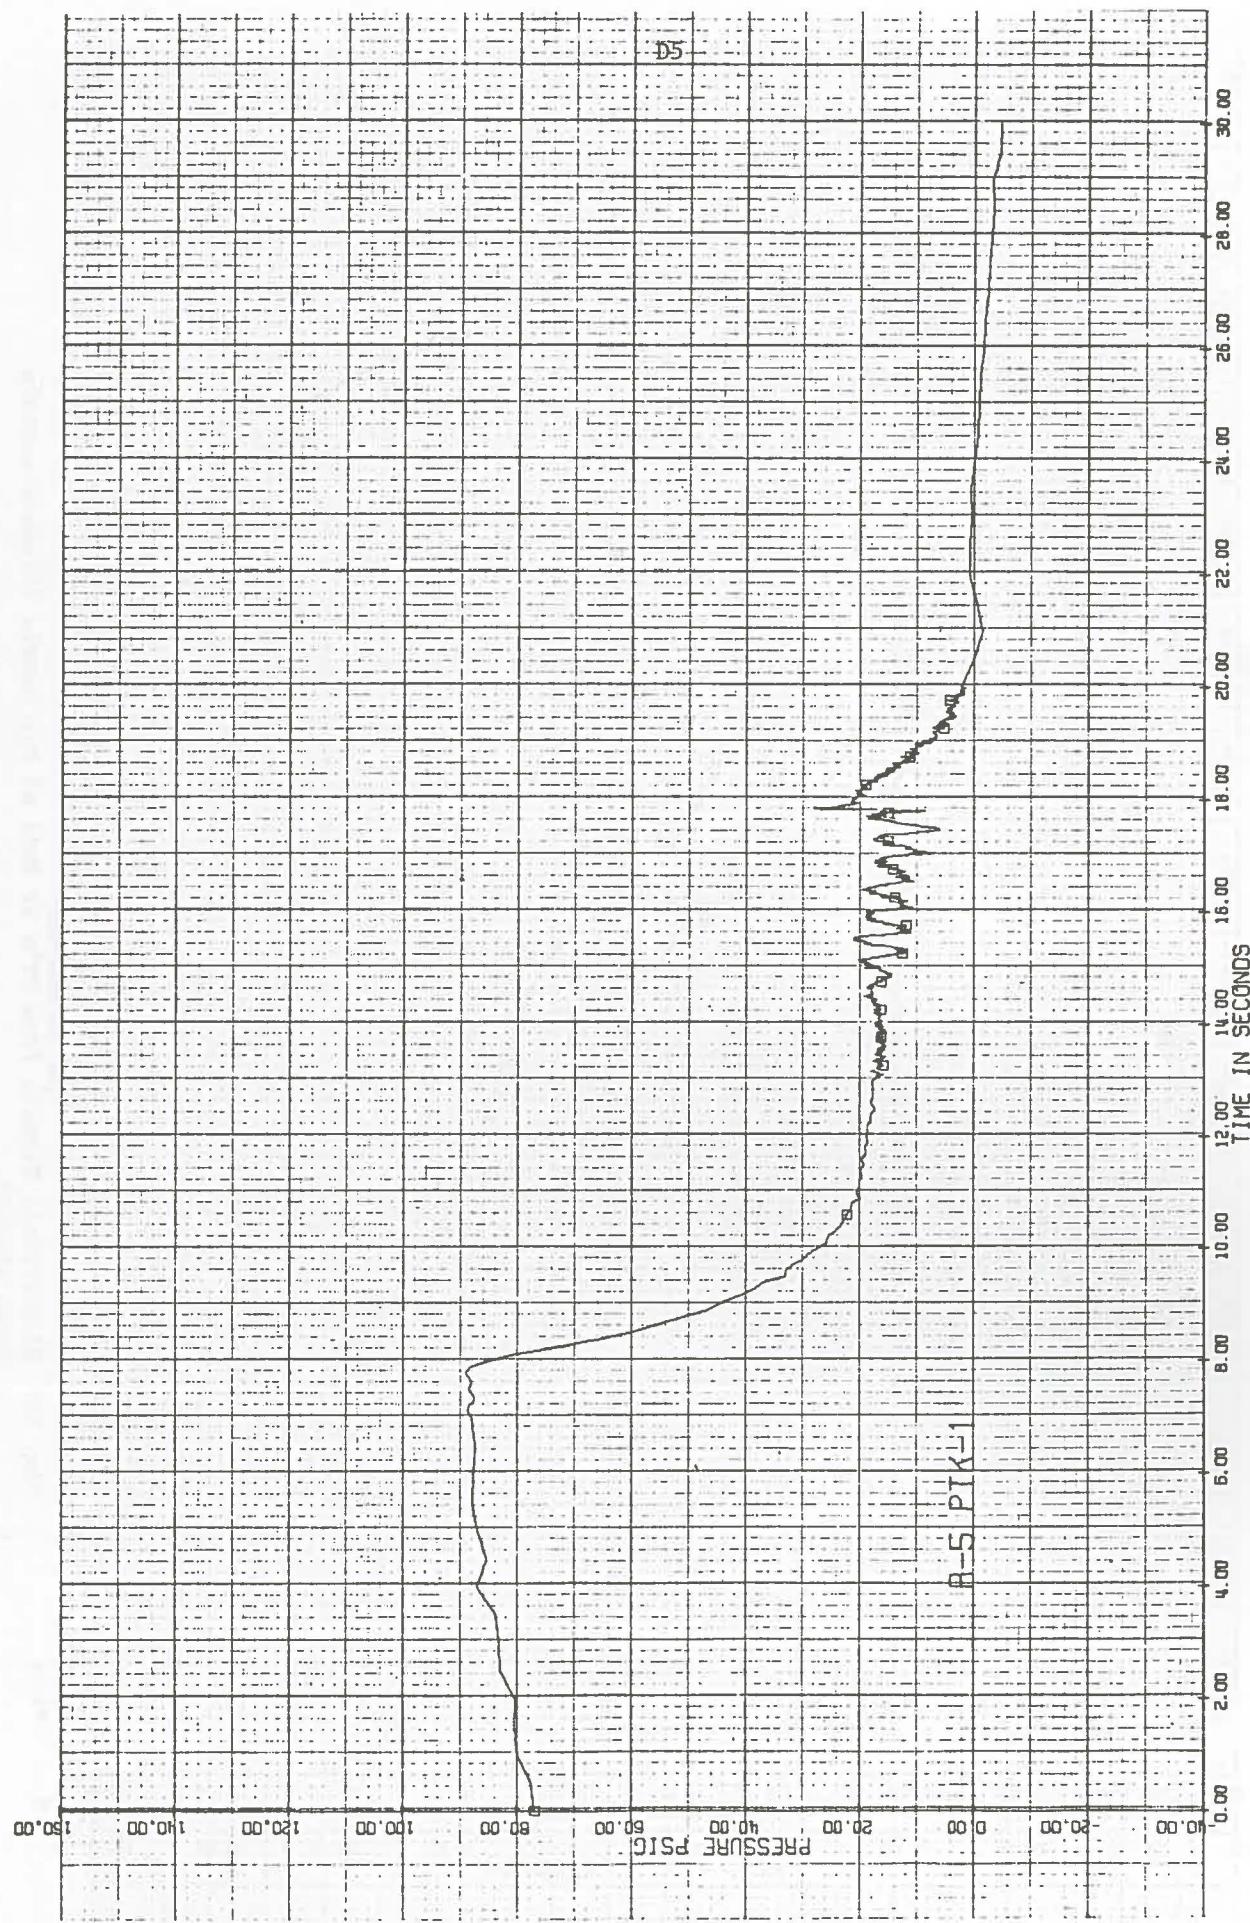
Fig. D4 R5 Pressure at Entrance to Pin Bundle.

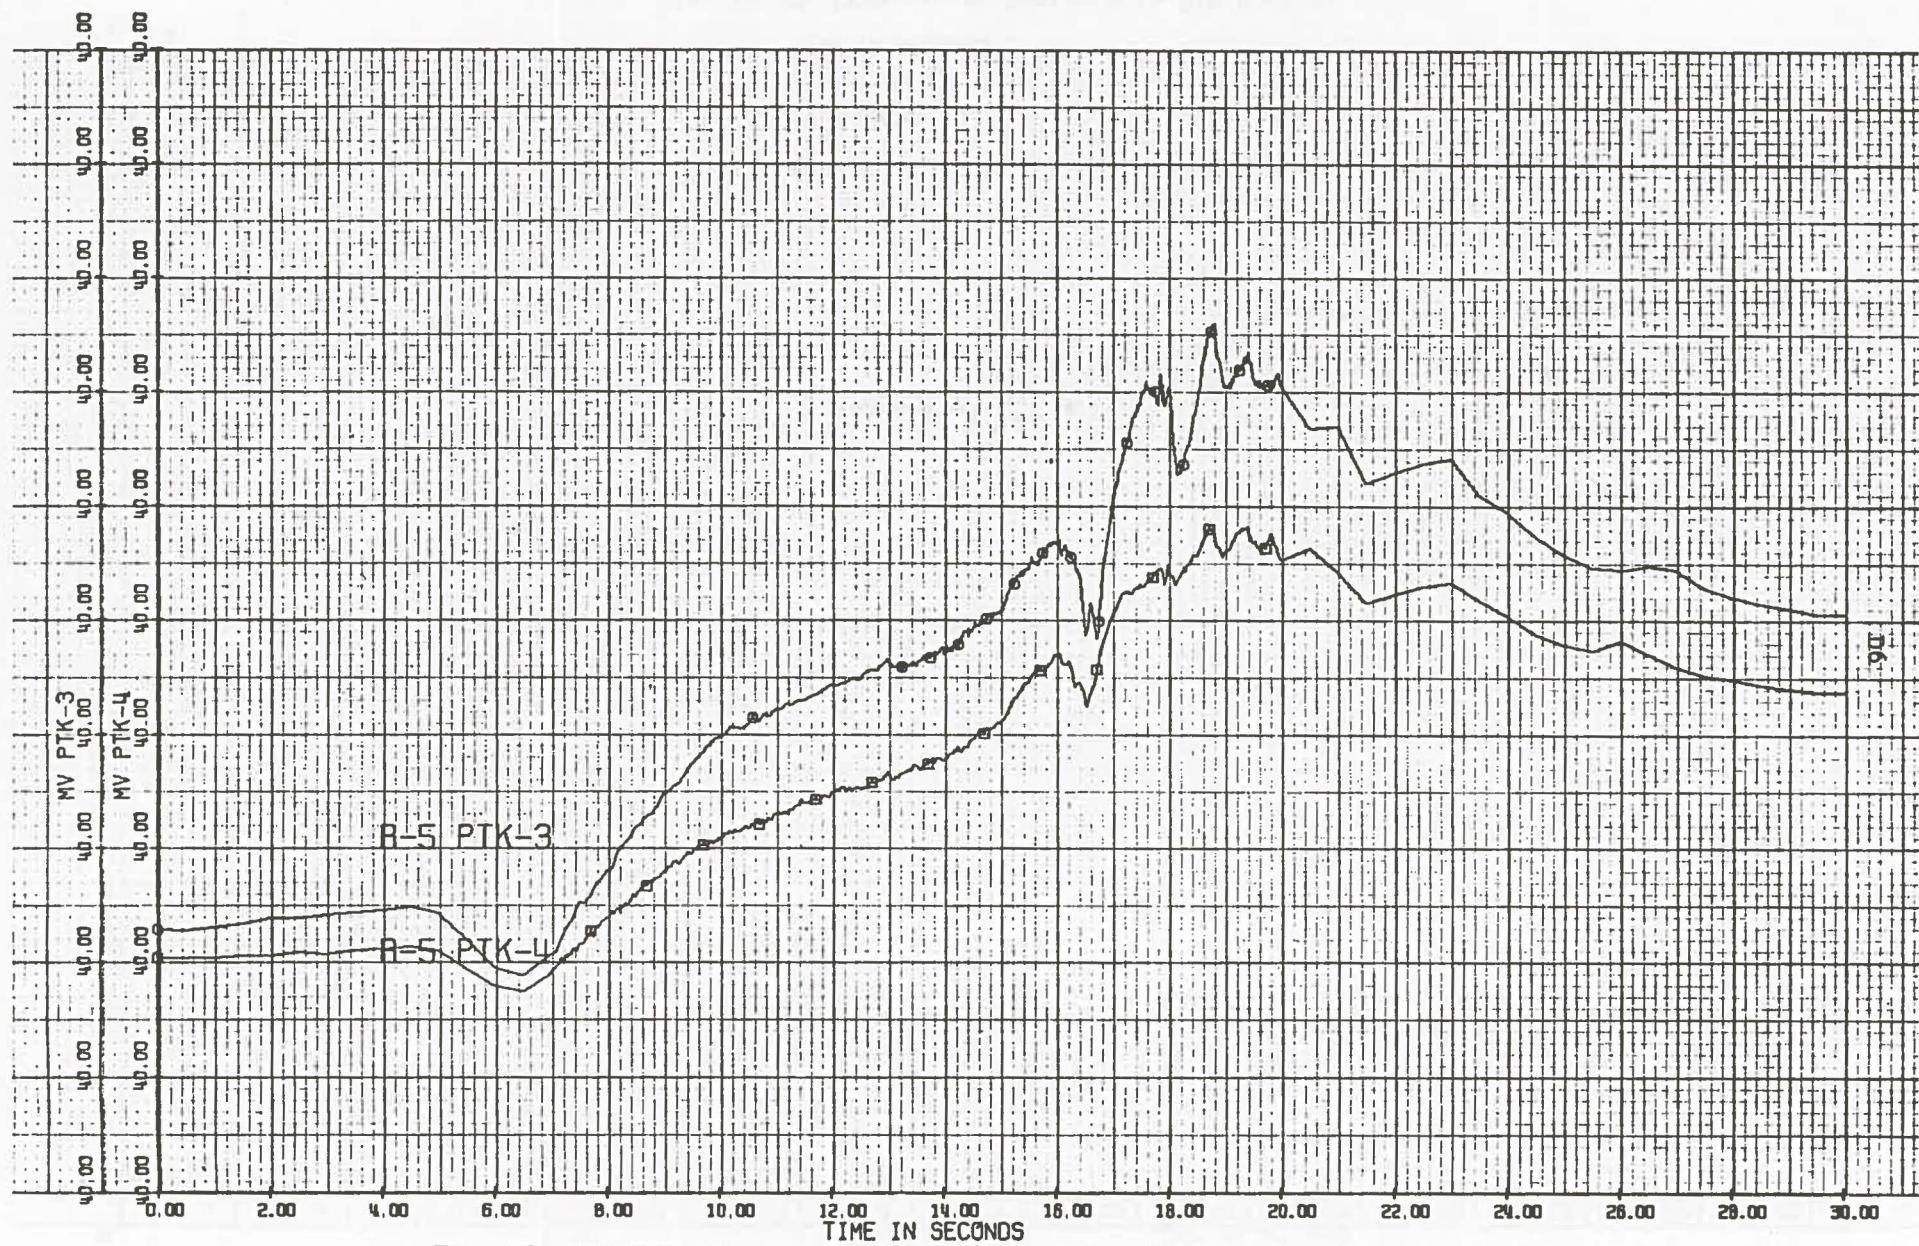
Fig. D5 R5 Millivolt Signals from PT's at Exit of Pin Bundle (Signals contain large effect).

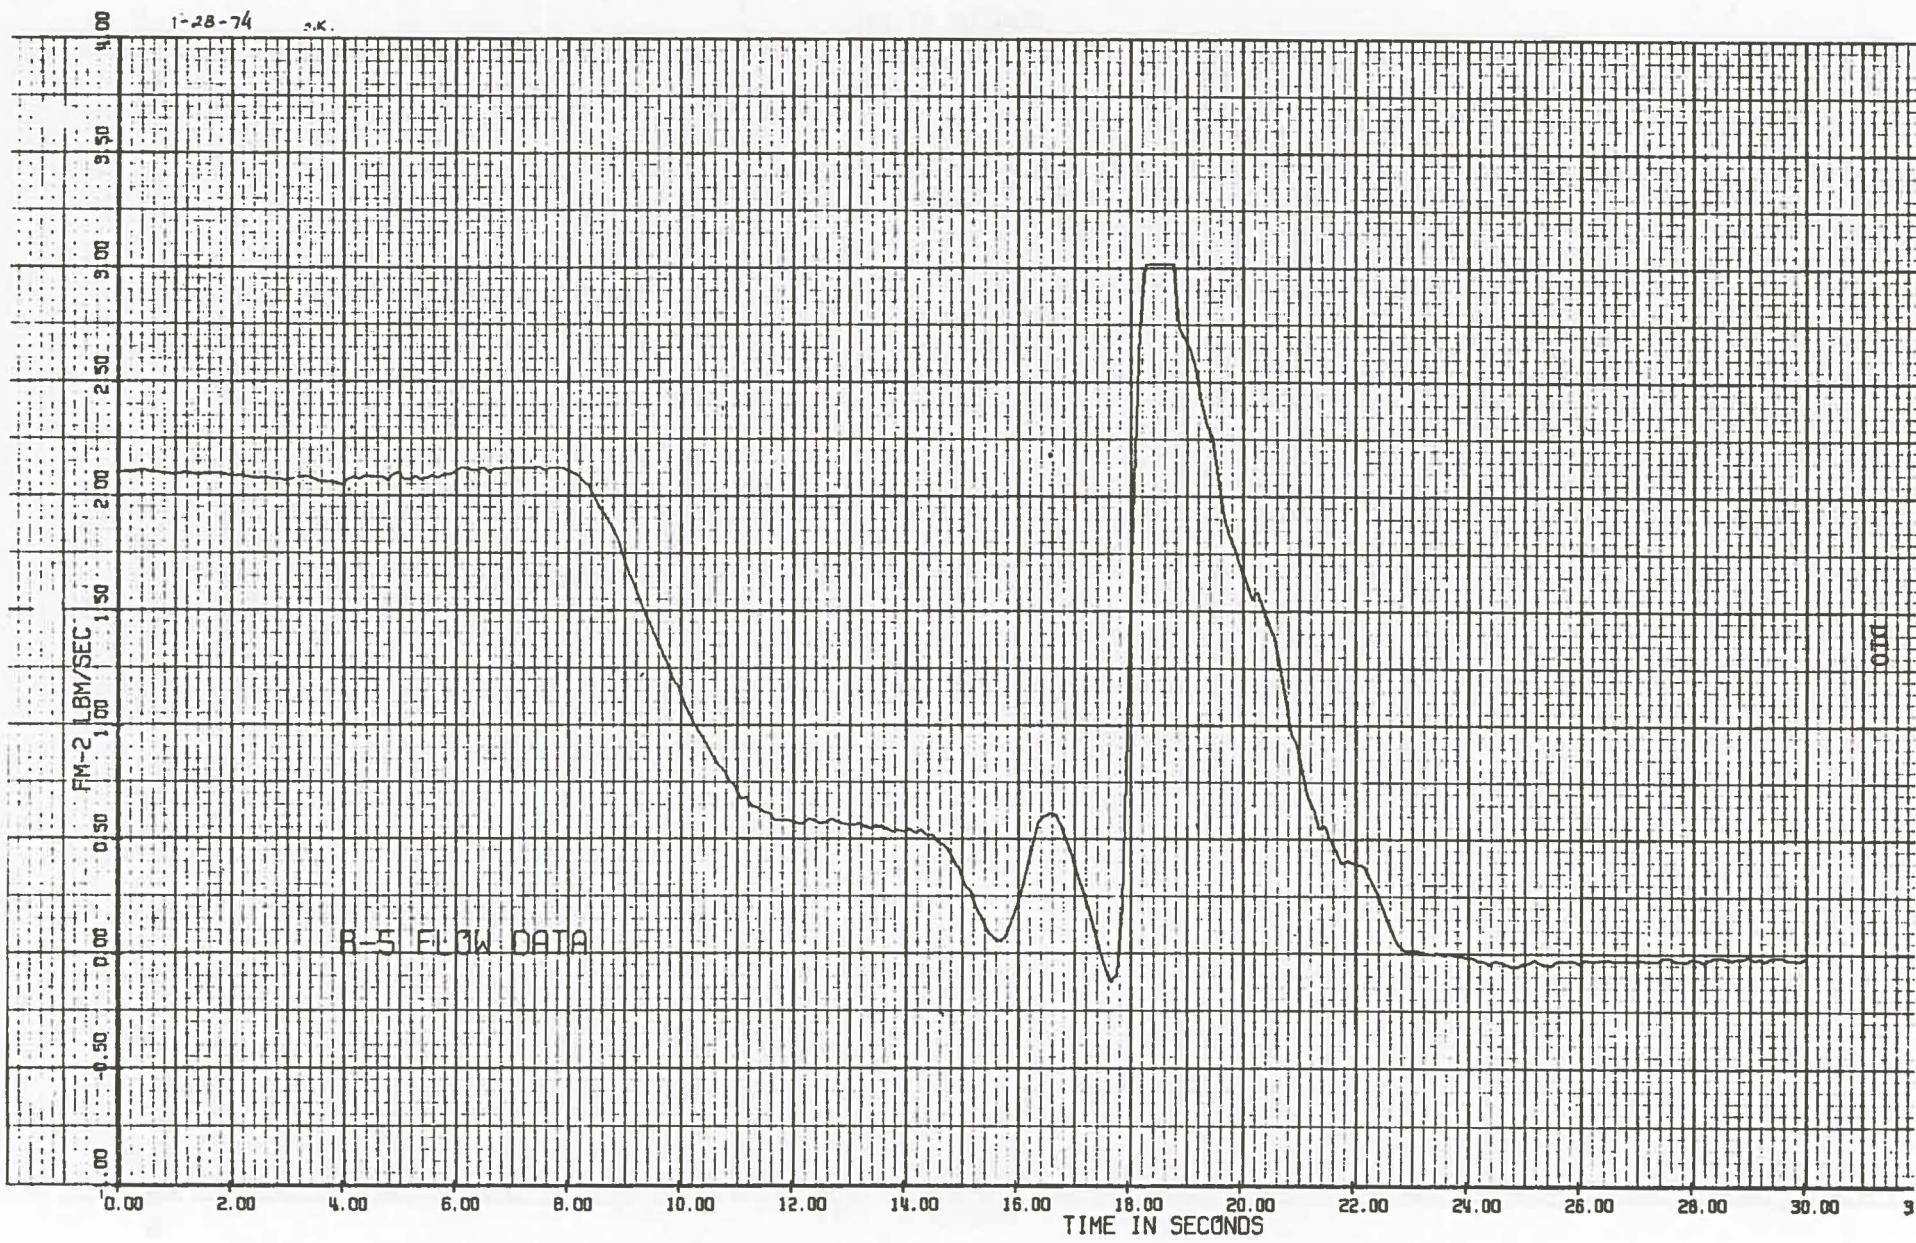
Fig. D9 R5 Plenum Simulator Discharge Flow Rate.
