**WSRC-MS-99-00601**

# Criteria for Corrosion Protection of Aluminum-Clad Spent Nuclear Fuel in Interim Wet Storage

James P. Howell  
Westinghouse Savannah River Company  
Aiken, SC 29808

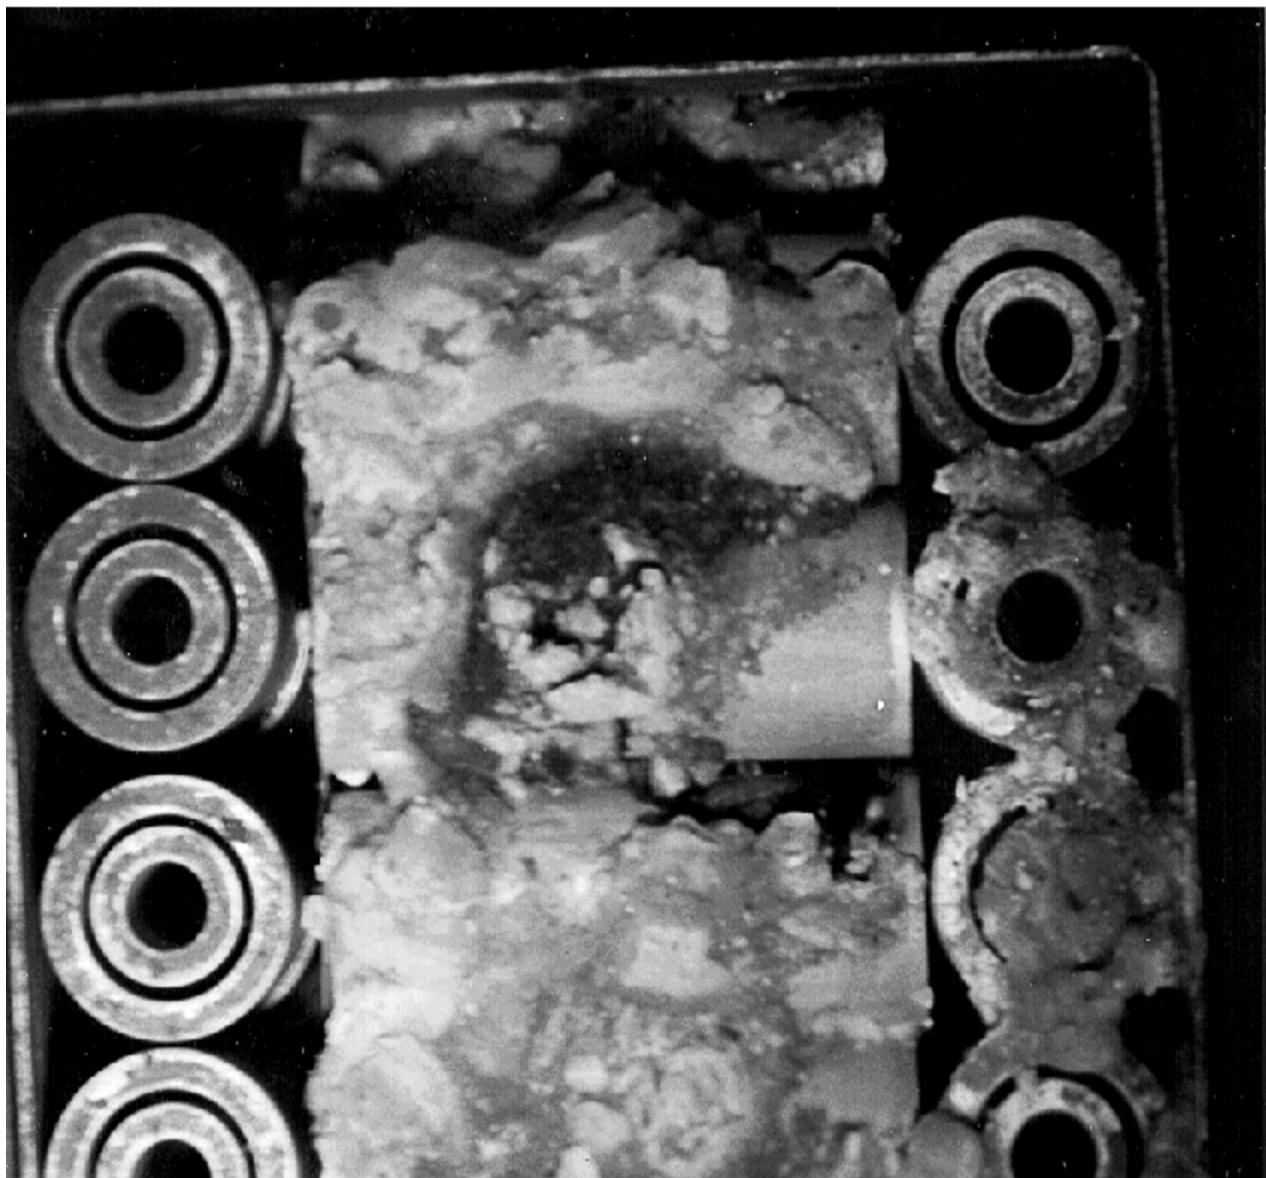
**Figure 1. Corrosion products on Mark 31A target slugs stored in L-Reactor basin.**

Most of the Foreign Research Reactor and SRS production fuel and target materials are clad with aluminum alloys, but the active core of the fuel is uranium metal or a uranium-aluminum alloy. Once the 30-mil cladding (some foreign fuels have 15-mil clad) is breached, the active core material is exposed to water. The Mark 31A target slugs stored in the SRS basins had an 1100-aluminum alloy cladding and a uranium metal core. When the cladding was breached during the first two years of storage, the corrosion continued into the uranium metal core material producing voluminous uranium oxide corrosion product as seen in Figure 1.

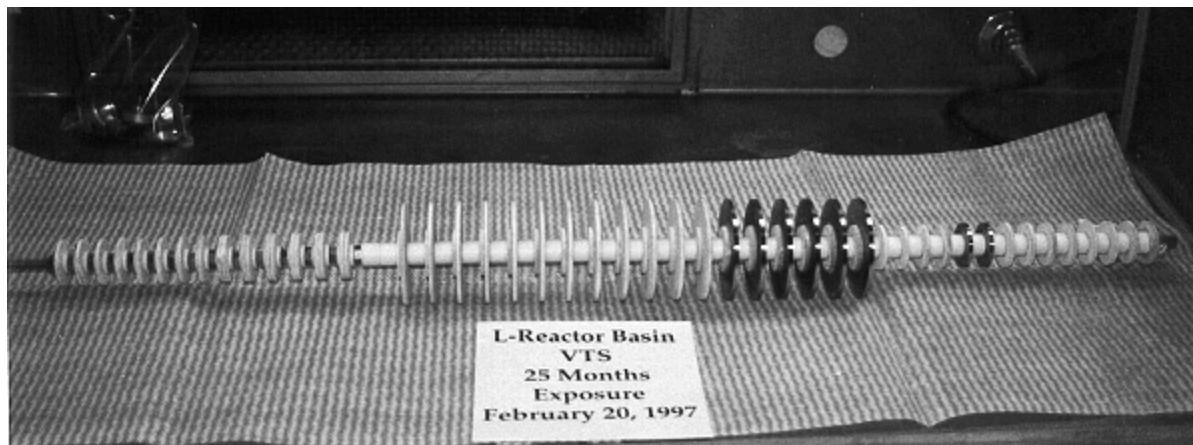
**Figure 4. Typical Corrosion Surveillance Rack**

Corrosion Racks and Test Coupons. The corrosion samples are 31.75 mm (1 1/4 in.) circular disks of 3.175 mm (1/8 in.) thickness with a hole in the center designed to fit over the insulated stainless steel rod rack. Plastic insulators separate individual samples. The coupons are not pre-oxidized at elevated temperature in water, but have the normal air formed oxide. This condition should make them more sensitive to any water chemistry changes. Four basic types of corrosion specimens are being tested in the L-basin and RBOF water environments:

Based on the current inventory of fuel in the RBOF basin and the available information for incoming research reactor fuel, 1100, 6061, and 5086 aluminum alloys are the primary cladding alloys expected to be stored in the basin. Welded and galvanic samples will concentrate on the 1100 and 6061 alloys. Some 304L stainless samples are included in galvanic couple tests to represent potential interactions that have typically existed over the years in most storage basins around the world. Multiples of each type coupon are included on each corrosion rack. Each rack contains 60 samples. A typical rack is shown in Figure 4.
