*Aquatic Invertebrate Sampling  
at Selected Outfalls in Operable Unit 1082;  
Technical Areas 9, 11, 16, and 22*

*Saul Cross*

**Los Alamos**  
NATIONAL LABORATORY

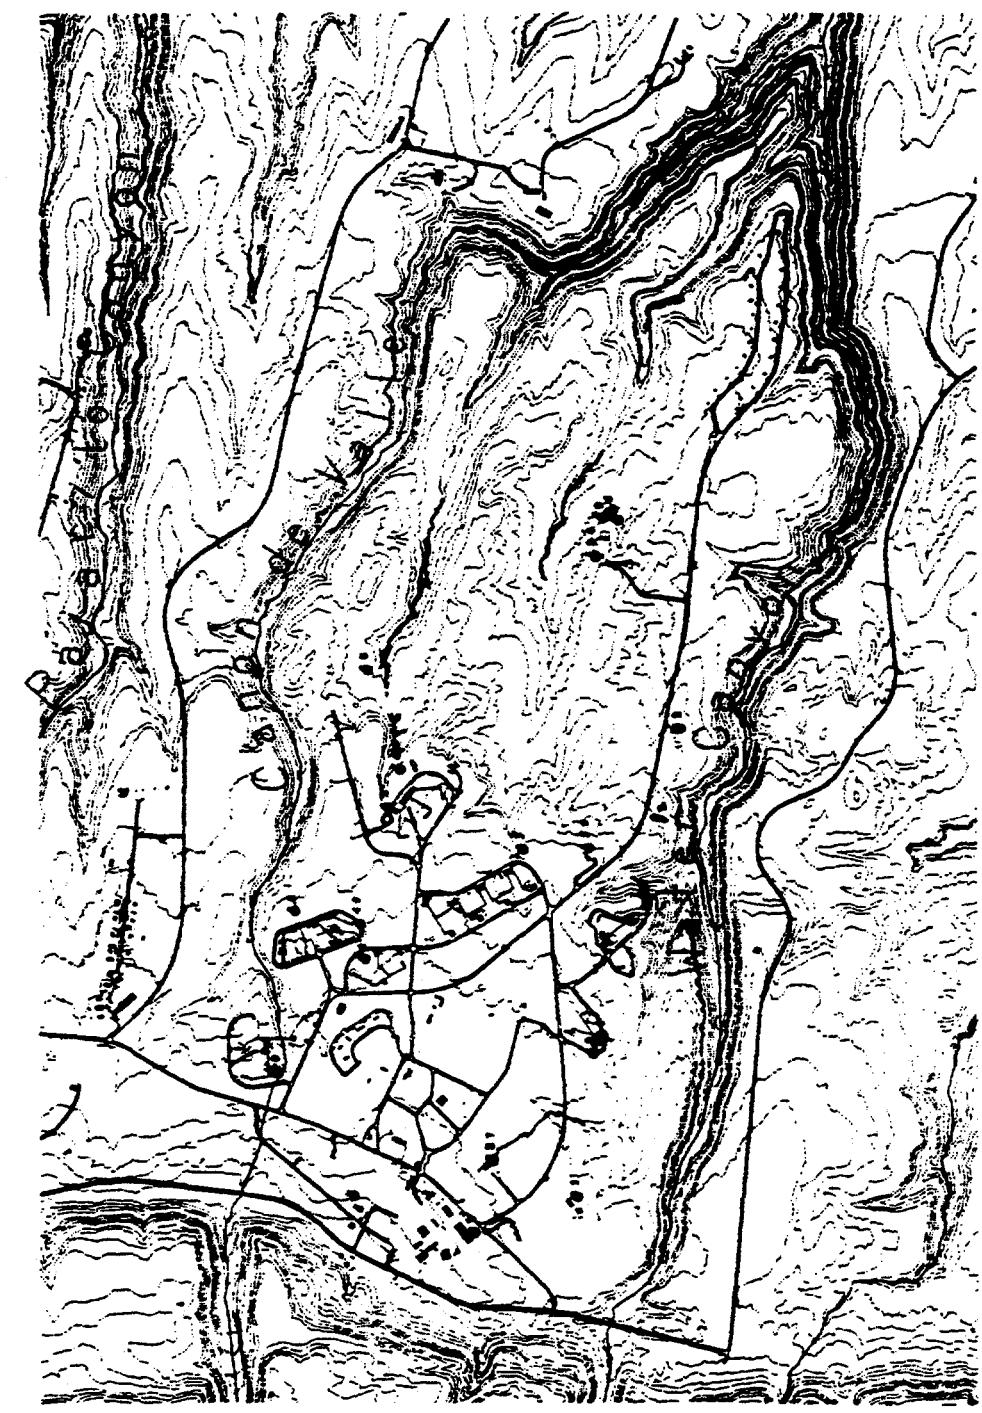
## Outfalls and Wetlands within OU 1082

Several outfalls of differing types are located with OU 1082 (Fig. 1). Due to recent project consolidations and water minimization practices, effluent discharges to many of these outfalls have been significantly reduced or entirely eliminated. Various projects within the OU have proposed further reductions and eliminations to these and other outfalls. To document resident aquatic invertebrate communities within the area, the Ecological Studies Team (EST) of ESH-20 conducted preliminary surveys of outfalls within OU 1082.
