LNG SHIP INSULATION EXPERIMENTS USING LARGE LNG POOL FIRE BOUNDARY CONDITIONS

Thomas Blanchat, Charles Morrow, and Michael Hightower

Sandia National Laboratories¹

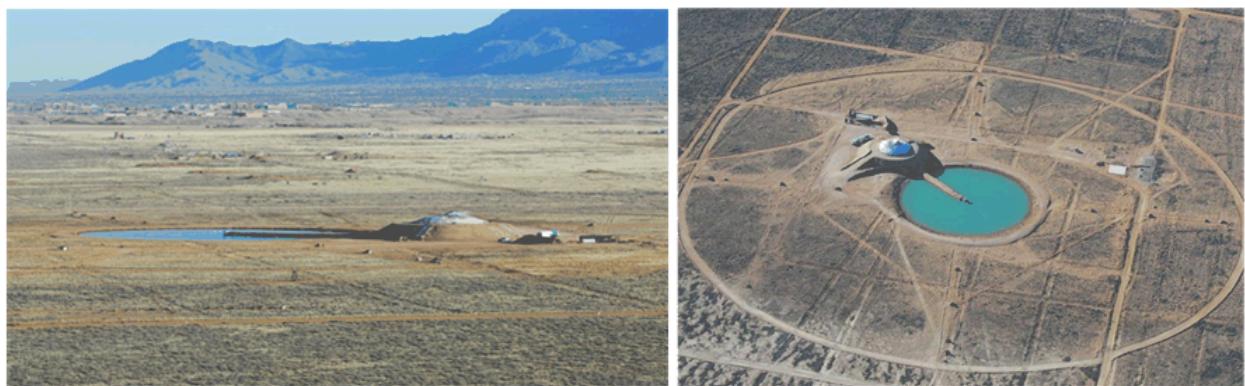
A key technical element in establishing hazard distances from fires is establishing the surface emissive power (SEP) of the fire. One of the deficiencies of historical data is due to the small scale of the fires (10 to 100 times smaller) relative to possible spill diameters, particularly when the SEP is a strong function of fire diameter. The principal reason for the small fire diameters was cost. Cost estimates to build a facility to conduct large-scale LNG pool fire tests were prohibitive. This forced Sandia to assess ways to develop a safe, low-fabrication-cost experimental setup. The selected solution necessitated significant operational safety considerations including unprecedented cooperation between numerous Sandia organizations, the DOE Sandia Site Office, and Kirtland AFB agencies (including flight-operations and emergency fire-response). By focusing on the experimental objectives, and using experience in conducting large-scale experiments, the team came up with a simple, low-cost experimental approach that enabled testing at an appropriate scale. The experimental design concept (Figure 1) included: 1) using the soil excavated from the creation of a shallow 120-m diameter pond to create a deep, 310,000 US gallon reservoir to hold the LNG while filling, 2) insulating and covering the reservoir to minimize vaporization losses, 3) using industry standard prefabricated reinforced concrete pipes to transport the LNG from the base of the reservoir to the center of the pool, and 4) using a simple, liftable plug to allow gravity and the reservoir geometry to control the flow rate.

Figure 1. The Large Scale LNG Pool Fire Experimental Site

This approach enabled high LNG flow rates onto water representative of potentially large spills, while minimizing the need for cryogenic rated high-flow rate pumps and hardware. This approach required significant environment, safety, and health analysis to provide confidence that the design and operations would be safe. Safety issues examined included reservoir integrity, thermal (cryogenic to fire fluxes) impacts, asphyxiation, explosion, drowning, and aviation operations (helicopter and airport traffic) issues. Advanced transient, three-dimensional transport simulations were used to estimate both the thermal performance of the reservoir and components, the transport of gaseous boil-off during the cool-down process, and in the design

of the diffuser in the middle of the pool needed to translate the linear momentum of the LNG in the discharge pipes into a radially spreading pool.

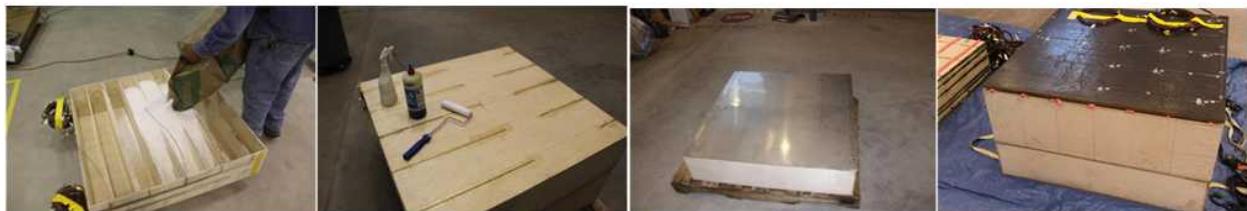
Care was taken during the perlite fill to obtain prototypic size distribution and density (~50-65 kg/m³) in the primary and secondary boxes. Figure 5 shows a few photographs taken during the assembly of the No96 test panel. They include the perlite fill, thermocouple layout and installation on the secondary box, gluing the thin steel membrane (representing the Invar membrane) between boxes, and final assembly of the insulation system.

Figure 5. No96 Insulation System Assembly.

The No96 configuration included a heated area of 1000 mm x 1000 mm (the steel outer hull plate, ~23 mm), a gap between outer hull and inner hull (~1065 mm), the steel inner hull plate (~14 mm) glued to the perlite-filled secondary plywood box (~0.3 m deep) set against resin beads, a stainless-steel membrane (~0.7 mm), the perlite-filled primary plywood box (~0.2 m deep), and the aluminum cryogenic tank (38 mm wall thickness) which was covered with polystyrene insulation on the back side (51 mm) to reduce boil-off.

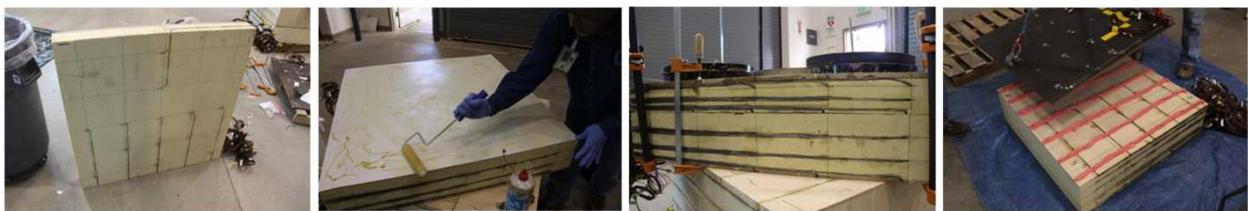
Small diameter holes (~5 mm) were drilled into the foam to depths appropriate for the location of thermocouples; a fixture guided the drill bit and provided accuracy of ± 2 mm at the maximum depth of 500 mm. Depending on the location, one, two, or three thermocouples were inserted to the correct depth and glued in place. Figure 6 shows a few of No96 panel insulation system assembly photographs. They include the thermocouple layout and installation on the primary foam/wood panel, gluing the thin composite secondary membrane between foam panels, gluing the primary and secondary panels including the final press and cure, and laying the mastic resin in preparation to attachment of the inner hull steel plate.

Figure 6. MK III Insulation System Assembly.

Final assembly of the MK III insulation system was performed in a similar manner as for the No96 system. The composite secondary insulation panel was glued to the inner hull plate. The same type of glue was used to bond plywood to foam and foam to the rigid composite secondary membrane. Specifications for pressing time, temperature, and pressure were provided by GTT.

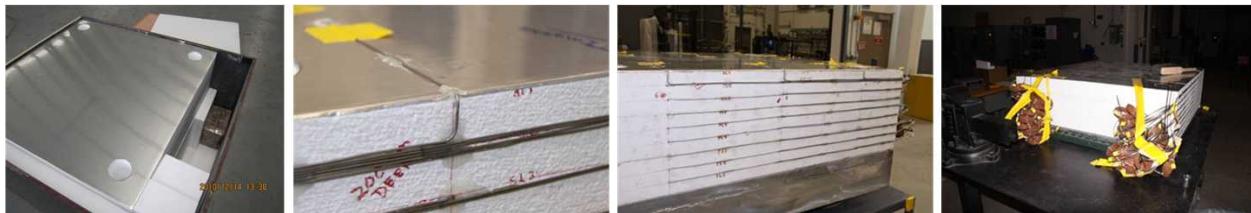
Figure 8 shows the polystyrene insulation panel as delivered, a close-up of the TC installation, the insulation divided into nine thermocouple measurement planes, and the final assembly.

Figure 8. Moss Polystyrene Panel Insulation System Assembly.

Four pre-drilled holes were used to bolt the panel assembly to an aluminum plate (bolts/nuts/washers and aluminum plate were supplied by Sandia). Polystyrene plugs with preattached aluminum sheet were also provided for insertion of the plugs inside the pre-drilled holes after the panel assembly was bolted to the aluminum plate. The aluminum plate (~19 mm thick, (0.75 inch)) had threaded rods for attachment to the polystyrene panel. After the panel was bolted to the plate, the four EPS plugs were glued in place using the bi-component polyurethane-based adhesive. As before, small diameter holes (~3 mm) were drilled into the foam to depths appropriate for the location of thermocouples. Depending on the location, one or two thermocouples were inserted to the correct depth and glued in place. The thermocouples were epoxied on the face aluminum sheet. As before, many thermocouples were installed on multiple planes within the insulation.

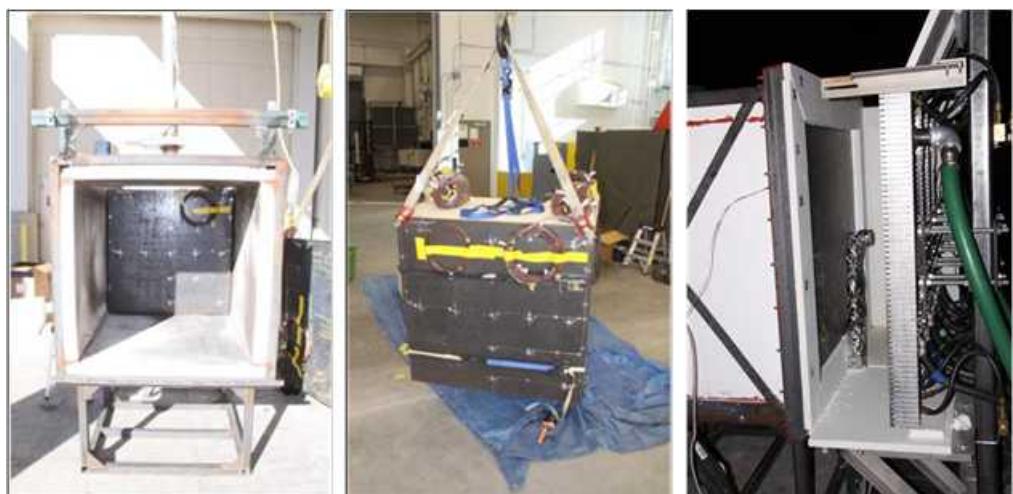
To conduct an insulation thermal damage test, an instrumented insulation system was placed in the test enclosure. Figure 9 shows the instrumented outer hull (or weather cover) installed at the front (heated side) of the test enclosure, an insulation system ready for installation at the rear of the test enclosure, and the front of the test enclosure with the radiometer set to measure the heat flux from the radiant lamp assembly.

Figure 9. Placing an Insulation System Into the Test Enclosure.
