# Computed Tomography and 3D Rendering of Composite Materials

**Burke L. Kernen and David G. Moore**  
**Sandia National Laboratories**  
**Structural Dynamics and X-ray/NDE**  
**[blkernen@sandia.gov](mailto:blkernen@sandia.gov)**  
**505-284-9096**

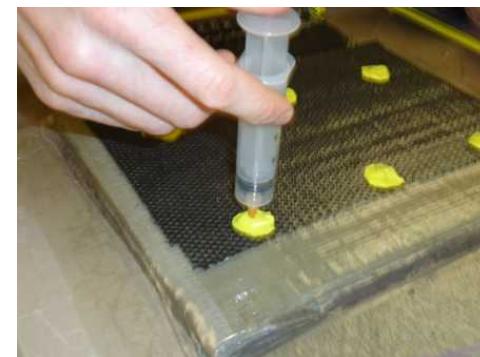
# Fiberglass Sample Preparation

- Specimens are fiber glass filled with resin
  - Each specimen filled with resin under vacuum
  - Air was introduced in various quantities to create different porosities
    - One method used clamped tubes vented to atmosphere
    - The second method used injection ports at various locations
  - The specimens were then allowed to cure

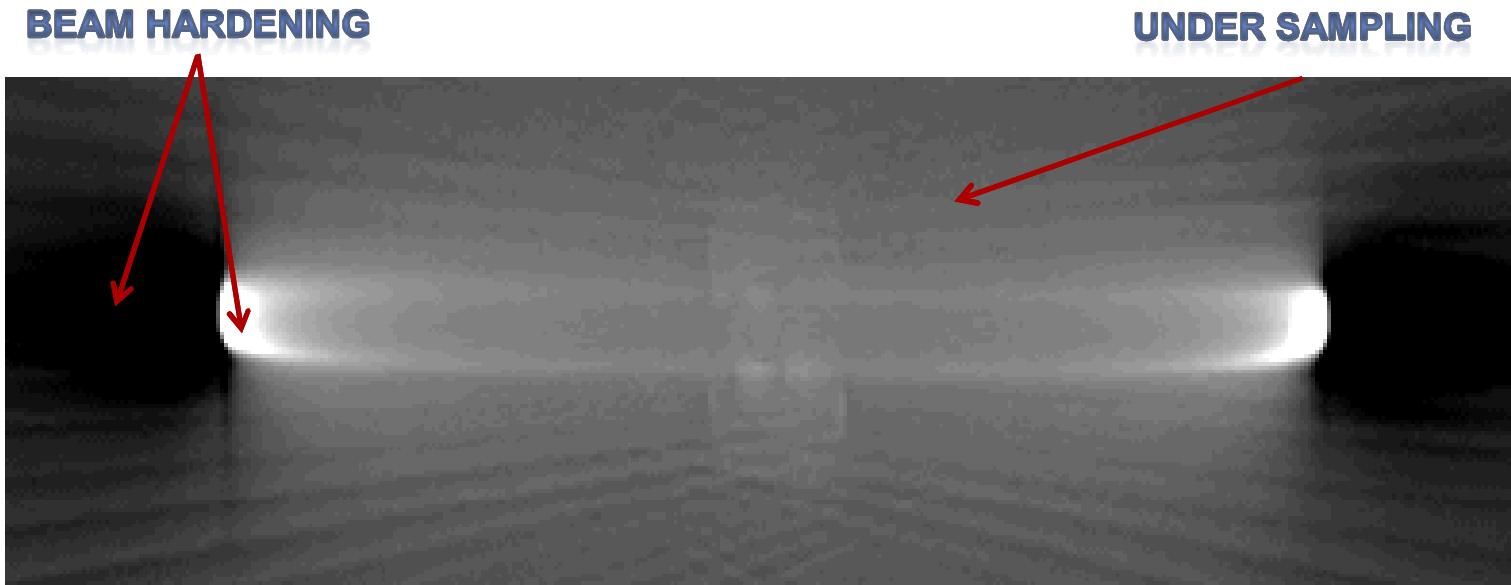
# Artifact – Beam Hardening and Under Sampling

- Non-Linear Photon Absorption
  - Increase Filtering
  - Collimate Beam
  - Software Correction
- Nyquist Sampling Criteria
  - Increase Sampling
