Determination of Loadings on Spent Nuclear Fuel Assemblies During Normal Conditions of Transport

International Symposium on Spent Nuclear Fuel (SNF) Management

Assembly Shaker Test

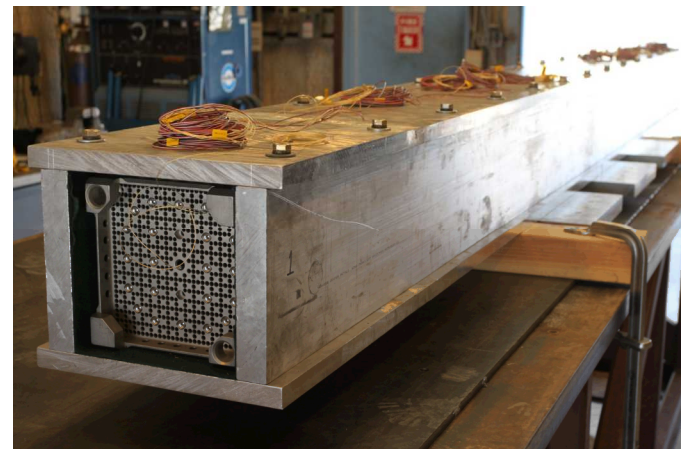
Surrogate 17x17 PWR Experimental Assembly

- The test unit included a fully loaded assembly and a basket.
- The test configuration was based upon the geometries of the NAC-LWT truck cask with a PWR basket.
- The assembly was placed in a basket which was placed on a shaker. The basket was bolted to the shaker. The clearances between the assembly and the basket matched those of the assembly/basket for the NAC-LWT design.
- The assembly had the same lateral and vertical freedom of motion as it would have in an actual cask.
- The mass and stiffness of the surrogate assembly match well with a real fresh fuel PWR 17x17 assembly

- 6061 Aluminum Basket
- Sides 1.5 inches thick
- Top/bottom 1 inch thick
- Length 161.5 inches
- Weight 837 pounds

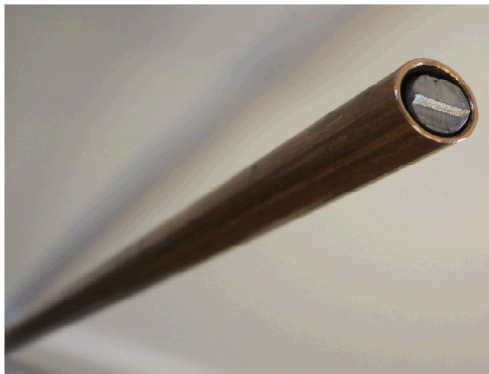
Surrogate rod:

- Three Zr-4 rods
- Remainder: Copper
- All filled with lead rope
- Mass simulates fresh UO_2 fuel

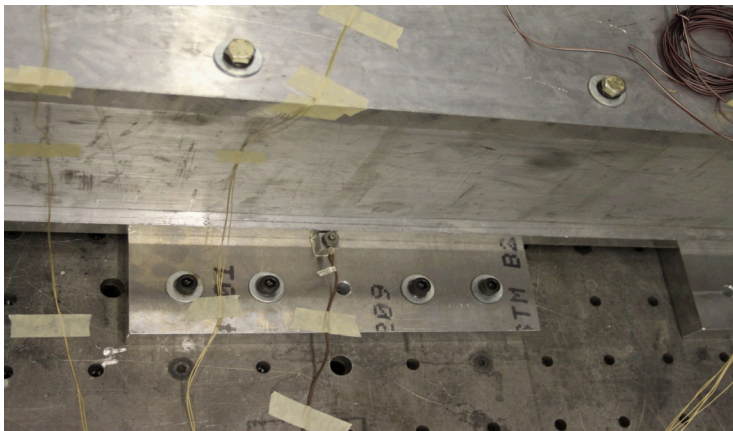
- Instrumentation placement based on pre-test finite elements analyses
- Only the Zr-4 rods and spacer grids were instrumented
 - 16 strain gages
 - 18 accelerometers on rods and grids
 - 7 accelerometers on basket and shaker table

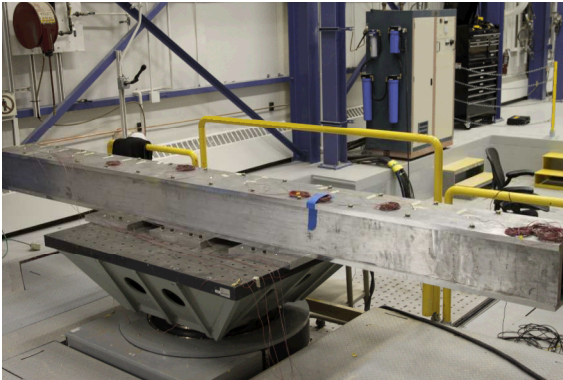
Mounted assembly and basket on the shaker table

- 6 vibration tests
- 5 shock tests
- Loading in vertical direction only
- Maximum measured strain was 213 $\mu\epsilon$

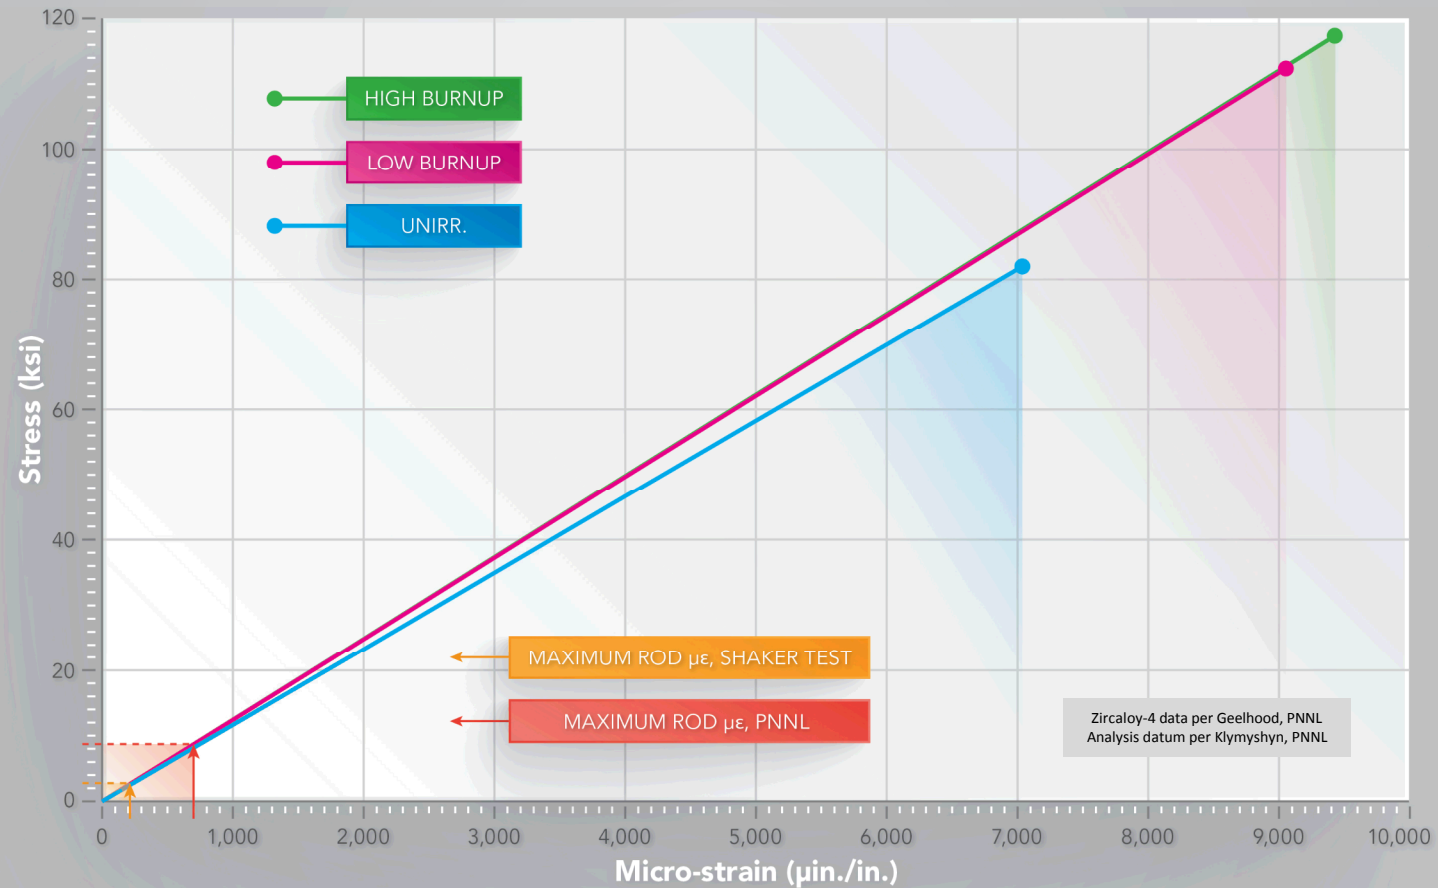
Maximum Micro-strains on Fuel Rods during Shock Test

Measured Strains are Very Low Relative to the Elastic Limit of Zr-4

Maximum Strains on Zircaloy Fuel Rods, Shock Test #1			
Rod Location	Assembly Span	Position on Span	Maximum Strain (μin./in.)
Top-middle rod	Bottom-end	Adjacent to spacer grid	90
Top-middle rod	Bottom-end	Mid-span	131
Top-middle rod	Bottom-end	Adjacent to spacer grid	171
Top-middle rod	Mid-assembly	Adjacent to spacer grid	104
Top-middle rod	Mid-assembly	Mid-span	97
Top-middle rod	Top-end	Adjacent to spacer grid	127
Top-middle rod	Top-end	Mid-span	199
Top-middle rod	Top-end	Adjacent to spacer grid	70
Top-side rod	Bottom-end	Adjacent to spacer grid	54
Top-side rod	Bottom-end	Mid-span	107
Top-side rod	Top-end	Mid-span	117
Top-side rod	Top-end	Adjacent to spacer grid	113
Bottom-side rod	Bottom-end	Mid-span	62
Bottom-side rod	Bottom-end	Adjacent to spacer grid	121
Bottom-side rod	Mid-assembly	Adjacent to spacer grid	110
Bottom-side rod	Mid-assembly	Mid-span	115
Average of All Strain Gages			112
Average Top-middle Rod			124

Average Top-side Rod			98
Average Bottom-side Rod			102
Average Bottom-end Span			105
Average Mid-assembly Span			107
Average Top-end Span			125
Average Top-end Span			118
Average Mid span			107
Average Adjacent to Spacer Grid			107

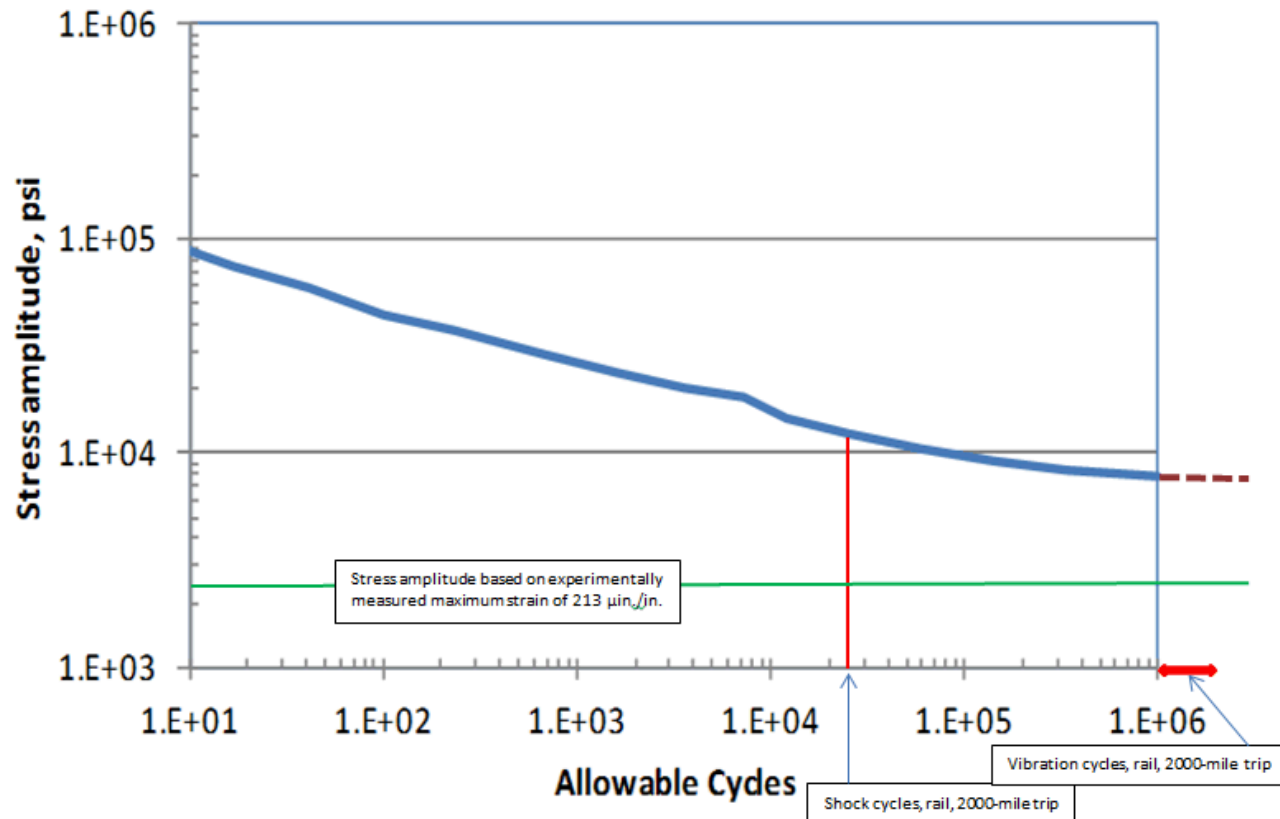
Fracture Mechanics & Fatigue Assessments Based Upon Experimentally-Measured Strains

Crack depth/Zircaloy-rod wall thickness	Applied stress intensity at crack tip, (MPa-√m)	Lower bound Zircaloy-4 fracture toughness, (MPa-√m)
0.10	0.3	20 - 30
0.25	0.4	
0.50	0.6
