Survey of Transport Airplane Structural Repairs, Alterations and Modifications (RAMs)

FAA/DOD/NASA 2009 Joint Conference on Aging Aircraft

Michel D. Bode¹, Walter M. Sippel², and John G. Bakuckas³

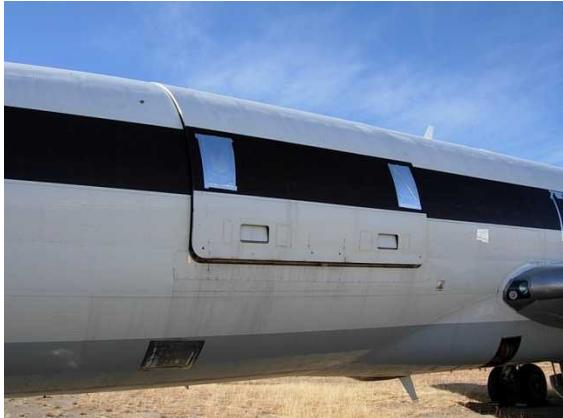
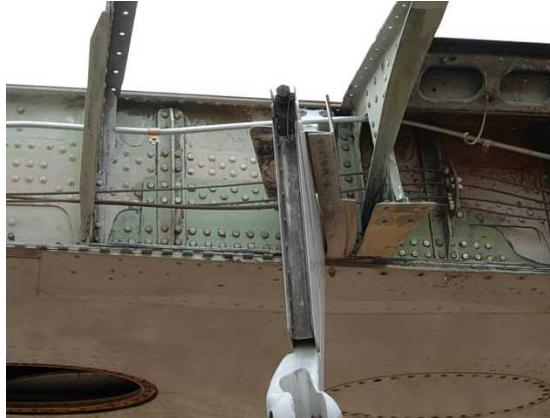
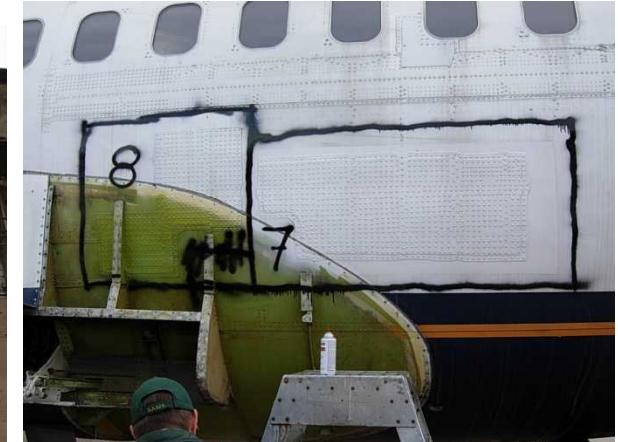
- Examples of general structures of interest :
 - Passenger to freighter cargo door conversion surround frame.
 - Wing spar repair/modifications.
 - Fuselage lap joint replacement modifications.
 - Large area repairs on fuselage, wing and empennage structures.
 - Small repair clusters on fuselage, wing and empennage structures.

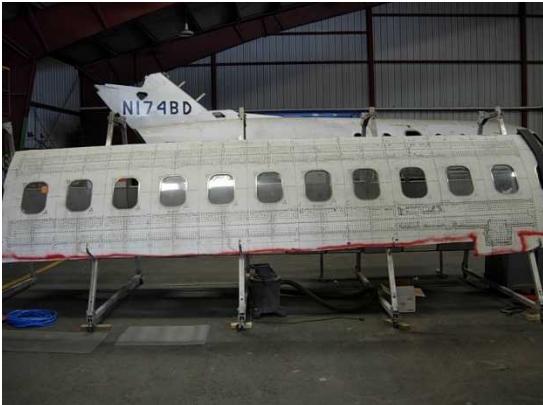
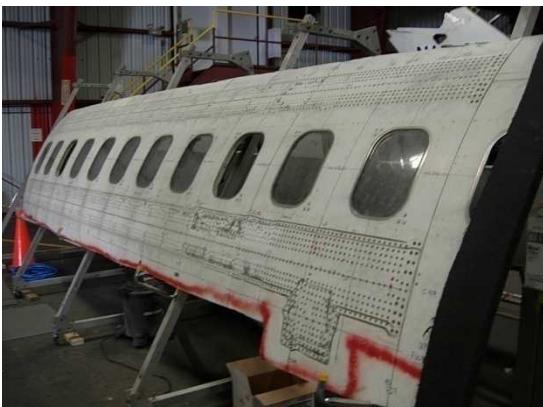
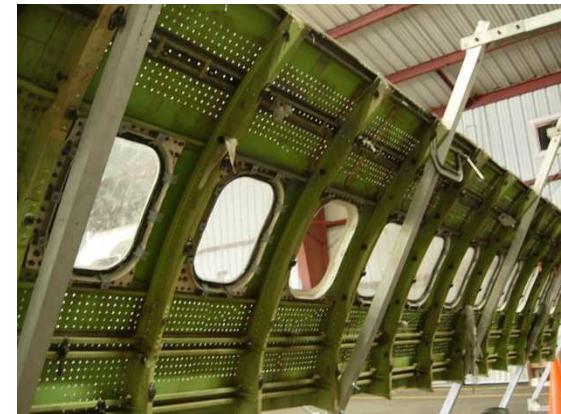
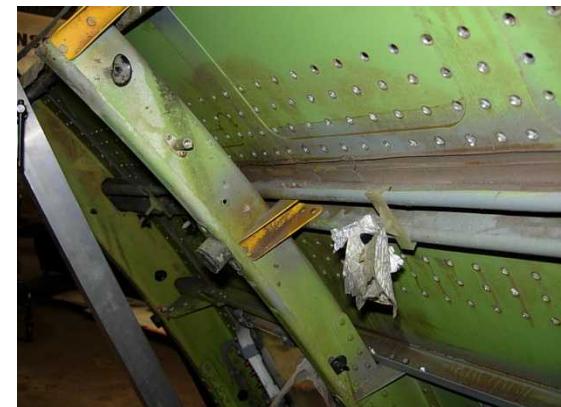
B737-200 fuselage sections – Lap Joint Modification

- Fastener removal of first large window belt lap splice alteration completed
- Bolt Hole Eddy Current NDI of fastener holes about half done. Other Eddy Current to follow
- Detailed Visual inspection of surrounding structure done
- Removal of layers and final NDI remains to be done
- Modified structure has 25452 cycles since installation and 76633 total cycles at retirement
