Tin Whisker Mitigation Methods

Defense Manufacturing Conference

Joseph Aragon, Richard Wavrik, Paul Vianco,
John Witham, Bonnie McKenzie

Sandia National Laboratories
P.O. Box 5800, MS 0352
Albuquerque, NM 87185-1076

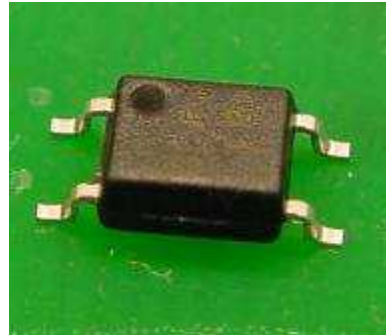
OPTO Coupler

Package size (mm)
= 4.40L x 3.75w x 2.00h
Case Type: SO4
Four leaded package
Tin Plated Matte Finish lead
Cu97%, Fe3% base material
Mitigation Methods
Solder Wicking
Fusing
Annealing

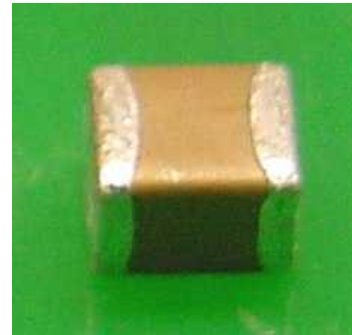
Capacitor

Package size (mm)
= 3.3L x 2.6W x 2.0H
1210 Chip Component with
5-sided Tin plated
Termination Ends with
**middle Ni barrier and an
interior Cu termination**
Mitigation Methods
Solder Wicking
AEM Plating
Conformal Coating
HSD

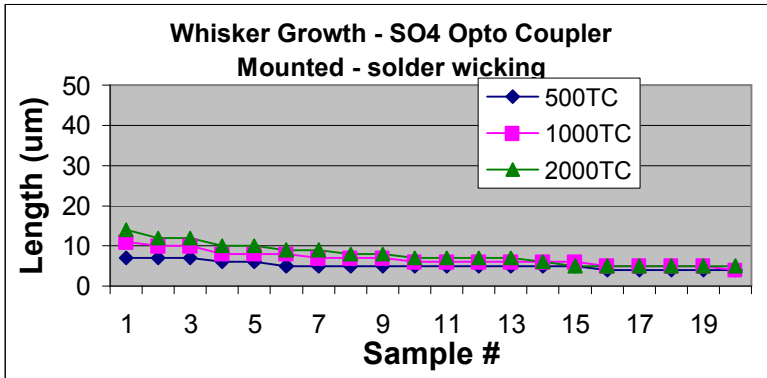
Typical whiskers found

Suggested maximum whisker length occurs at 1500TC. At 2000TC all growth is still in the “Stubble” stage. Risk level is very low

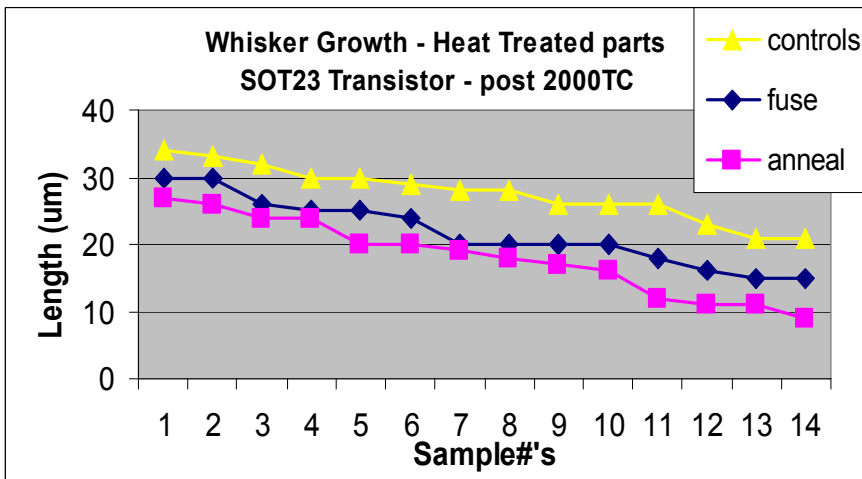
For leaded parts very minimal growth found at 500TC for the heat treated parts. Growth is more evident and defined at 1000TC.

Fusing and annealing have some effect on mitigating growth.

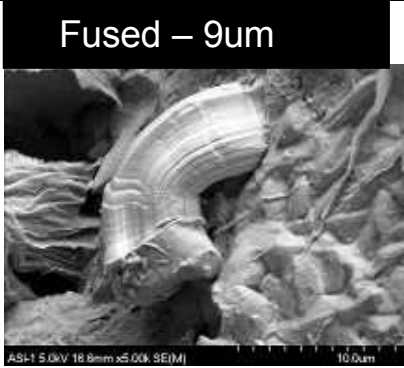
Loose Parts **HAST 1500 hours**

40 / 40 / 15um

40 / 40 / 10um

13 / 40 / 9um

Photos taken at 1500 hrs.

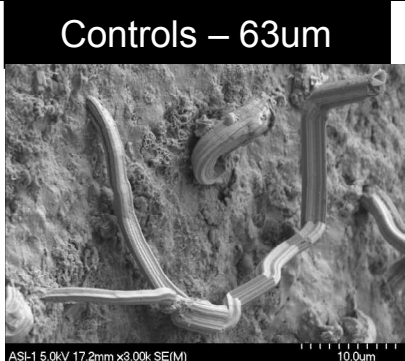
Loose Parts **HAST 1500 hours**

40 / 40 / 63um

40 / 40 / 64um

21 / 48 / 38um

Photos taken at 1500 hrs.

Solder wicking appears to be effective in eliminating tin whisker growth on the SO4 and SOT23 package under HAST conditions at 1500 hours.

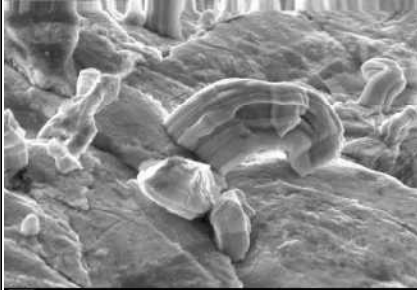
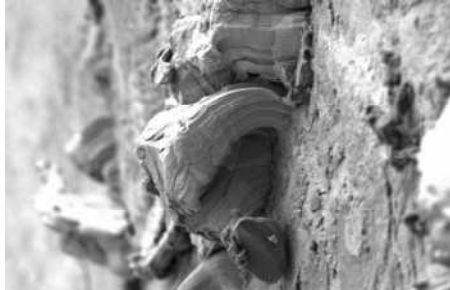
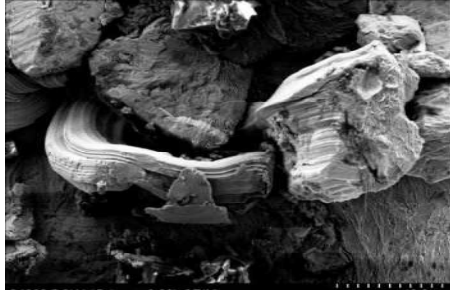
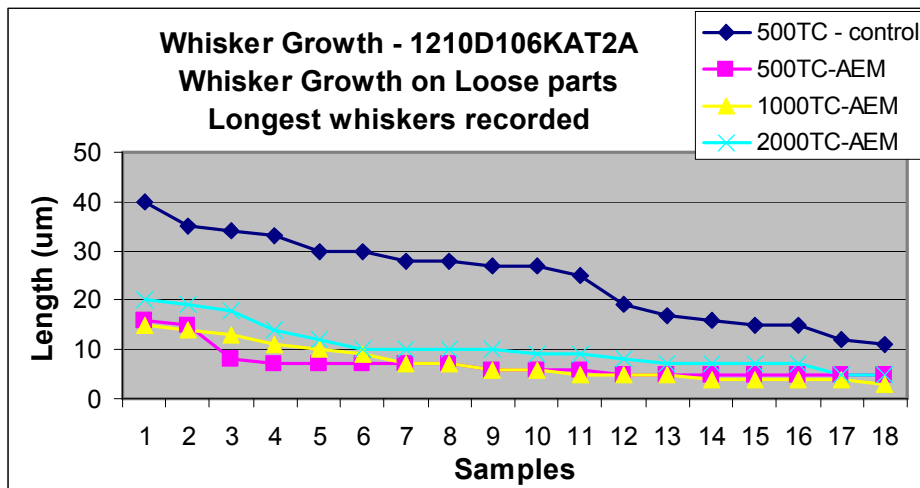
At 500TC the whisker growth is significant on the controls.

The AEM plating process stunts the growth at 500TC.

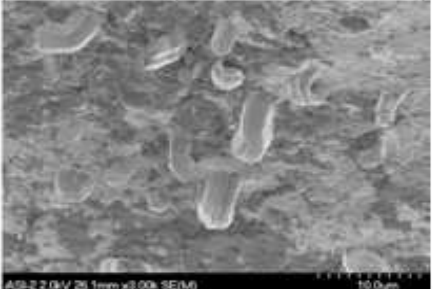
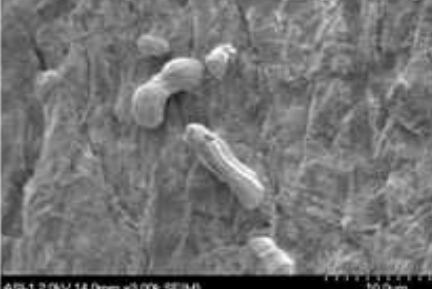
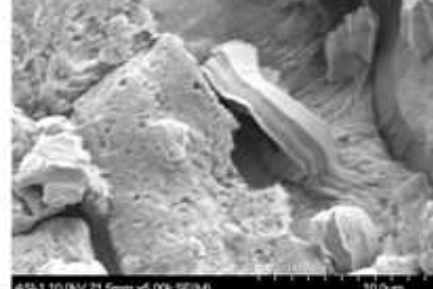
No additional growth after 500TC for AEM plated parts. All growth is still in the “Stubble” stage.

Very low risk level of whiskers growth using AEM plating
