Fracture Toughness of Hydrogen Precharged Stainless Steel GTA Welds

SAND2014-3808C

Steel&Hydrogen 2014: Second International Conference on Metals & Hydrogen
7 May, 2014

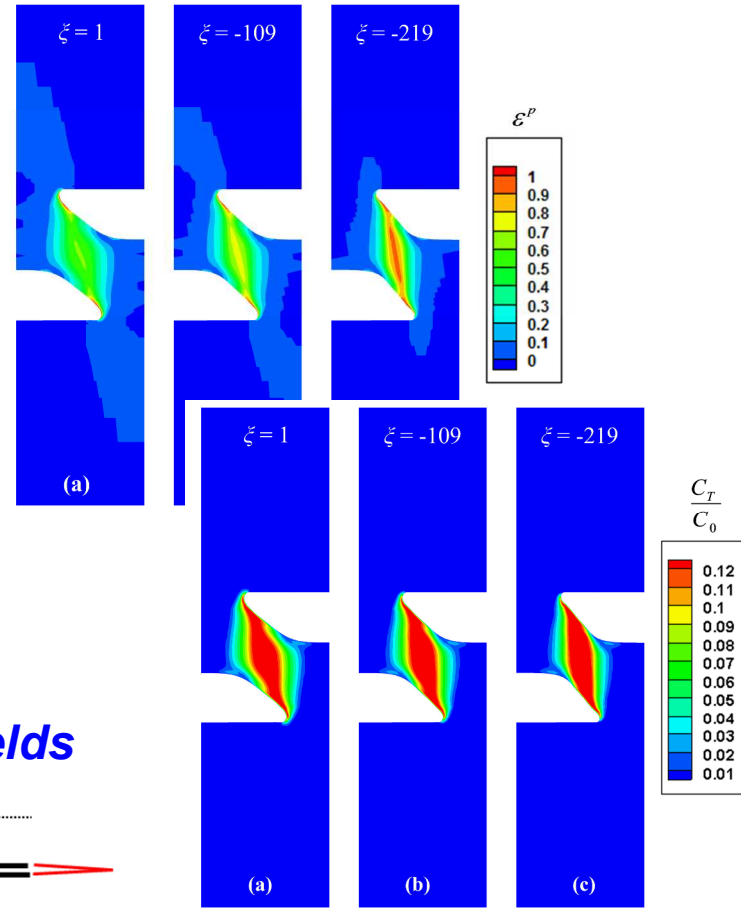
Fracture profile in H-charged 21-6-9/21-6-9 GTA weld

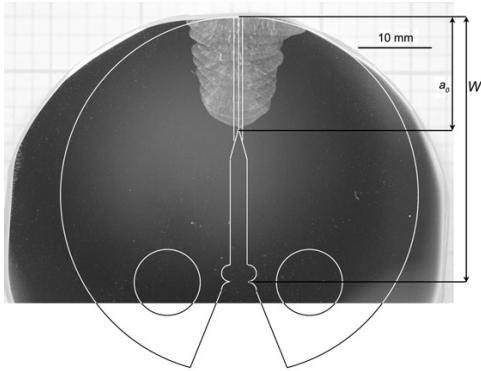
304L/308L and 21-6-9/308L GTA welds

Review: fracture toughness of H-charged GTA welds dictated by δ -ferrite content

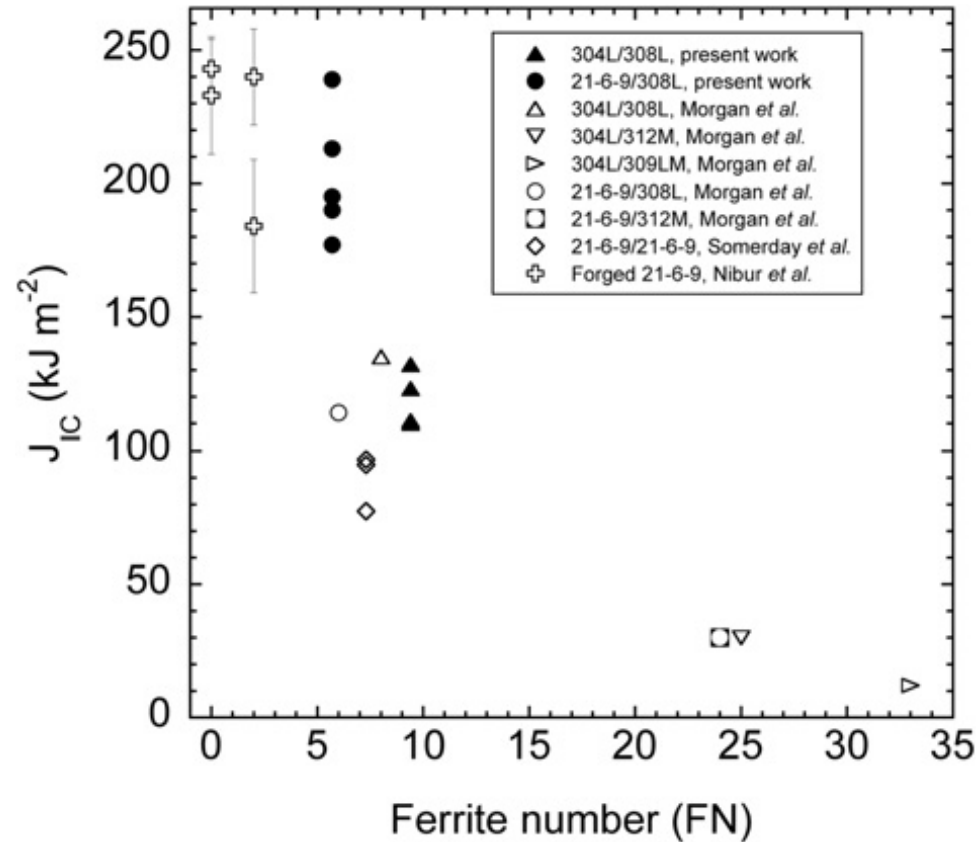
H-charged stainless steel: forged base metal and GTA welds

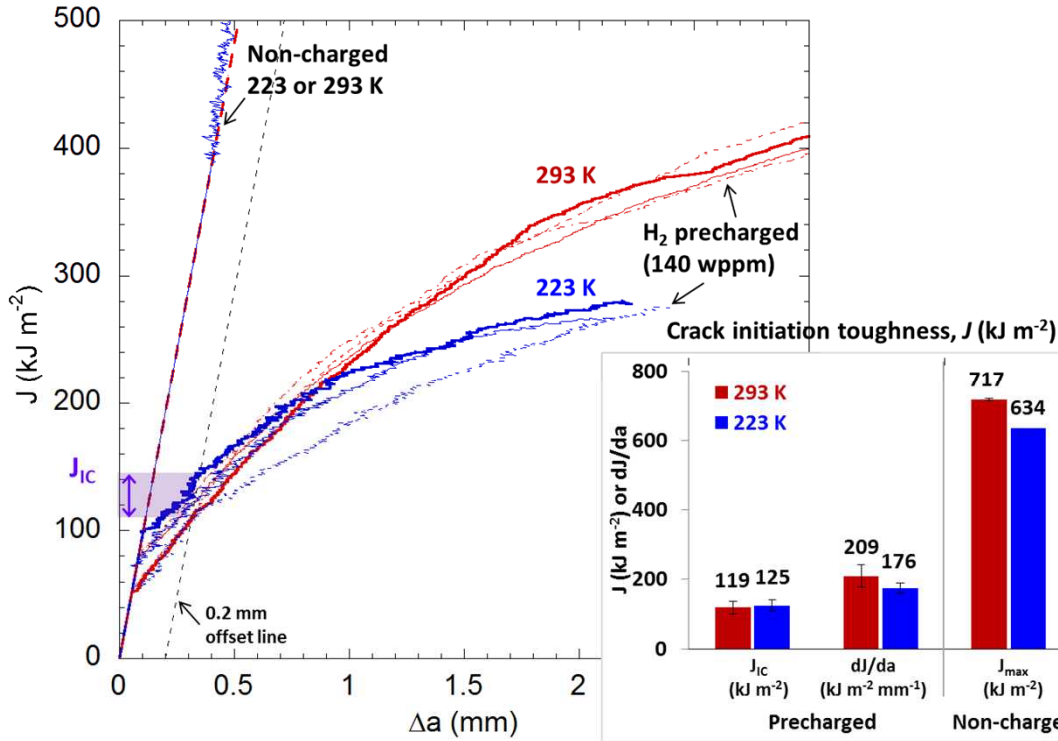
304L/308L
GTA welds

Review: low temperature does not affect fracture toughness but modifies damage mechanism

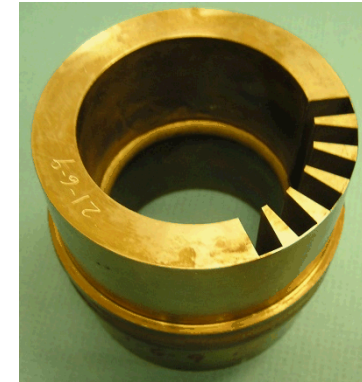
Fabrication of GTA welds from Forged Stainless Steel

- **Gas Tungsten Arc Weld (GTAW)**
 - Two weld pieces (J-groove) form 'Single-U' joint
 - 6-7 weld passes using 308L filler metal
 - Removed rectangular 3-pt bend (3PB) blanks from weld rings

Single U joint

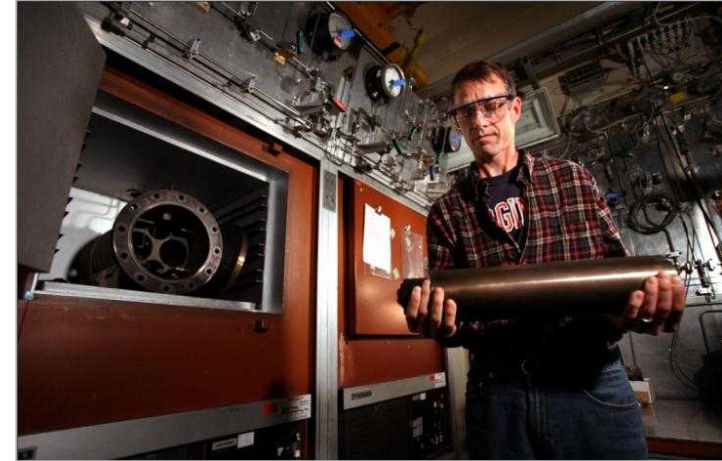
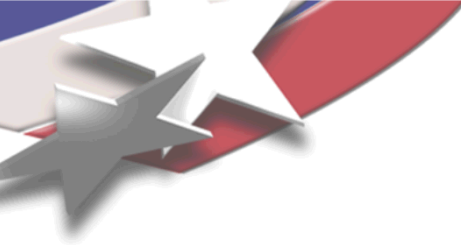
Thermal H₂ Precharging & Fracture Testing of 3-pt Bends

- Precracking was performed in air
- Gaseous Hydrogen Precharged
 - **573 K** (300 °C) in 99.9999% H₂ at **138 MPa** (20 ksi)
 - 16+ days
 - 140 wppm for 304L (0.8 at%*)
 - 220 wppm for 21-6-9 (1.3 at%*)
- Tested in air at 295 K (21 °C)
- Elastic-Plastic Fracture Mechanics
 - (J-R curves)
- Constant rising displacement
0.2 mm/min (0.6 MPa m^{1/2} s⁻¹)
- DCPD signal was used to detect crack initiation

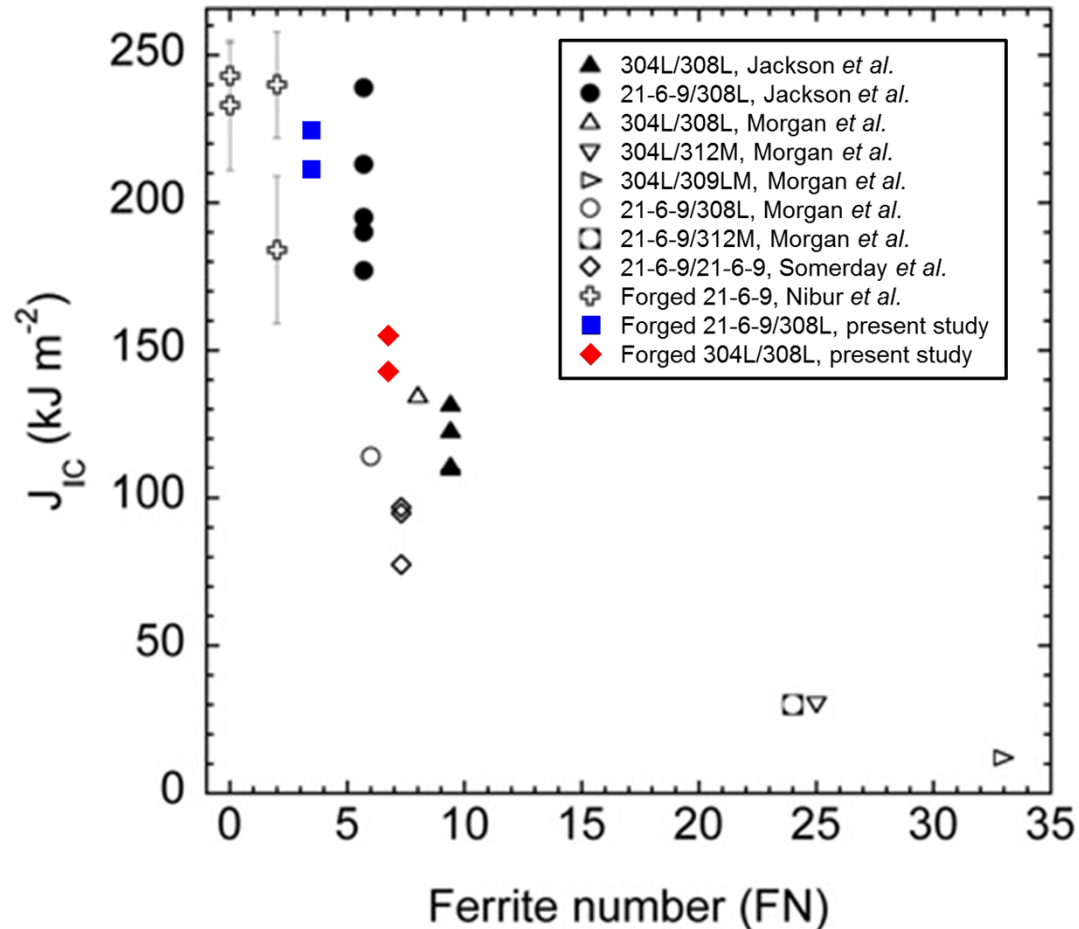
Ferrite in Fusion Zone Reduced Hydrogen Assisted Fracture Toughness

- Ferrite number (FN) in the weld was observed to have a degrading effect on fracture toughness*
- FN (21-6-9/308L) ~ 3-4%
- FN (304L/308L) ~ 7%
- Microcracks initiate at ferrite interfaces in weld
- Dendritic morphology promotes crack propagation

As δ – ferrite \uparrow ,
fracture toughness \downarrow

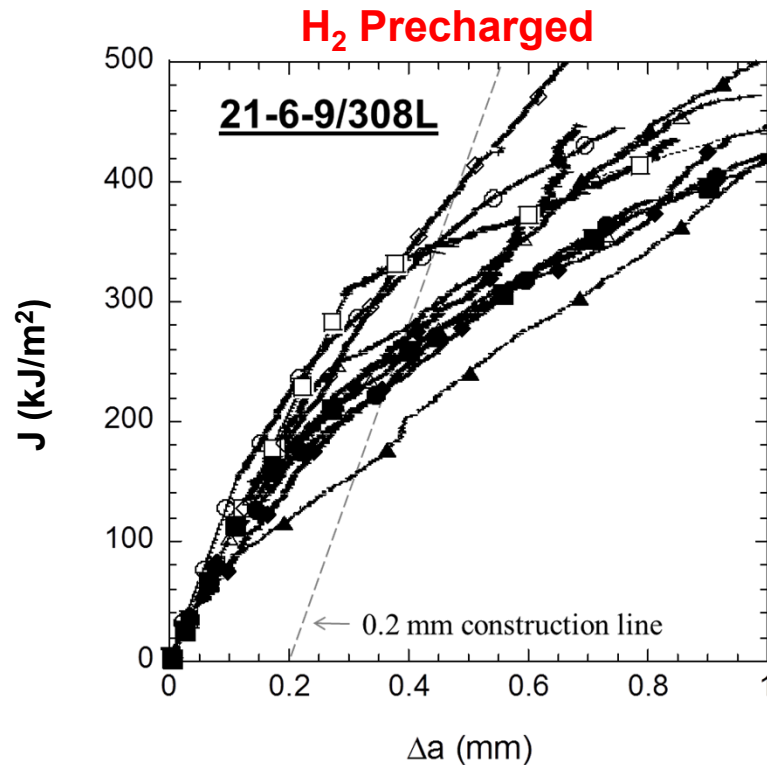
J-R Curves for HAZ Fracture Tests for 'Single U' Joint Geometry

- In general, observed higher fracture toughness in HAZ than fusion zone
- Scatter in the J-R curves

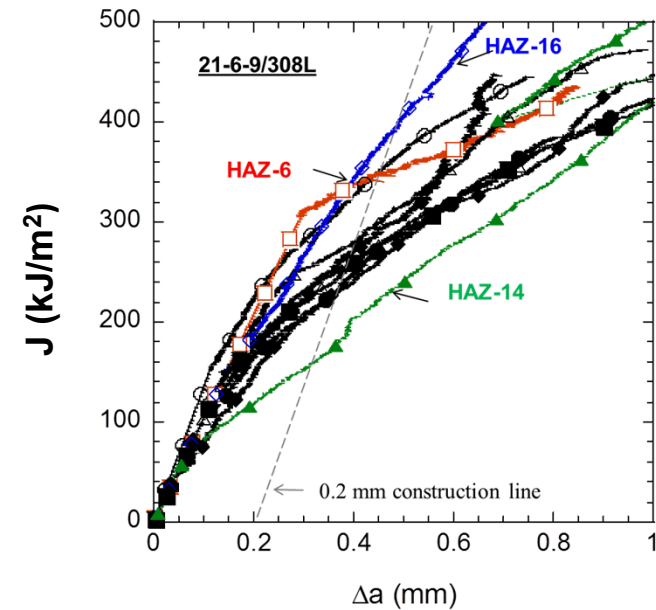
Extension of Precrack into Weld Metal in HAZ

- Profile LOM images show propagation of precrack into FZ for **HAZ-14** and **HAZ-6**
 - Significantly different J-R curves

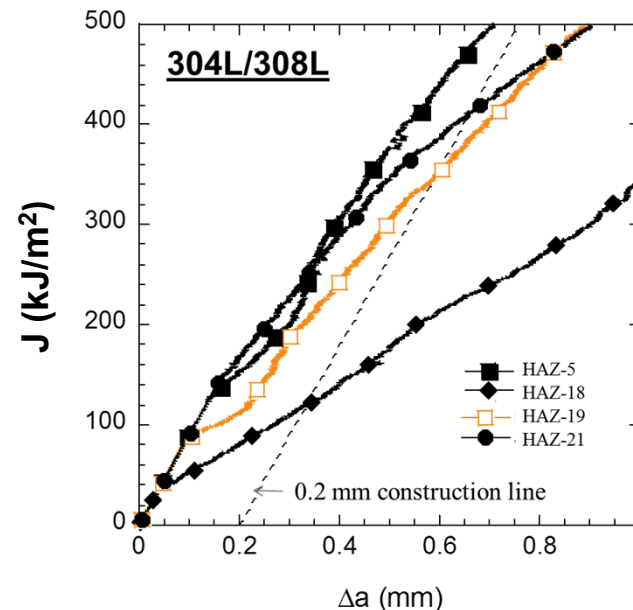
H₂-Assisted Crack Extension in HAZ

**21-6-9/308L
HAZ-16**

- Both fracture test data appear to be located in HAZ

**304L/308L
HAZ-19**

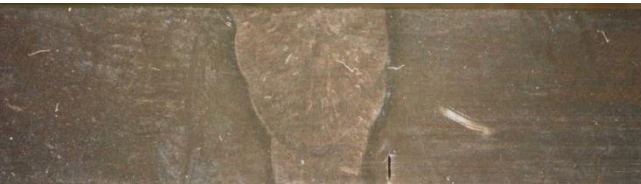
Modified 'Single J' Weld Joint Geometry of GTAW to Improve Consistency of Testing HAZ

- **Challenge:** Consistently terminating precrack in HAZ
- **Solution:** Modified weld pieces to 'single J' geometry
 - Precrack in 3PB specimen grows more parallel to fusion zone boundary and provides greater potential for terminating precrack in HAZ
