CHARACTERIZING PV ARCING CONDITIONS WITH IMPEDANCE SPECTROSCOPY AND FREQUENCY RESPONSE ANALYSIS

Jay Johnson*, Jason Strauch**, Scott Kuzmaul***, Ward Bower***, and David Schoenwald***

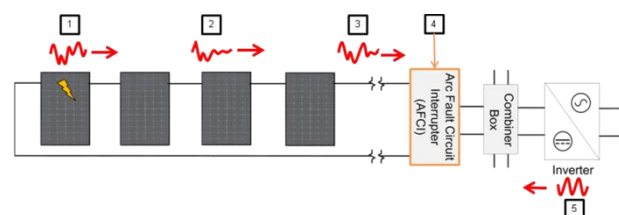
An example of the frequency content on the string during an arcing event is shown in Figure 1. The AC string spectrum is generated and manipulated by the following sources:

1. An arc fault initiates at a connection in a module and generates AC noise on the PV conductor. This signal travels down the line through the PV system. See [7] for characteristic arcing signatures.

2. As the signal passes through the modules and connectors, some of the frequency content of the electrical AC arc noise may be attenuated. Typically there is negligible attenuation in undamaged modules [11], but results from this report show different behavior.

3. Depending on the system line lengths, antenna effects and other RF phenomena, the spectral content of the arc signature will change [12].
4. The modified arcing signal reaches the arc fault detector within the arc fault circuit interrupter. Detection of either the current content (e.g., [7]) or the voltage content (e.g., [13]) can be performed by the AFCI. Depending on the cell technology, system topology, meteorological conditions, and health of the modules, the signal reaching the AFCI will be different than the original arcing signal—possibly allowing an arcing condition to go undetected.

5. In addition to these hurdles to arc detection, inverter switching generates noise in the system at a few kHz to 100 kHz [7-8, 14], which the AFCI must filter.

Figure 1: Arc fault signal propagation and detection.

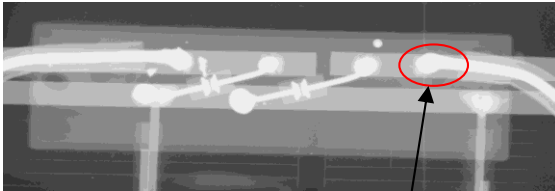
Failed Bond in Junction Box

To better ascertain the potential for missing an arc fault, Sandia National Laboratories is investigating the effect of module degradation on string arcing frequency content. In this paper, the arc fault frequency characteristics through an intermittent 80 W polycrystalline Si module are studied. The intermittent module failed from a solder joint in the junction box. An x-ray image of the junction box shows the failed bond in Figure 2.

Figure 2: X-ray of the test module junction box.

Frequency response analysis, impedance spectroscopy and infrared thermography were used to characterize an intermittent PV module. The module electrical response changed based on the connection quality of a failed solder bond in the junction box. The connection quality could be adjusted by orienting the wire in different directions. Four orientations of the wire were tested and produced very different frequency responses and impedance spectroscopy results.

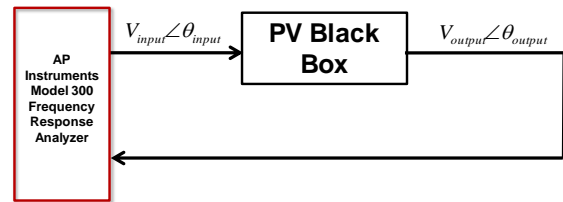
In order to determine which arcing frequencies are attenuated in a damaged module, an AP Instruments Model 300 Frequency Response Analyzer (FRA) was used to measure the AC response of the intermittent module under no irradiance. The input signal was a 250 mV AC sweep from 1 Hz to 10 MHz. The FRA recorded the magnitude of the input and output sinusoid, illustrated in Figure 3, and the attenuation of the AC signal was determined by the magnitude of V_{output}/V_{input} . Figure 4 shows the laboratory configuration for the tests.

Figure 3: Basic concept of a frequency response analyzer.

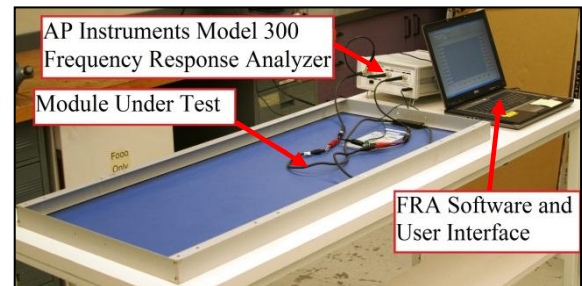
Figure 4: Experimental setup.

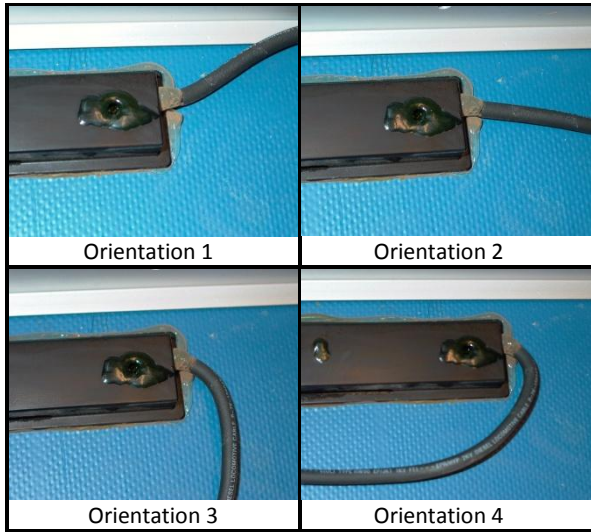
The intermittent module was scanned three times with the loose connection in four different orientations, shown in Figure 5. As shown in Figure 6, orientation 2 (scans 2.1-2.3) made a good connection within the junction box because the frequency response closely matched those of undamaged modules of the same technology [11]. The noisy behavior above 1 MHz is from crosstalk in the cables, RF effects, and noisy connections to the instrumentation [12]. Scans for the 1st and 3rd orientations show the module behaving as a low-pass filter, whereas orientation 4 strongly attenuates low frequencies. Scans 4.1-4.3 are coupled with 60 Hz noise from the instrument or ambient sources, so the change in attenuation is most likely artificial. Arc detection studies have indicated arc faults produce distinct noise signatures between 100 Hz to 100 kHz [7]. An arc detector tuned to those frequencies would miss a portion of the arc signature if the junction box wire was in orientation 1, 3, or 4.

Figure 5: The four orientations of the junction box wire.

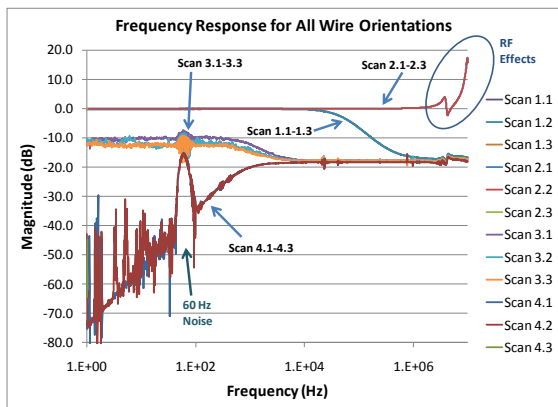
Figure 6: Frequency response of a single intermittent module configured with a loose junction box wire held in four different orientations.

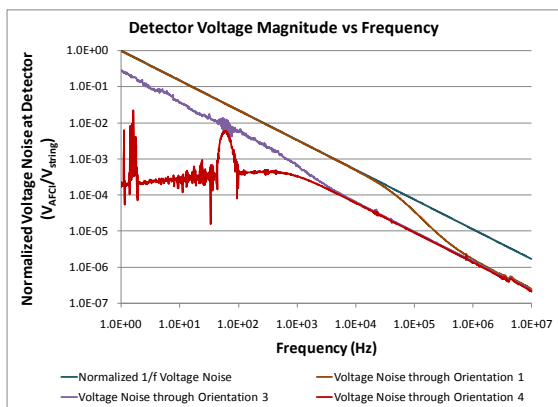
The frequency content of the arc reaching the detector is affected by the intermittent module. As cabling between modules swing and change orientation due to wind and weather, the arcing voltage spectrum would appear different to the AFCI. To quantify the difference, a theoretical $1/f$ voltage signature characteristic of arcing [20] is compared to the voltage reaching the arc detector when the intermittent module is in the string. As shown in Figure 7, the voltage noise reaching the arc detector with undamaged modules is

stronger than when the damaged module is in the string and the wire is in orientation 1, 3 or 4.

Figure 7: The AC arcing noise, intermittent module attenuation characteristics, and resulting detector signal.

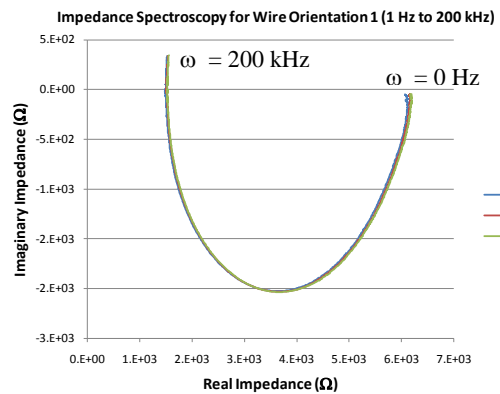
In order to better quantify electrical changes in the module circuitry due to wire manipulation, three impedance spectroscopy scans were performed for the four different wire orientations immediately after taking the frequency response data. The results are plotted from 1 Hz to 200 kHz to avoid the RF effects at high frequencies in Figures 8-11. Orientation 2 was consistent with plots of undamaged modules [11], in which the reactance and resistance asymptotically approach zero, shown in Figure 12. Impedance spectroscopy of wire orientation 1 revealed a $1.5 \text{ k}\Omega$ shift in the resistance when compared to orientation 2. This is the result of a series resistance increase in the module [11, 21], which indicates the electrical connectivity is reduced due to contact resistance in orientation 2. Orientations 3 and 4 exhibit a significant amount of noise and orders of magnitude more resistance and reactance. Orientation 3 has high resistances at low frequencies but returns to the standard semicircular path at higher frequencies. Orientation 4 contains an especially large amount of noise and is likely not accurately calculated by the FRA. This is because it contains negative resistances which are impossible with passive circuitry.

Figure 8: Impedance spectroscopy results for wire orientation 1.

Based on the frequency responses for the different orientations, the impedance spectroscopy trends are not unexpected. Orientation 2 was not attenuated and produced a “healthy” PV module impedance response; but when the attenuation increased in orientations 1, 3, and 4, the impedance was larger and more chaotic. For this reason, it is believed that either the frequency response or the impedance spectroscopy of modules, strings, or arrays could be employed to monitor the health of the system. If the frequency response deviated from the unattenuated, “healthy” response or the impedance spectroscopy results were uncharacteristic of normal PV systems, this would warn of an impending maintenance problem or potential arcing conditions.

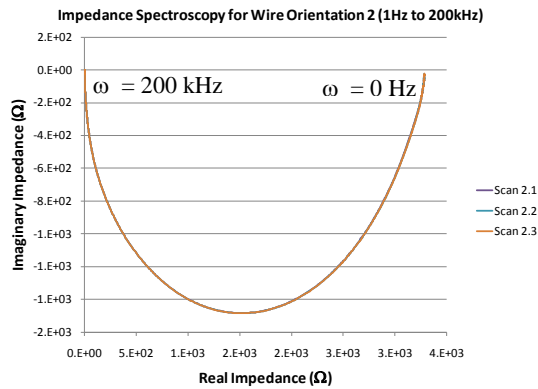
Figure 9: Impedance spectroscopy results for wire orientation 2.

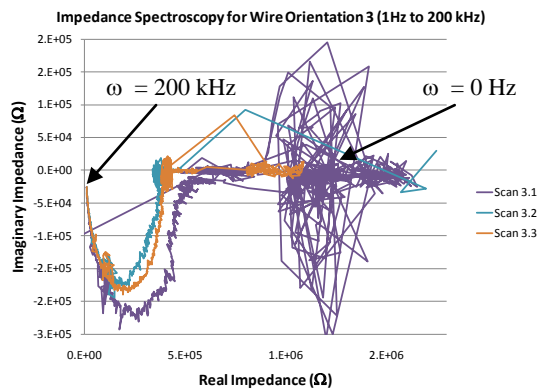
Figure 10: Impedance spectroscopy results for wire orientation 3.

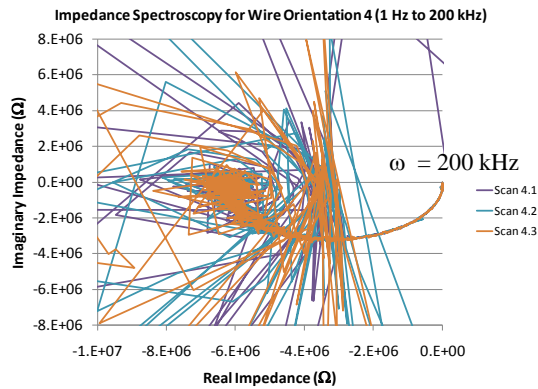
Figure 11: Impedance spectroscopy results for wire orientation 4.

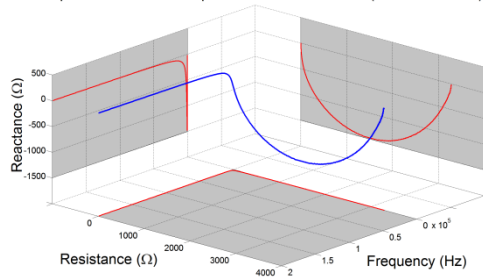
3D Representation of the Impedance for Orientation 2 (1 Hz to 200 kHz)

Figure 12: Three-dimensional depiction of the impedance spectroscopy results vs input frequency curve (blue) and projections of the curve on 2D planes (red).

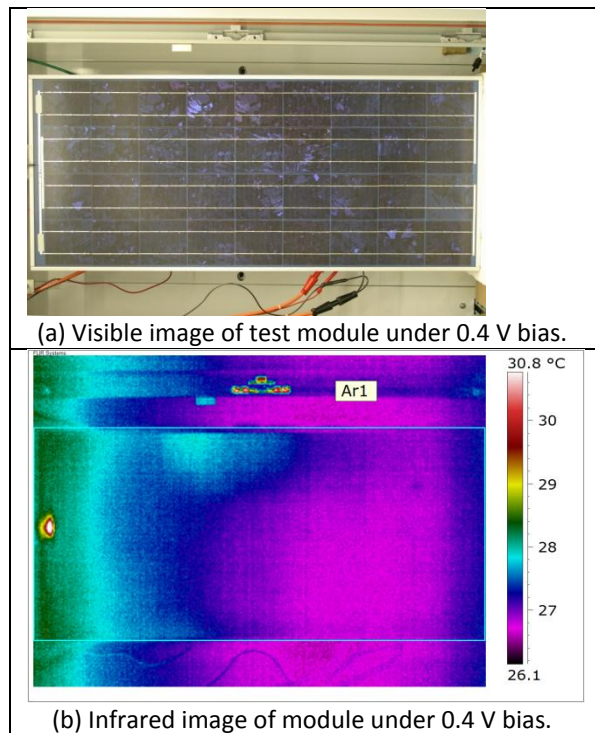
To determine if the junction box was the cause of the increased series resistance in orientations 1, 3, and 4, infrared (IR) images were taken of the module. The large series resistance in wire orientation 1, and possibly in orientations 3 and 4, will produce more Joule heating from i^2R losses. Figure 13 shows visible and IR images of the intermittent module taken from the same location. The IR image was taken after 20 seconds of 0.4 amps forward biasing and shows localized heating in the junction box. Although the wire orientation for this test was unknown, the IR results show elevated temperatures in the junction box from high resistance Joule heating. This heating is the result of reduced electrical conductivity from corrosion or poor conductor connections and can lead to arc faults if left unattended.

Figure 13: (a) Image of the front of the PV module after 20 seconds of 0.4 amps forward biasing in a Dark IV chamber, and (b) corresponding FLIR Thermacam P60 infrared image taken with wavelengths of 7.5 to 13 μm . The hot spot (center left) from Joule heating illustrates the high resistance in the intermittent module in the junction box.

mask the arc fault signature from AFCIs. Furthermore, infrared images identified a resistance increase in the intermittent module junction box which is characteristic of degradation and conditions leading to arc faults. Therefore, it is particularly concerning that conditions which cause arcs—i.e., discontinuities in the electrical conductors—are also responsible for AC attenuation on the line.
