Ground-Penetrating Radar

Jeremy Michaels, Operations Lead
Infrastructure Operations

Achieving Excellence in Facilities Management
and Sustainability Workshop

Albuquerque, New Mexico
August 30, 2011

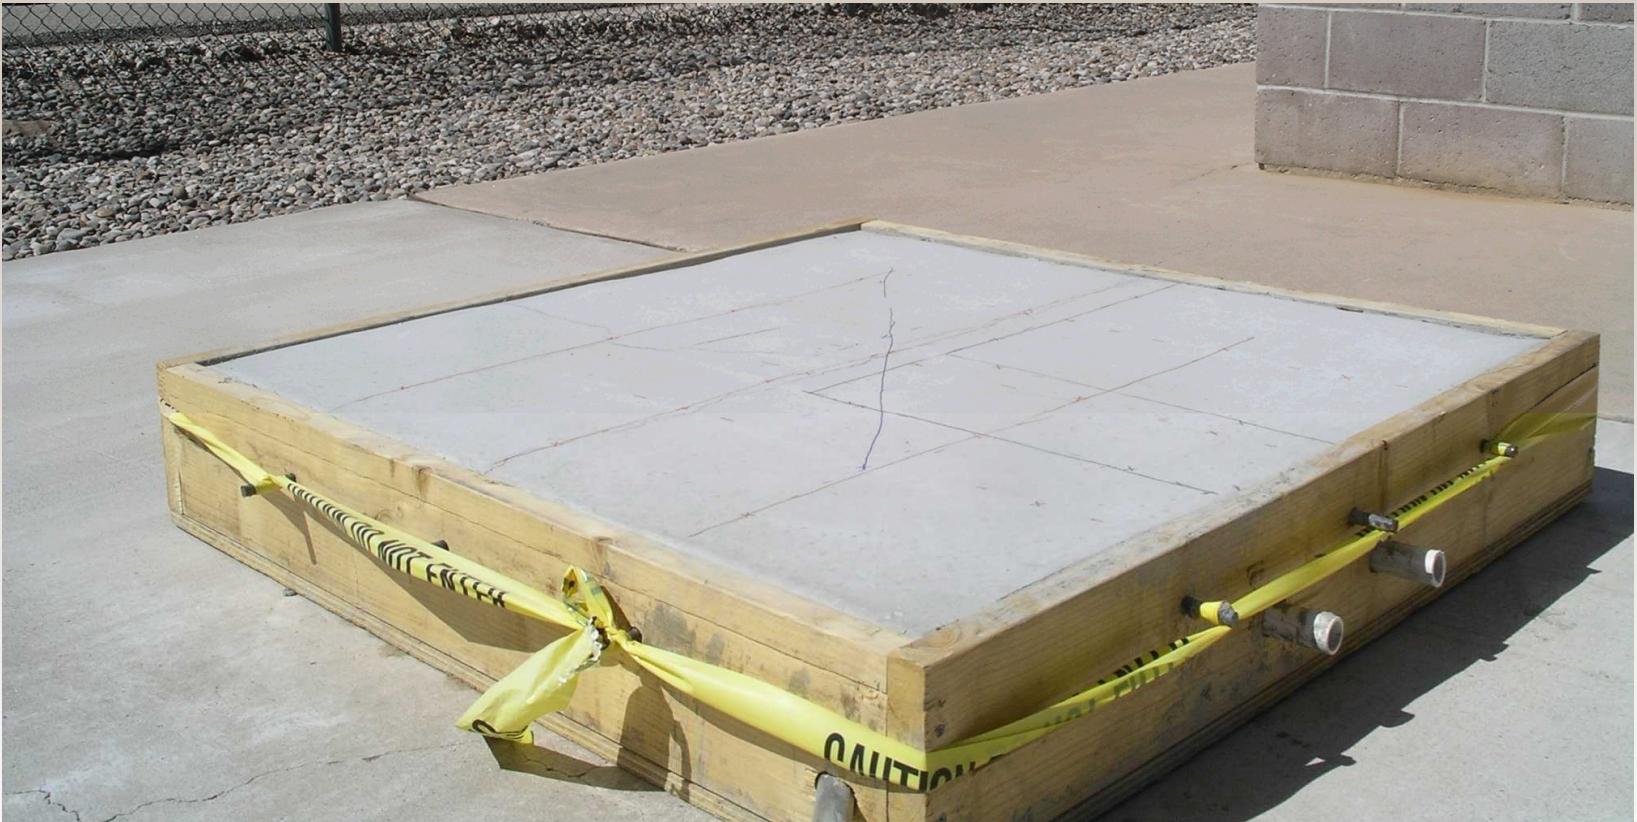
Test Block

Test block built for testing and calibrating equipment.

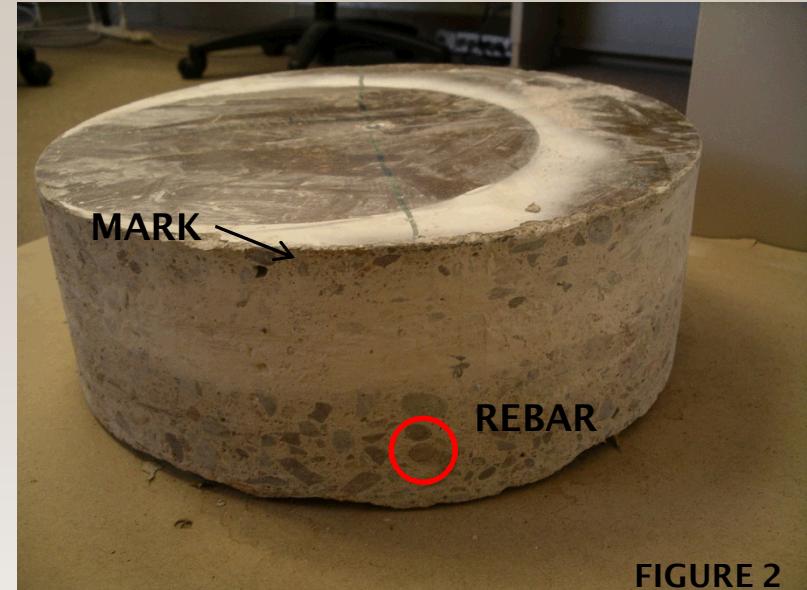
Scan Example 1

- Scope of work was to core drill 12" hole in slab.
- Area was also scanned by electrical spotter using a rigid spotting tool; no electrical utilities were detected.
- All anomalies located during the scan were marked with a green marker.
- Core shown in Figure 2 was kept to verify marked anomalies.

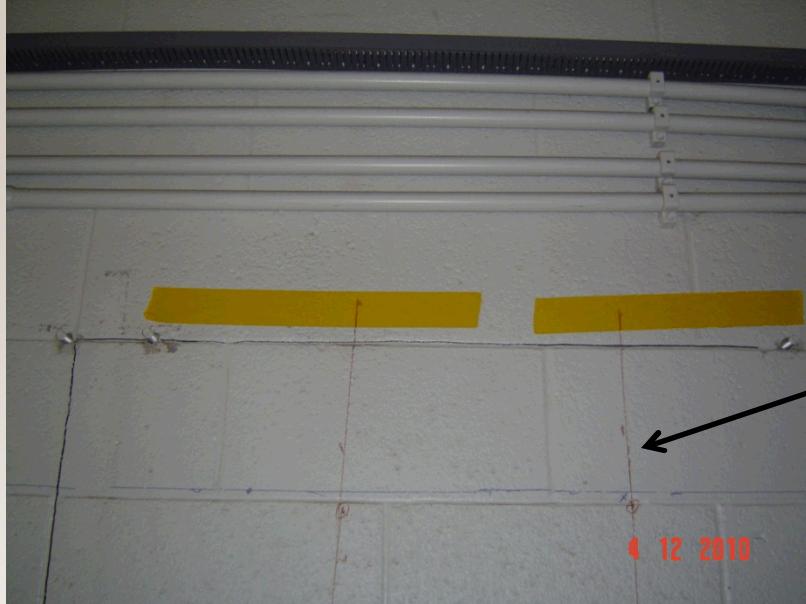
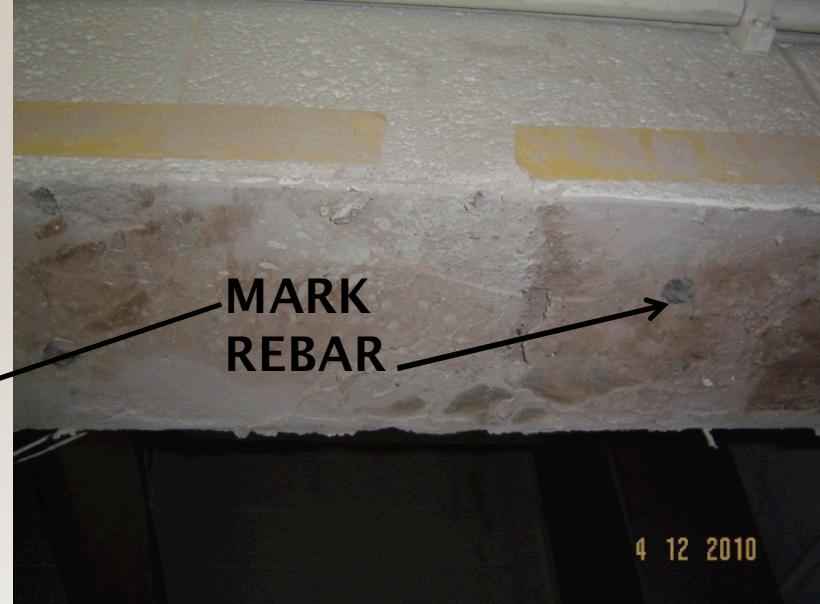
Scan Example 2

- Scope of work was to break down a section of the CMU wall to install a door.
- Area was also scanned by electrical spotter using a rigid spotting tool; no electrical utilities were detected.
- All anomalies located during the scan were marked with blue and red markers.
 - Different colored markings help the technician distinguish direction and depth of different objects.

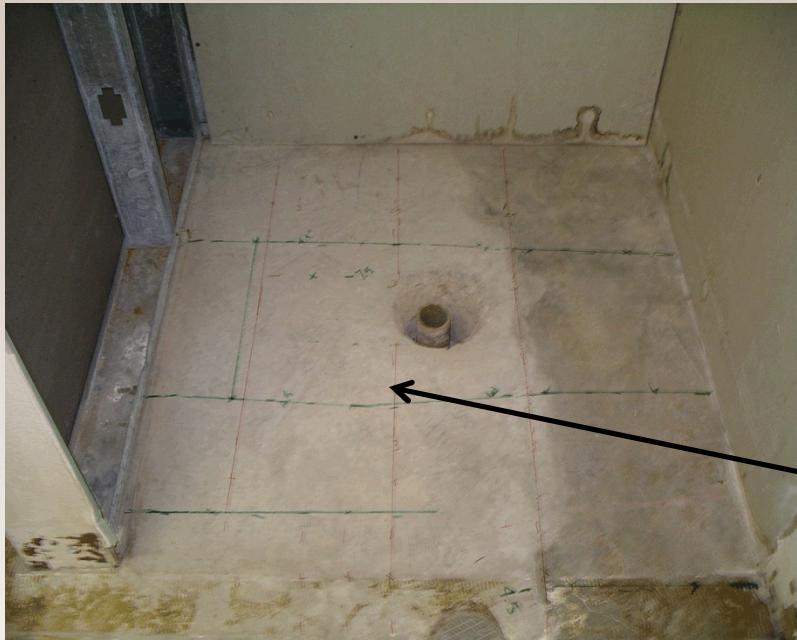
Scan Example 4

- Scope of work was to saw cut floor to expose shower drain.
- Area was also scanned by an electrical spotter using a rigid spotting tool; no electrical utilities were detected.
- Scan accurately located all anomalies.

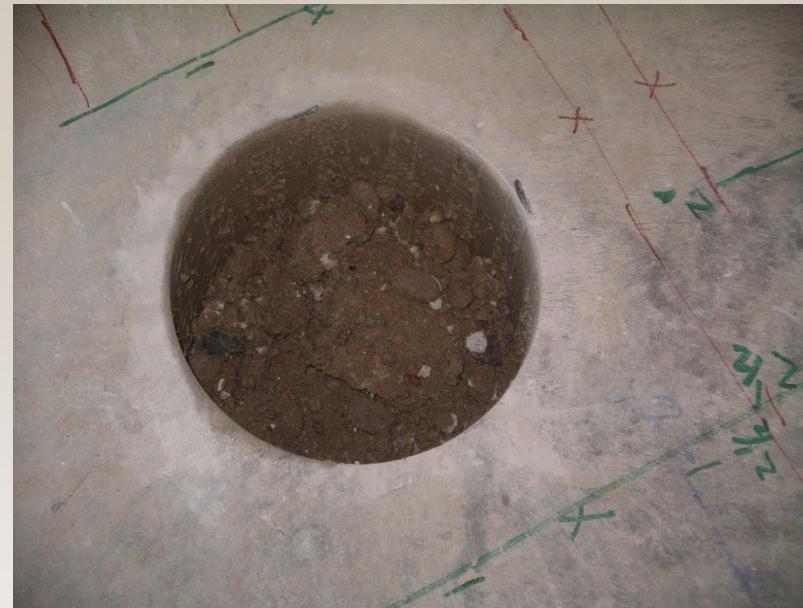
Scan Example 5

- Scope of work was to core drill 6" hole through the slab.
- Area was also scanned by an electrical spotter using a rigid spotting tool; no electrical utilities were detected.
- Anomalies located during the scan were marked with green, red, and blue markers.
- Core drill location was determined after the scan to avoid marked anomalies and was performed with no electrical outage.

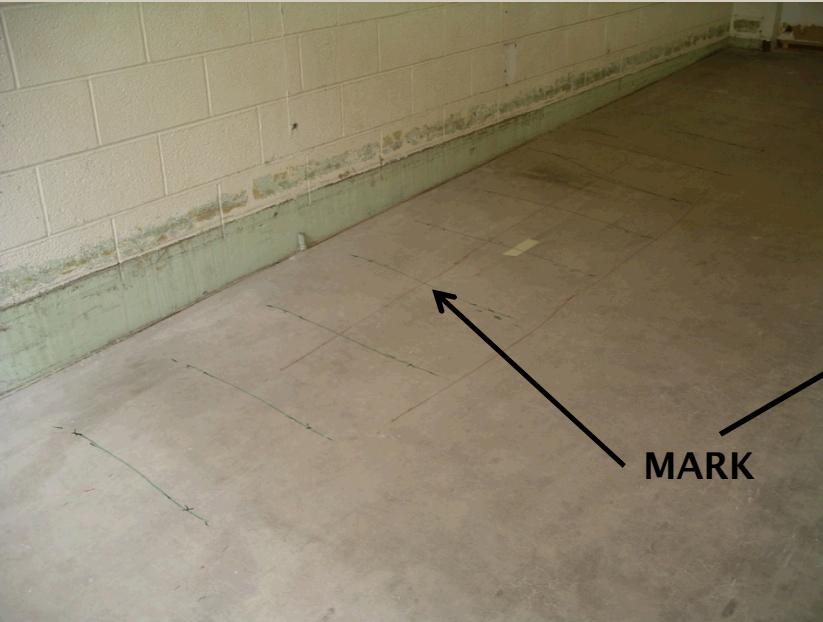
Scan Example 6

- Scope of work was to remove and replace the entire slab in the garage.
- Area was also scanned by an electrical spotter using a rigid spotting tool; no electrical utilities were detected.
- Anomalies located during the scan were marked with green and red markers.

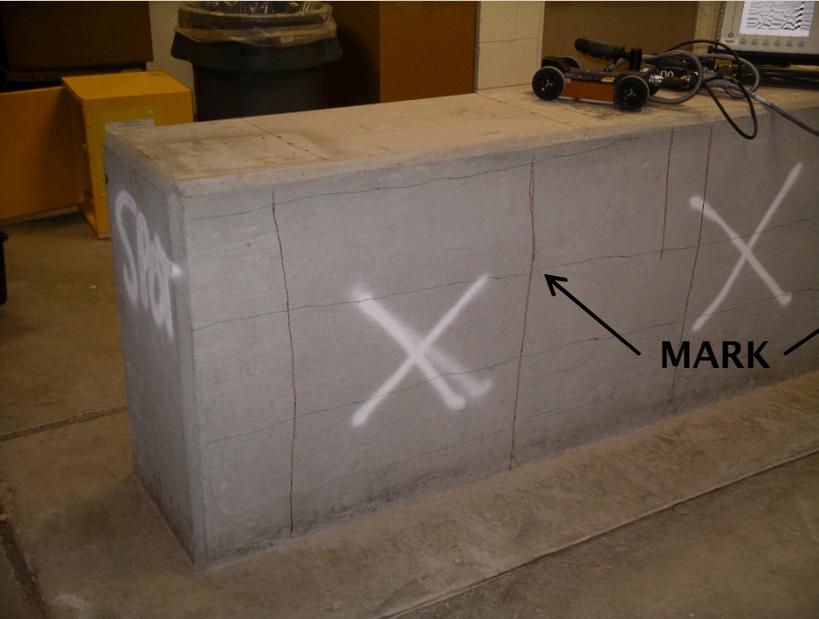
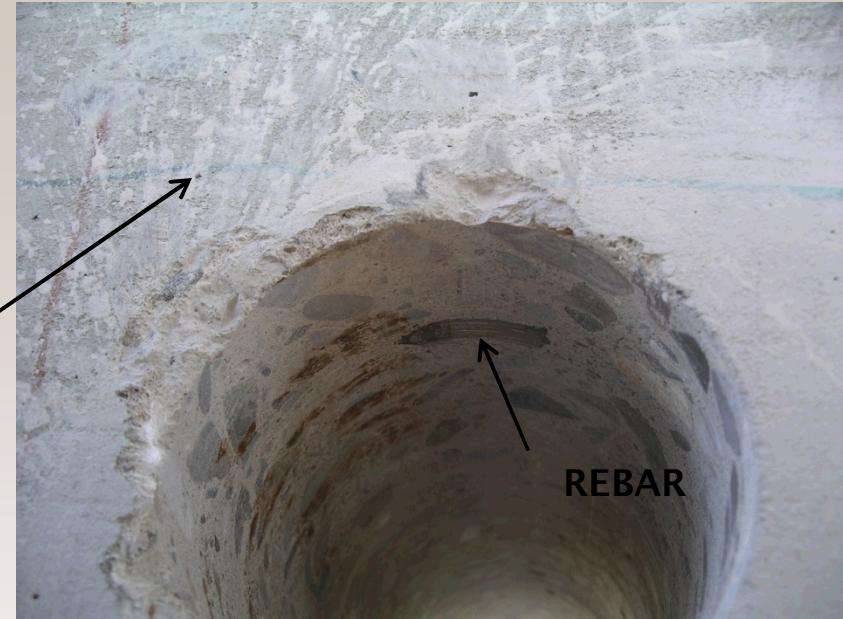
Scan Example 7

- Scope of work was to saw cut and remove concrete bench (13'x18"x33").
- Area was also scanned by an electrical spotter using a rigid spotting tool; no electrical utilities were detected.
- Anomalies located during the scan were marked with green and red markers.

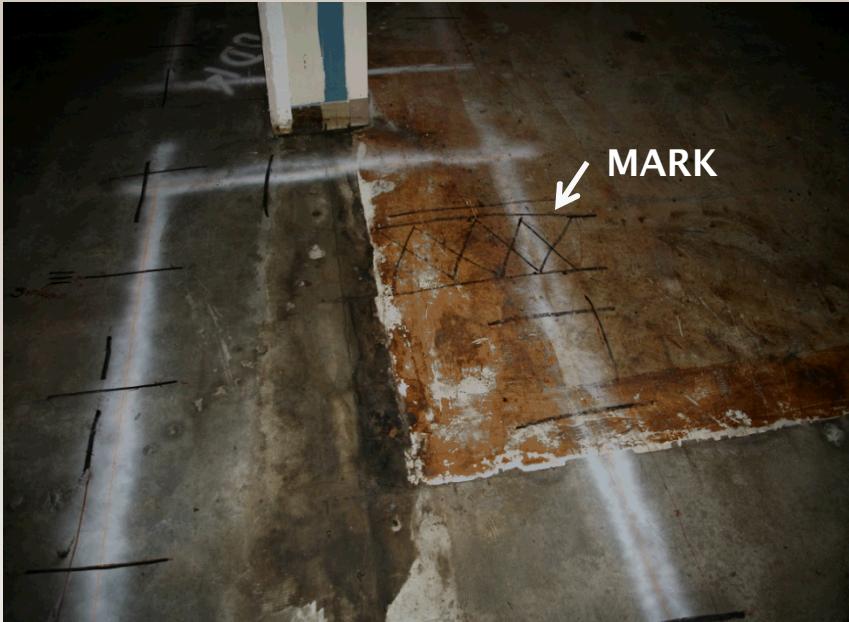
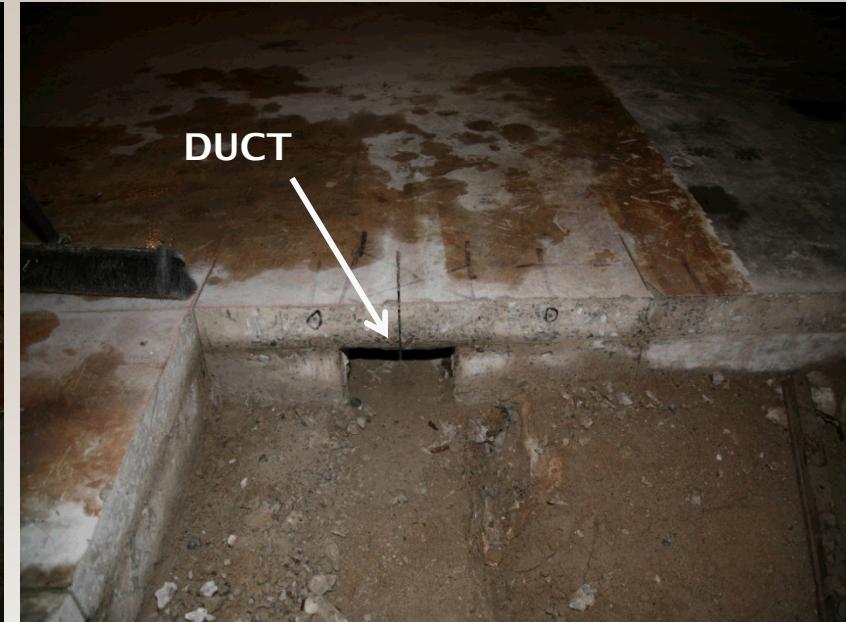
Scan Example 8

- Scope of work was to saw cut and remove concrete slab.
- Area was also scanned by an electrical spotter using a rigid spotting tool; no electrical utilities were detected.
- Anomalies located during the scan were marked with red and black markers.
- An object that resembled a duct was marked near the column.

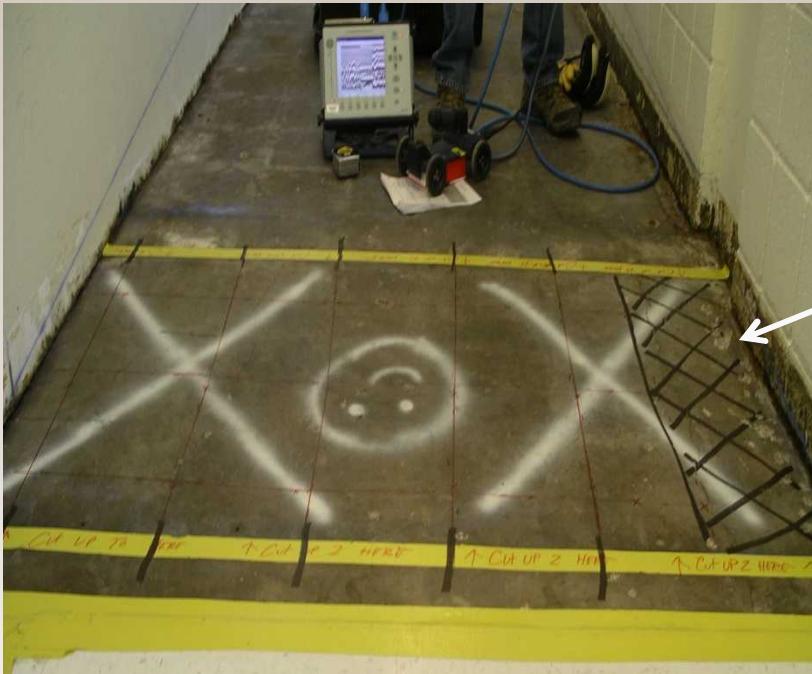
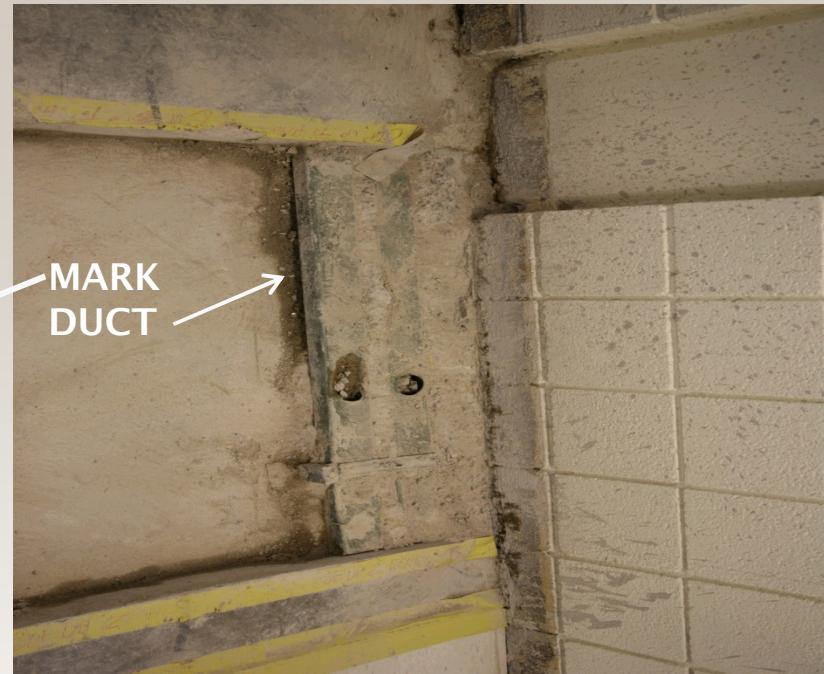
Scan Example 9

- Scope of work was to saw cut and remove concrete slab (6'x3'x10").
- Area was also scanned by an electrical spotter using a rigid spotting tool; no electrical utilities were detected.
- Anomalies located during the scan were marked with red and black markers.
- The other objects marked were not exposed because they were deeper than the 4" cut and removed.

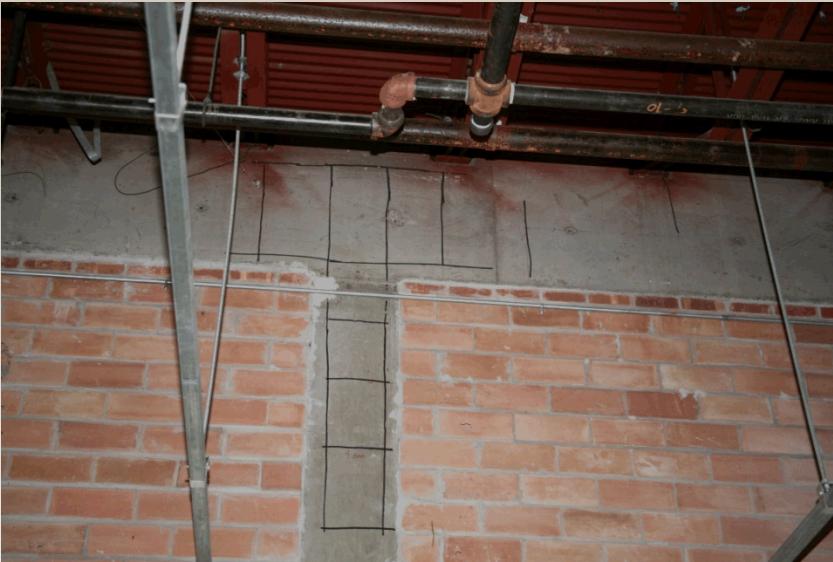
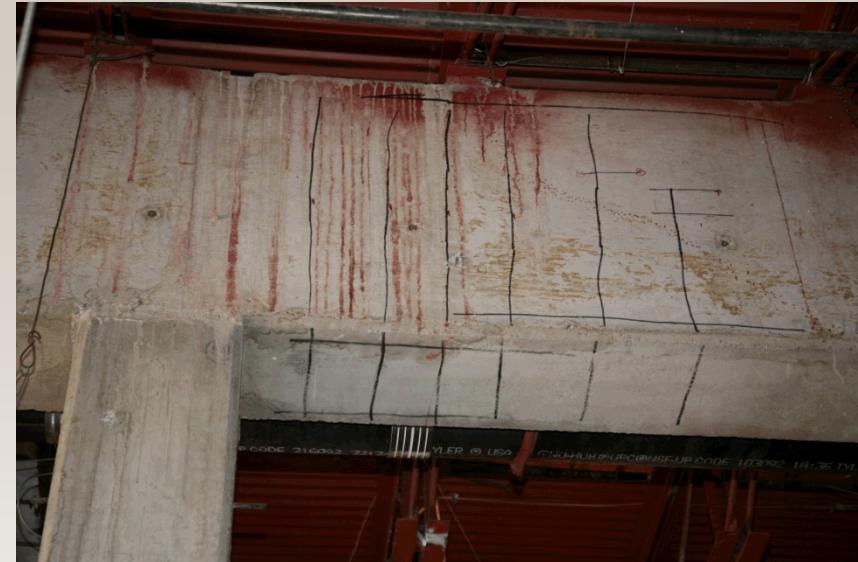
Scan Example 10

- These photos illustrate two different beams scanned for a job.
- Scope of work was to roto-hammer anchors onto structural members without hitting rebar.
- Area was also scanned by an electrical spotter using a rigid spotting tool; no electrical utilities were detected.
- Anomalies located during the scan were marked with a black marker.

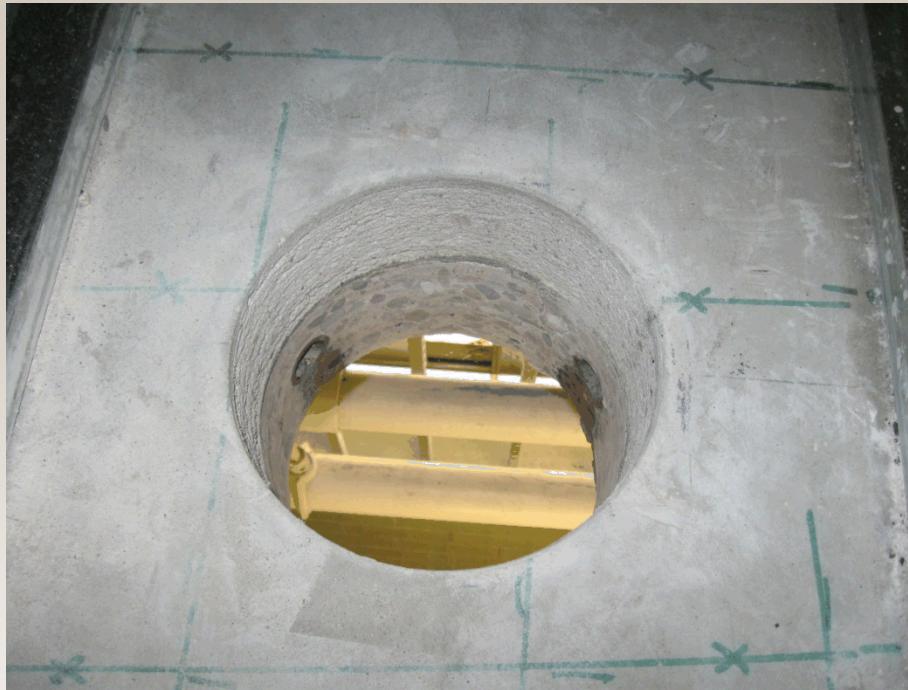
Scan Example 11

- Scope of work was to core drill through slab for waste lines and floor drains in restrooms, approximately 14 holes of various sizes.
- Area was also scanned by an electrical spotter using a rigid spotting tool; no electrical utilities were detected.
- Anomalies located during the scan were marked with a green marker.
- Contractor could not relocate the core drill above for the sanitary line, so continued with the task and drilled through marks, which turned out to be a conduit.

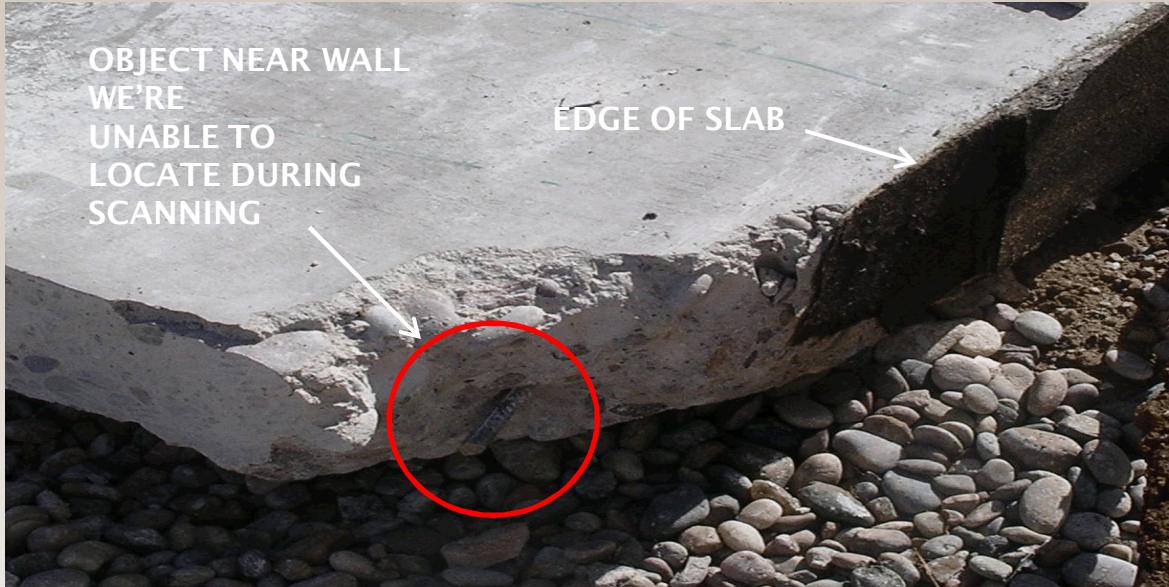
Errors and Lessons Learned

- Rebar along the wall was missed and not marked during the scan.
- The optical hand cart prevents scanning any areas smaller than 2'x2' and up to 6" away from any wall or corner because of the location of the sensor.
- A 2000 MHz palm antenna available from Geophysical Survey Systems, Inc. (GSSI) offers users the ability to reach tightly spaced areas that are inaccessible to the 1600. The palm antenna costs around \$6,500 and is compatible with our equipment.

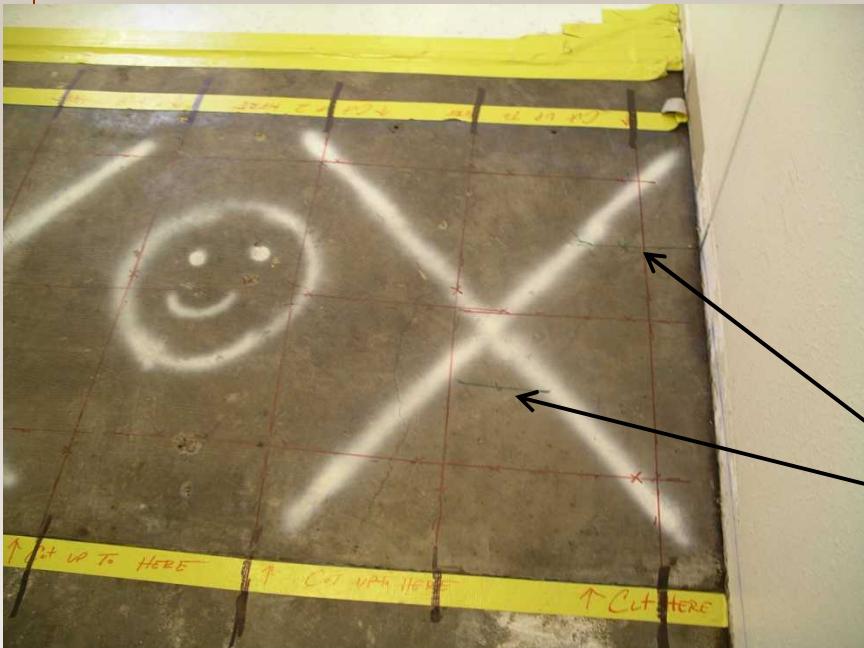
Errors and Lessons Learned

The conduit on the right was identified as an anomaly during the scan and marked in green, but the correct direction the object was traveling could not be identified. Experience should improve the ability to interpret these types of objects, and the palm antenna will help with these types of applications.

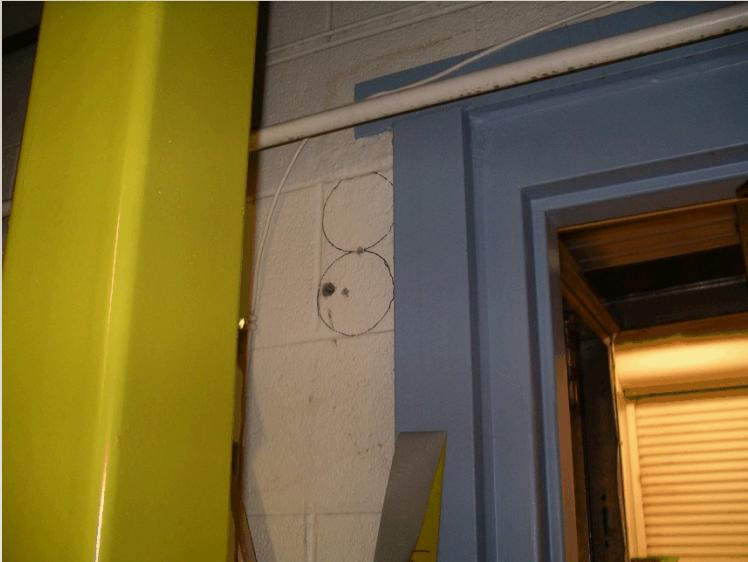
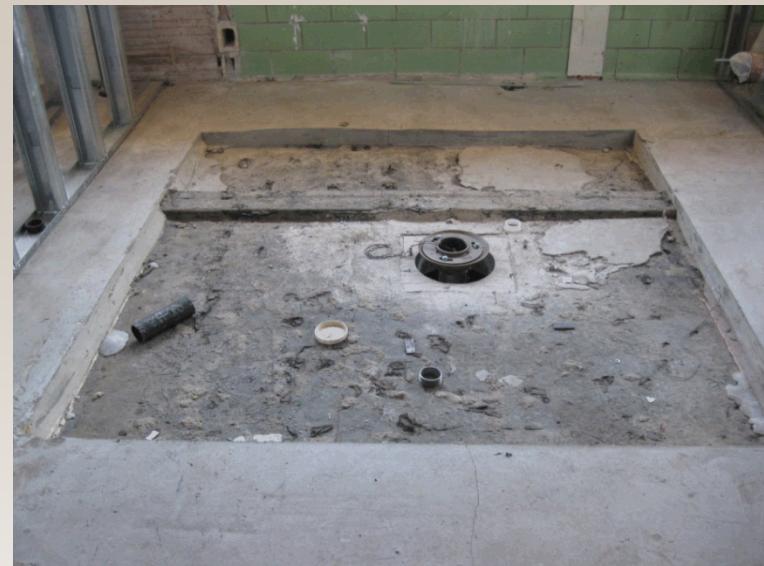
Errors and Lessons Learned

- The photos above show areas that cannot be scanned due to the existing conditions.
- The area on the left is too small an area for the equipment currently used.
- The area on the right has a rough surface that affects the rolling of the antenna wheels on the cart. Smooth wheel movement is critical to accurately determine the location of the objects in the concrete by calculating distance and time.
