## Metallurgy and thermal stability of Bi-Te thermoelectric modules

Nancy Y.C. Yang, Alfredo M. Morales, Peter van Blarigan, Bruce P. Mosier, April Nissen.

Sandia National Laboratories, 7011 East Ave., Livermore, CA 94550.

# Executive Summary: Scientific Study of Bi-Te Thermal Electric Modules

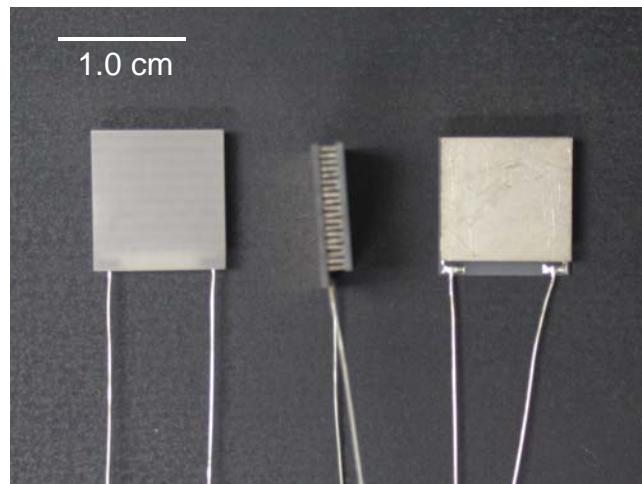
Sample description of the  $\text{Bi}_2\text{Te}_3$  thermoelectric (TEC) modules supplied by Thermix, Ukraine as follows:

- The cover support plates are Aluminum nitride (0.02" thick)
- Solder is SnSb, Melting Point is  $\sim 230$  C
- The individual TEC elements ("Legs") are 1.27 mm long and 0.27 mm square for both P-types and N-type.
- Modules dimension is shown below

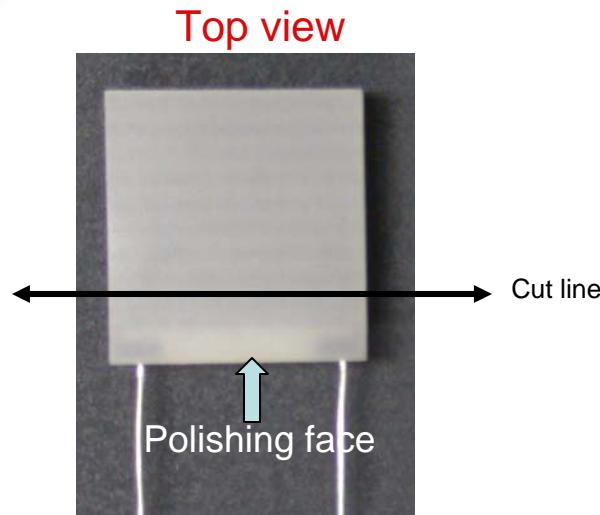
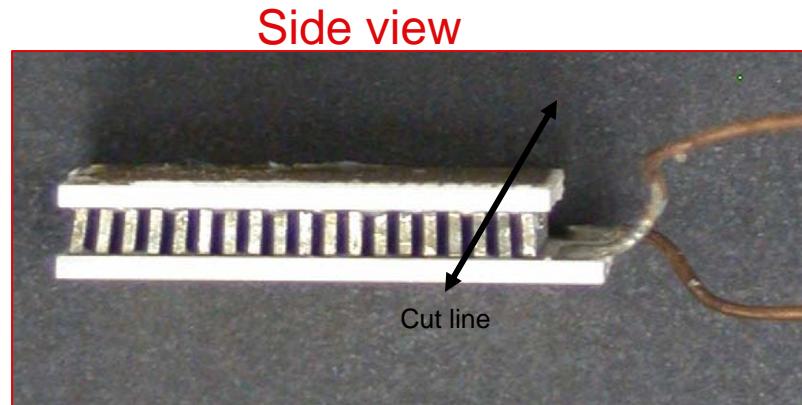
Cross section samples prepared using standard metallographic mounting and polishing process

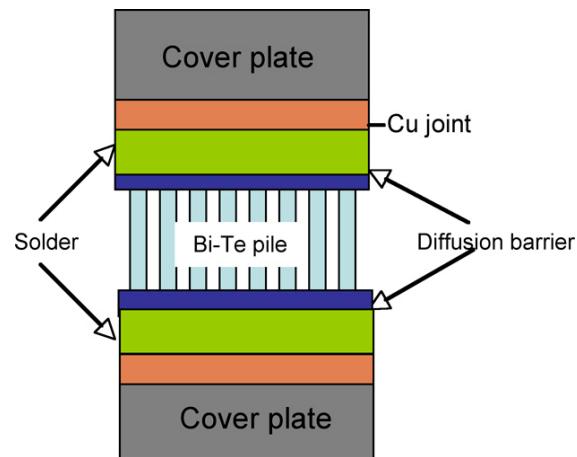
Schematic of multi-layered expected in the current TEC modules

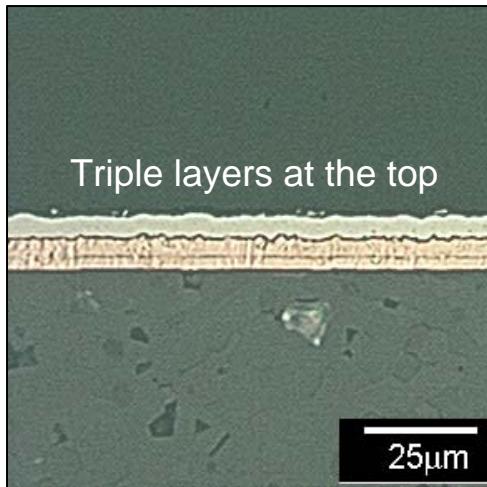
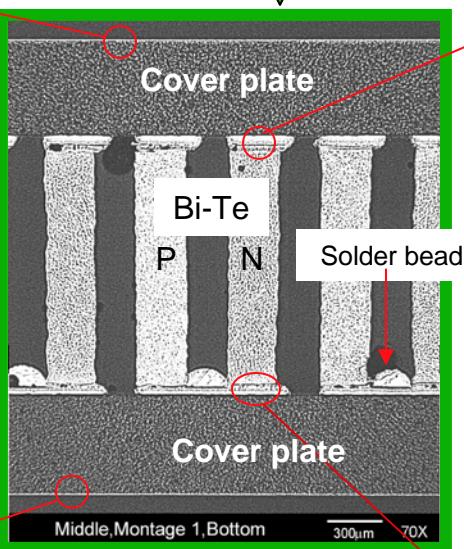
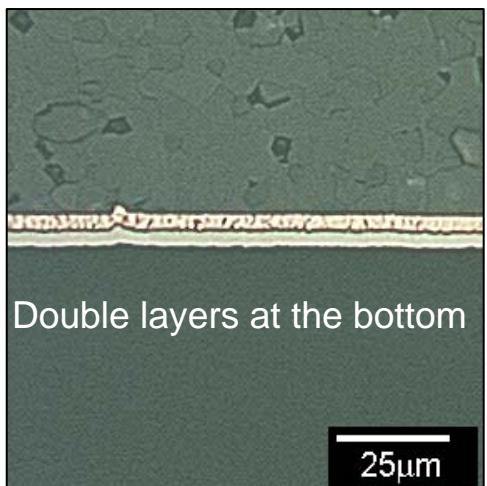
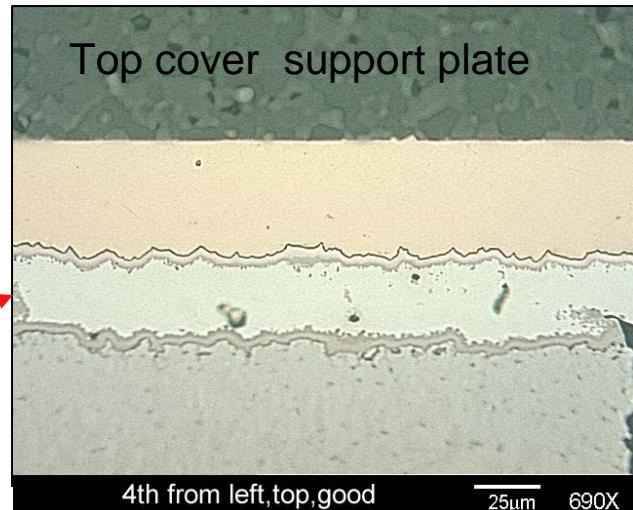
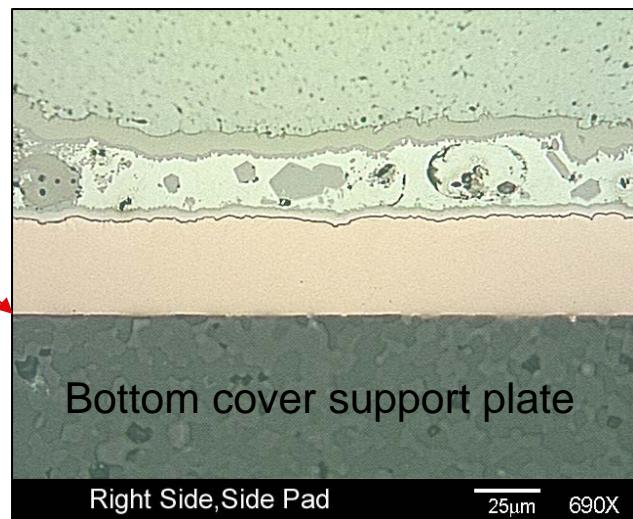
## Multi-layered construction of the TE modules were revealed using optical imaging

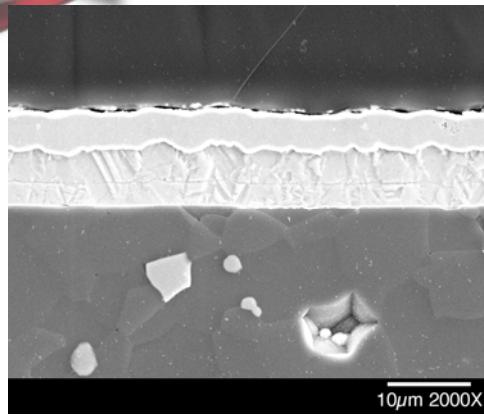
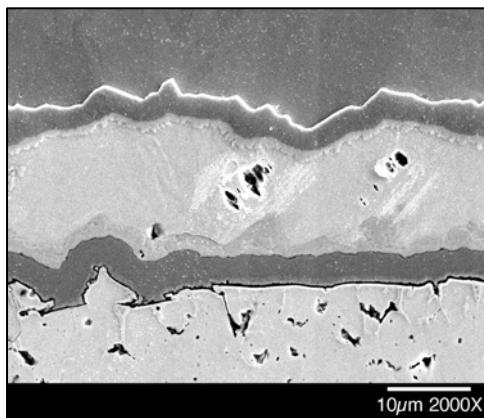
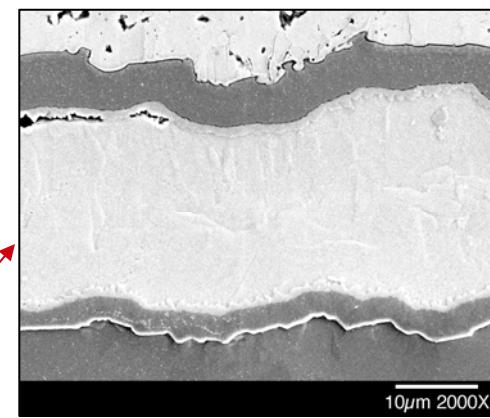
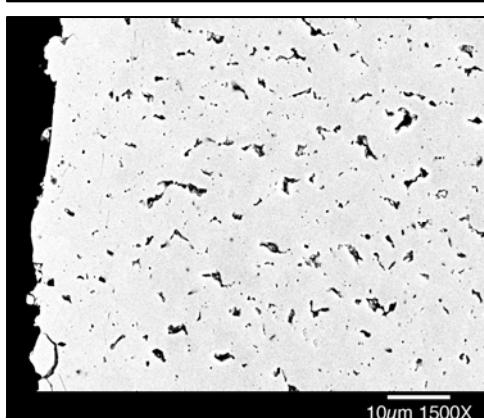
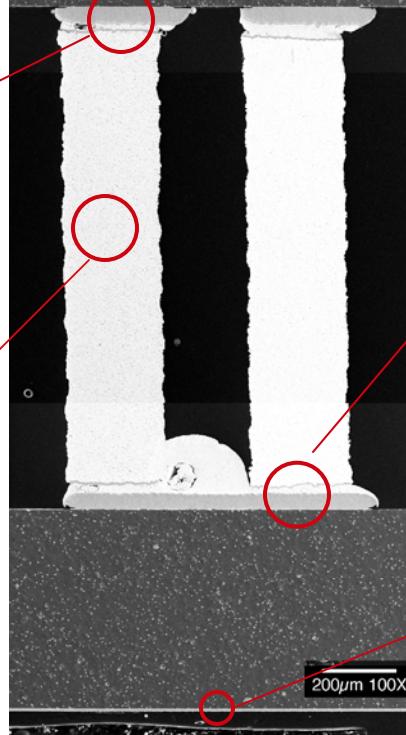
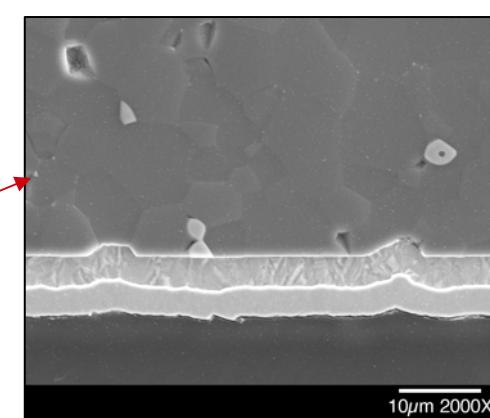
## Multi-layered structure was confirmed using scanning electron imaging

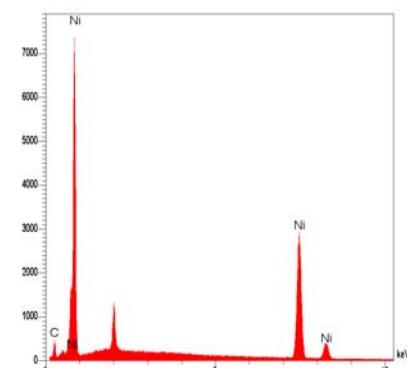
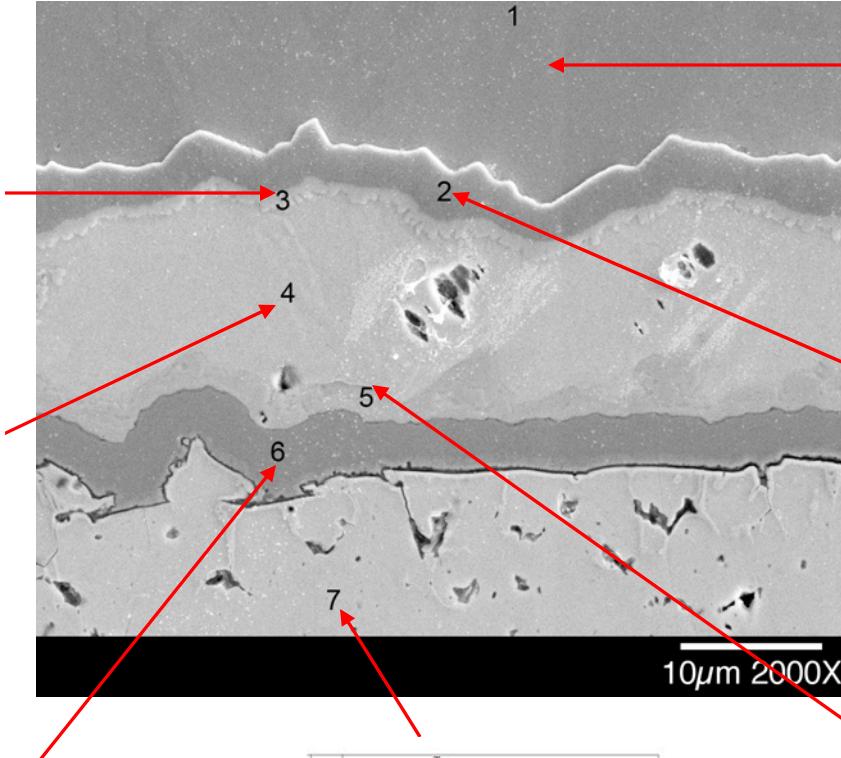
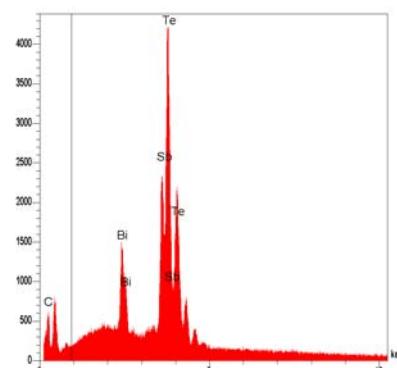
Chemical composition of each layer were qualitatively identified using Energy Dispersive X-ray Spectroscopy (EDS)

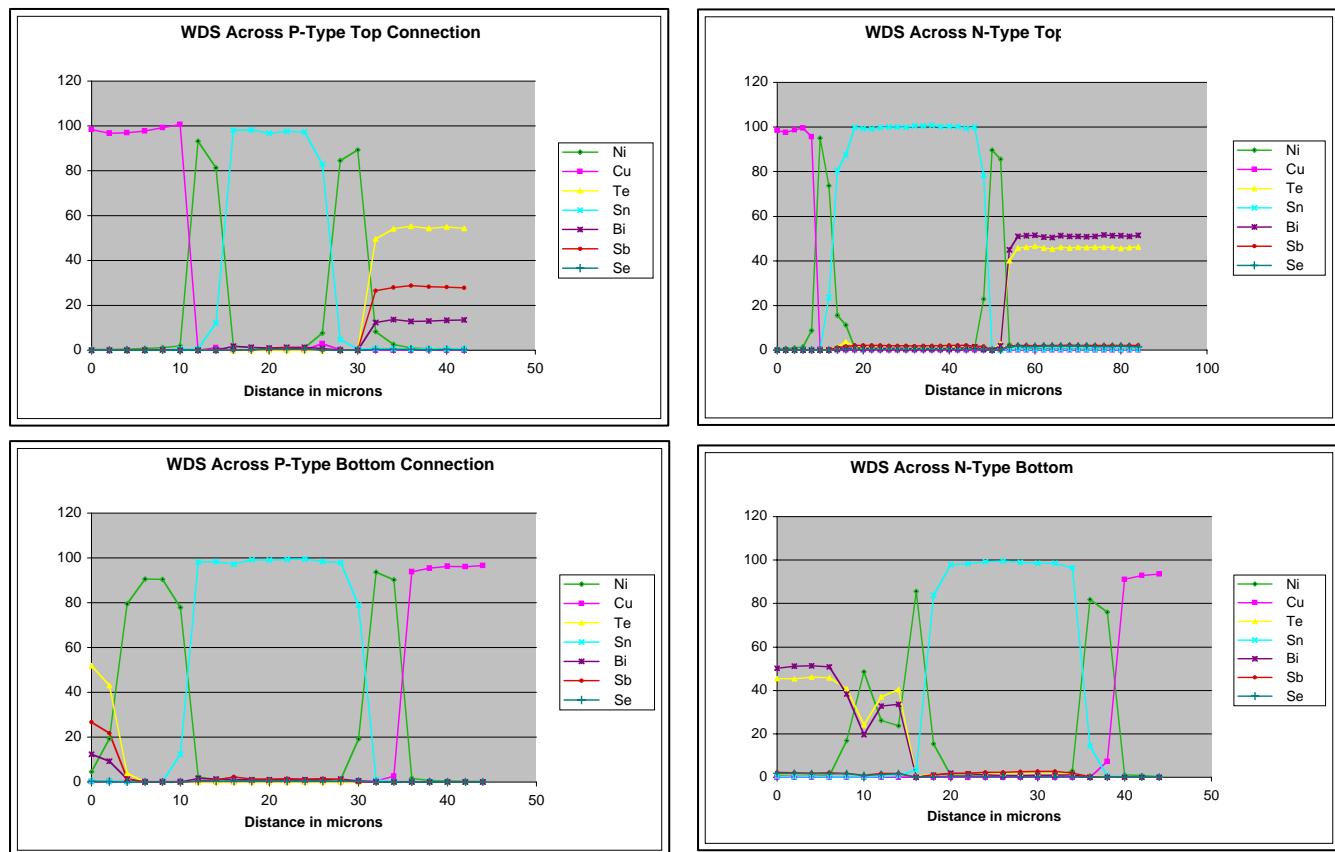
Chemical composition and its concentration profile across the layered structure were quantified using electron microprobe analyses (EMPA)

Chemical composition (wt%) measured using electron microprobe

Ni	P	Te	Sn	Bi	Sb	Se		
1.0		54.6	0.6	13.3	28.2	0.3	P-type	
0.4		46.0	0.3	51.1	2.1	1.7	N-type	
			99.0		1.0		Solder	
>99							Diffusion barrier Cu side	
90.0	10.0						Diffusion Barrier Bi-Te side

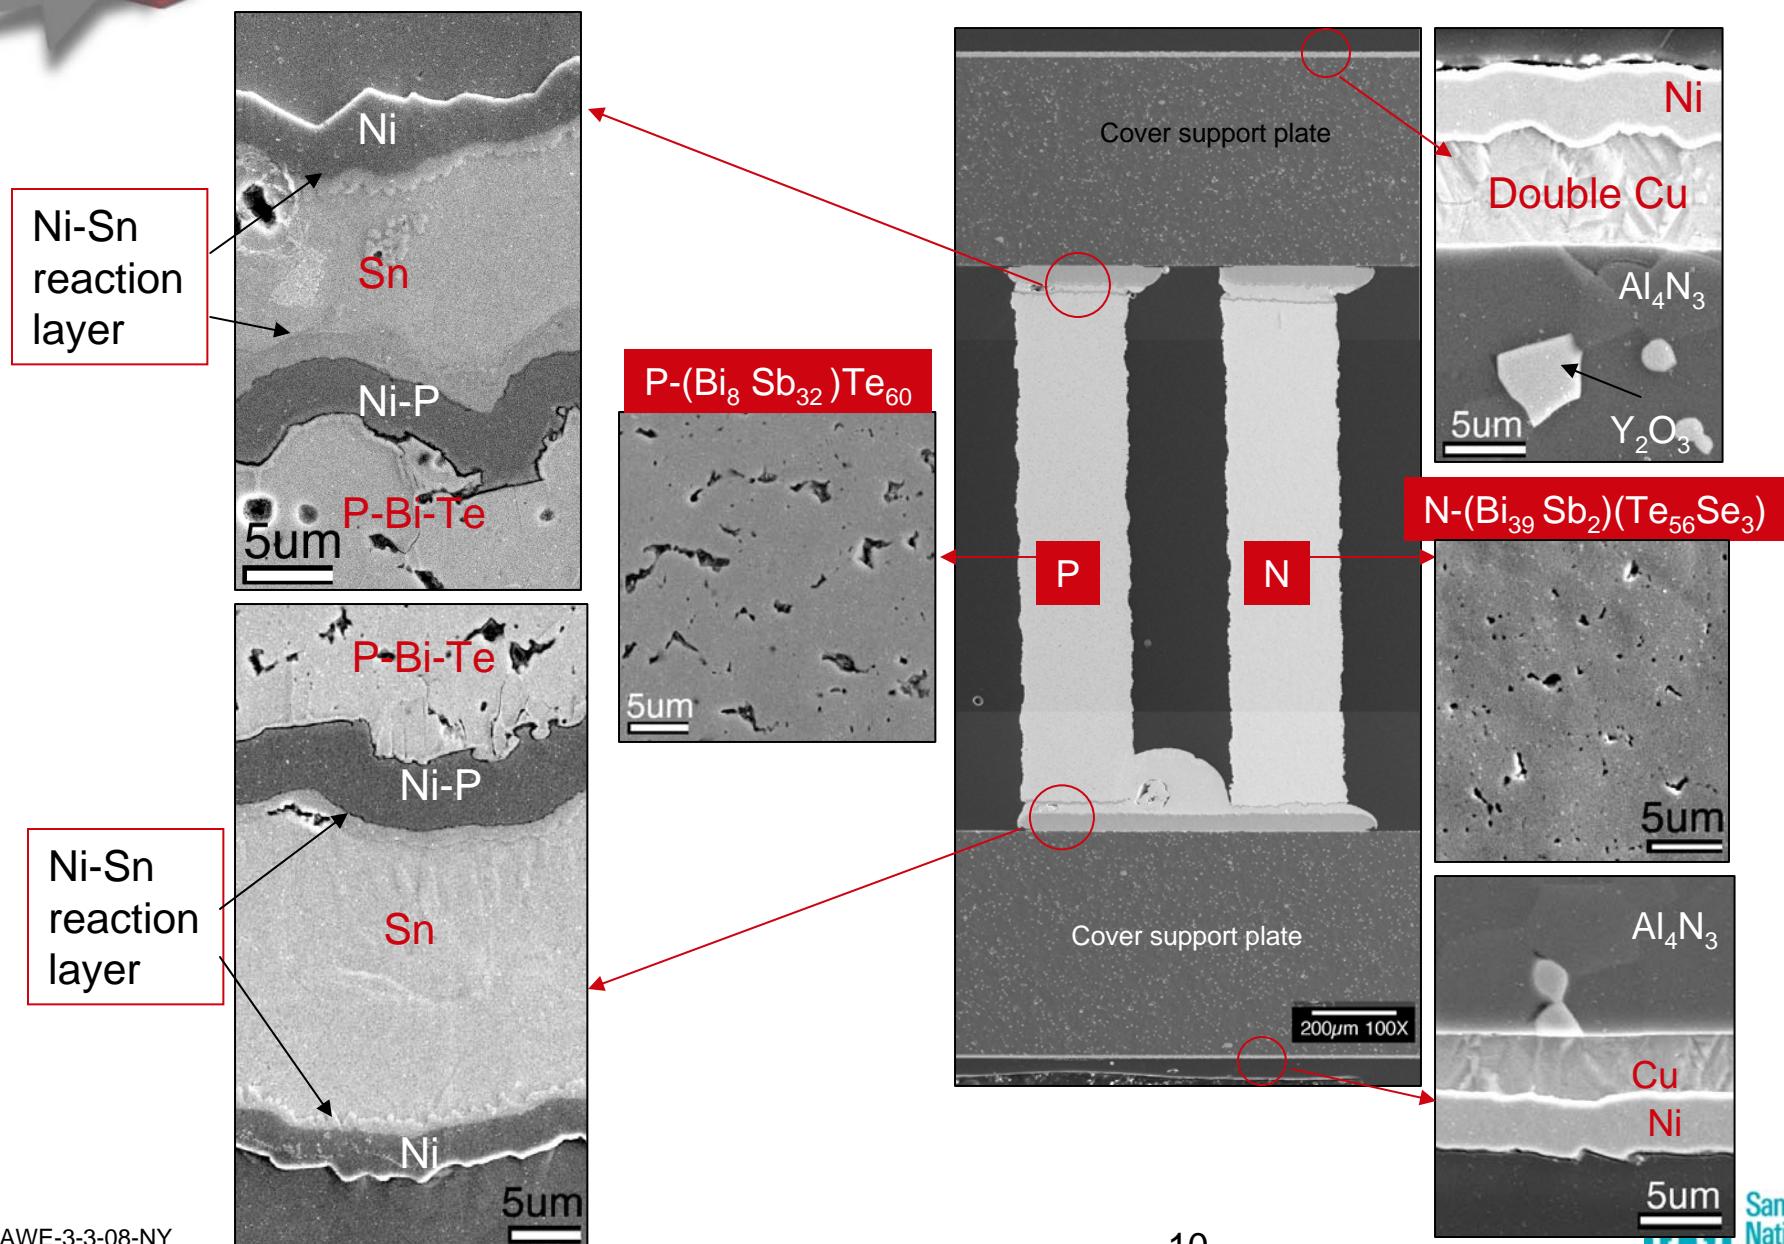
## Summary of material design for the multi- layered TEC modules

- Current TEC modules were constructed with P-(Bi<sub>8</sub>Sb<sub>32</sub>)Te<sub>60</sub> and N-(Bi<sub>39</sub>Sb<sub>2</sub>)(Te<sub>56</sub>Se<sub>3</sub>) thermal piles. Material selections for the cover support plates, diffusion barrier and solder were, Al-Nitride/Cu, Ni/Ni-P and Sn-Sb ( $\leq 1.0$  wt%) respectively.

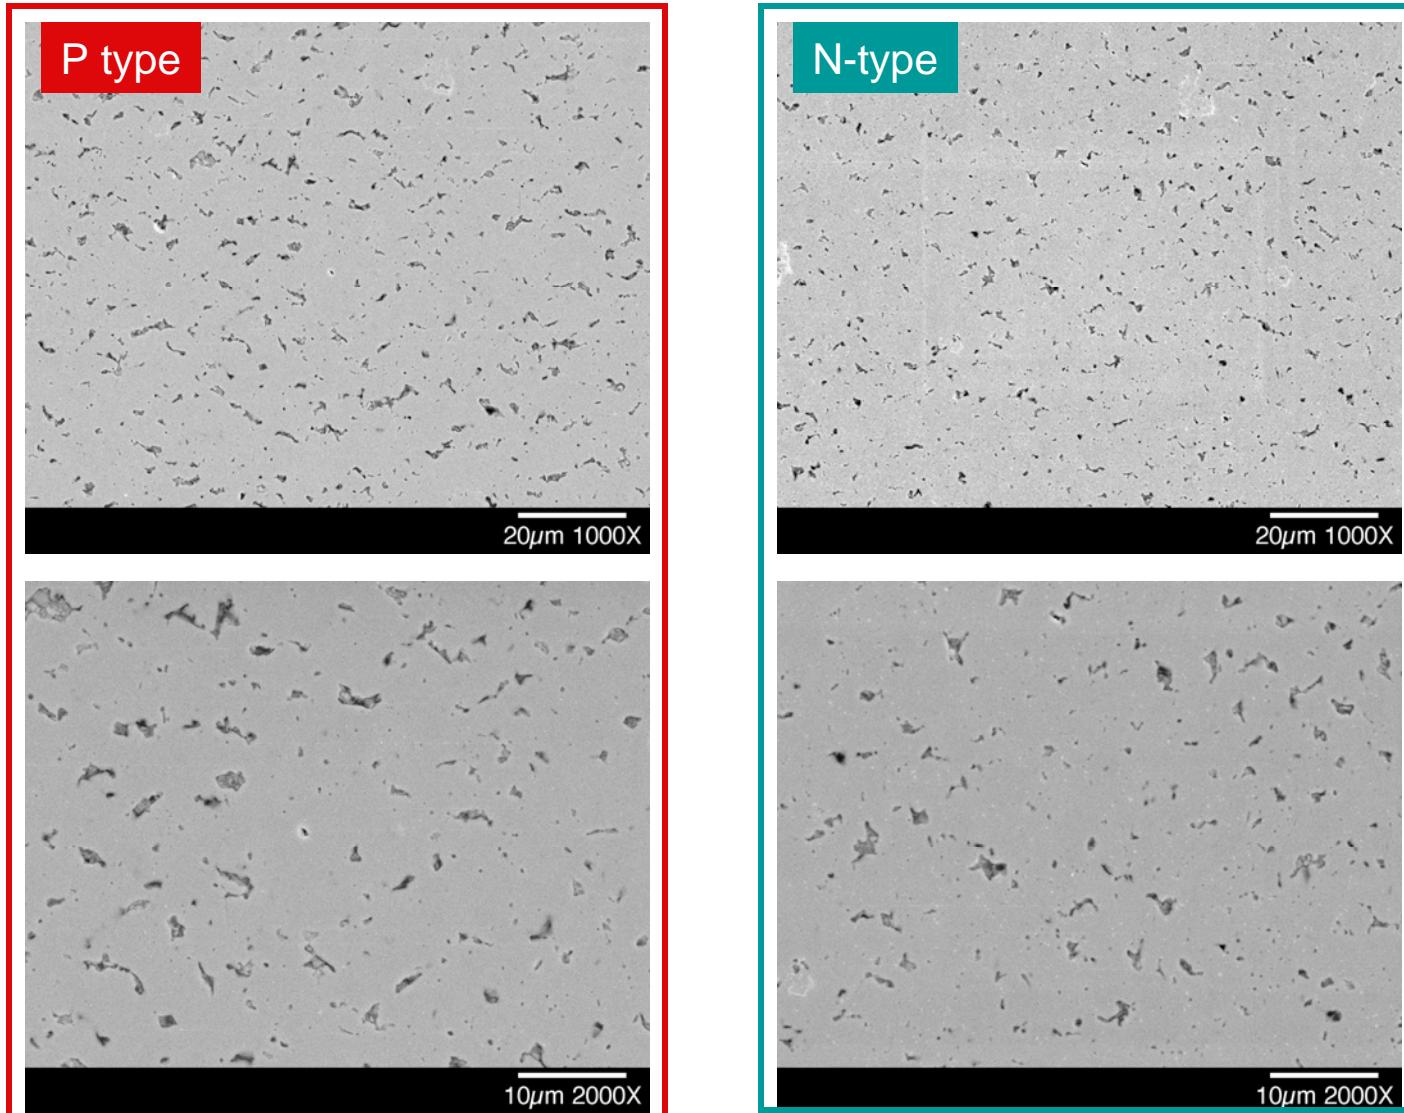
## Typical microstructure with respect to defect, e.g. pore or inclusion?

Defect Density is  $\leq 1\text{-}5$  vol. %

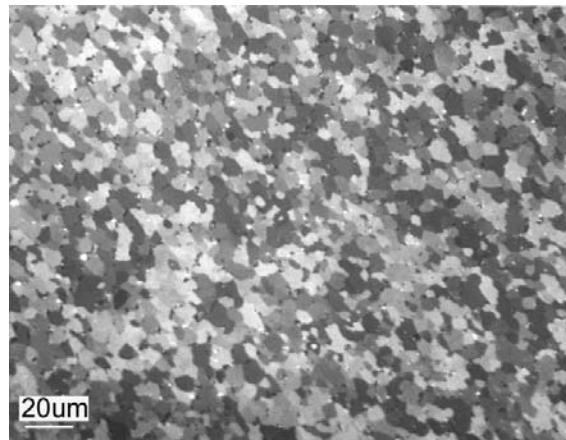
P-type-Thermix

Typical Bi-Te grain structure is equi-axed in shape and ~5-10um in size. Grain size varies slightly between the P-type and N-type

- P-type grains are equiaxed and  $\leq 10\text{um}$  in diameter
- N-type grains are slightly elongated and  $\leq 5\text{um}$  in width

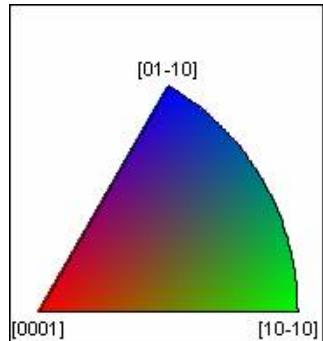
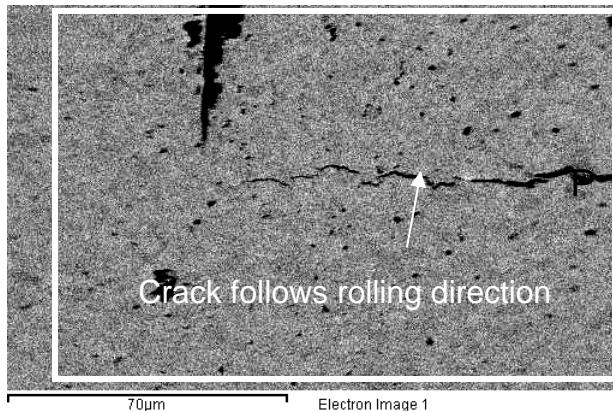
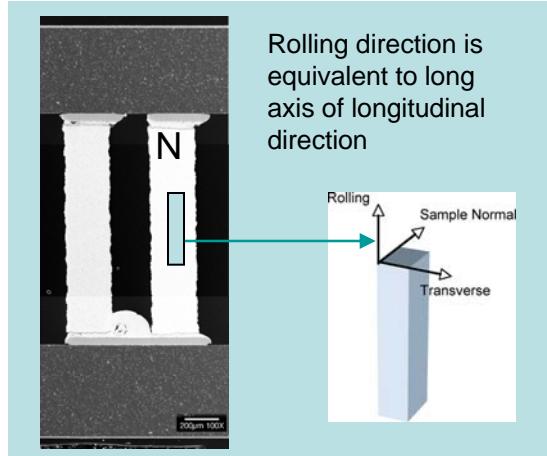
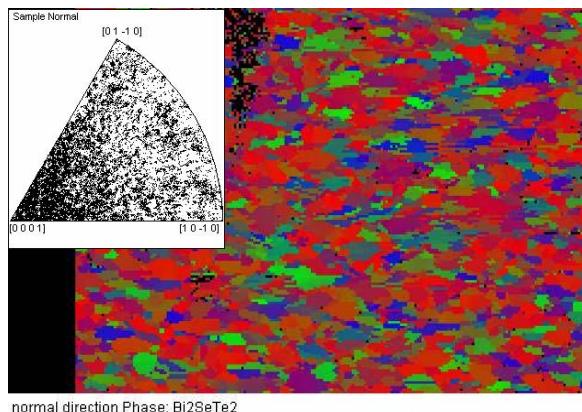
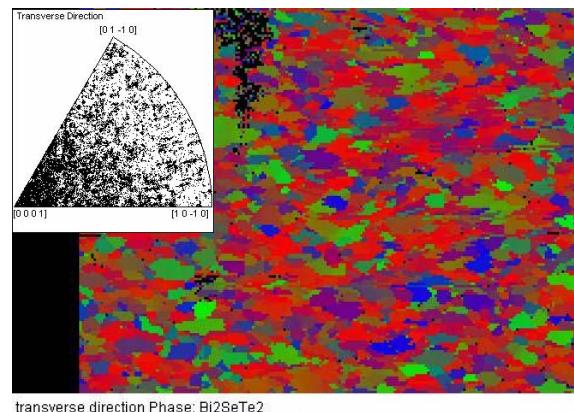
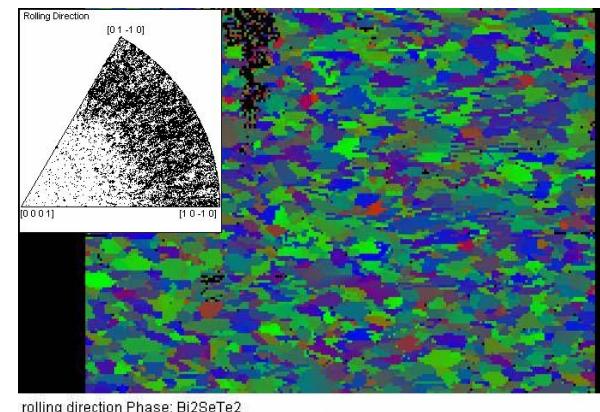
EBSP/inverse pole figures shows moderate texture along all three crystallographic axes (logitudinal, transverse and normal) of N-type

The crack in the SEM image above was an artifacts generated from the damage tolerance experiment by Vickers hardness indentation

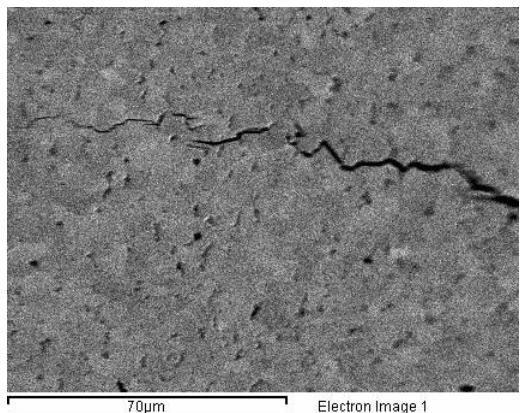
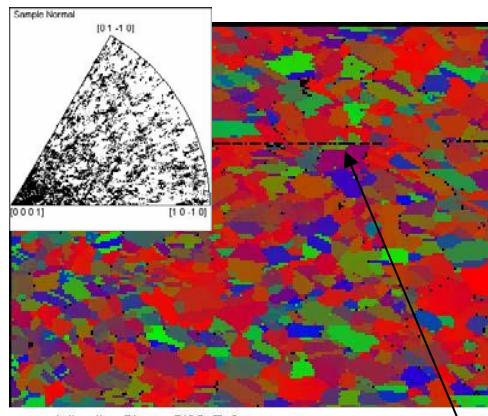
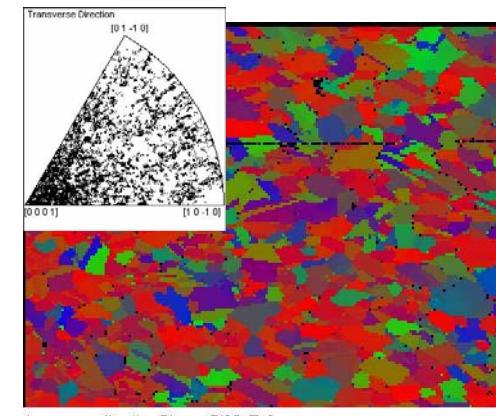
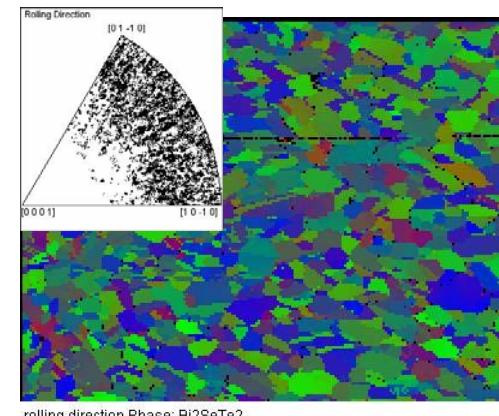
EBSP/inverse pole figures also shows similar texture along rolling, transverse and normal directions of the P-type Thermix device

Rolling direction is equivalent to long axis of longitudinal direction

The dark line in the orientation maps is a artifacts due to minor sample charging

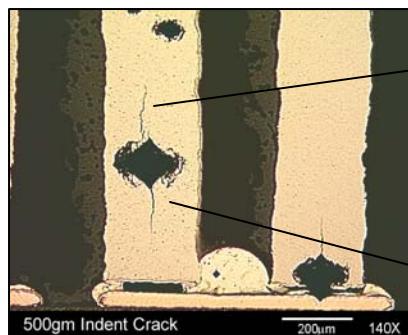
Vickers diamond indentations show Bi-Te for both P-type and N-type are soft but brittle and the crack along the long axis of the pile.

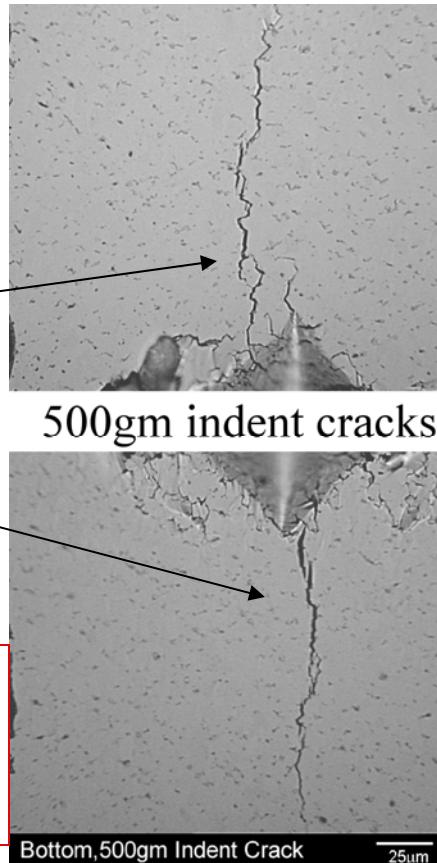
Cracks generated from 500 grams indent tend to propagated along longitudinal direction (Long axis of the P-type and N-type piles)

- Modulus of the Bi-Te piles is  $\sim 1$  Gpa. Damage crack under Vicker's diamond indentation load usually propagated along the long axis of the pile either through grain boundaries hexagonal basal planes

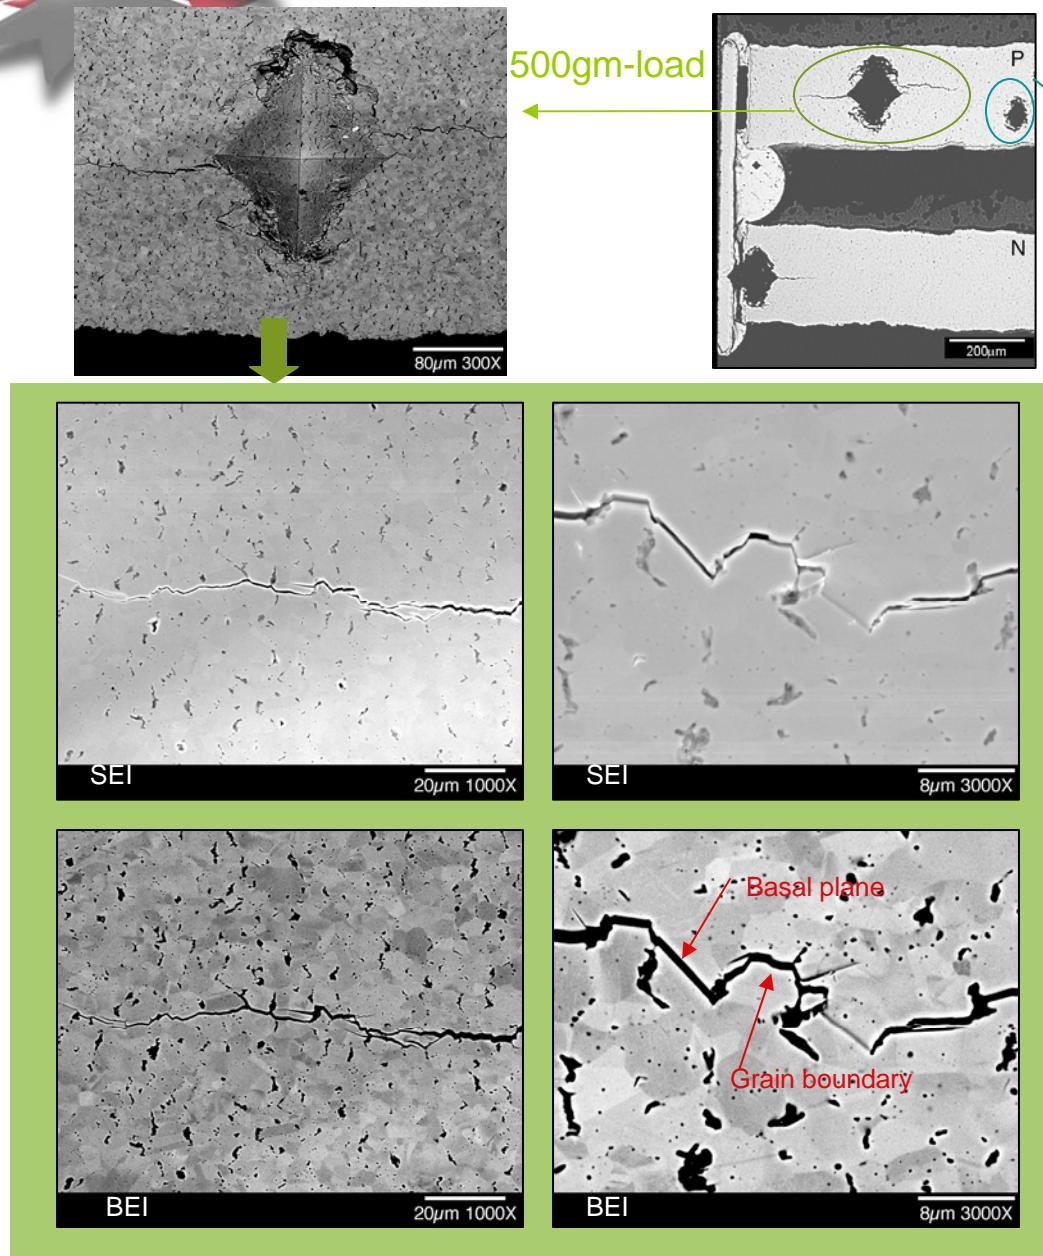
# Crack propagation of P-type, at 500 grams-load in general is along grain boundaries and/or basal plane of hexagonal lattice.

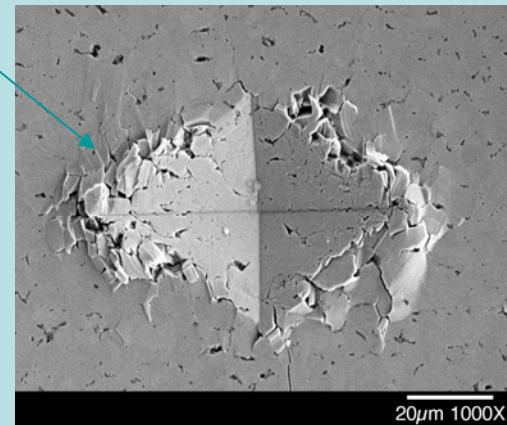
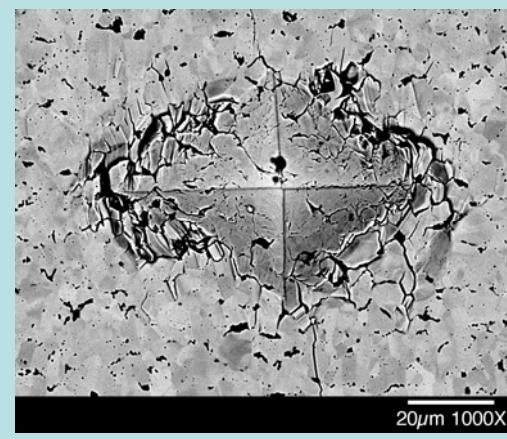
100gm-load (90 CCW rotation)

- At  $\leq 100\text{gm}$  load Bi-Te exhibits intergranular brittle fracture without preferred direction
- At  $\geq 500\text{gm}$ , both P and N type fractured and propagated along longitudinal direction

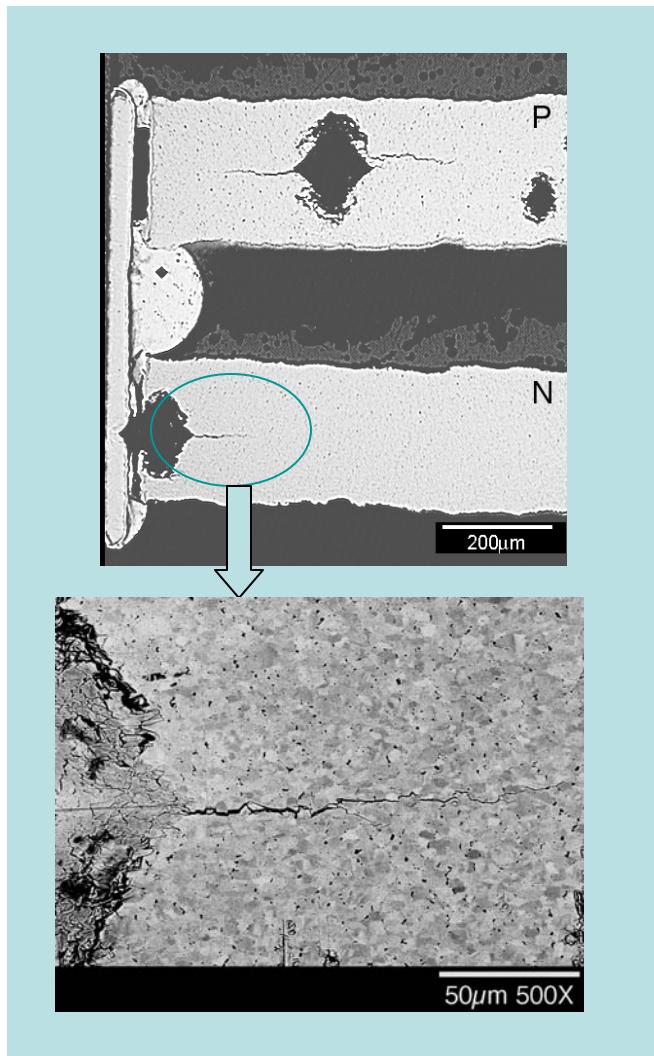
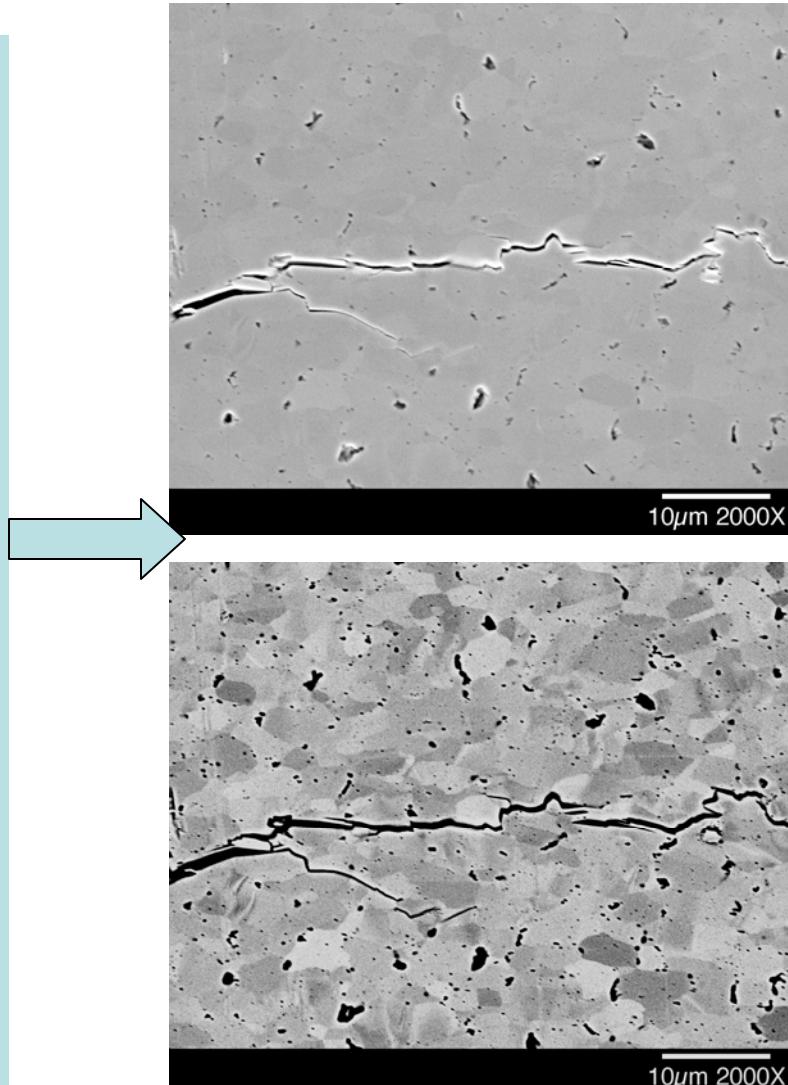
Damage tolerance/brittle crack of the N-type is comparable to those seen in the P-type described above

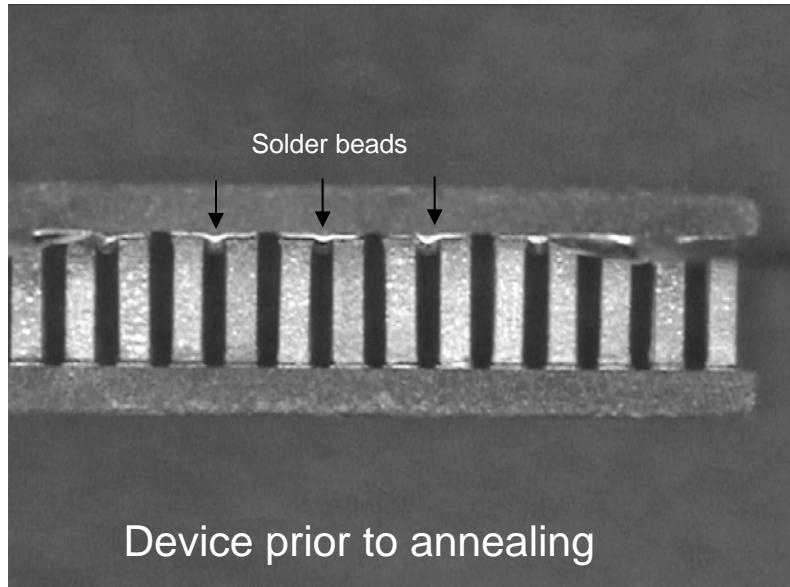
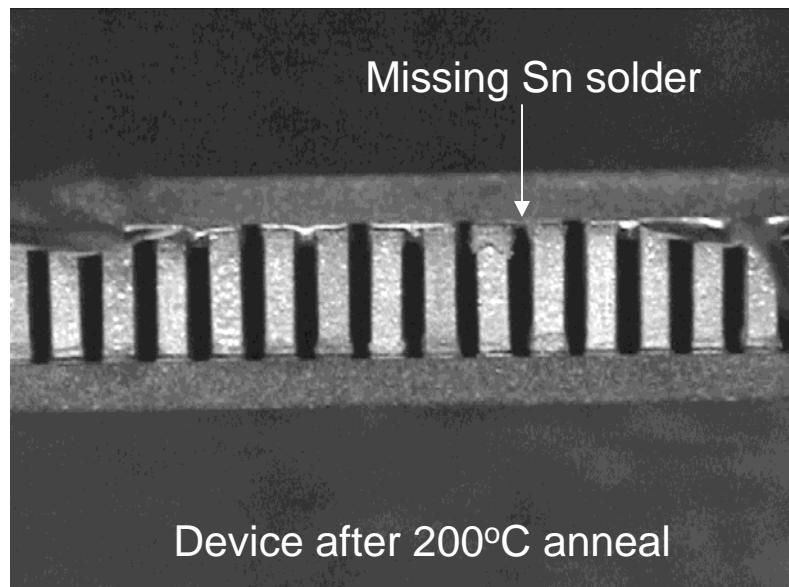
Sn solder melting is evident after being TMA tested annealed up to 200°C and the melting appeared to start ~160°C

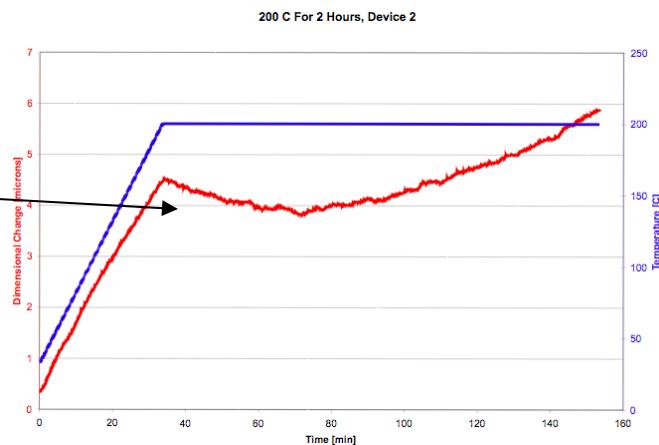
TMA analyses results of the 200°C annealed show drastic dimensional changes at 160°C. This large displacement is indicative of solder melting

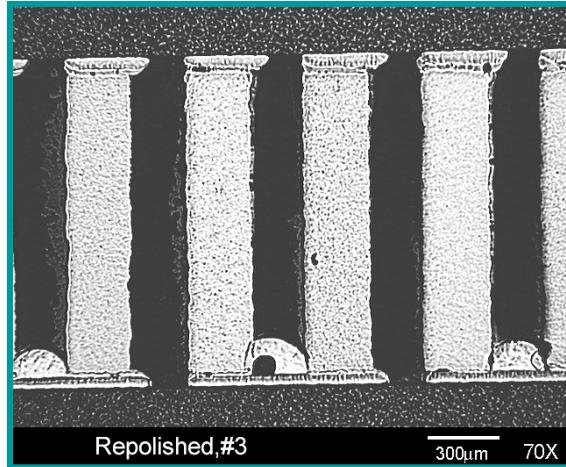
AR

Optical image show lost integrity at 160°C and 200°C of the TEC modules

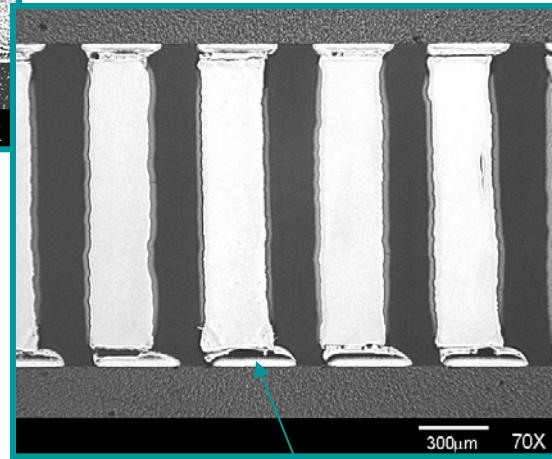
160°C

Sn solder melted at  $\geq 160^\circ\text{C}$

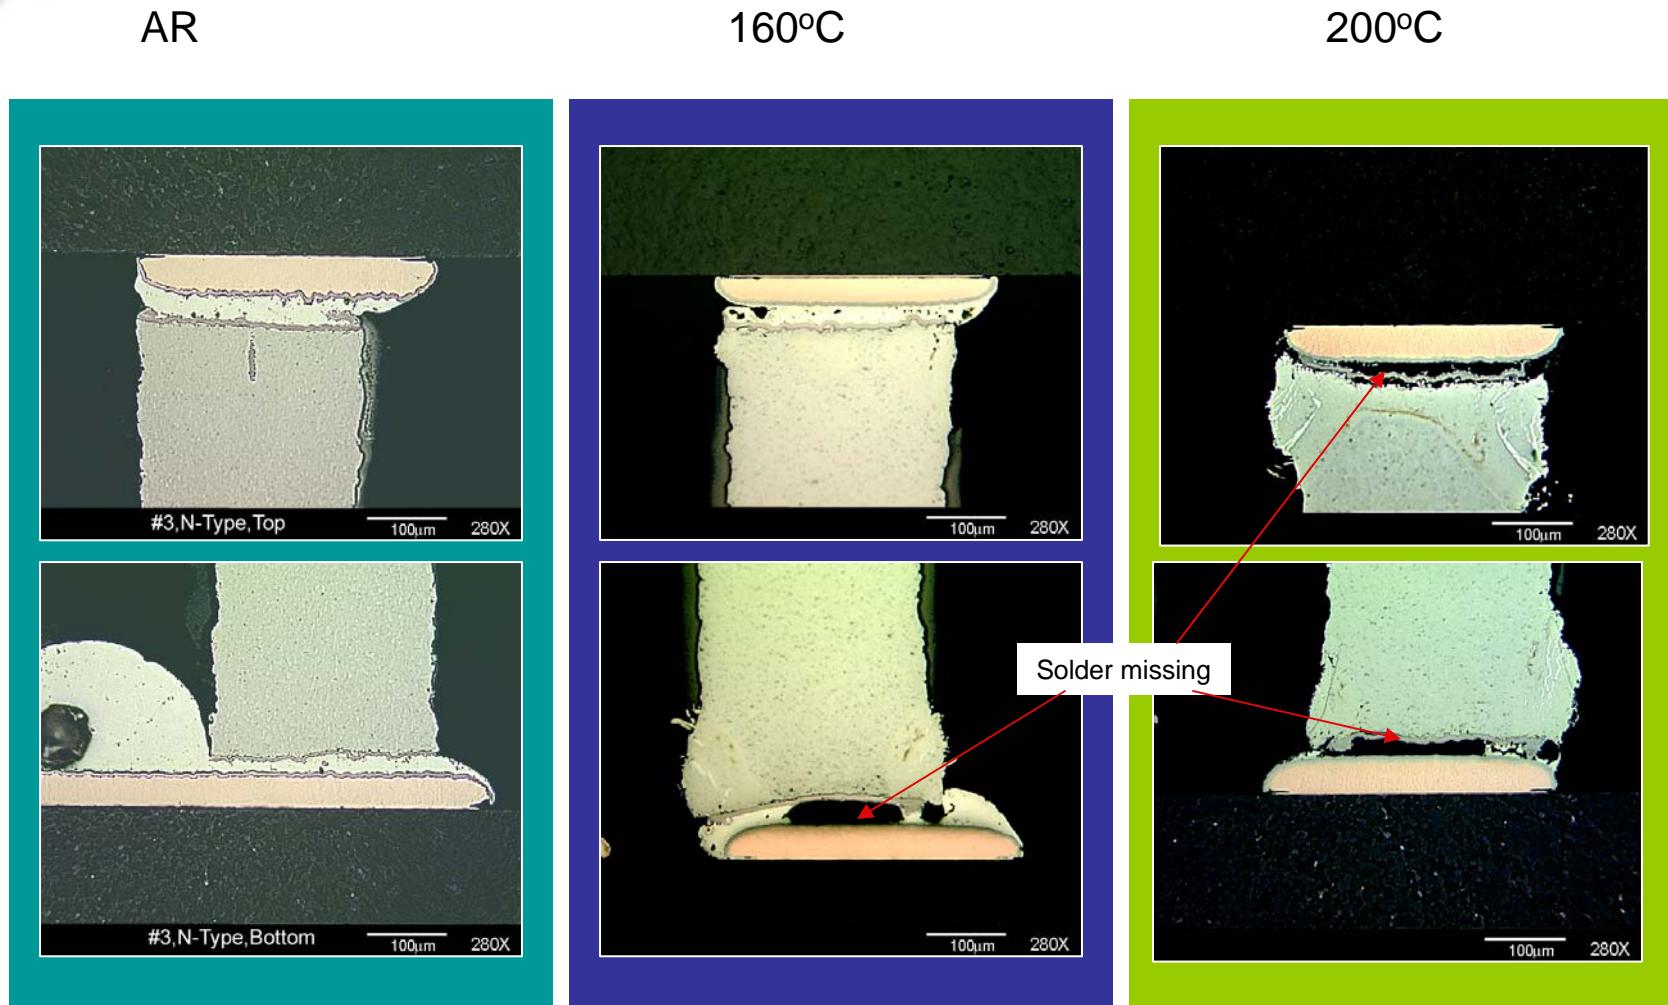
Optical images show thermal instability of the Sn solder beyond 160°C

Solder melted at  $\geq 160^{\circ}\text{C}$  and lost integrity is clearly revealed

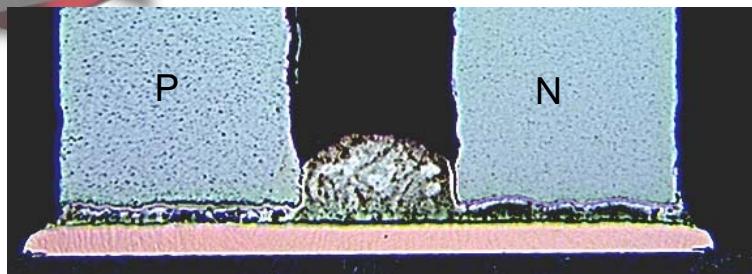
AR

Optical image show the layered structure losing integrity at 180°C and 200°C due to inter-elemental diffusion between Sn solder and Bi-Te

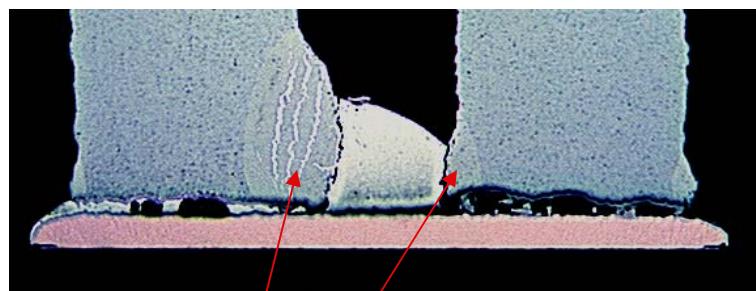
180°C/20hrs

- At 180°C and beyond, Sn solder diffused into P and N to form a reaction zone and lost integrity

- The reaction zone seems to be more pronounce on the sideway where the excess Sn-solder had a directly contact with Bi-Te pile directly without Ni-diffusion barrier

P  
N  
Reaction zones

- The TEC modules with Sn-rich solder lost its integrity at 180°C and beyond due to solder melting and inter-elemental diffusion
- The inter-diffusion between Sn solder and to Bi-Te piles changes local thermal pile composition with Te-Sn-Bi phase near the solder joint. The composition change is especially pronounced near the solder joint where Sn-solder is in direct contact with the Bi-Te pile on the sideway. This diffusion induced composition changes could lead to mechanical and/or poor electrical failure performance

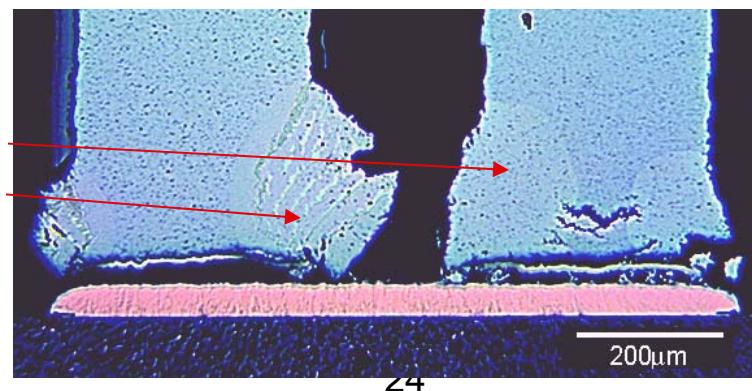
Elemental X-ray maps show a reaction zone derived from Sn-diffusion into both P and N near the bond lines
