## Metallurgy and thermal stability of Bi-Te thermoelectric modules

Nancy Y.C. Yang, Alfredo M. Morales, Peter van Blarigan, Bruce P. Mosier, April Nissen.

Sandia National Laboratories, 7011 East Ave., Livermore, CA 94550.

# Executive Summary: Scientific Study of Bi-Te Thermal Electric Modules

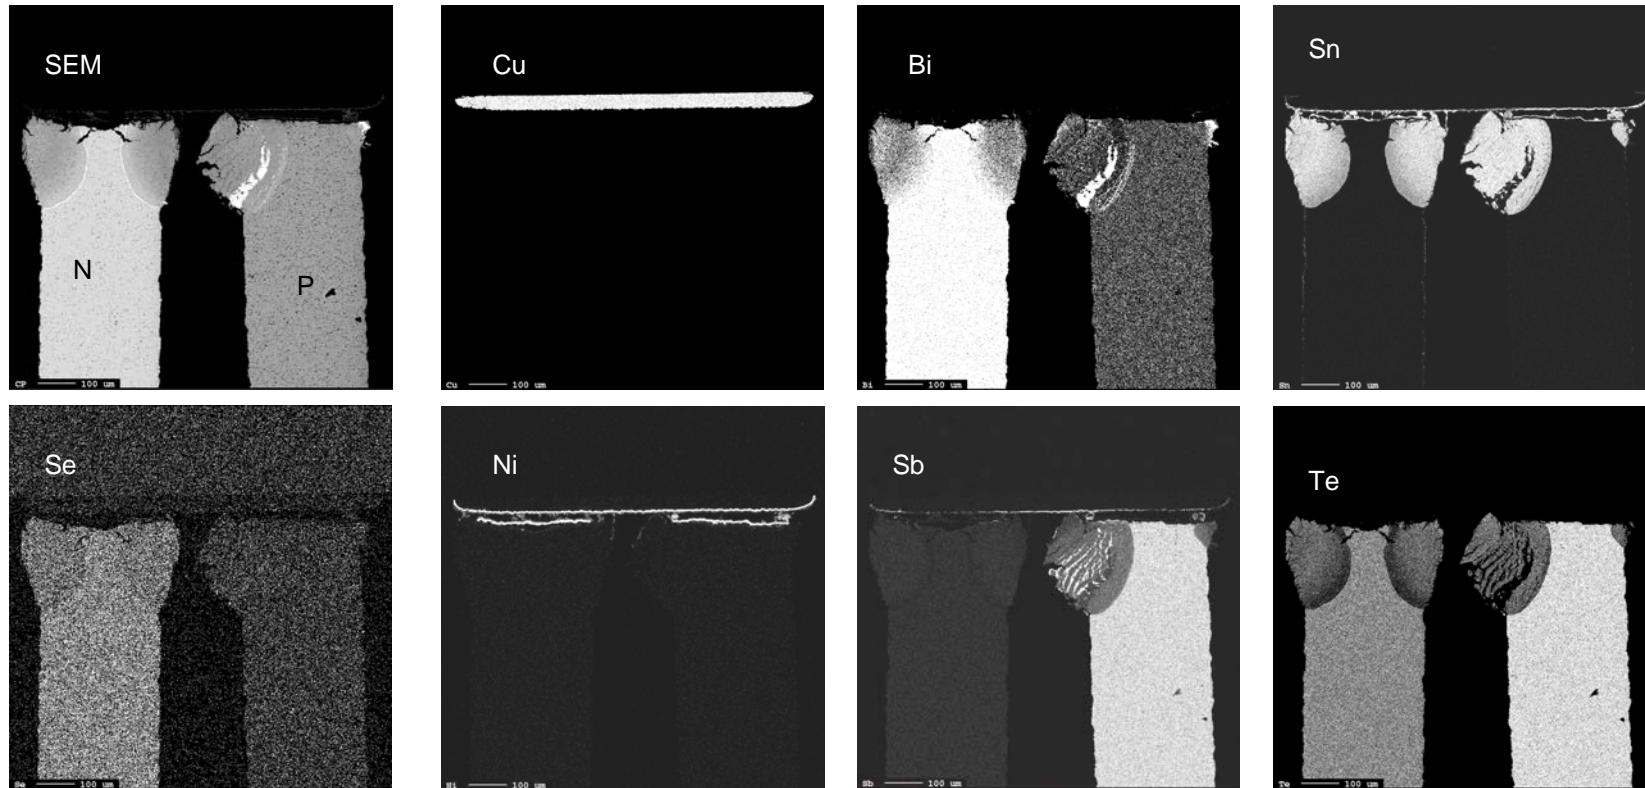
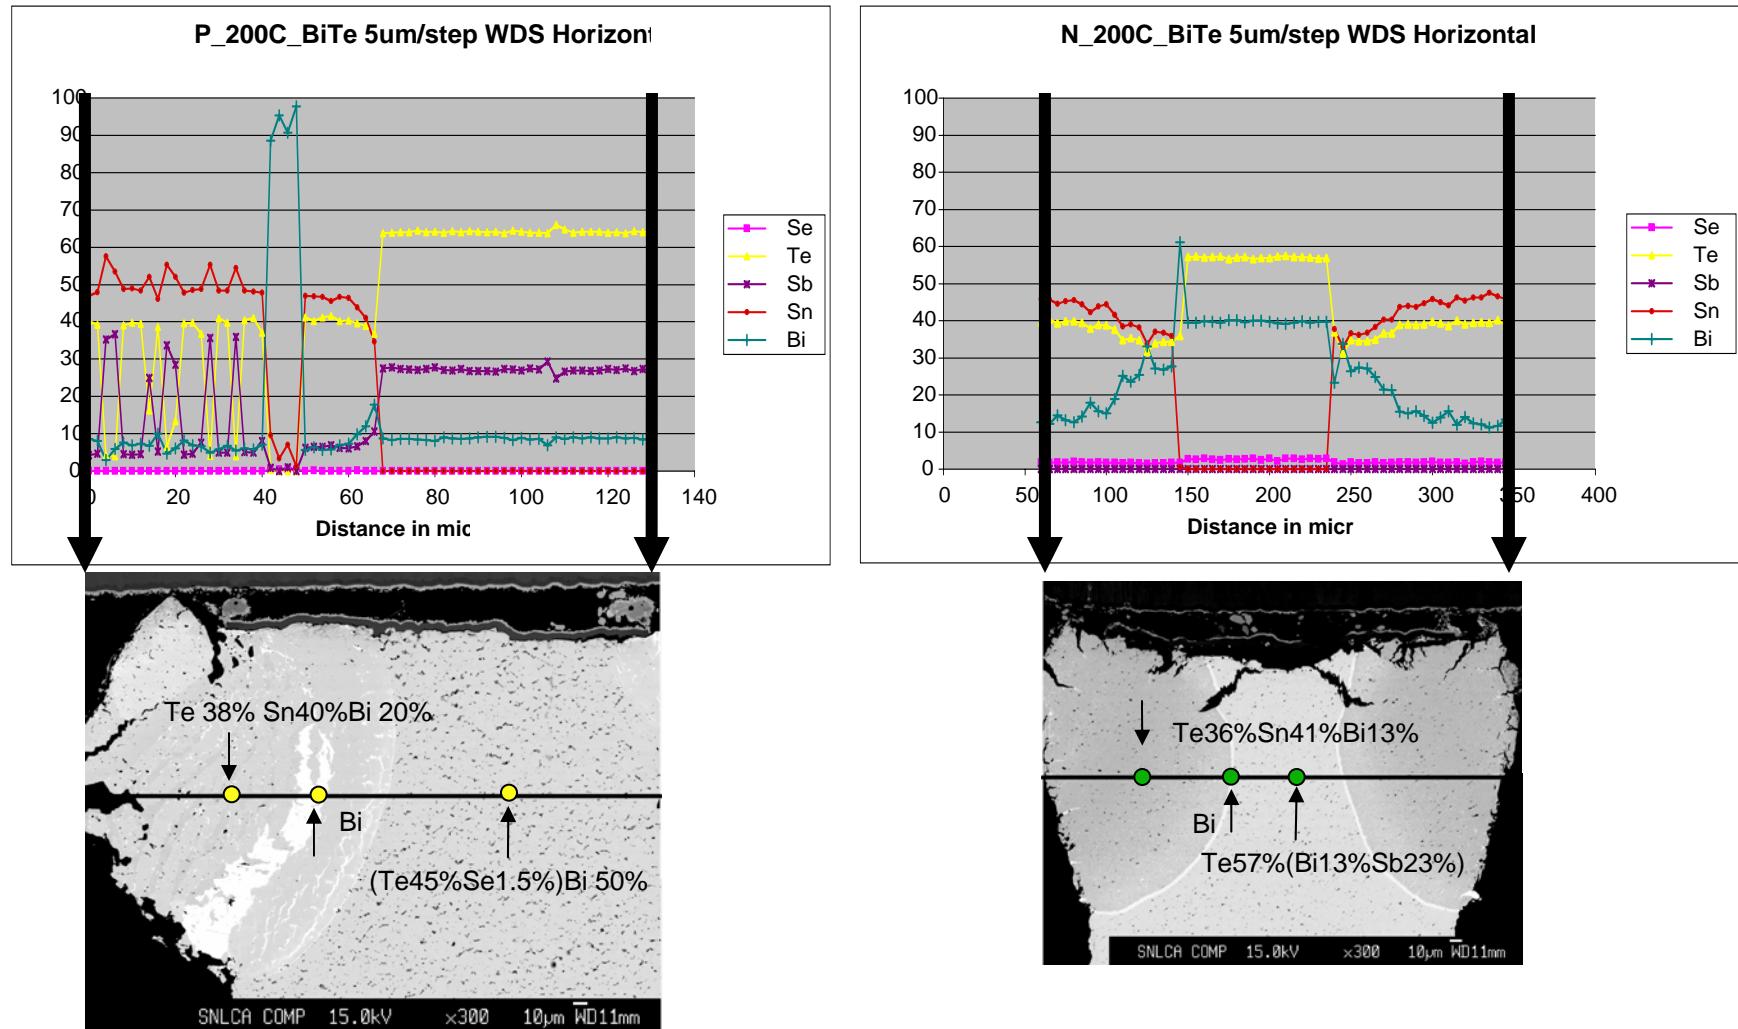
# Chemical composition profile across Sn-Te-Bi reaction zone

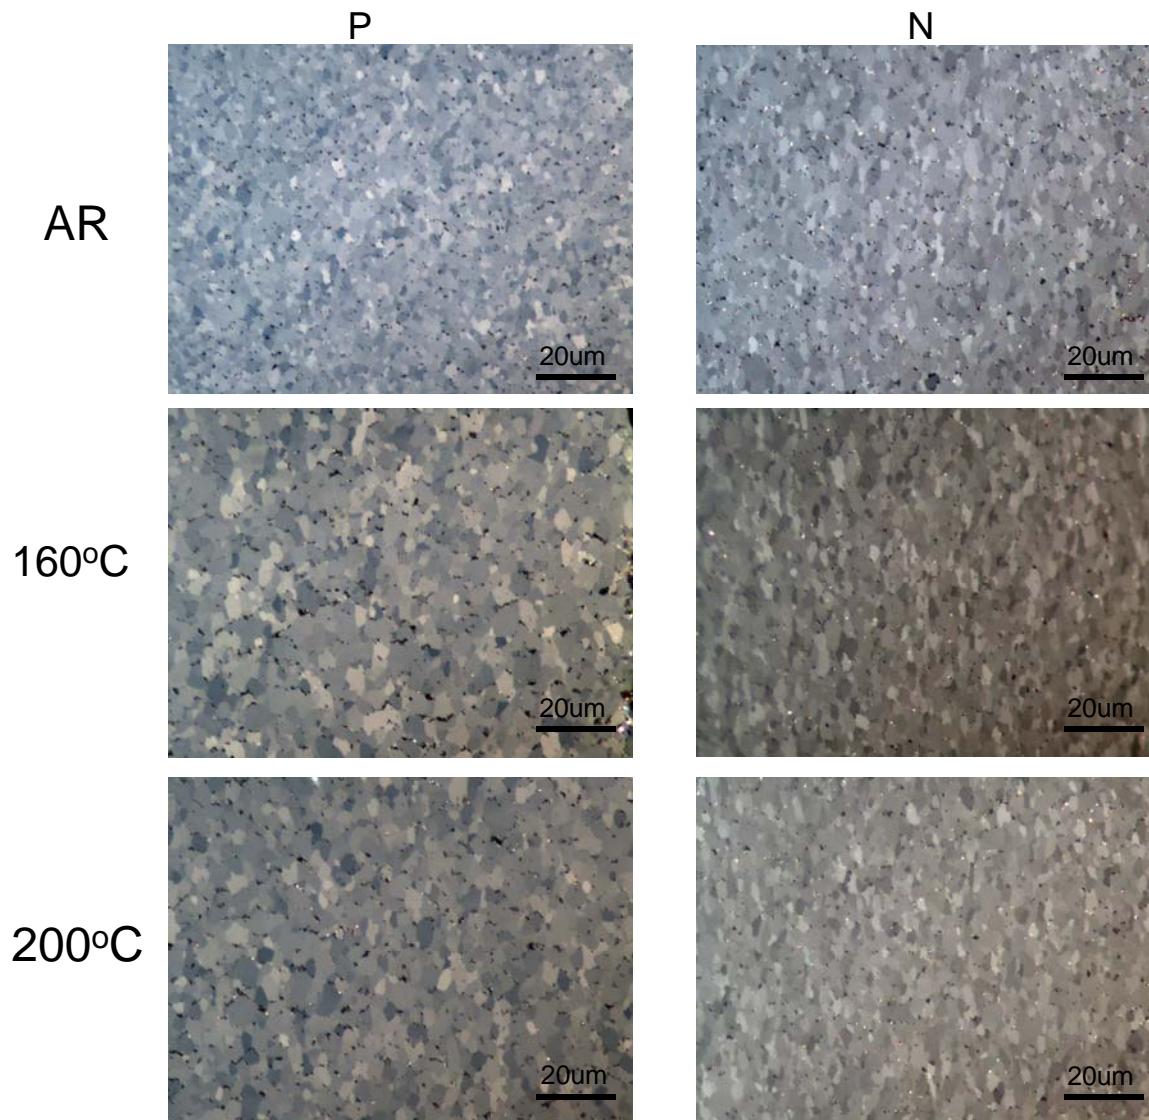
Grain structure of the Bi-Te is relatively stable up to 200°C.  
Recrystallization was not evident

- Physical metallurgy with respect to grain structure, hardness and texture of both P- and N-piles appeared to be thermally stable up to 200°C, the temperature interest

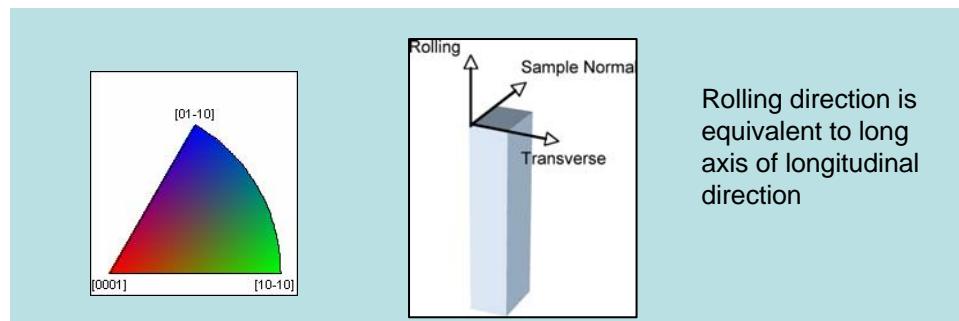
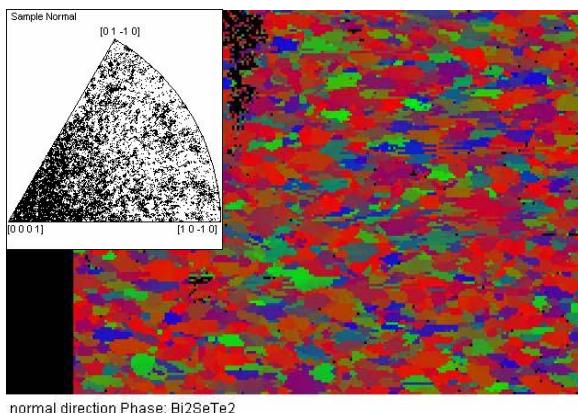
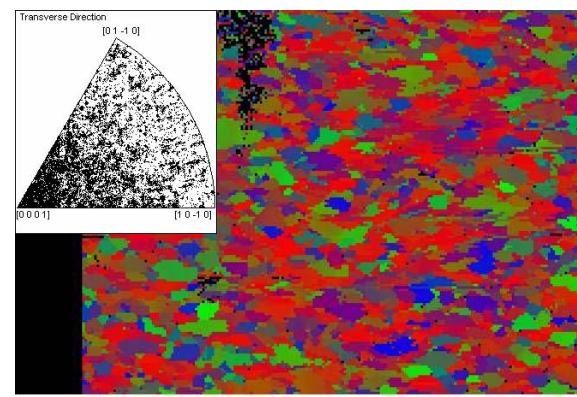
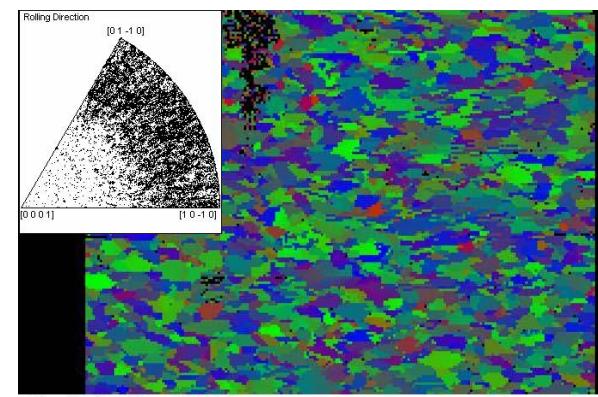
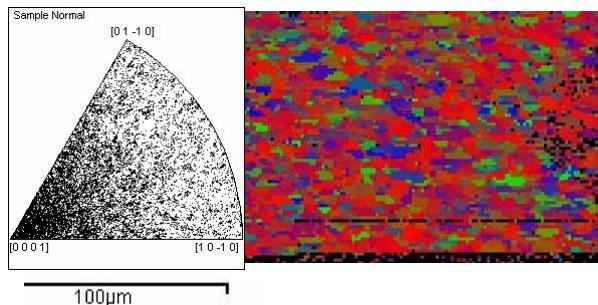
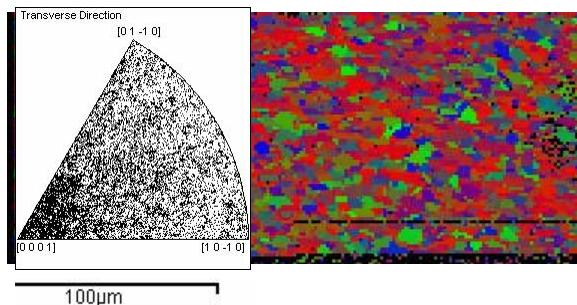
EBSP also show comparable texture of N-type pile after being annealed at 200°C

Rolling direction is equivalent to long axis of longitudinal direction

normal direction Phase: Bi<sub>2</sub>SeTe<sub>2</sub>

transverse direction Phase: Bi<sub>2</sub>SeTe<sub>2</sub>

rolling direction Phase: Bi<sub>2</sub>SeTe<sub>2</sub>
