Fatigue Testing of 9 m Carbon Fiber Wind Turbine Research Blades

Sandia National Laboratories

46th AIAA Aerospace Sciences Meeting and Exhibit

January 10th, 2008

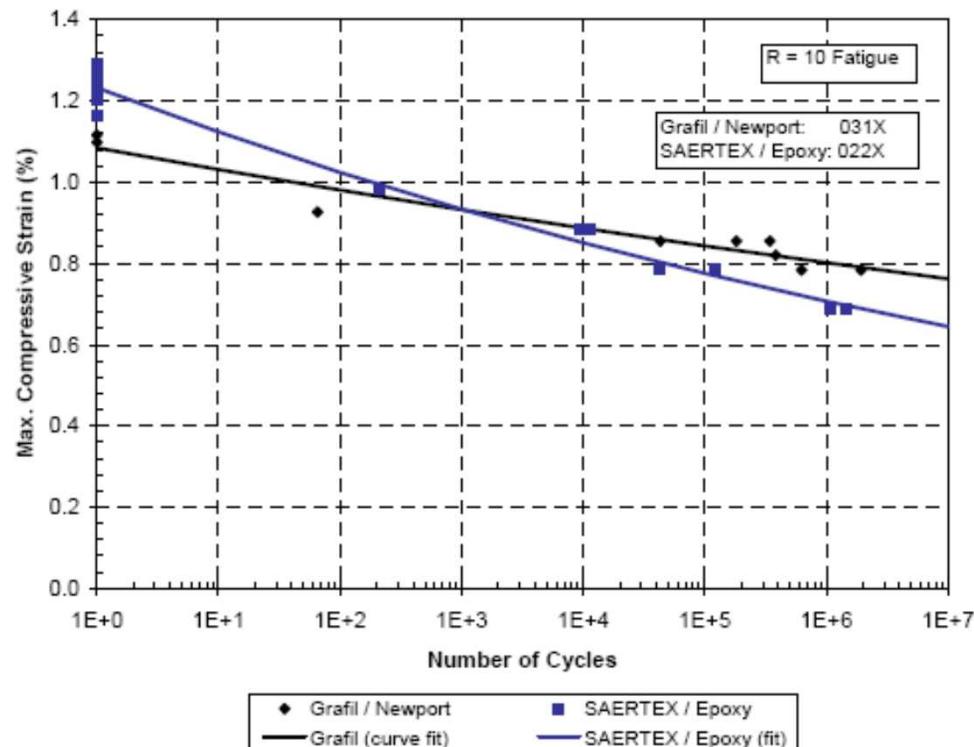
SAERTEX Carbon Tri-ax Fatigue Performance

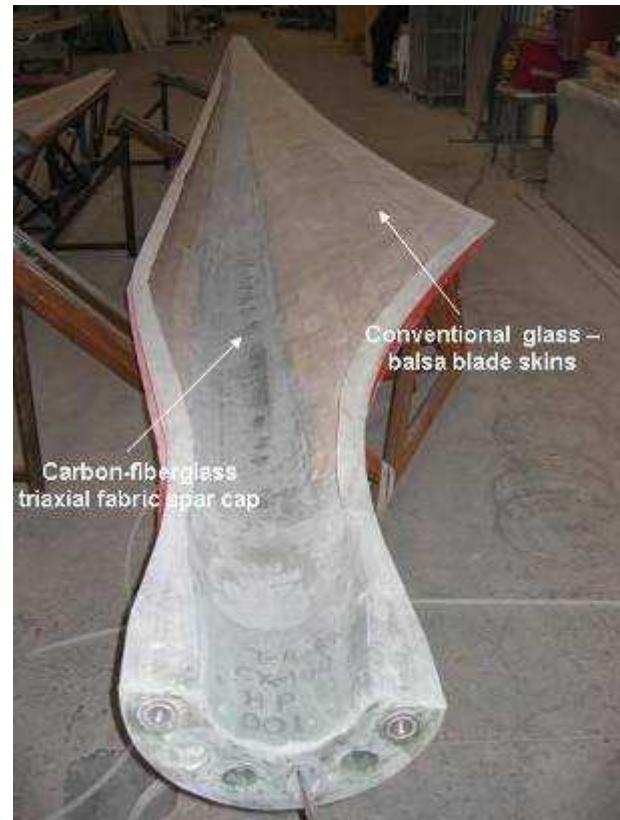
- CX-100 (Carbon Experimental 100 kW)
- Manufactured using existing 9 m molds
- Based on ERS-100 blade with non-scalloped root
- Glass-Epoxy blade with full length carbon spar cap

CX-100 Blade Skin

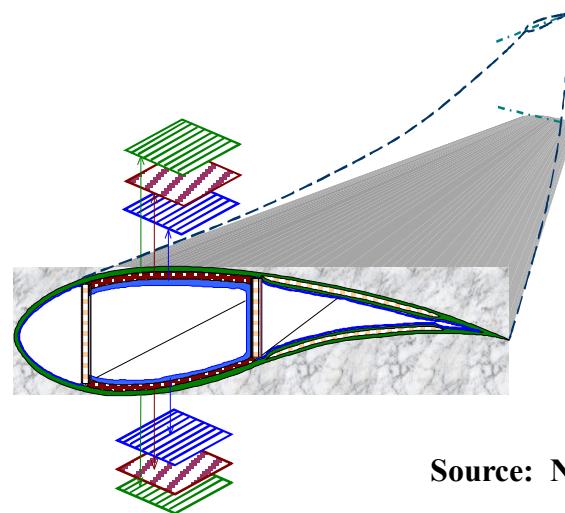
Material Induced Twist-Bend Coupling

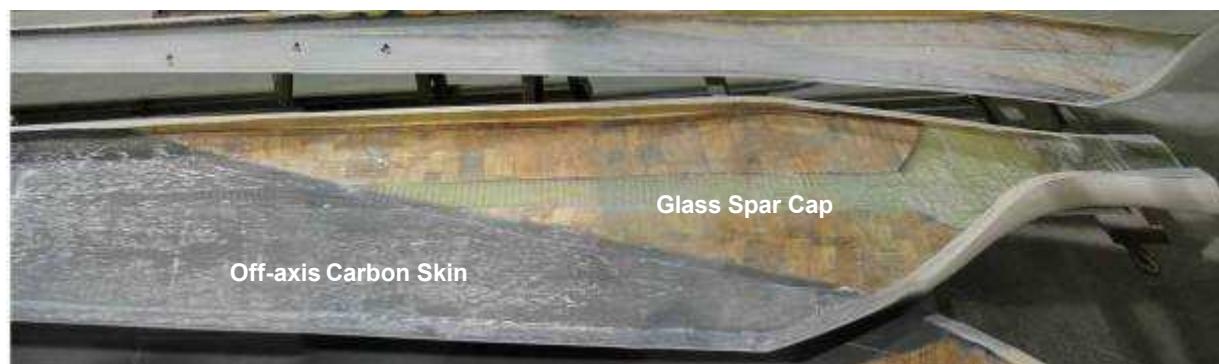
- TX-100 (Twist-Bend Coupled
Experimental 100 kW)
- Identical geometry to CX-100
- Partial-length glass spar cap
- 20° off-axis carbon in outboard (~>3.5 m) skins to produce material-induced, passive aerodynamic load alleviation

TX-100 Blade Skin

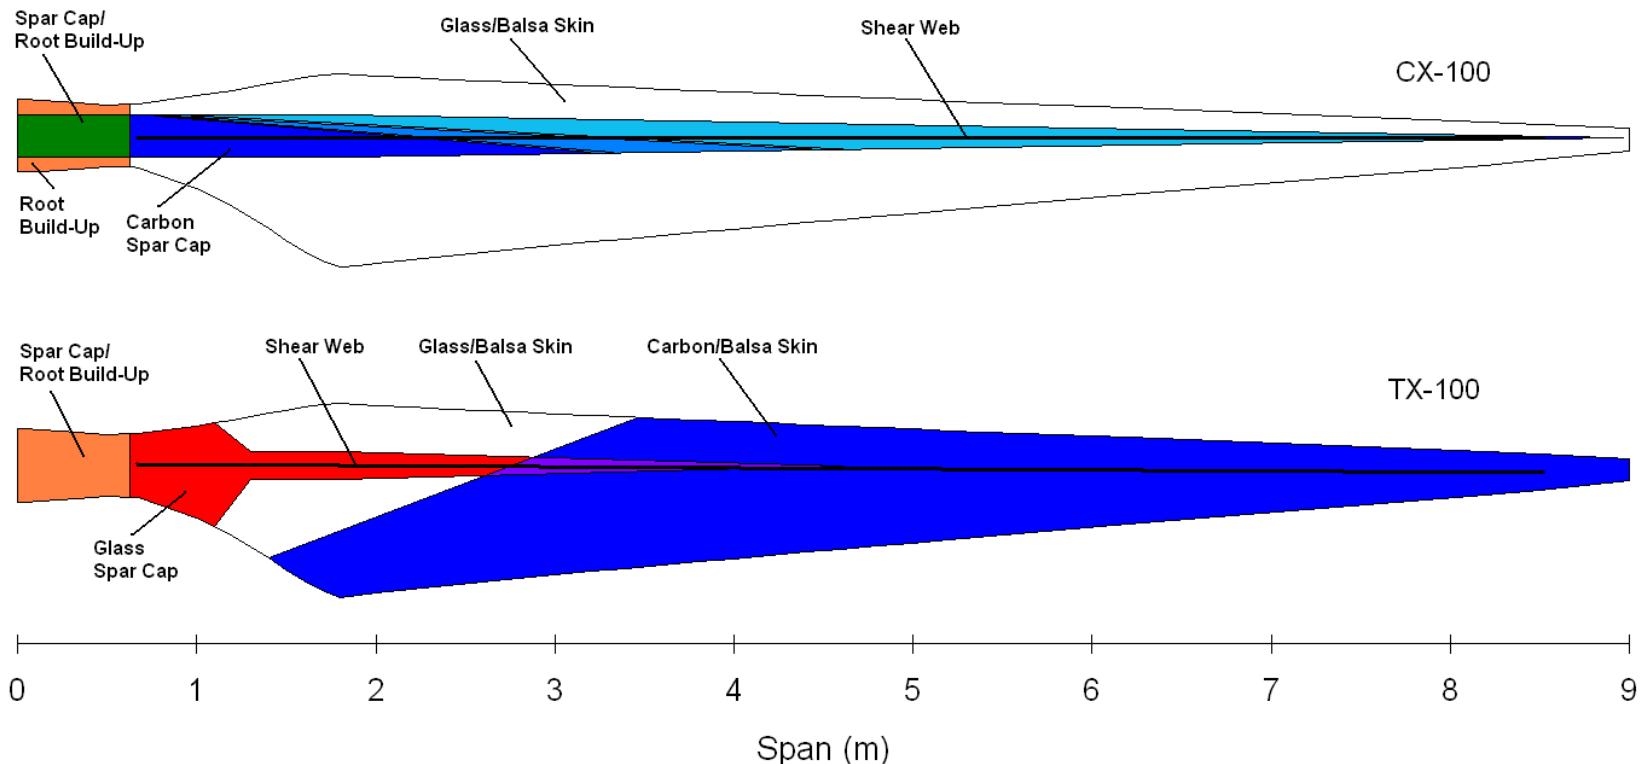
CX-100 (top) and TX-100 (bottom) Geometry and Major Laminate Regions

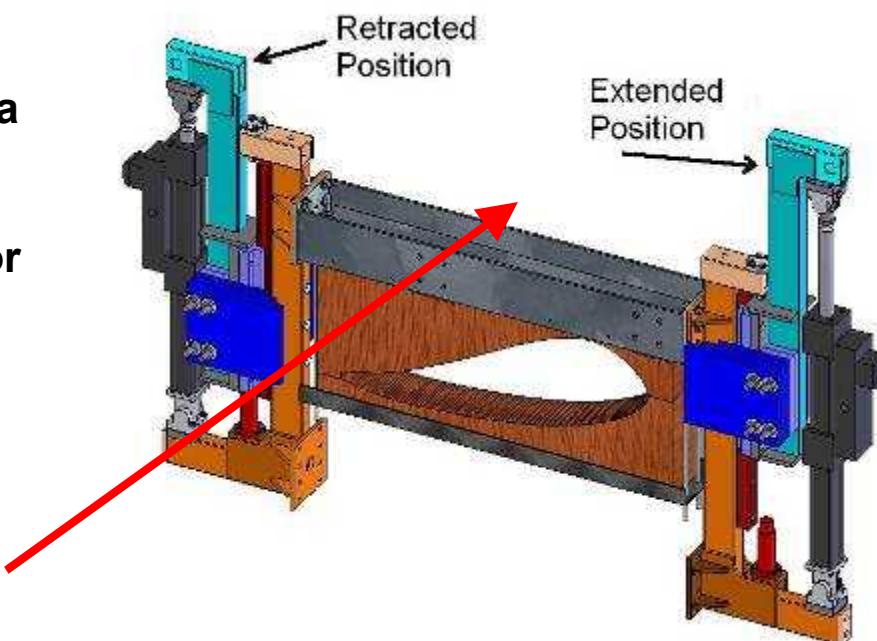
- Developed specifically for the unique aspects of testing bend-twist coupled blades
- Pair of hydraulic actuators mounted to the blade through a ballast saddle
- Rotational inertia minimized compared to mounting actuator and resonant mass above the blade
- Possible to apply torsional loading by adjusting actuator phases
- Horizontally mounted cylinder can be used to excite edge movement

UREX Schematic

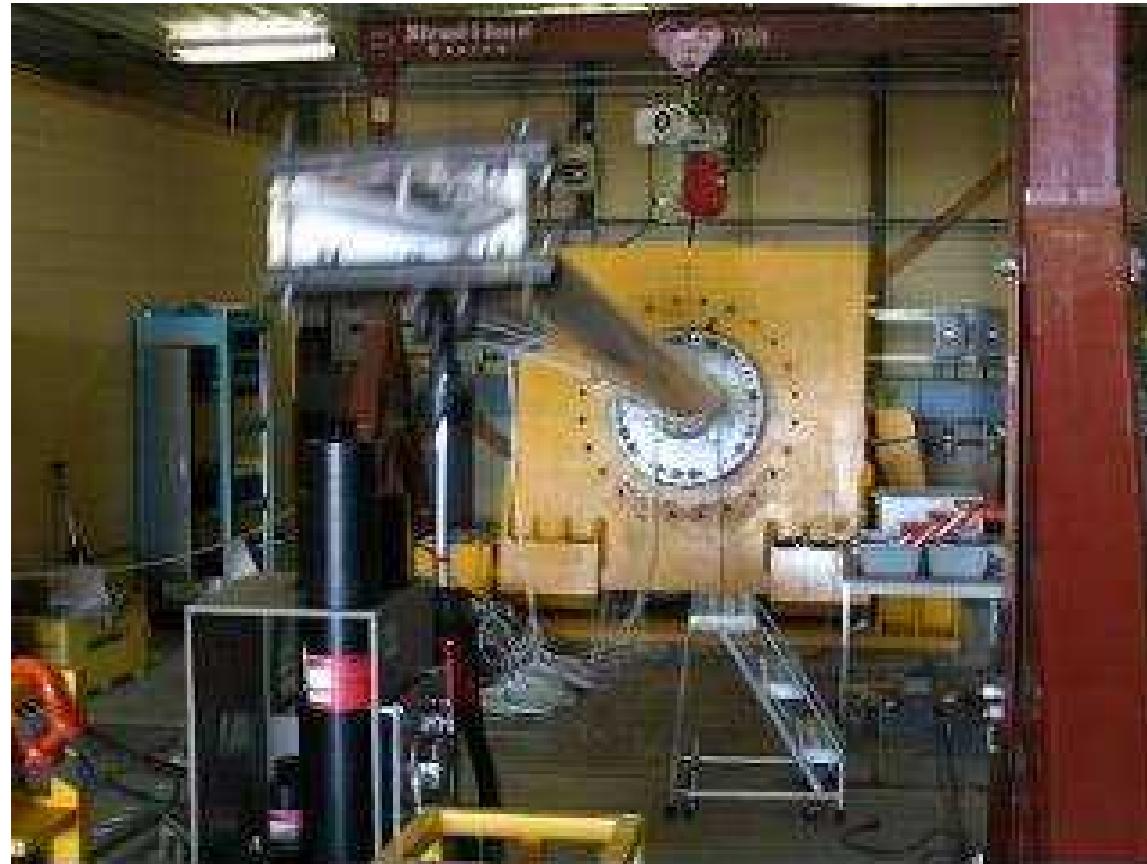
- **Fatigue analysis focused on carbon spar cap**
- **Slope parameter of 12 used (GL standards: 10 for glass, 14 for carbon)**
- **Single-axis flapwise point loading**
 - Hydraulic cylinder used to apply oscillating load at single point
 - Robust, simple setup
 - Only allows for target load matching in limited area
- **1.25-12.5 kN applied at saddle for 1M cycles, then increased by 10% every 500k cycles**
- **20-year fatigue equivalent life demonstrated in 6k cycles**

CX-100 Early in Fatigue Test

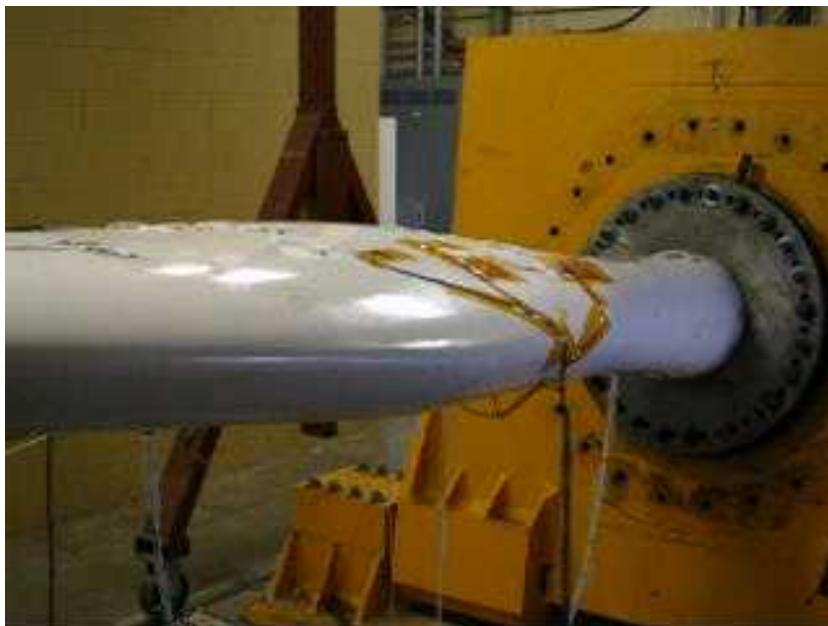
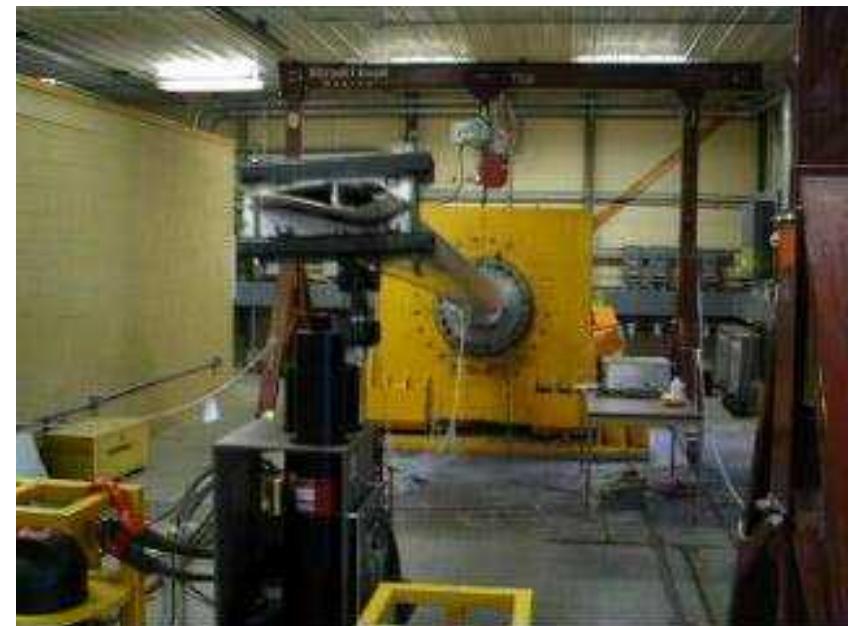
CX-100 Dimple (left) and Tip Movement (right) just before Failure

- Dimple formed early during test around max chord
- Low pressure skin pushed outward aft of sparcap and inward forward of sparcap
- At 1.5M cycles, crack began to grow along sparcap/aft-panel intersection
- Crack resulted in greatly decreased stiffness in the area and cause severe edgewise movement

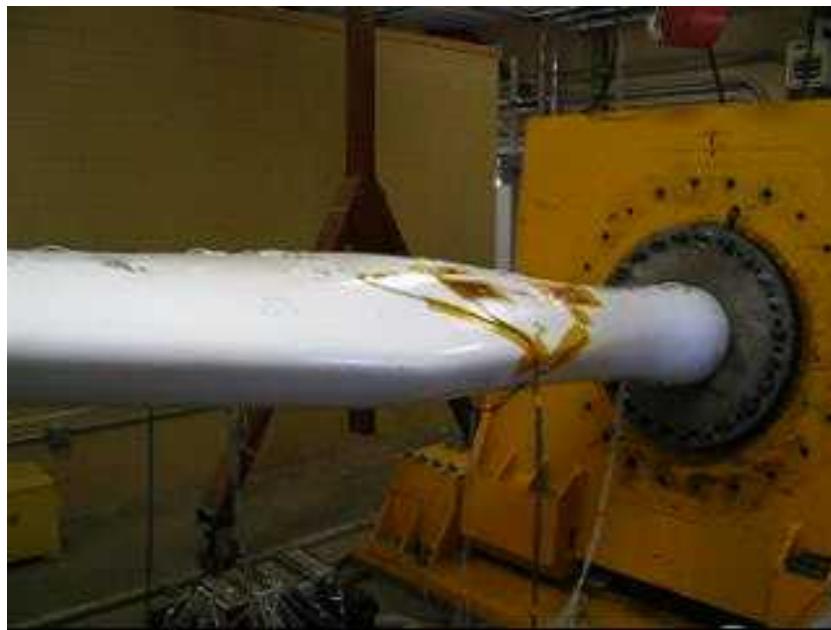
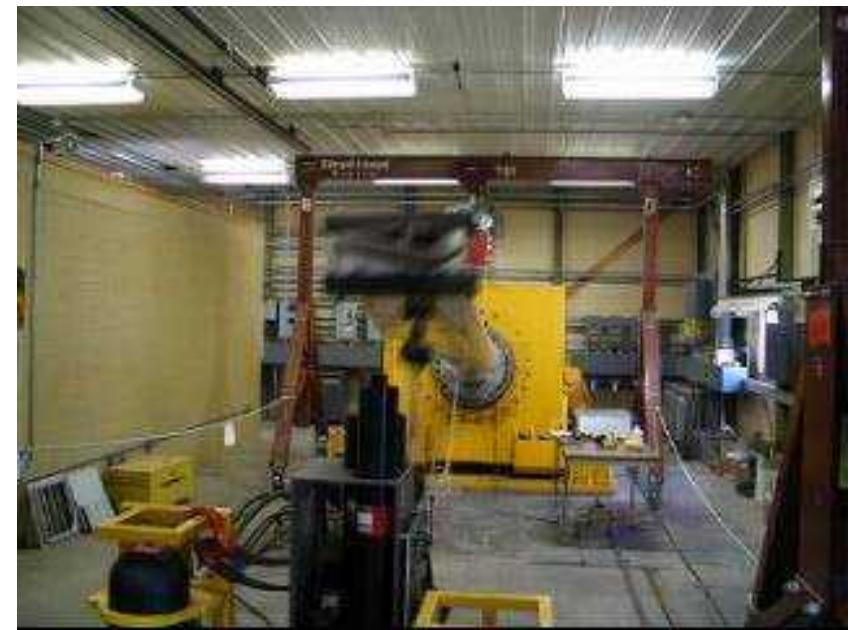
CX-100 Dimple (left) and Tip Movement (right) at Failure

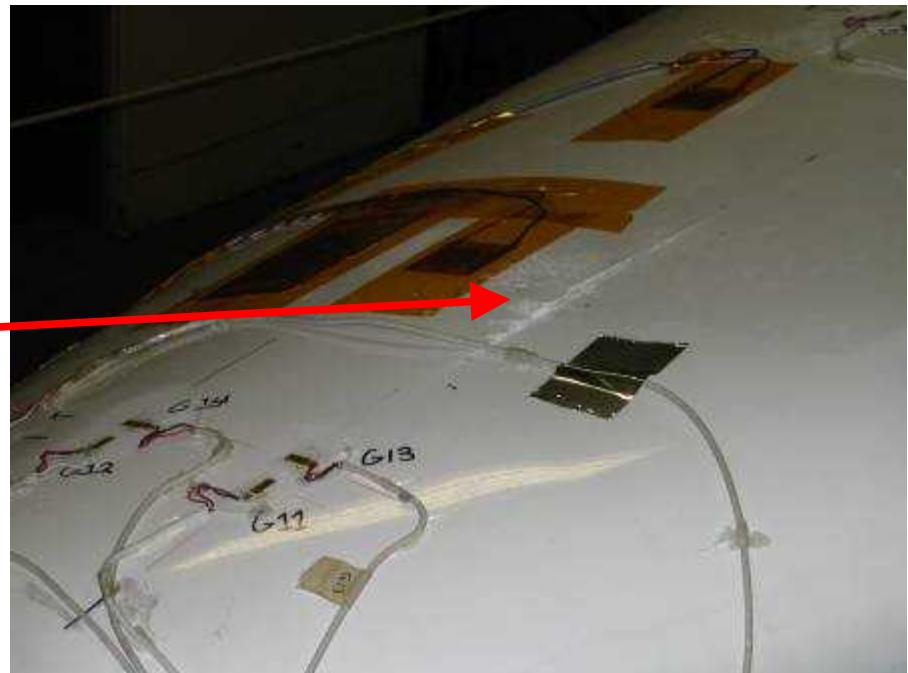
CX-100 Crack Growth

- CX-100 failed due to buckle formation near max-chord which caused a fracture between the sparcap and aft balsa panel leading to excessive edge movement
- TX-100 failed due to crack which grew from sparcap termination on HP surface along carbon fiber direction causing excessive tip rotation
- Infused carbon was effectively implemented in a CX-100 and TX-100 blade designs
- Both blades failed in carbon areas
- Blades failed due to damage in off-axis directions, showing the difficulty in using fiber-direction fatigue calculations

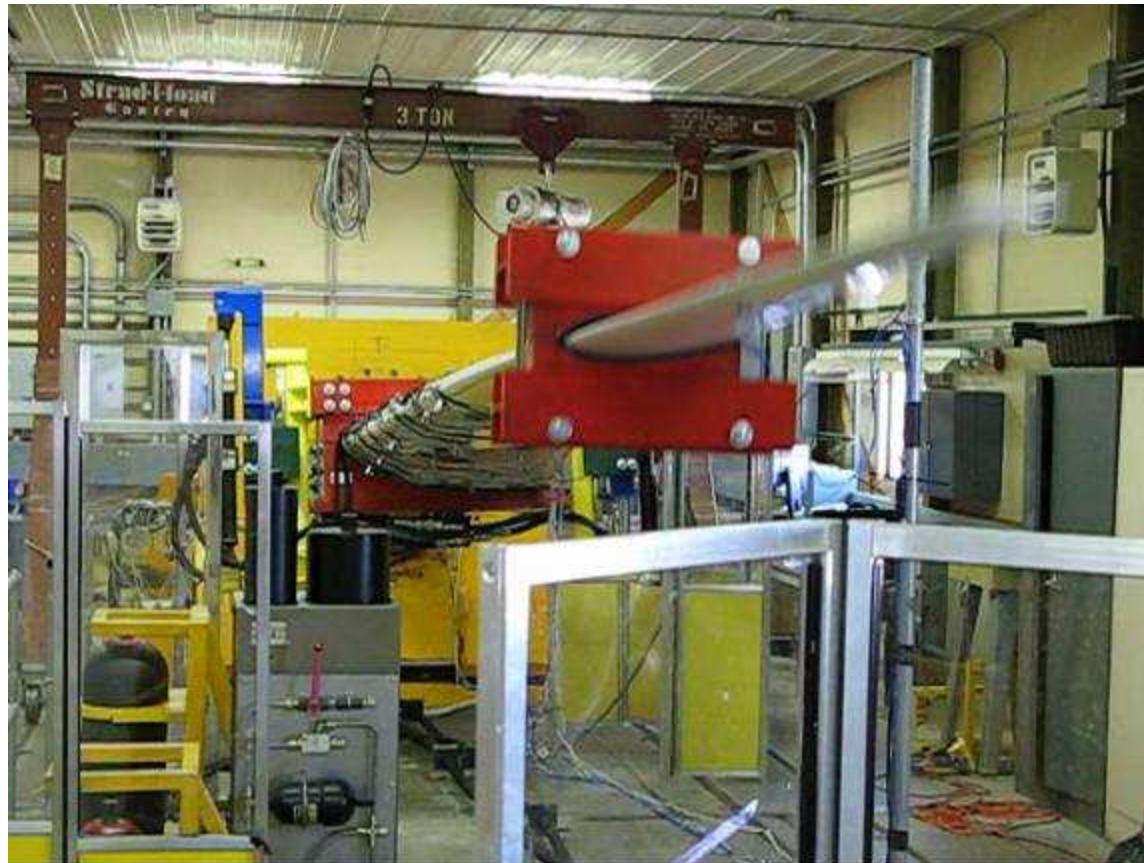
- **Fatigue analysis focused on both glass and carbon areas**
- **Slope parameter of 10 used (for off-axis loading)**
- **Single-axis flapwise resonant loading**
 - Uses oscillating mass to excite natural frequencies of blade-mass system
 - Mean load adjusted by exciter and ballast masses
 - Amplitude adjusted by exciter displacement
 - Complicated setup required to produce correct shape and amplitude
 - Potentially allows for load matching for large portion of blade span
- **1M, 2M, and 4M cycle test loads calculated**
- **Test began with 4M load and then increased 10% beginning at 1M cycle count and repeating every 500k cycles**
- **Unable to increase at 2.5M cycles, load was held constant thereafter**
- **20-year fatigue equivalent life demonstrated at 2M cycles**

TX-100 Early in Fatigue Test

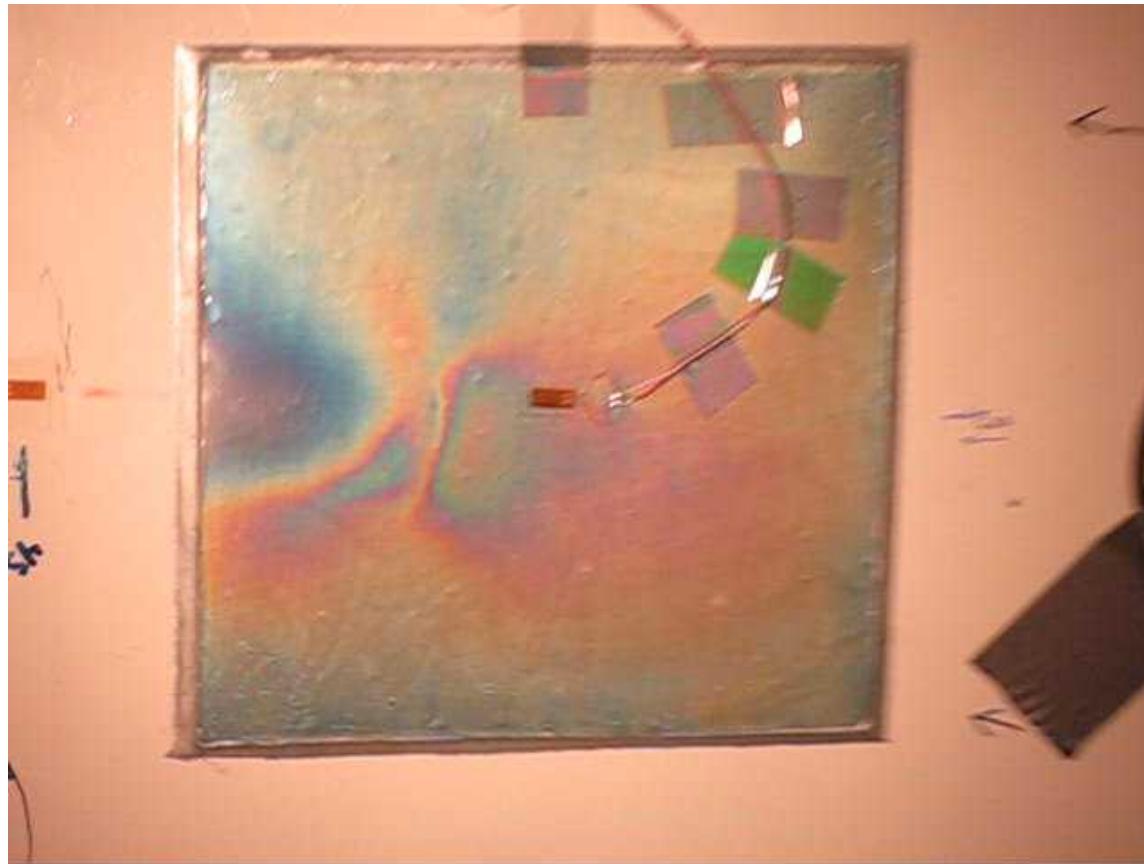
TX-100 Sparcap Tip Stress Contours

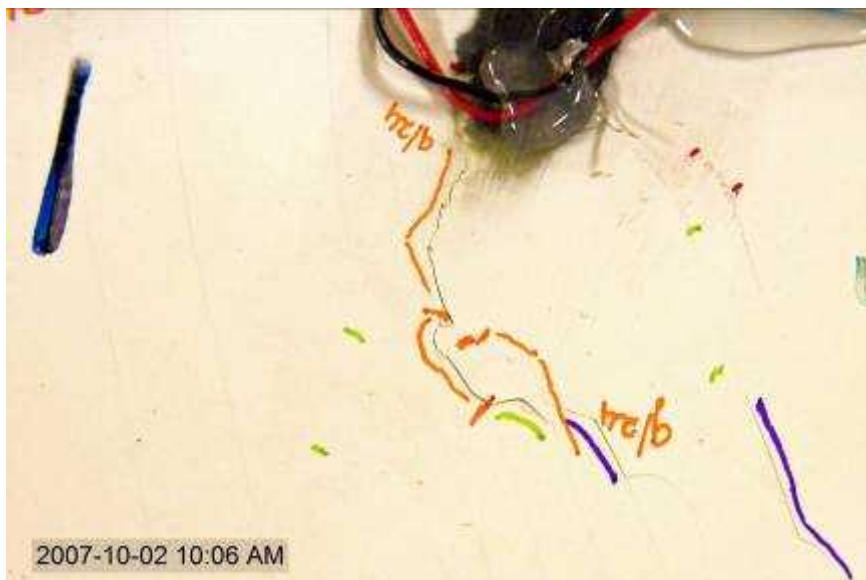
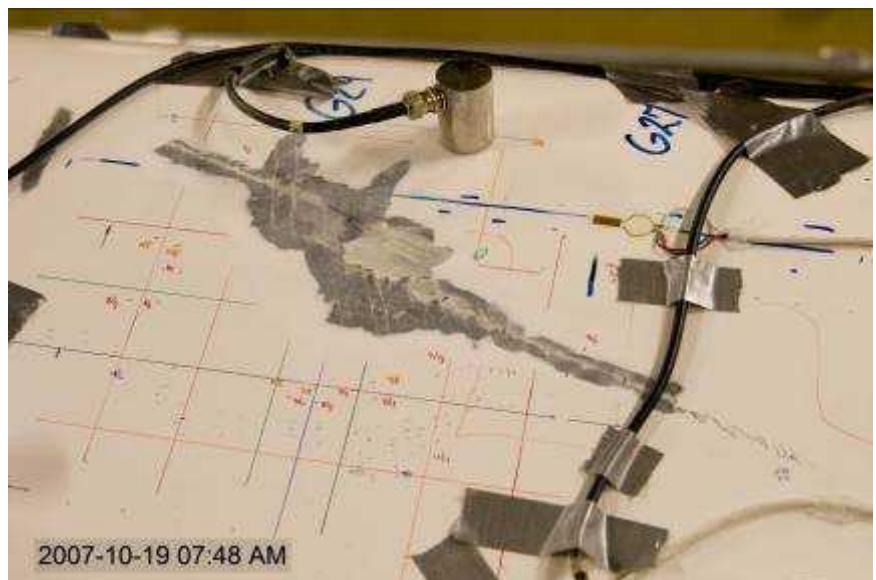
TX-100 Crack Growth Beginning (left) and Progression (right)

- At 723k cycle count, crack began to grow just outboard of HP sparcap termination
- Cracks grew at 65° angle from blade axis until 2.4M cycles
- Crack then changed direction and grew along 20° direction corresponding to carbon fiber direction
- Growth of crack continued until 4M cycles when excessive torsional movement of the blade tip occurred

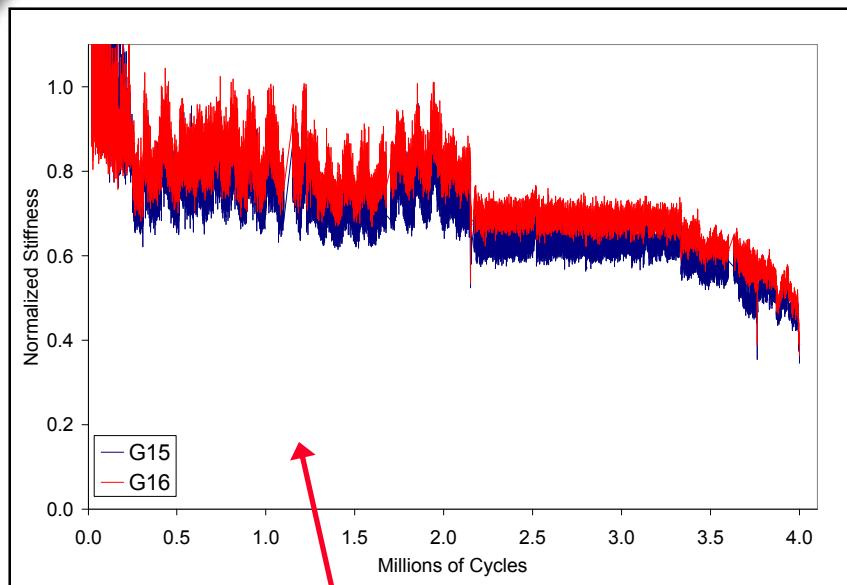
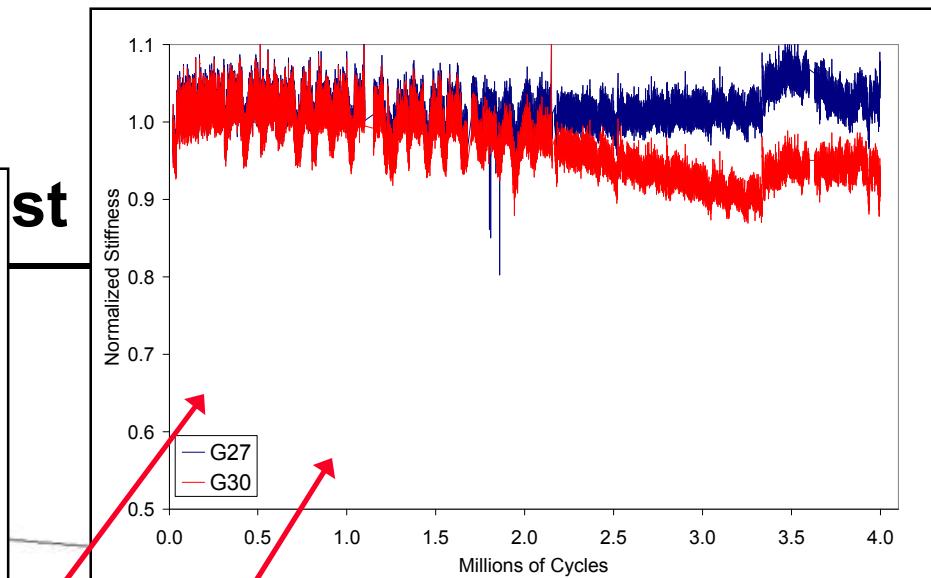
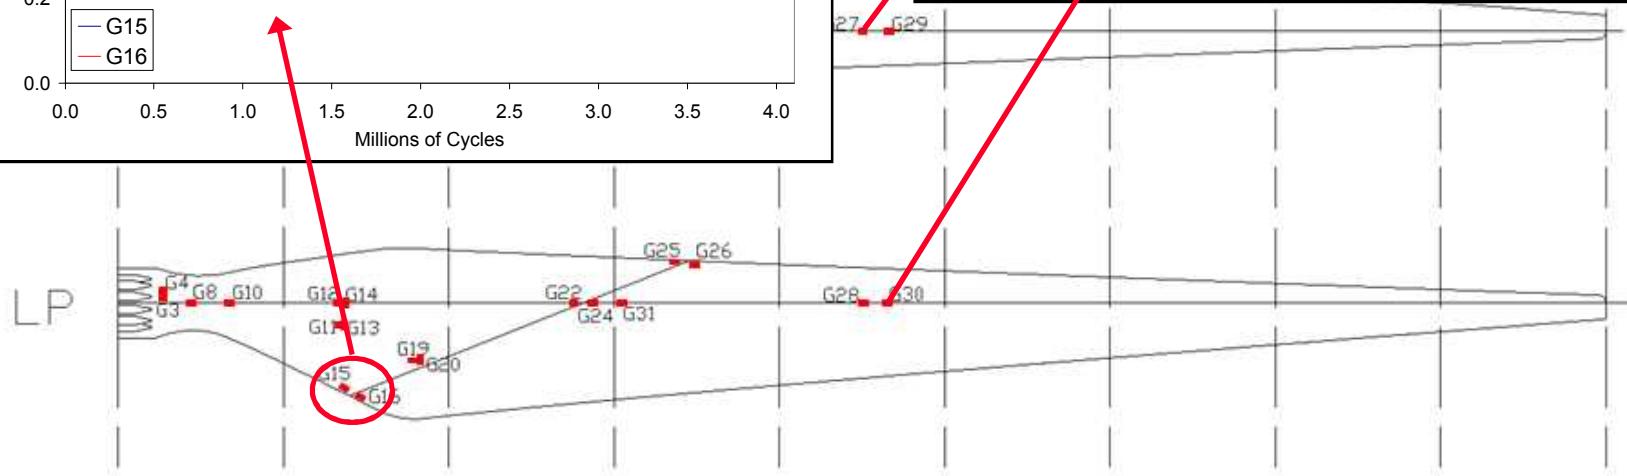
TX-100 Strain Gage Layout

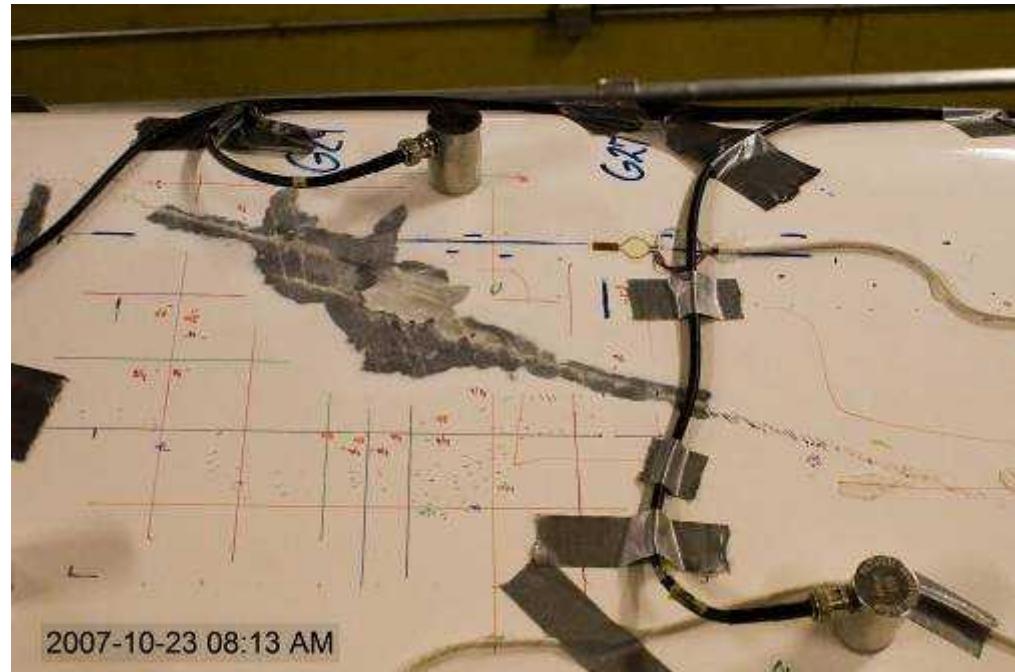
TX-100 HP Crack Growth
