Fatigue Testing of 9 m Carbon Fiber Wind Turbine Research Blades*

Fatigue testing was conducted on Carbon Experimental and Twist-Bend Experimental (CX-100 and TX-100) 9-m wind turbine research blades. The CX-100 blade was designed to investigate the use of a carbon spar cap to reduce weight and increase stiffness while being incorporated using conventional manufacturing techniques. The TX-100 blade used carbon in the outboard portion of the skin to produce twist-bend coupling to passively alleviate aerodynamic loads. In the fatigue tests, the CX-100 blade was loaded by a single hydraulic cylinder while the TX-100 blade was loaded via a hydraulically-actuated resonant loading system called the Universal Resonant Exciter. The blades were outfitted with approximately 30 strain gages as well as displacement and load sensors. Both blades survived to cycle counts sufficient to demonstrate a 20-year operational life. The CX-100 blade failed at approximately 1.6 million cycles because of a buckle and crack that formed and grew just outboard of max-chord. The TX-100 blade failed because of a crack that grew from the termination point of the spar cap at the midspan of the blade. This paper

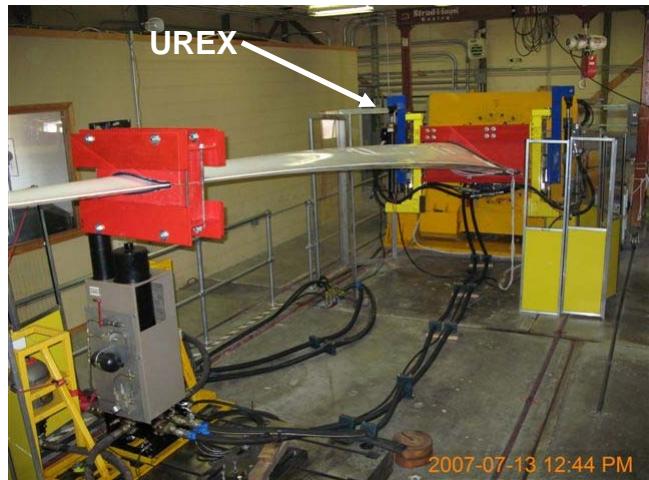
Figure 9: TX-100 Test setup photograph.

provides a photograph of the TX-100 test setup. In addition, although not employed for the TX-100 test, the UREX can tune an applied torsional loading by adjusting the displacements, relative phases, and associated oscillating masses for the two independent actuators.

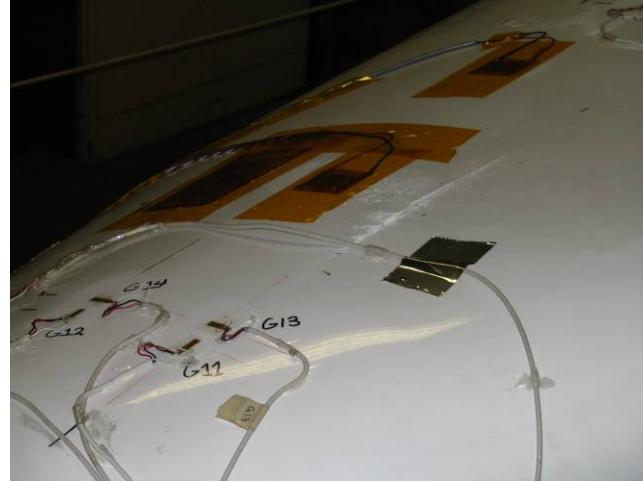
Figure 16: CX-100 low-pressure skin damage area.

The CX-100 test proceeded without significant damage until the 1.5-million cycle count. Throughout the test, a notable dimple in the blade was apparent in the low-pressure skin, at the 1100-mm station toward the trailing edge of the blade. The out-of-plane depth of the dimple progressed during testing. Spanwise surface cracks were noted at the 1.5-million cycle count between the 1200-mm and 1400-mm stations. These surface cracks formed at the junction of the carbon spar cap and the trailing edge panel. By the 1.6-million cycle level, the cracks had progressed through the thickness of the skin and the test was stopped. The out-of-plane movement of the skin once the crack had fully penetrated the skin became progressively larger. In addition, the blade stiffness had decreased by approximately 12% from the initial stiffness, and the lead-lag motion of the blade progressively

increased. Subsequent investigations indicate the increased crack length and development of a disbonding between the LP skin and spar cap led to increasing larger out of plane panel deformation leading to gross panel buckling. Figure 15 provides a photograph of the damage area of the CX-100.

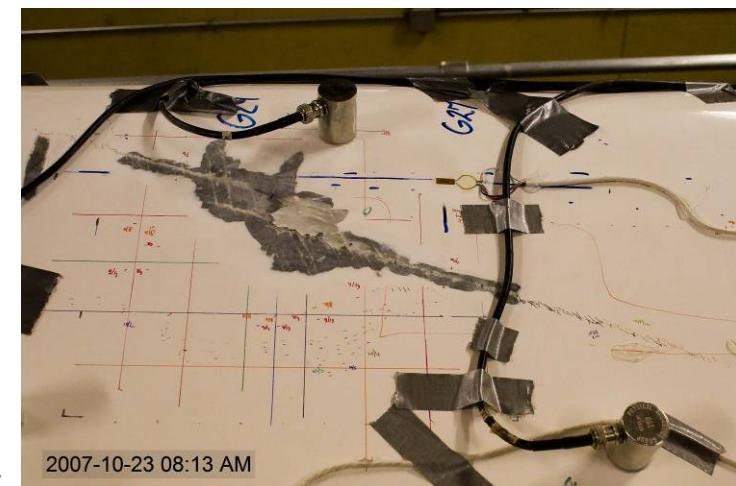
Figure 18: TX-100 high-pressure skin damage area.

The test was stopped at the 4-million cycle count because of excessive torsional motion of the blade tip and an accelerated increase in rate of crack length. Figure 18 provides a photograph of the damaged area on the high-pressure surface of the blade at the 4500-mm station; the gel coat was removed to expose the fiberglass and carbon fiber laminate. The incipient cause of damage to the TX-100 was the outboard

termination of the spar cap, which ends at the 4500-mm station. The spar cap termination caused a stress riser in the stressed-skin laminate.
