## OPERATIONAL RESULTS OF RUSSIAN-BUILT PHOTOVOLTAIC ALTERNATIVE ENERGY POWERED LIGHTHOUSES IN EXTREME CLIMATES

This paper summarizes operational histories of three Russian-designed photovoltaic (PV) lighthouses in Norway and Russia. All lighthouses were monitored to evaluate overall system and Nickel Cadmium (NiCad) battery bank performance to determine battery capacity, charging trends, temperature, and reliability. The practical use of PV in this unusual mode, months of battery charging followed by months of battery discharging, is documented and assessed. This paper presents operational data obtained from 2004 through 2007.

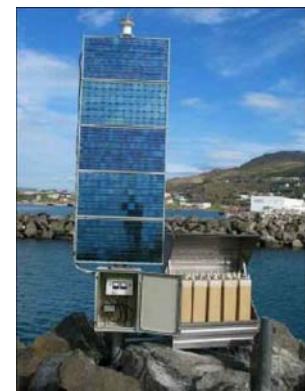
Initially, two Russian-built photovoltaic systems (Saturn Company of Krasnodar) were installed in Honningsvag, Norway and at Cape Shavor in the Murmansk region of Russia. Figure 1 shows the PV, controller, batteries, and lighthouse unit installed in Honningsvag, Norway. Sandia National Laboratories and the Southwest Technology

Fig. 1: PV Lighthouse, Honningsvag, Norway.

The photovoltaic system installed in the summer of 2003 in Honningsvag, Norway (Figure 1) is identical to the system installed in Cape Shavor. The system consists of five PV 40 Wp modules capable of producing 200 Wp total. A charge controller is used for charging the 12 Volt, 950 Ah NiCad battery bank. The system is designed to operate a 10 Watt Navi-Dals LED beacon at a 50 percent duty cycle throughout the polar night. The DAS was operated from January 27 through June 5, 2004. This allowed collection of data during the period of lowest battery voltage from maximum winter discharge to full summer recharge of the batteries. Figure 9 shows the battery voltage during this period (1).

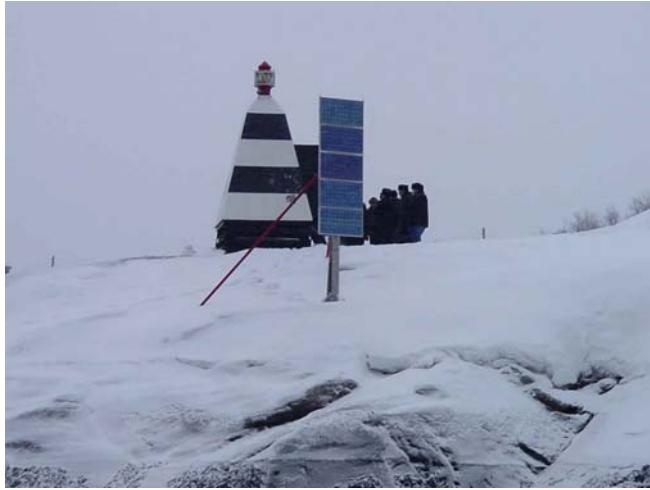
The Cape Shavor system in Russia, shown in Figure 3, was installed in 2003/4. The Cape Shavor data logger began recording data in June, 2004. Figures 4 and 5 present NiCad

Fig. 3 : Saturn PV lighthouse system at Cape Shavor, Murmansk, Russia.
