# Etch-Induced Defects Govern the Strength of Microfabricated Silicon

SAND2008-0570C

32nd International Conference & Exposition on Advanced Ceramics and Composites  
January 29<sup>th</sup>, 2008

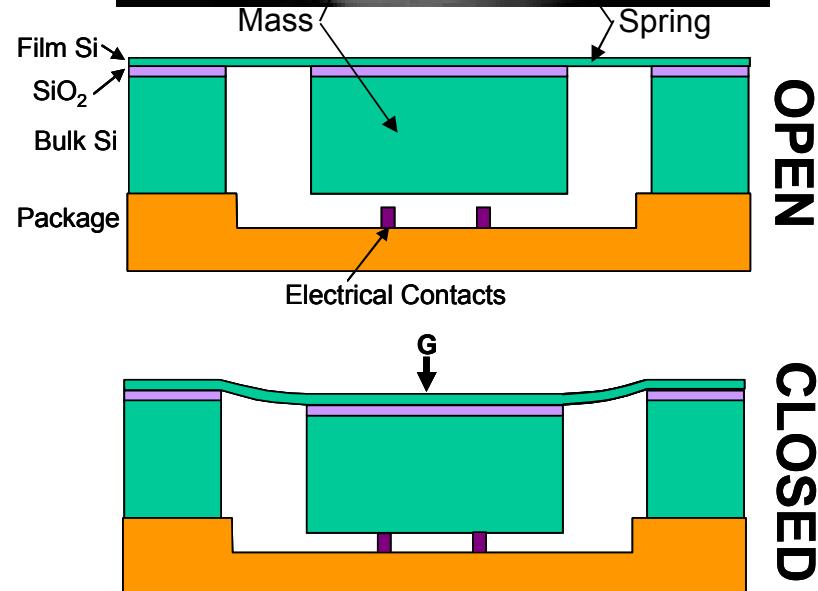
# Motivation: A Silicon-On-Insulator (SOI) Accelerometer Switch

## DESIGN REQUIREMENTS:

- Acceleration level requirements: activate at a specific G-band,  $G < 25$
- 3.3 V on switch, nominal 3 mA
- Stable, known contact resistance
- Lifetime of 30 years
- **Reliability of 0.95**
- Temperature requirements
  - (MIL SPEC -55C to 125)
- **Random Vibration, 20 to 2000 Hz**
- Flight Loading
- Shock requirements

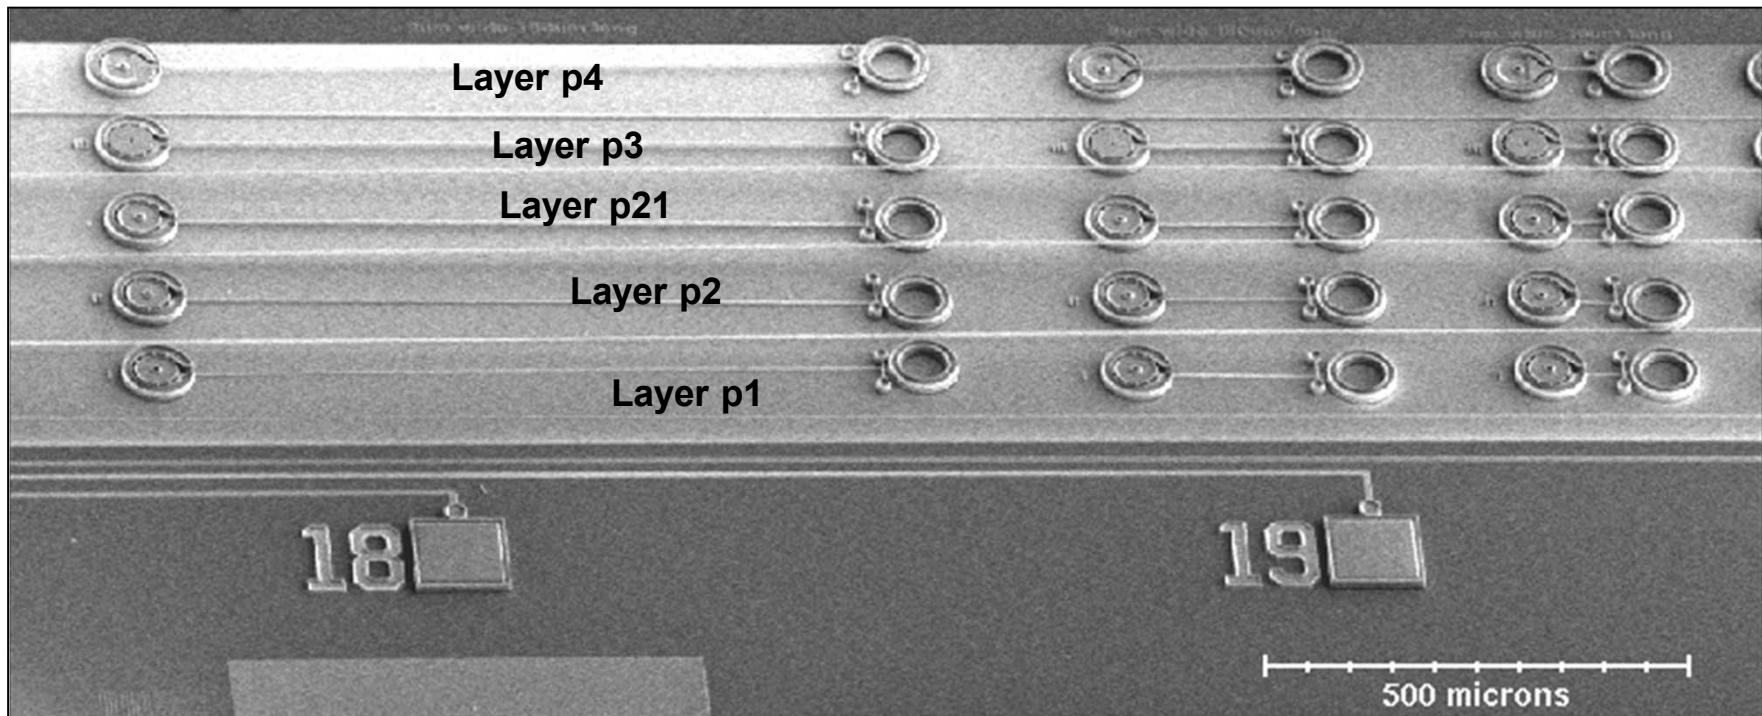
*SEM image of test structures*

**Tensile bars are 2  $\mu\text{m}$  wide with gage lengths  
of 30, 150, 750, or 3750 microns.**

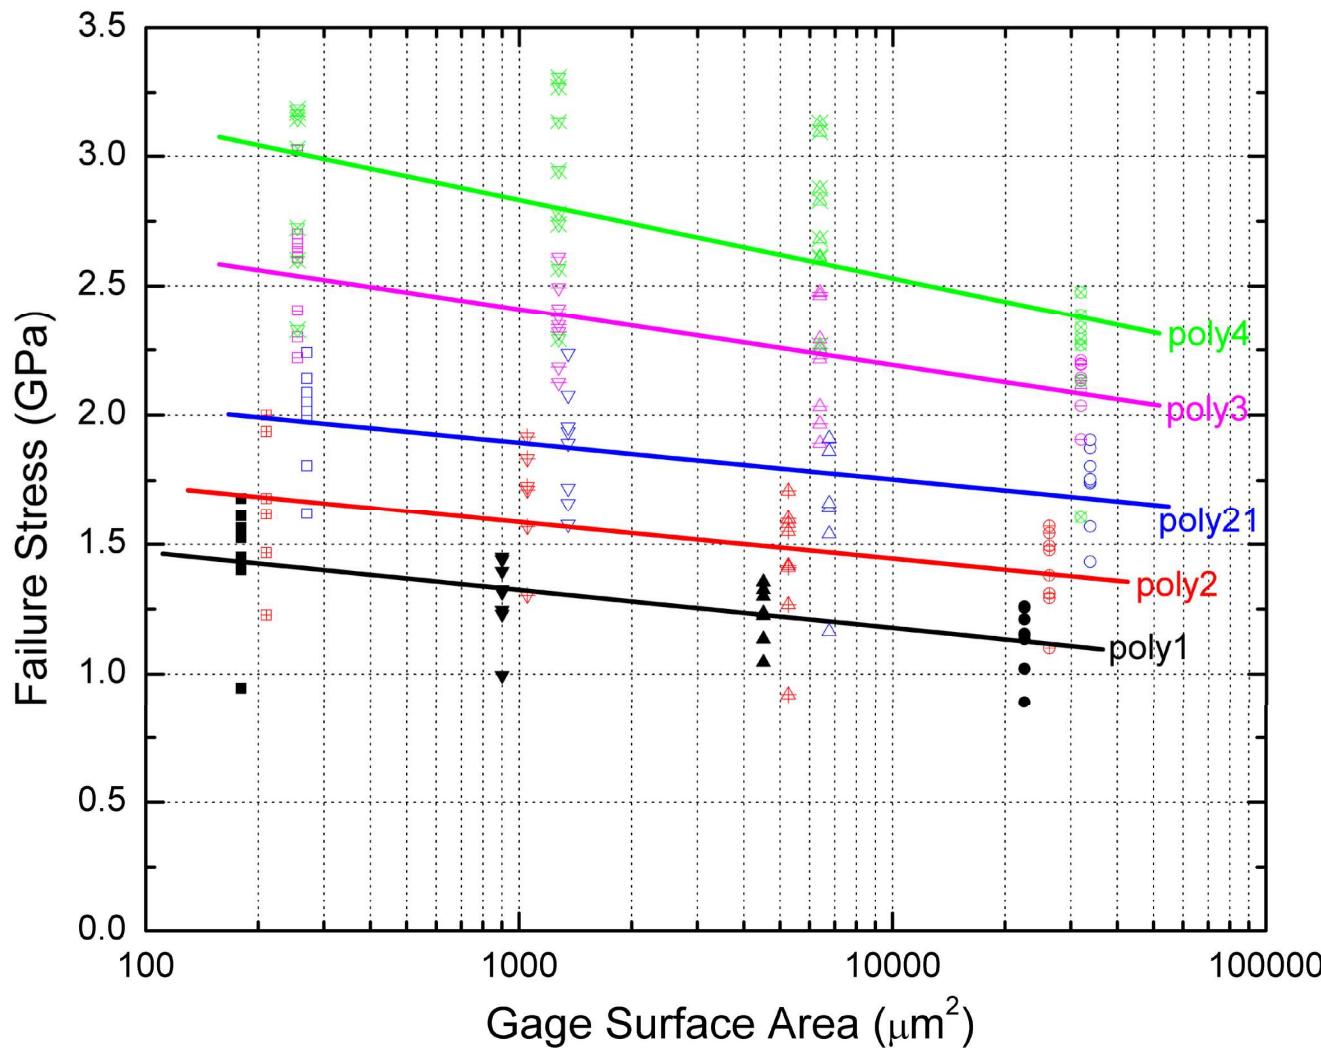
# Strength varies as a function of specimen size (Weibull size effect)

$$\left( \frac{\sigma_1}{\sigma_2} \right) = \left( \frac{A_2}{A_1} \right)^{1/m}$$

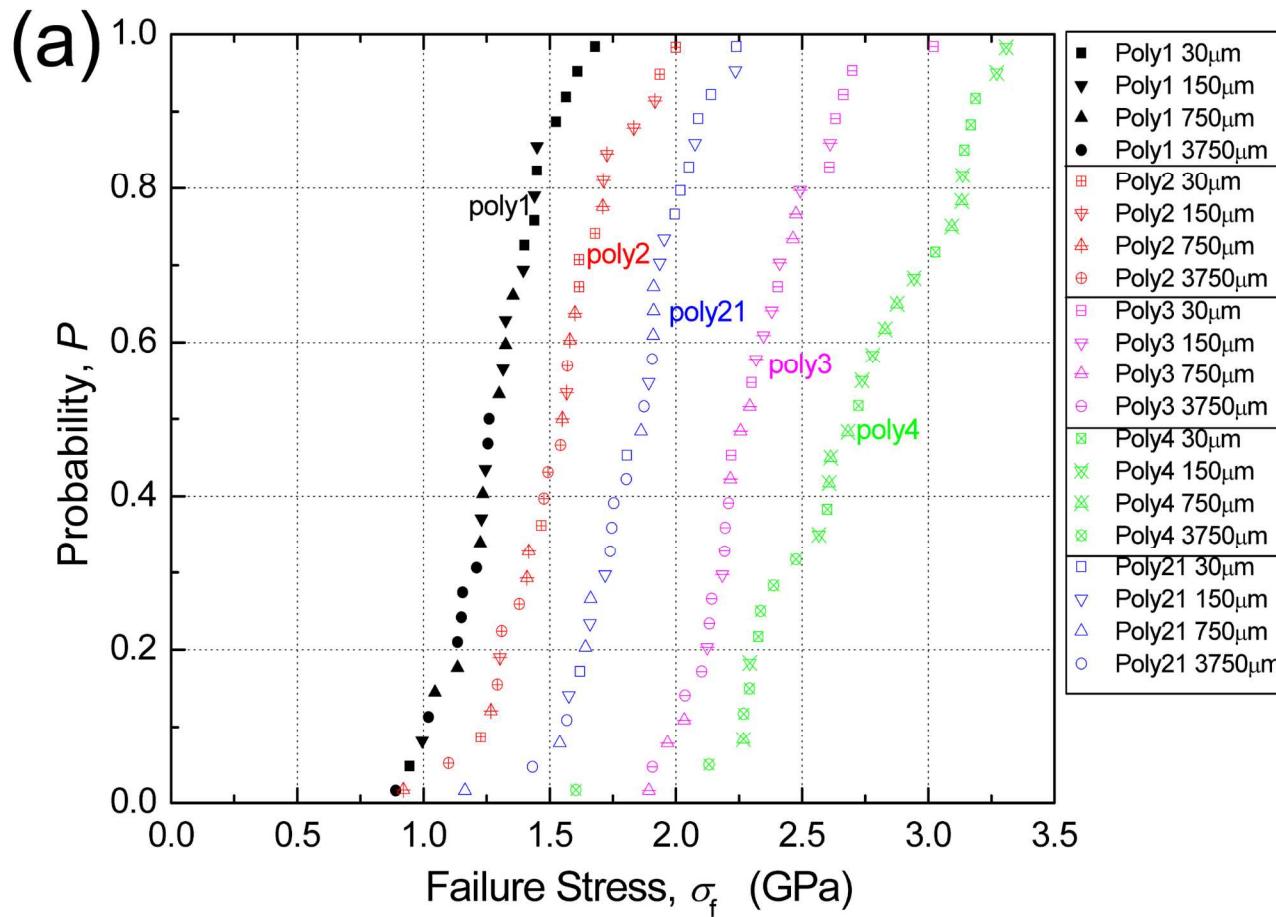
# Each layer of SUMMiT V polysilicon has a different strength distribution

Sandia's SUMMIT V MEMS process utilizes a stack of 5 layers of polysilicon. Each layer has a different strength.

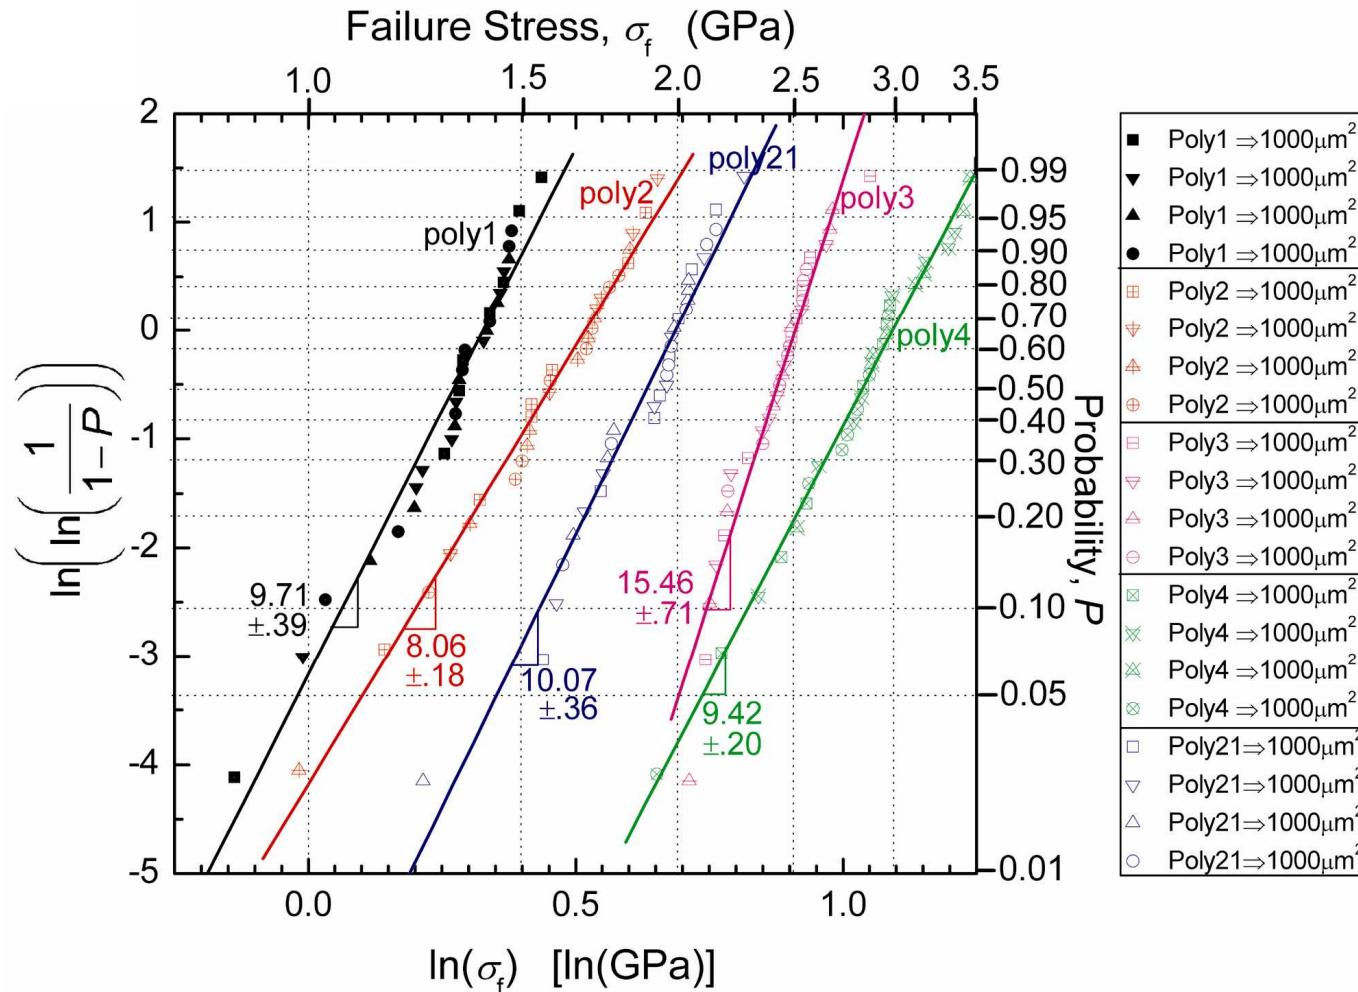
# Each layer of SUMMiT V polysilicon has a different strength distribution

$$P = 1 - \exp\left[-\left(\frac{\sigma}{\sigma_\theta}\right)^m\right]$$

$$\ln\left(\ln\left(\frac{1}{1-P}\right)\right) = m \ln \sigma - m \ln \sigma_\theta$$

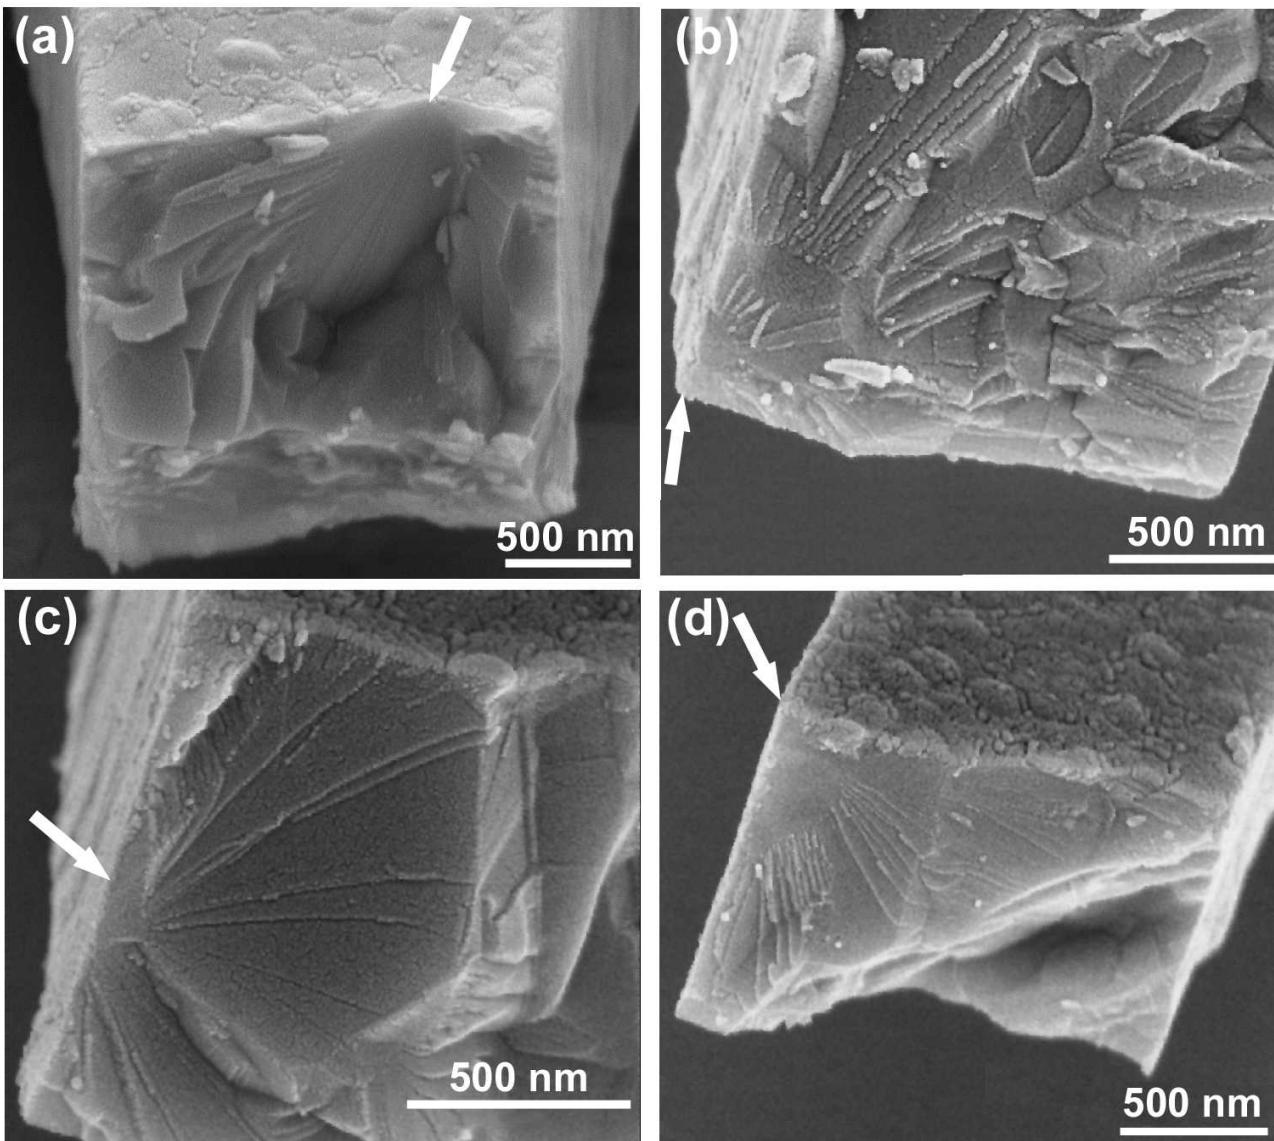
# 1 Release Etching Produces Nanoscale Failure-Inducing Surface Roughness

**Characteristic**  
“mirror”, “mist”, and  
“hackle” features can  
be confounded by the  
interplay between the  
relatively coarse  
crystallites and the  
crack path.

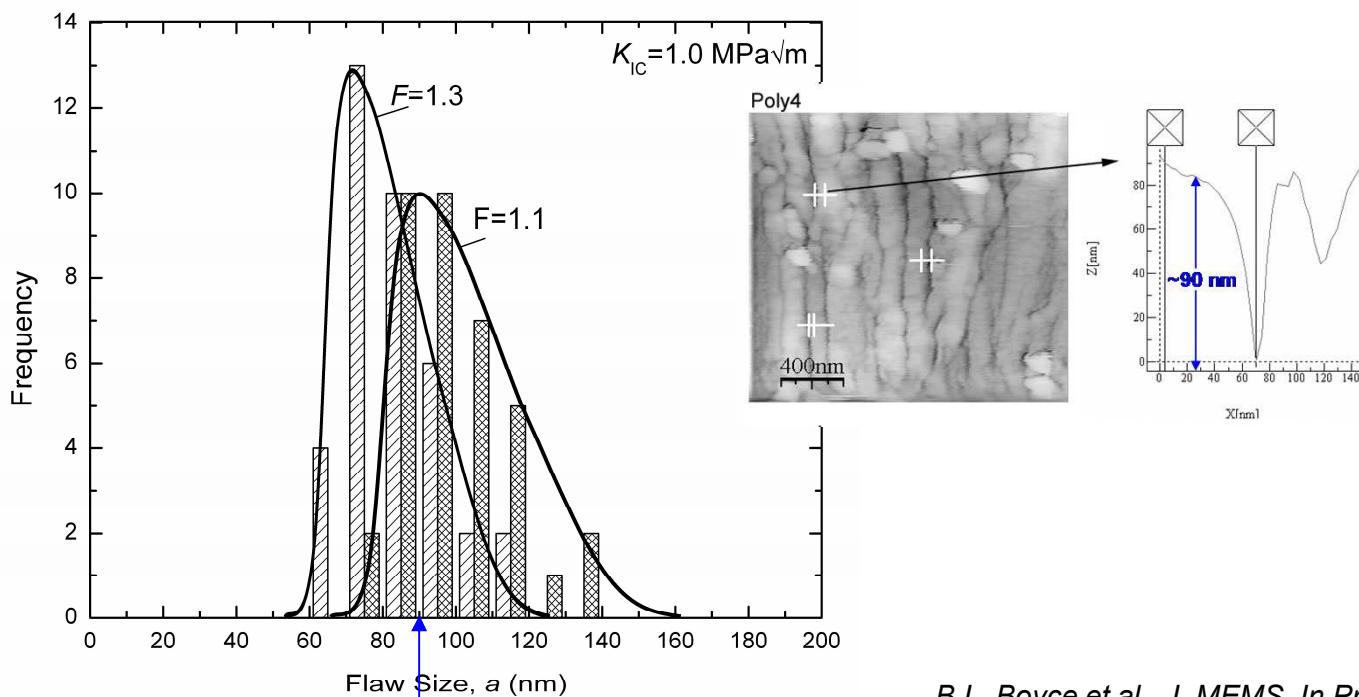
# Fracture Mechanics Is Consistent With Surface Roughness as a Critical Flaw

$$K_{IC} = \frac{2}{\pi} F \sigma_f \sqrt{\pi a} \Rightarrow a = \frac{\pi}{4} \frac{K_{IC}^2}{F^2} \frac{1}{\sigma_f^2}$$

fracture toughness  
flaw size  
geometry factor  
fracture strength

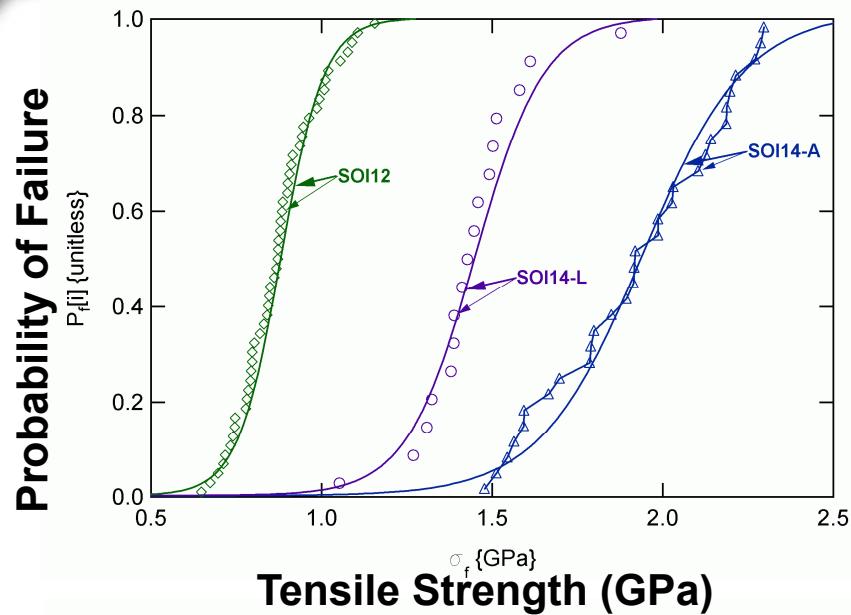
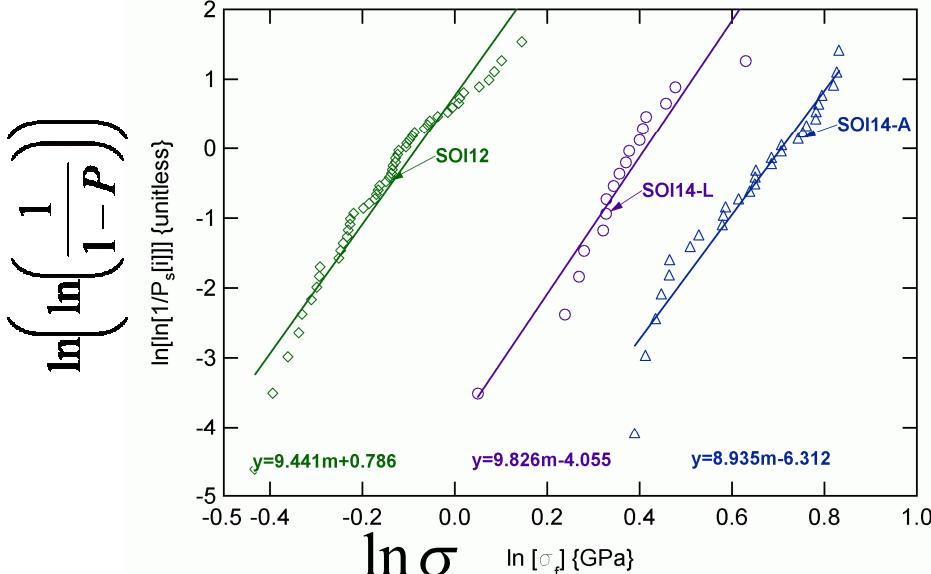
# Silicon-On-Insulator Exhibits Wide, Die-Dependent Strength Distributions

$$P = 1 - \exp\left[-\left(\frac{\sigma}{\sigma_\theta}\right)^m\right]$$

$$\ln\left(\ln\left(\frac{1}{1-P}\right)\right) = m \ln \sigma - m \ln \sigma_\theta$$

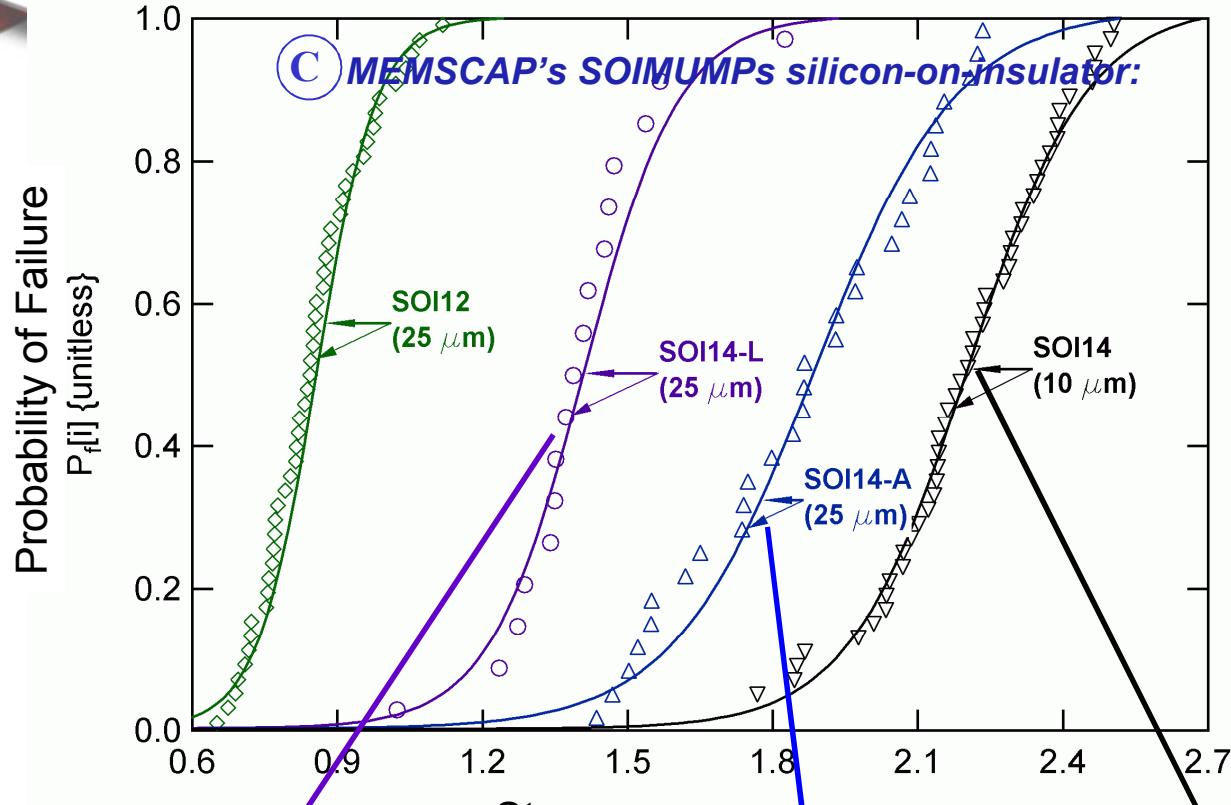
# 1 Example 2: Edge Defects in SOI

$\sigma_f = 1.39$  GPa

$\sigma_f \approx 1.9$  GPa

$\sigma_f = 2.15$  GPa

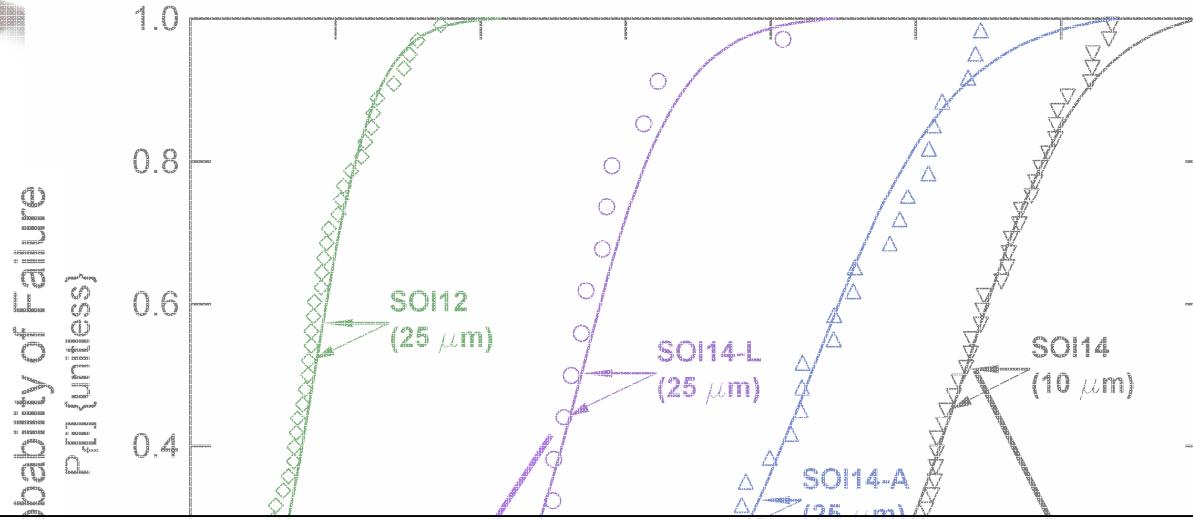
## Example 2: Surface Roughness in SOI

Erosion of the resist pattern's sloped edge is thought to be the cause of these defects. The slope of the resist is very sensitive to the coating, exposure and develop conditions.

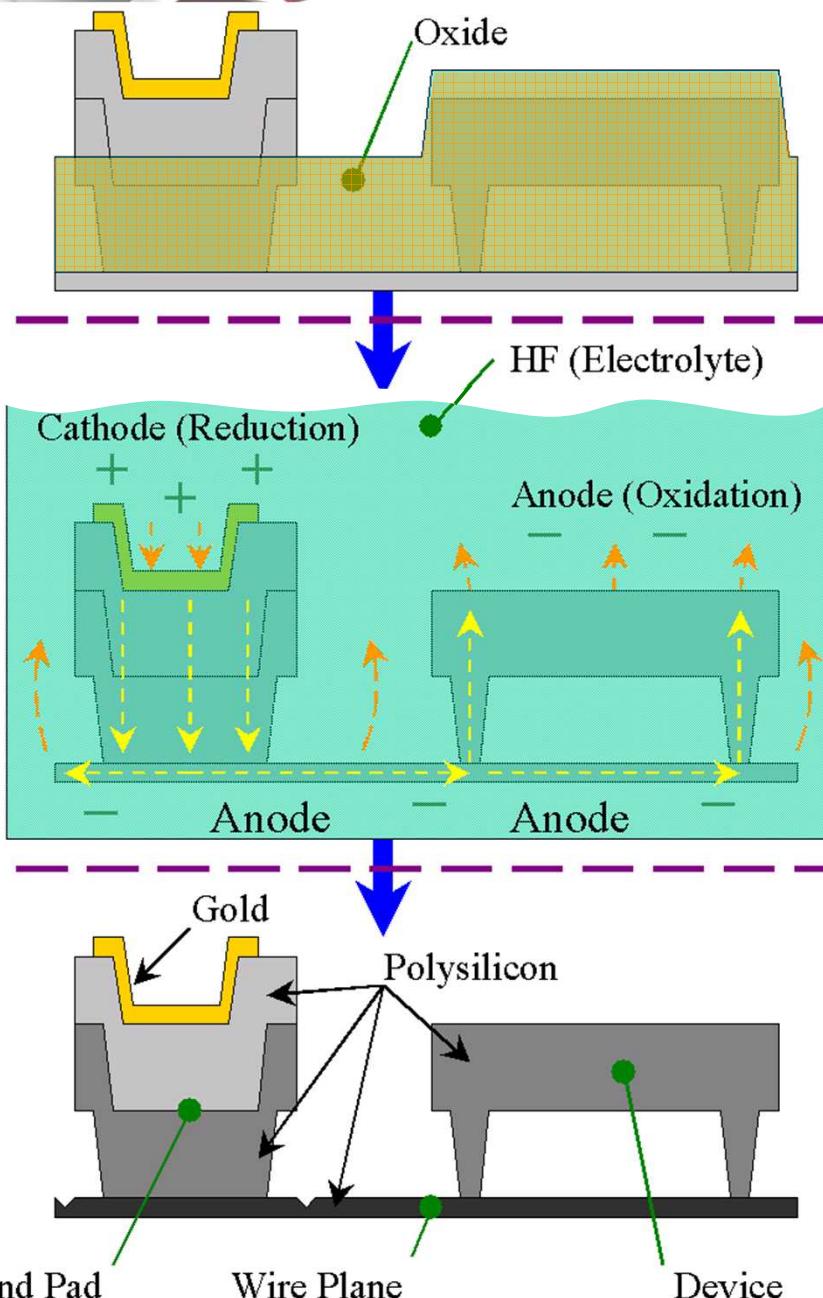
## 2 Au-Si Galvanic Corrosion during HF Release

*Oxygen reduction @ cathode*

*Silicon dissolution, flourine absorbed @ surface,  $\lambda=2$*

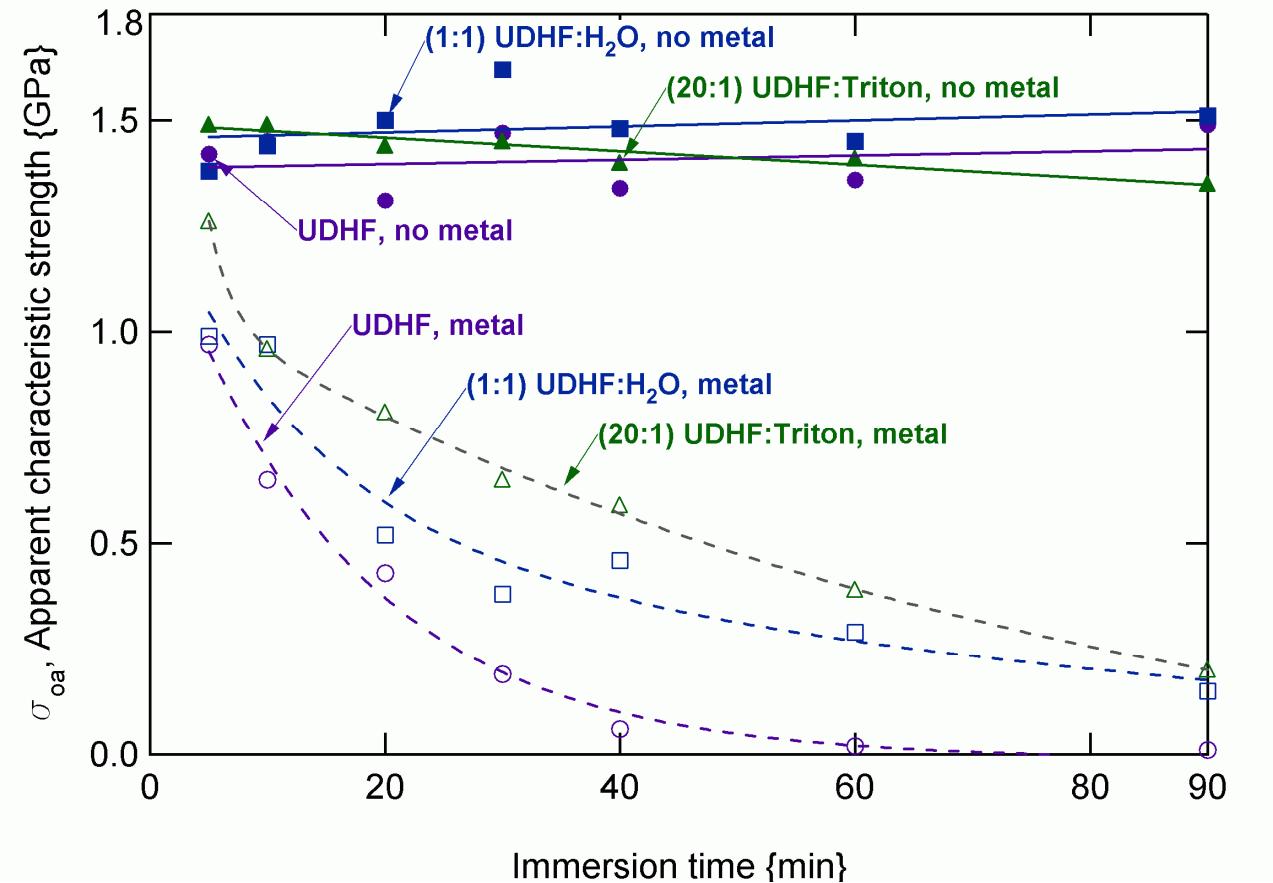
## 2 Observations on Etch-Time Dependent Strength Reduction

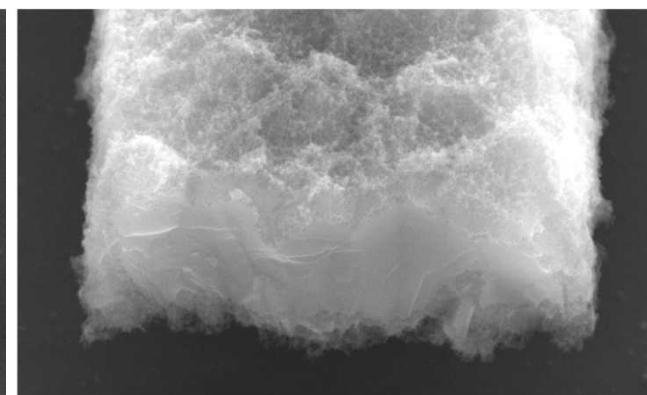
## 2 Corrosion Morphology Progression

5 min

30 min

60 min

90 min

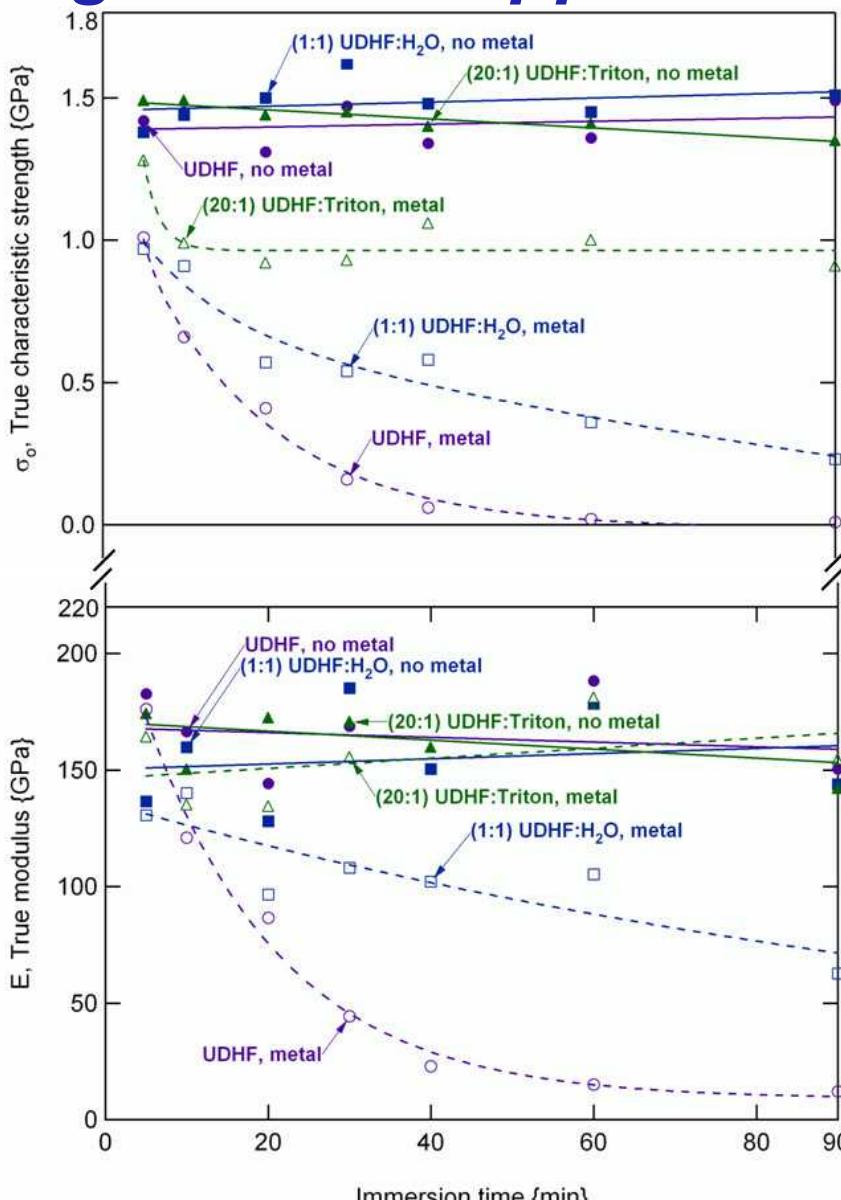
# The corrosion-induced structural damage also degrades the apparent modulus of Si

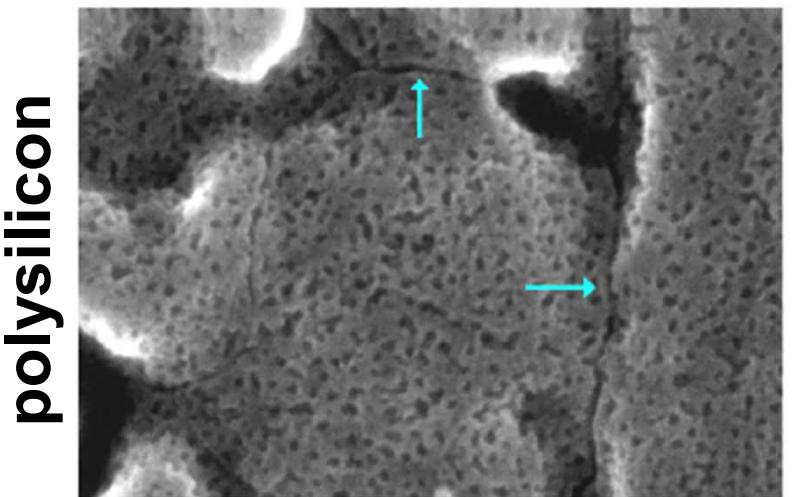
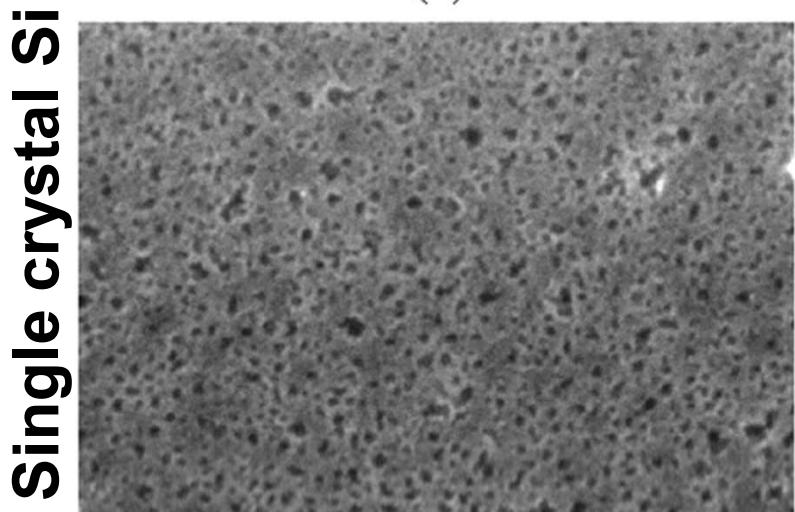
# Corrosion-Induced Nanoporosity

In both single crystal and polycrystalline Si, corrosion causes nanopores and ensuing surface oxidation, but of course single crystal Si does not suffer from preferential grain boundary attack.

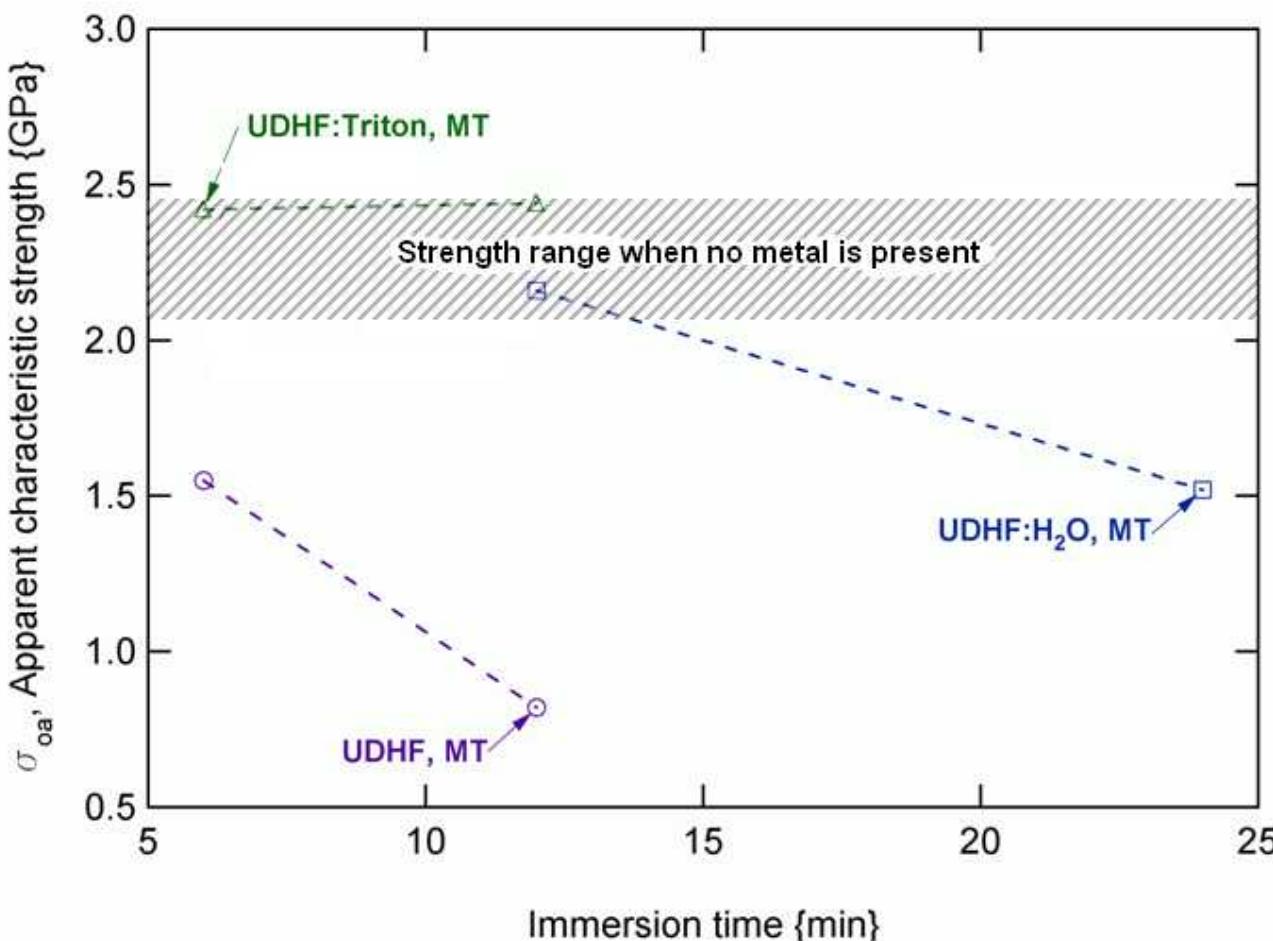
# Single-crystal Silicon (SOI) Etch-Time Dependent Strength Degradation

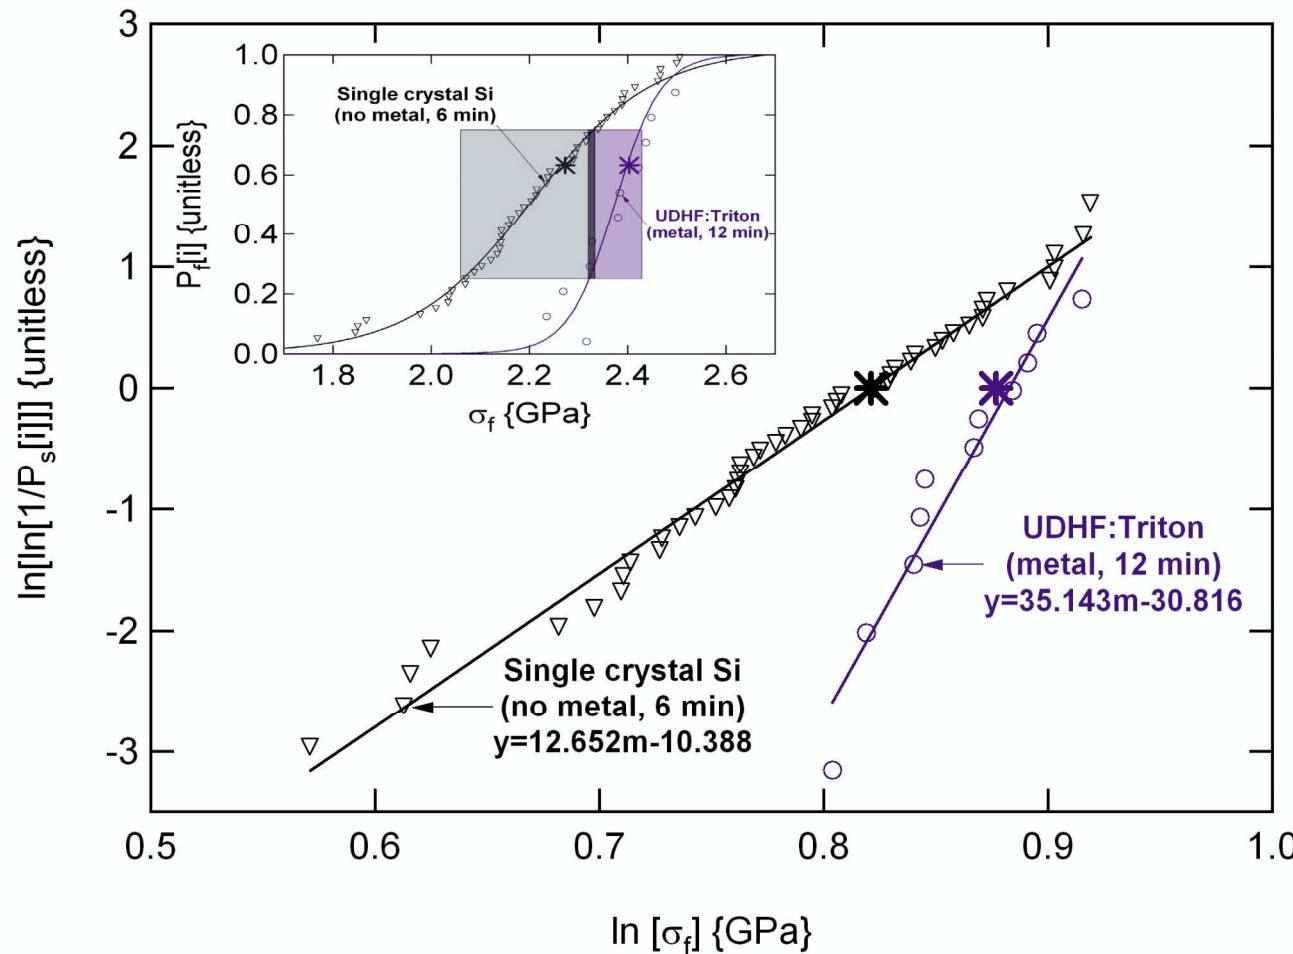
# Conundrum: galvanic corrosion of single-crystal Si in Triton actually improves strength!

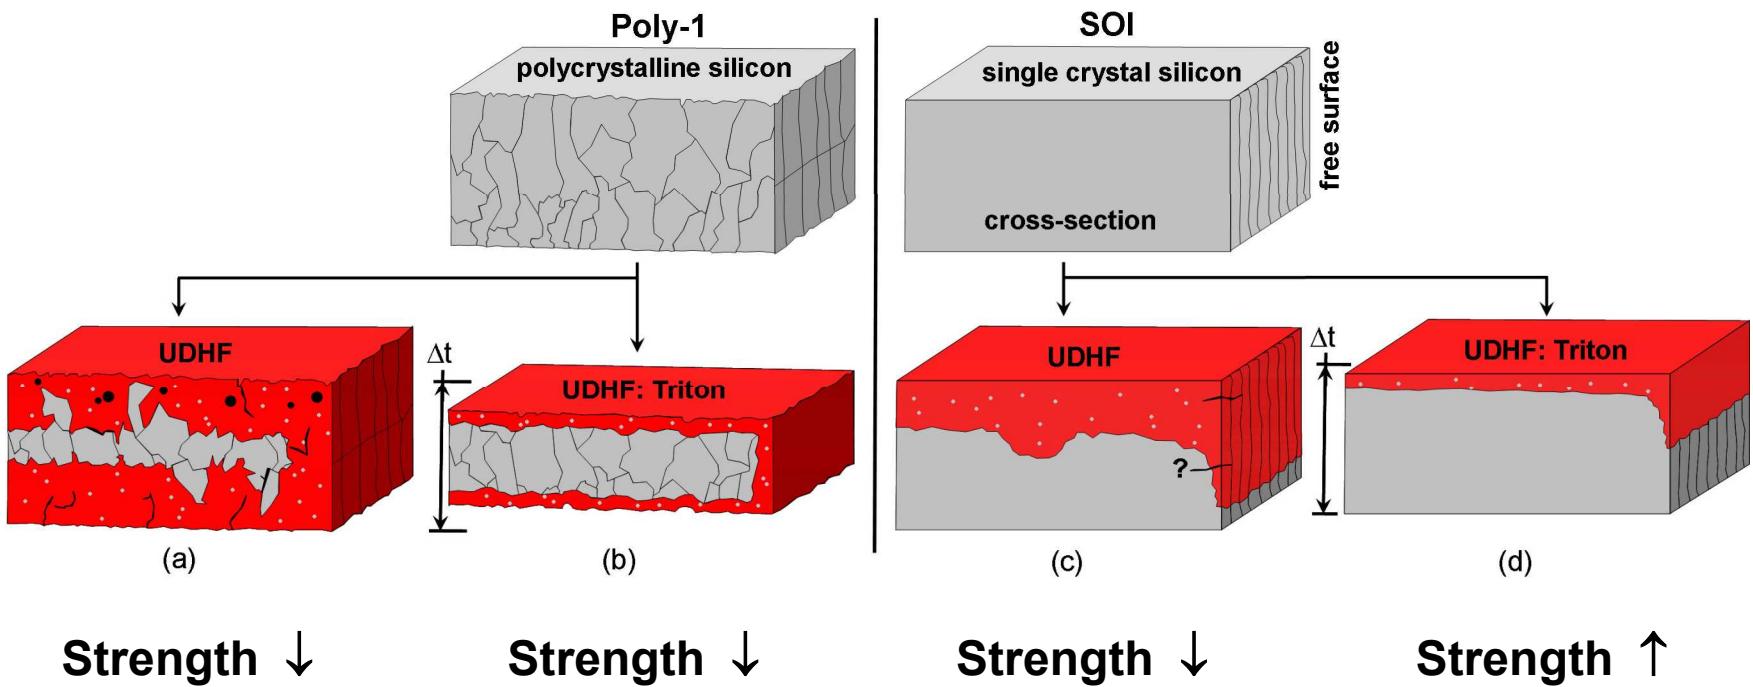
# Summary of Corrosion Damage Morphology In Silicon

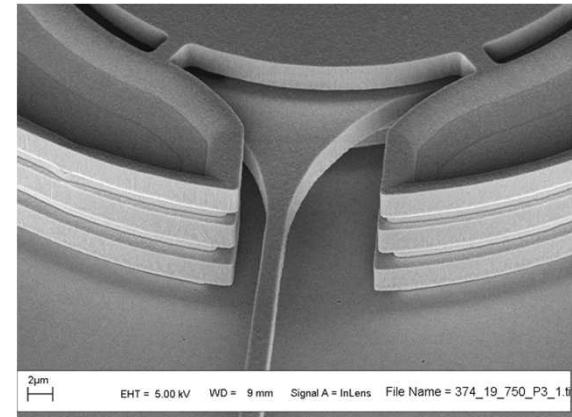
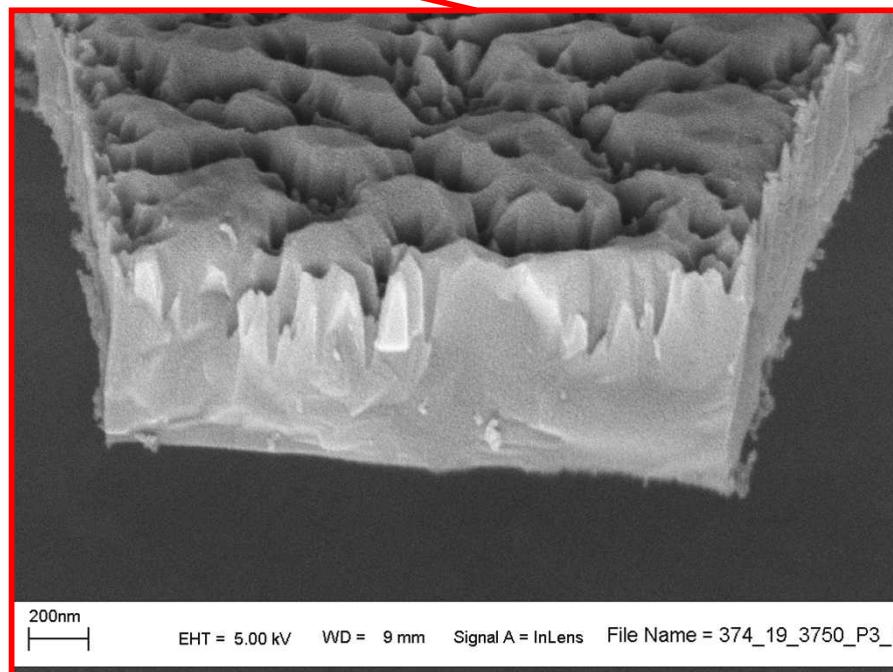
# Anomalous Surface Roughness

During routine tensile testing, of 100's of tensile bars over the past 5 years, one technician noted: “low odd failure”

This specimen failed at a stress of <0.1 GPa. “low, odd failure”

This anomalous zone of “bad” Si has terrible implications for the tails of our Weibull distribution.
