# Structural Health Monitoring of Wind Turbine Blades\*

Mark A. Rumsey<sup>†</sup> and Joshua A. Paquette<sup>‡</sup>  
 Sandia National Laboratories<sup>§</sup>, Albuquerque, NM 87185

## ABSTRACT

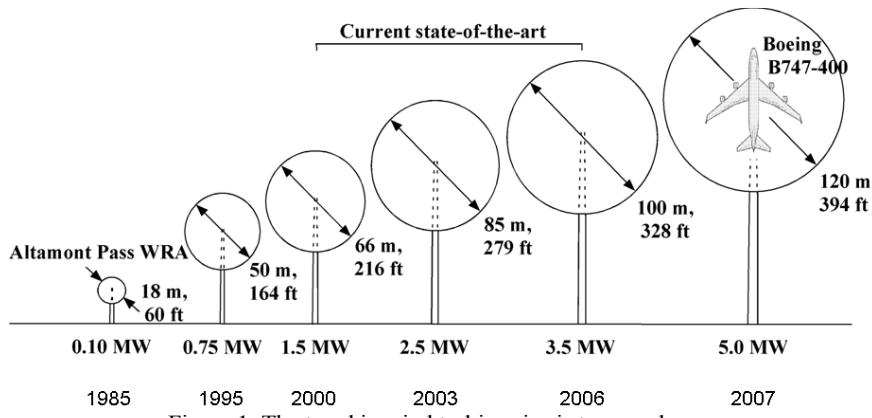
Figure 1: The trend in wind turbine size is to grow larger.

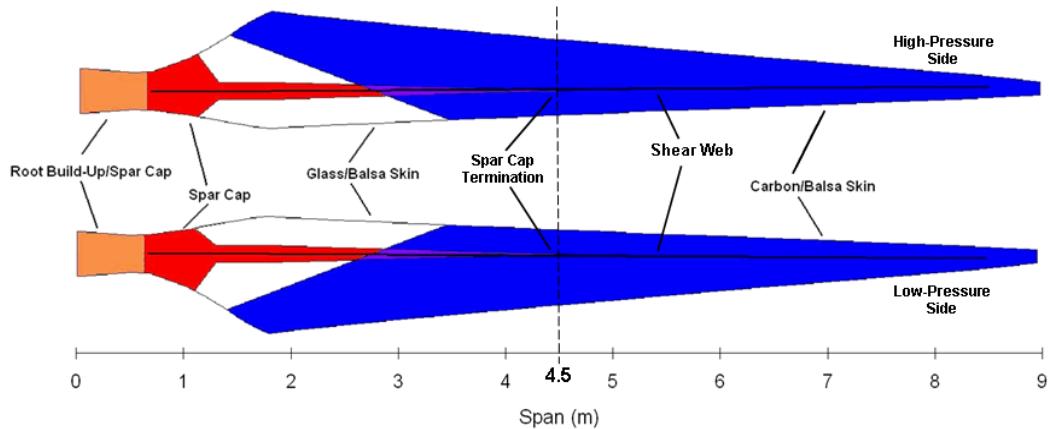
The second blade design, the TX-100 (Twist-bend Experimental), was designed to have passive aerodynamic load reduction by orienting unidirectional carbon fiber at an optimum angle of 20° off the pitch axis in the skins.<sup>22,23,24,25,26,27</sup> The TX-100 blade also contained a fiberglass spar cap that terminated at 4.5 meters, mid-span in the blade. It was determined that the large amount of carbon contained in the skin was adequate to carry loads outboard in this design, making a full-length spar cap unnecessary. A simplified drawing of the planform of the TX-100 blade is shown in Figure 2. The area of the blade skin containing carbon fiber is shown in blue, and the unidirectional fiberglass spar cap is shown in red.

Figure 2 – Diagram showing major structural elements in the TX-100 wind turbine blade.

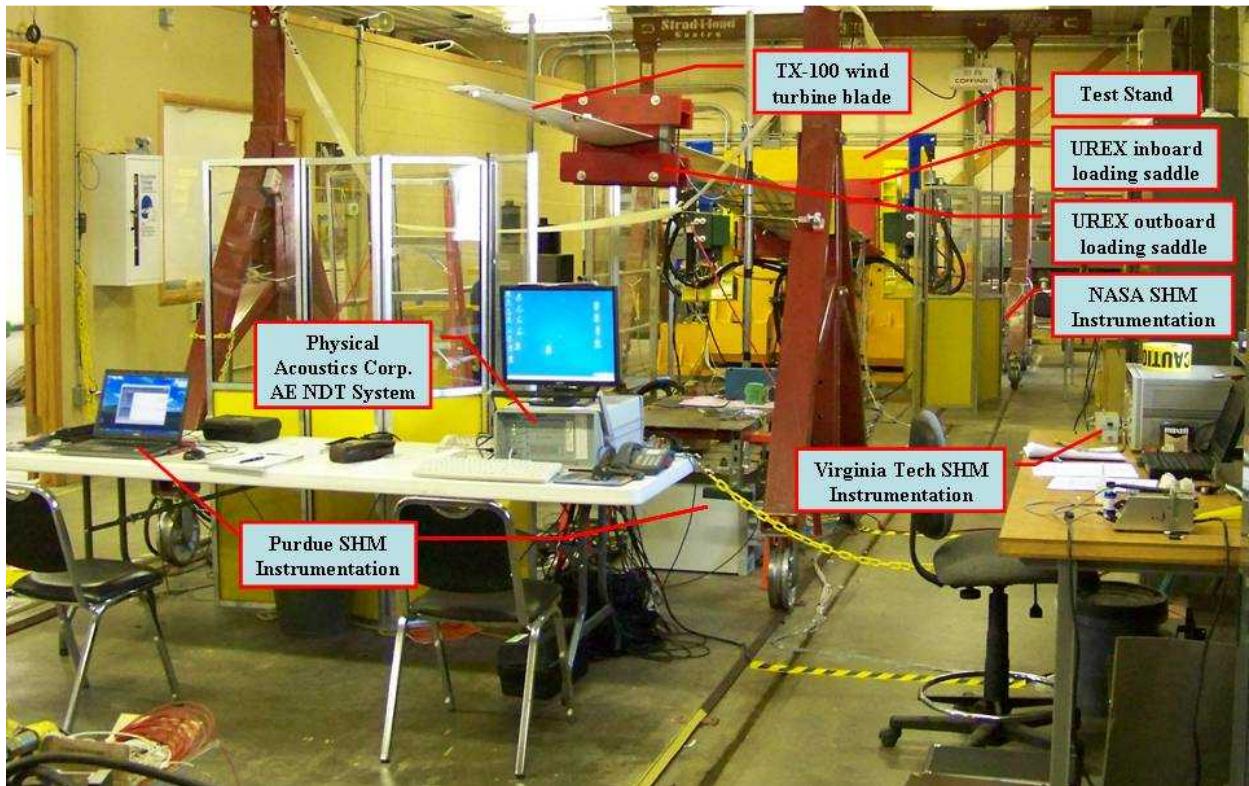
The blade was bolted to a 1,360 kiloNewton-meter (1,000 foot-kilopounds) test stand in a cantilever and approximate horizontal orientation with the low-pressure blade surface facing down. Figure 3 shows a photo of the test area. The fatigue test was planned such that the blade would fail sometime between 1 and 4 million cycles. The oscillating

Figure 3 – Photo of the blade fatigue test area.

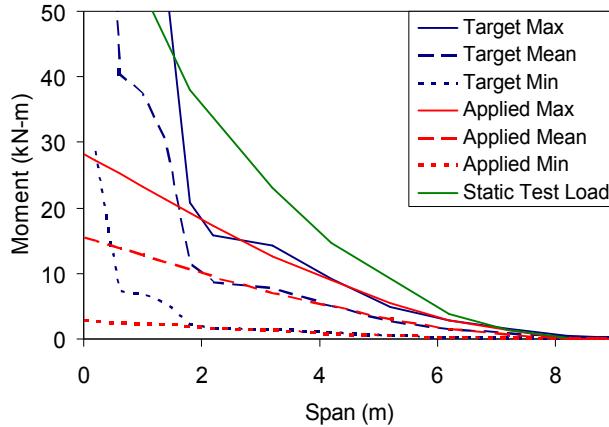
caused failure in the static test. This load level was predicted to cause failure in 4 million cycles. Starting at 1 million cycles, the load was increased in 10% increments and every 500k cycles thereafter. The target and applied test loads for the first load step and the applied test load for the static test are shown in Figure 4.

Figure 4 – Calculated UREX fit of 4-million-cycle target load for TX-100 fatigue test.

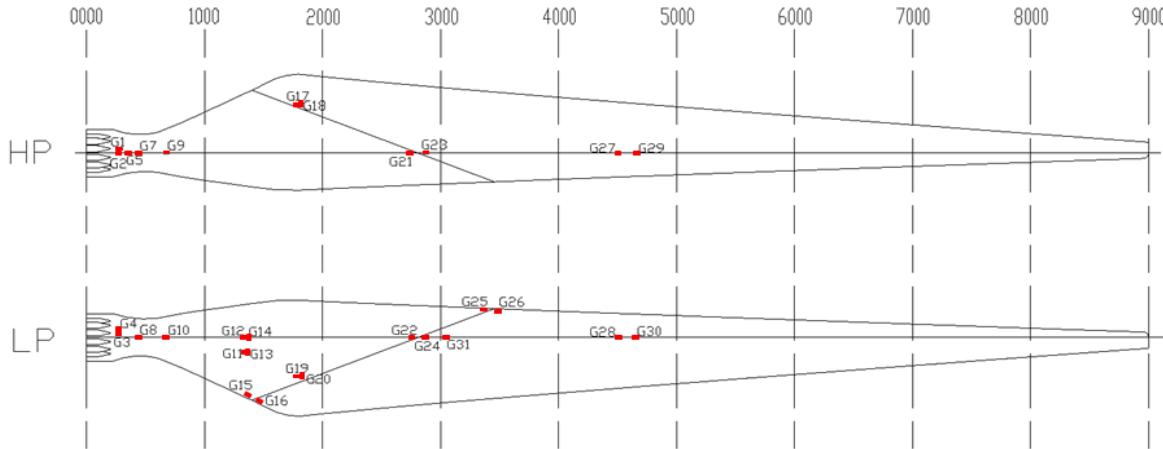
Figure 5 – Diagram showing the layout of strain gages.

Thirty 1000-ohm metal foil strain gages were installed on the gel-coat surface of the blade in a layout as shown in Figure 5. The strain gages were zeroed at the flapwise tare load. Detailed information about the strain gauge locations and orientations is given in reference 32.

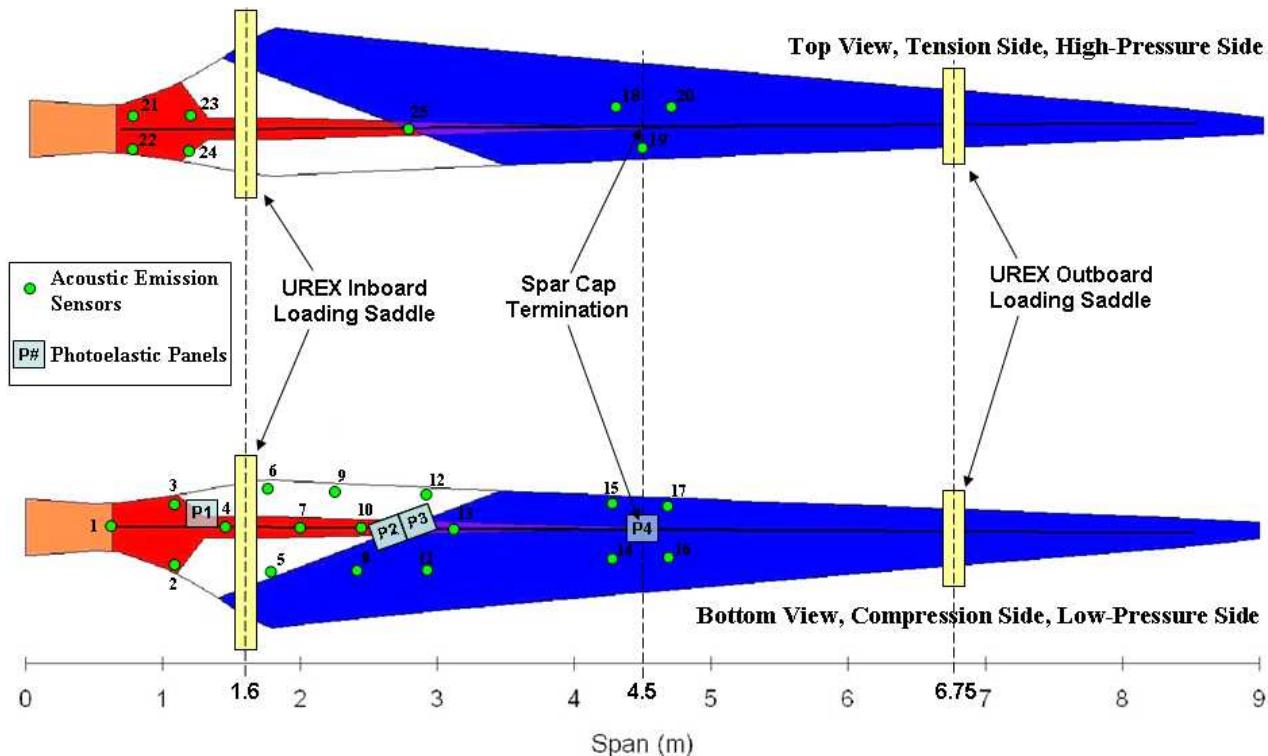
Twenty-four PAC Model R6I AE sensors were mounted on the blade surface over critical areas and interfaces inside the blade. The sensor layout shown in Figure 6 was determined on site after the acoustic characteristics had been measured. (Sensor #25 was not used during the fatigue test.) A PAC DiSP system using PAC AEwin software acquired and processed the AE signals. Much of the data processing was done by custom programs, developed by Beattie, because of the high acoustic anisotropy and variability produced by the diverse material characteristics, orientations and interfaces of the internal components of the blade.

Figure 6 – Layout of the acoustic emission NDT sensors and photoelastic panels.

Four 8 inch by 8 inch photoelastic panels were applied on the low-pressure (downward-facing) side of the blade surface over key locations in the blade as shown in Figure 6. Three of the four photoelastic panels are visible in the photos shown in Figure 11. The photoelastic panels were used to provide a qualitative evaluation of the load/strain paths.

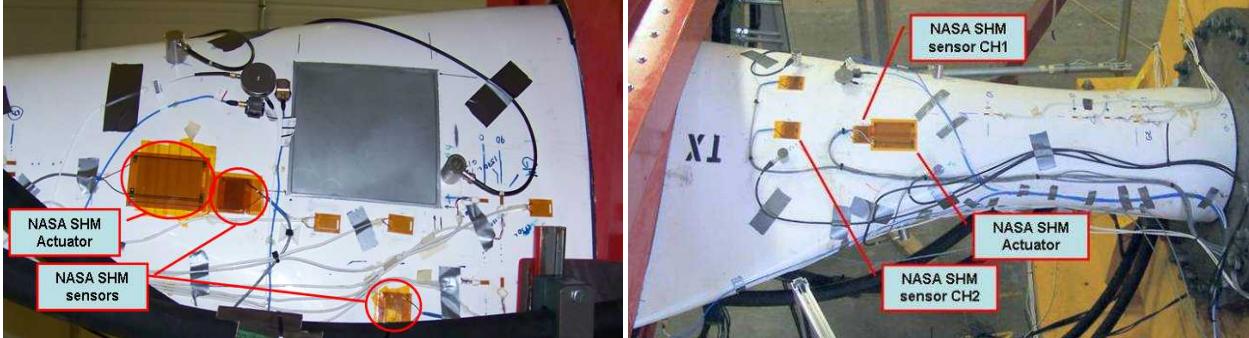
Rudy Werlink<sup>37</sup>, with NASA Kennedy Space Center, implemented a wave propagation based SHM technique by instrumenting the high-pressure side of the blade with a Macro-Fiber Composite (MFC) actuator and three MFC sensors, and on the low-pressure side an MFC actuator and two MFC sensors. His setup was an incremental enhancement, with the application of the electronic filter, to the setup on previous wind turbine blade tests.<sup>38</sup> The actuators were Smart Material<sup>39</sup> MFC, model 8557-S1, 3.375 x 2.25 inches in size. The sensors were Smart Material MFC, model 5-21, were 1.5 x 1 inches in size. The actuator/sensors needed to encompass the expected failure area. Close-up photos of the NASA sensor arrays are shown in Figure 7.

Figure 7 – Photos of the NASA SHM sensor arrays. The left photo shows the low-pressure (downward facing) side of the blade.

The right photo shows the high-pressure (upward facing) side of the blade. The larger MFC patches were used as actuators, the smaller MFC patches were used as sensors.

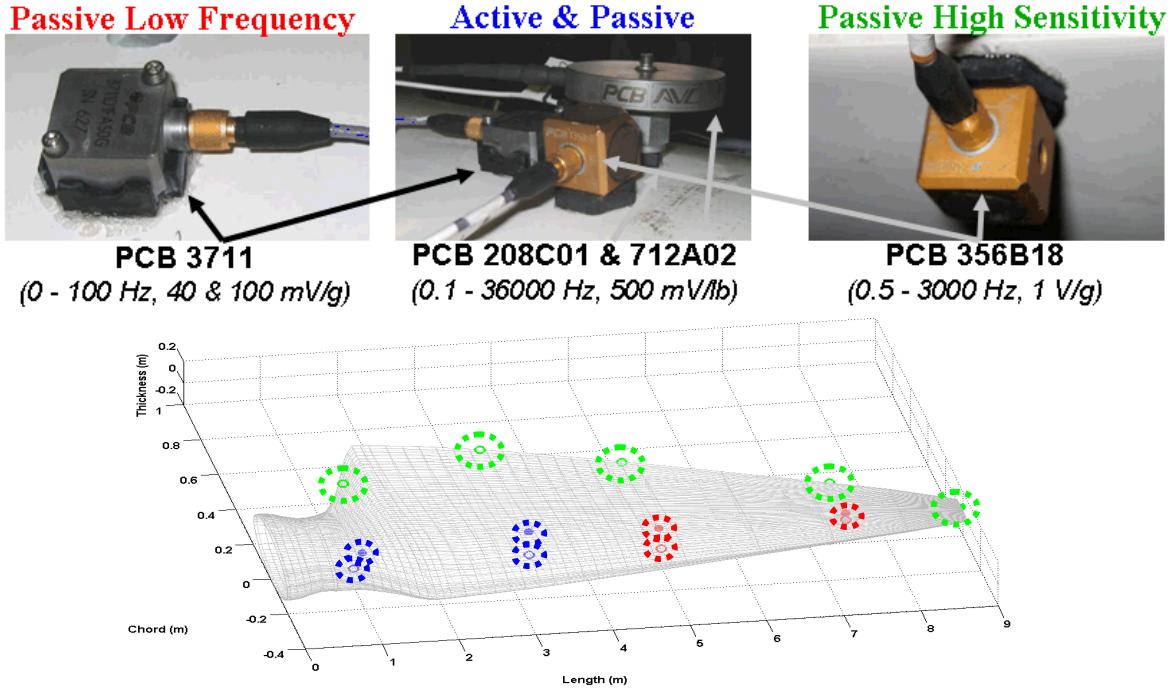
Sensor placement was determined ahead of time using the results from pre-testing on a 15-foot cantilevered helicopter rotor blade recently erected at the Herrick Laboratories at Purdue University.<sup>45</sup> An array of high sensitivity triaxial accelerometers, low-frequency capacitive accelerometers, and piezoelectric actuators with force sensors was distributed over the surface of the blade to monitor the loading and blade damage. A triaxial accelerometer at the tip was used to measure the tip deflection in the flap, lead-lag, and root-tip directions throughout the test. A few photos of the Purdue SHM setup are shown in Figure 8.

Figure 8 – Layout and some photos of the accelerometers used in the Purdue SHM system. (Accelerometers indicated with solid dots were on the upper high-pressure side of the blade, those with open dots on the lower low-pressure side.)

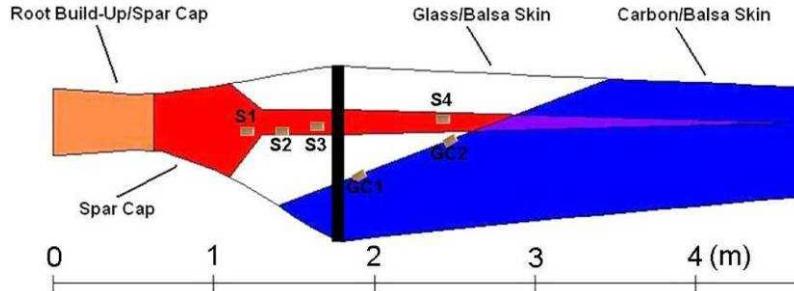
The MFCs were all bonded on the low-pressure (downward-facing) side of the blade between 1 and 3 meters from the root. Failure was expected in this area from modeling and previous similar tests.<sup>28</sup> The locations within this area were chosen based on the internal geometry of the blade. The blade geometry along with the sensor locations is illustrated in Figure 10. Figure 11 shows two photos of the MFCs bonded to the wind turbine blade, along with many other sensors used during the fatigue test. Failure was expected near the spar cap close to the 1 meter area, so three MFCs were mounted in this area and were named S1, S2, and S3. One additional MFC was mounted on the spar cap region near the intersection of the spar cap, glass/balsa skin, and carbon/balsa skin and was named S4. Finally, two MFCs were mounted on the glass/balsa and carbon/balsa intersection on the skin, one at about 2 meters, GC1, and one near the spar cap and carbon fiber interface, GC2.

Figure 10 – Diagram showing layout of Virginia Tech sensor array.

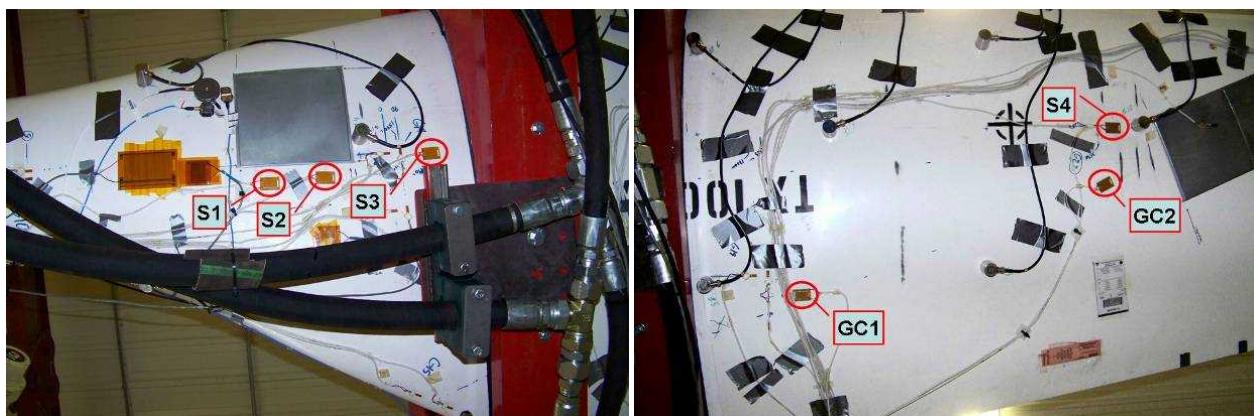
Figure 11 – Photos showing the Virginia Tech SHM sensor arrays. The self-actuating sensors S1, S2, S3, S4, GC1 and GC2 are circled in red.

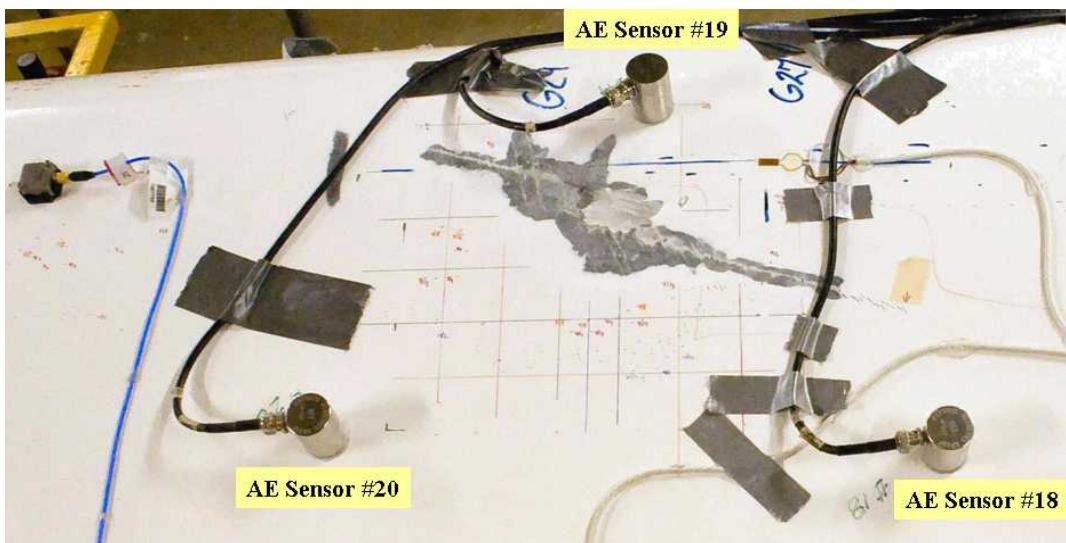
The TX-100 blade fatigue test started on July 19, 2007, and ended October 23, 2007, at 4,001,558 fatigue cycles. Starting at about 700,000 cycles, a multitude of fine gel-coat cracks developed on the high-pressure (upward facing) side of the blade running at an angle of 65 degree with respect to the spanwise axis. The cracks were most apparent in the 4.0 to 5.6 meter span of the blade. The 65 degree angle coincides with the principal axis of the  $\pm 45$ -degree fiberglass laminate that is a constituent of the carbon/glass triax material used in the blade skins. As these gel coat cracks progressed in length and gap width, from 723,000 cycle count to 2.4 million cycle count, the principal axis of the crack front changed from 65 degrees to 20 degrees, which is the same angle as the principal direction of the carbon fiber in the blade skins. At about 2.5 million cycles, a larger visible crack developed parallel to the chord axis on the high-pressure (upward facing) side, near the 4.5 meter station. The crack then grew along the 20 degree off-pitch-axis carbon fiber direction until the test was stopped at 4 million cycles because of excessive torsional motion of the blade tip and an accelerated growth rate in crack length. Figure 12 shows the high-pressure (upward facing) surface damage above the spar cap skin interface at the 4.5 meter station.

The incipient cause of damage, and the resultant failure in the TX-100 blade, was a stress riser at the spar cap termination point at the 4.5 meter station.

Figure 12 – Photo showing the blade surface around the area of failure. Some of the gel-coat has been manually removed to better evaluate the underlying damage in the fiberglass and carbon fiber laminate.

Soon after the fatigue test started, the PAC AE NDT system received significant AE events around AE sensors 18, 19 and 20, and then clearly followed the evolution of blade failure. The acoustic emission data showed damage accumulating on the high-pressure (upward-facing) surface around the end of the spar cap at 4.5 meters, with no significant damage in any of the other monitored areas. Significant damage did not appear until about 3.55 million cycles and extreme damage started at 3.78 million cycles. Compare the AE events shown in Figure 13 to the visual damage shown in Figure 12.

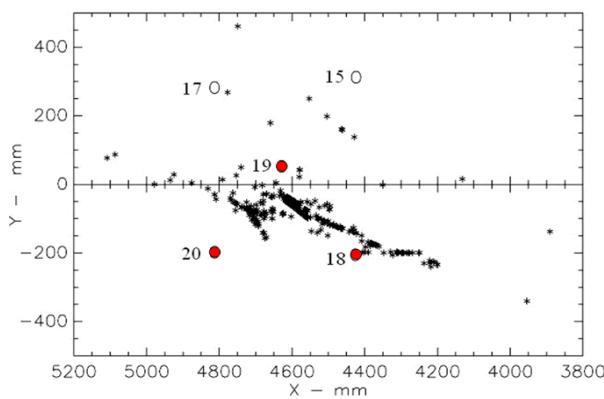
Figure 13 – Map of the acoustic emission events on the blade.

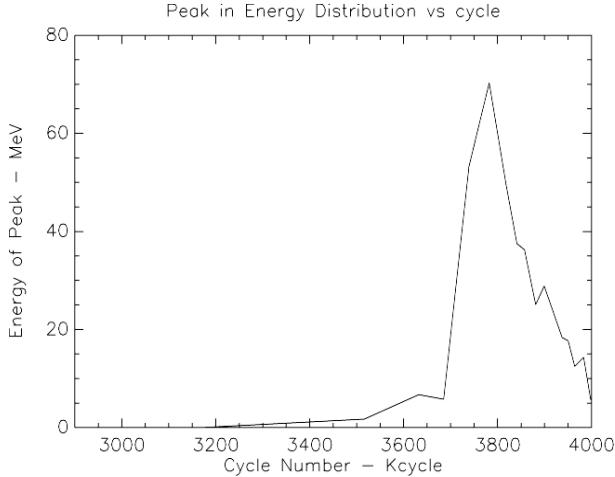
The AE parameter used to indicate damage was a measure of the detected acoustic energy emitted per cycle in the damaged region. To determine the intensity of the emission, the true energy of the waveforms was used. Once the acoustic waveform was digitized, the true energy was easy to measure. It is simply the sum of the product of the square of each digitized voltage times the digitization interval over the entire length of the transient signal. Knowing the input impedance of the preamplifier allows the calculation of the energy. In PAC DiSP energy units, the calibration of N units is  $E = Nx0.000931$  milli-attoJoules or  $E = Nx6.7041 \times 10^{-6}$  million-electron-Volts (MeV). The rate of generation of acoustic energy can be obtained from the slope of the summed energy versus time curves. Knowing the frequency of blade cycling gives the acoustic energy generation rate in MeV/cycle. For most of the test, this rate was less than 0.01 MeV per cycle. At the point of peak damage, this rate went up to 30 MeV per cycle. See Figure 14 and Figure 15.

Figure 14 – Peak acoustic emission energy versus cycle count.

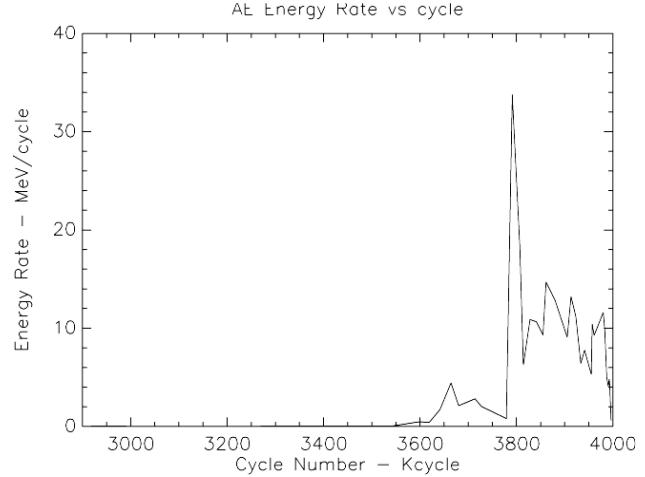
Figure 15 – Acoustic emission energy rate versus cycle count.

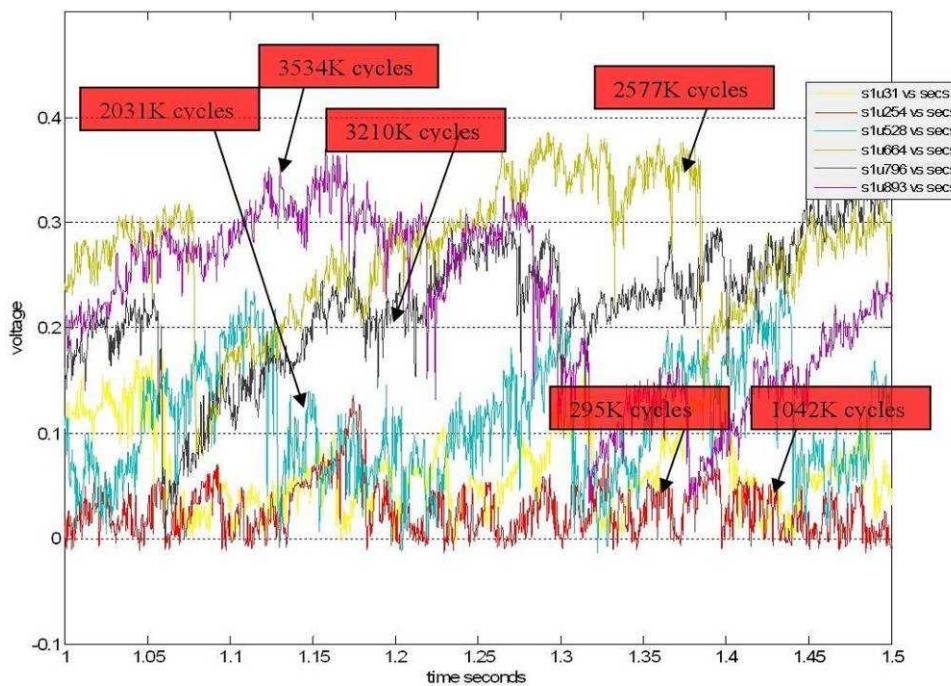
The NASA SHM system was placed entirely in-board from the maximum blade chord. This was the location where the blade had failed previously in static testing.<sup>28</sup> However, and unfortunately, this was not where the blade failed in fatigue.

Figure 16 – Plots showing the increase in CH1 response as the fatigue cycles increased from 295 kilocycles to 3,534 kilocycles.

The strains placed on the MFC sensors as the blade was loaded from the UREX mass and the blade movement may have blocked the random input signals from the actuators causing erroneous sensor data. All this resulted in noisy data. However, the analysis to date suggests that the effects of the blade deterioration did affect the boundary conditions enough for sensors CH1 and CH2 to show trends as shown in Figure 16 and Figure 17. The SHM data taken while the blade was cycling has not been analyzed.

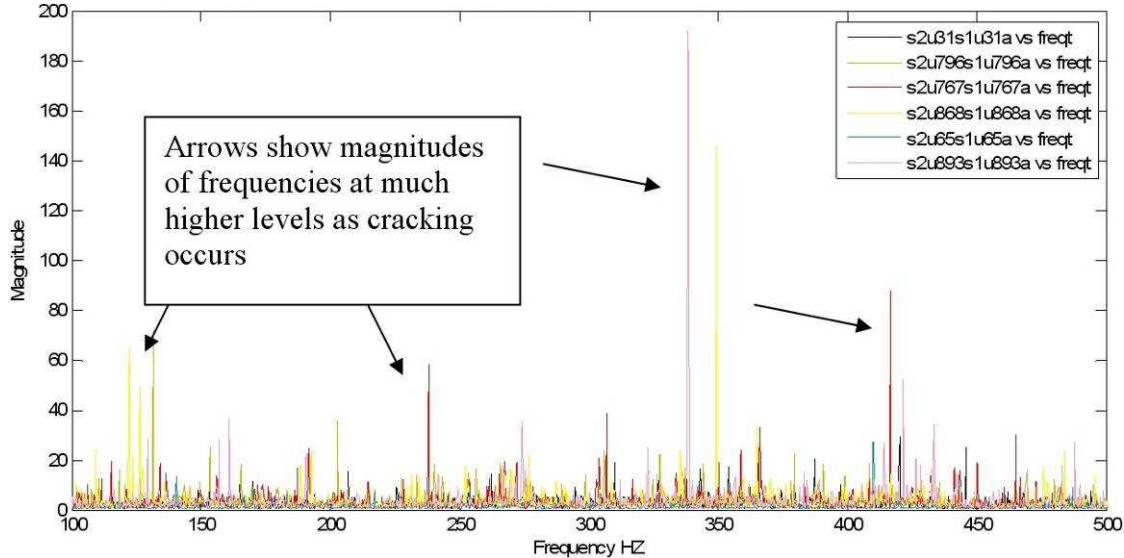
Figure 17 – Plots showing the random input frequency response function for CH2/CH1 showing higher magnitudes as cracking progresses.

That the sensors showed a trend is very encouraging and with improvements to the system and testing methods, and closer placement of the sensors to the failure area, the NASA SHM system appears viable. NASA will perform the data analysis and report the results of the SHM measurements at a later date.

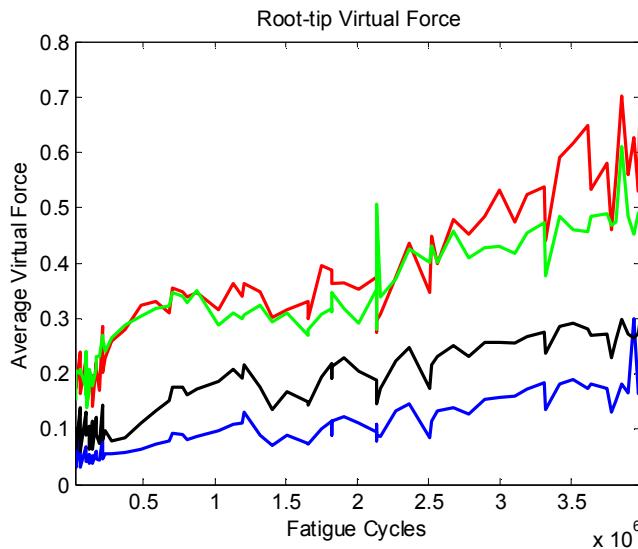
The Purdue SHM system did have damage detection sensors mounted on the blade. However, none of the sensors were within 2 meters of the failed location. Summarizing the Purdue analysis to date, the in-plane displacement measurements between the damage and root were found to be sensitive to the crack growth and direction.<sup>46</sup> Of particular interest, the dynamic features of the blade were sensitive to the variations in ambient temperature. Active diagnostics with the method of virtual forces was sensitive to the damage for in-plane measurements following adjustment for thermal effects (see Figure 18). Impact identification was demonstrated with 93% accuracy of the location and within 1.3% accuracy of the magnitude.

Figure 18 – Root-tip virtual force throughout the fatigue test.

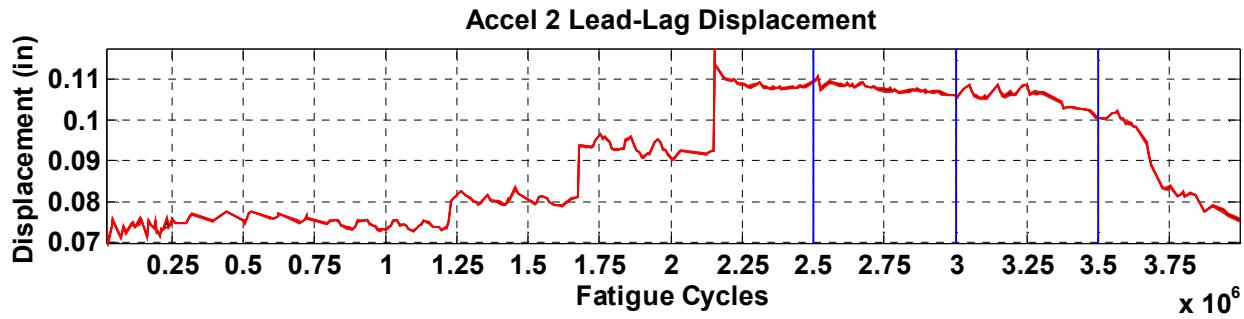
Figure 19 – The blade lead-lag (edge) tip displacement throughout the fatigue test.

Modal decomposition was an accurate prediction of the excitation mode shapes throughout the test and a practical approach for near-real time load monitoring. Second order harmonics excited by the fatigue system were shown to be on the magnitude of the driving frequency at the tip in the lead-lag and root-tip direction (see Figure 19 and Figure 20). Findings of this test will be instrumental in future development of accelerometer-based wind turbine rotor blade monitoring.

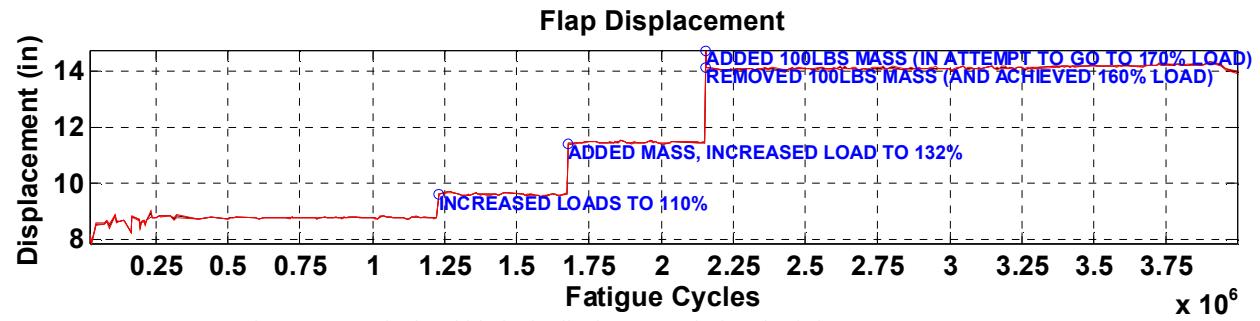
Figure 20 – Calculated blade tip displacement during the fatigue test.

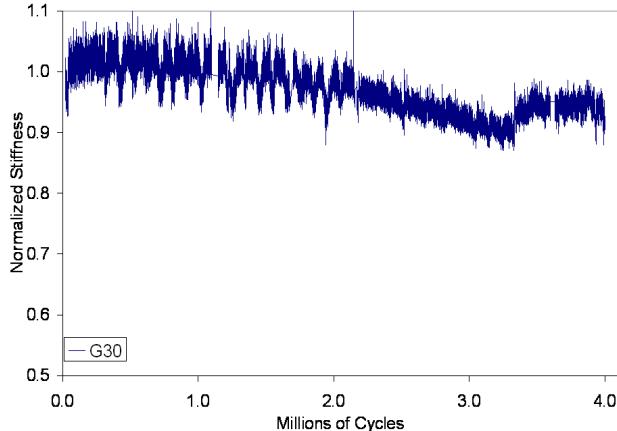
Figure 21 – Normalized response of strain gage G30.

Figure 21 shows the normalized response of strain gage G30 as a function of the fatigue cycle count. The blade can be seen to soften at this location as the cycle count increases. For more information on the strain gage dataset, refer to reference 32.

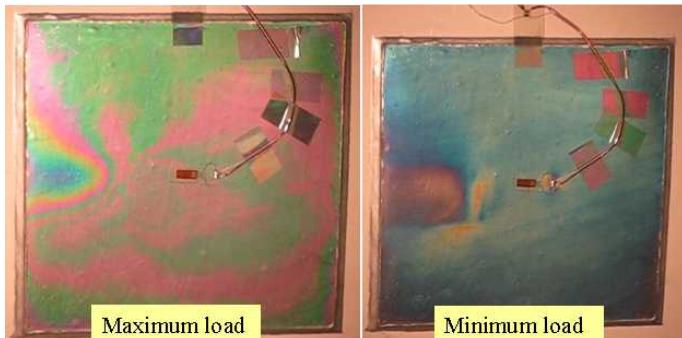
Figure 22 shows two snap-shots of the photoelastic panel that was on the low pressure, compression, downward facing blade surface over the out-board spar cap termination point at 4.5 meters. Figure 23 shows the thermal gradients around the damage area on the high pressure, tensile, upward facing surface at the 3.8 million cycle count.

Figure 22 - Two snap-shots (at maximum and minimum fatigue load) of the photoelastic panel on the low pressure, compression, downward facing, blade surface over the spar cap termination point at 4.5 meters. Note the high strain gradients around the termination point of the spar cap.

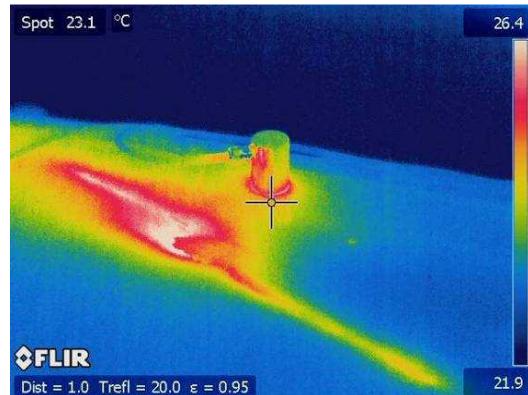
Figure 23 - Infrared thermography image of damage area at 3.8 million fatigue cycles.

Two FLIR ThermaCAM infrared thermography cameras, models P60 and SC640, were used at various times to monitor and obtain snapshots of thermal gradients and hot-spots as the fatigue test progressed.
