First Wall Quality Mockup Testing

ITER FWQM 5 meeting
Sept 26-29, 2007
Caderache, Fr

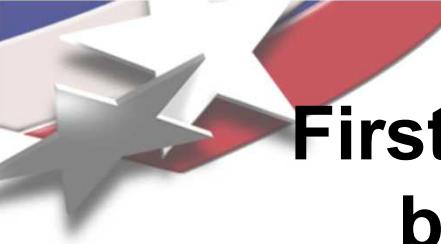
First wall-the initial heat and radiation barrier for the vacuum chamber

- **Steady state heat load**
 - 10,000 “shots” at 0.25-0.50 MW/m² of surface heat
 - 20,000 shots at below 0.25 MW/m² of surface heat
 - Approx 6 MW/m³ of nuclear heating from the neutrons (exact estimates vary with nuclear analysis)
- **MARFE**
 - 1,000 shots between 0.5 and 1.4 MW/m² <10s long
- **VDE**
 - 10 shots with <60 MJ/m², <0.2 s long

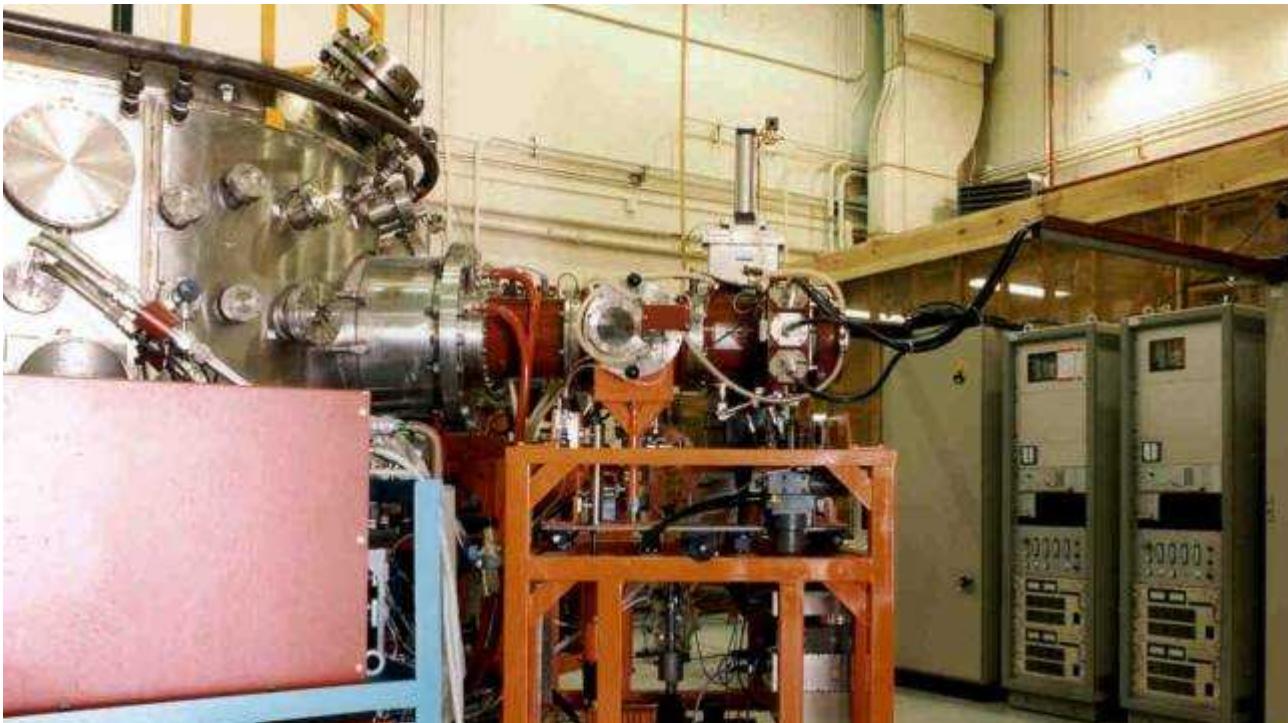
- The US facility is the Plasma Materials Test Facility at Sandia National Laboratories
- We plan to use EB1200 which has an electron beam that can be focused and moved across the beryllium tiles
