EARLY THERMAL TESTING OF TYPE B RADIOACTIVE MATERIAL PACKAGES IN THE US TO ENVIRONMENTS BEYOND THE REGULATORY PACKAGE THERMAL TEST STANDARDS

H. R. Yoshimura*
Sandia National Laboratories
PO Box 5800
Albuquerque, NM 87185

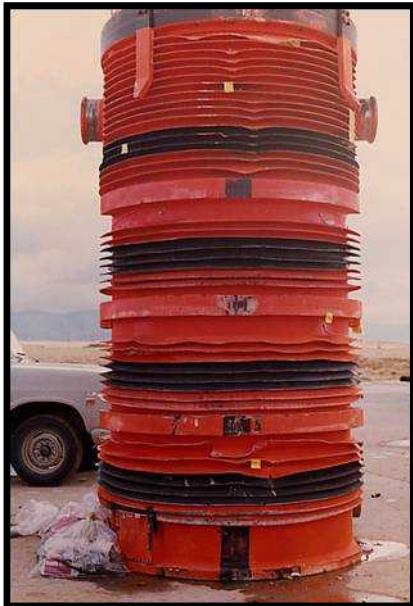
Fig. 1. Photograph of the obsolete 67-tonne cask prior to fire test.

Railcar/Cask Design used in Pool Fire Testing: The obsolete 67-tonne SNF cask, which was designed in the late 1950s and was fabricated in 1962, was of steel/lead construction. It was a stainless steel, double-walled, lead-shielded cylindrical vessel 3.96 m in length and 1.5 m in diameter. The lead was contained in a cylinder between the two stainless steel shells, where the combination of stainless steel and lead provided gamma-shielding of the radiation emanating from the SNF. This early-designed cask utilized an auxiliary water cooling system of stainless steel channels welded to the outside of the inner shell of the cask body. The cooling system was provided not for safety purposes, but for facilitating rapid handling of the cask and its contents after shipment. Also, copper fins were welded to the inside of the outer shell to facilitate heat transfer from the lead to the outer shell. The cask, which is shown photographically prior to the fire test in Figure 1, had previously been impacted in its transport railcar into a massive barrier at 131 km/h^[3]. As can be seen from Figure 1, the cask sustained only "cosmetic" damage as a result of this dynamic structural test; there was only minor bending of the external heat transfer fins.

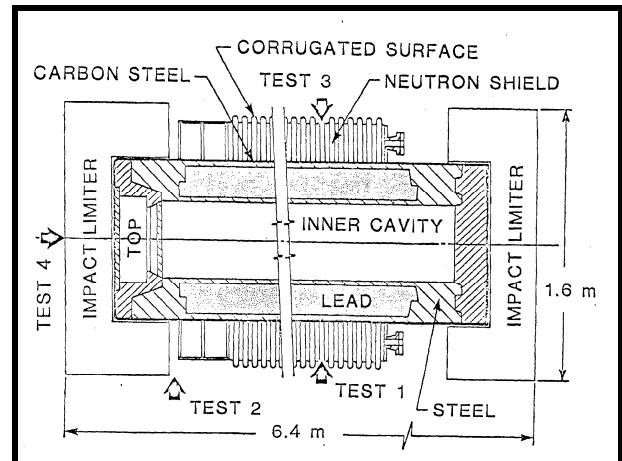
Fig. 4. Schematic of the modified HNPF tested in the torch tests.

impact limiting capability. In order to test a cask system that more closely resembled contemporary casks, a neutron shield was added to the cylindrical outer shell of the cask and impact limiters were added to the ends of the cask. The resulting cask is shown schematically in Figure 4, which illustrates the locations where the torch was applied during testing.

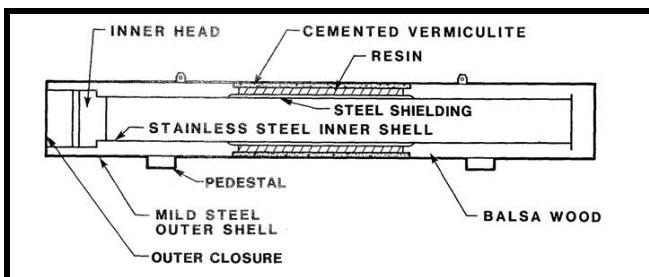
Fig. 3. Schematic of the PNC SNM cask design.

Truck/Cask Design used in Pool Fire Test: A special nuclear material (SNM) package (i.e., a 2-tonne mixed-oxide breeder reactor fresh fuel cask) was designed by PNC during the early 1980s. The design of the transport system was intended to allow up to three of these packages to be transported in a tractor/trailer road vehicle domestically in Japan. The DOE/PNC Joint Program included a full-scale simulated accident test of a head-on collision of three of the casks in their tractor/trailer conveyance impacting a massive concrete barrier at a speed of 90 km/h. This impact accident-simulation test was followed by testing one of the casks to the regulatory 9 m drop test of the cask onto an unyielding target, and then to the regulatory 1 m puncture test onto a probe mounted on the unyielding target. Finally the impacted cask/transport system, using the cask that had been tested three times along with the two casks that had only been involved in the simulated impact crash, was exposed to a fully-engulfing fuel fire for one hour. This paper only addresses the one-hour fire test of the cask/transport system. The cask tested is shown photographically in Figure 2 and schematically in Figure 3. The cask had sustained only minor structural damage during the series of mechanical tests that preceded the thermal test. The cask design consisted of thin concentric steel shells; the annular spaces were filled with balsa wood. Although the cask had sustained some deformation (up to approximately 5 cm deep), the inner lid and seals were still intact. The cask was relocated into the tested trailer for the thermal test.

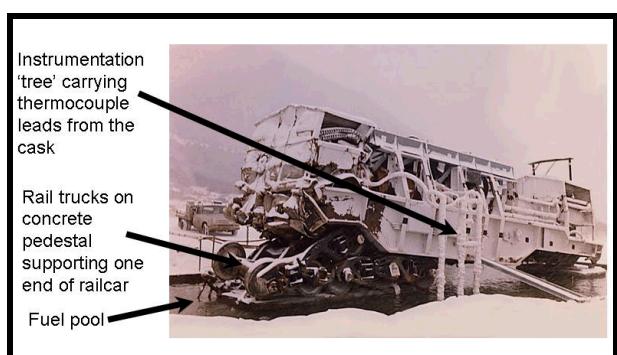
Fig. 5. Cask/railcar assembled over fuel pool prior to testing.

Pool Fire Test Facility: A fuel pool was constructed specifically for the rail car/cask test. It measured 0.9-m deep, 9.1-m wide and 18.3-m long. JP-4 (jet) fuel was continuously piped into the pool to maintain a 15-cm layer of fuel above 60-cm of water. The cask/railcar combination was reassembled over the large fuel pool, supported on concrete pedestals. The cask/railcar and the wheel trucks that had become disengaged during the preceding impact test were positioned as they had been following the impact with the barrier as shown in Figure 5. Extensive thermocouple monitoring of the flame and the cask was undertaken during the test. The thermal-shielded “trees” for the thermocouples leading from the edge of the pool into the cask can be seen in Figure 5.

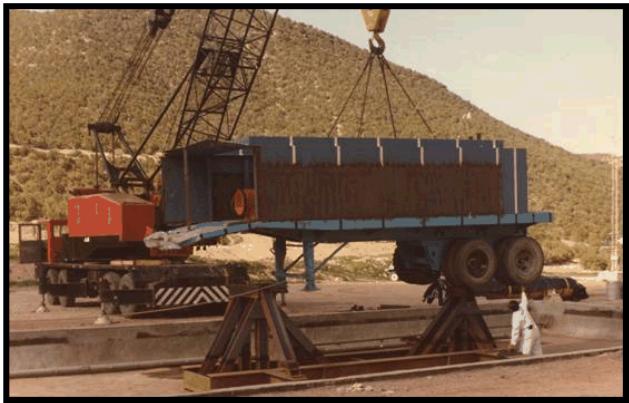
Fig. 6. Placement of SNM cask in tested trailer over fuel pool.

The fuel pool that had been used for the railcar/cask pool fire test was also used for the truck/cask pool fire test. The casks that – as described previously – had been exposed to the structural tests were relocated into the tested trailer, and cask/trailer system was then positioned over the fuel pool as shown in Figure 6, for the thermal test. The trailer included the sides and the top of 0.8 cm thick mild steel plating; however, because the front end of the trailer was severely damaged in the impact test, it was fully removed for the thermal test. One tear occurred in the trailer deck during the impact test, which showed a weakness in the design and the design was corrected for actual use to prevent such damage from happening in an actual accident. Therefore the tear in the deck was repaired prior to the thermal test. The thermal characteristics of the fire and the thermal response of the cask and trailer during the fire test were monitored with 106 thermocouples. This included monitoring temperatures inside the cask, on the cask and trailer surfaces, on towers located at the four corners of the trailer, and on 21 calorimeters. The details of the locations and measurements taken are provided in Reference 8.

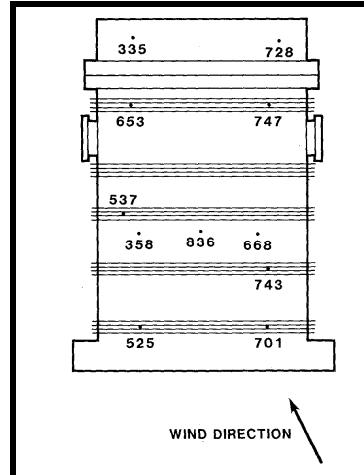
Fig. 9. Schematic of cask showing maximum surface temperatures (in °C) after 60 minutes exposure.

Figure 9 depicts the cask from a top view (the cask was positioned with its axis horizontal), showing the general wind direction and the maximum measured surface temperature at various locations. Temperatures were higher on the top than on the bottom, and on the windward side than on the leeward side.

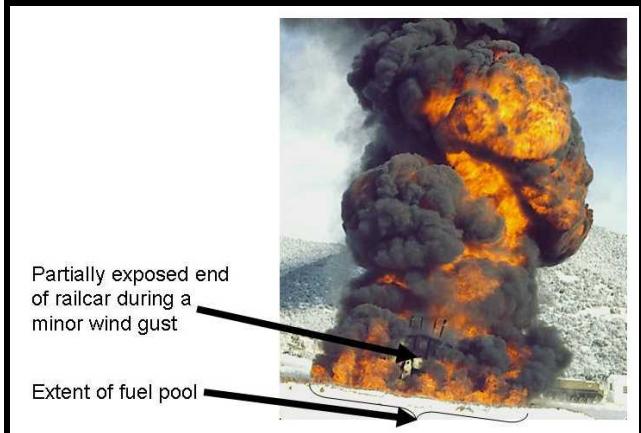
Fig. 7. Cask/Railcar during thermal test.

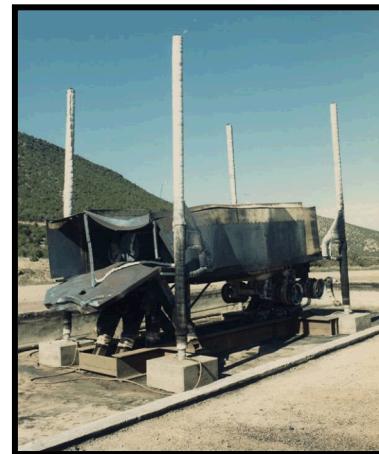
Fig. 10. Photograph of cask/trailer system following fire exposure.

Truck/Cask Pool Fire Test: The test was performed at a time which would provide as near-optimal weather conditions as possible. The wind speed varied from 0 to no more than 8 km/h. Once the fuel was ignited, flames quickly engulfed the trailer/cask system. A study of the films of the test showed that, during the 72 minutes of the fire, the system was totally engulfed for 69 minutes (i.e., for 96 percent of the time). The tested system, following termination of the fire exposure is shown in the photograph provided in Figure 10.

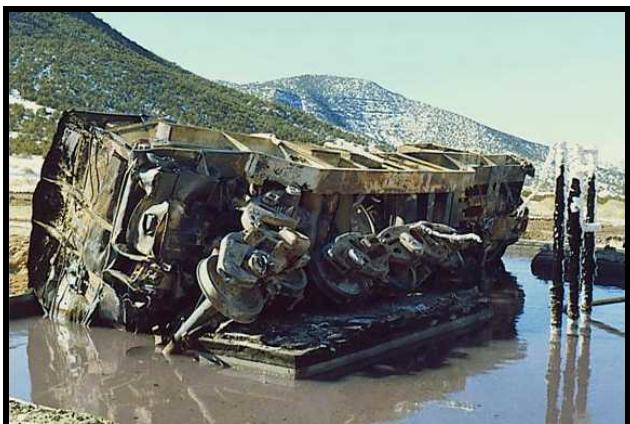
Fig. 8. Cask/Railcar following exposure to fire for 125 minutes.

During approximately the first 90 minutes of the test, the cask experienced a relatively mild temperature response. After 90 minutes the rate of temperature rise increased more rapidly. At approximately 100 minutes, a white cloud of smoke, determined to be lead oxide, was visually detected emanating from the cask. At this time the supply of fuel to the pool was terminated, but the fire continued to burn until all fuel was consumed. Due to the weakening of the concrete and metal supports and the metal railcar, at approximately 122 minutes the railcar still containing the cask toppled onto its side, severing all thermocouple connections. The fire self-extinguished at 125 minutes. The final position of the railcar/cask following fire exposure is shown in Figure 8.

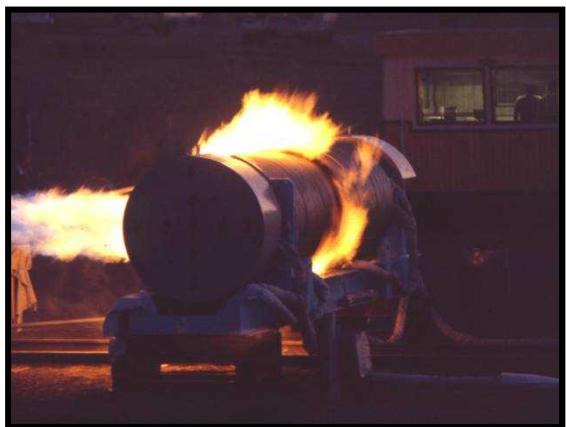
Fig. 11. Photograph of modified HNPF cask being exposed to torch environment at the side of the cask in the centre.

Cask Torch Tests: A photograph of one of the torch tests is shown in Figure 11.
