## UTILIZING A ROBOTIC VEHICLE TO ACCESS AND CLEAN A HAZARDOUS UNDERGROUND TANK

*A remotely-operated robot, designed and built at Sandia National Laboratories (SNL), was used to remove approximately 600 gallons of mixed waste from a leaking underground water tank. The uniqueness of the activity was that the robot vehicle was never intended for this application, but employed only after workers were faced with what seemed to be an insurmountable challenge to safely access the tank. This paper is relevant to the development and deployment of remote, robotic, and intelligent systems to reduce hazards to personnel and the environment*

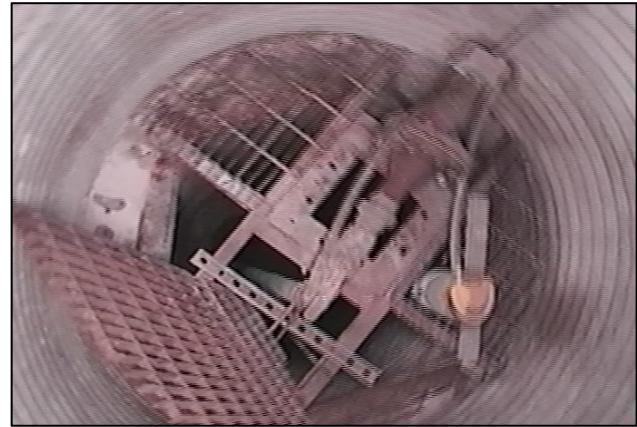
**Figure 2. Tank Interference Designated for Removal**

Very early, the team recommended manned entry into the tank. The tank height is five feet, and a bucket and shovel approach was imagined to be simple and effective. Physical obstructions in the shaft (grating, piping, a pump, and pump control devices) put that choice on hold until a contractor was hired to remove the obstacles and to increase the tank opening from 18-inch diameter to 30-inch diameter. However, during the

obstruction removal process, with aggressive ventilation of the air space in the vicinity of the workers, O<sub>2</sub> measurements were made and demonstrated that entry into the tank itself would require supplied air. Recovery equipment was purchased, a procedure was developed, and training was completed. Management approval could not be secured, however, regardless of the controls selected because the safety subject matter experts would not accept the risk of confined space entries. Also, there was the risk that the tank itself may not be structurally sound, further compounding the challenge to send personnel into the tank.

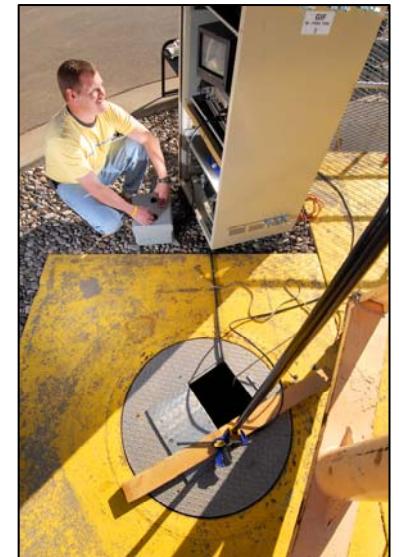
**Figure 3. Initial Field Test of Robot**

Dubbed “Swarmy,” the robot’s first tests were disappointing. When the robot was first tried, it was weighted with metal plates and equipped with a snow-plow feature. At the time, the idea was to use the robot to solve the horizontal problem by plowing sludge toward the entry point and lifting the sludge (somehow). But the sludge was wet and the robot heavy and the plow set low. So the robot became trapped in the sludge and churned to a halt.

After a discussion with the robotics group, the treads of the robot were modified with the addition of “ice screws” to improve the traction of the treads. At the same time, the snow plow was removed and the metal plates replaced with bags of steel shot, so that the weight of the robot could be adjusted remotely, and to make raising and lowering of the robot into and out of the tank easier. A

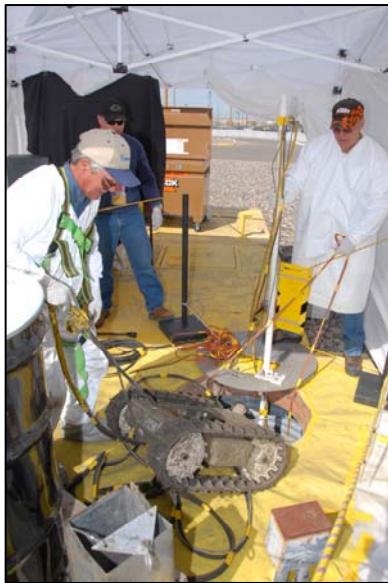
**Figure 4. Final Success in Using Robot to Clean Tank**

remotely-operated camera and lighting system were lowered into the tank. Surprisingly, the robot navigated over the surface of the (relatively dried-out) sludge. In fact, with the aid of the camera, the robot could be navigated to the far corners of the tank. This breakthrough led to the idea to place a bucket on the robot and drive the robot to a point in the tank when a rope (attached between the bucket and an operator above ground) was pulled. The bucket quickly filled with sludge and was pulled to the surface and emptied. The process was repeated and was successful at solving both the horizontal and vertical problems. The three contractors employed to complete the job included two “tech-savvy” individuals who quickly mastered the robot and camera controls. Thus in very short order, over a period of two weeks, these workers were able to clean up the material from the tank in a manner far exceeding anyone’s original expectations. They continued to improve the process as the work proceeded. With the sludge scraped down to the concrete floor, they came up with the idea of trying a small

shop-vac pushed around by the robot in order to brush and vacuum the rough floor surface and, especially, clean the corners. It was also a success. Over 99% of the sludge was safely removed.
