**2007 AWS/Fabtech International
Chicago, Illinois**

Laser Ultrasonic NDE of Small Component Braze and Weld Joints

(A non-contact, non-immersion ultrasonic NDE technique)

**Gerald A. Knorovsky
Sandia National Laboratories
Albuquerque, NM**

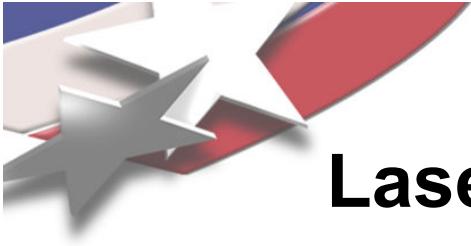
Laser Ultrasonic NDE - Characteristics

Similar to conventional Ultrasonic NDE, except:

Non-contact (no coupling gel)

Non-immersive (no water bath)

Can operate in adverse environments:

in a furnace (950 C),

in a factory production line (tubing mfr.)

Automated process

However:

Needs to have line-of-sight to surface

For best S/N ratio, surface ablation by probe laser needed

**Each case needs development of data processing procedure
to extract features of interest**

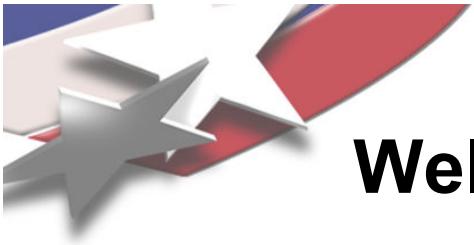
Weld Examination Geometry: Initial

Initial weld penetration measurement configuration.

Beams are scanned side by side toward the top edge (2 locations).

The red dot and the green dot mark the initial locations of the generation and probe lasers.

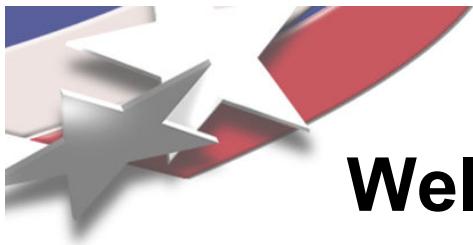
Weld Metallography & Scan Results

Differentiated signal

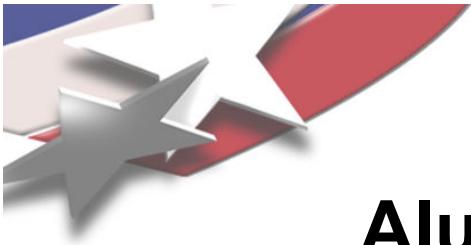
Brazement: Alumina Insulator to Kovar Header

Several assemblies have leaked through the braze.

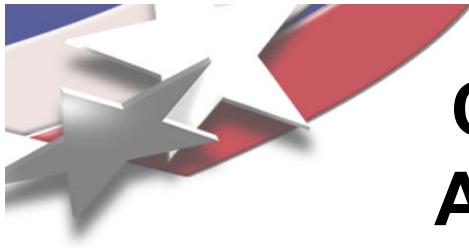
Comparison of Thermoelastic L-US, Ablation L-US, SAM & Metallography

Metallography

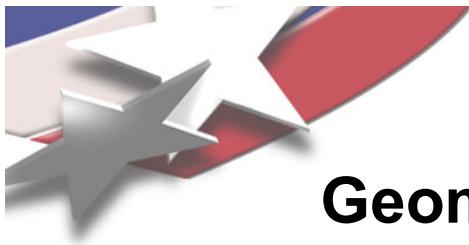
Geometry and SAM Image from Connector

Connector found to have internal glass crack via Scanning Acoustic Microscope.

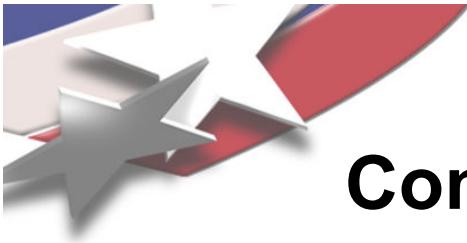
Connector Circumferential Scan Dataplot

There are two clearly different regions along the scan:

Region 1: 90° wide

Region 2: 270° wide

SAM image suggests that:

Region 1 is "good"

Region 2 is "bad"

Lack of damping in B-scan Region 1 suggests this region is "good"

Conflicting evidence:

Period of resonance in Region 1 of B-scan is $\sim 0.6 \mu\text{s}$;

From SAM data a period of $1.5 \mu\text{s}$ was measured.
