# Detection of Micro-Subsurface Defects in Peened Surfaces to Support the Adoption of Damage Tolerance Methods in Propeller Designs

SAND2007-5239C

**Dennis Roach & Tony DeLong  
Sandia National Labs  
FAA Airworthiness Assurance NDI Validation Center**

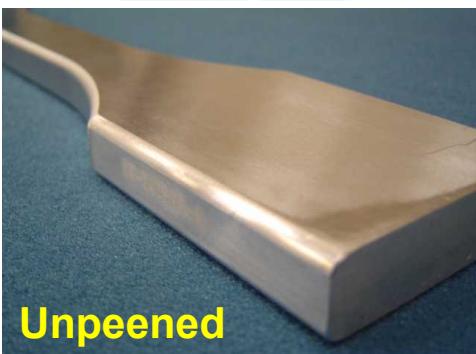
Unpeened

Assess depth &  
affect of cold work

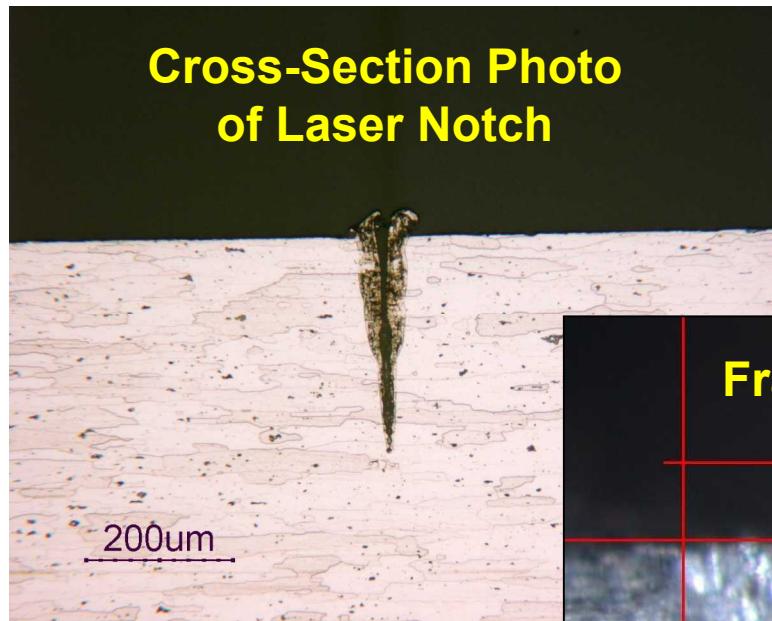
**Cross-Section Photo  
of Laser Notch**

- Traverse rate, pulse frequency, length of travel, and power are all varied with each pass to mill away the desired shape
- The notches evaluated at HS have been 0.013" deep X 0.026" long

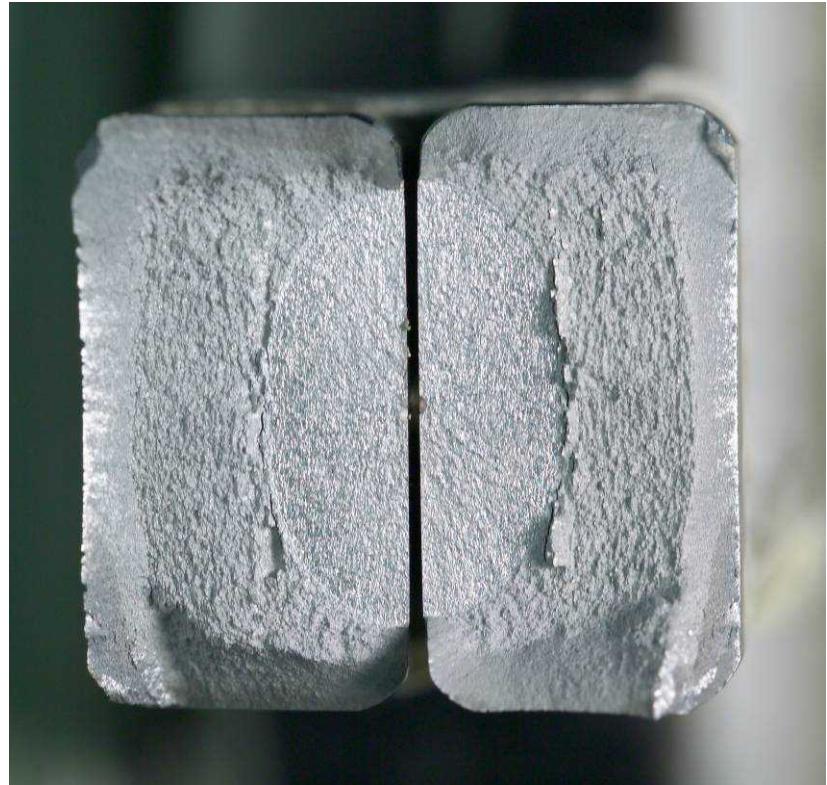
- Non-elliptical crack growth
  - Corrosion pitted specimens:  
 $c/a = 1.29 - 1.49$
  - Laser notched specimens:  
 $c/a = 1.14 - 1.27$
- Software development underway to calculate  $da/dN$  vs.  $dK$

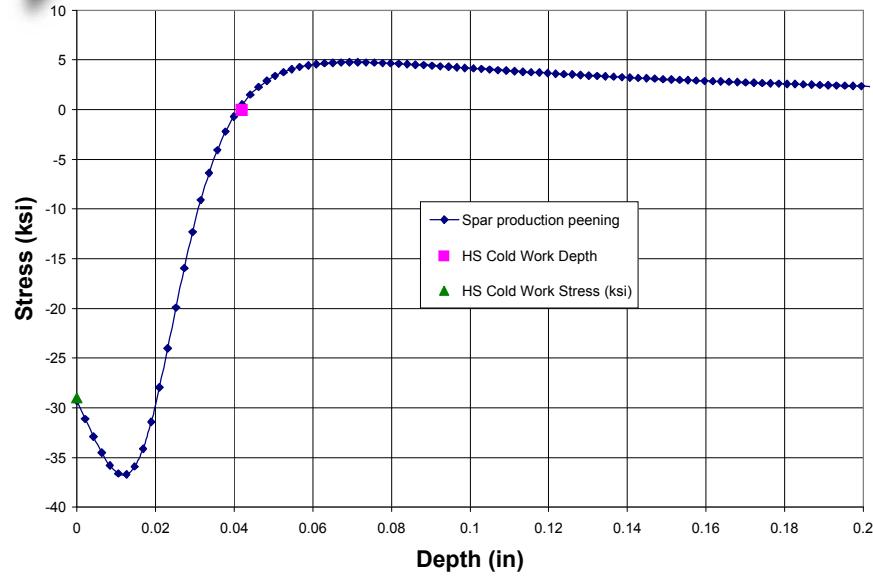
Estimated Shot Peening Residual Stress Profile for 0.125" shot, 5-7 Y and spar thickness>0.64 in.

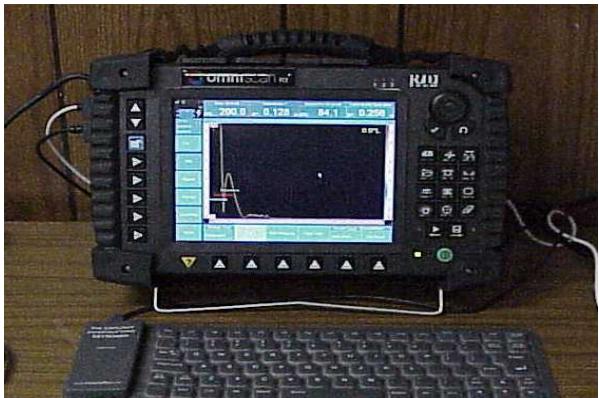
OMNI Scan UT Inspection Unit  
( 10 MHz Phased Array Probe)

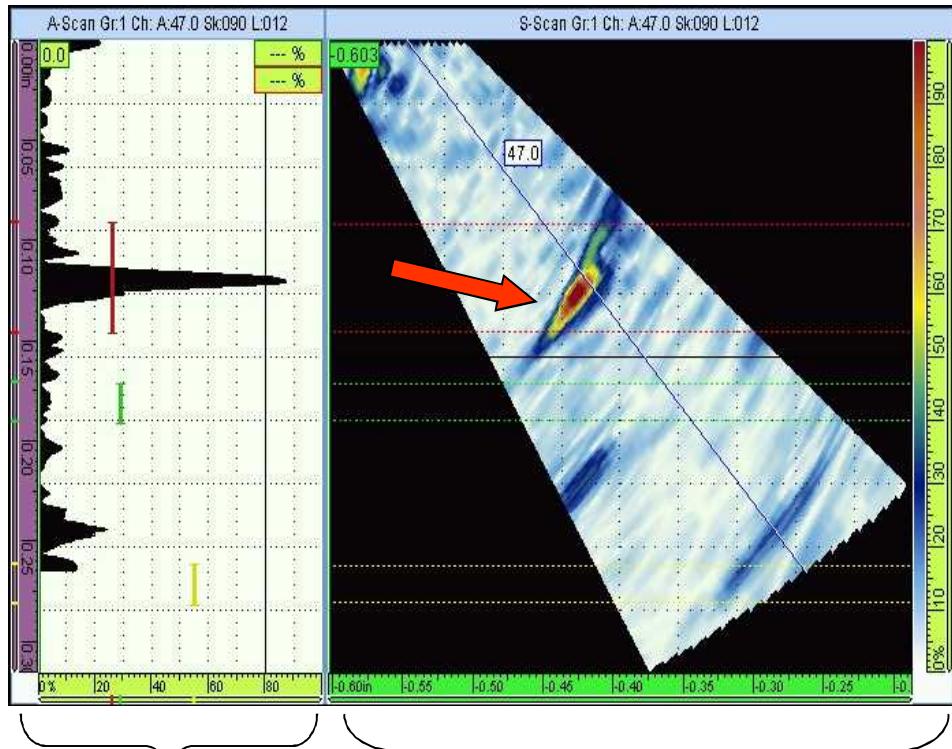
A-Scan signal

Sectoral-Scan  
(Collection of A-Scans)

Measured Length = 0.038"

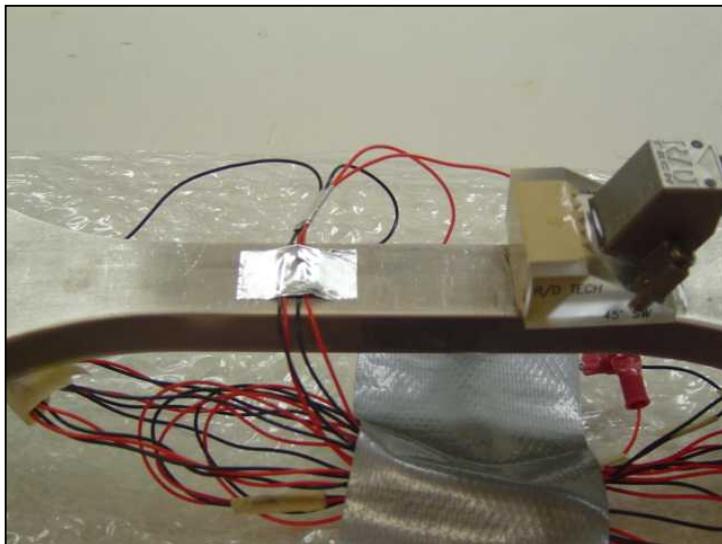
0.5" th. Dogbone Specimen with Center Crack, Potential Drop Leads & UT Array Probe

PD measurement = 0.414"  
UT measurement = 0.414"

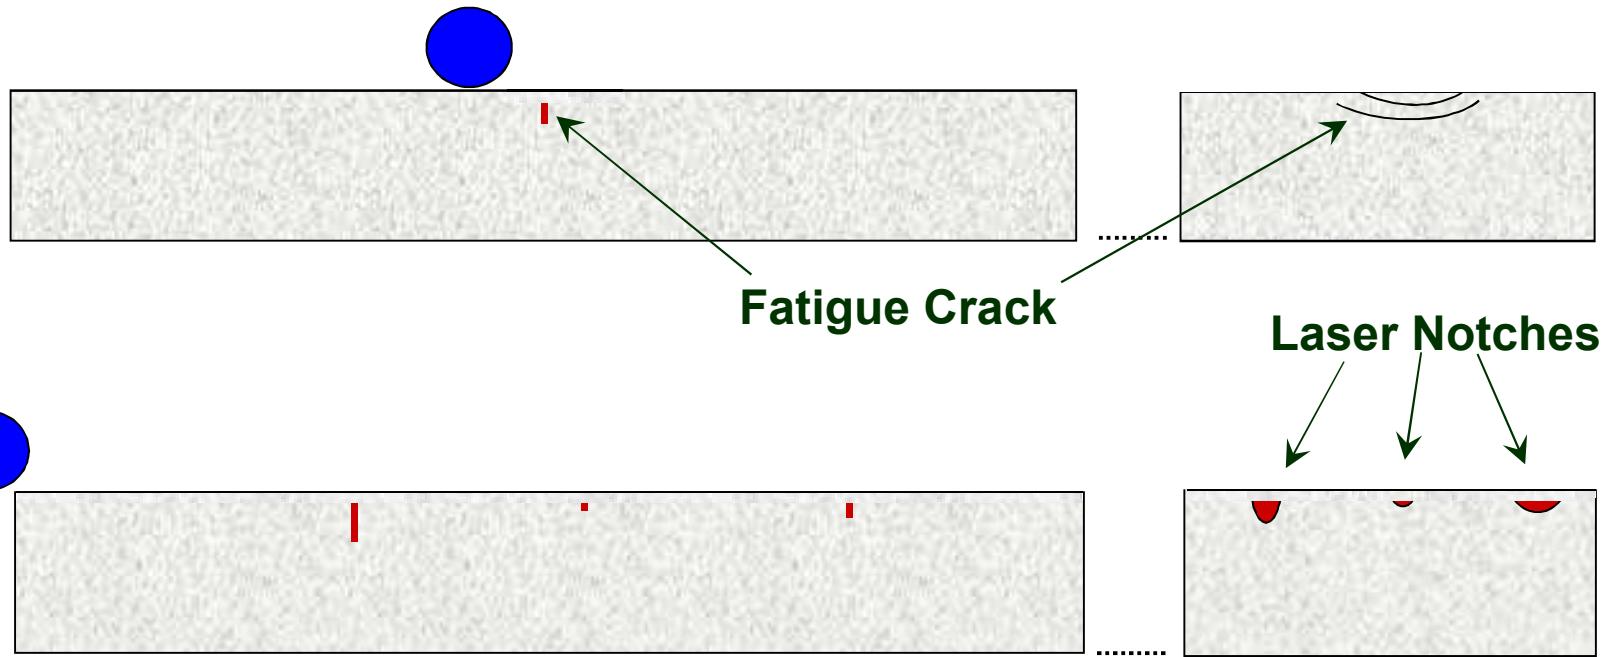
Specimens = 3.5" W X 6" H X 0.125" th.

Cracks = 0.014" – 0.080" L X 0.006" – 0.035" D

*Machining process removes visual indication of crack*

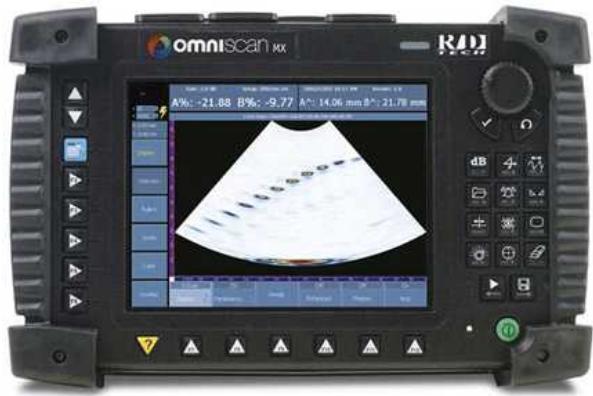
Instrument: ONMIScan MX

Transducer: 10 MHz, 16 element phased array

Set-up: Shear wave using A-scan along with a Sectorial view (collection of A-scans)

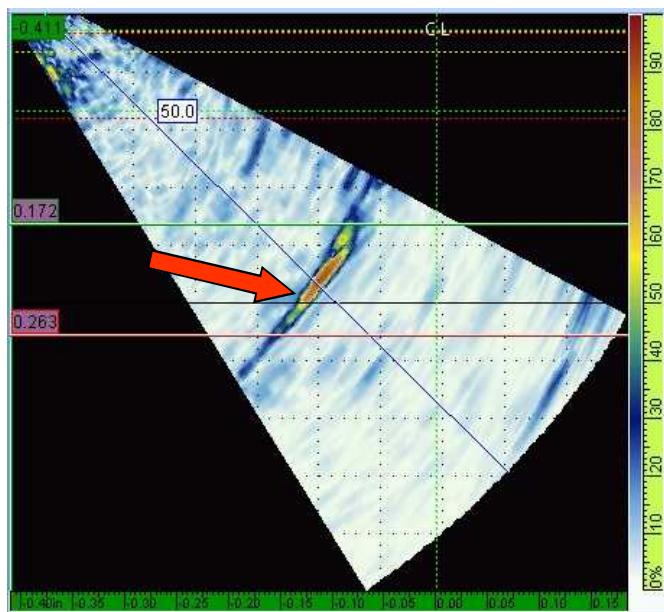
2024-T8 Specimen  
3.5" W X 6" H X 0.125" th.

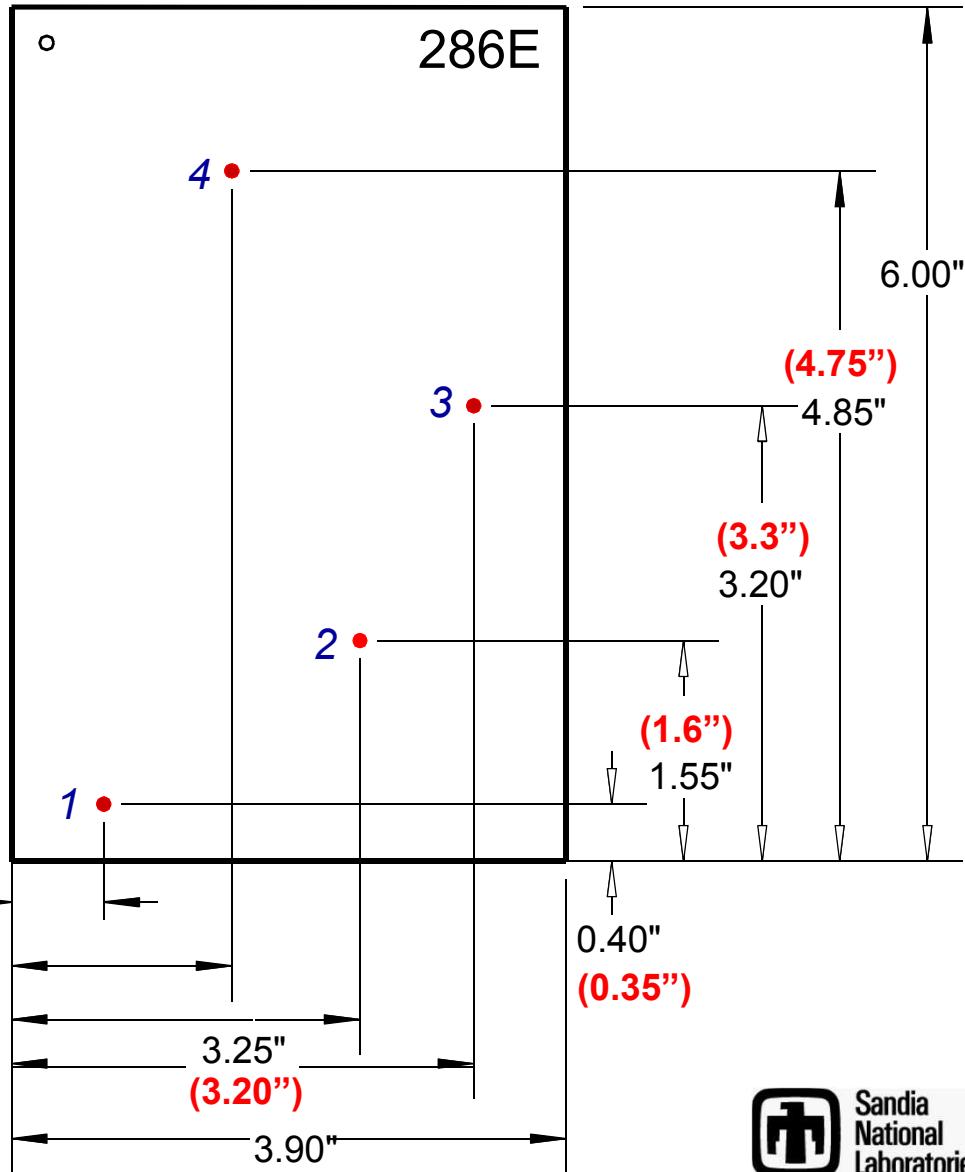
## Phased Array UT Method

(0.78") 0.65"  
 (1.55") 1.55"  
 (2.45") 2.45"

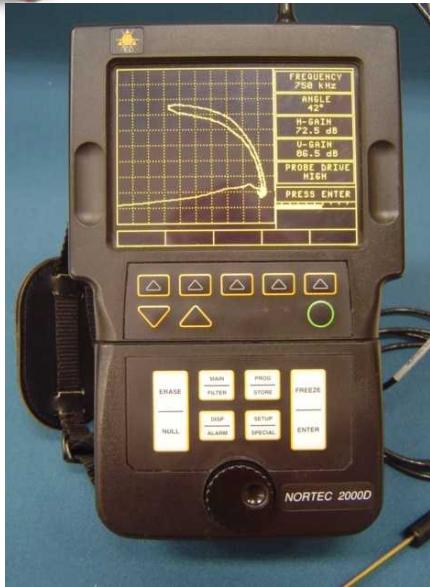
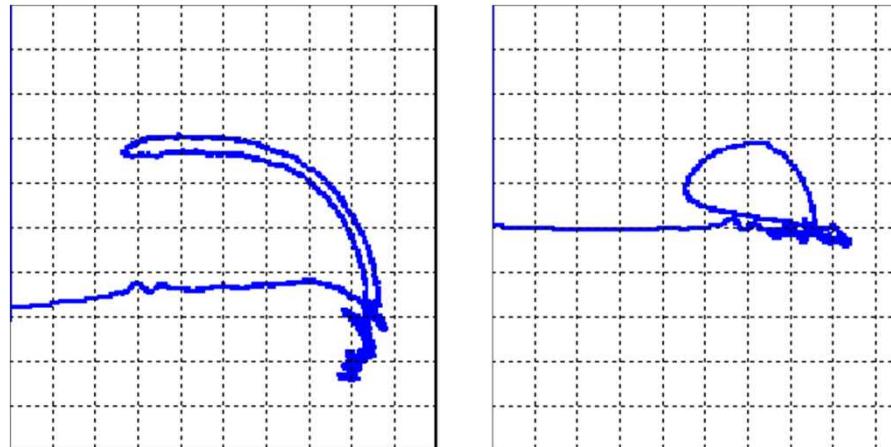
EC is limited to Non-Peened Surfaces

## Actual Crack Lengths

- 1) 0.094"
- 2) 0.080"
- 3) 0.102"
- 4) 0.070"

## Crack Length Predictions

- 1) 0.230"
- 2) 0.175"
- 3) 0.230"
- 4) 0.160"

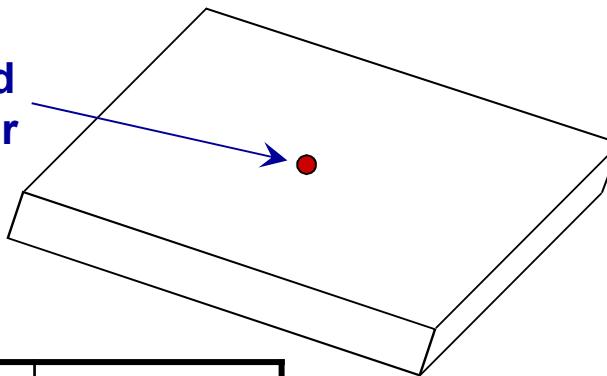
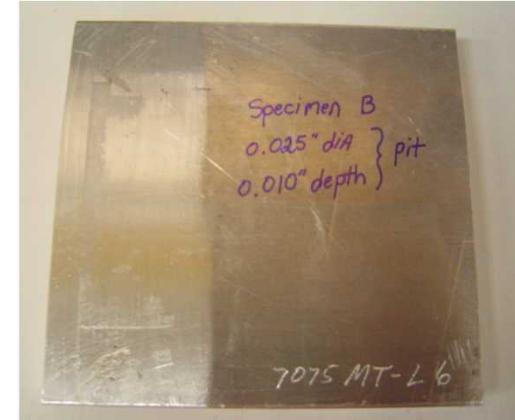
Chemically-controlled corrosion pit measured with optical micrometer

Specimen	Pit Depth	Pit Diameter
B	0.010	0.025
C	0.018	0.040
D	0.022	0.065

Aluminum 7075  
(4" X 4" X 0.5" th.)

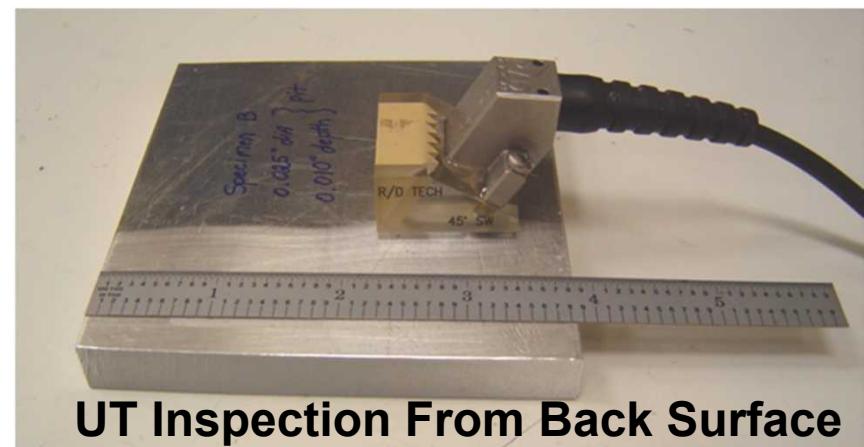
UT Inspection From Back Surface

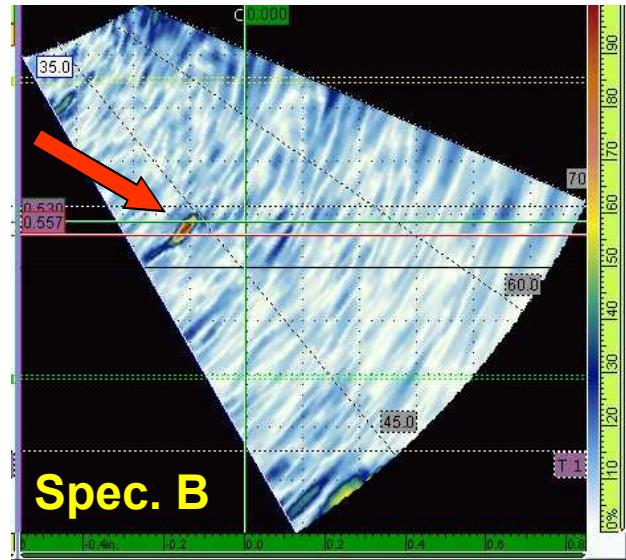
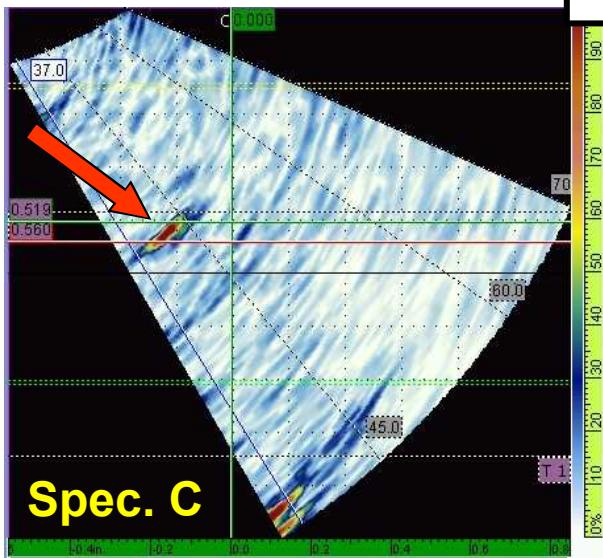
Specimen	Actual Corrosion Diameter	Estimated Corrosion Diameter
B	0.025	0.027
C	0.040	0.041
D	0.065	0.065
