Long Term Dormant Storage Experiment of COTS Components Under Field Conditions

SAND2007-4942C

19th ANNUAL 2007 INTERNATIONAL MILITARY & AEROSPACE / AVIONICS COTS CONFERENCE

John López
Sandia National Labs
jrllope@sandia.gov
(505) 845-0834

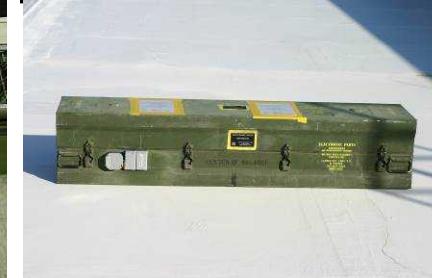
- **Storage, Site Selection and Monitoring**

- Five More Hellfire Missile Containers.
- Same Storage Sites (NM, AZ, FL, Alabama and Alaska)
- Use commercial data loggers to collect temperature and humidity data.

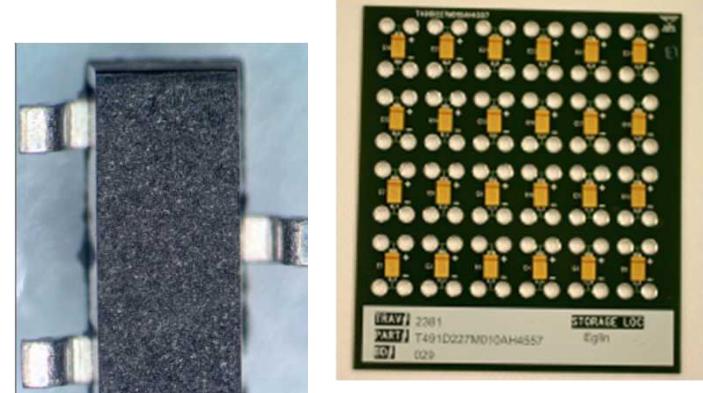
- **Parts packaged loose and soldered to boards.**

- Investigate solder fatigue
- Investigate tin whiskering on some capacitor leads
 - Populated as-is, Pb-plated and Pb-solder-dipped.
 - Some conformal coated and some not.

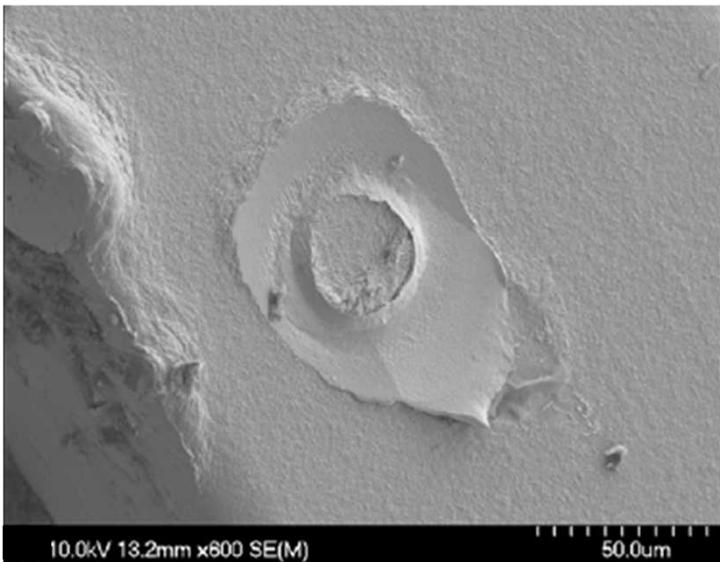
OP400 and CY7C199-15VI

- **Passivation failure on OP400 die.**
 - Scraped die during production
- **One CY7C199 component failed electrical testing**
 - New Mexico after one year of storage.
 - Device intermittent failure at -40 C was caused by over-bonding.
 - Note excessive thinning at the heel.

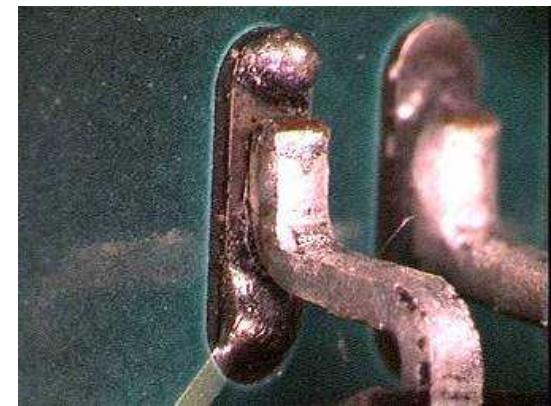
- OP400 (2nd year)
 - CSAM contamination
 - Leakage current
 - Passed after cleaned

- OP400 (1st year)
 - Cold solder joints

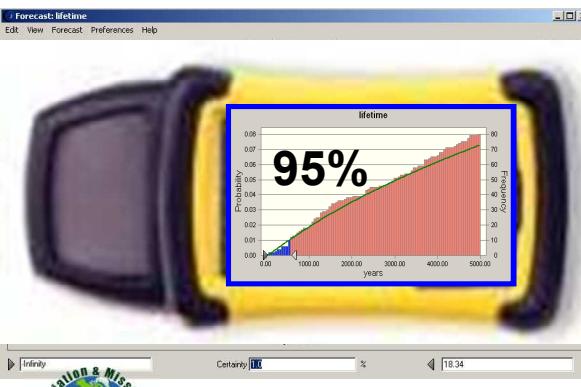
MODELS

- Corrosion and Die-Crack in COTs;
- Solder joint;
- Tin whisker;
- Adhesives (missiles);
- Propellant (missiles).

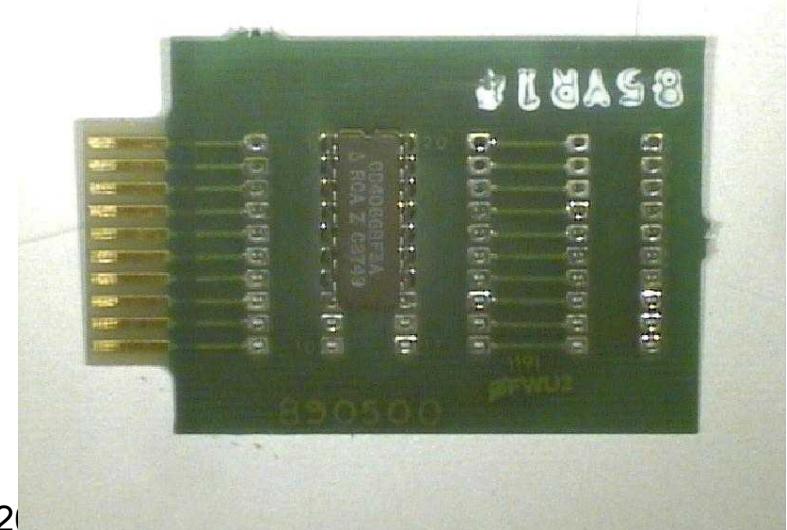
AMRDEC long term dormant study

- Received 75 additional part types from AMRDEC long term Dormant Study (Alaska, and Yuma)
 - Ceramic
 - 12 years in dormant storage in Alaska and Arizona
 - Will de-lid population sample for internal inspection
 - Tentative electrical test of sample population
