Aging Effects on the Surface Chemistry and Resulting Performance of Microsystems

Michael T. Dugger

**Microreliability and Nanoreliability
in Key Technology Applications**

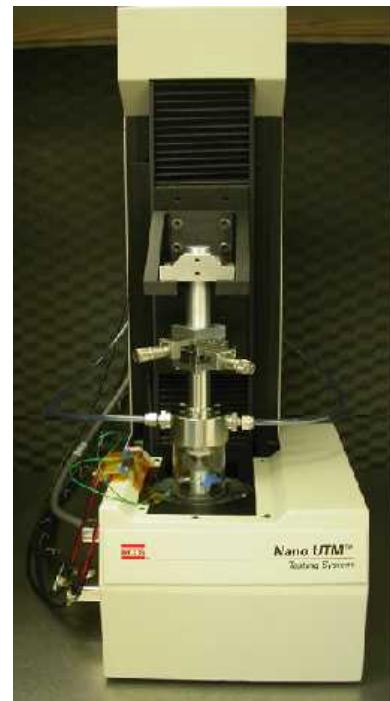
Apparatus Schematic

Force, displacement, and resistance simultaneously recorded during each contact cycle

$$\begin{aligned} F_n &= 150 \mu\text{N} \\ V_s &= 3.3 \text{ V} \\ R_L &= 1.1 \text{ k}\Omega \\ I &= 3 \text{ mA} \end{aligned}$$

$$R_c = \frac{R_L}{\frac{V_s}{V_{out}} - 1}$$
