# First Wall Quality Mockup Testing

**SOFE 2007**  
**June 19-21, 2007**  
**Albuquerque, NM USA**

**Tina J. Tanaka\*, Alice Ying†, Manmeet Narula†, and  
Michael A. Ulrickson\***

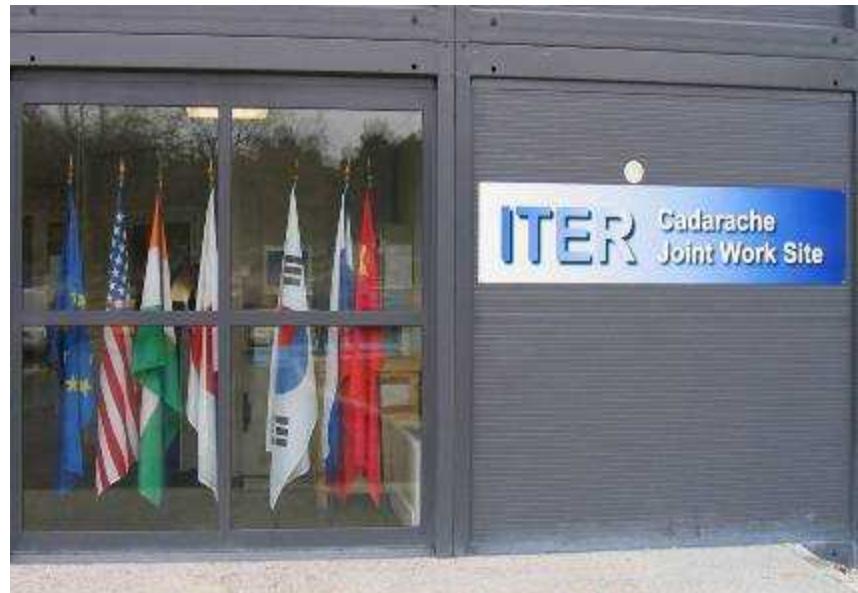
- **ITER is being built by 7 parties**
- **Unlike for other components where one or two parties are collaborating...**
- **SIX different parties are building the first wall**

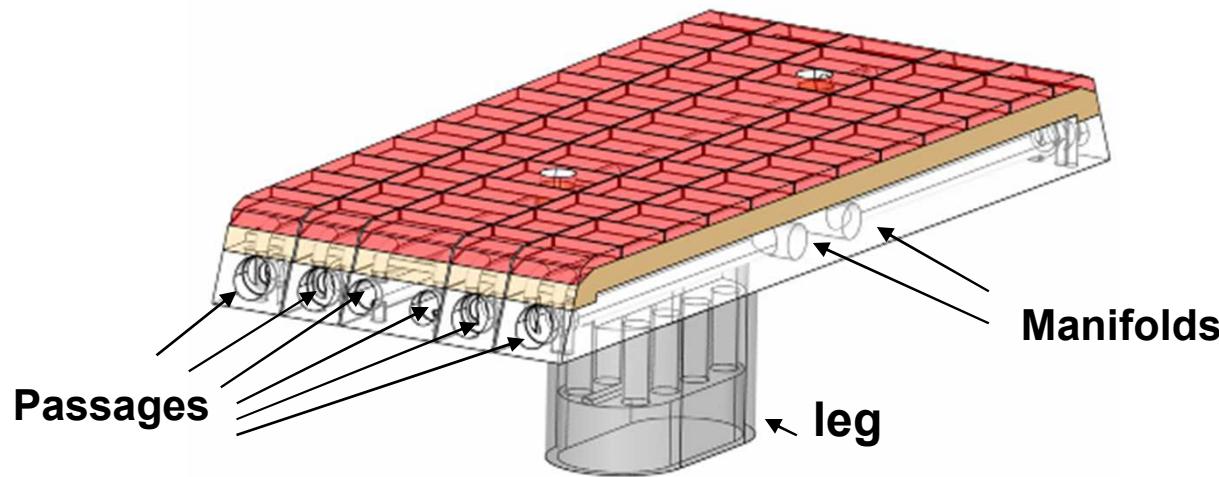
# First Wall Design

- Beryllium tiles that are between 57-90 mm wide and long, 10 mm thick
- Cu alloy substrate (C18150) with embedded stainless steel tubes and water coolant inside that is 22-25 mm thick
- Stainless Steel (316LN) with water coolant passages
- Water coolant flows about 3 m/s through 10 mm diameter tubes in copper alloy, temperature 100-120 C

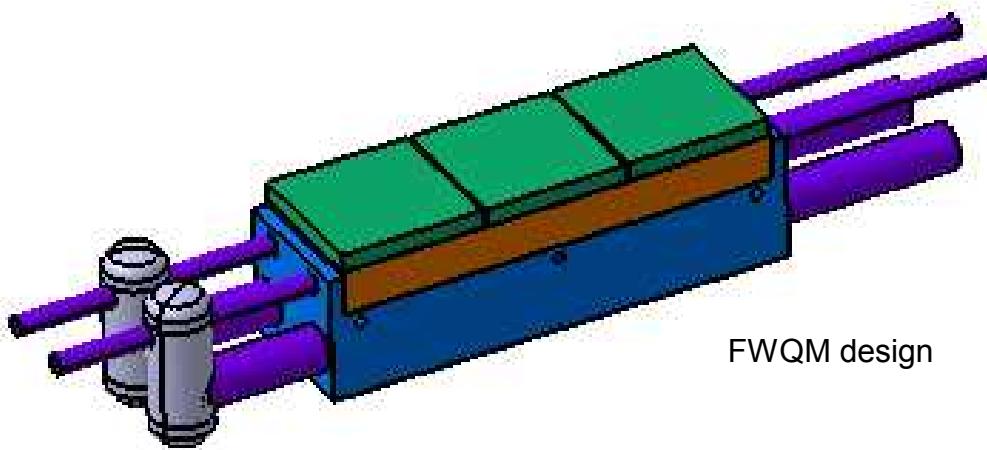
# Test Article

- The ITER international organization (IO) has proposed a mockup to be used for qualification of the joining process
- Mockup uses typical tile sizes, copper alloy thicknesses from the inboard vacuum vessel
- But does not include the curved tubes that are in the real first wall.
- Parties are required to make 3 mockups and have 2 that pass fatigue tests
- Test conditions were proposed by IO which includes slowing water velocity to make up for lack of neutronic heating

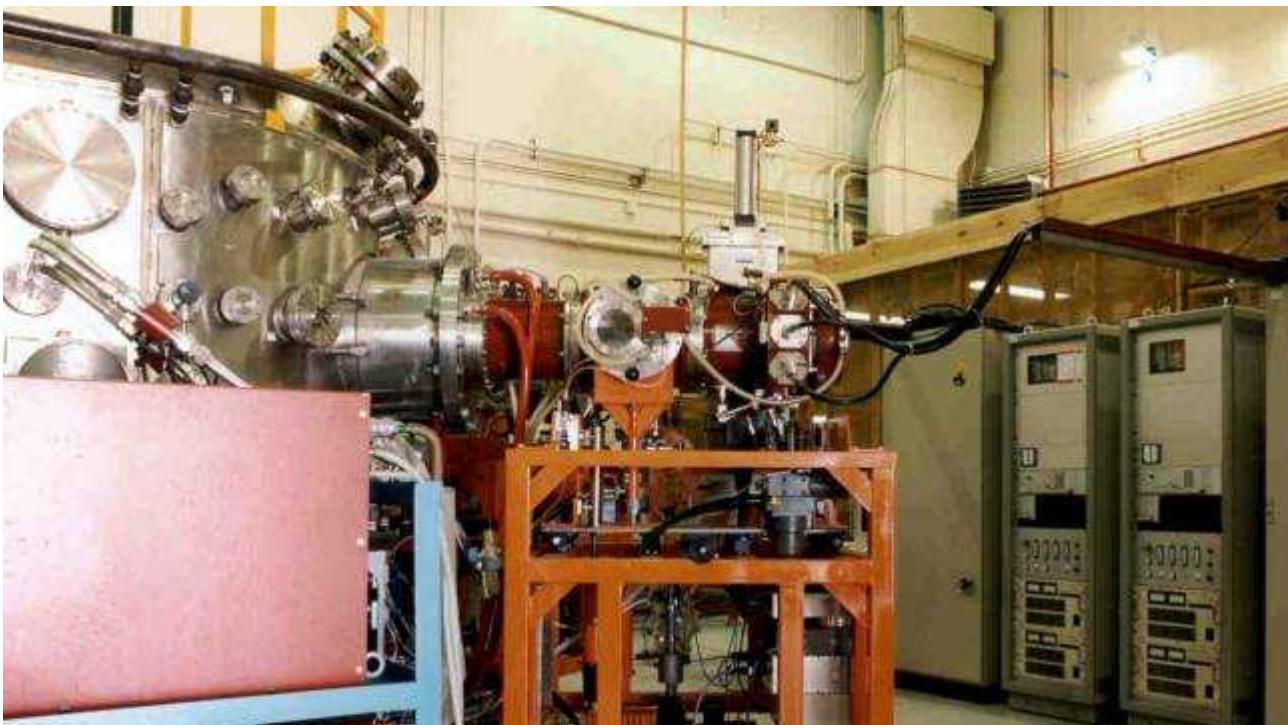
## Mockups will be tested in US or EU

- The US facility is the Plasma Materials Test Facility at Sandia National Laboratories
- We plan to use EB1200 which has an electron beam that can be focused and moved across the beryllium tiles

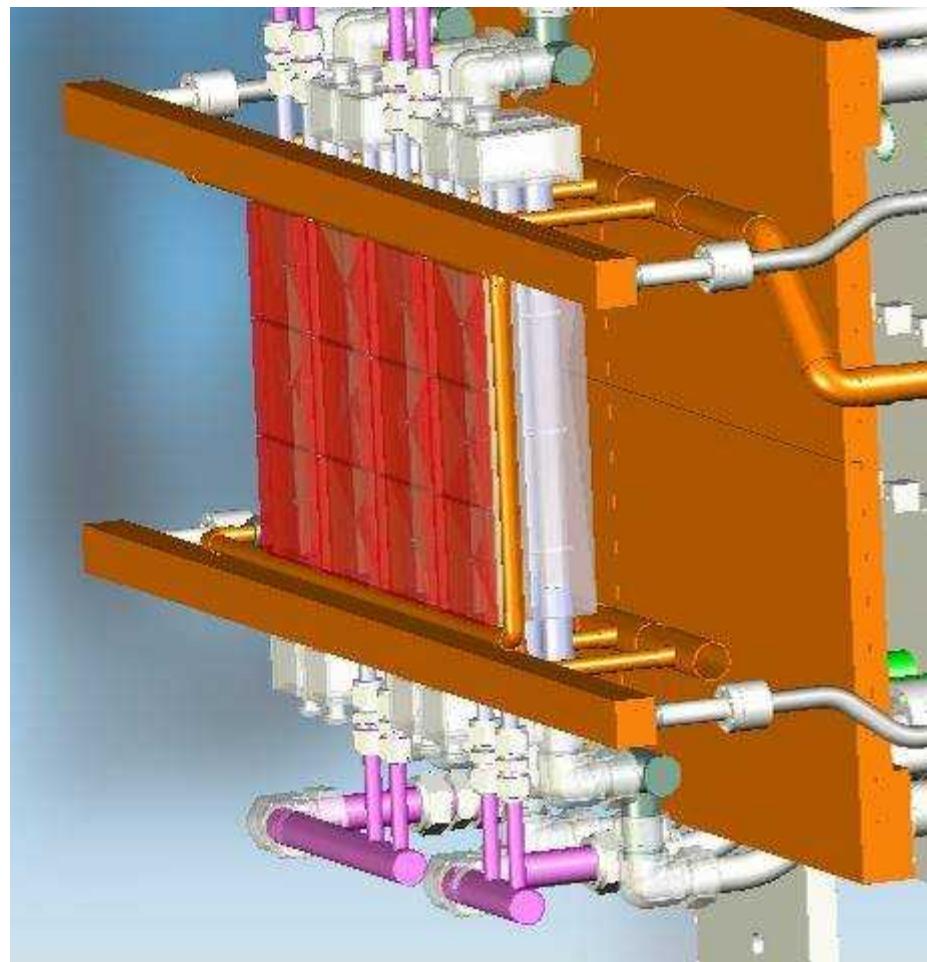
# Test conditions at SNL

- We plan to test four FWQM at one time using 2 e-guns
- Detection of failure with IR cameras

Heat flux on tiles	0.7 MW/m <sup>2</sup>
<b>Coolant velocity in tubes</b>	<b>1 m/s</b>
Coolant Temperature	100 C
Number of cycles	12,000
Cycle time (on and off)	96 s

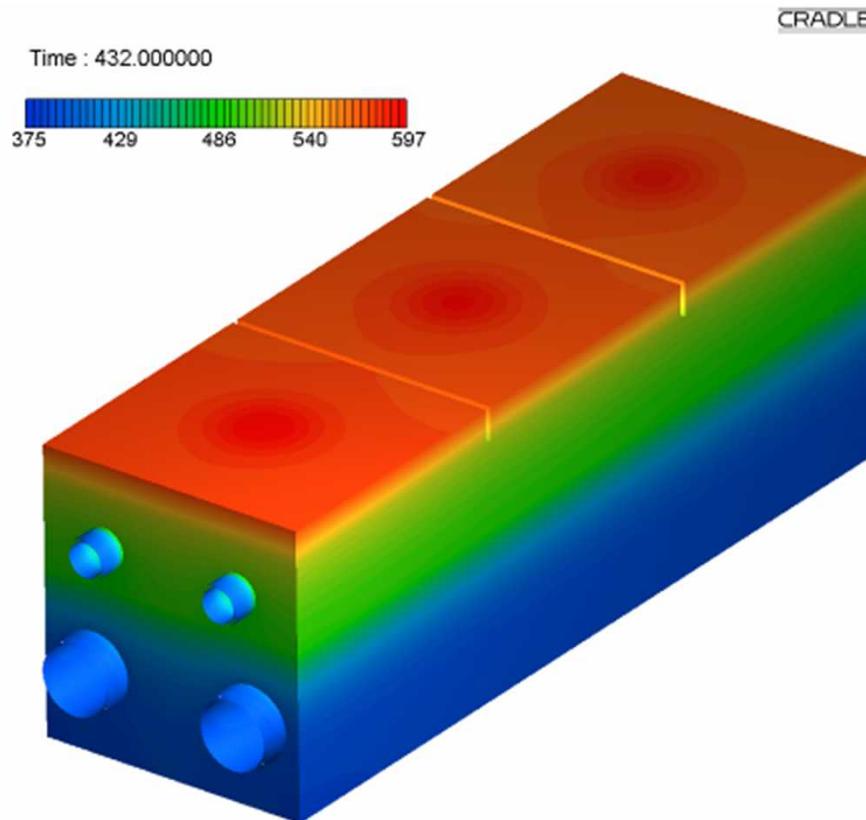
# Expected temperatures for test conditions

Max Temperature/ BeCu interface	227 C
Min Temperature/ BeCu interface	127 C
Max Temperature/ Be	282 C

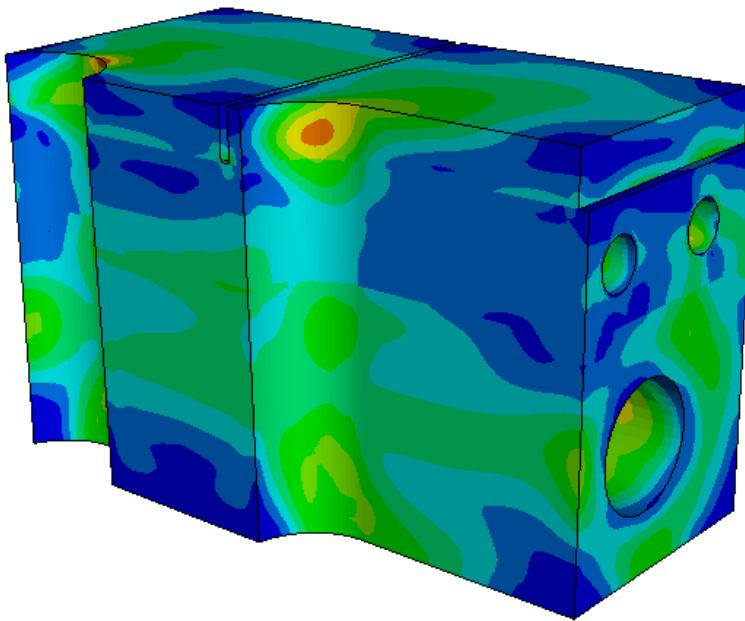
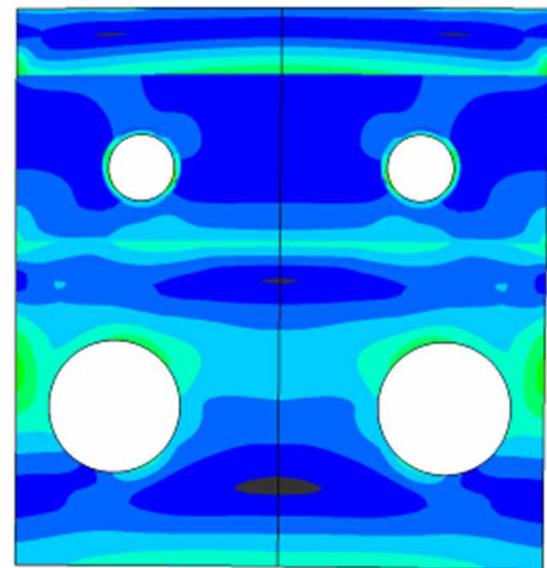
# Stress calculation comparisons

First wall stresses calculated with  
plasma and neutron heating

Max stress near BeCu interface\* 90 MPa  
Min stress near Be Cu interface\* 37 MPa

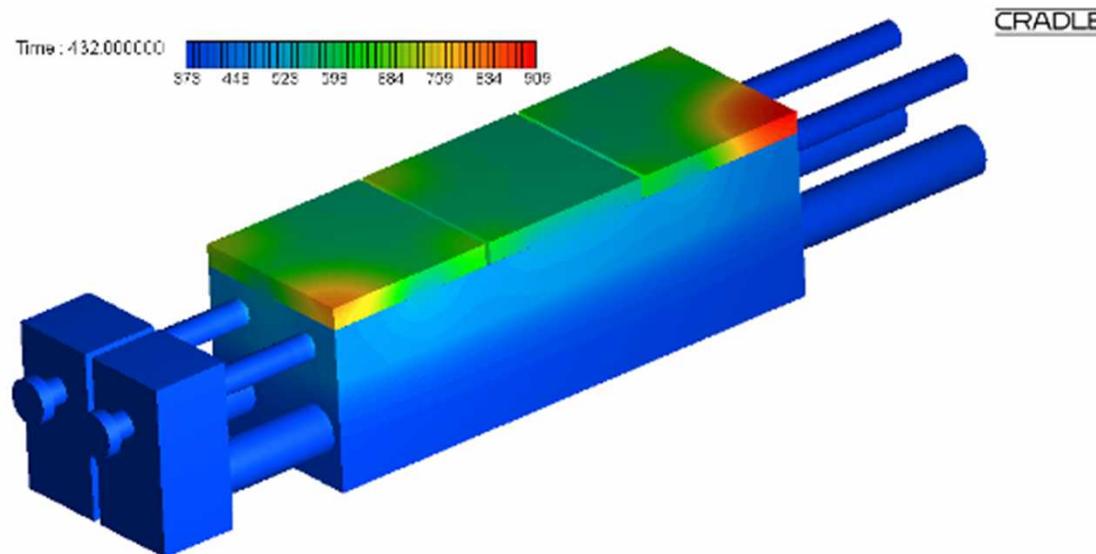
# Failure criteria

- If at any time, the average temperature on any  $100 \text{ mm}^2$  local area minus the average temperature on the whole Be top surface is greater than  $50 \text{ C}$ , the mockup has failed.
- This will be determined by IR camera for PMTF

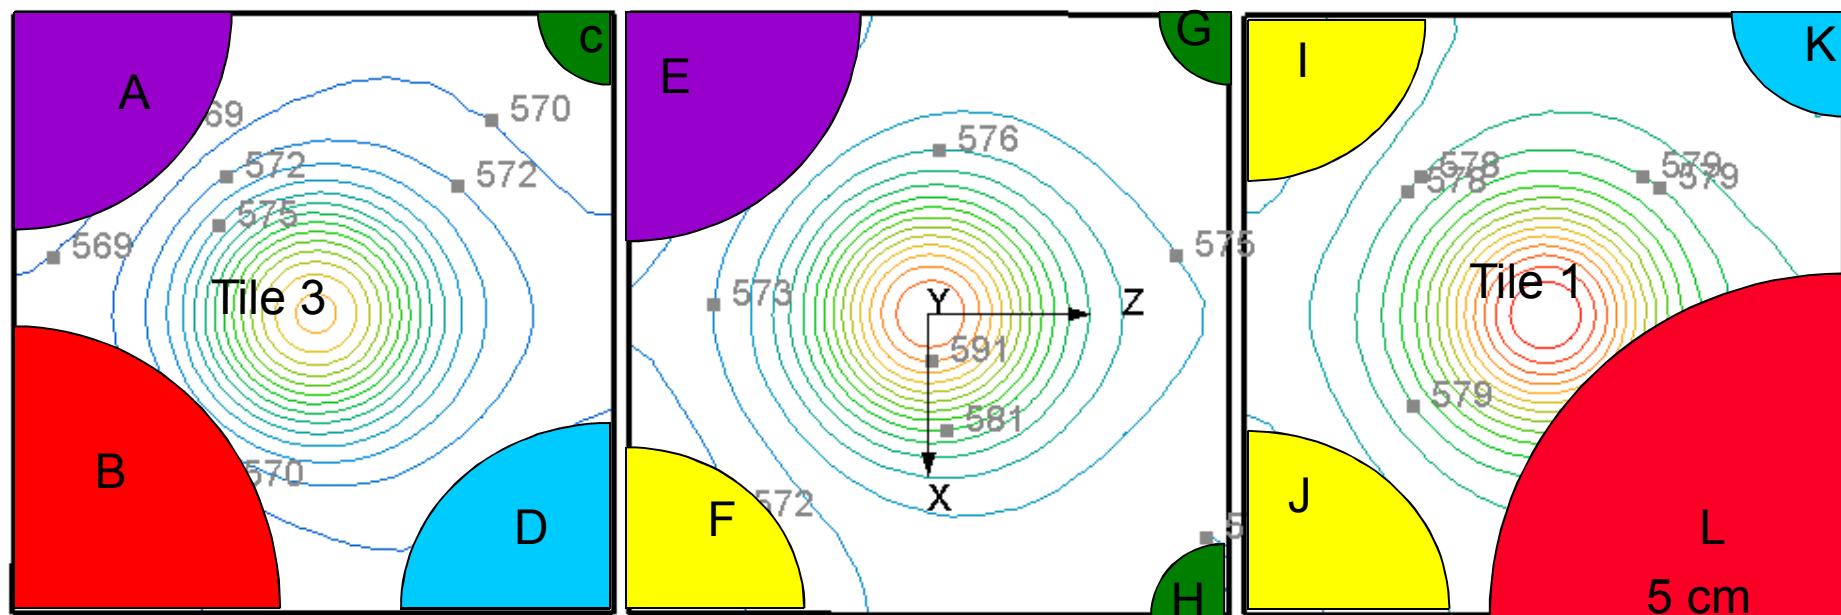
## Be surface temperature for different flaw sizes

**Various flaw sizes under study****In this set of calculation, a flaw means 0.1 mm deep gap of void in Be near Be/copper interface**

Coupled effect appear not significant

A flaw size of  $\sim 2$  cm radius quarter circle creates a spot area of  $100 \text{ mm}^2$  or larger with  $\Delta T$   $50^\circ\text{C}$  higher than temperature under normal operating condition

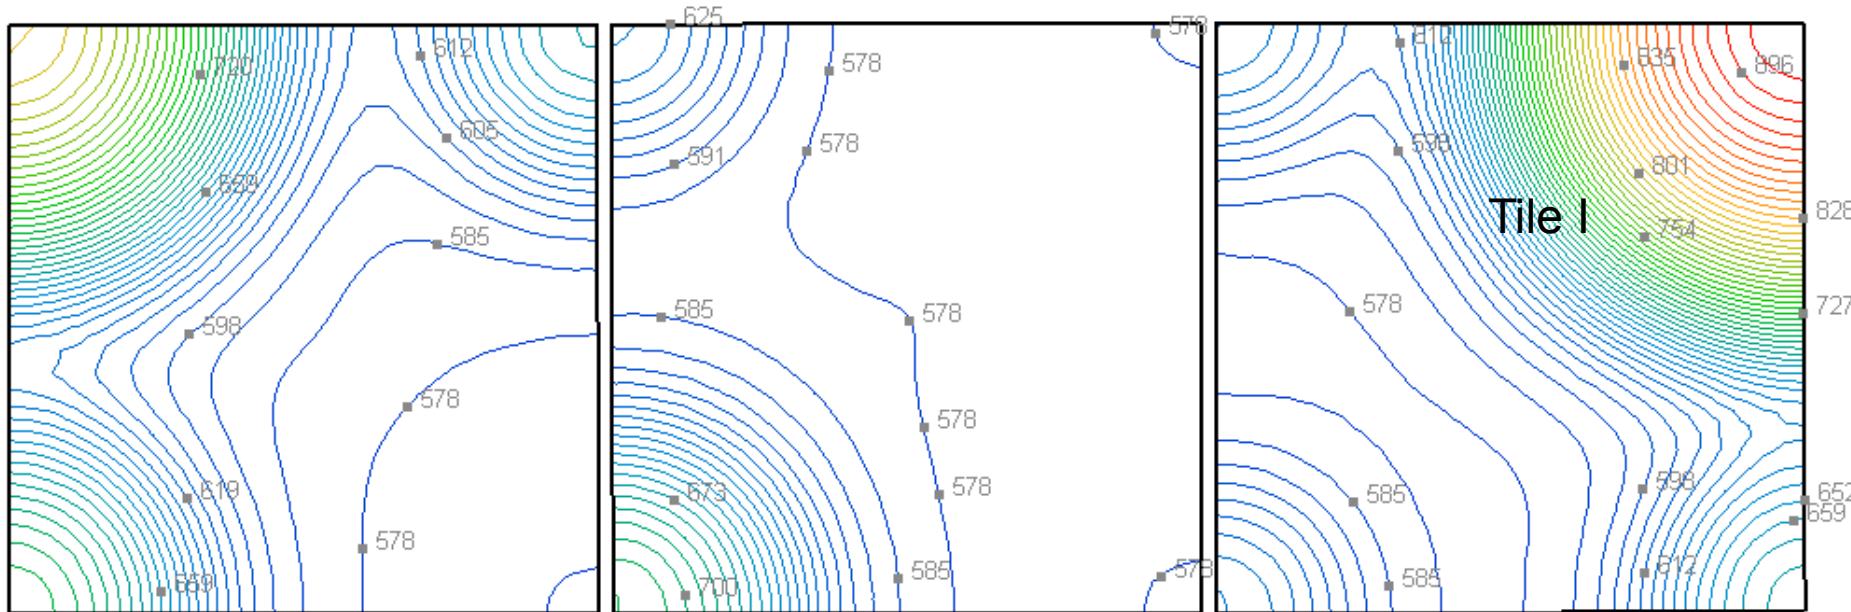
## Tile III Be surface temperature details

$T_{\max}$  under normal operating condition for Tile III= 578K

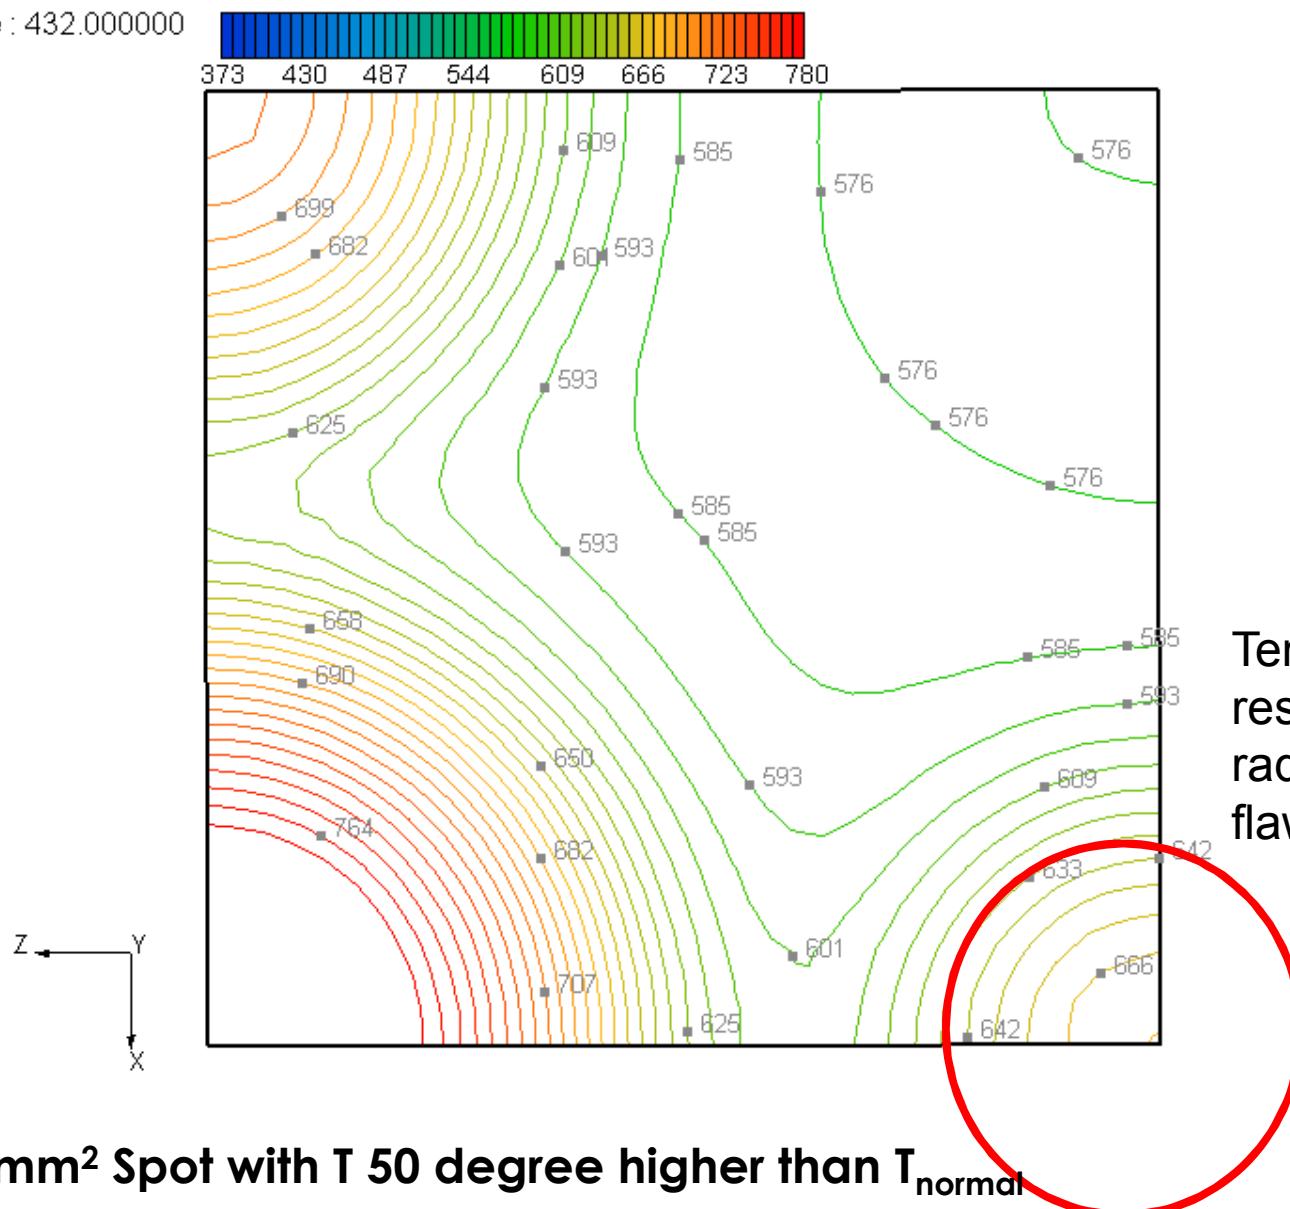
Temperature contour results from a 2.5 cm radius quarter circle flaw

A 100 mm<sup>2</sup> Spot with T 50 degree higher than T<sub>normal</sub>

- **First Wall Quality Mockup testing will determine if a party team is qualified to manufacture first wall panels**
- **Testing will be performed at PMTF (Sandia National Laboratories) on an electron beam facility or in EU**
- **The failure criteria for the US facility is dependent on the surface temperature; a 100 mm<sup>2</sup> area that is 50 C above rest of tiles**
- **Predicted flaw size calculated to generate the failure criteria is a 25 mm radius quarter circle**
