Results of Stainless Steel Canister Corrosion Studies and Environmental Sample Investigations

Fuel Cycle Research & Development

*Charles Bryan and David Enos
Sandia National Laboratories
September 25, 2014*

FCRD-UFD-2014-000055
SNL DOC# 166112

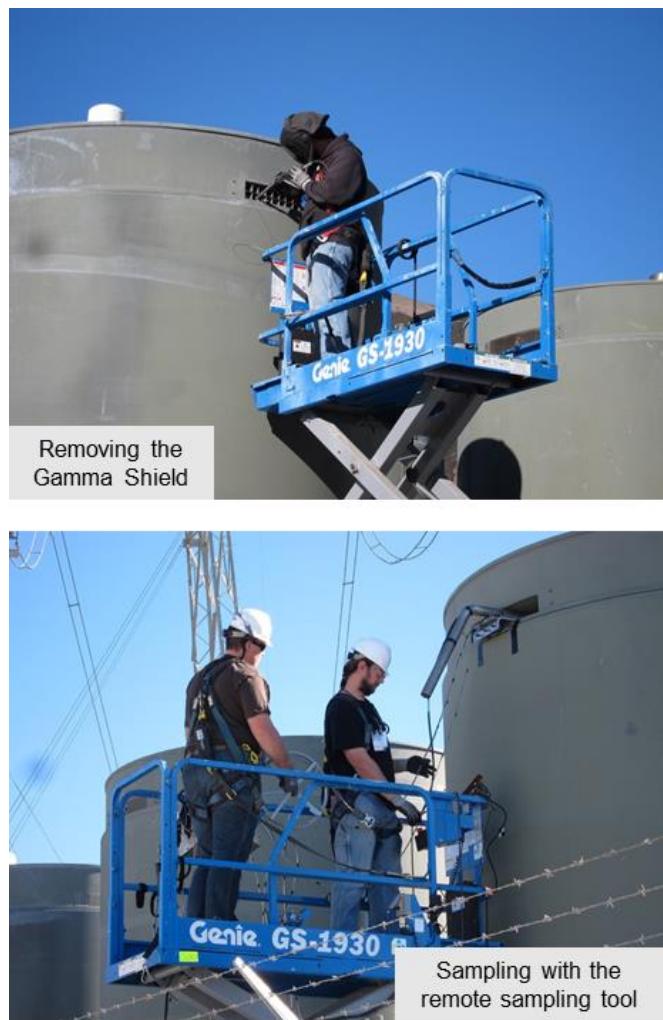
Figure 2. Sampling dust from the surface of interim storage canisters within their overpacks.

Sampling at Hope Creek and Diablo Canyon was carried out through one of the upper ventilation openings on each package. After removal of the screen covering the opening, spot welds holding the gamma shield in place were cut, and the gamma shield extracted. Then a guide rail for the sampling device for the side of the package was inserted into the opening by workers on a scissor lift (Figure 2). This rail guided the remote sampling tool down into the narrow (~2 inch) annulus between the canister and the overpack. The sampling tool was forced down the annulus with a steel ribbon, with trailing tubing to operate a pneumatic system on the sampling head. The wet samples were collected using SaltSmart™ sensors, which are used in shipyards to quantify the amount of salts on metal surfaces per unit area. The sensors were mounted on the sampling head in a shallow recess, so that they did not contact the metal surface during the emplacement process. Each sensor has a flat wick, which was pressed flat against the metal surface pneumatically. A small amount of deionized water was then injected into one end of the sensor, and was drawn across the wick by capillary forces to a reservoir pad

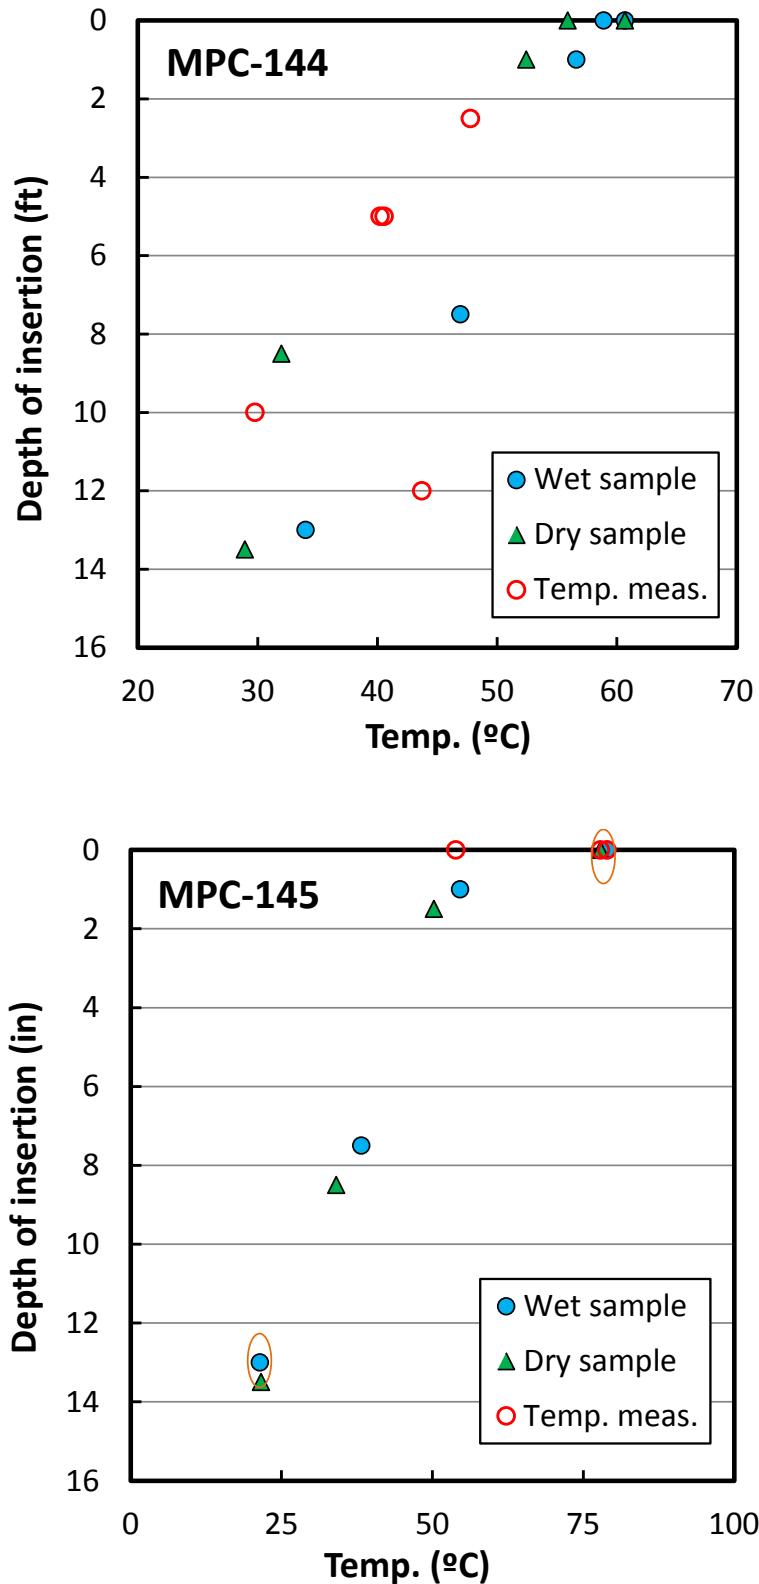
Figure 3. Hope Creek sample locations and temperatures. Orange ovals mark SaltSmart™ samples with heat-damaged wicks or unsaturated reservoir pads.

The surface temperatures at each sampling location are provided in Table 1 and Table 2, and are plotted versus sample location in Figure 3 and Figure 4 for the Hope Creek and Diablo Canyon canisters, respectively. It should be noted that in the case of Hope Creek MPC-144 and Diablo Canyon MPC-170, temperatures were not consistent over the course of the sampling effort, with measured temperatures for the wet and dry sampling forming two different trends as a function of depth. The observed temperature differences are too large to be due to variations in the external air temperature, and it is assumed that readings from one or more of the thermocouples are inaccurate; possibly, poor contact was achieved with the canister surface.

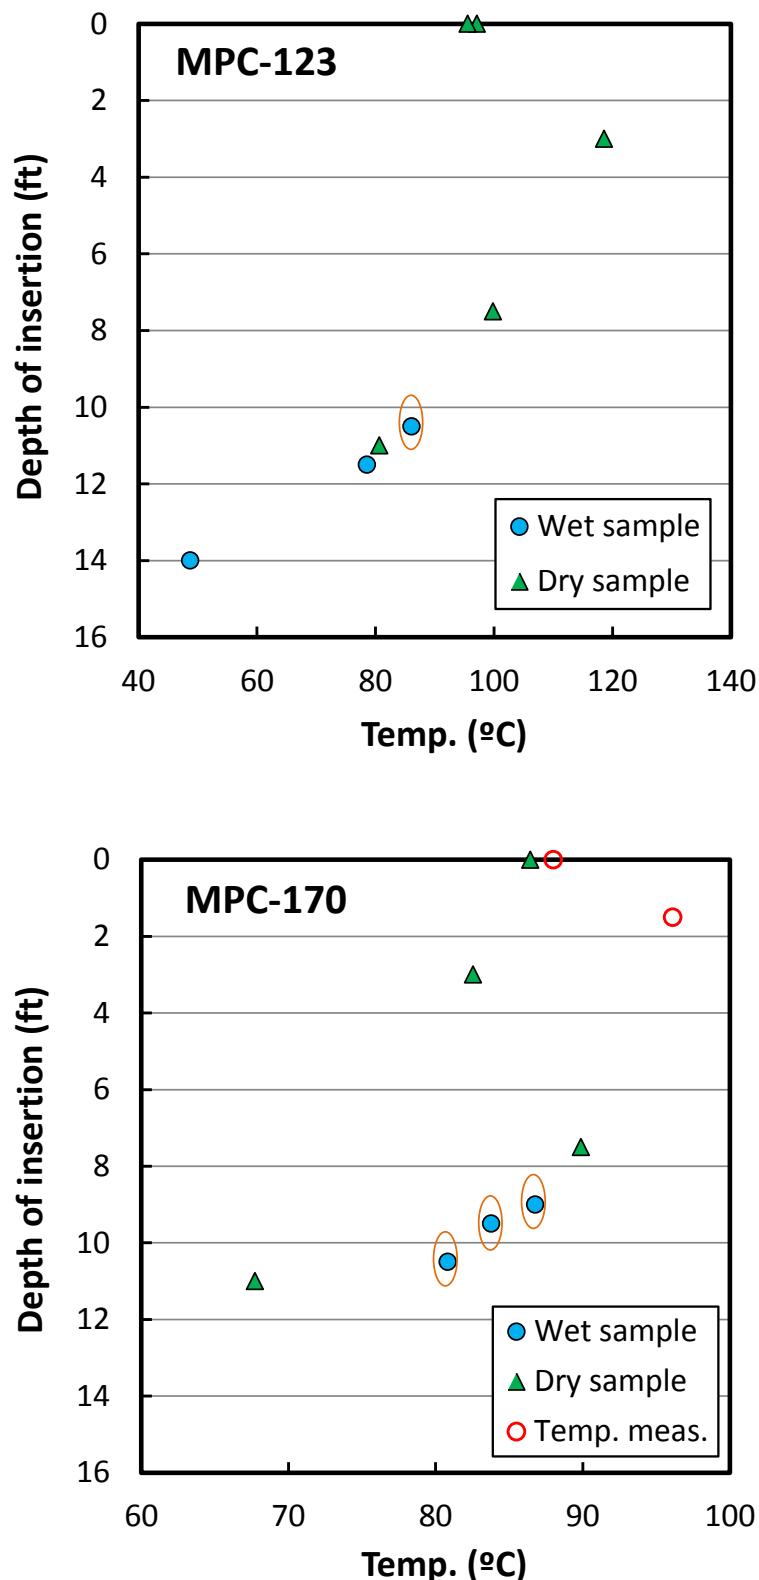
Figure 4. Diablo Canyon sample locations and temperatures. Orange ovals mark SaltSmart™ samples with heat-damaged wicks or unsaturated reservoir pads.

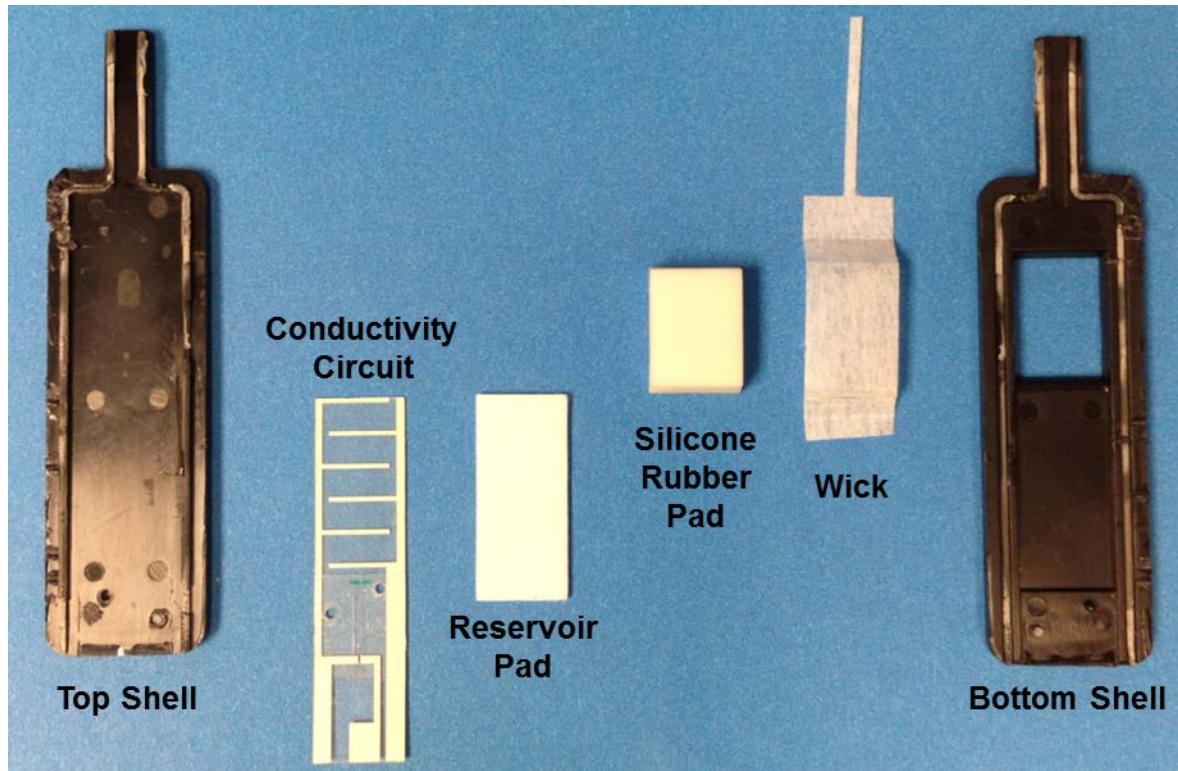
Figure 5. Disassembled SaltSmart™ Device.

For analysis, the SaltSmartTM sensors were removed from the 50 ml centrifuge tubes and split open along the seam with a small chisel. The component parts of each sensor are shown in Figure 5. The wick and the reservoir pad inside the SaltSmartTM device were removed and transferred to a pre-weighed 50 ml polypropylene screw-cap sample tube. Moisture was observed on other plastic internal pieces of the sensors and on the inside surfaces of the two halves of the shell. The internal pieces, and the inside surfaces of the shells, were rinsed with deionized water ($>18\text{M}\Omega$) and the water transferred to the polypropylene sample tubes containing the wicks and pads. The original centrifuge tubes used for shipping the samples commonly contained condensate, and these were also rinsed into the polypropylene

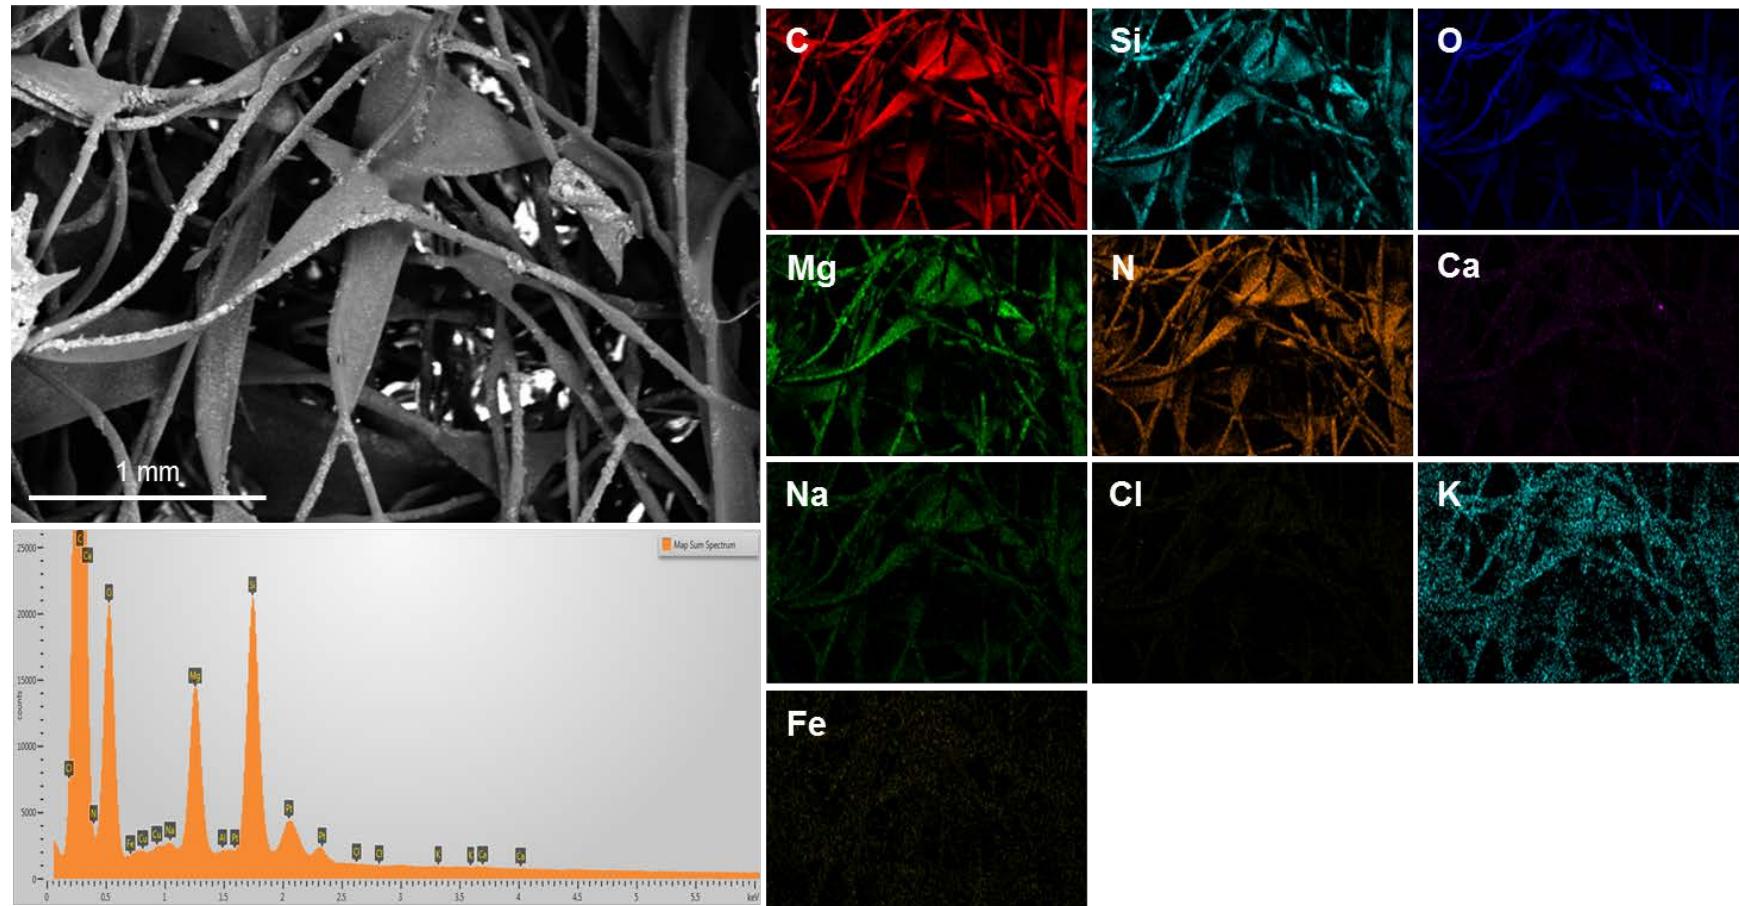
Figure 6. Low magnification SEM image/EDS map of Scotch-Brite™ pad blank.

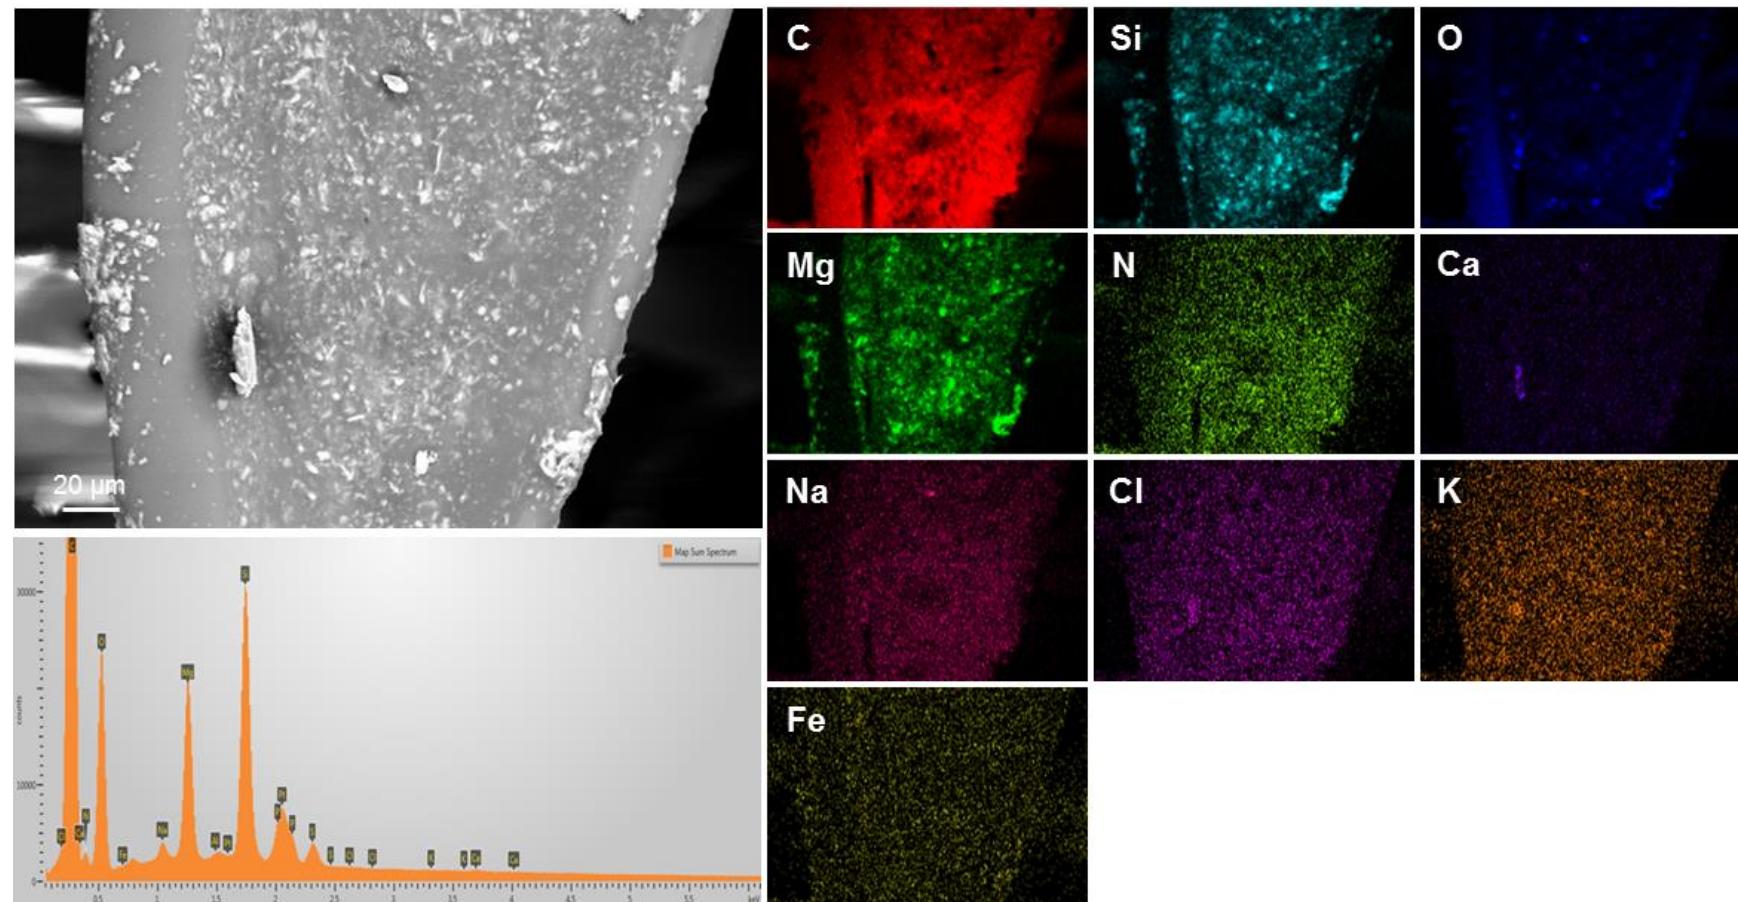
Figure 7. High magnification SEM image/EDS map of Scotch-Brite™ pad blank.

Figure 7 is a higher resolution image of the bad blank, showing the texture of the pad and the embedded talc. In general, the blank pad had little adhering particulate matter, other than talc particles freed by abrasion during cutting and handling of the pad for SEM analysis.

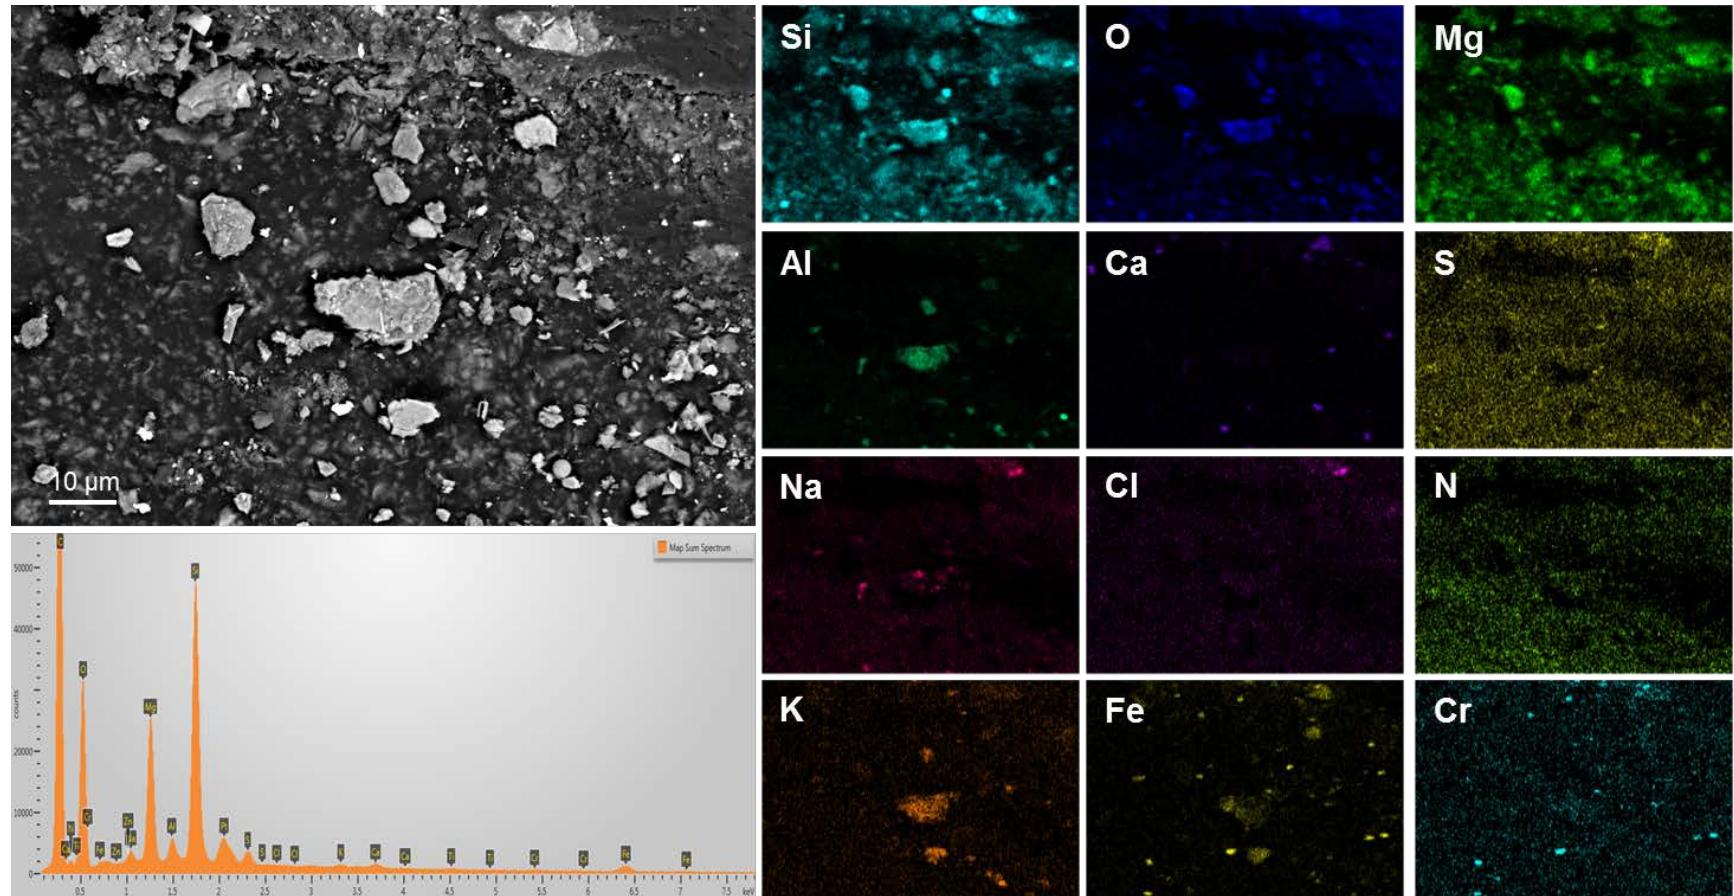
Figure 8. SEM image/EDS map (#2) of Sample 145-003, collected from the canister side, 13.5 feet below the upper edge.

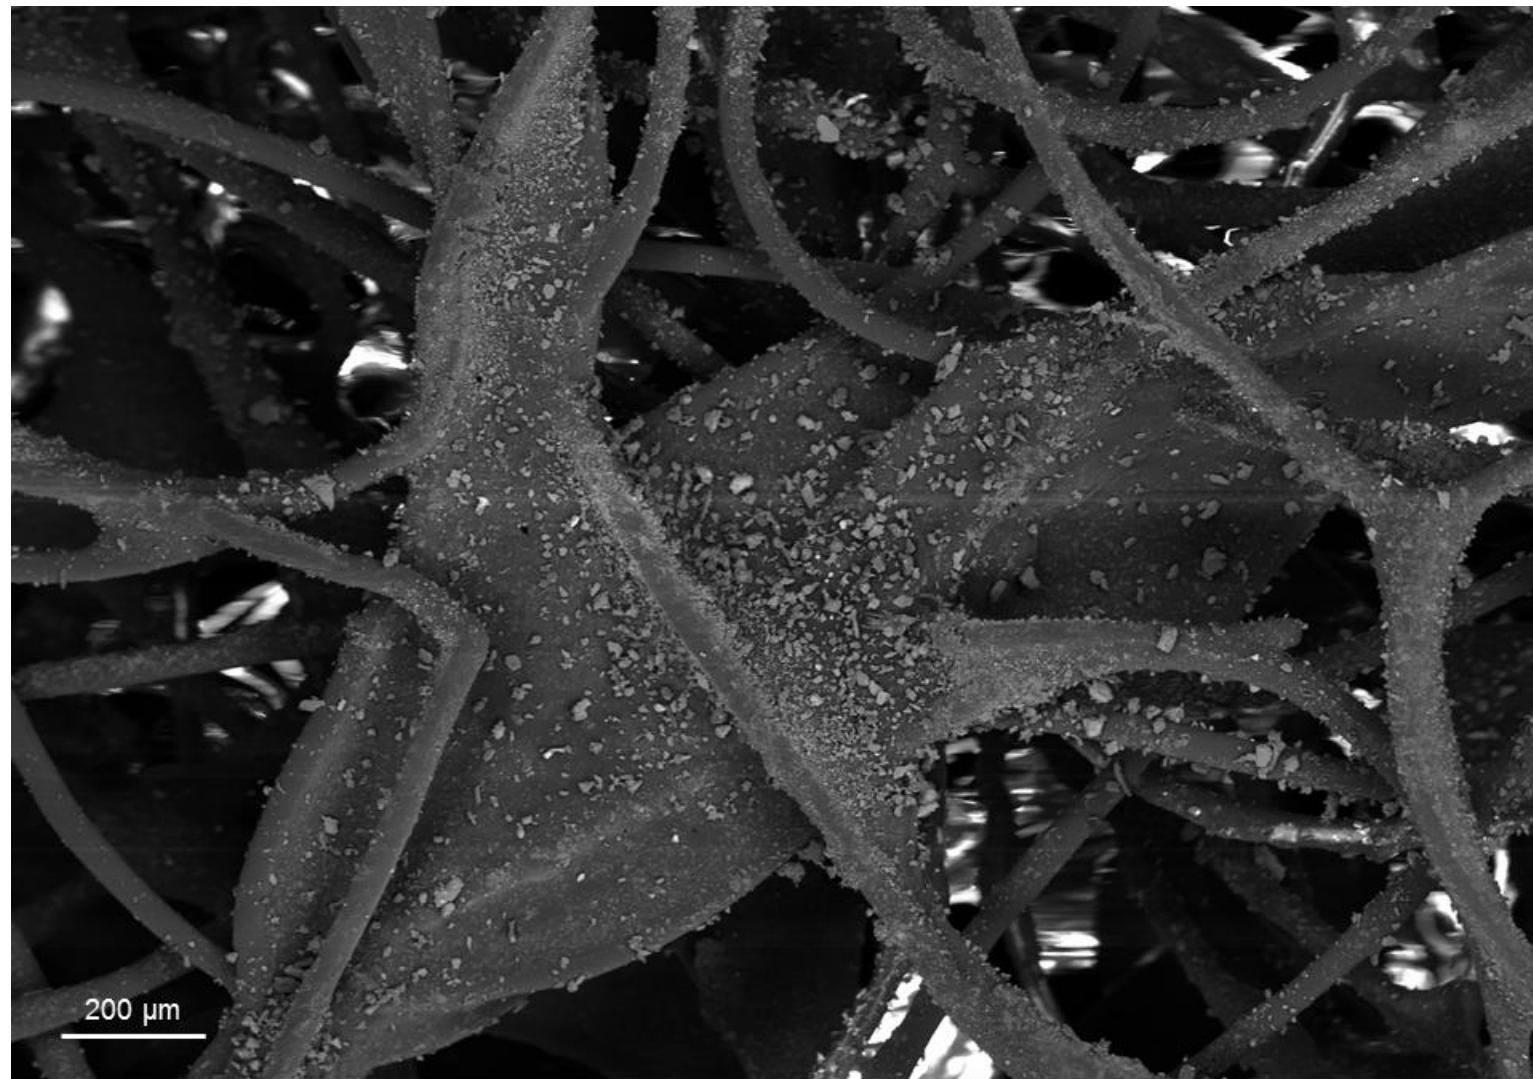
Figure 9. SEM image of sample 145-012, collected from the canister top, showing the heavy dust load.

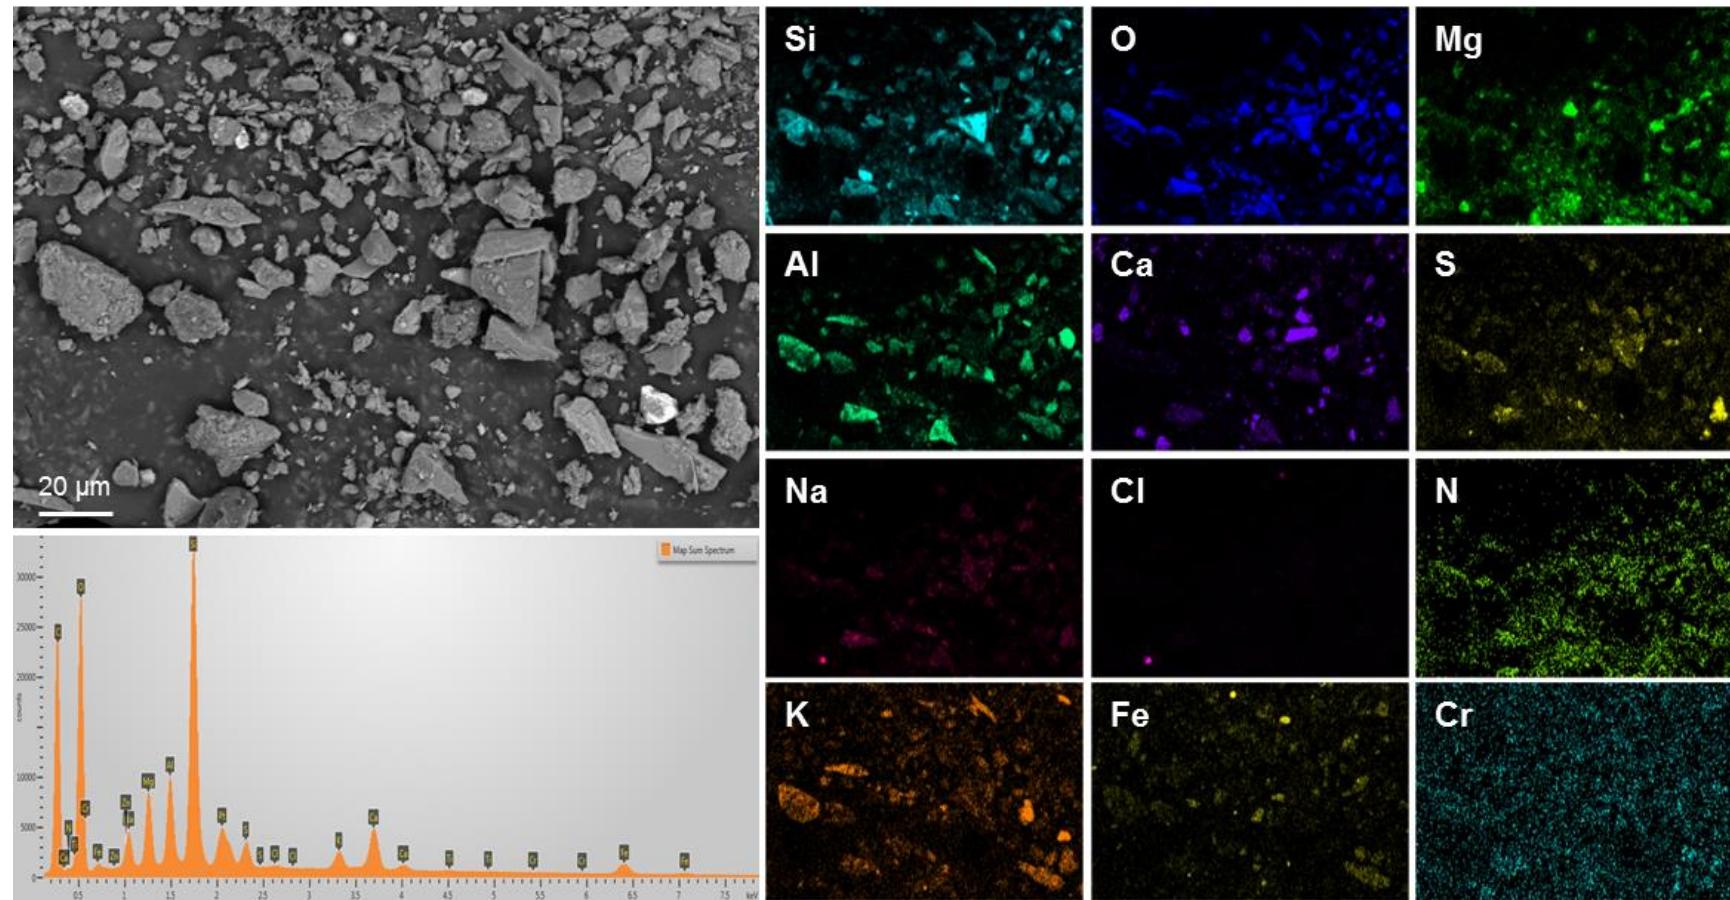
Figure 10. SEM image/EDS map of sample 145-012, collected from the canister top.

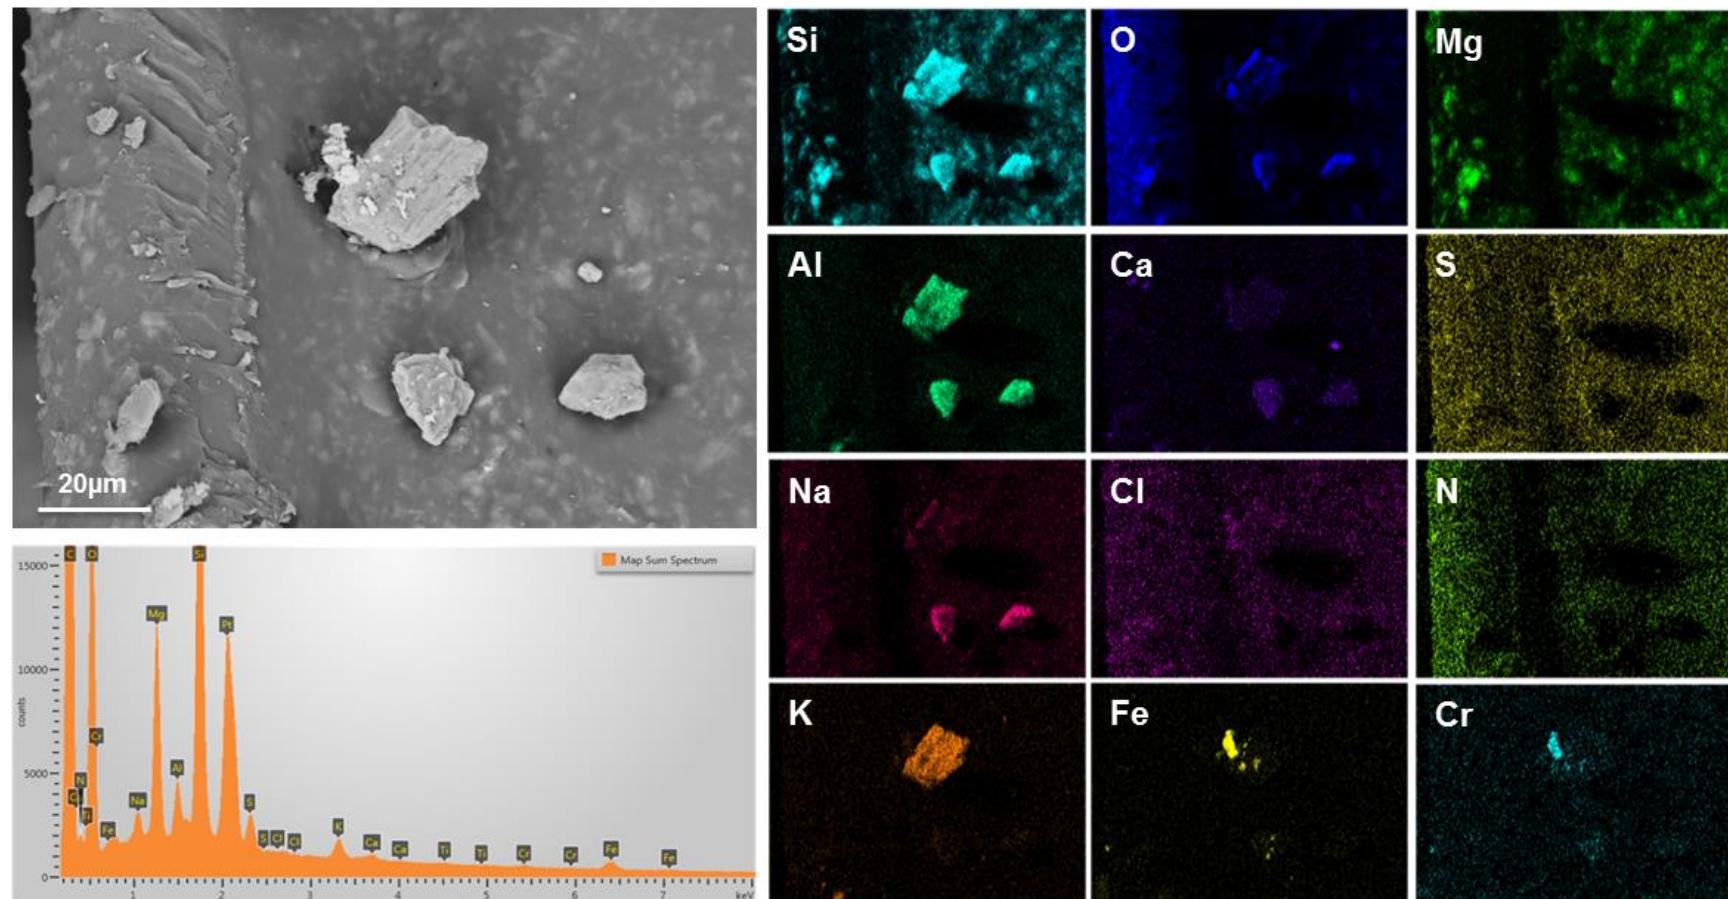
Figure 11. SEM image/EDS map (#1) of sample 144-005, collected from the canister side, 13.5 feet below the upper edge.

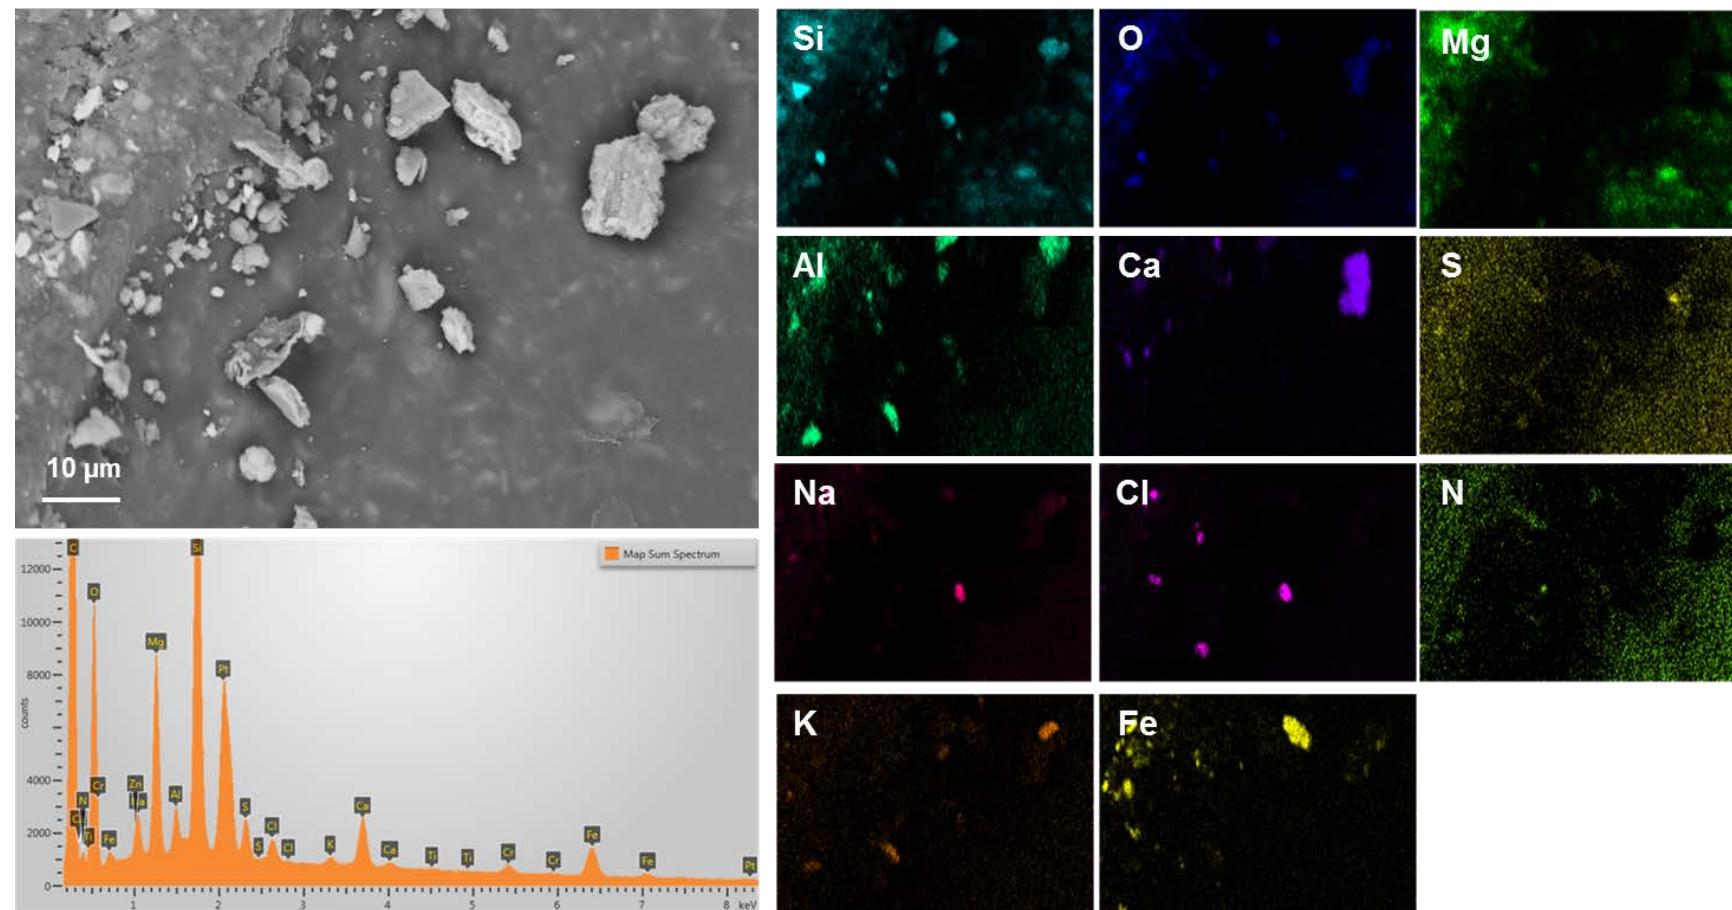
Figure 12. SEM image/EDS map (#2) of sample 144-005, collected from the canister side, 13.5 feet below the upper edge.

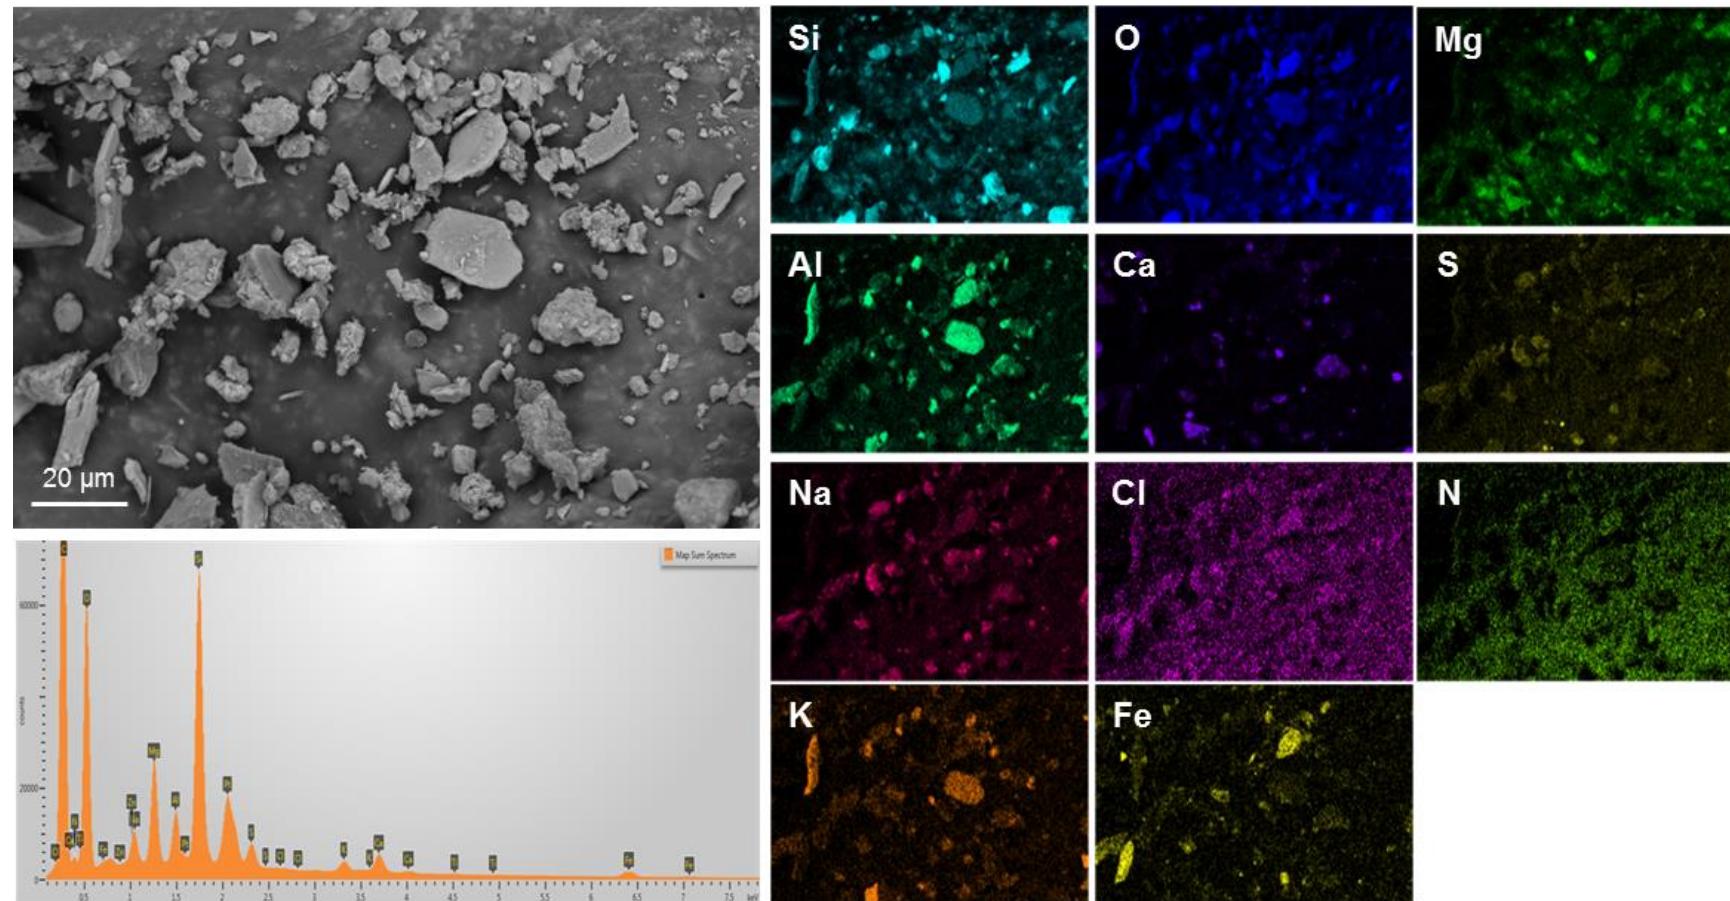
Figure 13. SEM image/EDS map (#2) of sample #144-011, collected from the canister top.

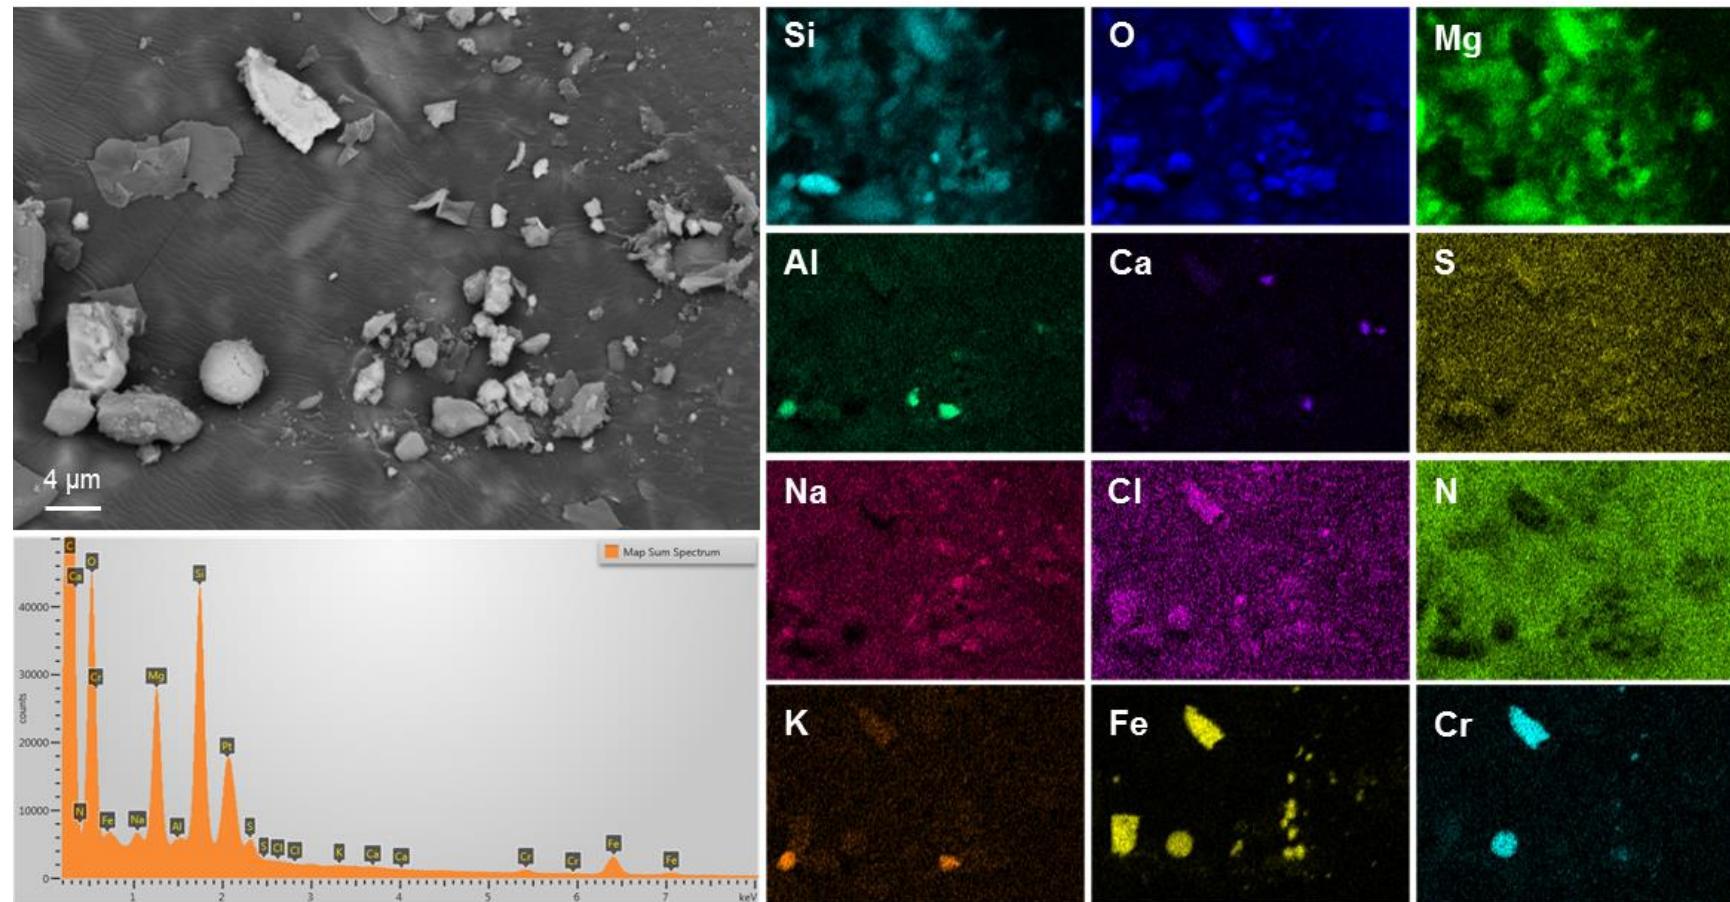
Figure 14. SEM image/EDS map (#1) of sample 123-006, collected from the canister side, 11.0 feet below the upper edge.

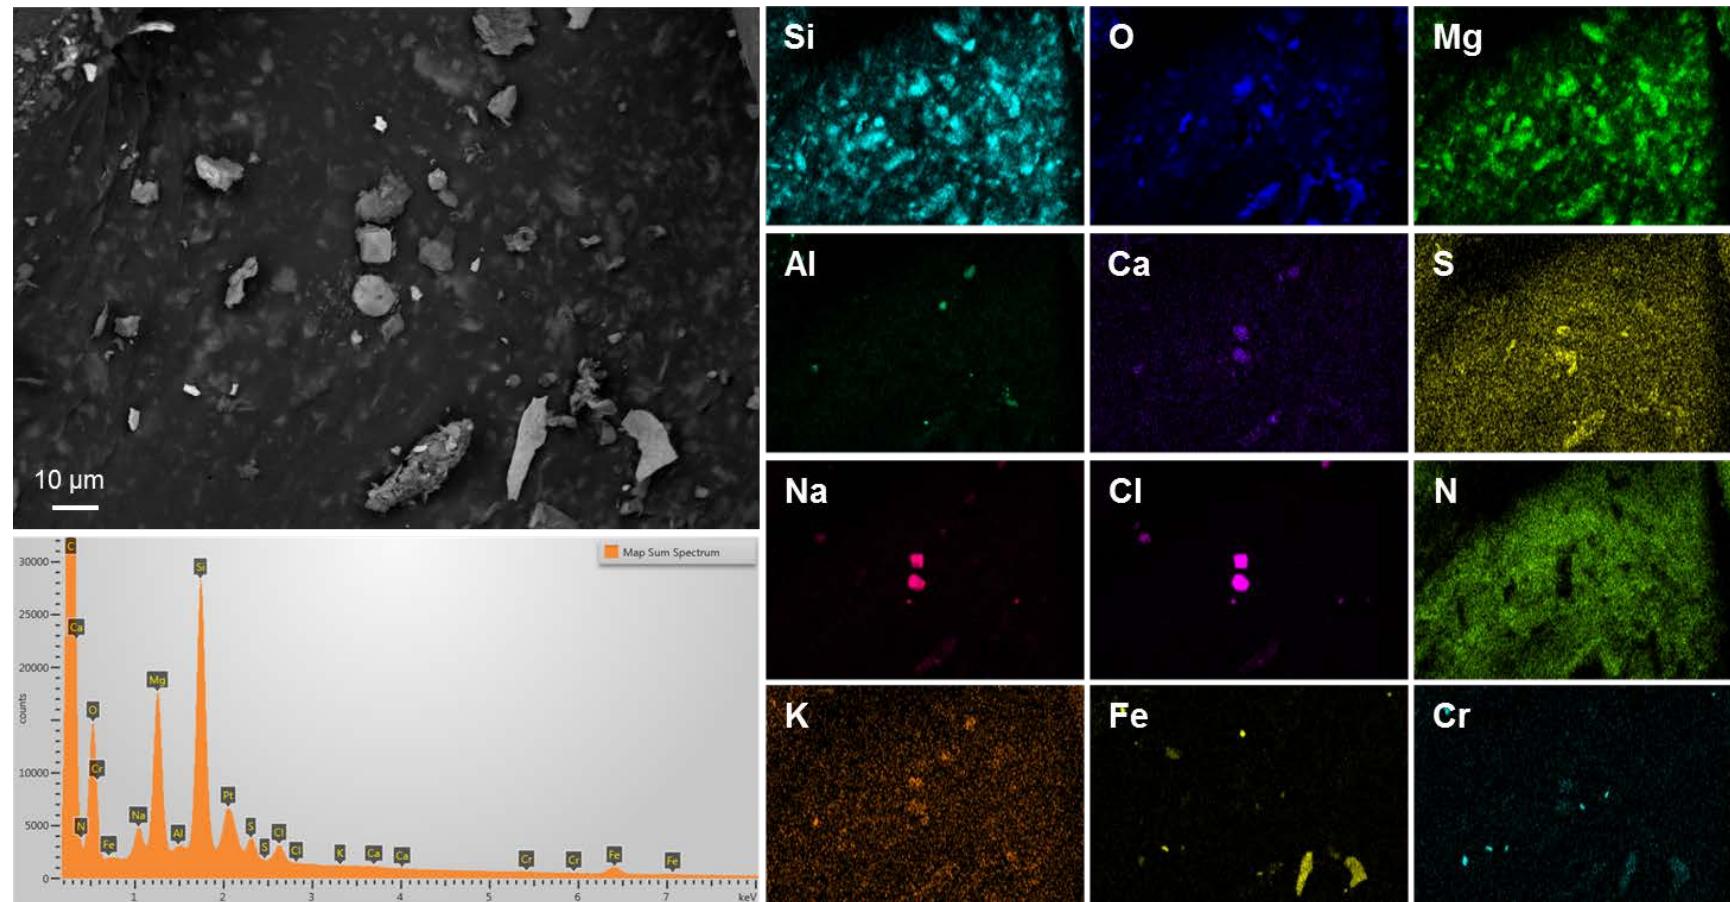
Figure 15. SEM image/EDS map (#2) of sample 123-006, collected from the canister side, 11.0 feet below the upper edge.

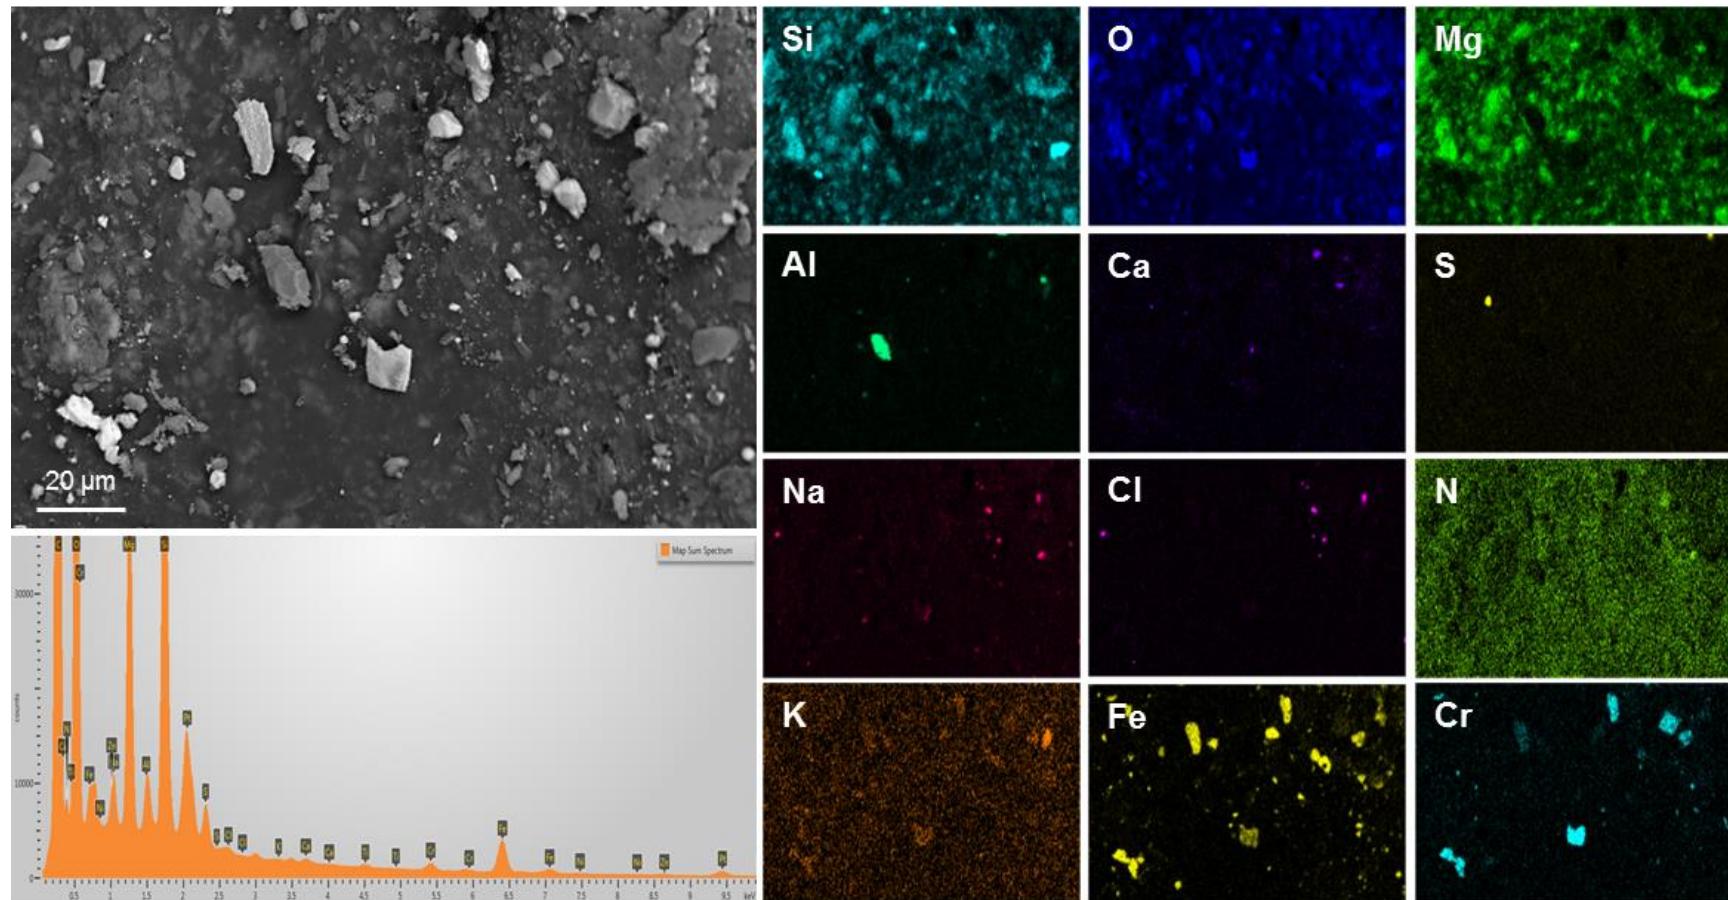
Figure 16. SEM image/EDS map (#1) of sample 123-008, collected from the canister side, 7.5 feet below the upper edge.
