Results of Stainless Steel Canister Corrosion Studies and Environmental Sample Investigations

Fuel Cycle Research & Development

*Charles Bryan and David Enos
Sandia National Laboratories
September 25, 2014*

FCRD-UFD-2014-000055
SNL DOC# 166112

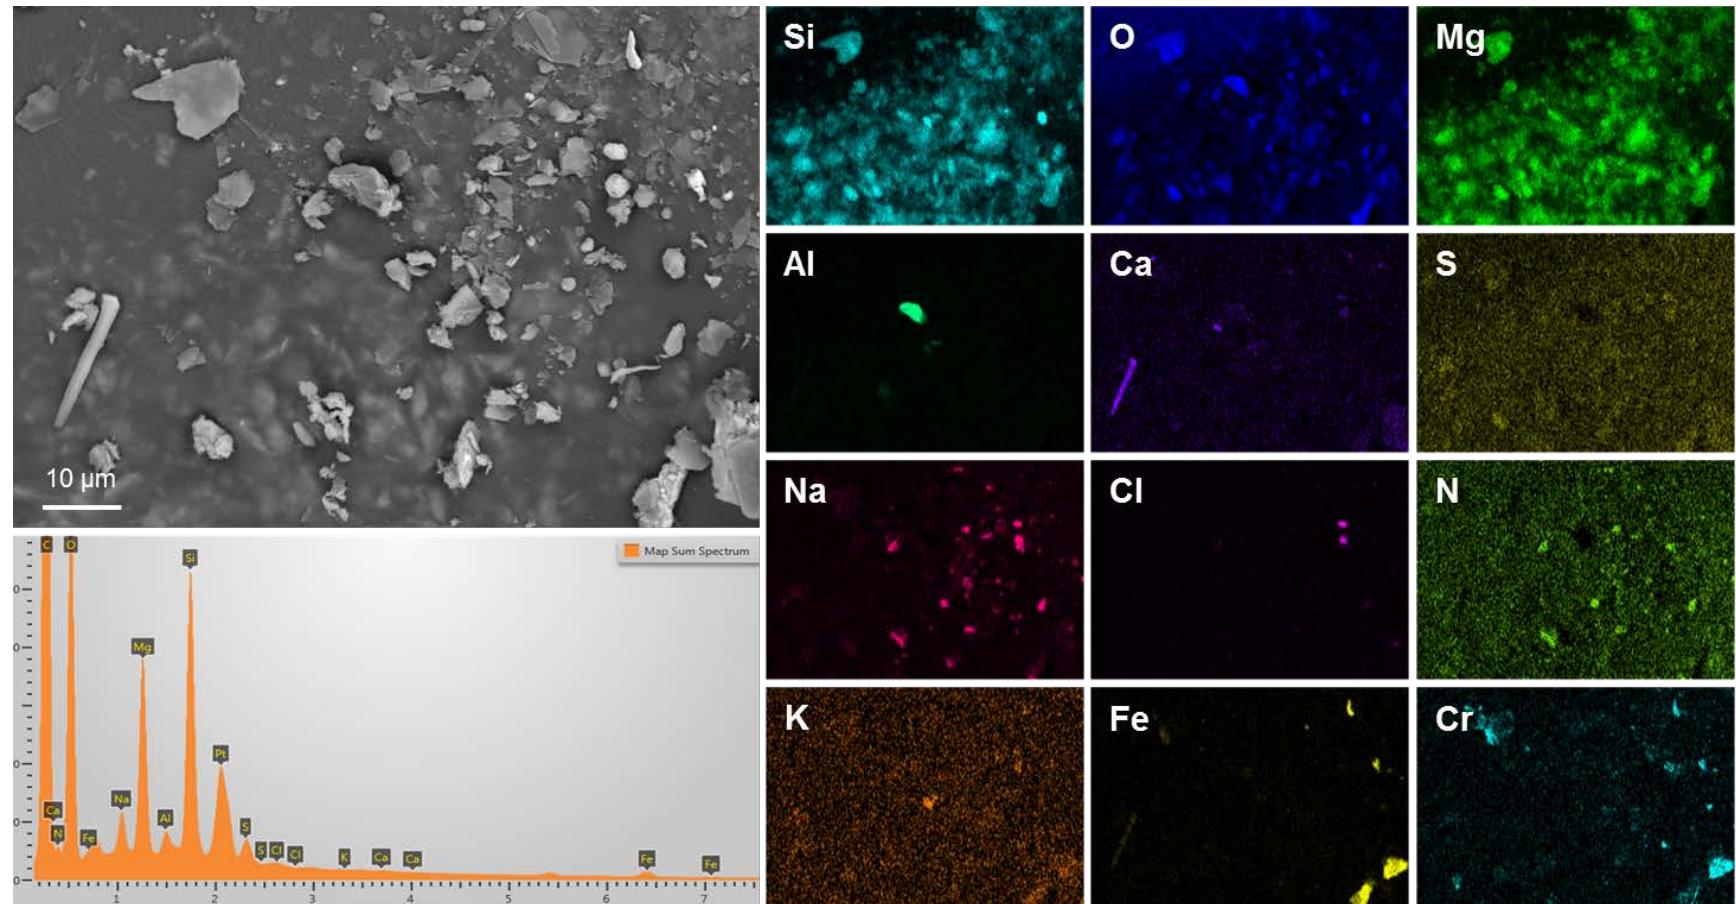
Figure 17. SEM image/EDS map (#1) of sample 123-009, collected from the canister side, 3.0 feet below the upper edge.

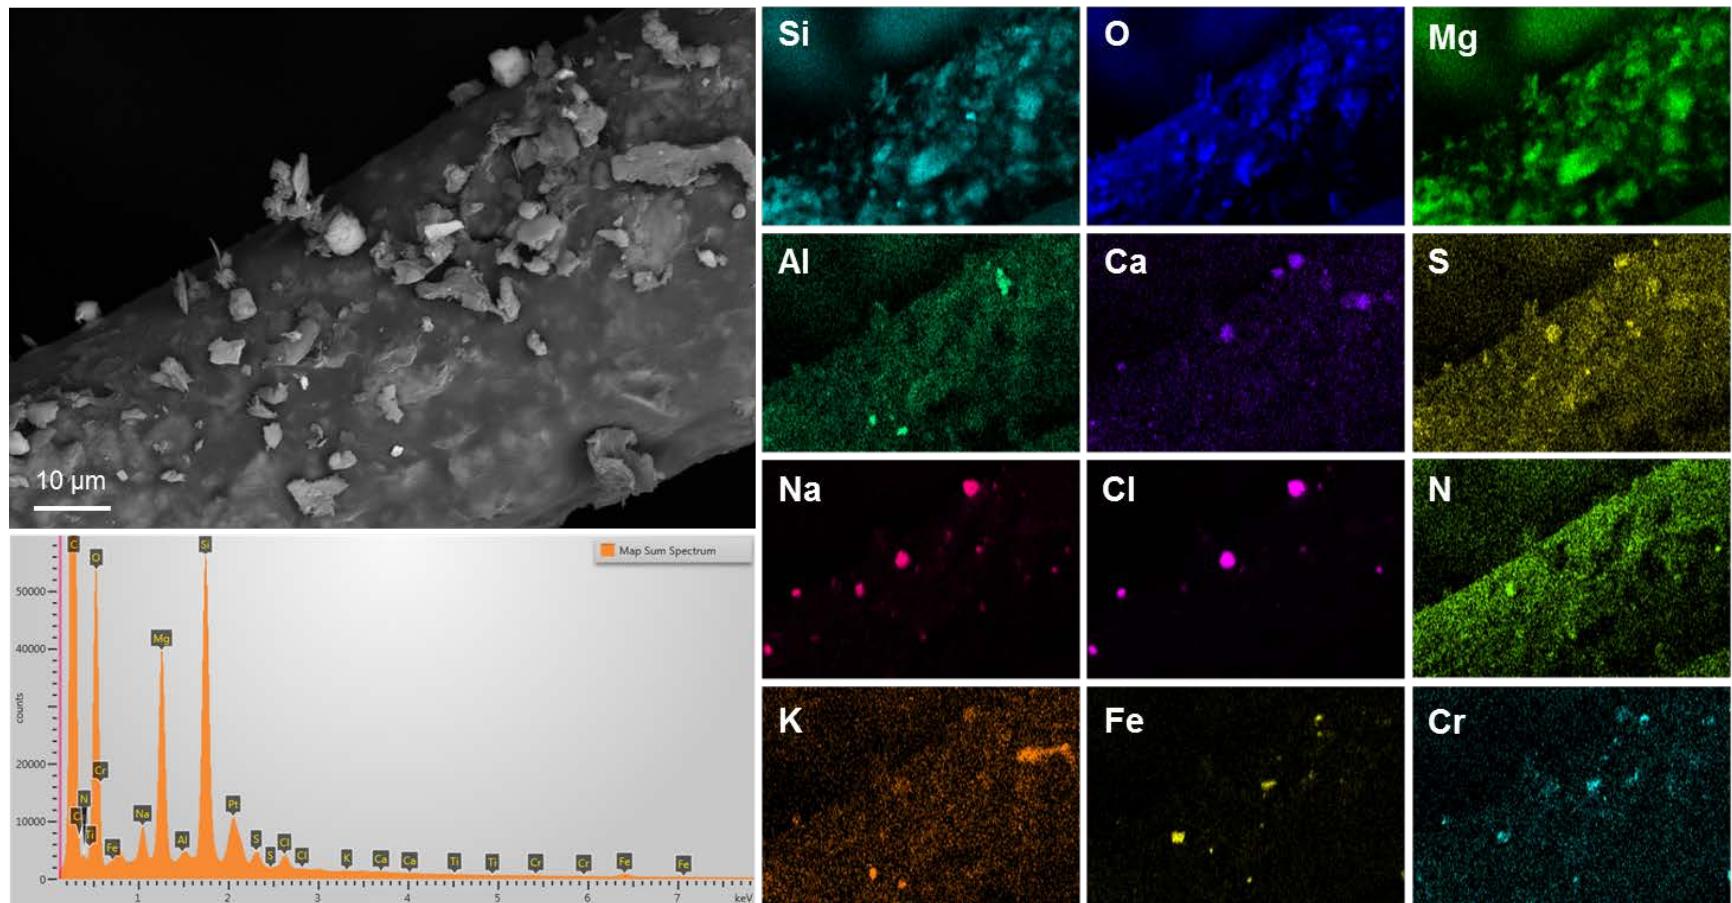
Figure 18. SEM image/EDS map (#2) of sample 123-009, collected from the canister side, 3.0 feet below the upper edge.

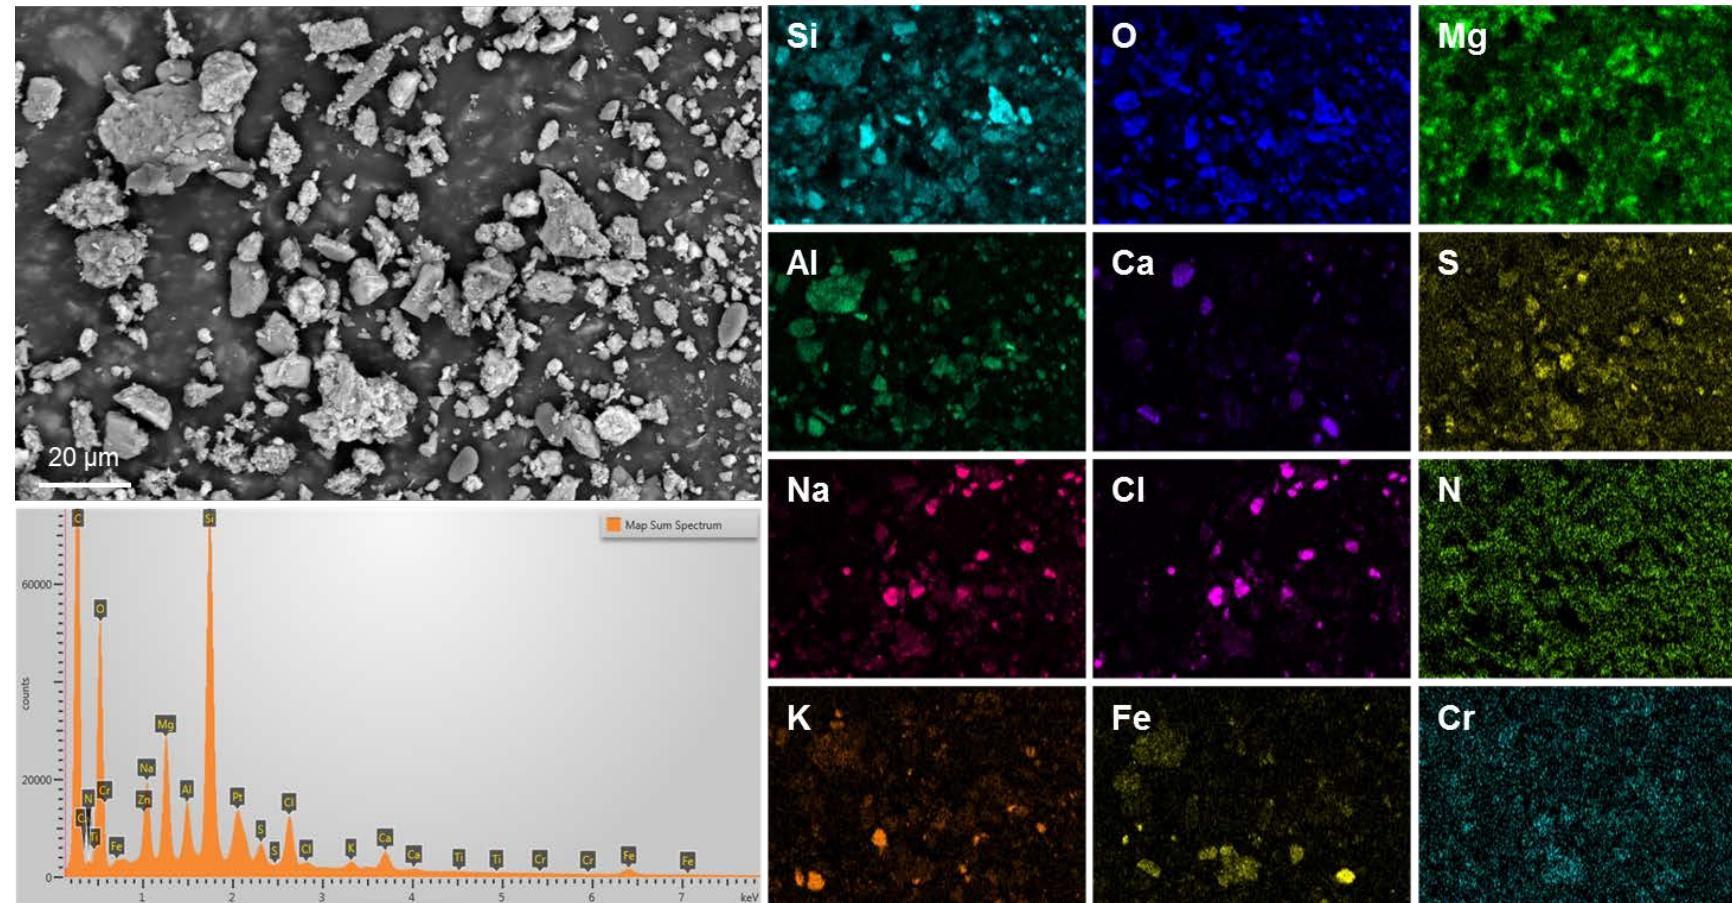
Figure 19. SEM image/EDS map (#1) of sample 123-012, collected from the canister top.

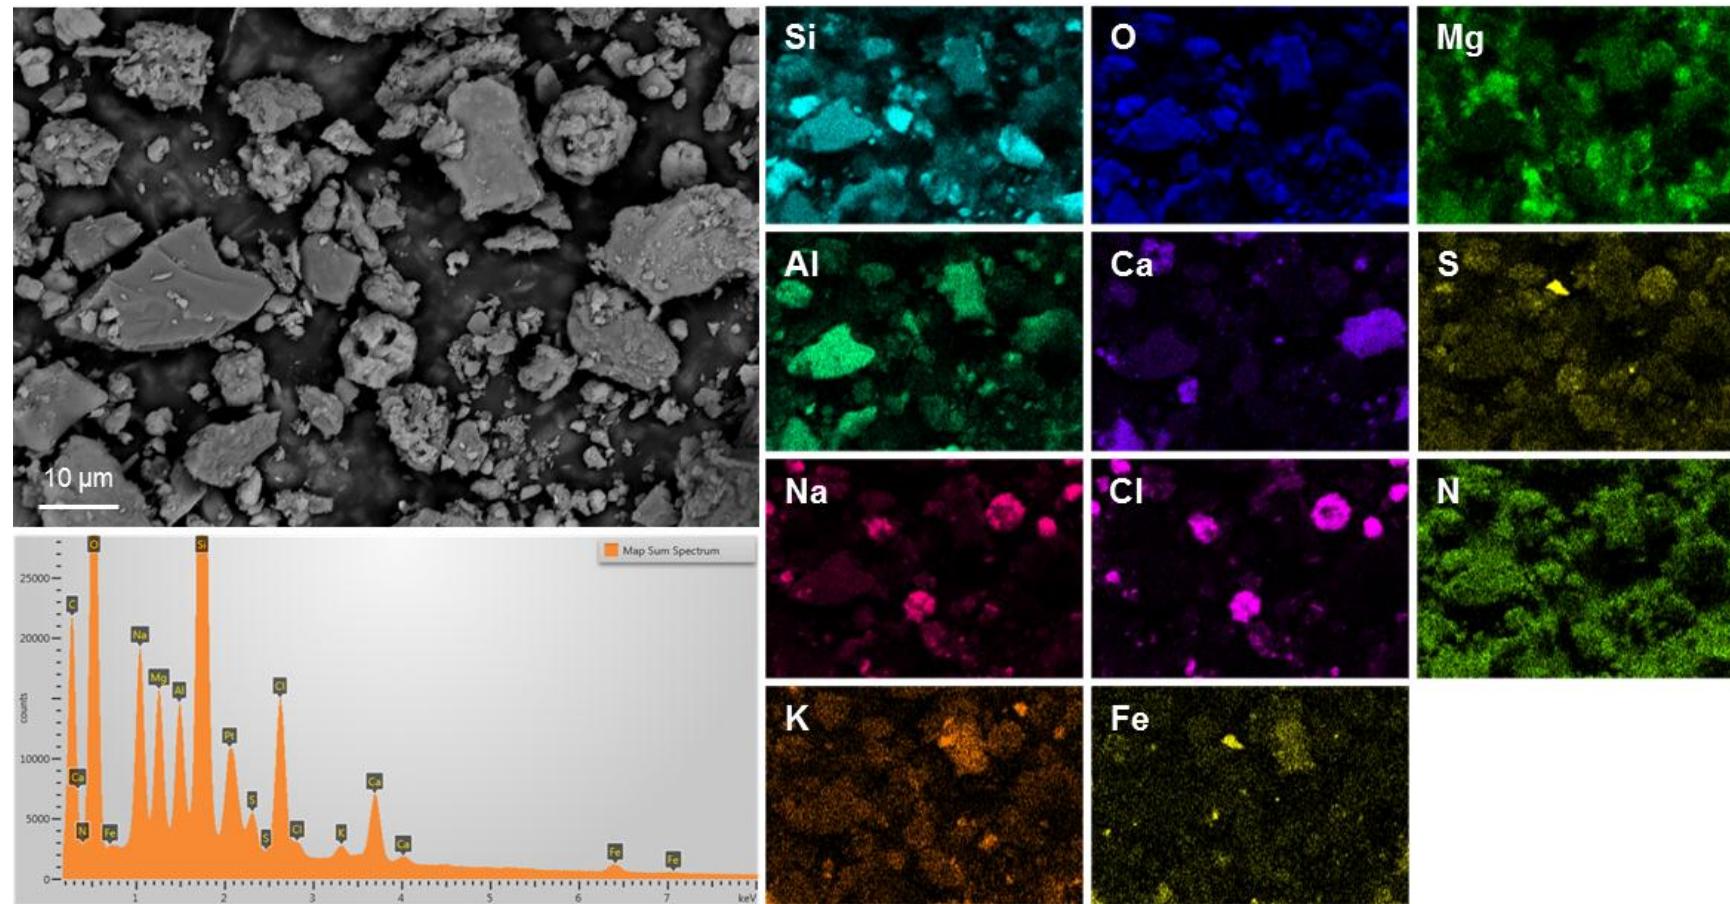
Figure 20. SEM image/EDS map (#2) of sample 123-012, collected from the canister top.

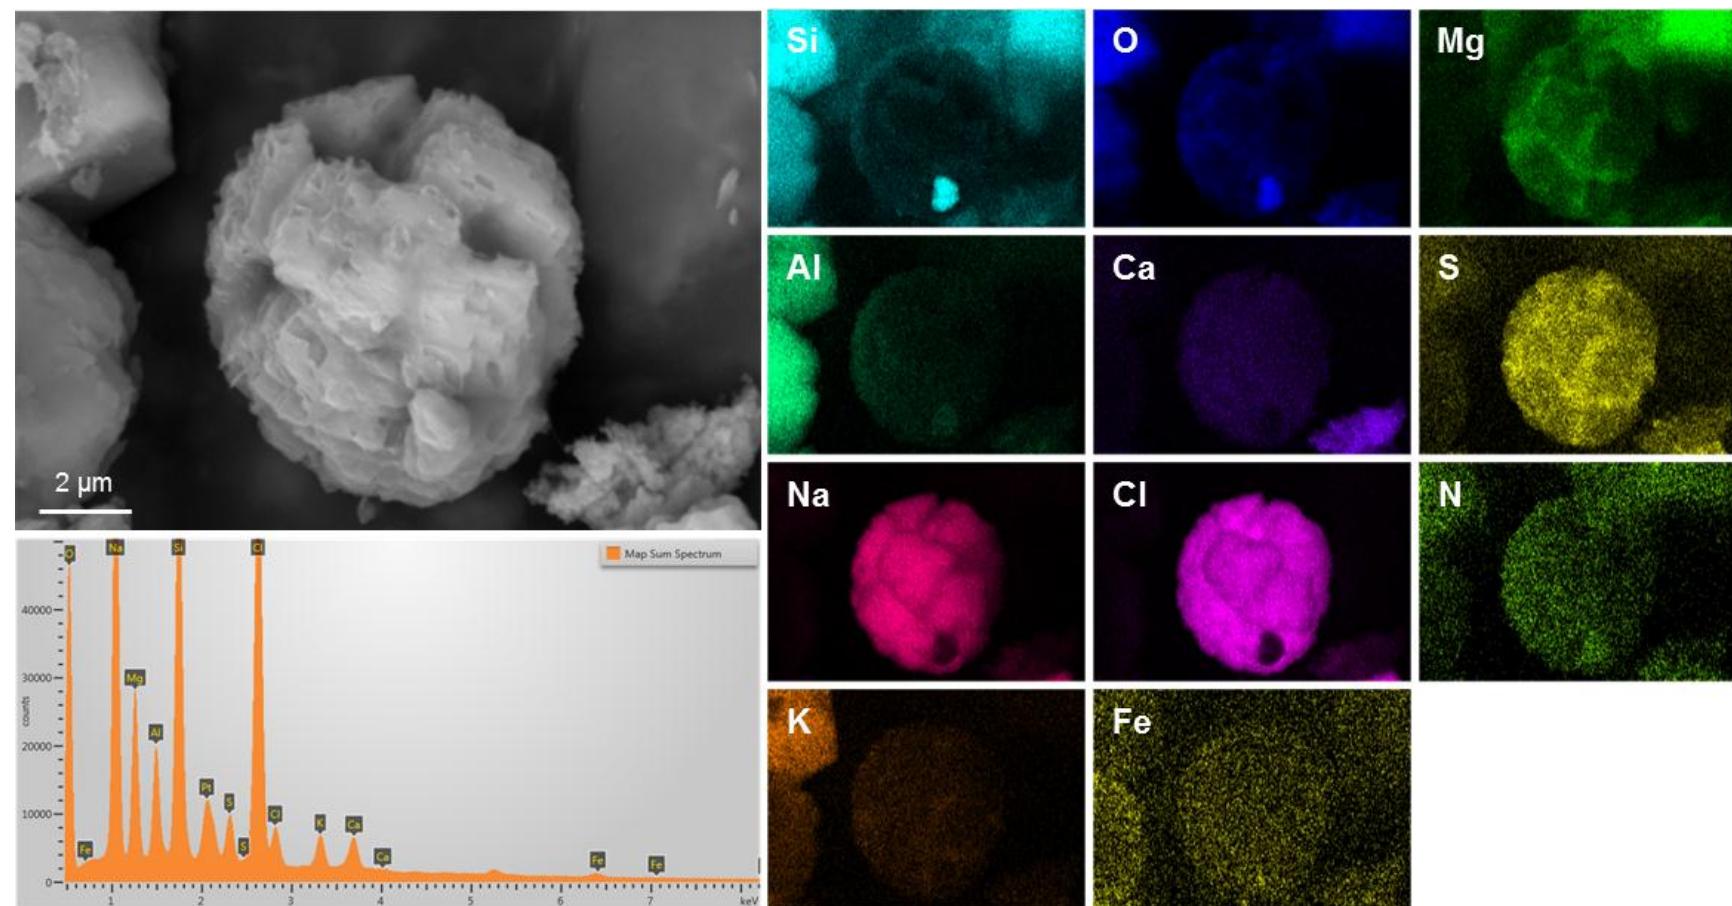
Figure 21. SEM image/EDS map of a sea-salt cluster in sample 123-012, collected from the canister top.

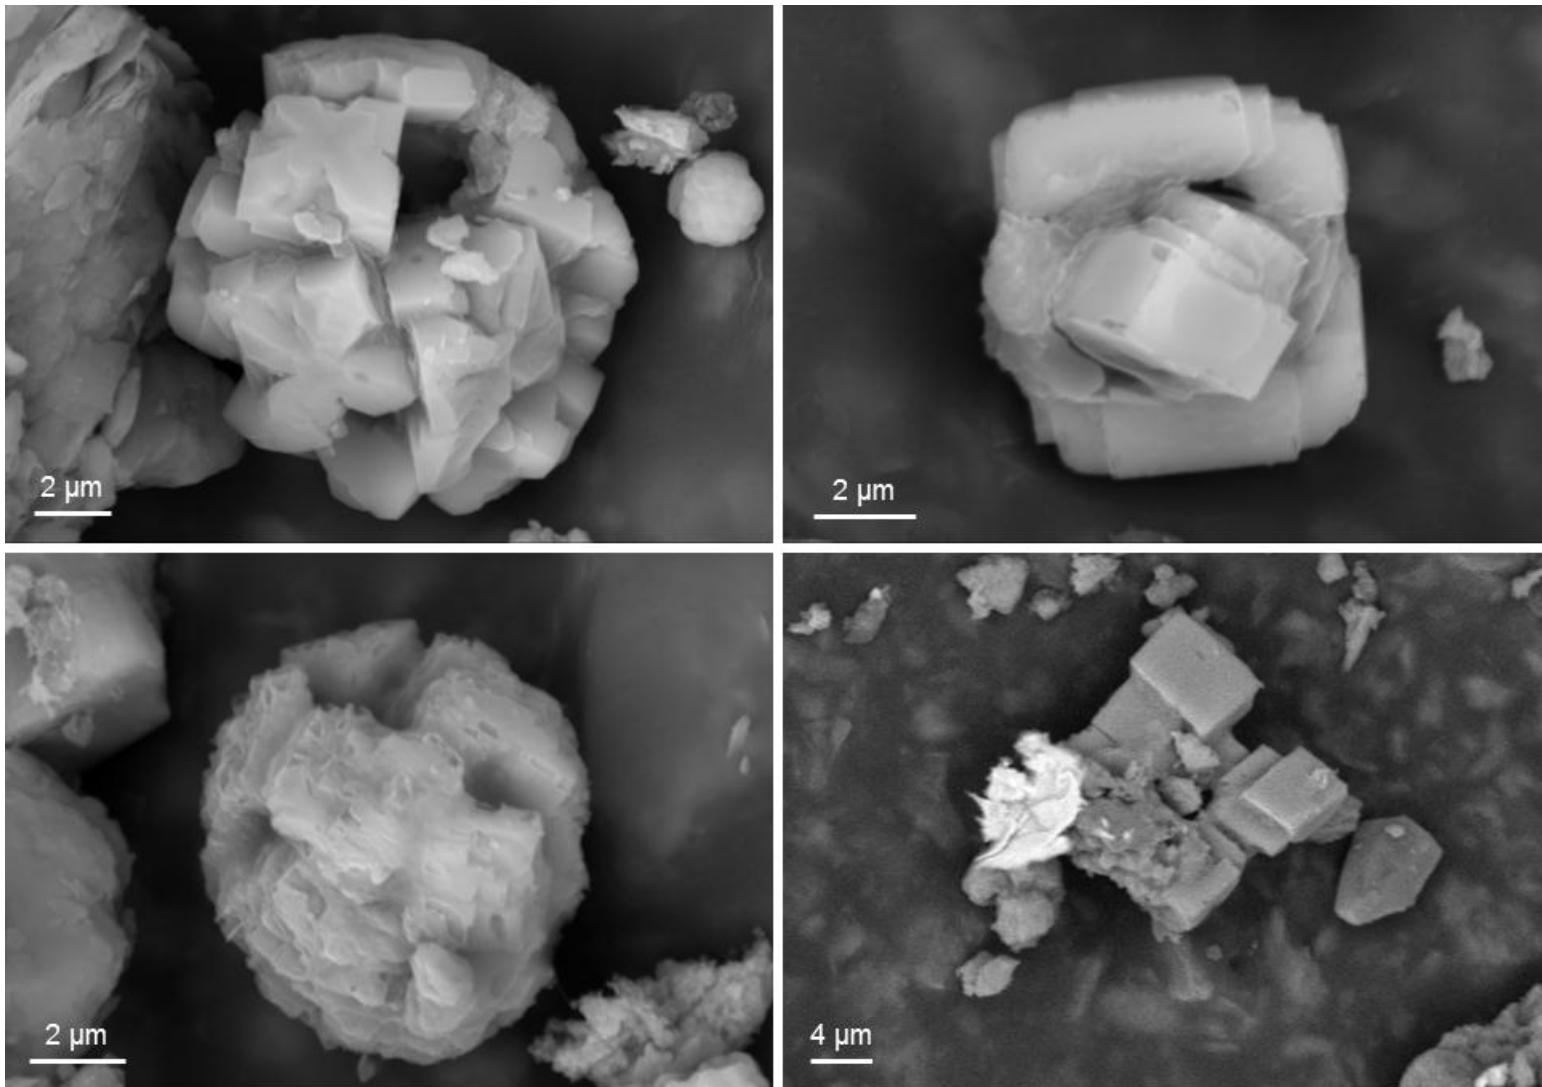
Figure 22. SEM images of sea-salt (intergrown NaCl cubes with interstitial Mg-SO₄) aggregates in sample 123-012, collected from the canister top.

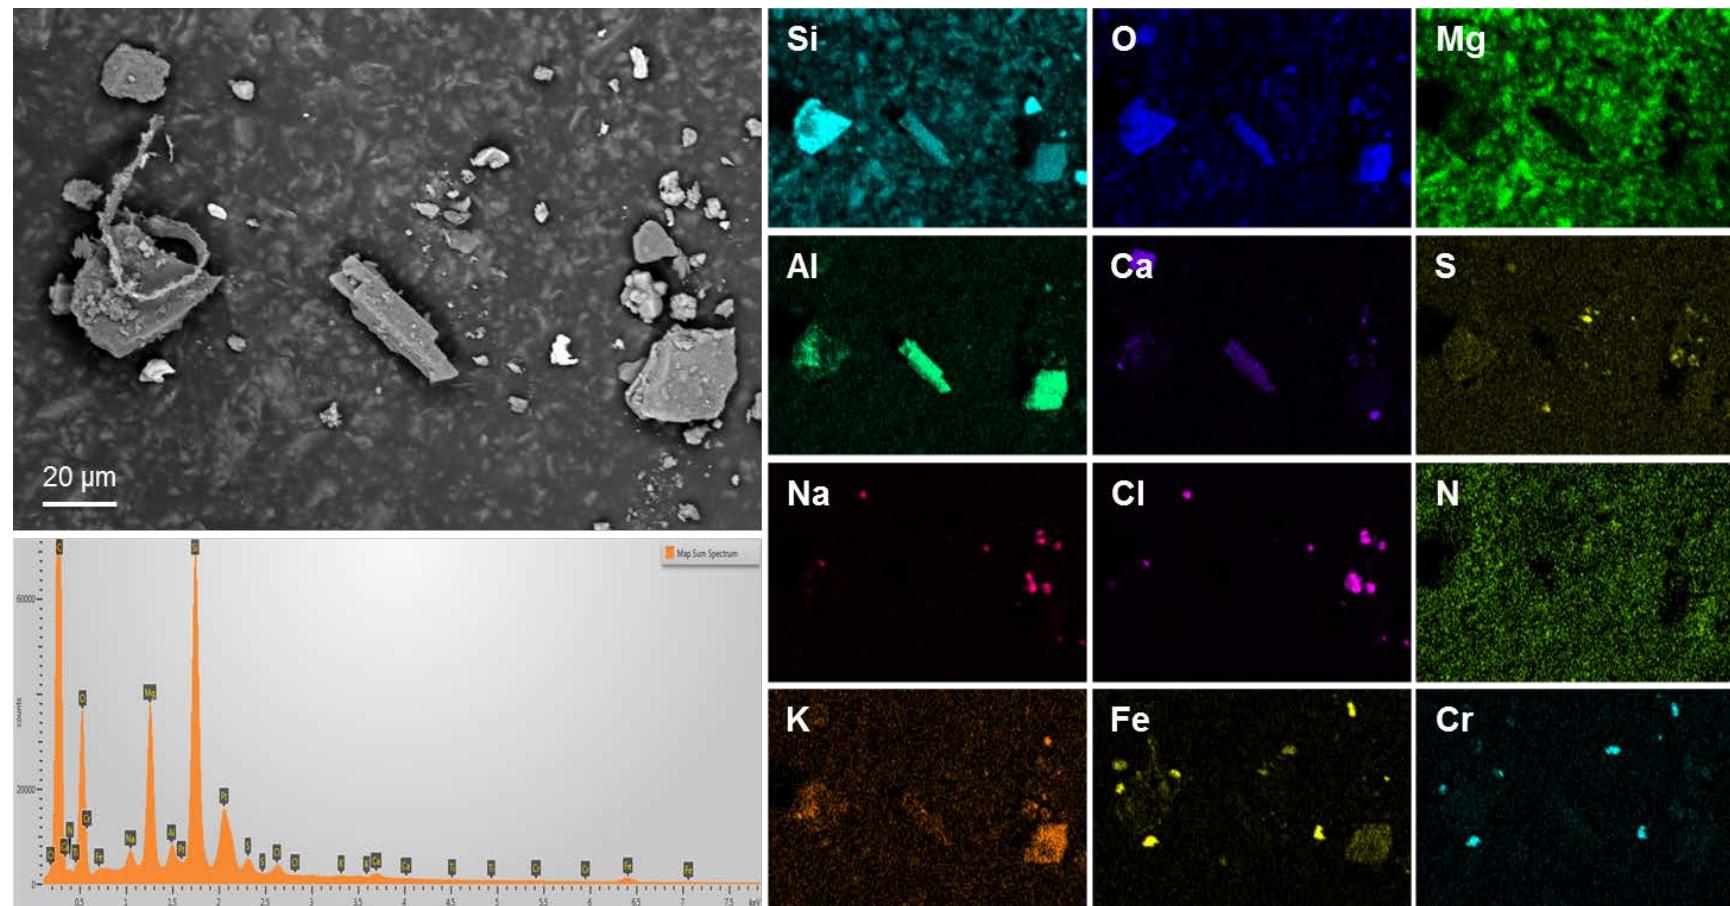
Figure 23. SEM image/EDS map (#1) of sample 170-004, collected from the canister side, 11.0 feet from the upper edge.

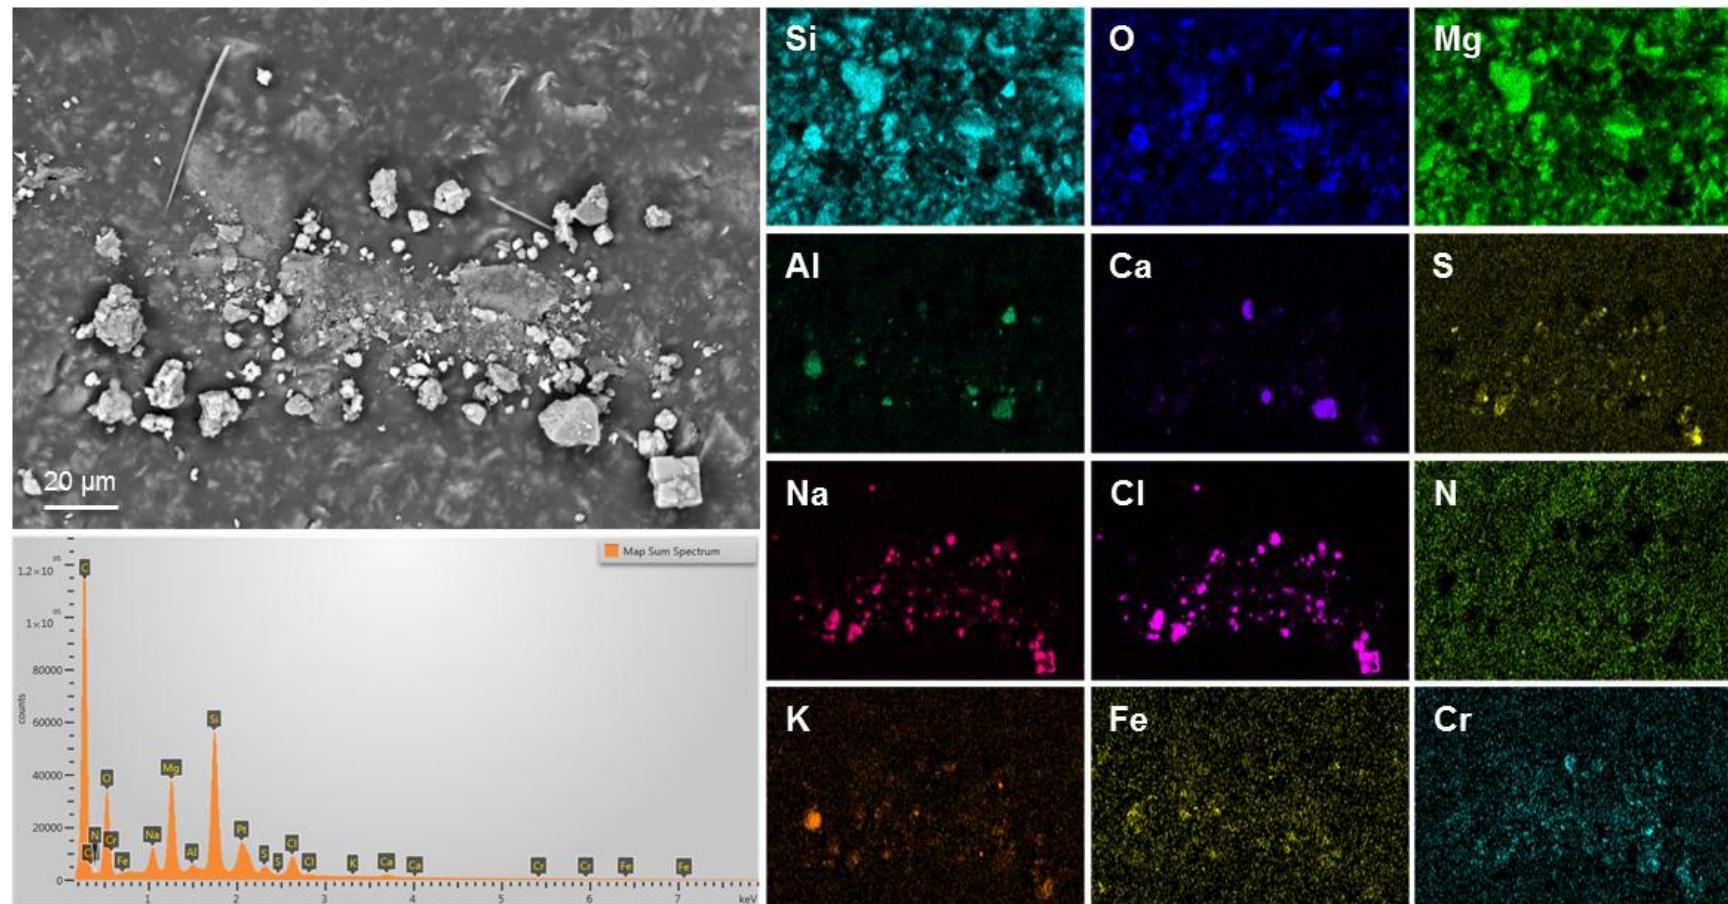
Figure 24. SEM image/EDS map (#2) of sample 170-004, collected from the canister side, 11.0 feet from the upper edge.

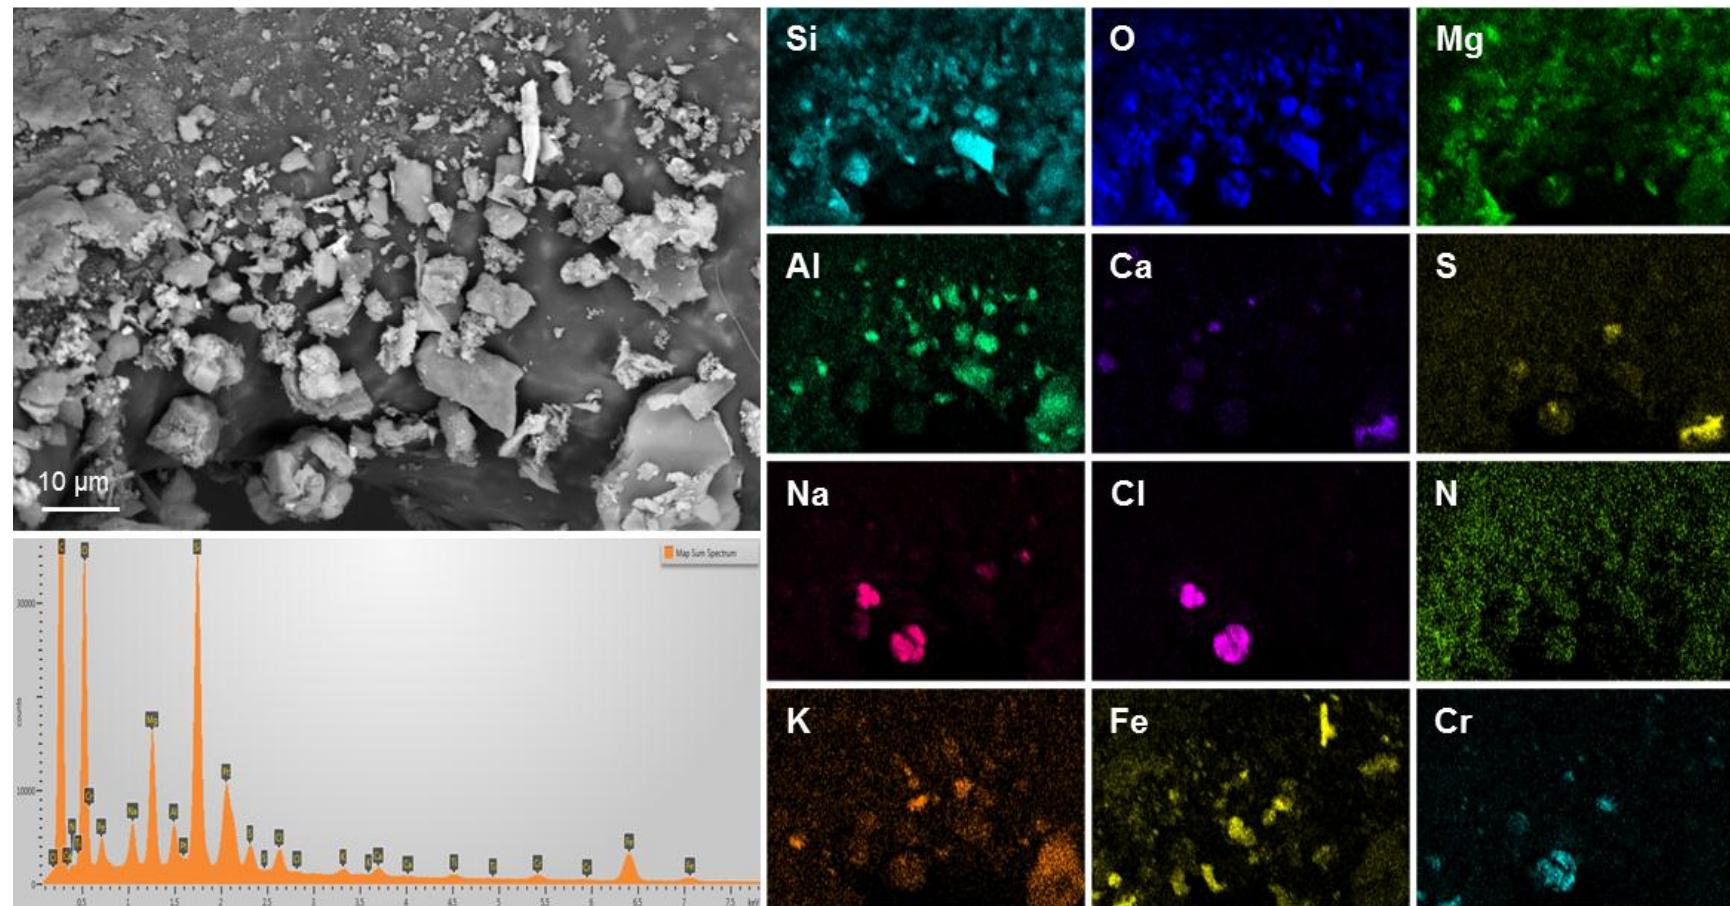
Figure 25. SEM image/EDS map (#2) of sample 170-005, collected from the canister side, 7.5 feet from the upper edge.

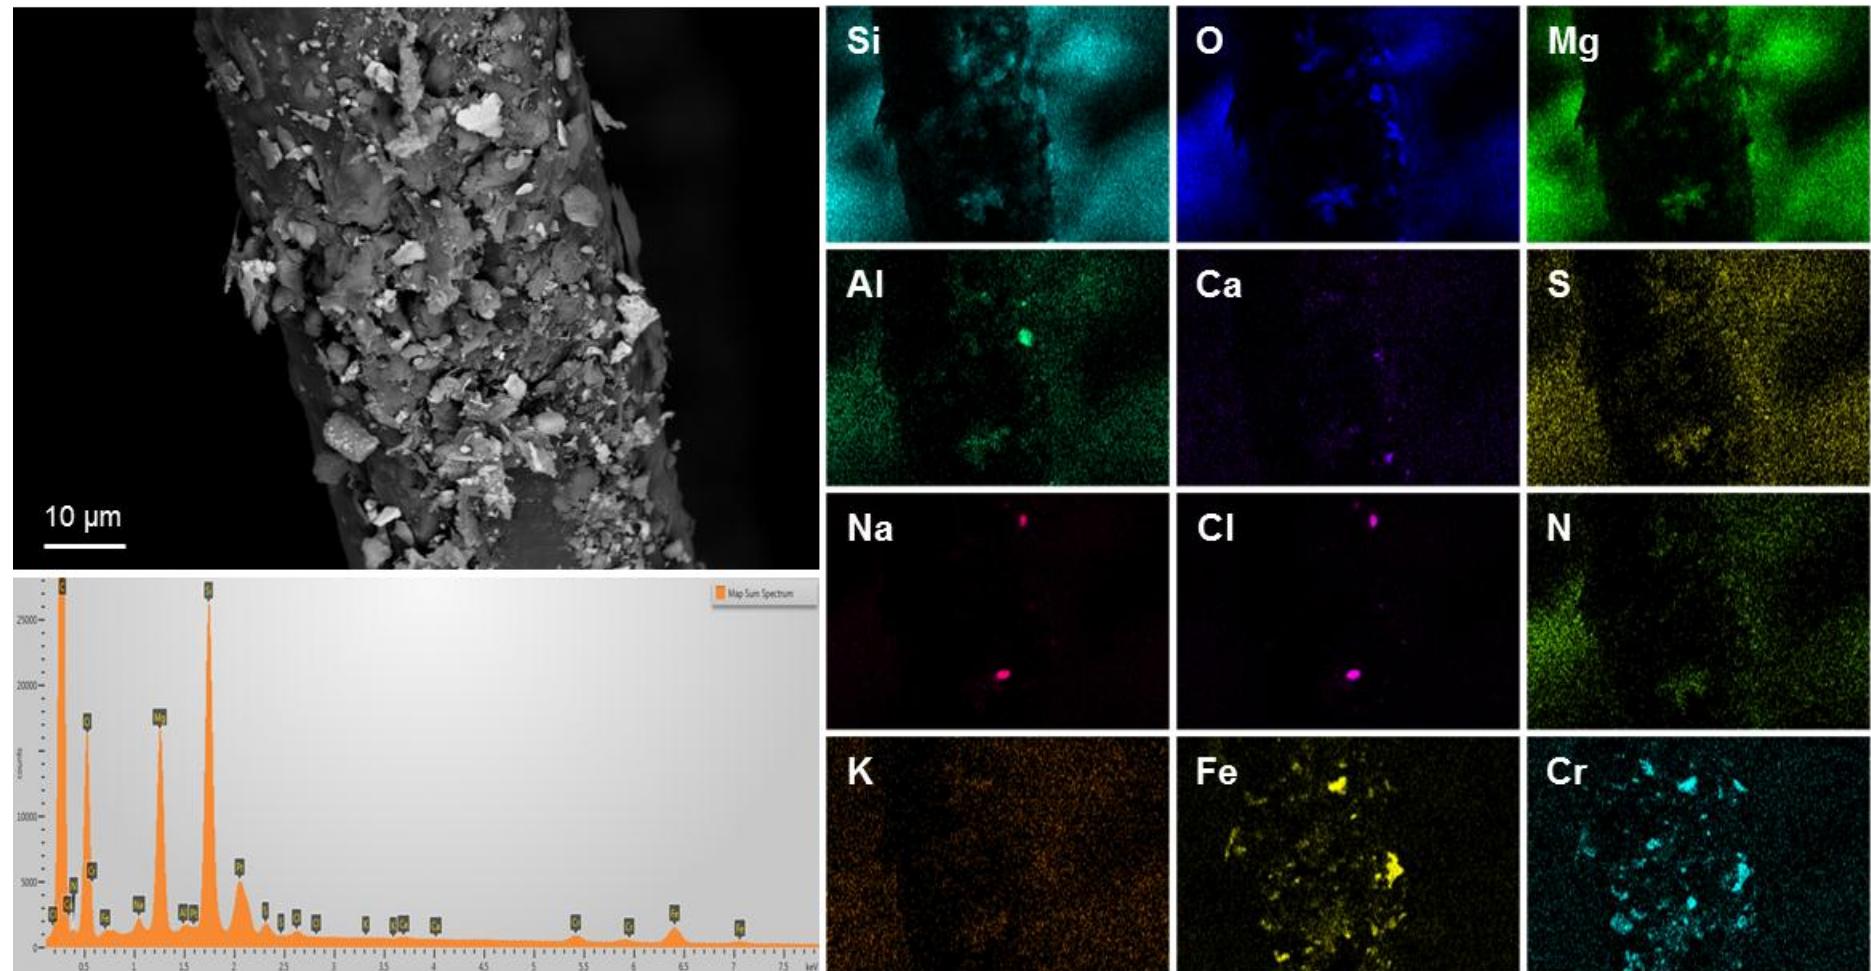
Figure 26. SEM image/EDS map of sample 170-006, collected from the canister side, 3.0 feet from the upper edge.

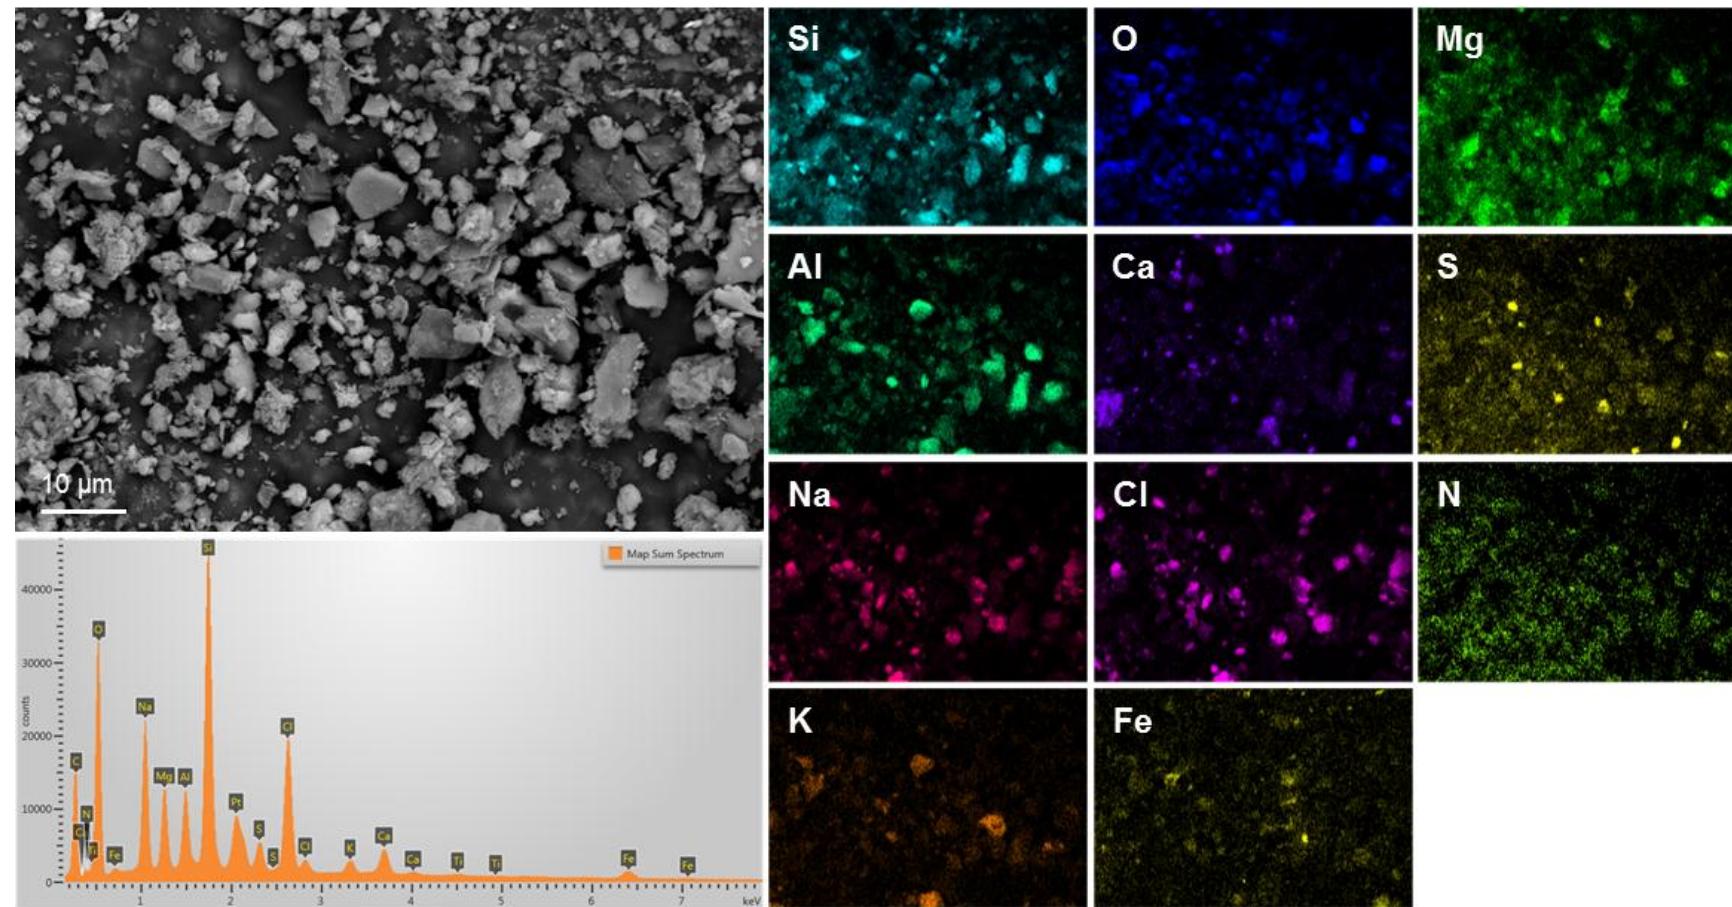
Figure 27. SEM image/EDS map (#1) of sample 170-003, collected from the top of the canister.

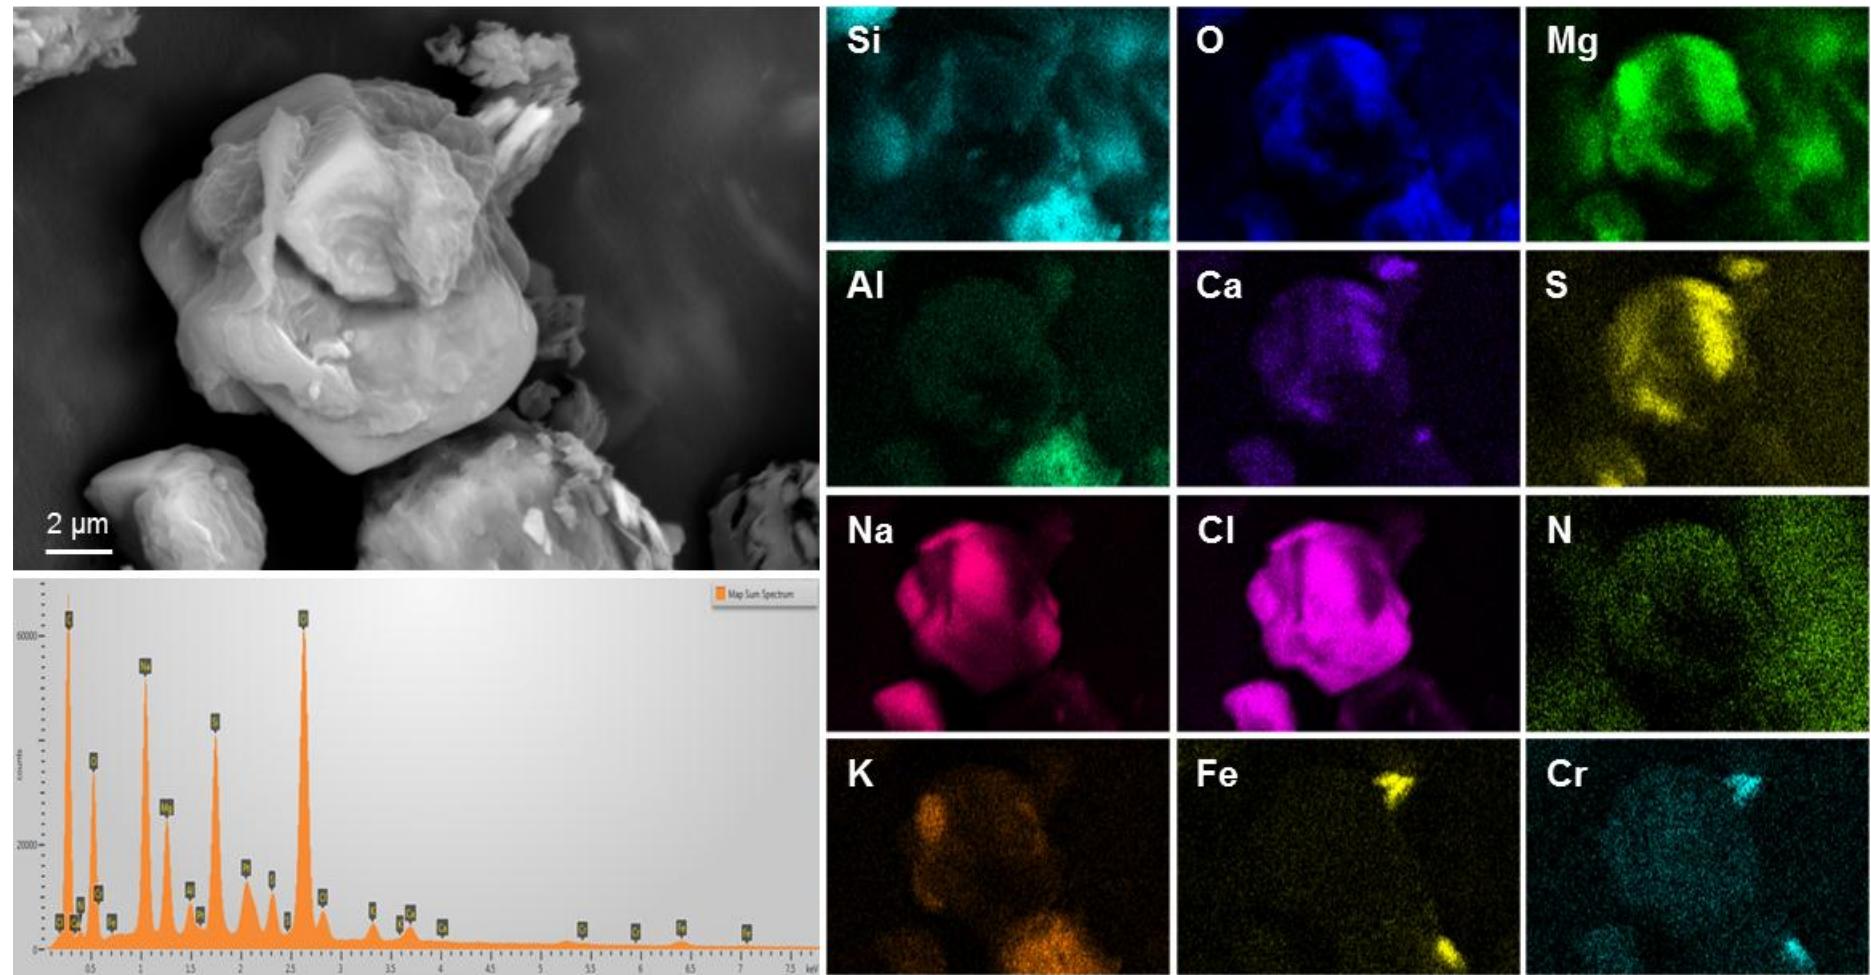
Figure 28. Magnified view of a sea-salt particle from sample 170-003, showing intergrown NaCl and Mg-SO₄.

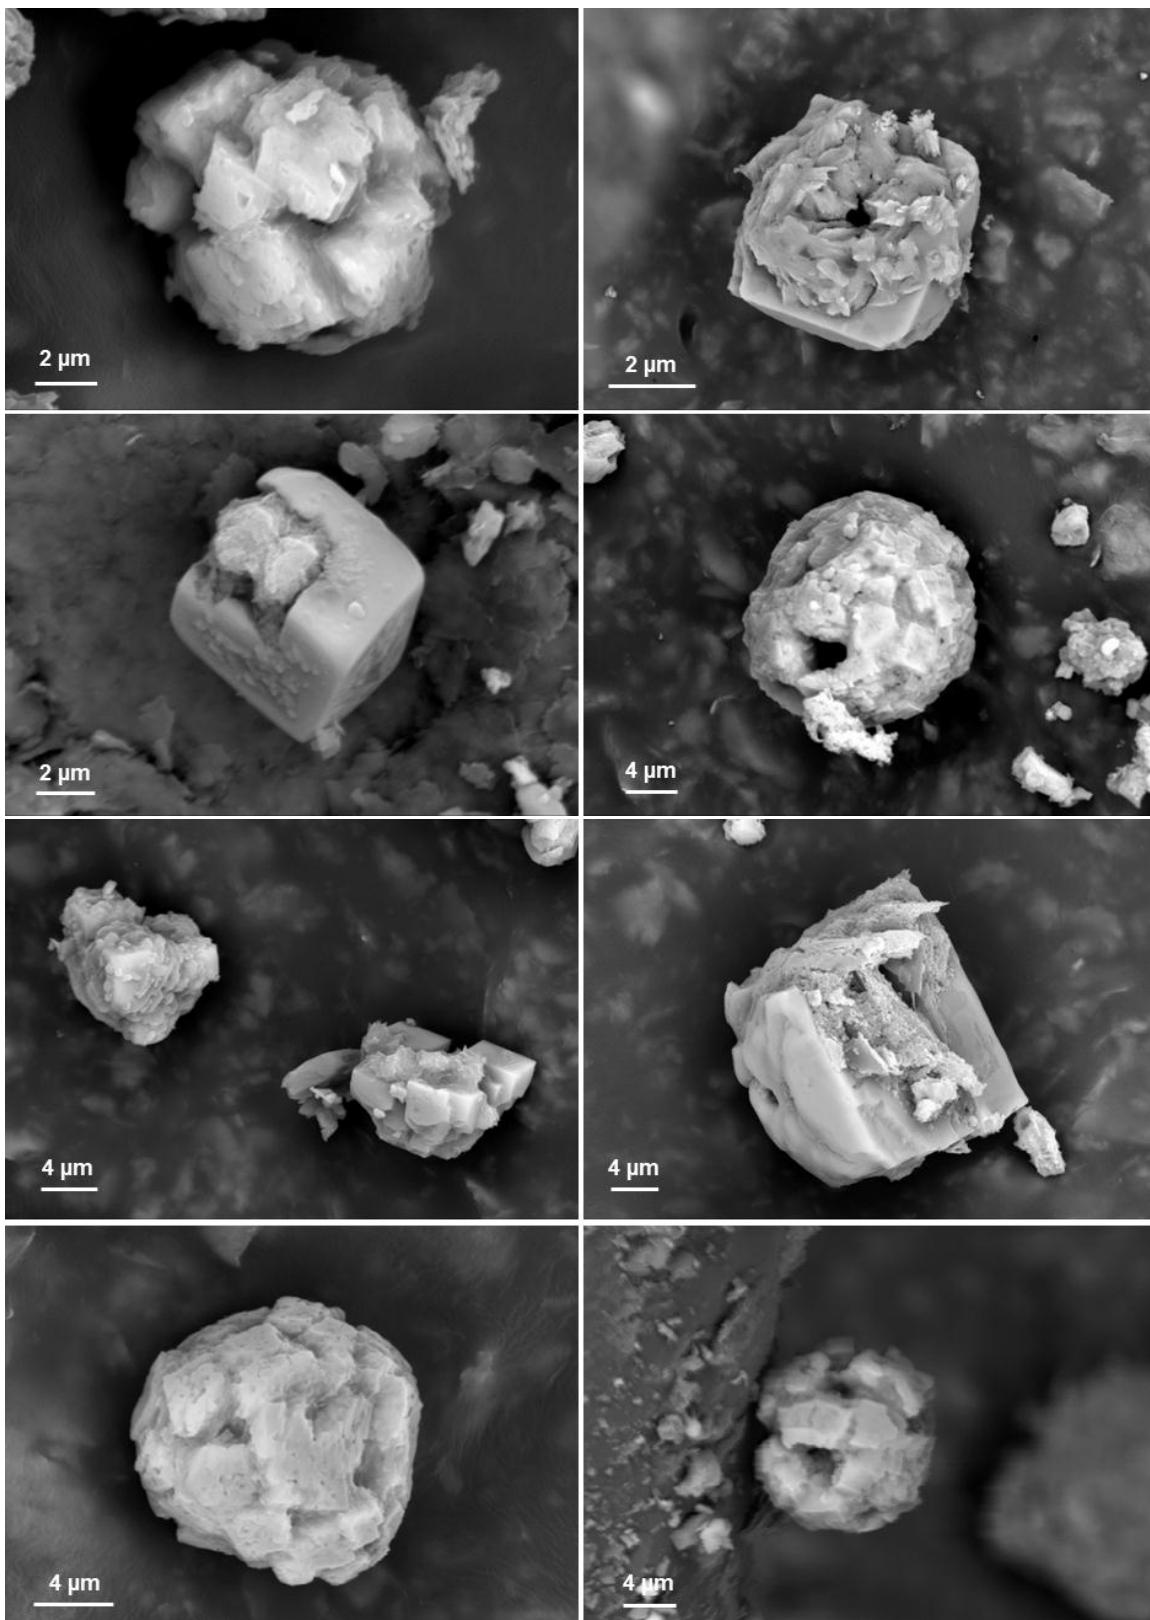
Figure 29. SEM images of sea-salt aggregates (intergrown NaCl cubes with interstitial Mg-SO₄) on sample 170-003, collected from the top OF mpc-170.

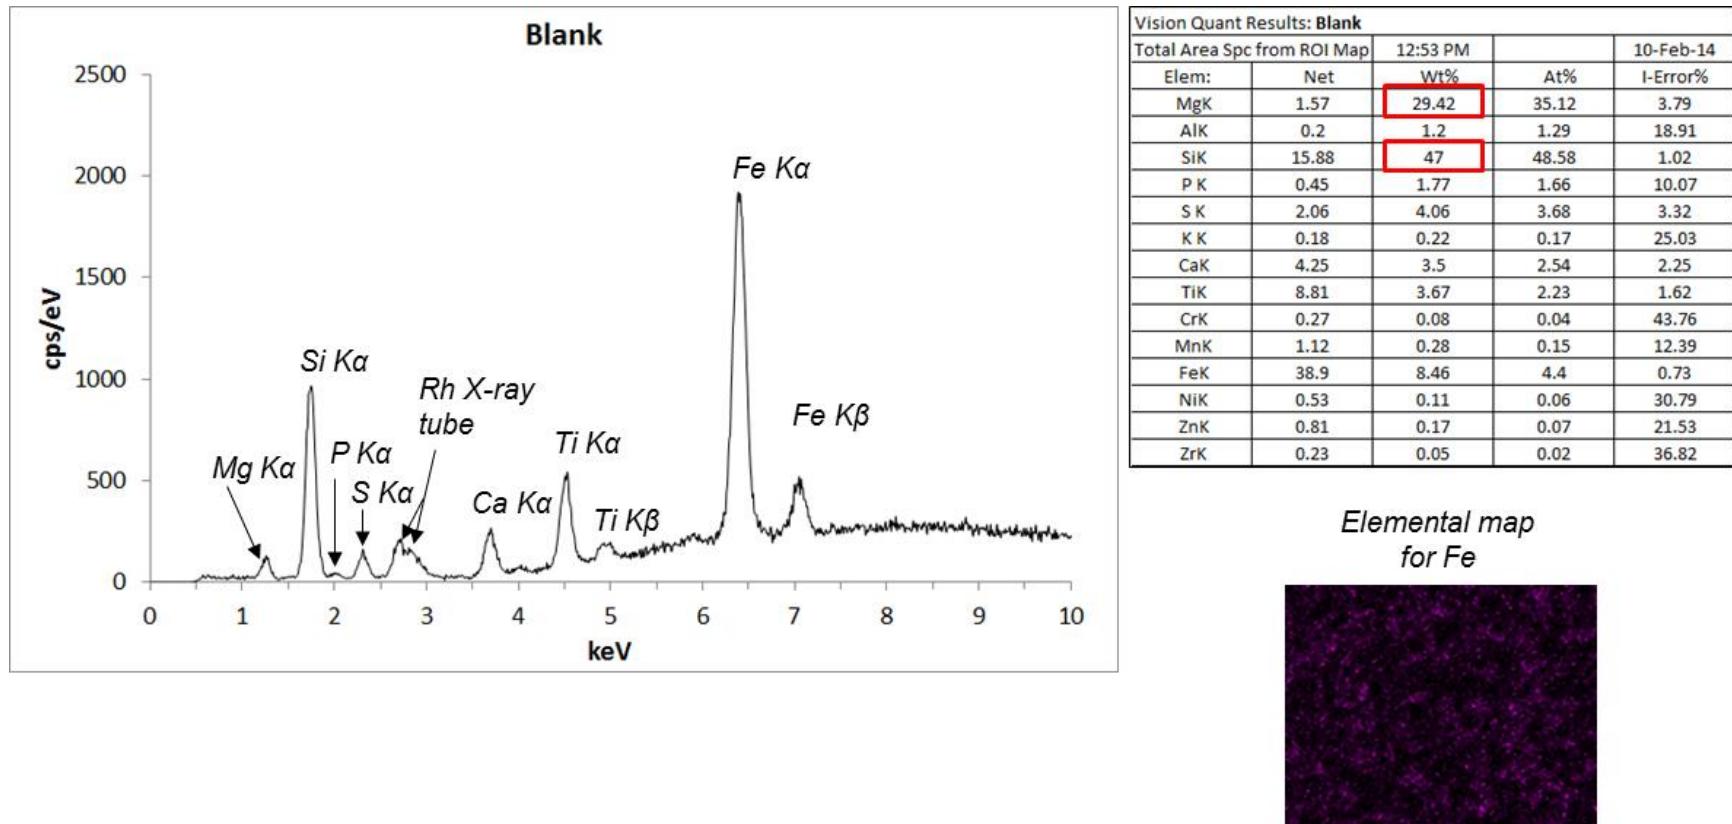
Figure 30. XRF pattern and XRF qualitative analysis results for the pad blank.
