Results of Stainless Steel Canister Corrosion Studies and Environmental Sample Investigations

Fuel Cycle Research & Development

*Charles Bryan and David Enos
Sandia National Laboratories
September 25, 2014*

FCRD-UFD-2014-000055
SNL DOC# 166112

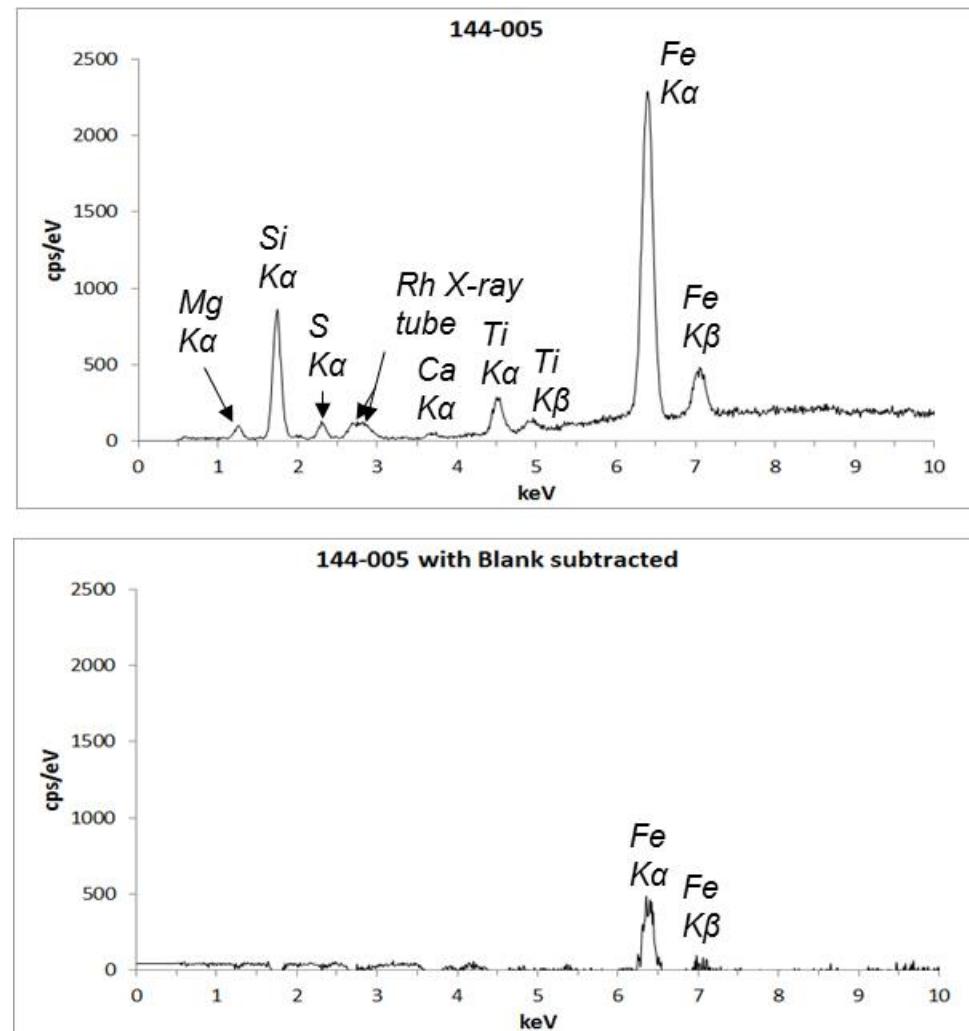
Figure 31. XRF pattern and XRF qualitative analysis results for Hope Creek sample 144-005, from the side of the canister.

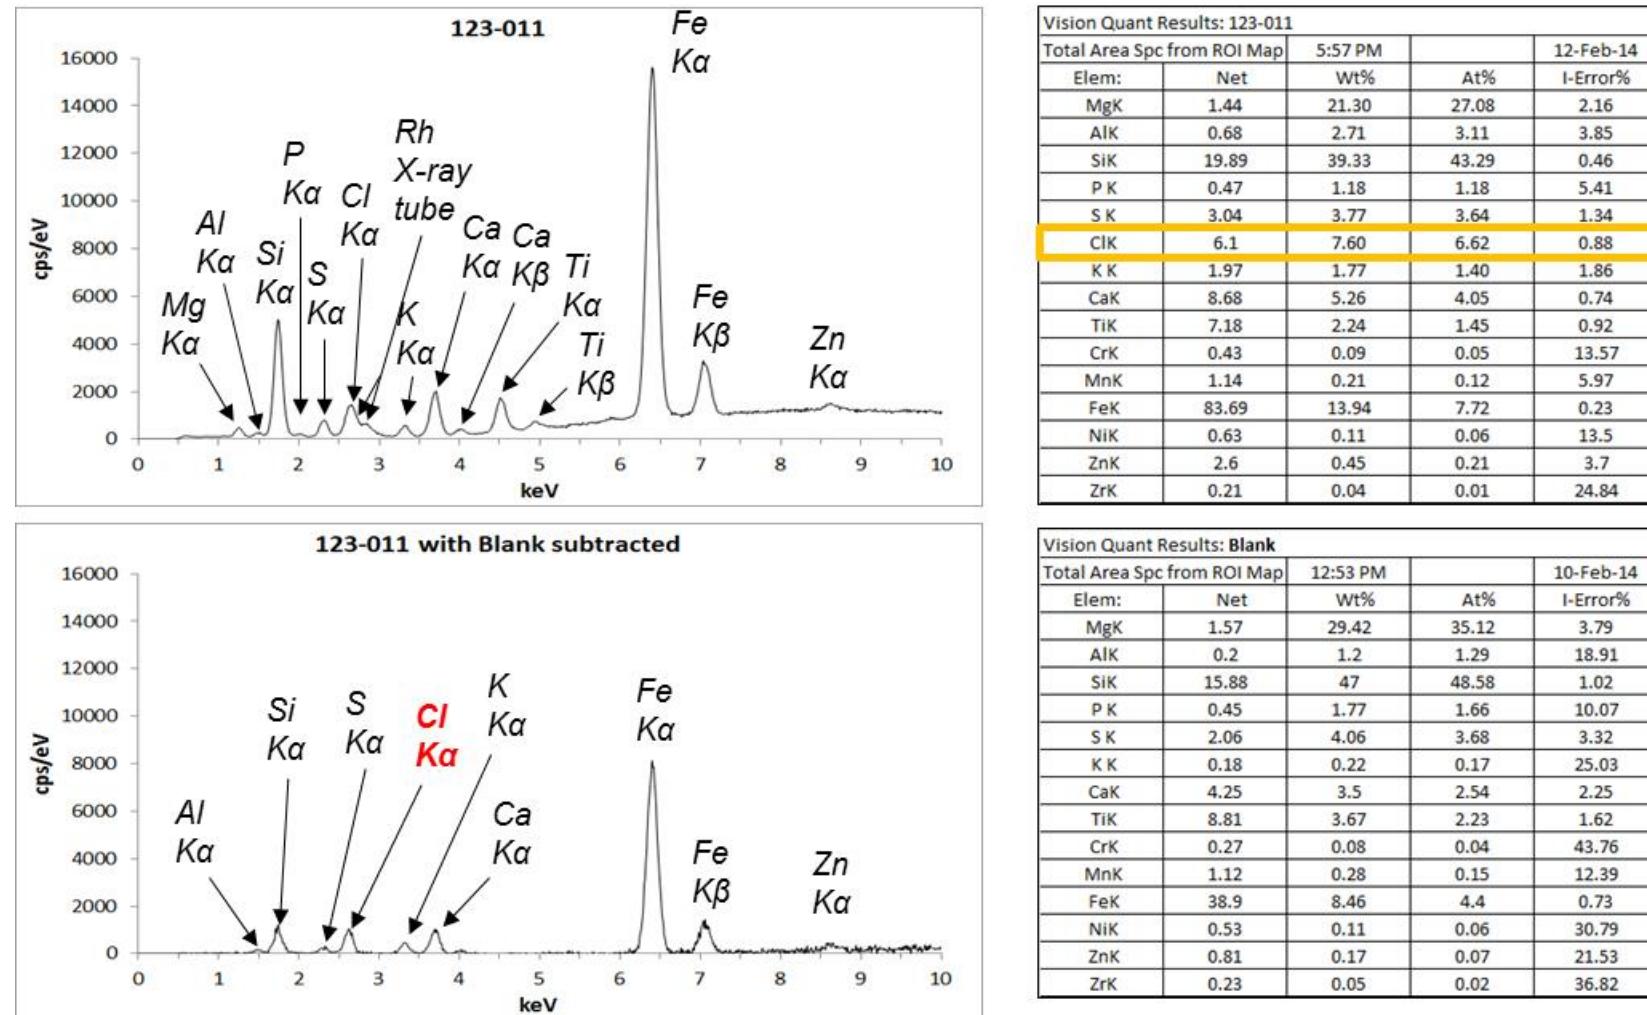
Figure 33. XRF pattern and XRF qualitative analysis results for Diablo Canyon sample 123-011, from the top of the canister.

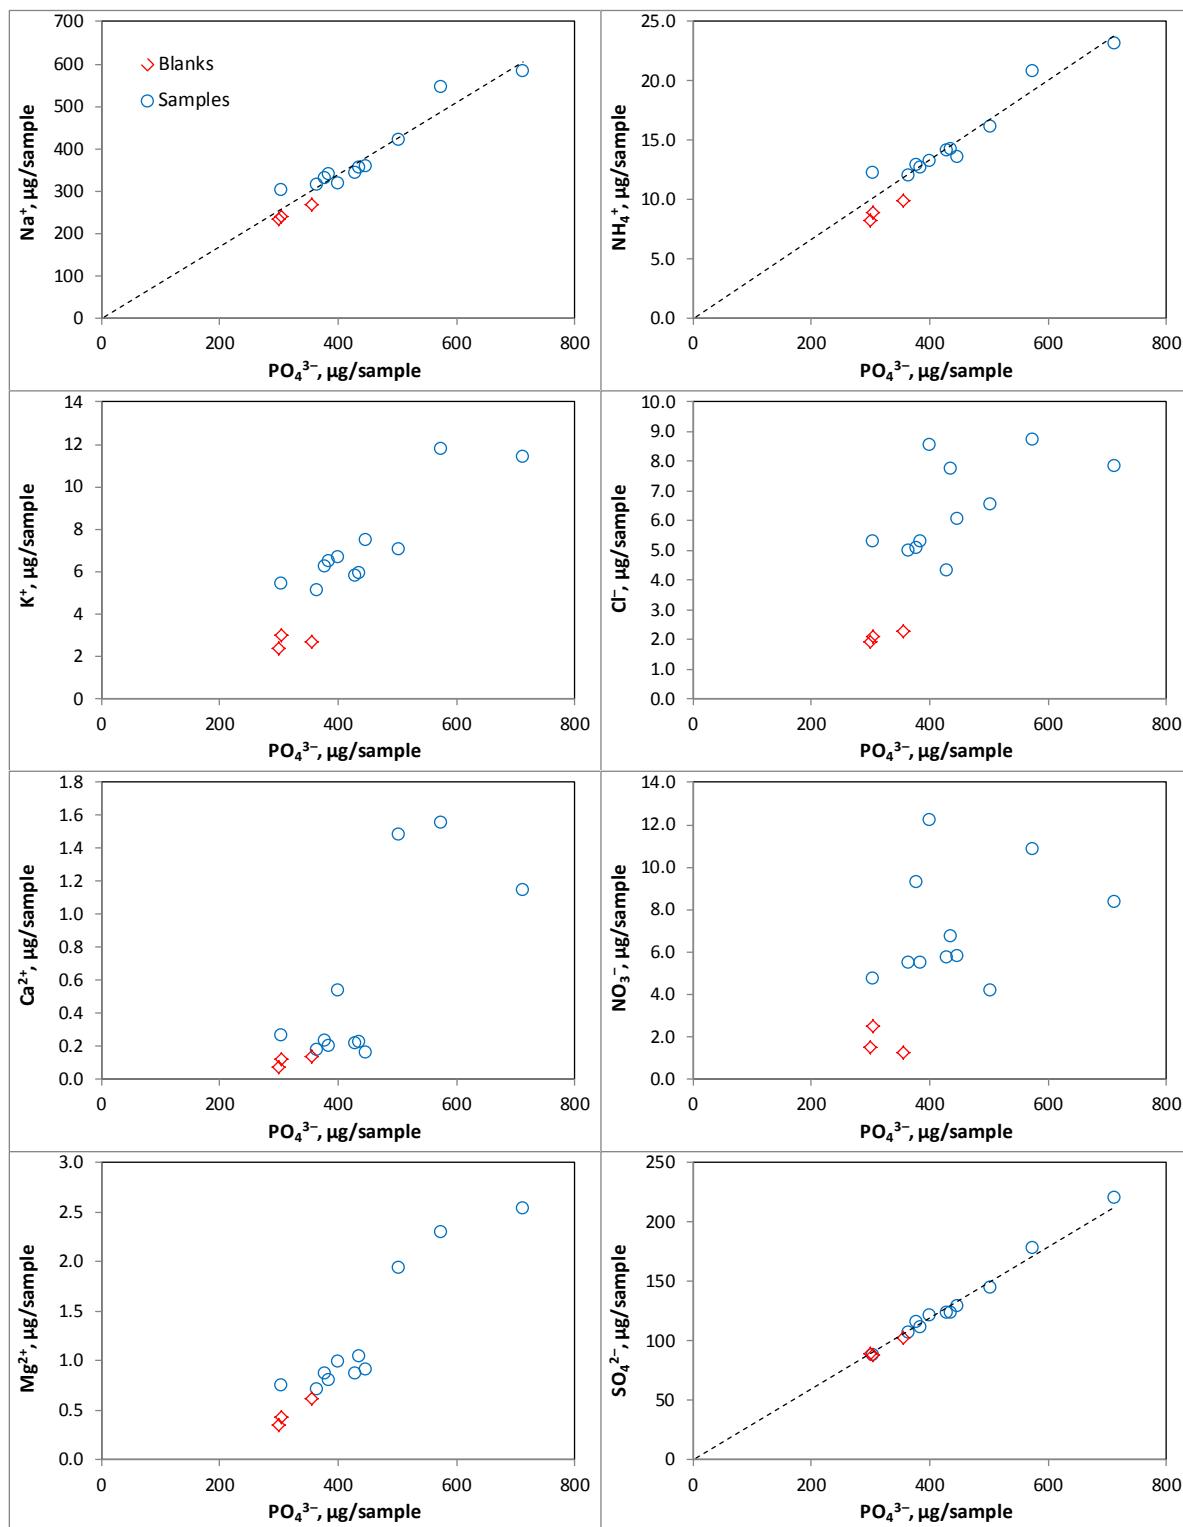
Figure 34. Plots of soluble species concentration versus PO_4^{3-} concentration for the Hope Creek dry pad samples.

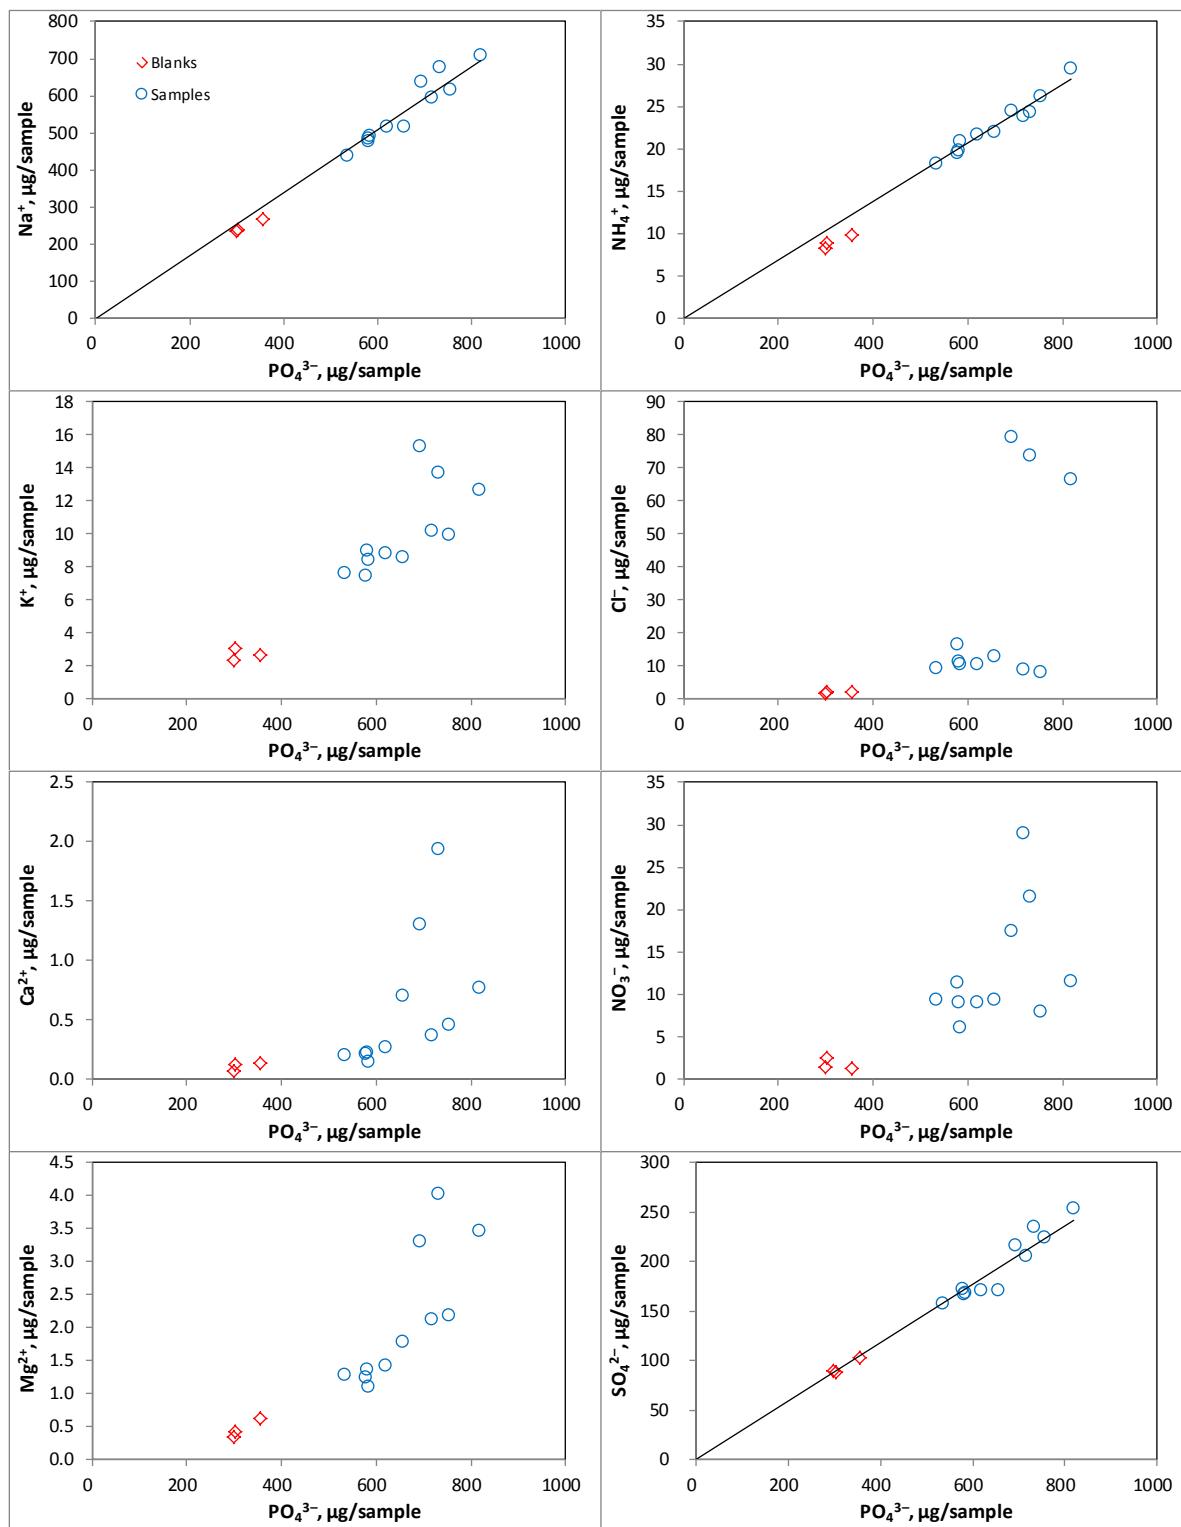
Figure 35. Plots of soluble species concentration versus PO_4^{3-} concentration for the Diablo Canyon dry pad samples.

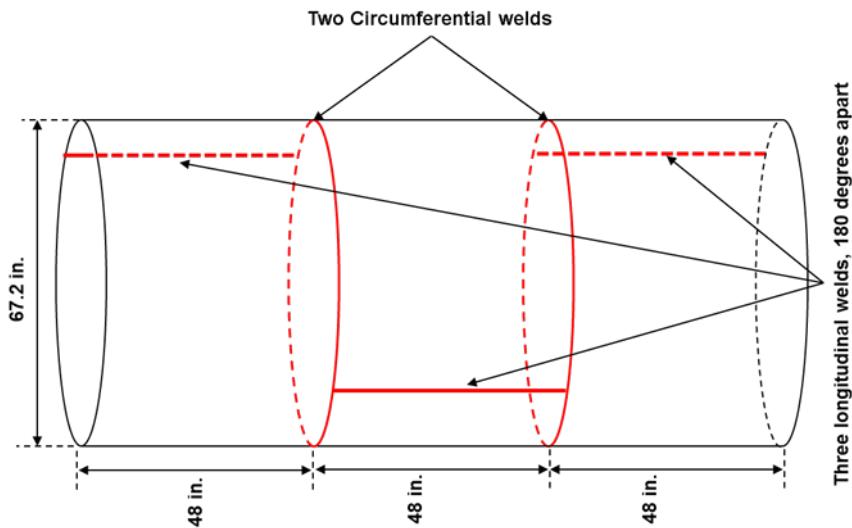
Figure 36. Schematic representation of the full scale mock storage container manufactured at Ranor.

welded together to form a single large cylinder 12 feet in length with two circumferential welds. All of the welds were formed via the submerged-arc welding process and were multi-pass. The inner diameter was welded first, followed by the outer diameter.

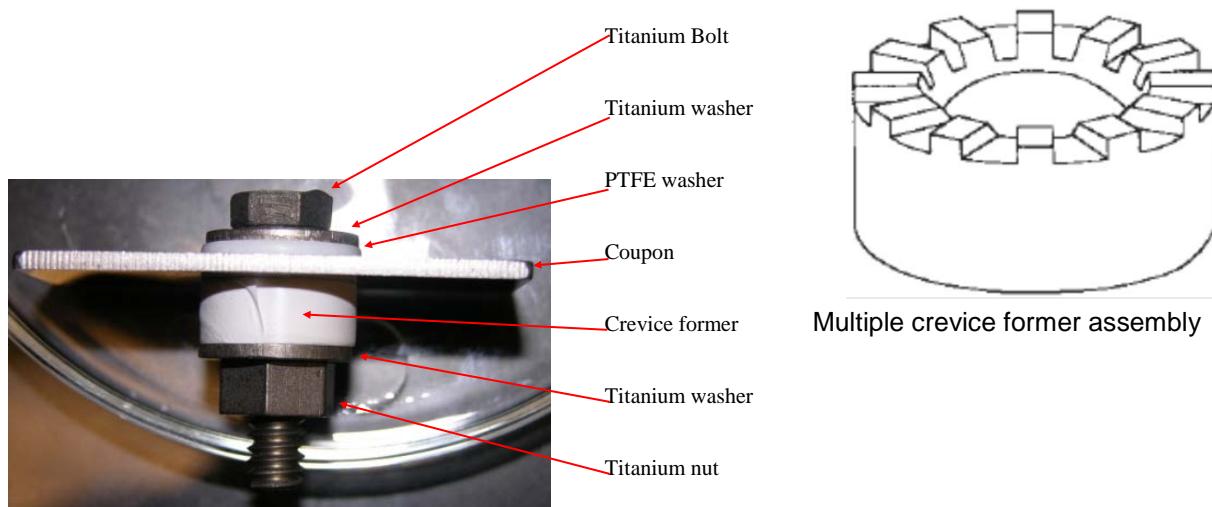
Figure 37. Experimental configuration for crevice corrosion experiments. The MCA was held in place via a torque of 70 in-lbs. Salt was deposited only on the side where the MCA was located.

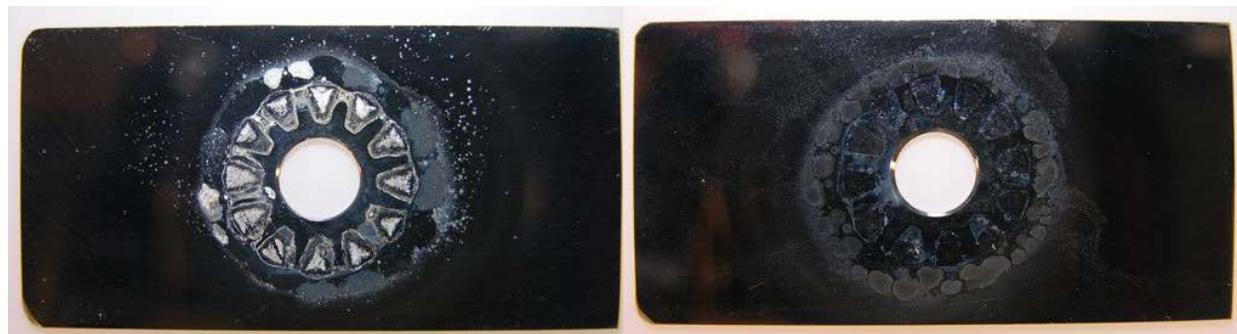
Figure 38. 304SS coupon with $200 \mu\text{g}/\text{cm}^2$ and 7 day exposure after crevice former removal (L) and rinsing (R).

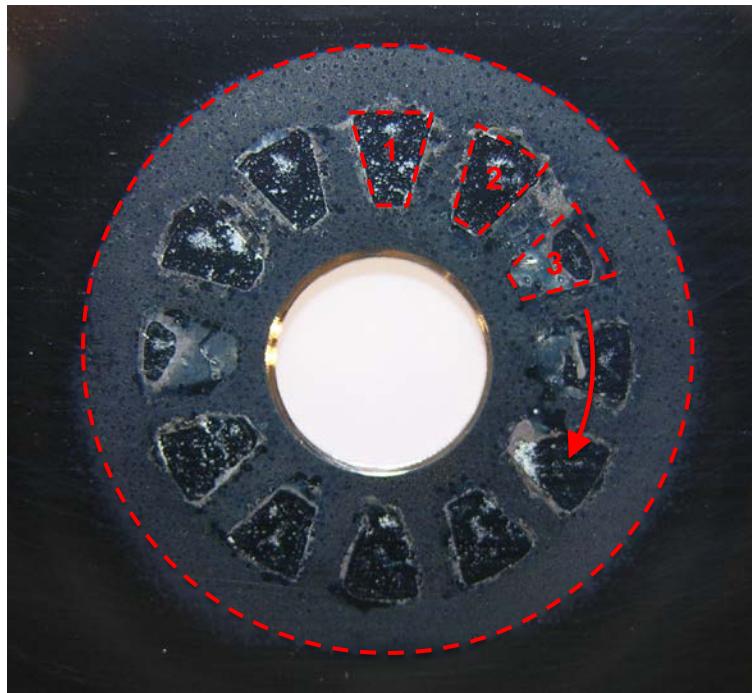
Figure 39. Crevice corrosion site survey location and pattern.

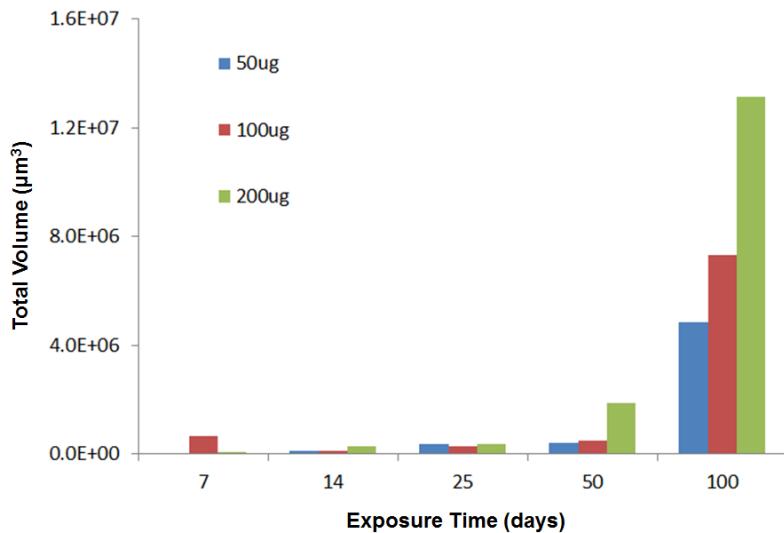
Figure 40. Estimate total crevice corrosion volume as a function of salt loading and exposure time. Volumes are based upon laser confocal microscope measurements taken from representative sites corresponding to the different site geometry “bins” used when reporting the 2-D surface area of corrosion sites.

The data presented below, combined with the number density of crevice sites presented previously in (Enos, 2013) indicate that site nucleation occurs primarily at early times, perhaps within the first few weeks of exposure, followed by growth of the sites over time. It is not clear why such a substantial increase in volume occurred between the 50 and 100 day data sets. One possible explanation is that the material source, and hence the composition and underlying microstructure, of the samples used for the 100 day tests (which were the first experiments performed) was different than that used for the later tests. As such, tests will shortly be underway using material from the 7 and 14 day experiments that have been re-polished and loaded with salt for 100 and 150 day exposures. These experiments should first, establish if the 100 day is an anomalous result related to the material source, and second, determine if site growth continues beyond the 100 day mark or if it stifles.

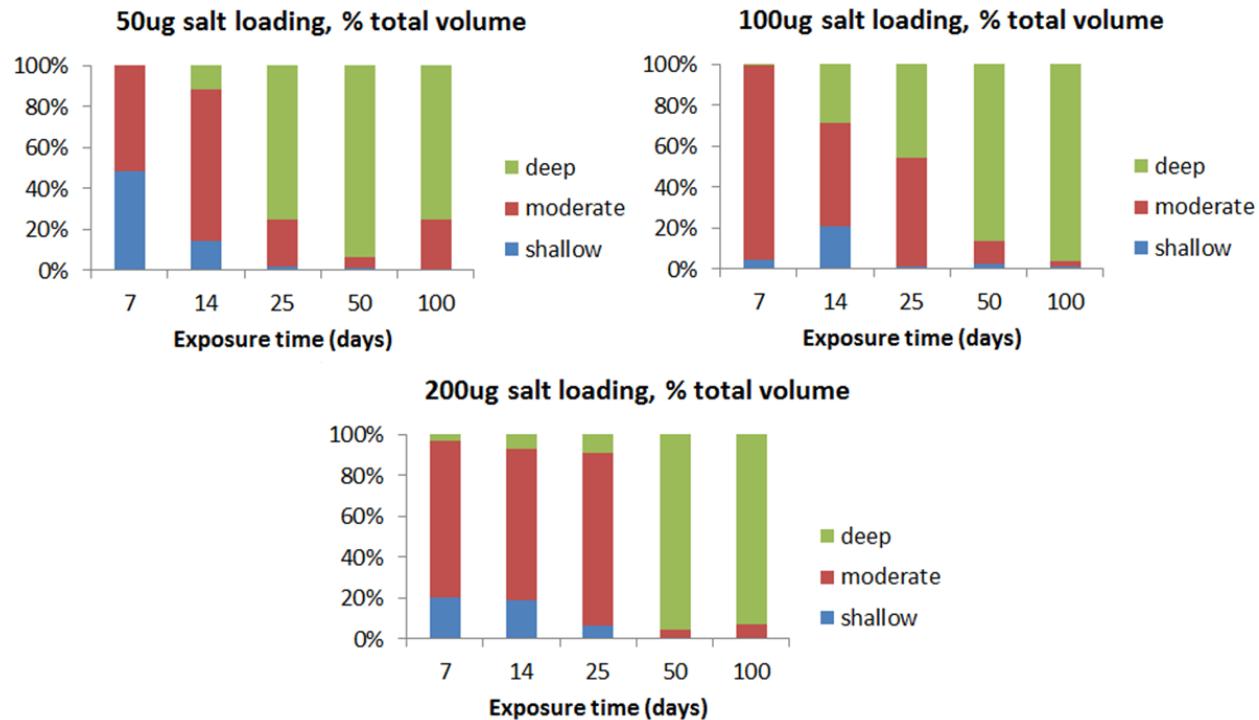
Figure 41. Corrosion site distribution as a function of time for each loading level. Shorter times are dominated by shallow and moderate depth sites, while longer times are dominated by deep sites.

Laser confocal microscopy was used to assess the depth and volume of typical crevice corrosion sites. In past work, the sites were generically classified based upon their perceived depth from SEM images. The actual data from the laser confocal microscopy was combined with the previously reported area data in order to provide an approximate volume of corrosion as a function of salt loading and exposure time. The total volume, estimated as described, is presented in Figure 40 as a function of salt loading and exposure time. As seen in the figure, the change in total volume of attack from 50 to 100 days is substantial, and indicates that stifling has not yet occurred. As expected, with time the number (and hence overall volume) of larger, deep sites increases with time irrespective of the salt loading, as illustrated in Figure 41.

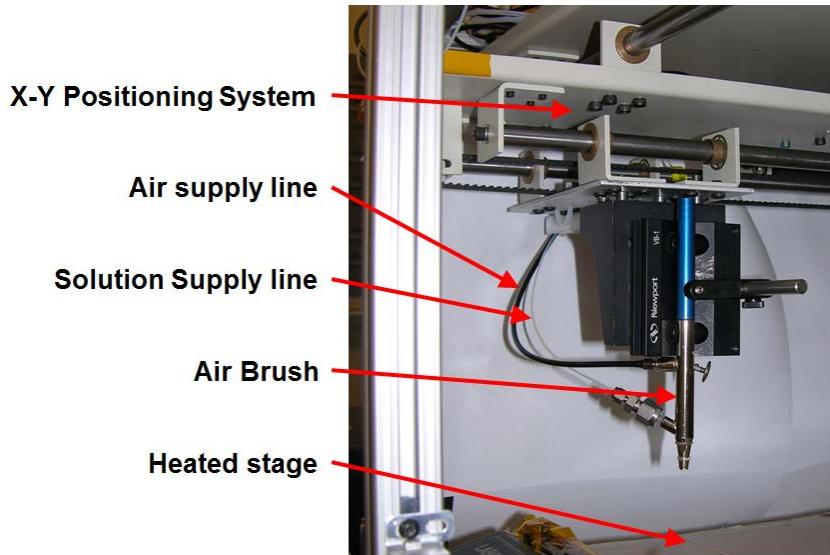
Figure 42. Salt aerosol deposition system used to apply well defined salt loadings using either a water or methanol carrier solvent. Both NaCl/KCl mixtures and a mixture simulating ASTM artificial ocean water (salt loading per ASTM D1141).

In addition to depositing NaCl/KCl mixtures as used in the crevice corrosion experiments described above, an effort was made to deposit marine aerosols using a salt chemistry similar to that described in ASTM D1141 "Standard Practice for the Preparation of Substitute Oceanwater". The chemistry deviated from that mixture in that minority constituents were omitted. While the NaCl/KCl salt mixture was readily deposited with a methanol carrier, this was not the case for the oceanwater. One of the main constituents, sodium sulfate (Na_2SO_4) is insoluble in alcohols. Several attempts were made to grind the material into a fine powder to be incorporated into the solvent (to be deposited as a solid), but XRD analysis of the resulting deposit indicated that the composition differed from that of a salt layer that would evolve from evaporation of an aqueous solution. As a result, experiments were initiated using alcohol-water mixtures as well as water alone. While deposition is more difficult with these solutions, the resulting deposit had the desired chemical composition.
