## DESCRIPTION OF U16a TUNNEL CULTURAL FEATURES

### FEATURE DESCRIPTIONS

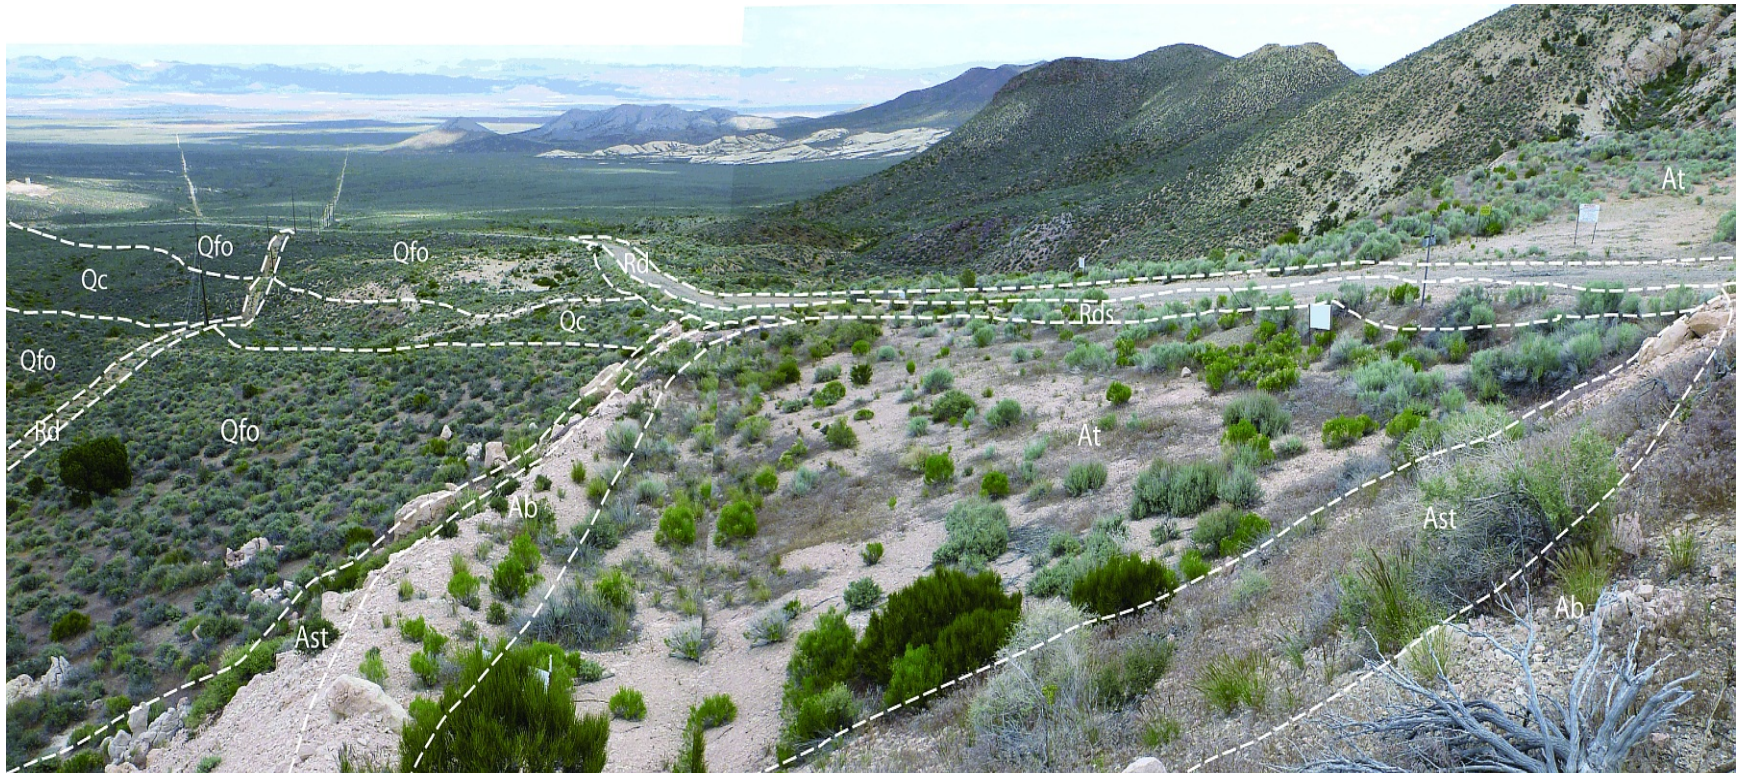
Figure 34. View to the southeast of the principal access road that ascends the incised, east sloping piedmont alluvial fan surface (Qfo). A linear, two-track road visible on the left side of the photograph is a power-line road. Also visible in the photo are prominent berms constructed along the edges of the tailings (At).

Berms (Ab) have been pushed up along the edge of the tailings (Figures 32-34), likely in an effort to reduce the amount of surface runoff from the portal area and reduce the severity of gully activity on the tailings slopes. Tailings are visible in the tributary drainages.

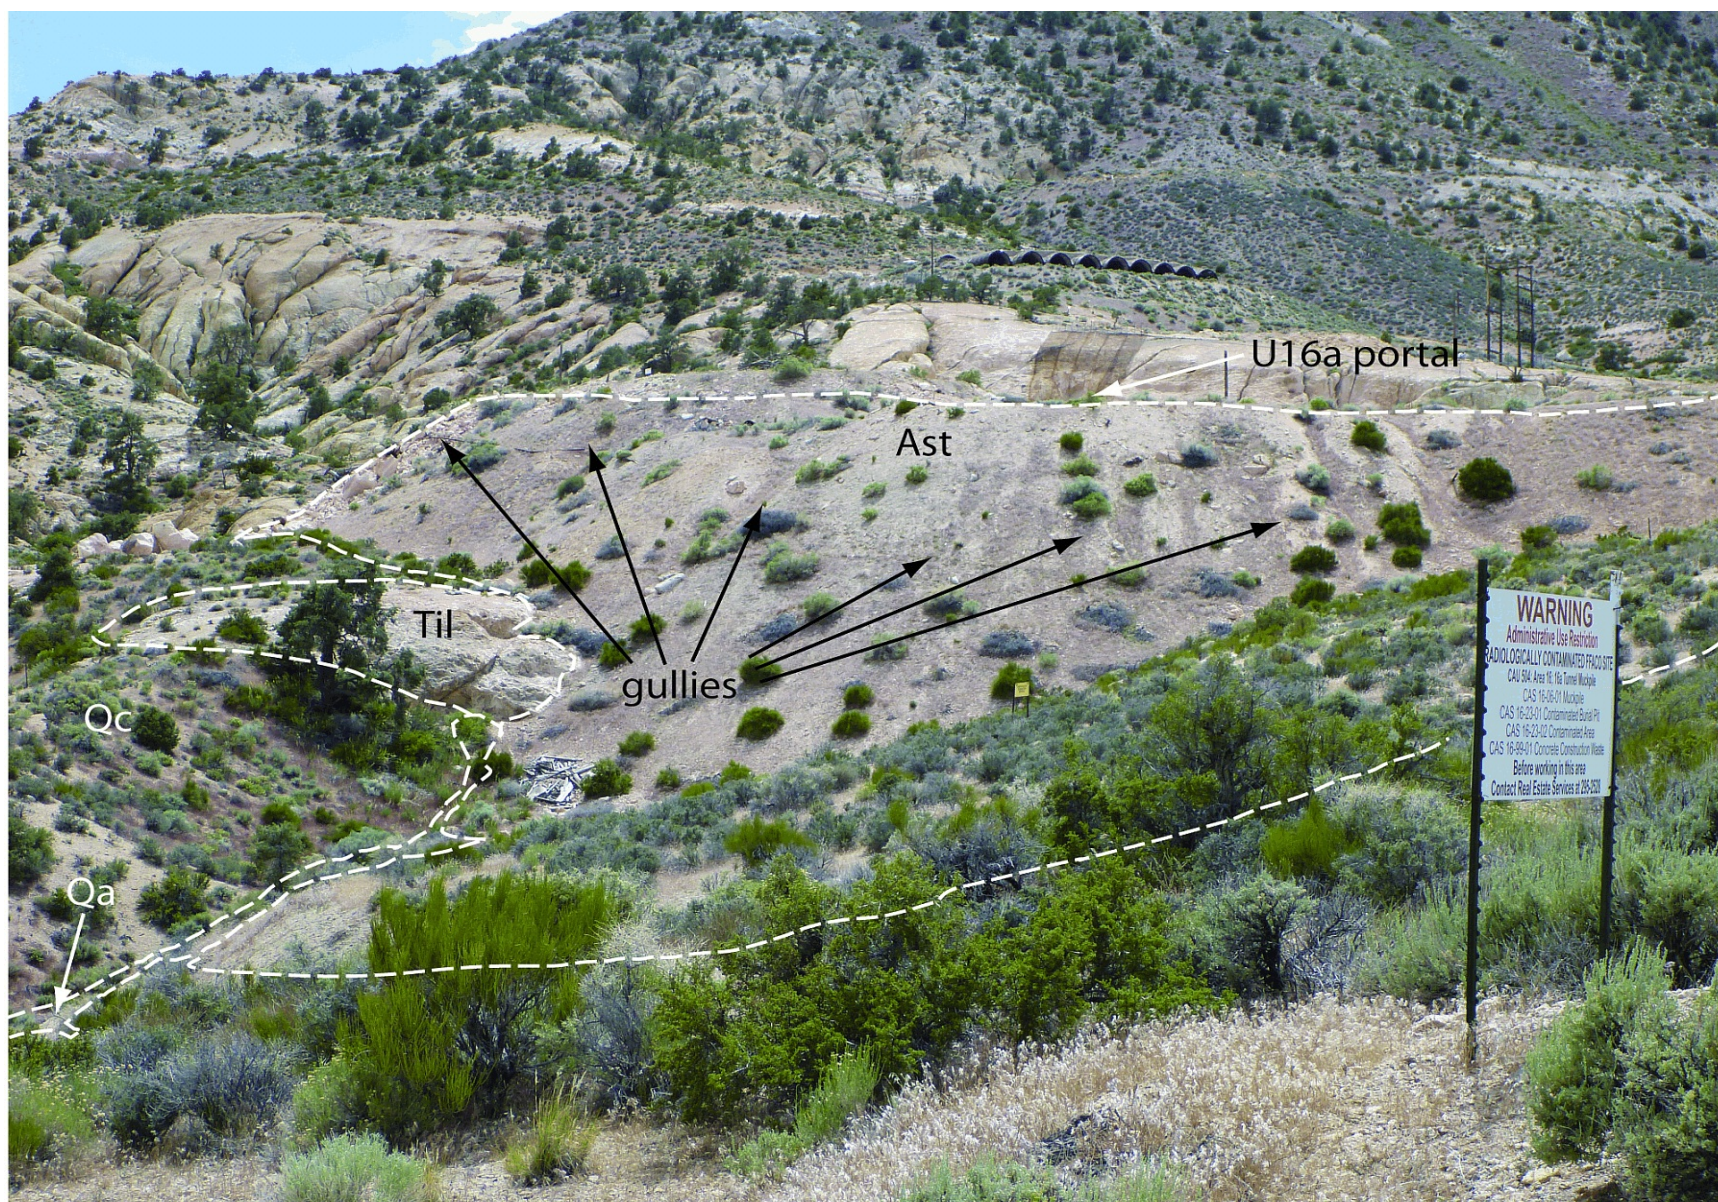
Figure 35. View west from the access road toward the U16a Tunnel portal. In the middle of the photograph the rilled and gullied tailings slope (Ast) is visible. Debris and tailings are visible in the stream along the base of the tailings slope.

Small drainage networks have developed on the tailings and tailings slopes (Figures 23, 35, and 37) and provide an effective transport linkage between potentially hazardous tailings and the downstream geomorphic and hydrologic systems. Rilled and eroded tailings occur on relatively unvegetated tailings slopes (Ast) and are characterized by visible dendritic networks of rills, parallel rills, and large, incised gullies. Approximately 1.3 hectares (3.3 acres) of unvegetated tailings slopes (Ast) are present on the margins of the tailings area.

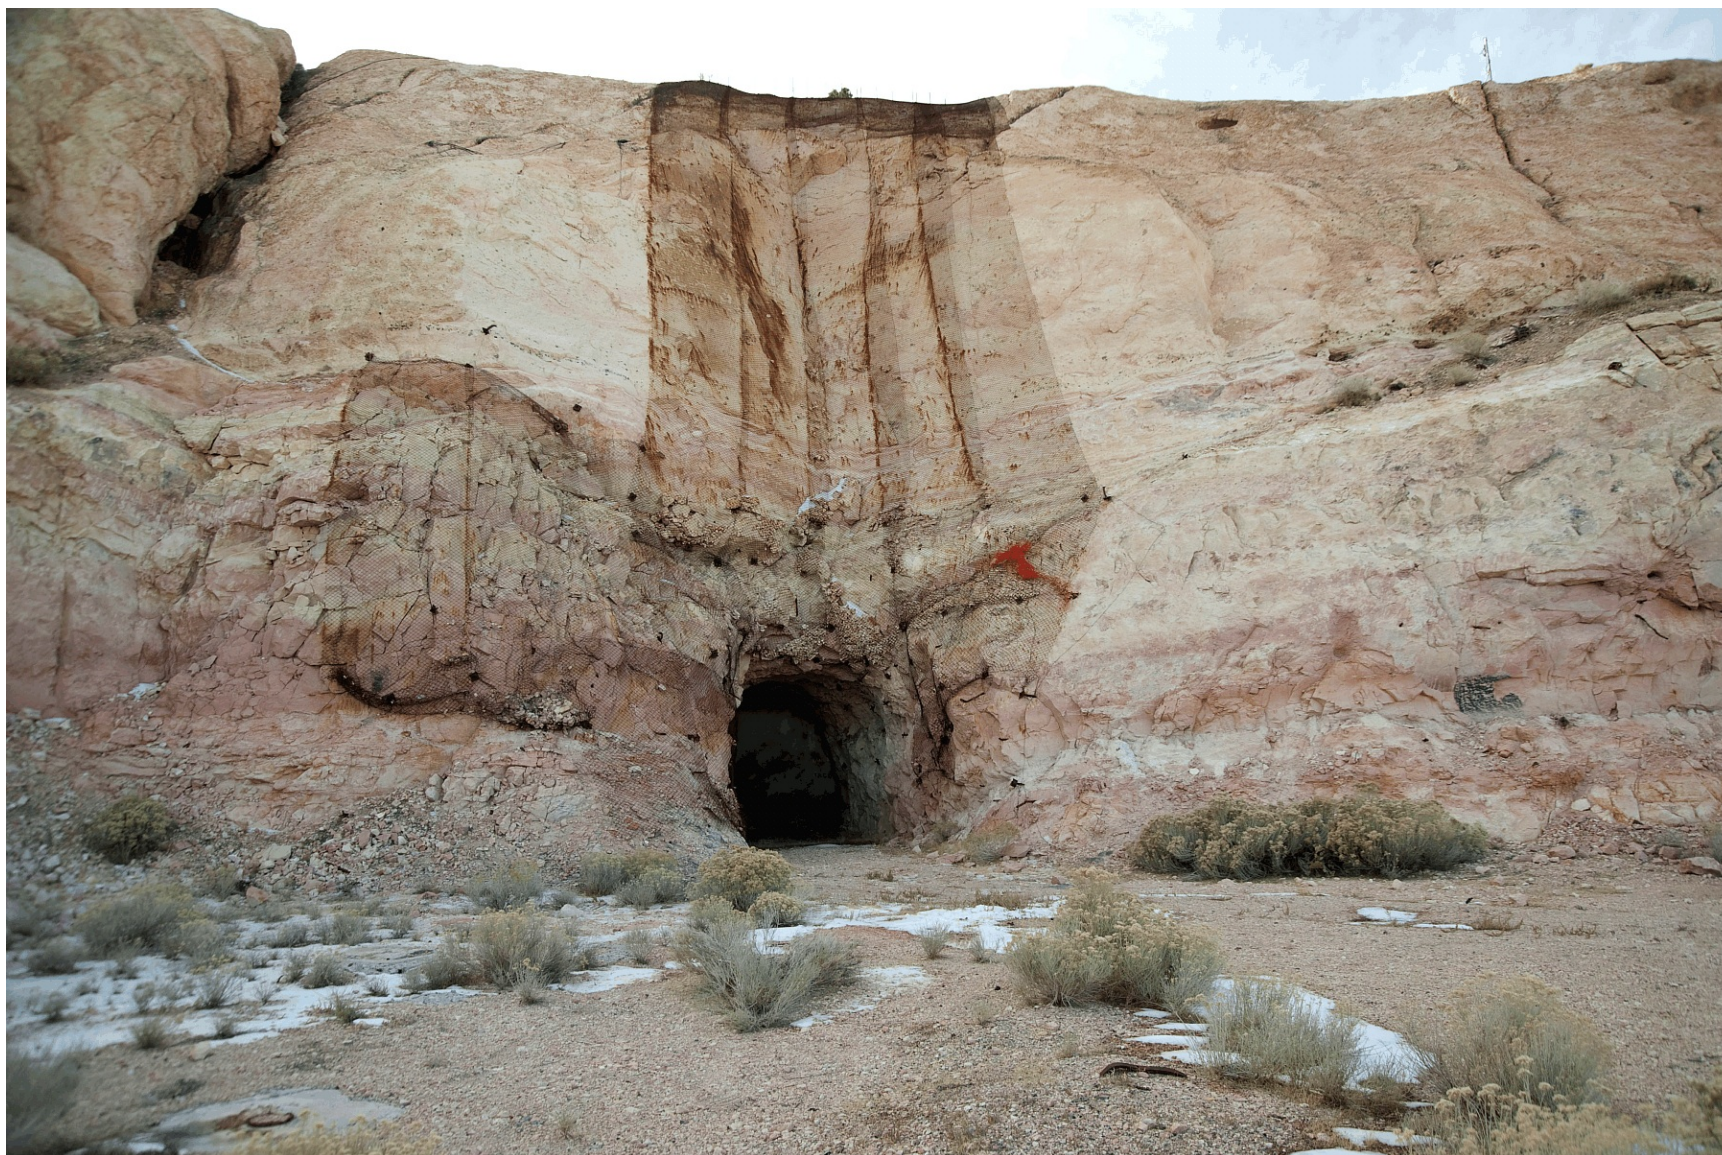
Feature 1 is the U16a Tunnel Portal at UTM coordinate 571683 E, 4096300 N (Figures 39 and 41). The portal has been excavated into the northeast-facing exposure of tuff on the slope of Shoshone Mountain at an elevation of 1,649 m (5,410 ft). Visually, the opening is arched (Figure 41) and measures 4.57 m (15 ft) in width and 3.96 (13 ft) in height (at plug). Approximately 7.62 m (25 ft) within the tunnel is a concrete plug that seals the tunnel. The plug is dated August 12, 2008. The portal from the concrete plug to the rock face contains no sets or lagging to support the tunnel. Rock

Figure 41. U16a Tunnel Feature 1, Portal, view west (2011).

bolts have been drilled into the sides and back of the tunnel and wire mesh has been rock bolted to the rock face above and around the portal.

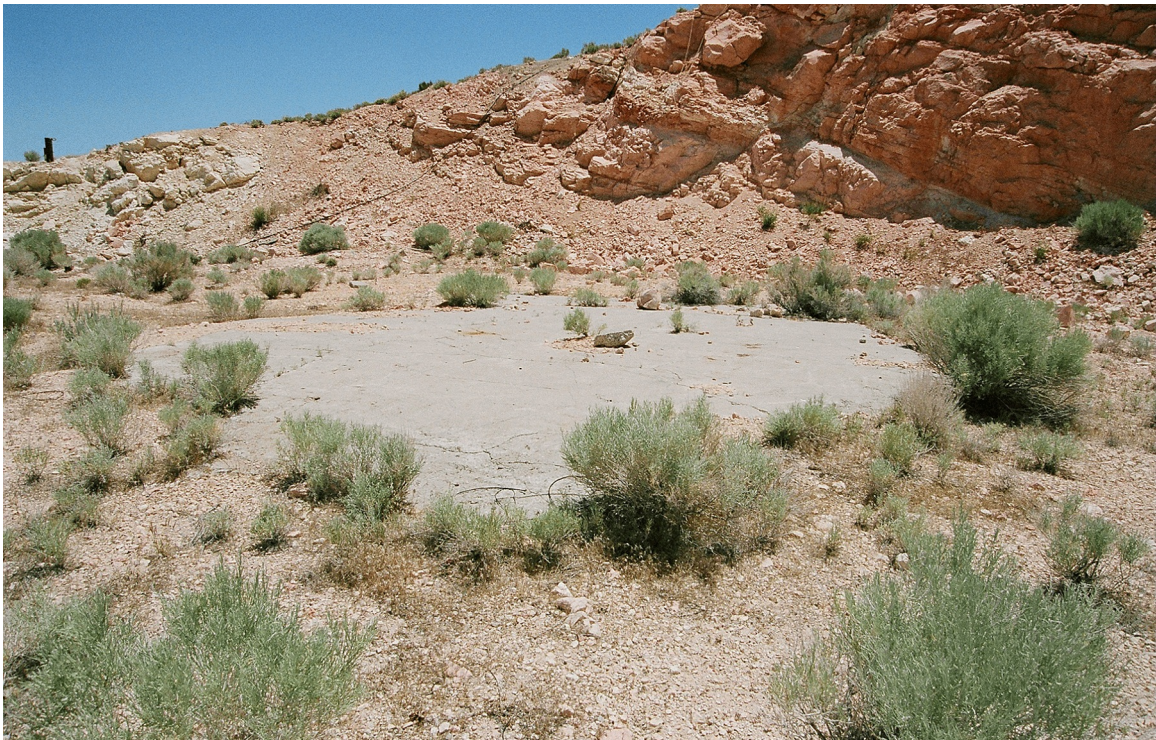
Feature 4 is a six-sided concrete foundation for the Welding Shop at UTM coordinate 571661 E, 4096302 N. It measures 7.62 m north-south by 6.4 m (21 ft) east-west (Figure 45). Various sized conduits have been cut flush with the surface. The pad is aligned at 0 degrees. The location for the pad corresponds to the Welding Shop as shown on engineering drawings JS-016-U16a.04C2.B, dated December 1968 (Figure 43). Associated artifacts are wire, nails, I beam, and shrapnel.

Figure 45. U16a Tunnel, Feature 4, plan map and photograph of concrete foundation for Welding Shop, view southeast (2011).

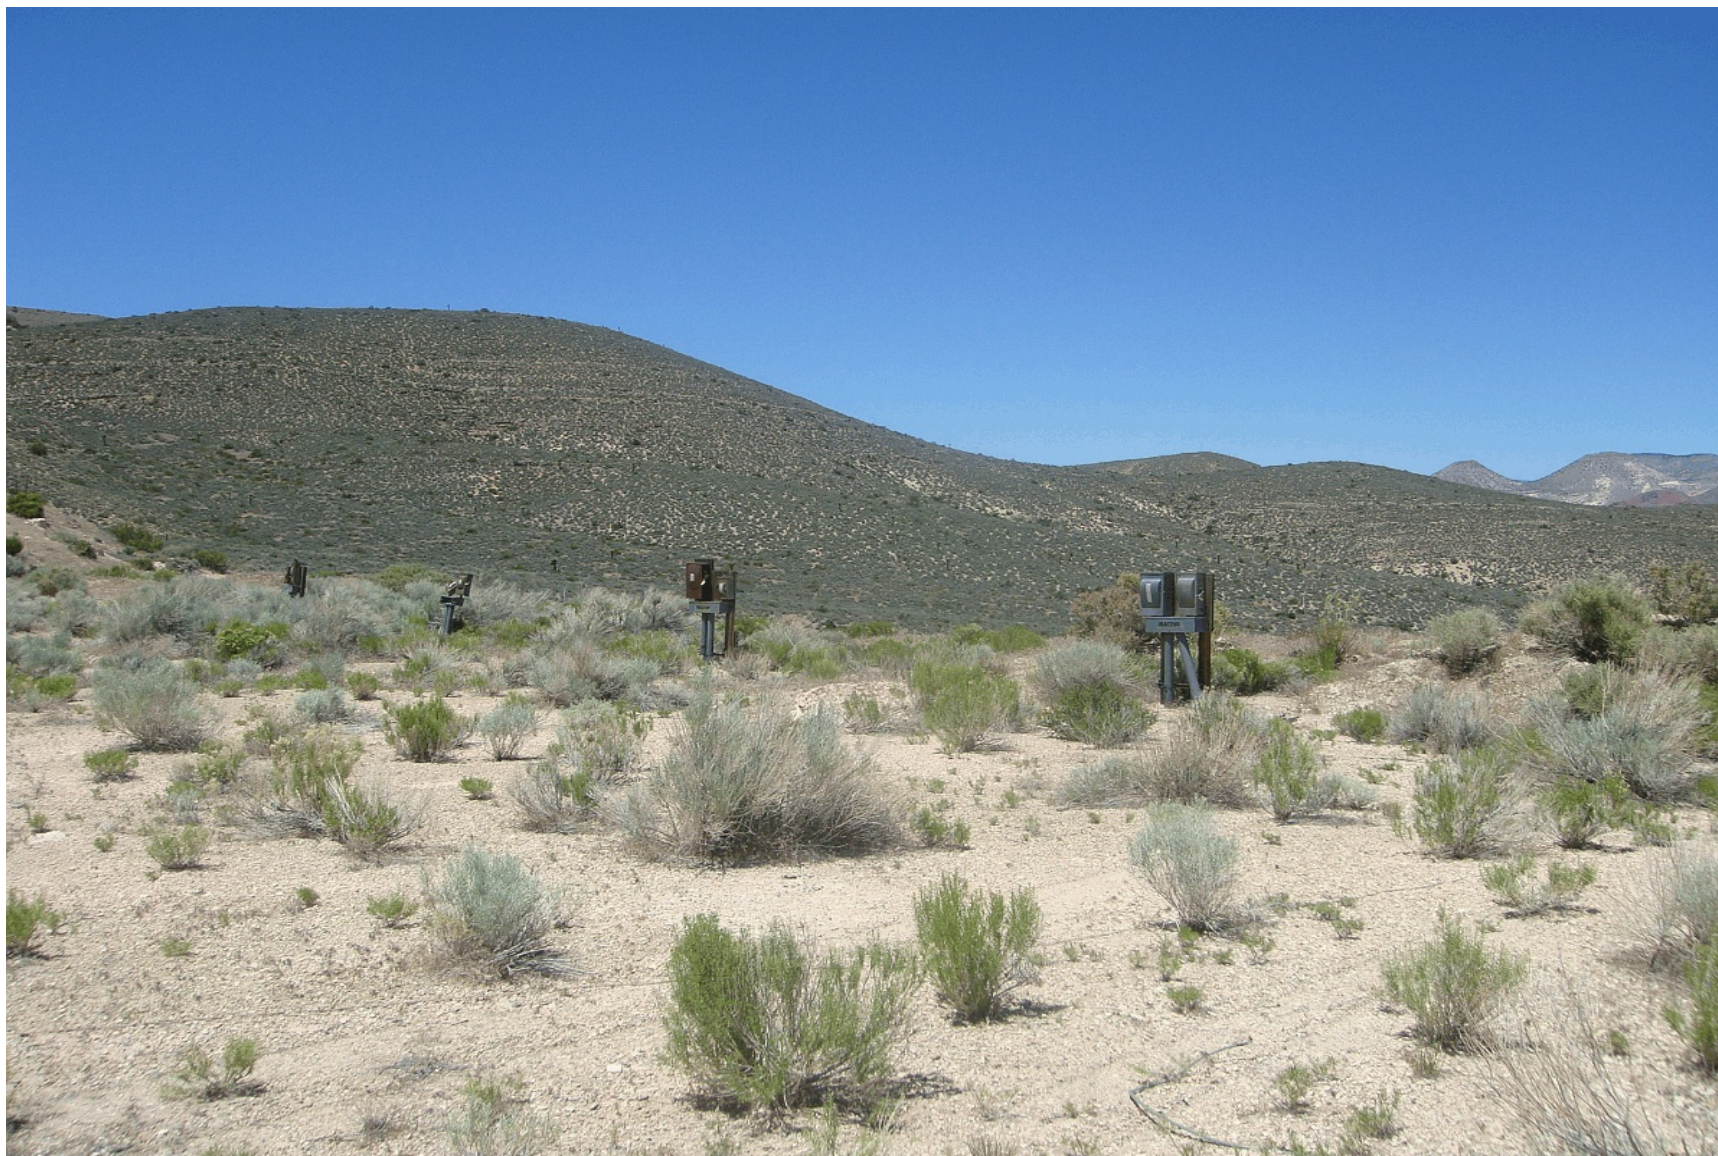
Feature 15 consists of four sets (2 per backboard) of electrical switch boxes along the north edge of a dirt pad (Figures 39 and 57). Each switch box is mounted to a 3/4-inch plywood backboard that is attached to two 4 x 4 inch wood posts that are 1.42 m (56 inches) in height. Electrical cable extends below the surface through 8.89 cm (3.5 inch) galvanized conduit. The switch boxes are spaced approximately 8 m apart. The plywood backboard on the third panel box (from east) is lying on the surface; however, the panel boxes remain upright.

Figure 57. U16a Tunnel Feature 15, switch boxes, view northwest (2011).

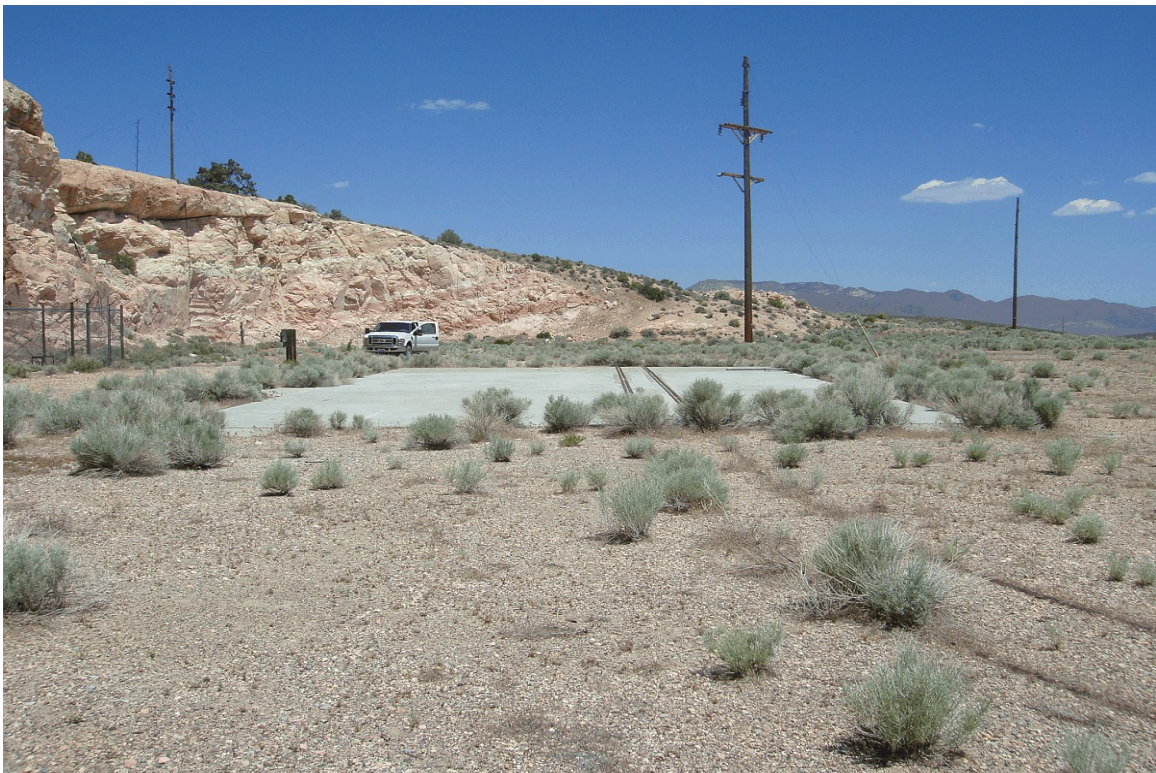
Feature 18 is the concrete foundation for the Assembly Building 16-101 at UTM coordinate 571632 E, 4096399 N (Figures 39 and 60). It consists of a 12.19 m (40 ft) east-west by 23.77 m (78 ft) north-south concrete pad that is aligned at 345 degrees. A 2.13 x 1.22 m (7 x 4 ft) concrete pad for a pedestrian entrance is 40.64 cm (16 inches) west of the southeast corner and a similar pad is at the southwest corner of the foundation. A 3.05 x 1.22 m concrete entrance pad is along the west side of the foundation 8.23 m (27 ft) north of the southwest corner. Two metal rail lines (Feature 10) extend north-south the length of the foundation. They are 4.01 m (158 inches) from the east edge of the pad and 0.91 m apart. Two electrical switch boxes are near the Assembly Building (Feature 18) pad. They are mounted to a 3/4 inch plywood backboard that is 76.2 x 60.96 cm (30 x 24 inches). The backboard is attached to two 4 x 4 inch posts that are 1.52 m (60 inches) in height. Extending from the switch boxes are 7.62 cm galvanized conduits. The location for the Assembly Building corresponds to the one shown on engineering drawing JS-016-U16a.04-C2.B, dated December 1968, drawing U16a.06, dated March 1971, and drawing 016-002-C1.4, dated May 1970 (Figures 43, 51, and 61).

Figure 60. U16a Tunnel Feature 18, plan map and photograph of foundation for Assembly Building 16-101, view southeast (2011).

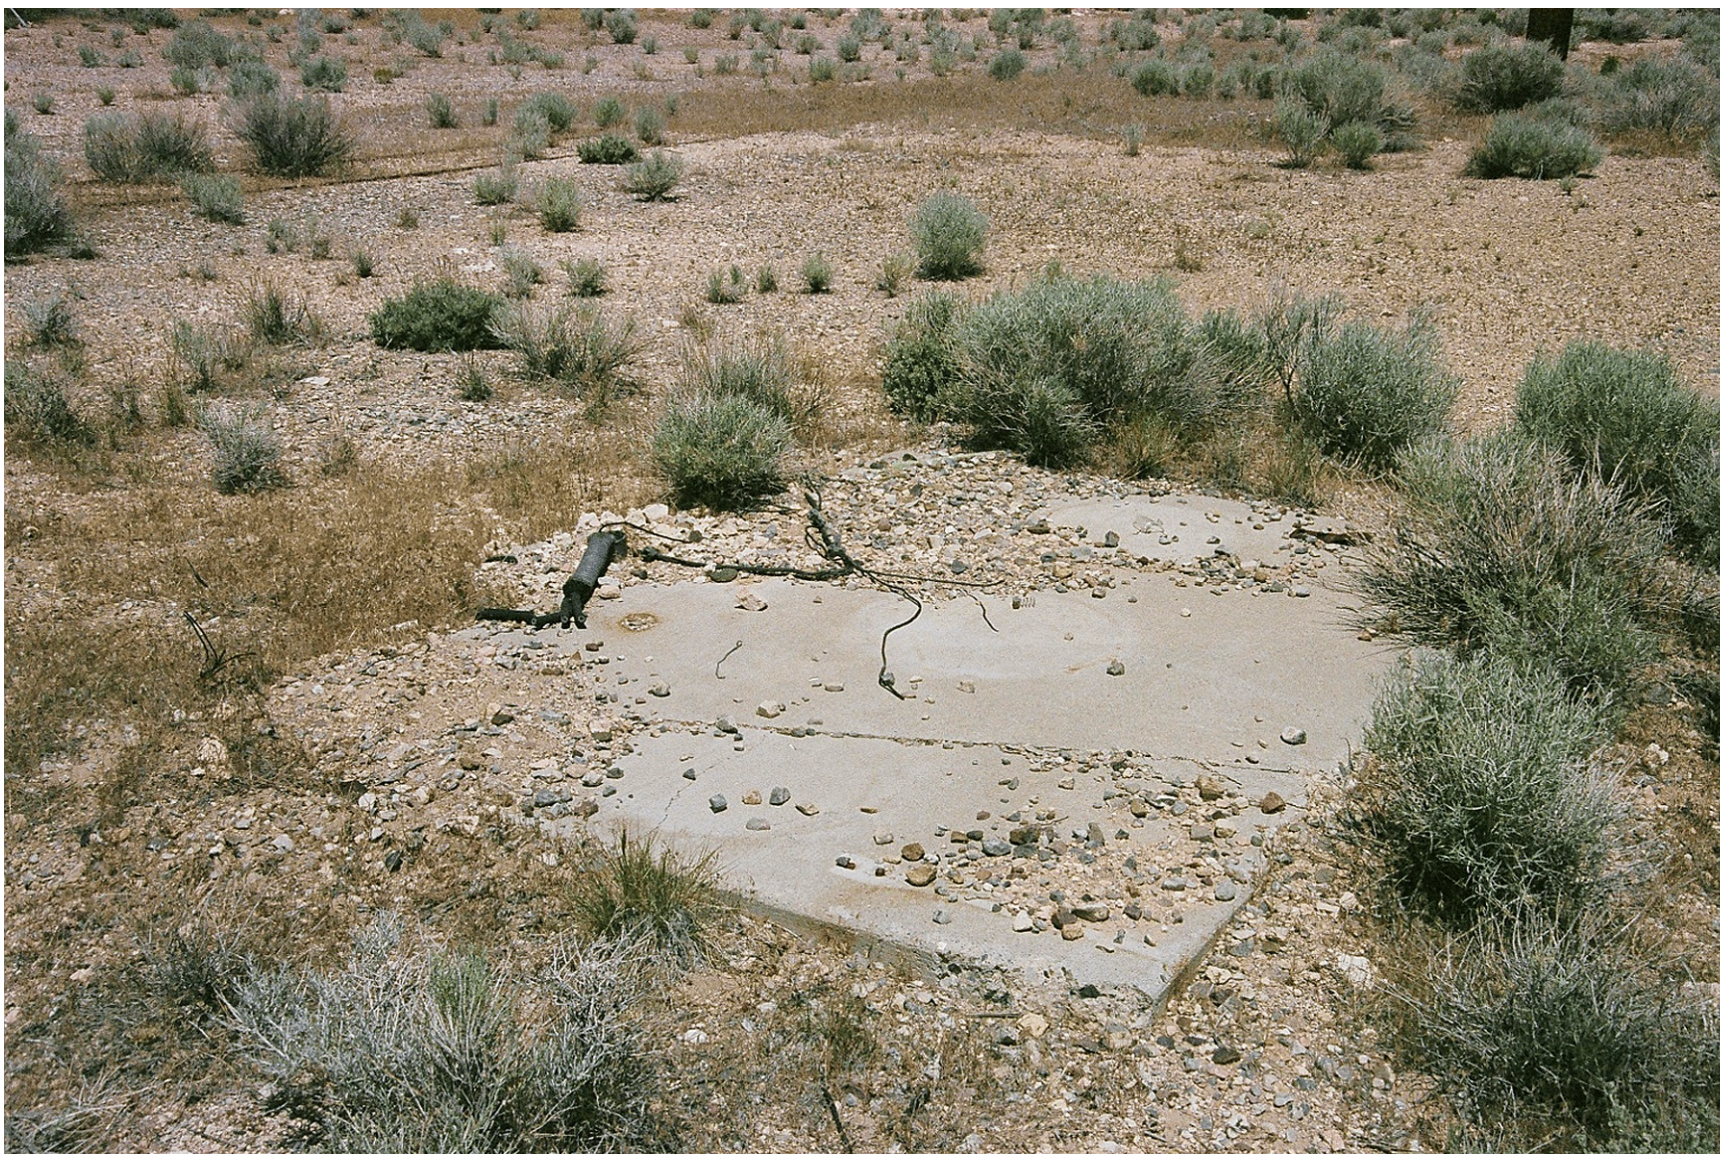
Feature 19 is a concrete pad at UTM coordinate 571634 E, 4096407 N (Figure 62). The pad is 2.44 m north-south and 1.83 m east-west and aligned at 345 degrees. A 7.62 cm galvanized conduit with insulated cables is centered along the west edge of the pad. The conduit has been cut off near the surface of the pad.

Figure 62. U16a Tunnel Feature 19, concrete pad, view southeast (2011).

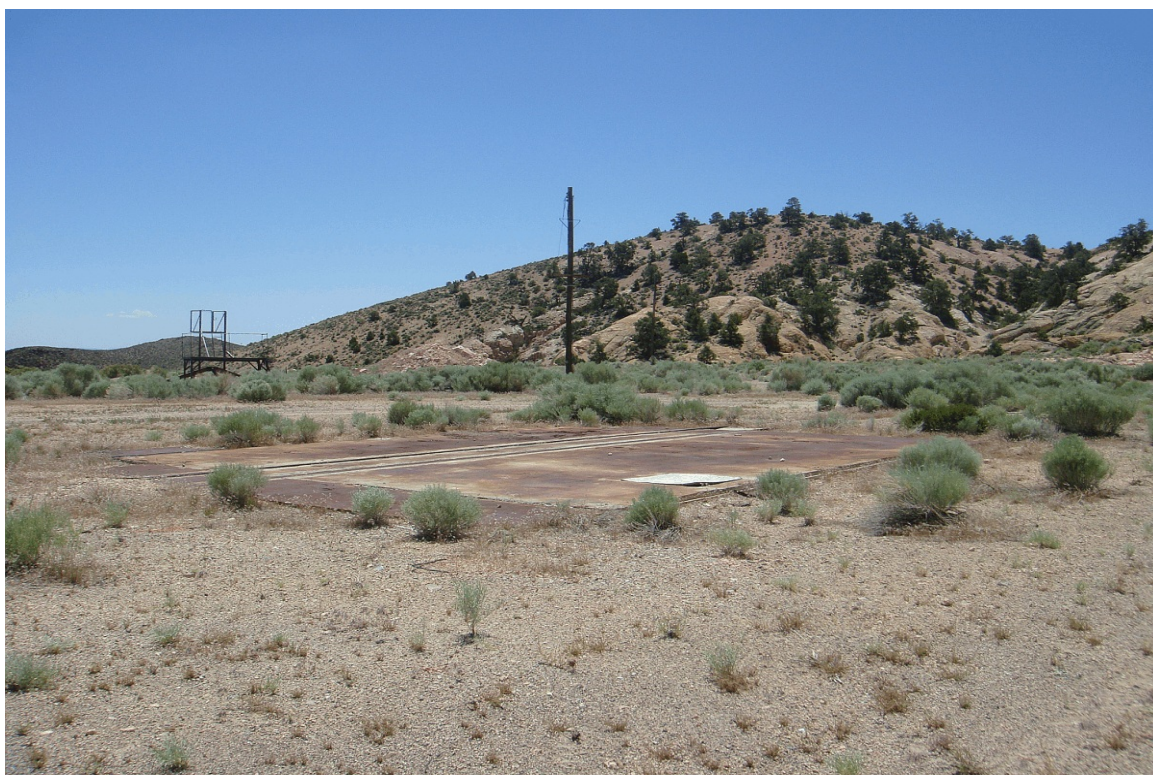
Feature 20 is a concrete foundation for Building 16-100 at UTM coordinate 571661 E, 4096394 N (Figures 39 and 63). It is 10.36 m (34 ft) east-west and 9.14 m (30 ft) north-south and aligned at 345 degrees. Along the east edge at the northeast corner is a 1.22 x 2.13 m concrete pedestrian entrance pad. Along the north edge is a 6.4 x 1.22 m (21 x 4 ft) concrete ramp 1.07 m (42 inches) from the northeast corner. A similar concrete ramp is 1.07 m from the southeast corner along the south edge. A 0.91 x 0.91 m access plate for a drainage is 1.9 m (75 inches) from the north edge and 30.48 cm from the west edge of the pad. Two 10.16 cm pipes in the bottom of the drainage exit through the west edge of the pad. Two metal rail lines (Feature 10) extend north-south across the pad. They are 2.18 m (86 inches) from the east edge and 0.91 m apart. Centered between the rails adjacent to the south concrete ramp is a drain covered with a 0.91 x 0.91 m metal grate. Centered in the bottom of the drain is a 20.32 cm pipe. On the 1968 engineering drawing JS-016-U16a.04-C2.B (Figure 43), the feature is listed as a concrete pad adjacent to the Shower Trailer and as a Change House on engineering drawing U16a.06, dated March 1971 (Figure 51).

Figure 63. U16a Tunnel Feature 20, plan map and photograph of foundation for Building 16-100, view southeast (2011).

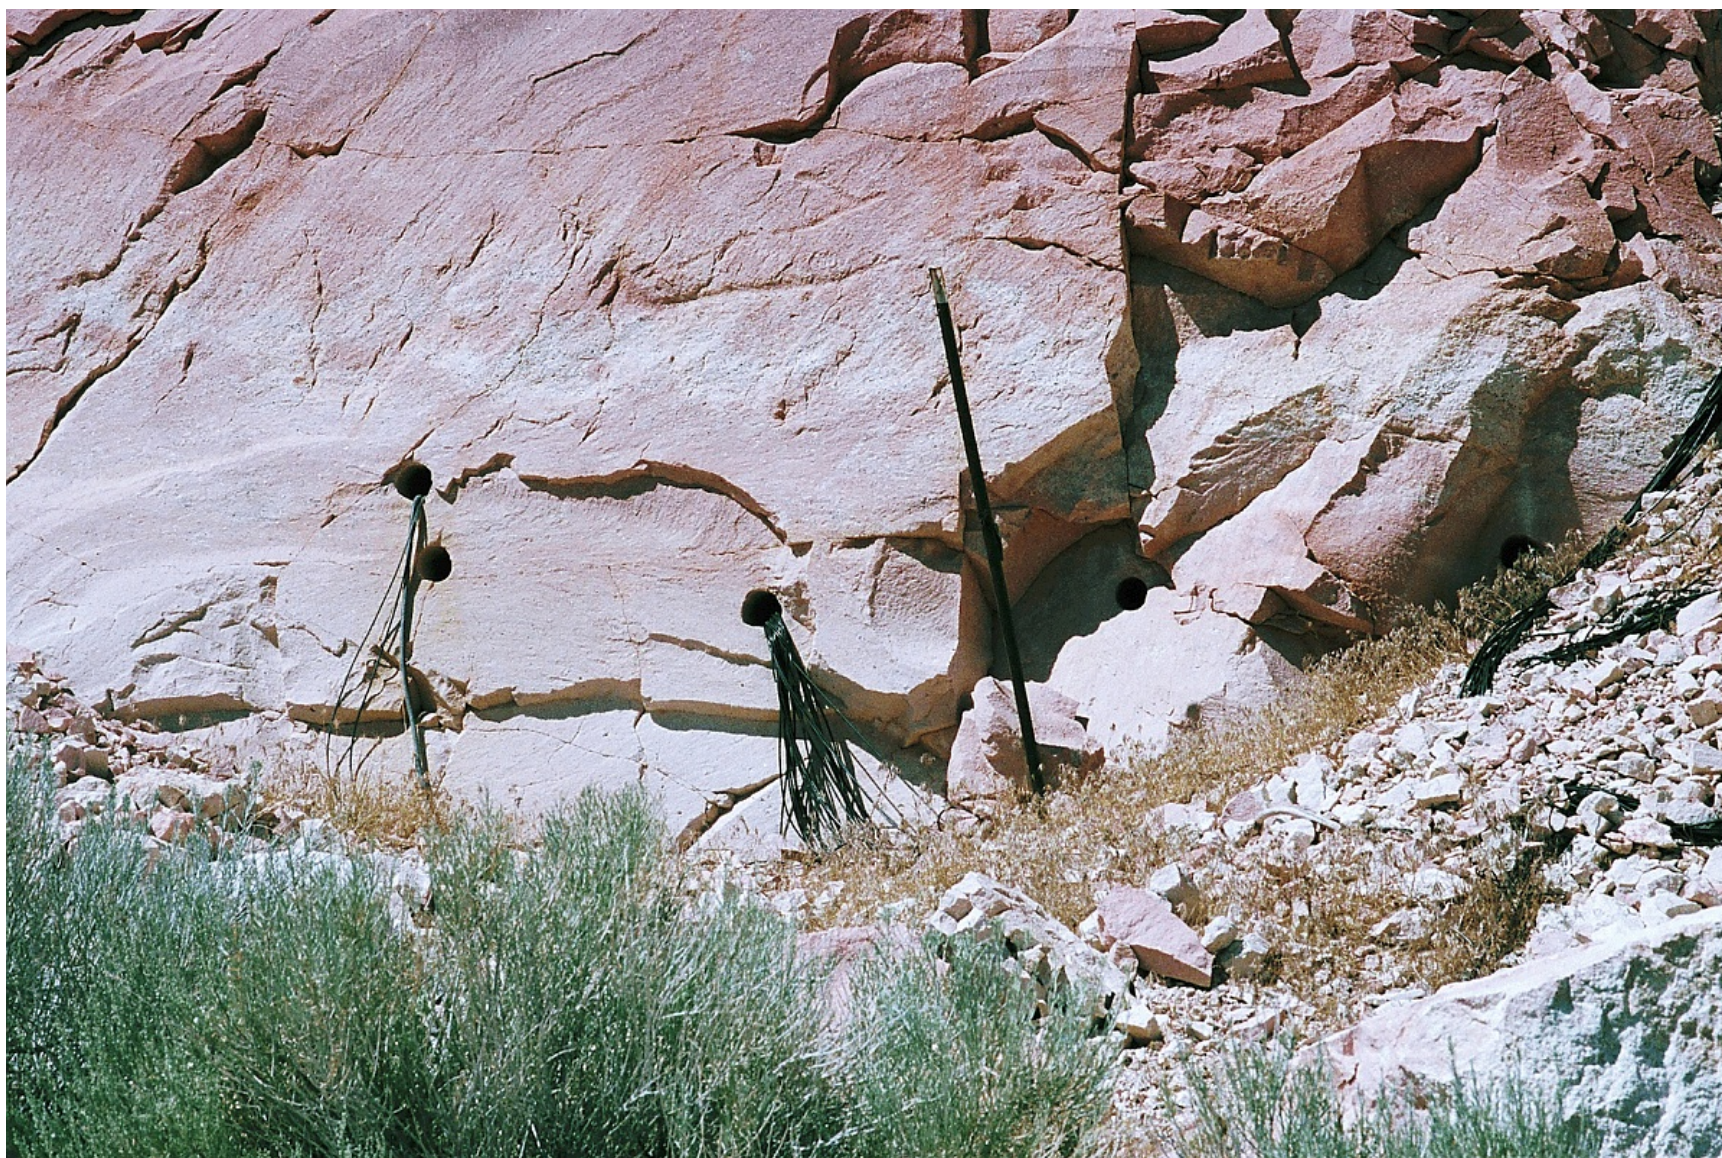
Feature 23 is four holes drilled horizontally into the rock face of Shoshone Mountain at UTM coordinate 571623 E, 4096331 N (Figures 39 and 66). The holes are 8.89 cm (3.5 inch) in diameter and provide cable access into a drift off of the U16a tunnel. They were used during the Divine Kingfisher 31 high explosives test in 2001. Associated artifacts include cable fragments, broken concrete, communication wire, and wood fragments.

Figure 66. U16a Tunnel Feature 23, cable holes, view southwest (2011).

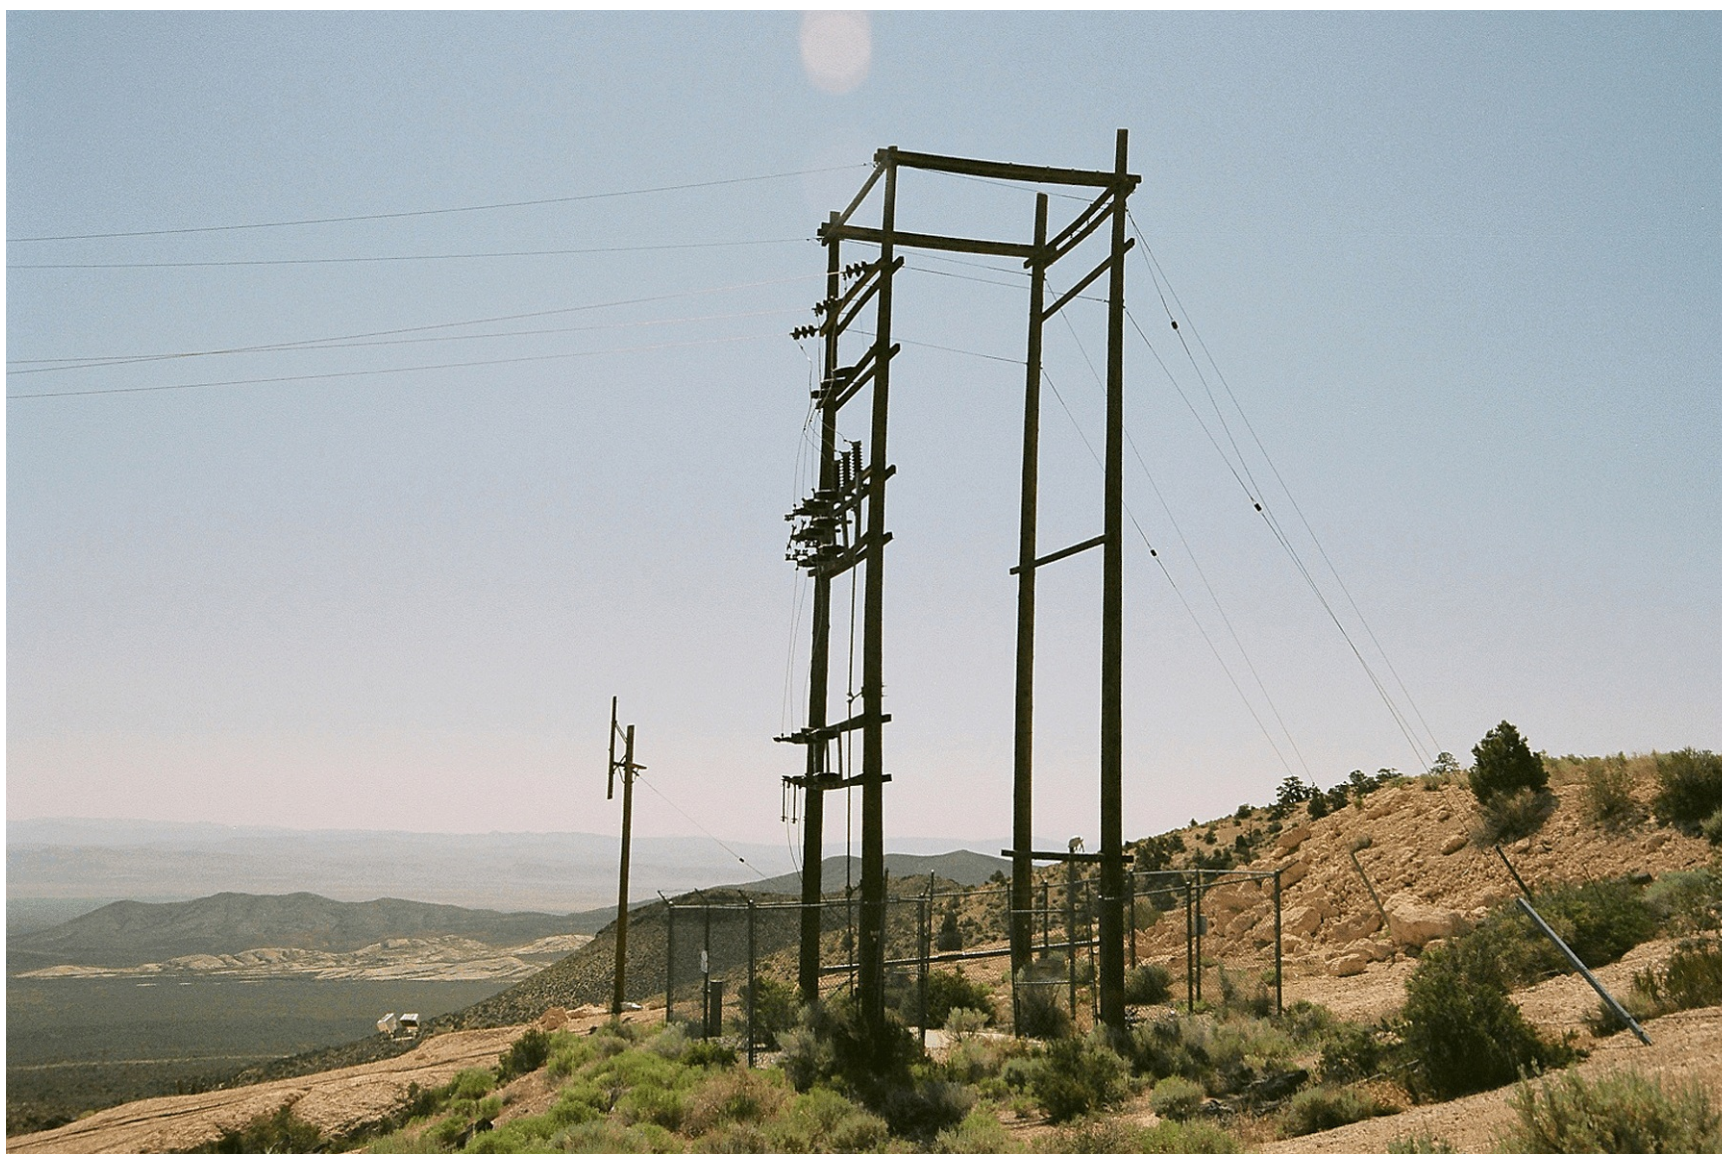
Feature 24 is an electrical transformer/substation at UTM coordinate 571575 E, 4096337 N and an elevation of 1,676 m (5,500 ft). The feature consists of a chain-link fence, a concrete pad, and four power poles (Figures 39 and 67). The fence is 6.1 m east-west by 9.45 m (31 ft) north-south and 2.44 m in height. Three strands of barbed wire are attached to the top of the fence. Two 1.52 m wide gates on the west side provided access into the fenced area. The concrete pad is 3.66 x 3.66 m. The four

Figure 67. U16a Tunnel Feature 24, electrical substation, view southeast (2011).

power poles are approximately 30.5 cm in diameter and are near the four corners of the concrete pad. The four poles are connected at the top with wood braces. Fuses (cut outs) are on wood braces between the northern poles. Associated artifacts are broken ceramic insulators, wire, and wood.

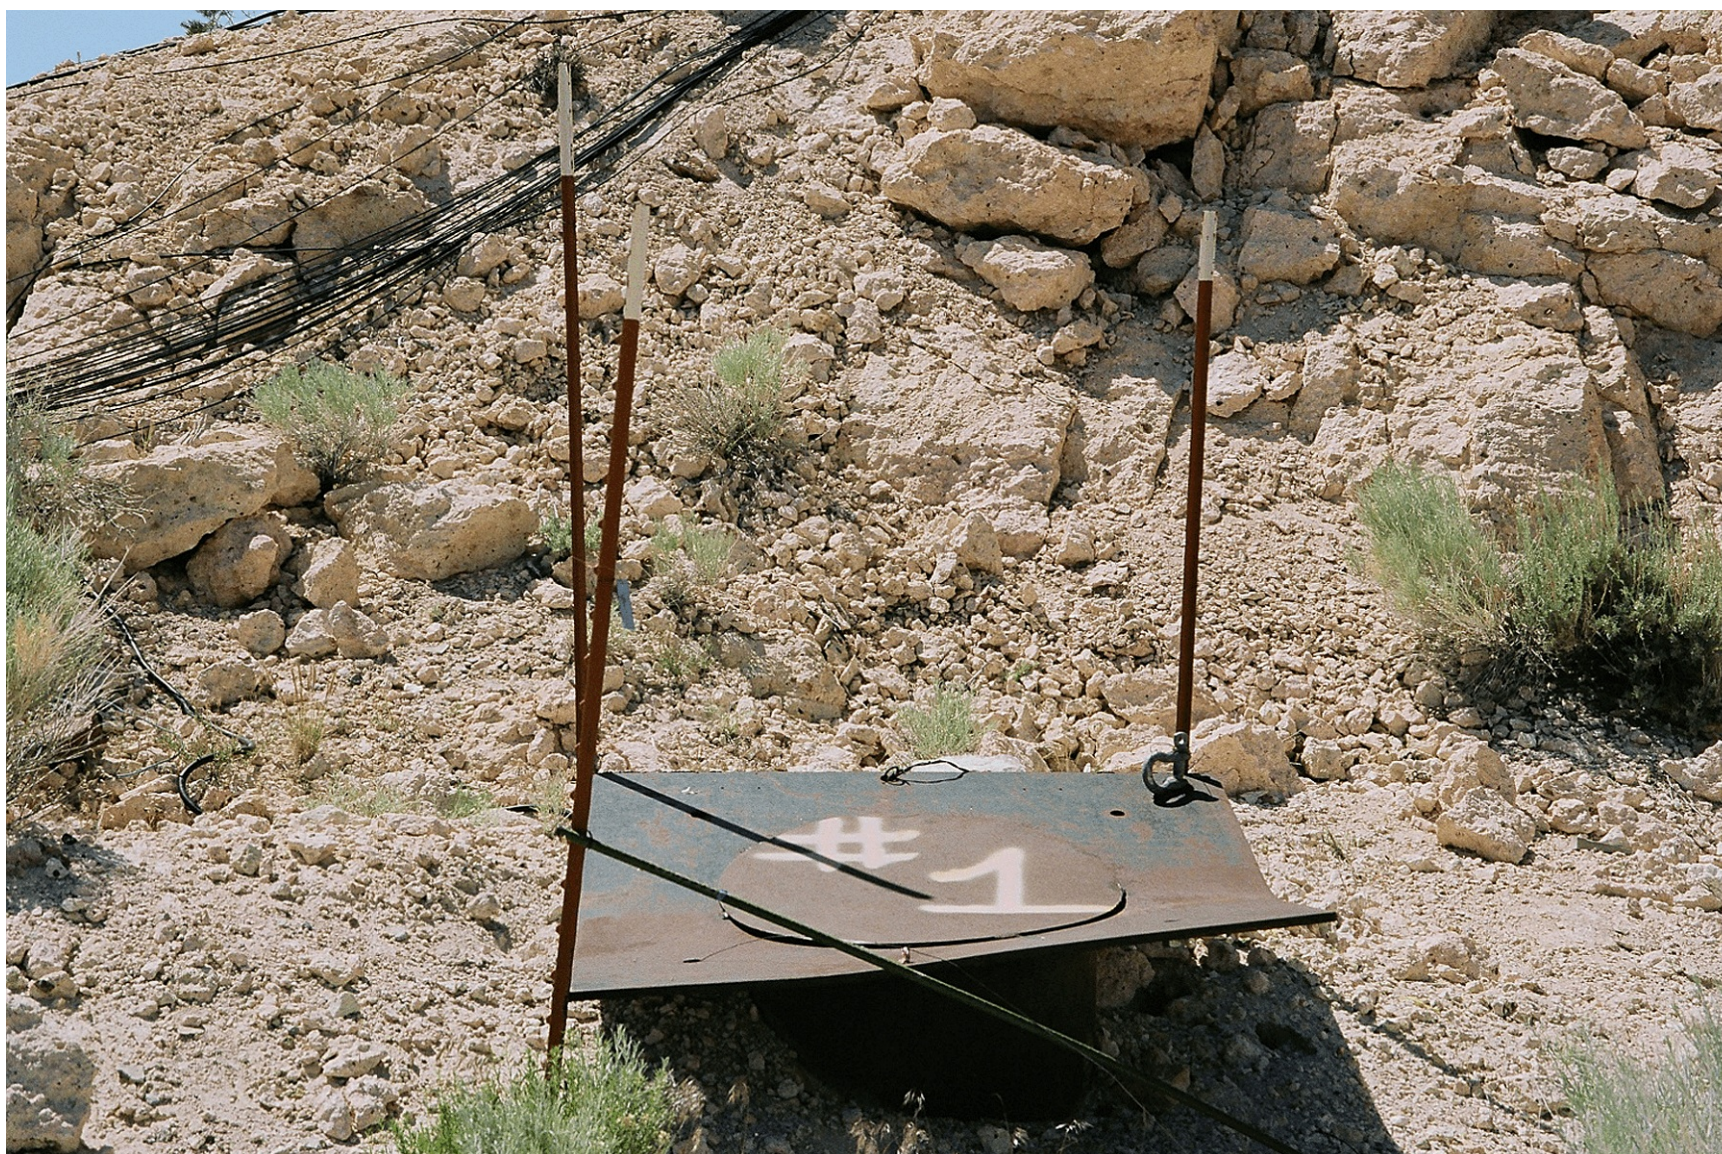
Feature 29 is a piece of 71.12 cm diameter pipe and metal T posts at UTM coordinate 571590 E, 4096280 N and an elevation of 1,686 m (5,540 ft). It extends 30.48 cm above the surface and has a 1.22 x 1.22 m sheet of 1.27 cm (1/2 inch) thick steel plate welded to the open end of the pipe (Figures 39 and 72). A #1 is painted on top of the plate and a D shackle is welded to the southwest corner of the plate. The metal T posts are near the southwest, southeast, and northeast corners of the metal plate. The pipe was used during the later high explosives testing. Features 29, 30, and 31 are on a small dirt pad that was the location for water tanks, a compressor, diesel storage tanks, and a generator in 1962 (see Figure 61).

Figure 72. U16a Tunnel Feature 29, pipe, view south (2011).

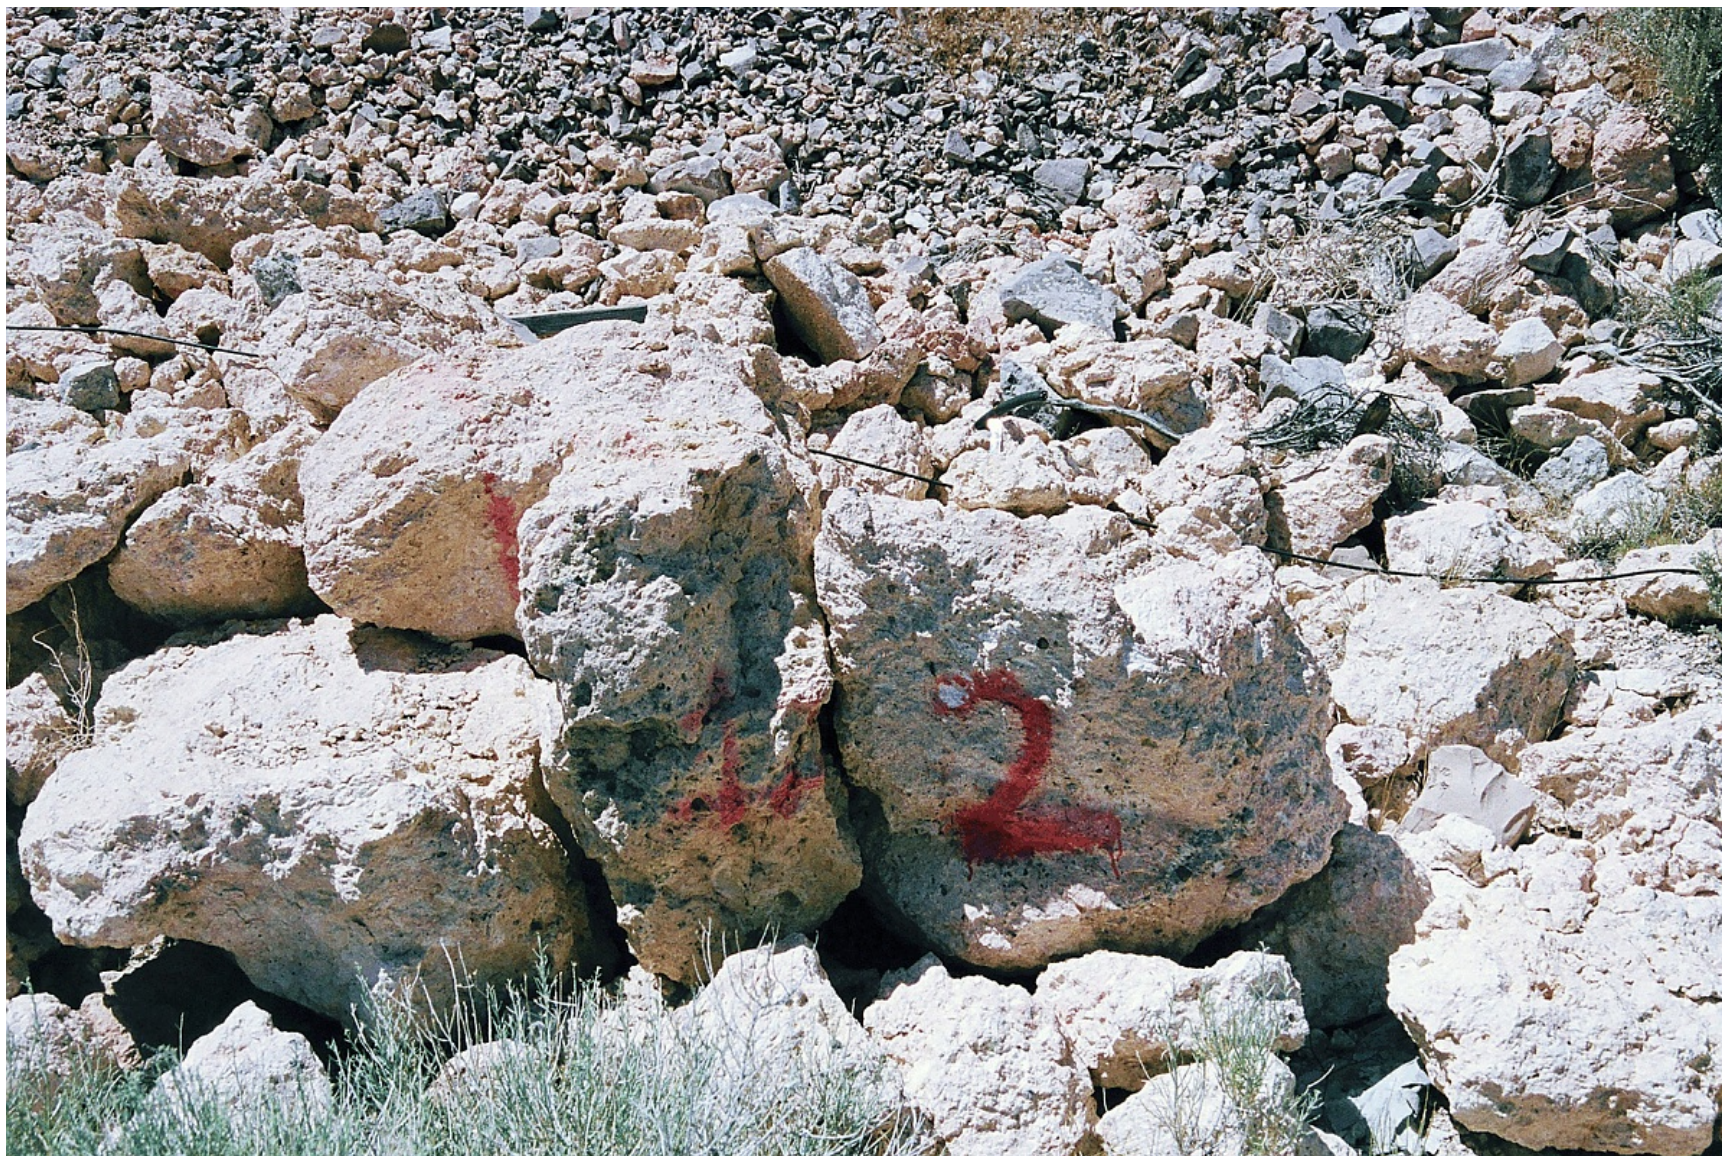
Feature 31 is a painted boulder and insulated cable fragments at UTM coordinate 571572 E, 4096283 N and an elevation of 1,691 m (Figures 39 and 74). The boulder is part of loose debris (boulders, rocks, etc.) from the adjoining slope. One broken boulder has #2 is painted on one side. The cable is fragments that are 1.9 cm (3/4 inch) in diameter and partially hidden in the debris. Associated artifacts are insulated wire, shrapnel, and wood.

Figure 74. U16a Tunnel Feature 31, painted boulder and insulated cable fragments, view southwest (2011).
