## DESCRIPTION OF U16a TUNNEL CULTURAL FEATURES

### FEATURE DESCRIPTIONS

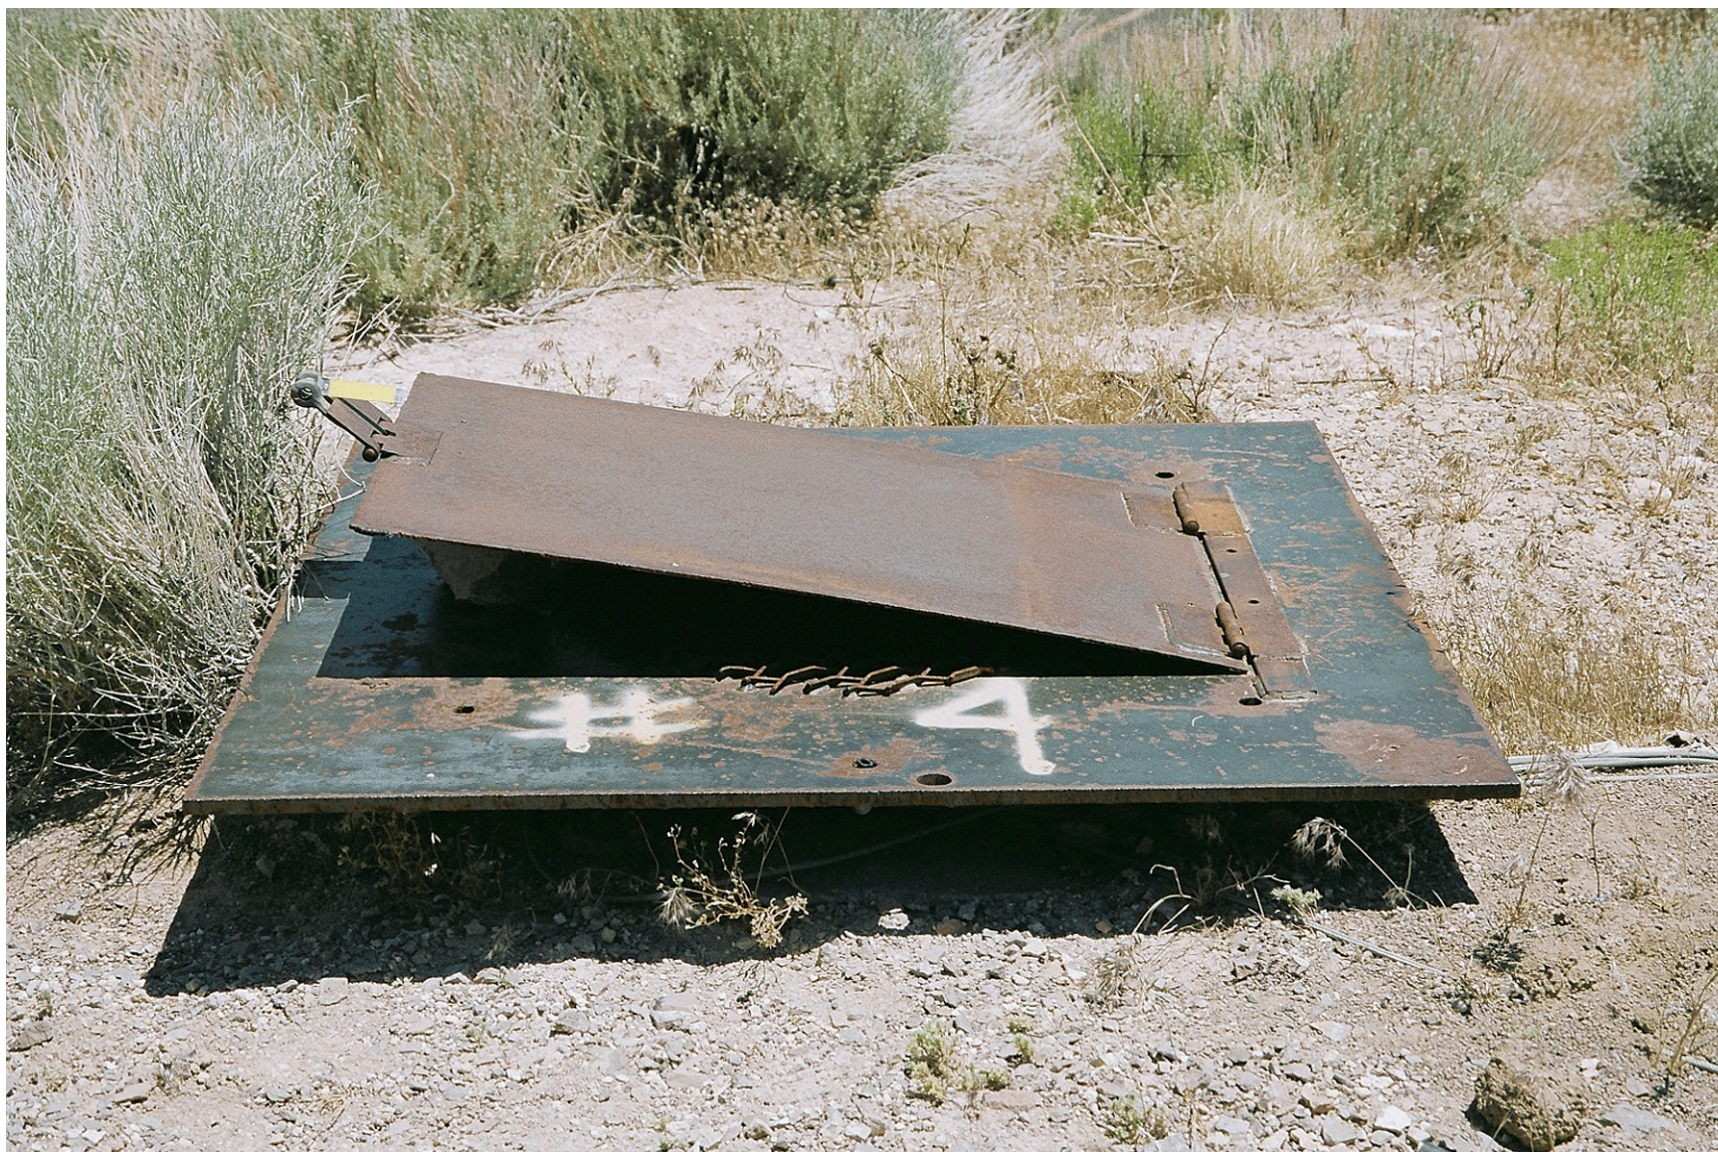
Feature 34 is a vertical pipe extending from the subsurface at UTM coordinate 571547 E, 4096247 N and an elevation of 1,670 m (5,480 ft) (Figures 39 and 77). The pipe is 60.1 cm diameter and extends 15.24 cm above the surface. The end is sealed with expanded metal welded to the inside of the pipe. A 1.22 x 1.22 m metal plate that is 1.27 cm thick with a #4 painted on the top is welded to

Figure 77. U16a Tunnel Feature 34, pipe, view northeast (2011).

the end of the pipe. Access through the plate is by a 91.44 x 61 cm hinged metal door. The casing was used during high explosives testing.

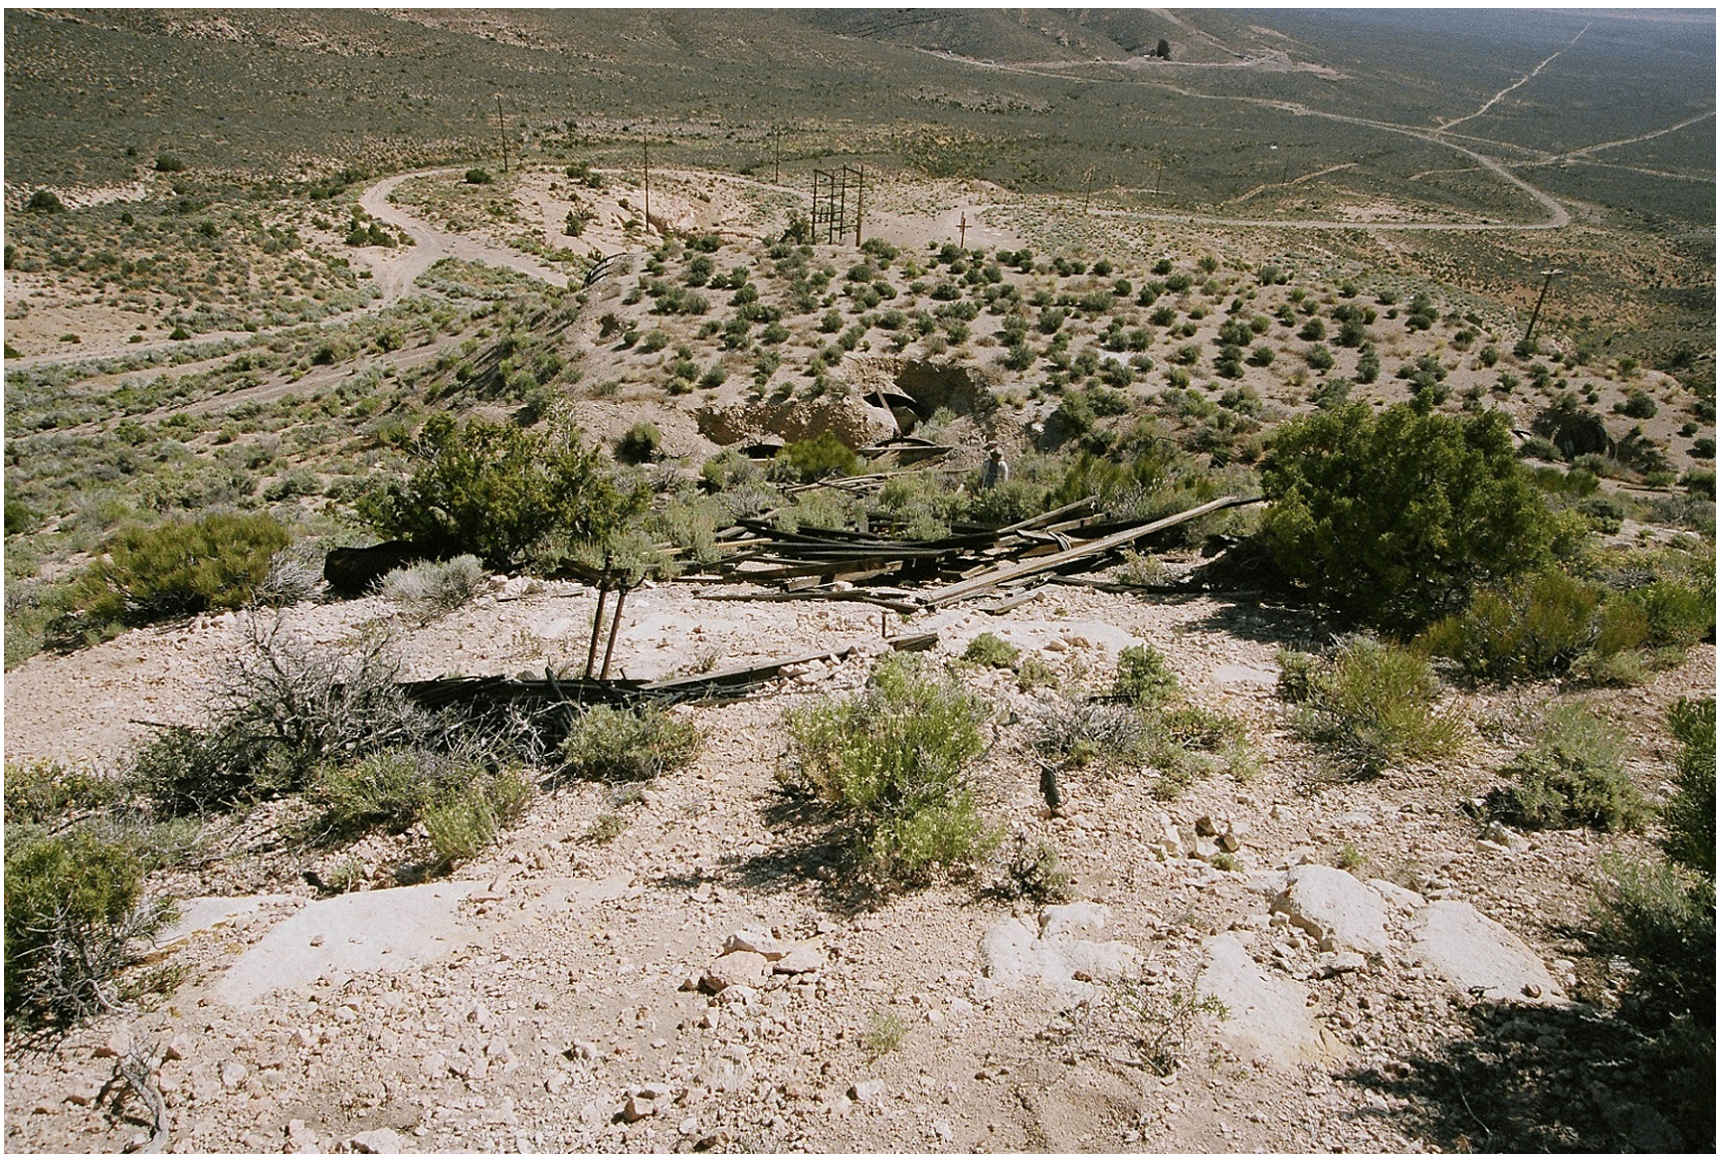
Feature 38 is a cable hole, cable trough, and pipe at UTM coordinate 571496 E, 4096204 N and an elevation of 1,719 m (5,640 ft) (Figure 82). This is the U16a CH#3 cable hole that is 150.6 m (494 ft) in depth. According to Bennett (1991), the cable hole was drilled from the tunnel to the surface. No casing was installed in the bedrock and the area around the cable hole is covered with rocks and boulders obscuring its exact location. Insulated cable extends from the rock rubble in the area of the cable hole, along the surface, and is within the remains of the cable trough. The cable trough extends approximately 22 m (72 ft) from the north trailer emplacement at the trailer park to the area near the cable hole. The cable trough is highly deteriorated and collapsed. The trough was constructed of 2 x 4, 2 x 12, 4 x 4 and 4 x 6 inch milled lumber similar to the one shown on engineering drawing JS-016-U16a-S7.1 (Figure 83). The area around the cable trough is unstable and large areas have collapsed into the covered trailer locations. Three pieces of 2.54 cm pipe extend 1 m above the surface. Each pipe has a 2.54 cm valve on the end and grout has hardened in the end of the valves. This is one of the locations where grout was injected into the bedrock in an attempt to seal cracks.

Figure 82. U16a Tunnel Feature 38, cable trough, view northeast (2011).

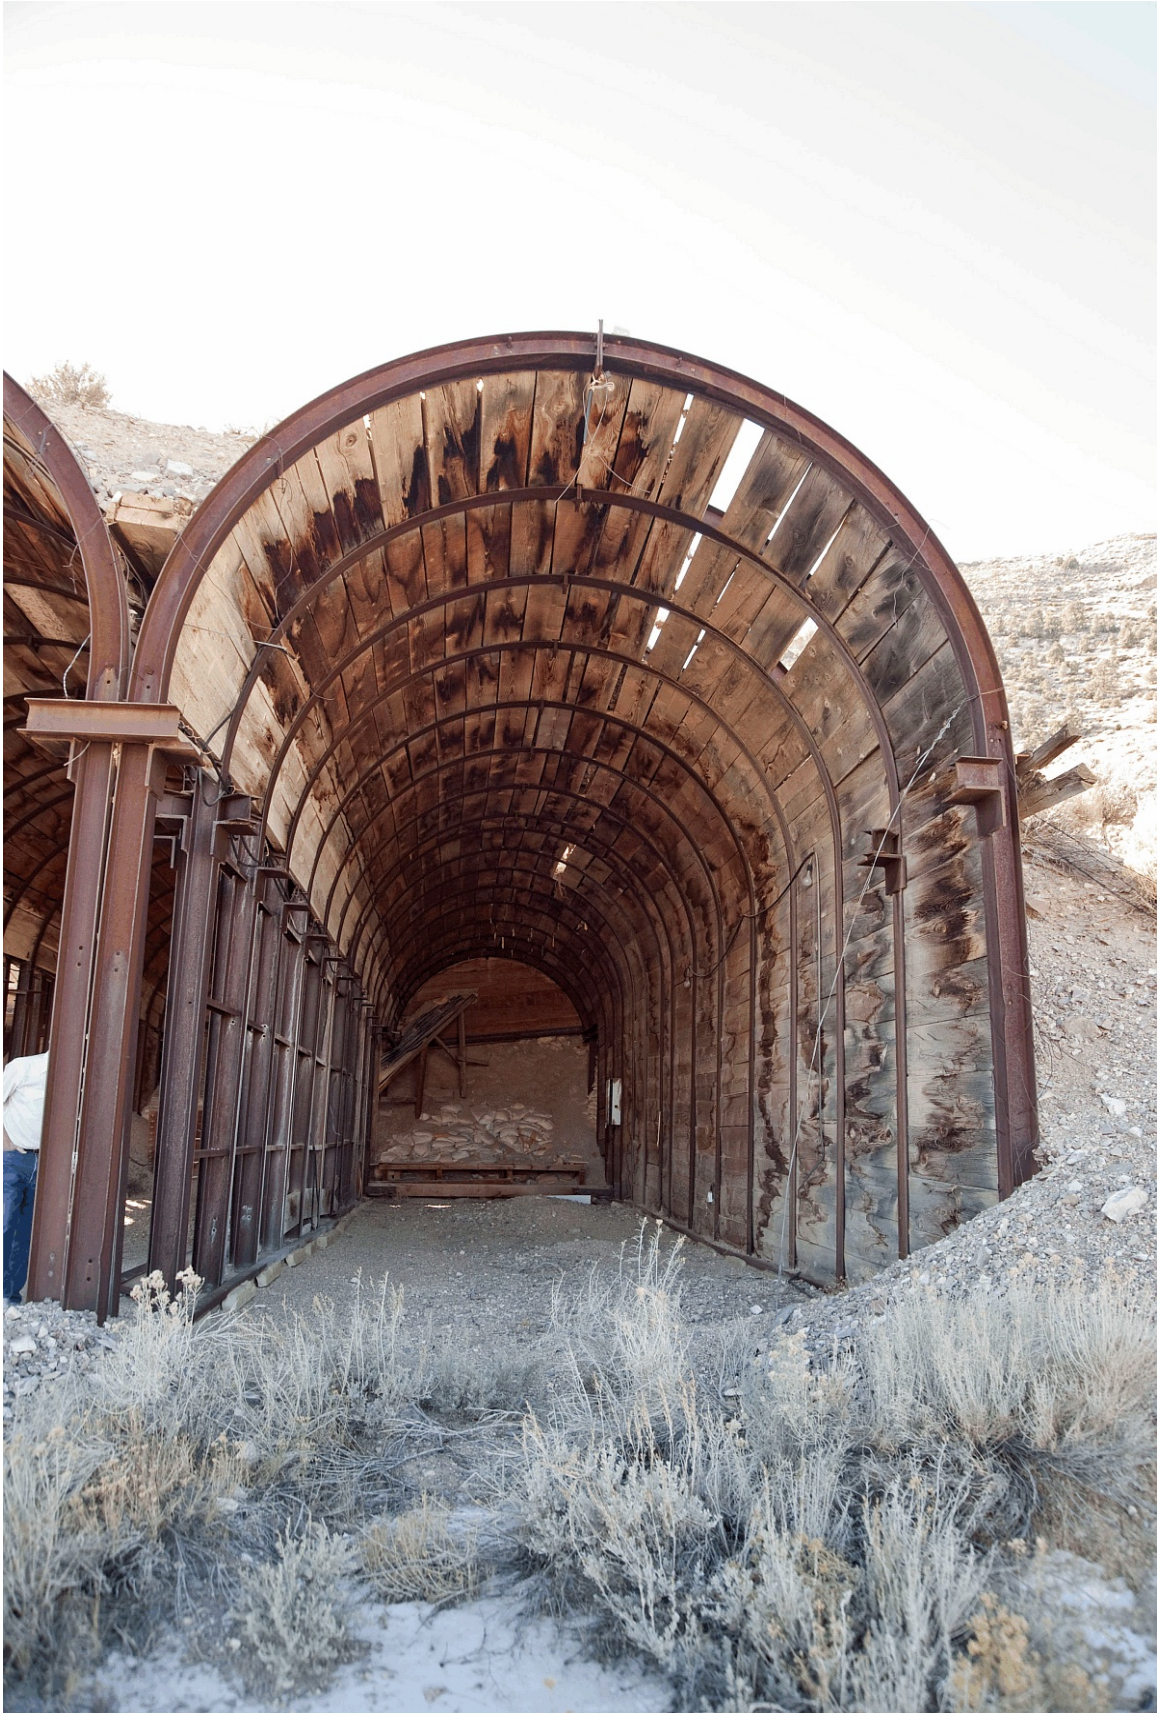
Structure 1 is constructed similar to the description above (Figure 85). The lagging between the sets on the west wall extends from the surface, over the top of the structure (arch), and ends at 3.05 m above the surface on the east wall. The exposed vertical members of the sets on the east wall are not lagged but braced with horizontal pieces of 10.16 cm angle iron spaced every 0.91 m vertically to prevent racking. On the east wall at 2.7 m above the surface, 20.32 cm angle iron plates are welded to each set. Electrical wires and incandescent lighting are attached to the bottom piece of lagging on the east wall and at approximately 2.74 m on the west wall. Two 76.2 x 50.8 x 17.8 cm electrical panel boxes are attached to the west wall 1 m above the surface and a third panel box is lying on the surface. The arched west end of the structure has been lagged from the top of the sets down to 3.05 m above the surface. At this point, exposed bedrock covered with sand bags closes the south end of the structure. At the west end of the structure along the bedrock and sand bags is a wood platform 1.22 m in width. It extends the width of the structure, through the east wall, and into Structure 2.

Figure 85. U16a Tunnel Feature 39 Structure 1, view southwest (2011).

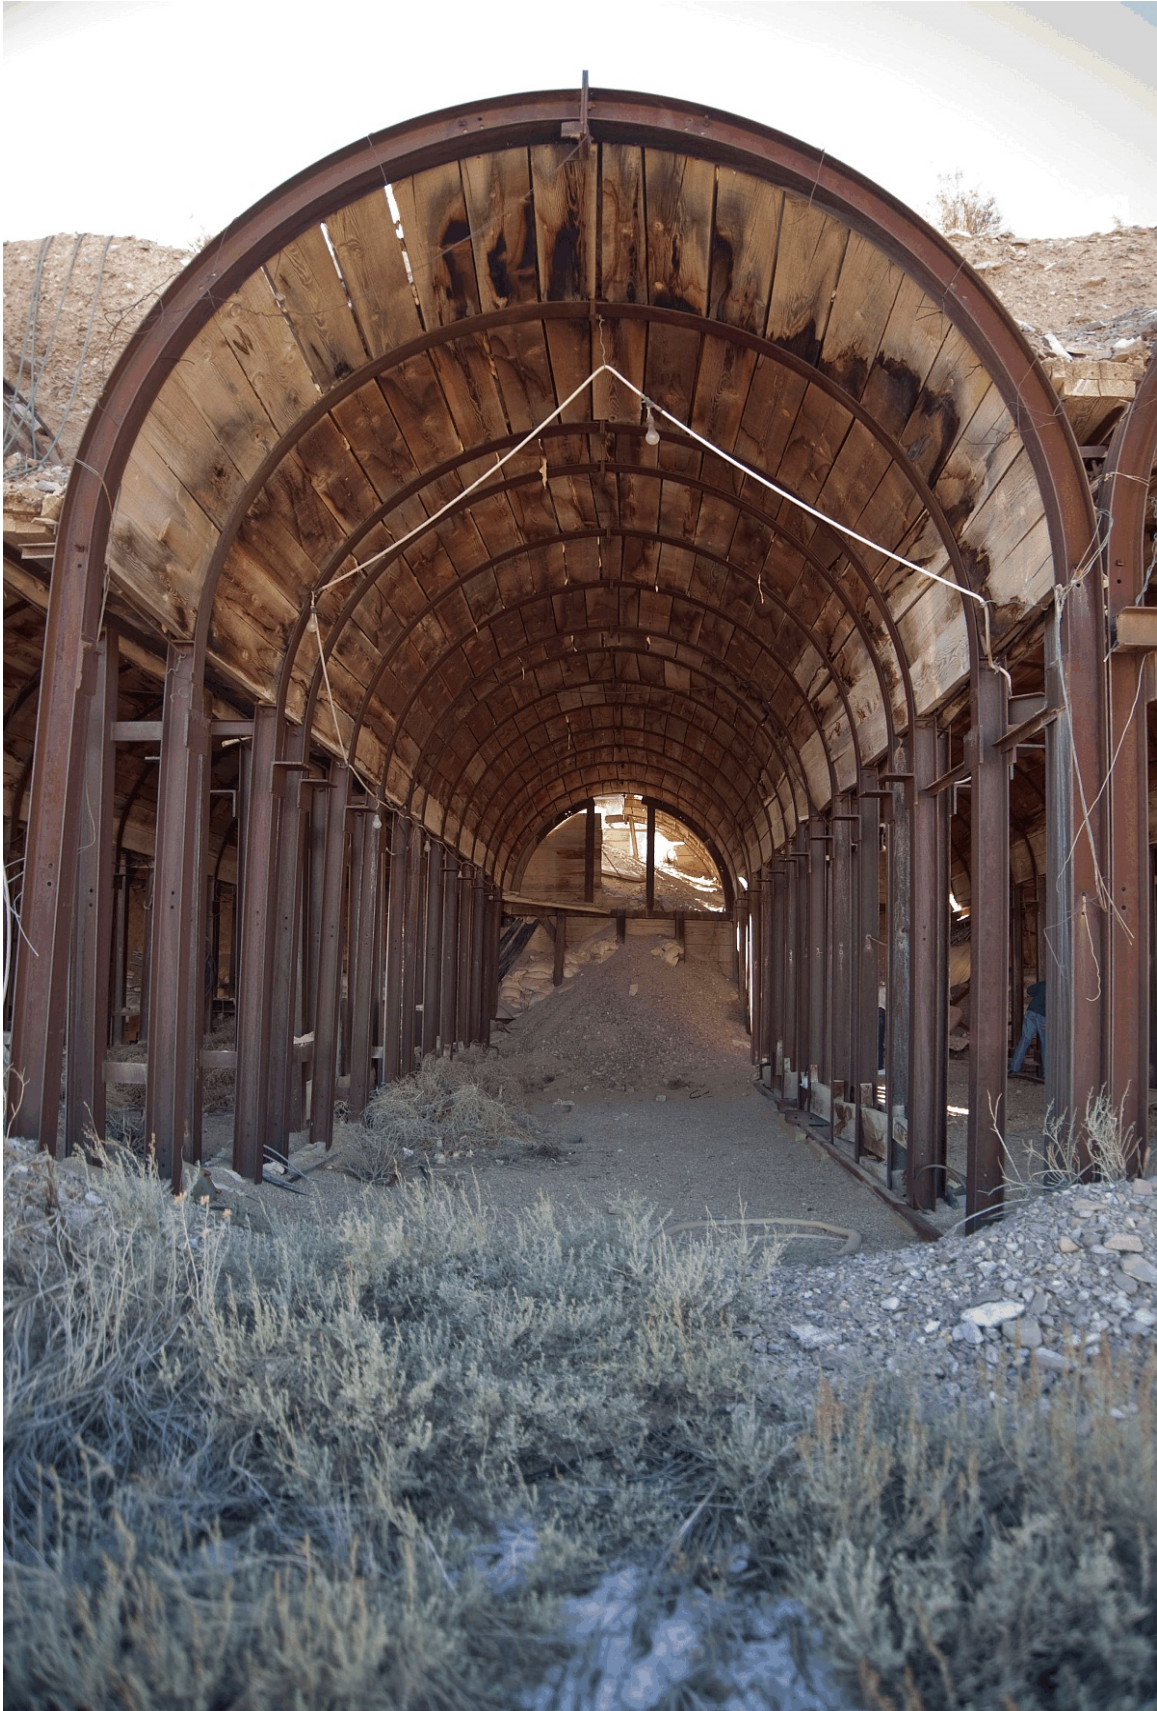
Structure 3 is similar in size and construction to the previous structures (Figure 87). The west wall of Structure 3 abuts the east wall of Structure 2 (no space between) and the north ends are plumb east-west. The west and east walls contain no lagging from the surface up to 3.05 m. The south end of the structure was constructed similar to the previous ones with lagging down to exposed bedrock. In addition to the end wall, a second wall was constructed at 3.7 m from the south end (fourth set). The bottom wall is constructed in two sections. The bottom section consists of three vertical I beams, spaced at 3 ft intervals, that extend from the surface up to 3.05 m. A horizontal I beam (header) was placed across the top vertical pieces. The top section consists of two I beams placed vertically on top of the horizontal I beam and extending to the arch of the fourth set. On the bottom section, wood lagging was placed between the vertical I beams and sand bags were placed on the east side of the wall. At least one half of the lagging in the arched section of the second wall has been removed or was never installed. Also, the south section of the roof between the south and second wall is missing as is most of the back wall lagging. This has allowed soil from the outside to slough off into the structure and cover all of the space between the south wall and the second wall and the sand bags and wood platform along the second walls lower section. Insulated cables enter the second wall below the horizontal I beam at the west end. The modification to the south end of the structure may have been due to the drilling of the U16a CH#6 cable hole that is located directly behind Structure 3 and the insulated cables may be from this cable hole.

Figure 87. U16a Tunnel Feature 39 Structure 3, view southwest (2011).

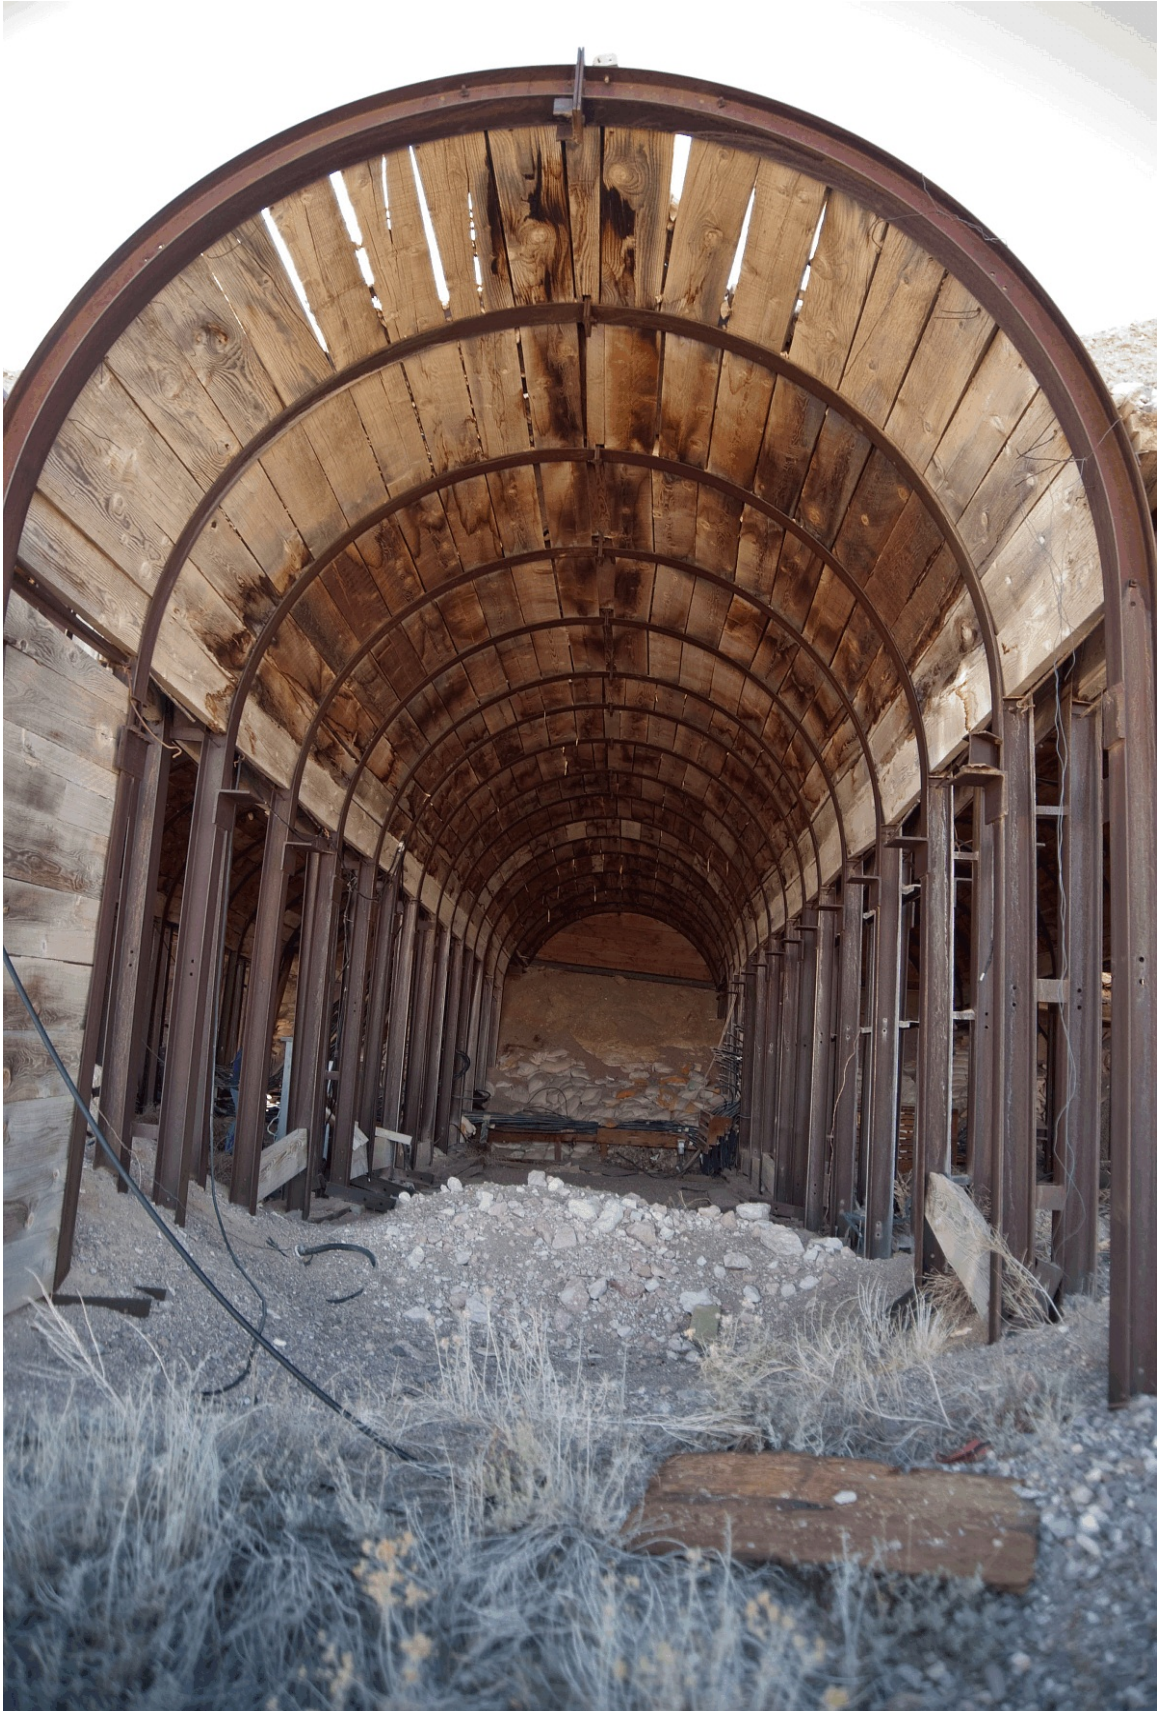
Structure 5 is similar in size and construction to the previous structures (Figure 89). The west wall of Structure 5 is offset 16.51 cm from the east wall Structure 4 and the north ends are plumb east-west. The west and east walls contain no lagging from the surface up to 3.05 m. The south end of the structure was constructed similar to the previous ones with lagging down to exposed bedrock. Sand bags have been placed on the exposed bedrock at the south end. The wood platform found in the previous structures extends along the south end between the west and east walls. Approximately 100 insulated cables extend through the west wall from Structure 4, along the wood platform, and exit through the east wall into Structure 6. Approximately 40 cables from the wood platform have been ganged together, looped around a set in the west wall, and attached to a wood rack attached to the seventh set (from south). These were probably attached to the instrument trailer that has been removed from the structure. A large pile of soil has been placed inside the entrance of the structure.

Figure 89. U16a Tunnel Feature 39 Structure 5, view southwest (2011).

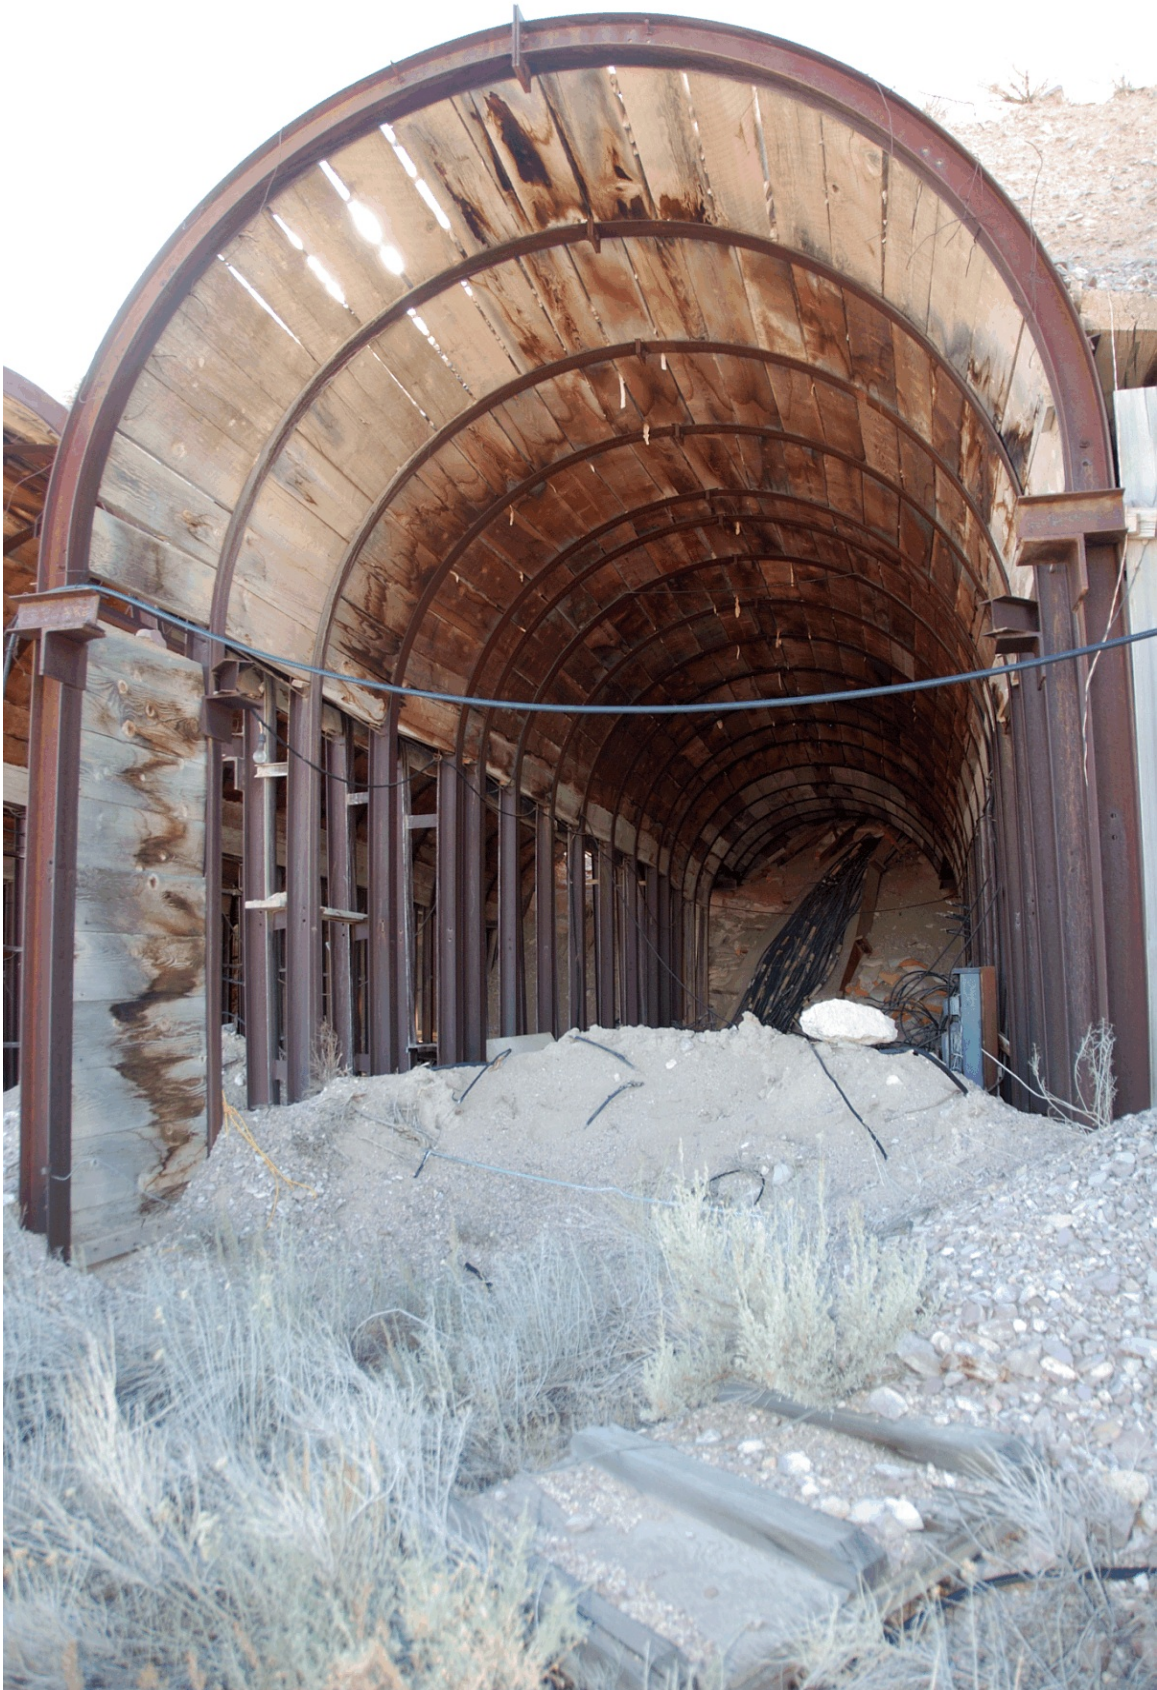
Structure 6 is similar in size and construction to the previous structures (Figure 90). The west wall of Structure 6 is offset 12.7 cm from the east wall of Structure 5 and the north end of Structure 6 is set back to the south 132.08 cm (52 inches) from the north end of Structure 5. The west and east walls contain no lagging from the surface up to 3.05 m. An electrical switch box is mounted to a 1.22 x 1.22 m plywood backboard on the west wall at set 6 (from north end). The switch box measures 99.06 x 50.8 x 20.32 cm (39 x 20 x 8 inches). A 1.83 x 1.38 m (72 x 55 inch) metal electrical panel backboard is mounted to the west wall between sets 7 and 8 (from north end). Attached to the backboard is one 60 amp, one 30 amp, and three 200 amp switch boxes. There are no angle iron plates welded to the sets as in the other structures. The south end of the structure was constructed similar to the previous ones with lagging down to exposed bedrock. Sand bags have been placed on the exposed bedrock at the south end. The wood platform found in the previous structures extends

Figure 90. U16a Tunnel Feature 39 Structure 6, view southwest (2011).

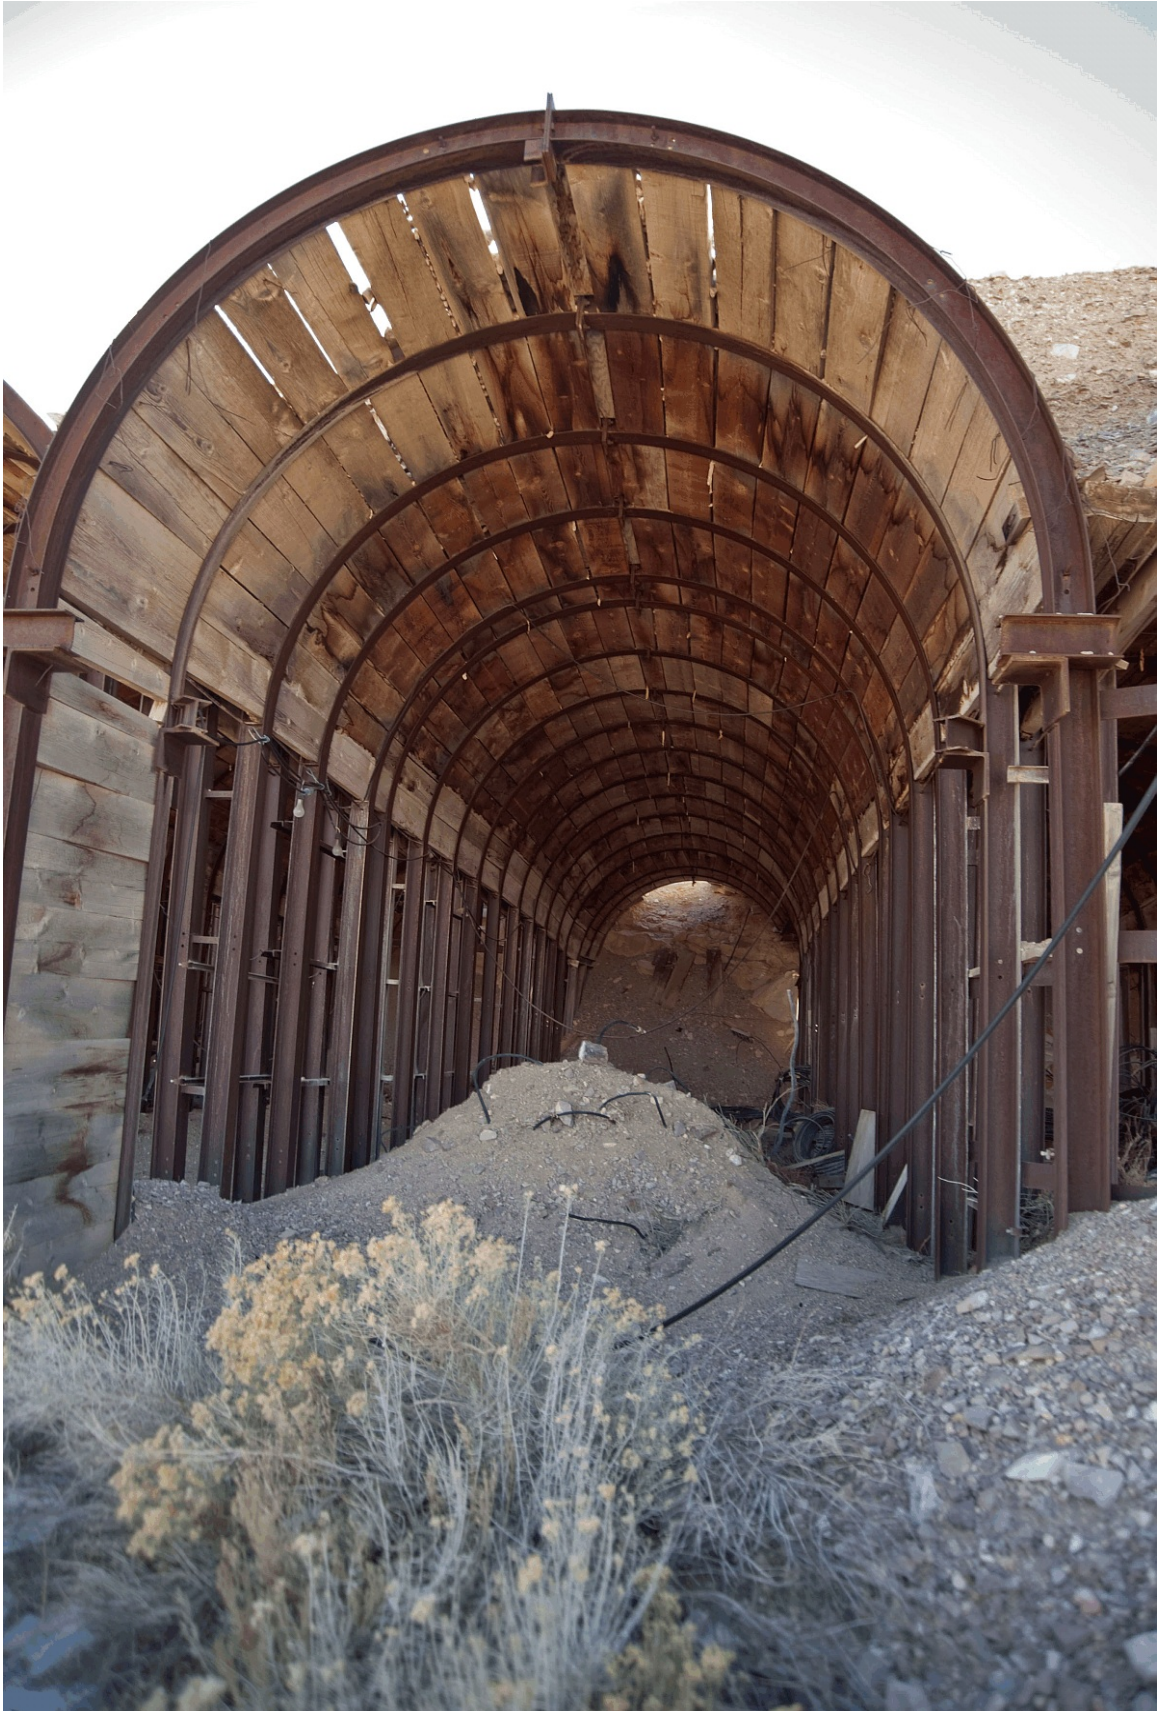
Structure 7 is similar in size and construction to the previous structures (Figure 91). The west wall of Structure 7 is offset 22.86 cm from the east wall of Structure 6 and the north end of Structure 7 is set back to the south 1.52 m from the north end of Structure 6. The west and east walls contain no lagging from the surface up to 3.05 m. There are no angle iron plates welded to the sets. The wood platform found in the previous structures extends along the south end between the west and east walls and contains approximately 30 cables. The roof at the south end has collapsed on the west side between the first two sets and the arched end section is missing. Rocks and soil have sloughed onto the wood platform. A large pile of soil has been placed inside the entrance of the structure.

Figure 91. U16a Tunnel Feature 39 Structure 7, view southwest (2011).

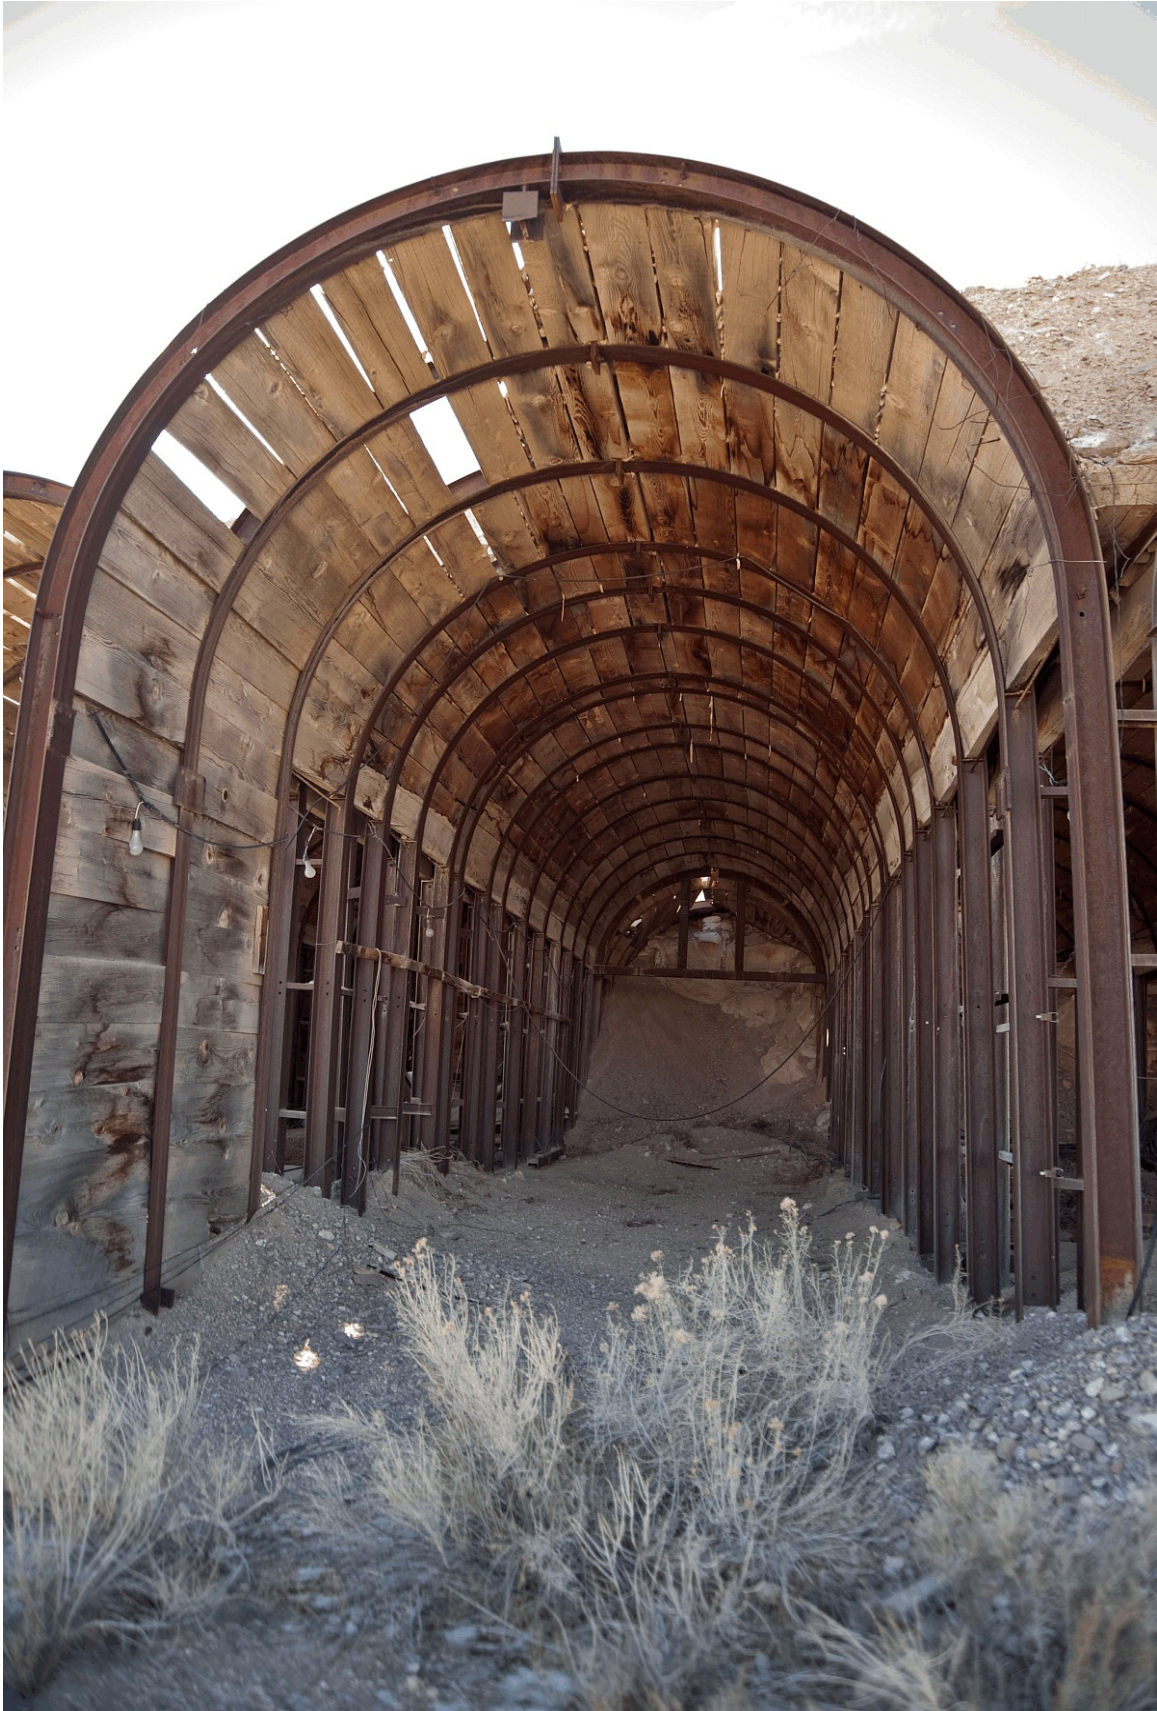
Structure 8 is similar in size and construction to the previous structures (Figure 92). The west wall of Structure 8 is offset 17.78 cm from the east wall of Structure 7 and the north end of Structure 8 is set back to the south 1.22 m from the north end of Structure 7. The west and east walls contain no lagging from the surface up to 3.05 m. There are no angle iron plates welded to the sets. The wood platform found in the previous structures that extends along the south end between the west and east walls is not visible as rocks and soil have sloughed off of the roof and covers the bedrock, sandbags, and platform. This is due to missing lagging on the west side of the arched section at the south end between sets 1 and 3. A horizontal I beam has been set at 30.5 m above the surface between the west and east walls at set 5 (from south). Two I beams were placed vertically on top of the horizontal I beam and extend to the top of the arched section (similar to Structure 3).

Figure 92. U16a Tunnel Feature 39 Structure 8, view southwest (2011).

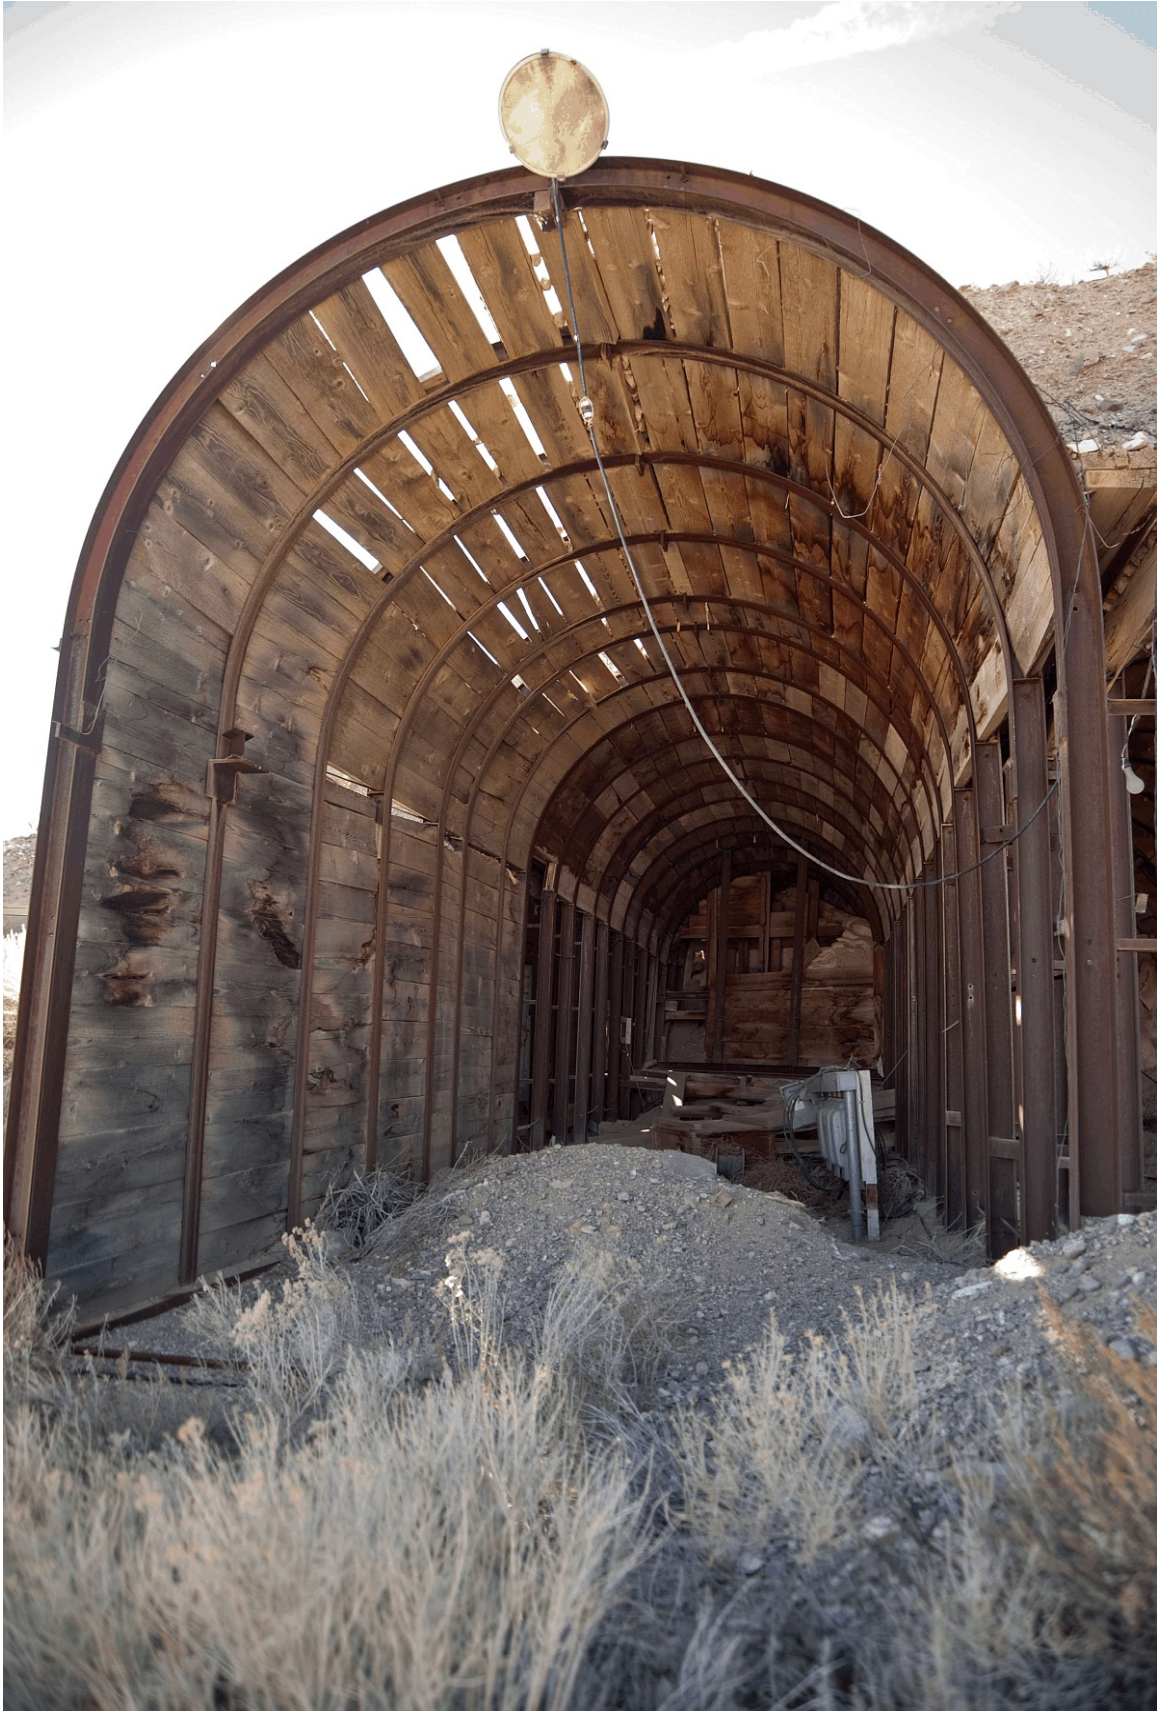
Structure 9 is similar in size and construction to the previous structures (Figure 93). The west wall of Structure 9 is offset 22.86 cm from the east wall of Structure 8 and the north end of Structure 9 is set back to the south 2.44 m from the north end of Structure 8. The west and east walls contain no lagging from the surface up to 3.05 m. A 3.35 x 1.42 m electrical panel backboard is near the west wall between sets 6 and 9 (from north). Attached to the backboard are four 200 amp switch boxes, three 60 amp switch boxes, and one 100 amp switch box. At the south end, additional 6 x 8 inch milled lumber extends from the surface at set 2 on the east wall to set 3 on the west wall. This helps support the roof and acts as shoring to control the loose soil at the south end. A partial wall has been

Figure 93. U16a Tunnel Feature 39 Structure 9, view southwest (2010).

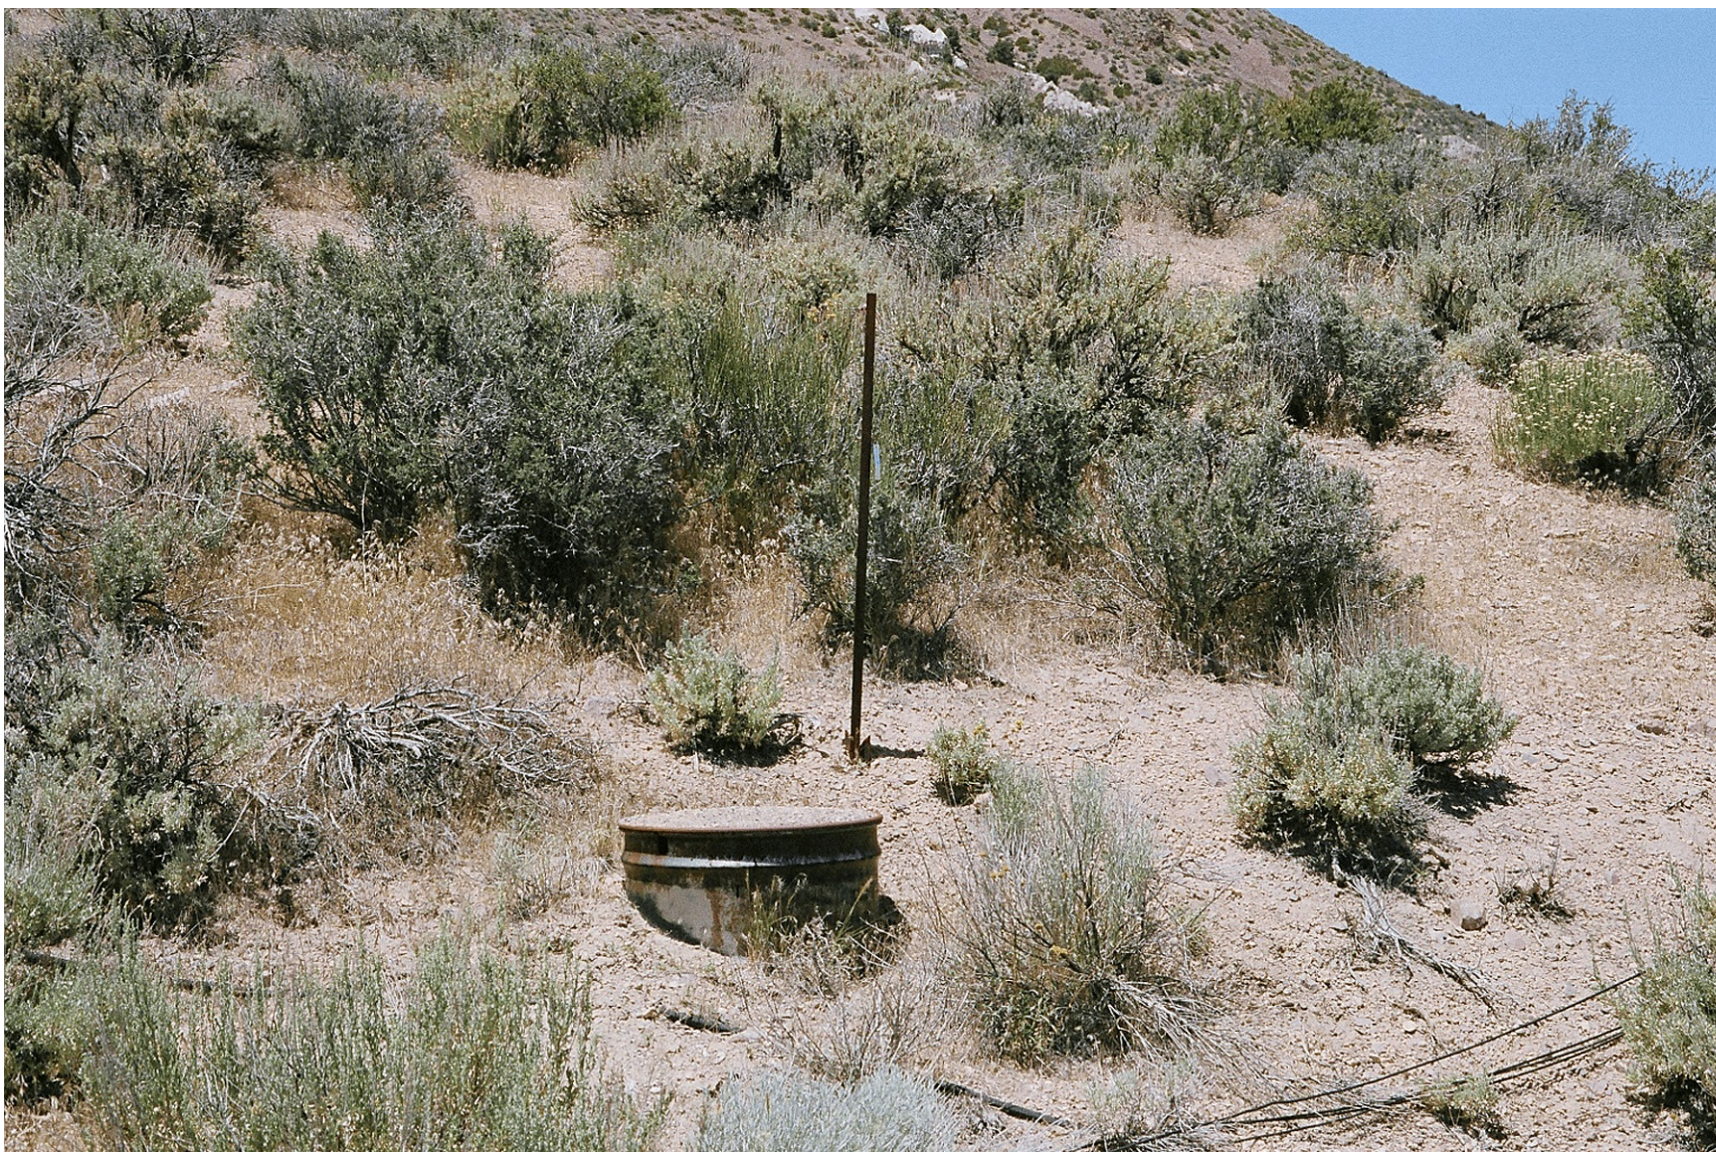
Feature 40 is a buried barrel at UTM coordinate 571512 E, 4096339 N and an elevation of 1,689 m. The barrel is 61 cm in diameter and extends 15.24 cm above the surface (Figures 39 and 97). The bottom of the barrel is filled with concrete leaving 61 cm of empty space in the barrel. The top of the barrel is sealed with a metal lid. A 1.07 m metal T post is along the northwest side of the barrel. Associated artifacts are communication wire and insulated cable.

Figure 97. U16a Tunnel Feature 40, barrel, view north (2011).
