## DESCRIPTION OF U16a TUNNEL CULTURAL FEATURES

### FEATURE DESCRIPTIONS

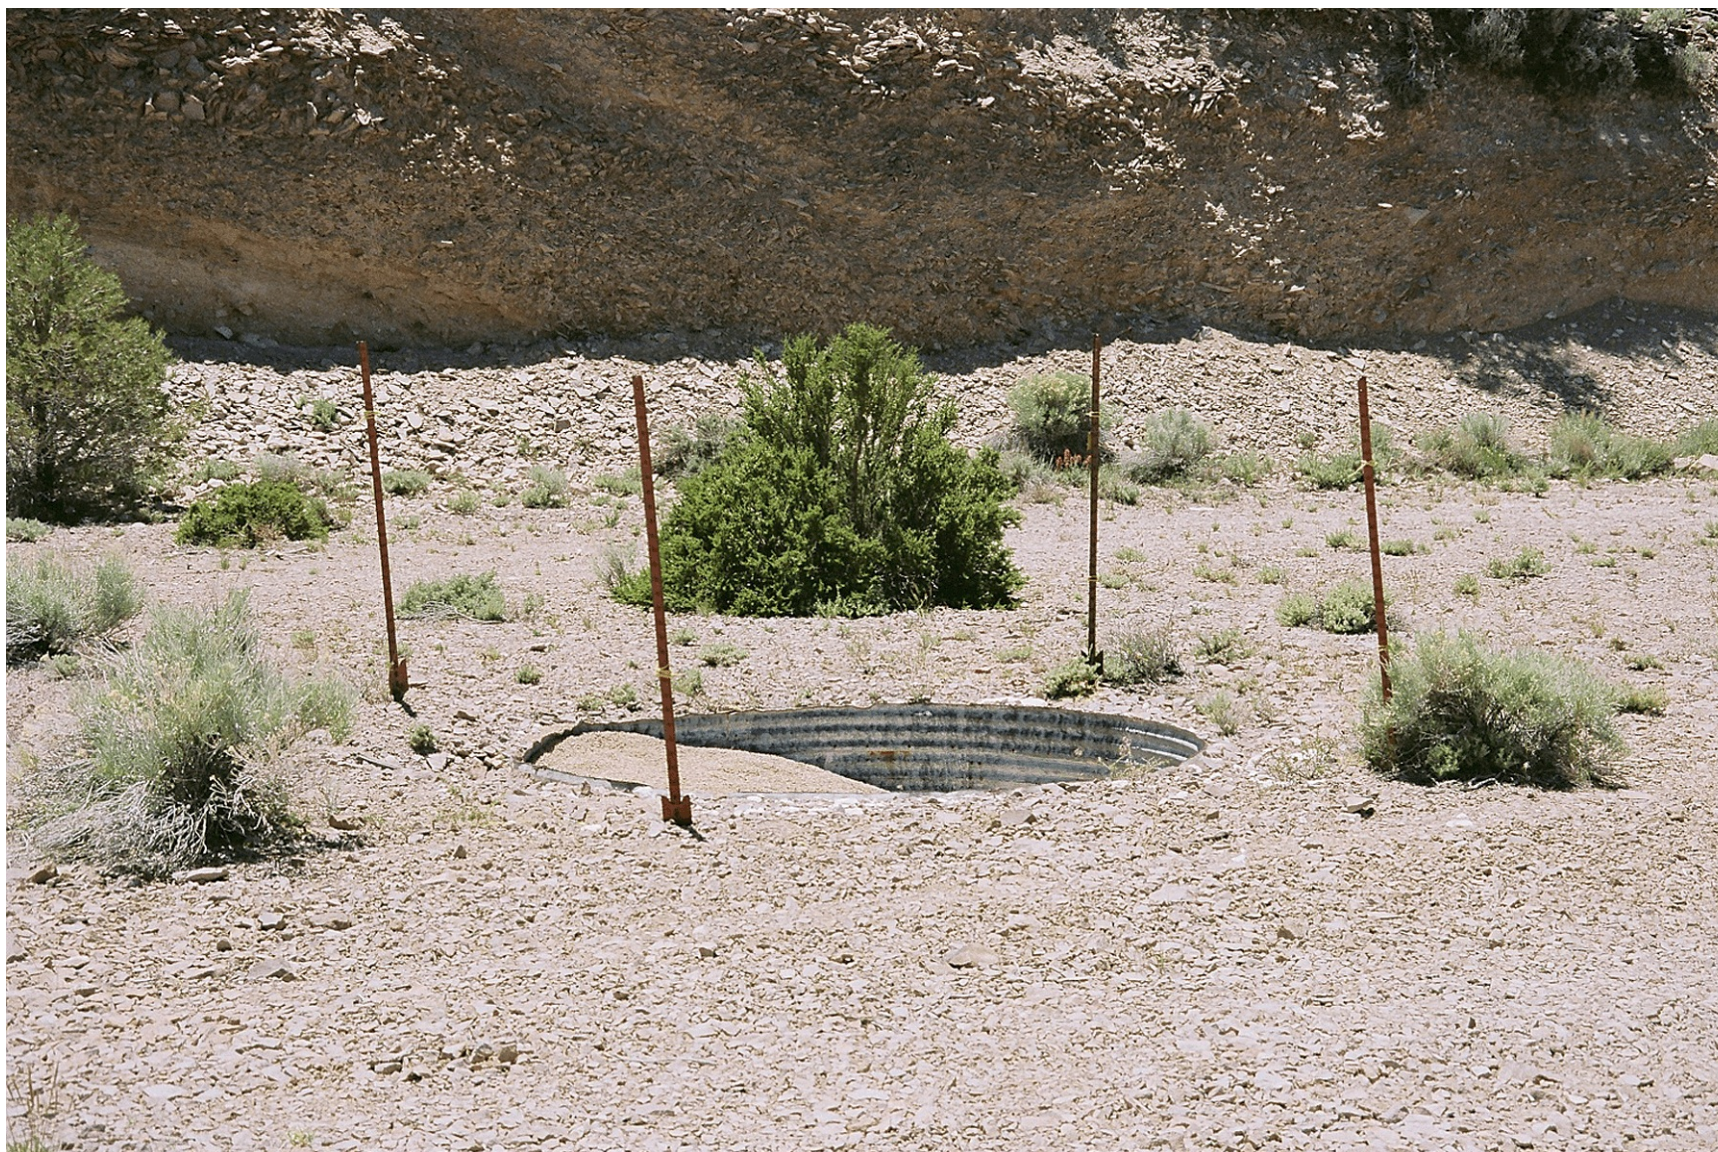
Feature 45 is the U16a.03 PS #1A and PS #1AS drill hole at UTM coordinate 570914 E, 4096115 N and an elevation of 1,951 m (6,402 ft). It consists of a 2.74 m diameter corrugated metal cellar filled with sand (Figures 39 and 1012). Four metal T posts form a rectangle around the metal cellar.

Figure 102. U16a Tunnel Feature 45, U16a.03 PS #1A and PS #1AS drill hole, view southeast (2011).

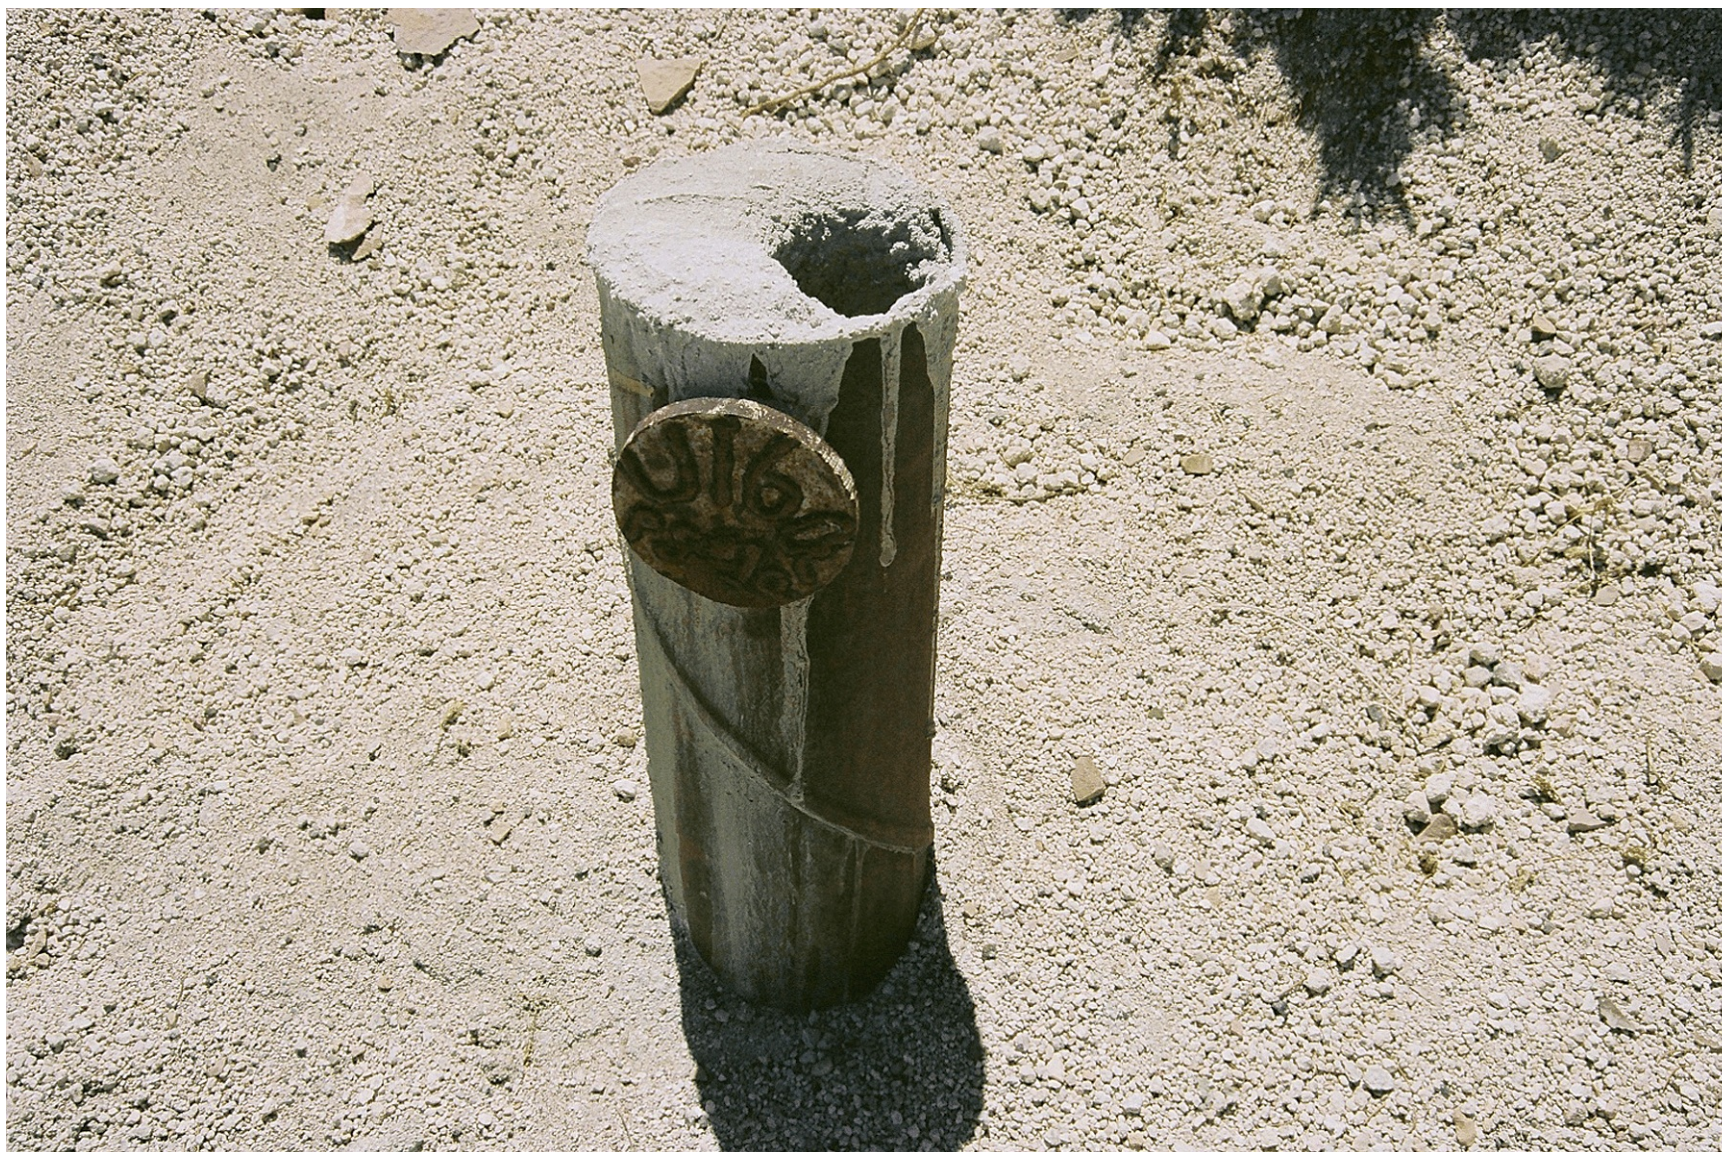
Feature 47 is the U16a PS#1 drill hole at UTM coordinate 571082 E, 4095978 N and an elevation of 1,962 m (6,437 ft). It consists of a 45.7 x 45.7 (18 x 18 inch) rectangular piece of rough poured concrete with a 22.86 cm diameter hole (Figures 39 and 104). The hole was for pipe that extended above the surface that has since been removed. The abandoned drill hole is approximately 2.4 m south of U16a #1 water sampling well.

Figure 104. U16a Tunnel Feature 47 U16a PS#1 drill hole, view southeast (2011).
