**STRESS CORROSION CRACKING OF AUSTENITIC STAINLESS STEEL
CORE INTERNAL WELDS***

H. M. Chung, J.-H. Park, W. E. Ruther, J. E. Sanecki, R. V. Strain, and N. J. Zaluzec
Argonne National Laboratory
Argonne, IL 60439, USA

March 1999

To be presented at Corrosion '99, April 25-30, 1999, San Antonio, Texas.

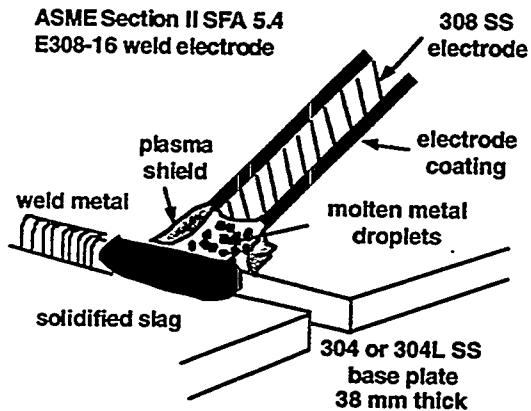
FIGURE 1:
Schematic illustration of shielded-metal-arc welding procedure.

To simulate the microstructure of a core shroud horizontal weld, mockup SMA welds were prepared from the steel plates described in Table 1. For comparison, GTA welds were also prepared from the same plates. The SMA procedure, which is shown schematically in Fig. 1, uses welding electrodes that are coated with a welding flux. In SA welding, a similar flux is used in powder form to cover the base-metal plate. Consequently, similar impurity contamination occurs in the weld and heat-affected zones (WZ and HAZ) in both types of welds. Vertical welds in a core shroud are usually welded by an SA procedure, whereas horizontal welds are prepared by an SMA procedure. Composition of the SMA welding electrodes, described in ASME Specification Section II SFA 5.4, "Specification for Stainless Steel Electrodes for Shielded Metal Arc Welding," is given in Table 3. The electrode consists of $\approx 60\%$ coating and $\approx 40\%$ Type 308 SS. Fluorine was contained in granules of fluorspar dispersed in the silicate binder. Fluorine content in the electrode coating, determined by separate chemical analysis, was $\approx 2.86 \text{ wt.\%}$, and analysis by SEM energy-dispersive spectroscopy confirmed the presence of CaF₂.³ Fluorspar is readily vaporized during welding and produces a plasma shield over the molten steel under the high voltage applied.

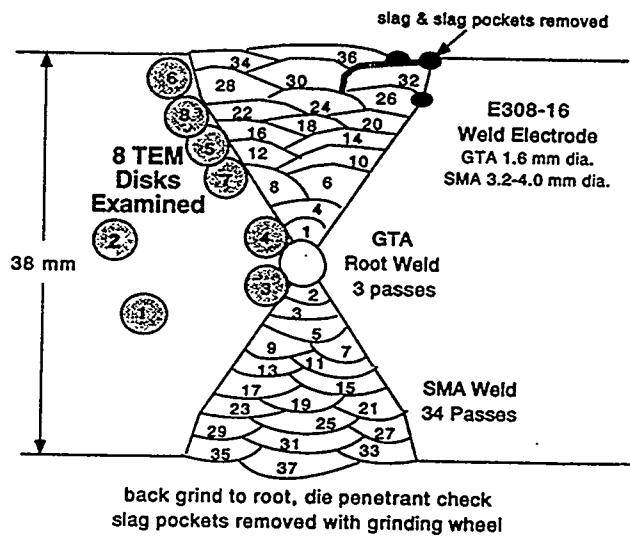
FIGURE 2:
Schematic diagram of weld passes and TEM disk locations of a 38-mm-thick plate of Type 304 SS, Heat 19611. Weld slag and slag pockets were removed after each pass.

thick plates required as many as 38 weld passes. A schematic diagram of the welding passes and TEM disk locations of the 38-mm-thick plate of Type 304 SS, Heat 19611, is shown in Fig. 2. Weld slag and slag pockets were removed after each welding pass. Weld slags trapped in the weld cusps were removed with a grinding wheel.

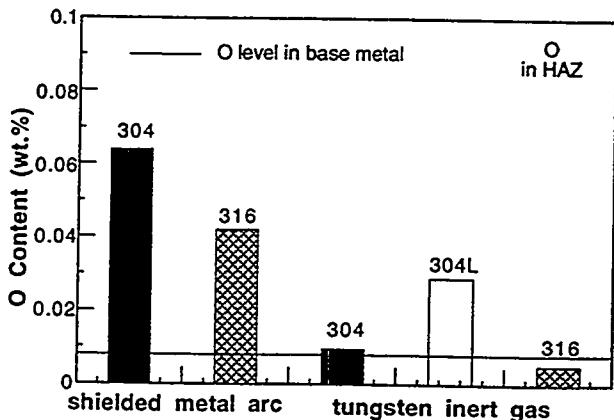
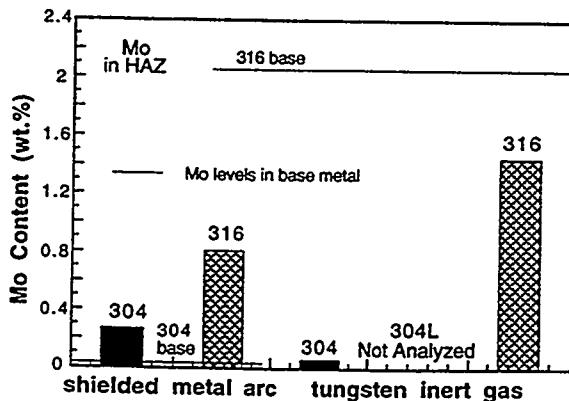
FIGURE 3: Oxygen (left) and Mo (right) contents of SMA and GTA weld HAZs.

Chemical Analysis. Compositions of the SMA and GTA weld HAZs of Type 304 SS Heat C1, determined by wet chemistry, are summarized in Table 4. Oxygen and Mo contents of the SMA and GTA (or tungsten inert gas, TIG) weld HAZs of the Type 304 SS Heat C1, Type 304L SS Heat C3, and Type 316 SS Heat C21 are plotted in Fig. 3. Oxygen and Mo contents of the base metals of the heats are also shown in the figure for comparison. While contamination in the GTA weld HAZ was insignificant, the SMA weld HAZ was significantly contaminated by O, Mo, and F, the elements from the E-308-16 electrode or air.

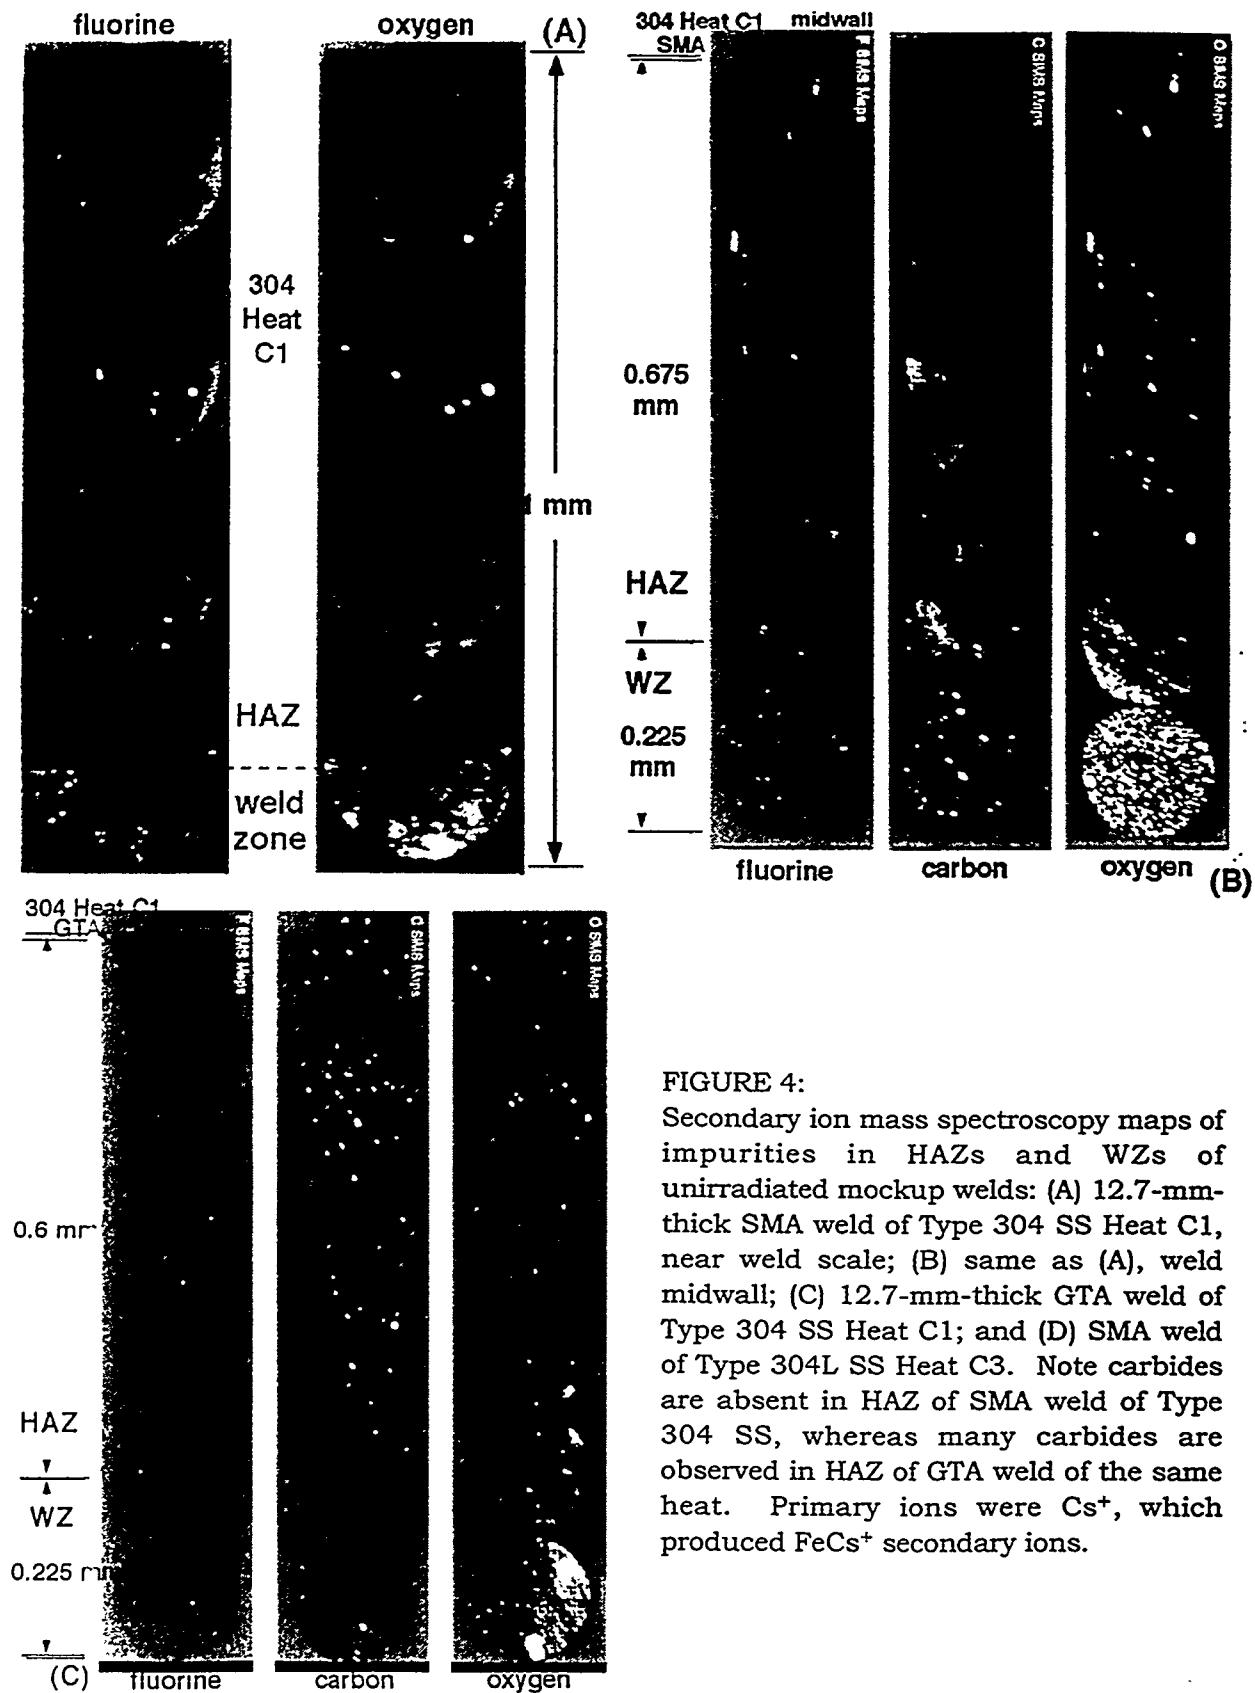
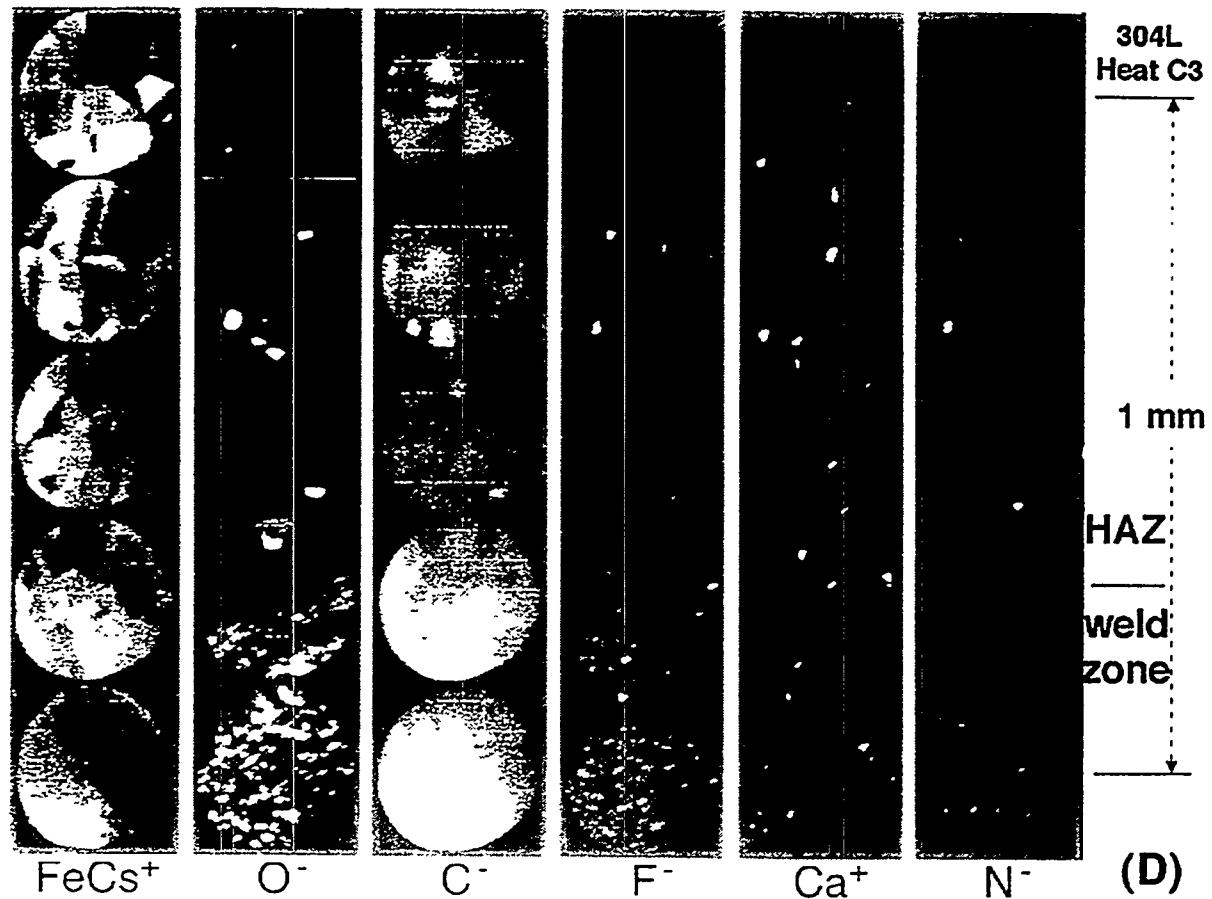
FIGURE 4:
 Secondary ion mass spectroscopy maps of impurities in HAZs and WZs of unirradiated mockup welds: (A) 12.7-mm-thick SMA weld of Type 304 SS Heat C1, near weld scale; (B) same as (A), weld midwall; (C) 12.7-mm-thick GTA weld of Type 304 SS Heat C1; and (D) SMA weld of Type 304L SS Heat C3. Note carbides are absent in HAZ of SMA weld of Type 304 SS, whereas many carbides are observed in HAZ of GTA weld of the same heat. Primary ions were Cs^+ , which produced FeCs^+ secondary ions.

FIGURE 4: Continued.

Analysis by SIMS. Distributions of O, F, and other impurities were analyzed by SIMS on the SMA and GTA welds of a Type 304 SS, Heat C1 and the SMA weld of the Type 304L SS, Heat C3. Results of mapping in color of the secondary ions of O, F, Ca, C, and N from the weld zone and HAZ were obtained using Cs^+ as primary ion (see Fig. 4). Black, red, orange, and white in the map correspond, respectively, to regions of proportionately higher ion population; black corresponds to no or negligible ions detected, and white corresponds to the highest ion population. For the ion maps given in the figure, the boundaries between WZ and HAZ are also marked. The results of the SIMS analyses can be summarized as follows:

- (a) Oxygen and F contamination was significant in all SMA welds. Oxygen contamination was significantly more pronounced in the WZ than in the HAZ.
- (b) In contrast to SMA welds, F contamination was negligible and O contamination was less significant in GTA welds.

- (c) Sparsely populated oxide inclusions were present in the base metal of Type 304 SS Heat C1. These oxides were rich in F, showing that the base metal of this heat of Type 304 SS contained F in spherical oxide inclusions that formed during the ingot-melting process.

- (d) Nitrogen and C contamination was insignificant in the SMA, as well as in GTA welds.
- (e) Significant carbide precipitation occurred in the HAZ of the GTA weld. In contrast to oxides, F atoms were not enriched in the carbides, which is consistent with the results of AES analyses of BWR neutron-absorber tubes reported previously.²

- (f) Carbide precipitation was negligible in the HAZ of the SMA weld of Type 304 SS Heat C1 (≈ 0.060 wt.% C), as well as in Type 304L SS Heat C3 (≈ 0.016 wt.% C). That is, in contrast to GTA welding, thermal sensitization did not occur during SMA welding, even in high-C Heat C1.

- (g) Calcium-rich precipitates were present in SMA welds in the WZ and in the HAZ up to ≈ 0.6 mm away from the fusion line. Most of the precipitates were also rich in O and F. No calcium-rich precipitates were present in GTA welds.

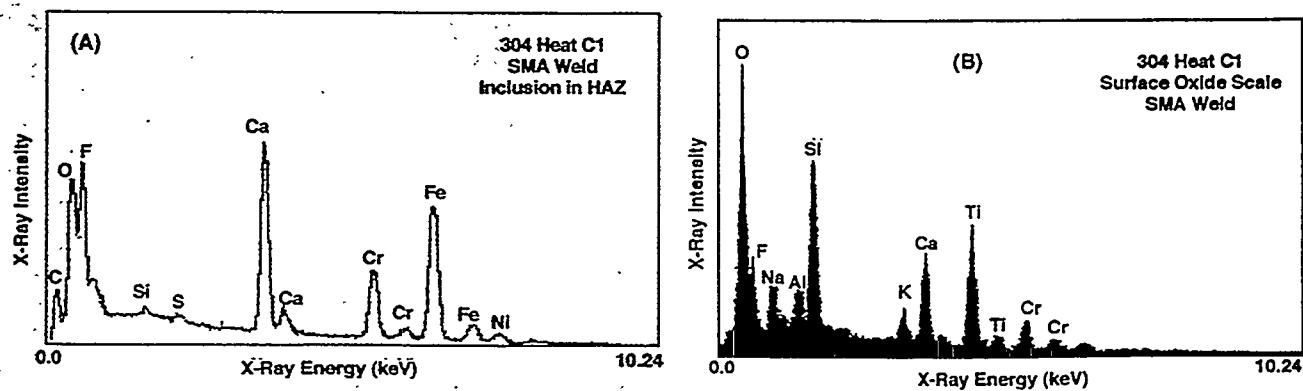
FIGURE 5: Composition of (left) Ca-rich precipitates in HAZ and (right) surface weld scale of unirradiated SMA weld of Type 304 SS Heat C1 that were analyzed by X-ray energy-dispersive spectroscopy in SEM.

compositions of the calcium-rich precipitates were determined in an SEM by energy-dispersive spectroscopy. The results are shown in Fig. 5. The calcium-rich precipitates were high in O, F, and Si, the same elements that are also high in the flux compound in the weld electrode coating (Table 3). The composition of the surface weld slag was similar but contained more Si, K, and Ti. Therefore, it is obvious that the calcium-oxyfluoride-type precipitates form in association with the contamination that occurs during the SMA welding. After each welding pass, the weld slag pockets were removed mechanically from weld cusps by a grinding wheel, and this process may have assisted the formation of the Ca-rich precipitates by impregnating small particles of broken weld scale. The Ca-rich inclusions dissolved readily when in contact with water during either SSRT testing at 288°C or polishing at room temperature. When the specimen surface was polished in an oxalic solution, however, the inclusions did not dissolve. These observations indicate that the calcium-oxyfluoride-type inclusions are soluble in reactor coolants and hence could accelerate the release of F ions into the crack tip.

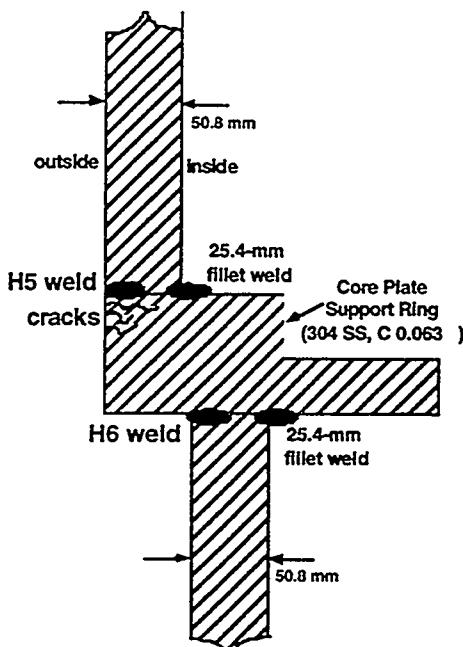
FIGURE 8:
Schematic diagram of H5 and H6 welds and cracked core plate support ring of BWR-D.

A Type 304 SS core shroud sample that accumulated a fluence of $\approx 1 \times 10^{20} \text{ n}\cdot\text{cm}^{-2}$ ($E > 1 \text{ MeV}$) and had cracked during service in BWR-D was obtained for microstructural analysis by TEM and AES. The boat sample was sectioned from the cracked core plate support ring. Cracks in the Type 304 SS ($\approx 0.063 \text{ wt.\%C}$) ring were detected near the horizontal H5 weld along the entire circumference (see Fig. 8). In many later-design BWRs, the H5 weld is referred to as the H6A weld. The low-magnification optical photomicrograph in Fig. 9 shows three cracks in the boat sample; a high-magnification photomicrograph is shown in Fig. 10. Cold-worked grains are visible in the HAZ near the #1 crack, which nucleated $\approx 3.5 \text{ mm}$ away from the fusion line. The other two cracks are located ≈ 9 and $\approx 14 \text{ mm}$ away from the fusion line, apparently in the base metal. Compared to the surface region (Fig. 10, top-left inset), the phenomena of grain encirclement and grain fallout were more pronounced in the crack tip regions (Fig. 10, top-right and bottom-left insets). Apparently, grain encirclement in the crack tip region occurred in the reactor during operation, and fallout of the encircled grains occurred at room temperature during mechanical polishing of the specimen. Grain encirclement could have been strongly influenced by the water chemistry in the crack tip crevice in which concentration of deleterious ions would be relatively higher, e.g., F ions dissolved gradually in the water from the surrounding grains in the contaminated HAZ.

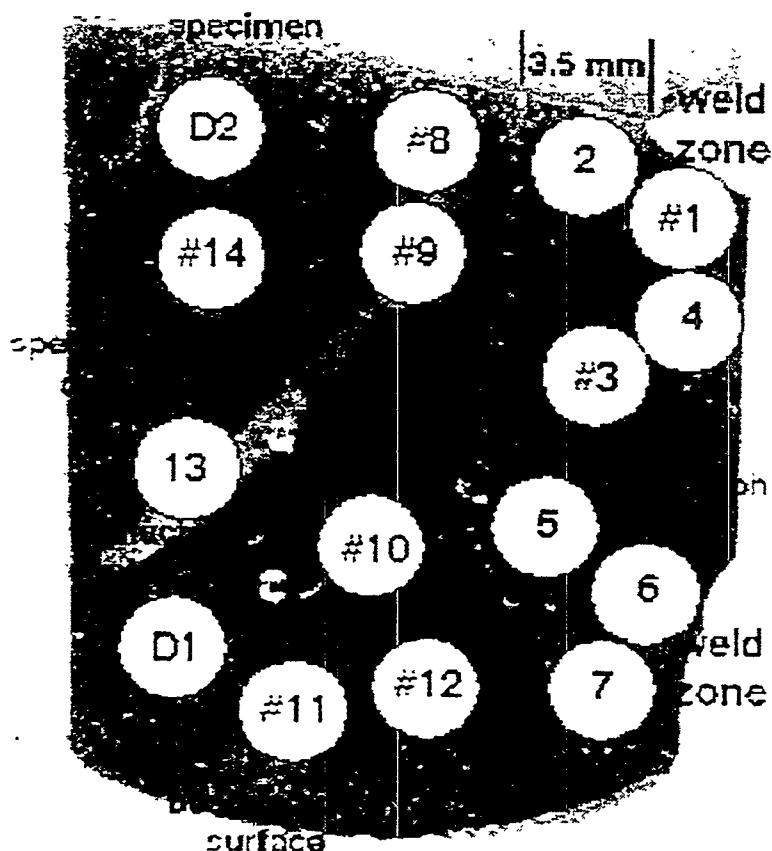
TEM Disk Location, BWR-D H5 Weld Crack

FIGURE 9:
Location of cracks and TEM disks in boat sample from a Type 304 SS core shroud weld from BWR-D irradiated to a fluence of $\approx 1 \times 10^{20}$ n·cm $^{-2}$ ($E > 1$ MeV). Disks 1, 3, 8, 9, 10, 11, 12, and 14 were examined. No grain-boundary carbides were observed in any of the disks.

Characterization by TEM of grain-boundary carbide precipitation and thermal sensitization was conducted on the boat sample shown in Fig. 9. A total of 16 TEM disks were prepared near the cracks located in the HAZ and base metal. Of the 16 disks, 8 were jet-polished and examined by TEM. No grain-boundary carbide was observed in any of the 8 disks that were examined. A typical example of carbide-free "clean" grain boundaries is shown in Fig. 11. Some disks exhibited a light-contrasted feature that is an indication of localized thinning during the jet-polishing procedure in association with significant inhomogeneity of local chemical composition. Because grain-boundary carbide precipitation was absent in the HAZ near the cracks, it is difficult to explain the cracking in the Type 304 SS shroud weld on the basis of classical thermal sensitization.

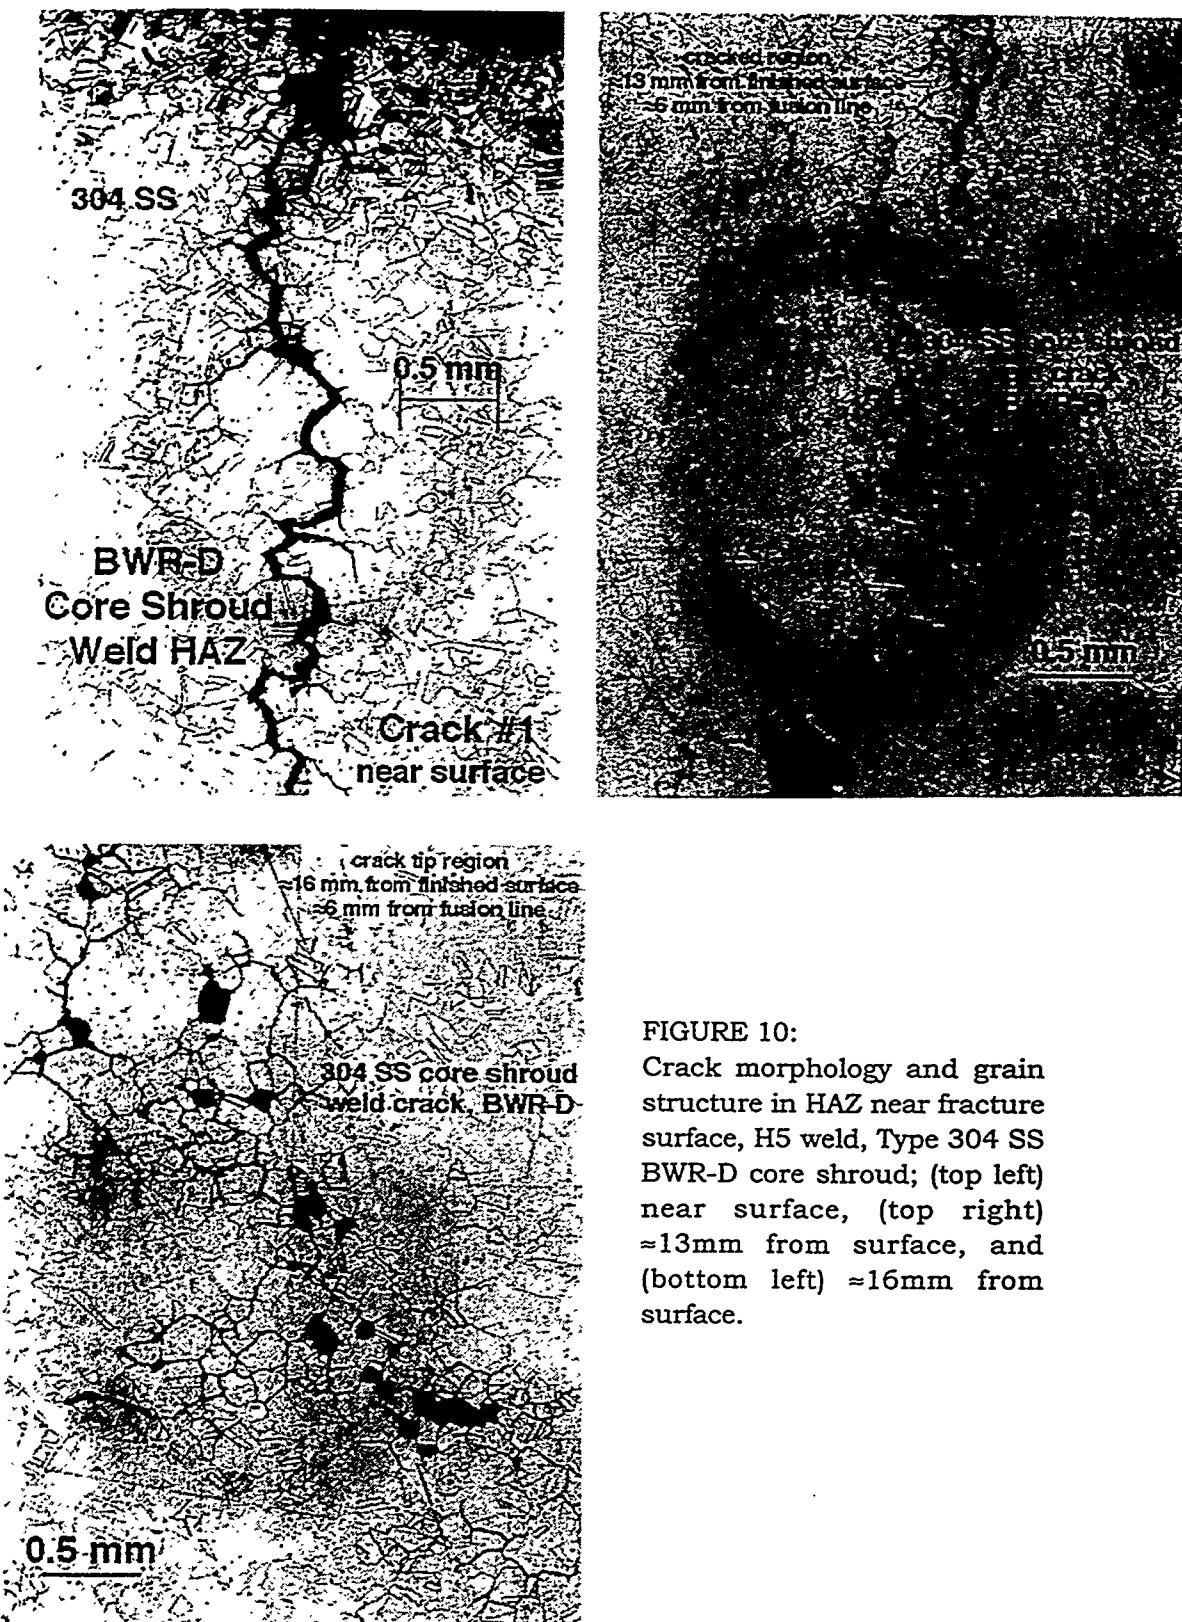
FIGURE 10:
Crack morphology and grain structure in HAZ near fracture surface, H5 weld, Type 304 SS BWR-D core shroud; (top left) near surface, (top right) ≈ 13 mm from surface, and (bottom left) ≈ 16 mm from surface.

Many Fe oxides were also observed in the specimen prepared from HAZ of the H5 weld of the Type 304 SS BWR-D core shroud. As shown in the optical photomicrographs in Fig. 10, the number density of oxide inclusions was significantly lower in the Type 304 SS BWR-D shroud weld specimen than in the BWR-C specimen. This indicates that welding-related contamination was lower in the BWR-D H5 weld than in the BWR-C H3 weld.

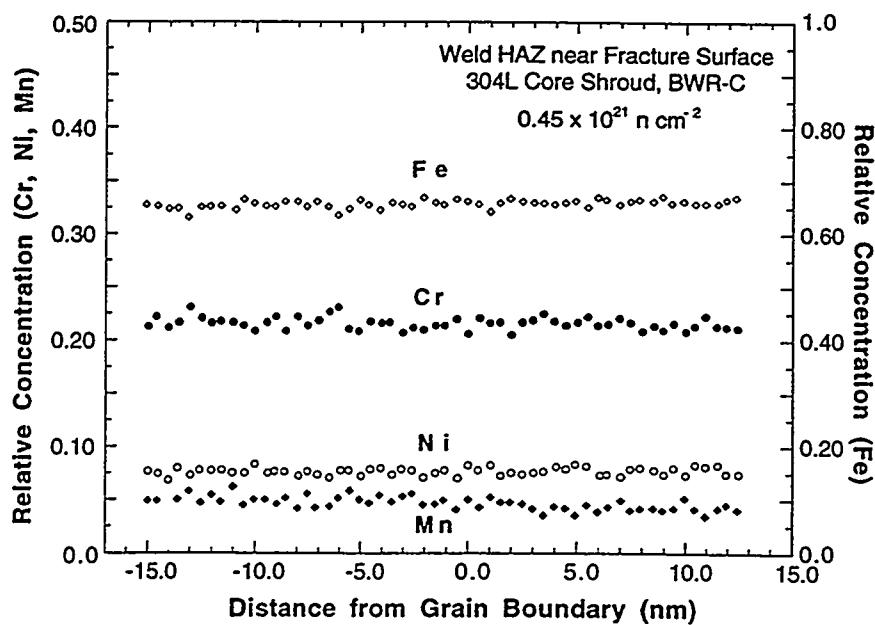
FIGURE 14:
Profiles of Fe, Cr, Ni,
and Mn near grain
boundary of Type 304L
BWR-C core shroud
weld HAZ shown in
Fig. 9. Grain-
boundary Cr depletion
is negligible.

Neither carbide, Cr depletion, nor martensite thin film was detected on grain boundaries of HAZ specimens that were characterized by an HB603 FEG-AAEM (see Figs. 13 and 14). The Type 304L SS weld HAZ was not thermally sensitized, and grain-boundary Cr depletion by a thermal or irradiation-induced process was negligible. Therefore, cracking of this Type 304L core shroud weld cannot be explained on the basis of either classical IGSCC or IASCC.

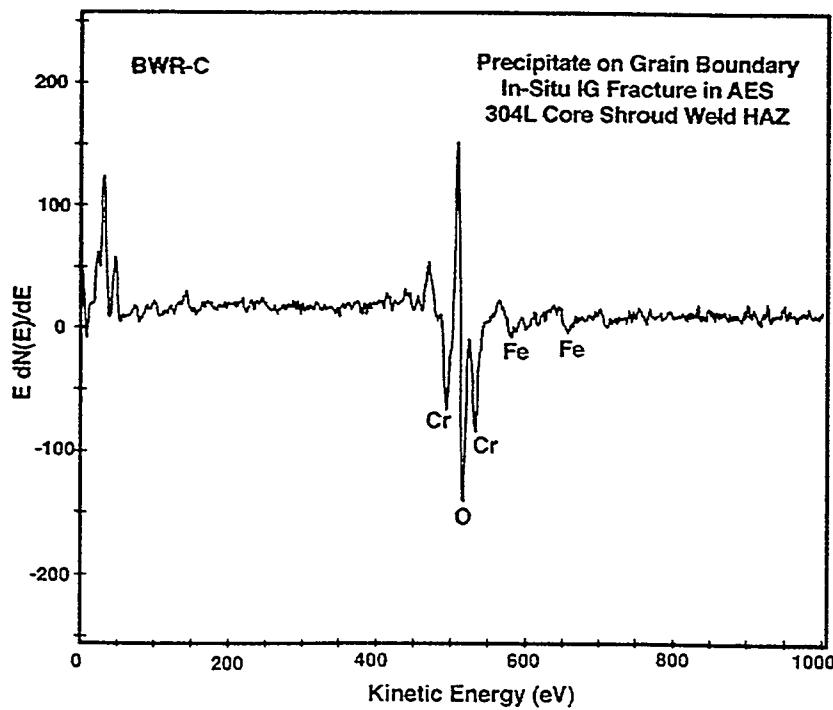
FIGURE 16:
AES signals from
particle denoted "ppt"
in Fig. 15, showing
composition of a
chromium oxide.

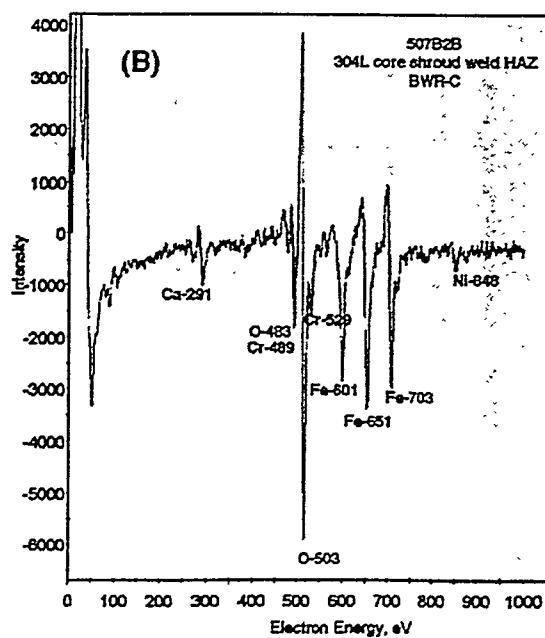
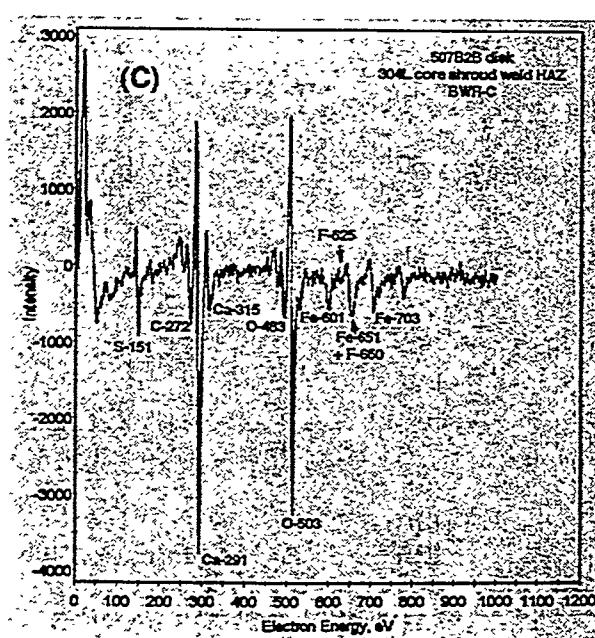
FIGURE 18:

AES secondary-electron image of polished and Ar-ion-sputter region of HAZ near fracture surface, H3 weld, Type 304L SS BWR-C core shroud (A). Each precipitate denoted as "oxide" or "CaO" was identified by analyzing AES spectra from the precipitate. Spectra from Fe oxide and CaO are shown in (B) and (C), respectively.

Similar evidence for presence of numerous grain-boundary oxide particles could be also obtained from AES analysis of polished specimens. An optical photomicrograph of a polished surface, obtained from the H3 weld HAZ of Type 304L SS BWR-C core shroud, is shown in Fig. 17. Besides elongated cold-worked grains, numerous inclusions are visible, many on or near grain boundaries. These inclusions located on or near grain boundaries are denoted with white arrows in the figure. To identify the inclusions, the polished specimen was analyzed by AES after sputtering a selected area with Ar ions for ≈ 300 s. On the surface of the sputtered specimen, many light-contrasted inclusions were visible in a secondary-electron image (Fig. 18). The light contrast indicates that the inclusions are insulators and are charged electrically. Most of the inclusions were found to be Fe- or spinel-type oxides (see Figs. 18). Some of the inclusions were identified as CaO, which is consistent with the observation of Ca oxyfluorides in the mockup core shroud weld by SIMS mapping (Fig. 4D). No carbides were observed. The presence of Fe oxides and CaO inclusions in both BWR-C core shroud and the mockup SMA weld HAZ is consistent with the premise that significant contamination by O and Ca occurred during welding. Furthermore, the high number density of oxides that were observed on the grain boundaries (Figs. 15 and 17) indicates that O atoms are concentrated on grain boundaries of the H3 weld HAZ of the BWR-C core shroud.

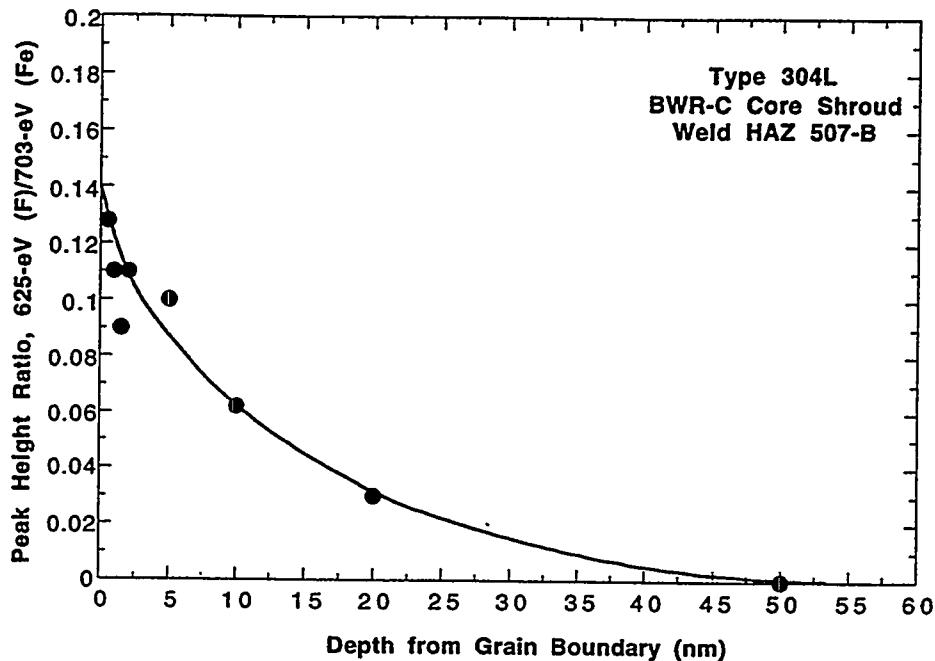
FIGURE 19:
Fluorine AES signal intensity as function of sputter distance
from grain boundary surface in HAZ of Type 304L BWR-C
core shroud weld

boundary fracture surface that was produced in-situ and shown in Fig. 15. The decreasing intensity of F signal is shown in Fig. 19. The result of the figure indicates that F atoms have segregated to grain boundaries of the BWR-C core shroud weld HAZ.

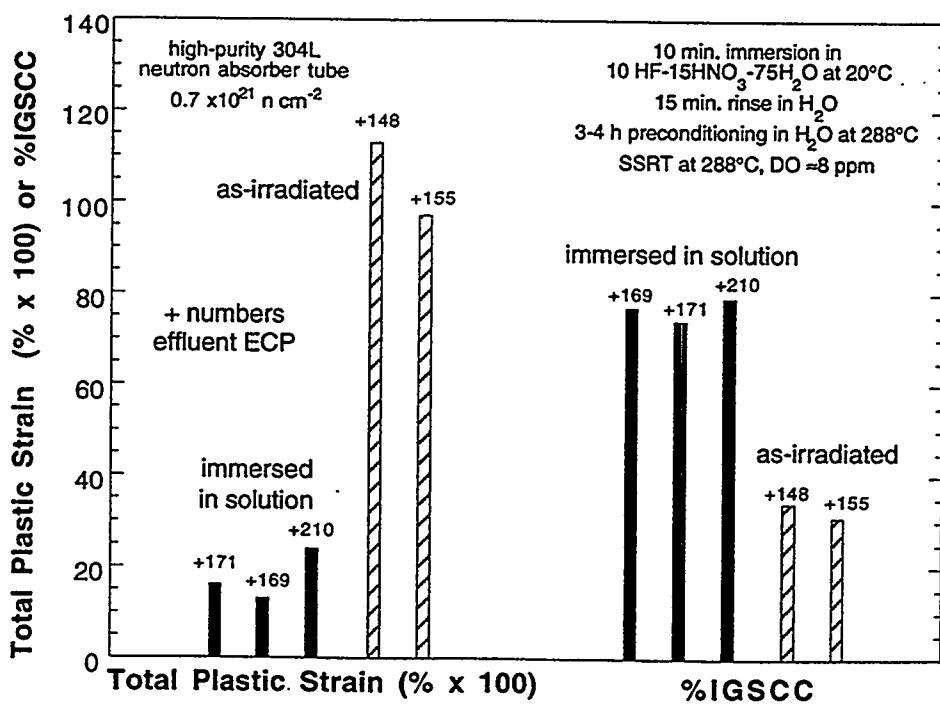
FIGURE 20:
Effect of F contamination by immersion in HF-containing
solution on total plastic strain and percent IGSCC; high-purity
Type 304L neutron absorber tube, fluence (E > 1 MeV) $0.7 \times 10^{21} \text{ n} \cdot \text{cm}^{-2}$.

In view of these reports, SSRT tests were conducted to determine more directly the effect of F contamination by immersing BWR neutron absorber tubes in a solution that contains HF. The high-purity absorber tubes irradiated to a fluence of $0.7 \times 10^{21} \text{ n} \cdot \text{cm}^{-2}$ ($E > 1 \text{ MeV}$) were immersed for 10 min in a solution of $10\text{HF}-15\text{HNO}_3-75\text{H}_2\text{O}$, followed by a 15 min rinse in distilled water and 3-4 h preconditioning in 289°C water before loading. The results, compared in Fig. 20 with those of the as-irradiated specimens, show significant effects on total strain and susceptibility to IGSCC. The specimens in Fig. 20 were covered with $\approx 20\text{-}\mu\text{m}$ -thick oxide layer that formed during service; thus, F from HF will be incorporated in the oxide and in the O-rich layer beneath the oxide. These brittle layers cracked readily with or without an immersion treatment; therefore, cracks appear to nucleate early during SSRT. Fluorine atoms, incorporated in the oxide and O-rich layer, appeared to slowly dissolve in the crack tip water and exacerbate IG crack propagation, which caused fracturing at a significantly lower plastic strain. The oxide layer on some specimens sloughed off, a phenomenon also reported by Ward et al.,⁵ Bryant and Habicht,⁸ and Takemoto et al.⁹ This is shown in Fig. 21.

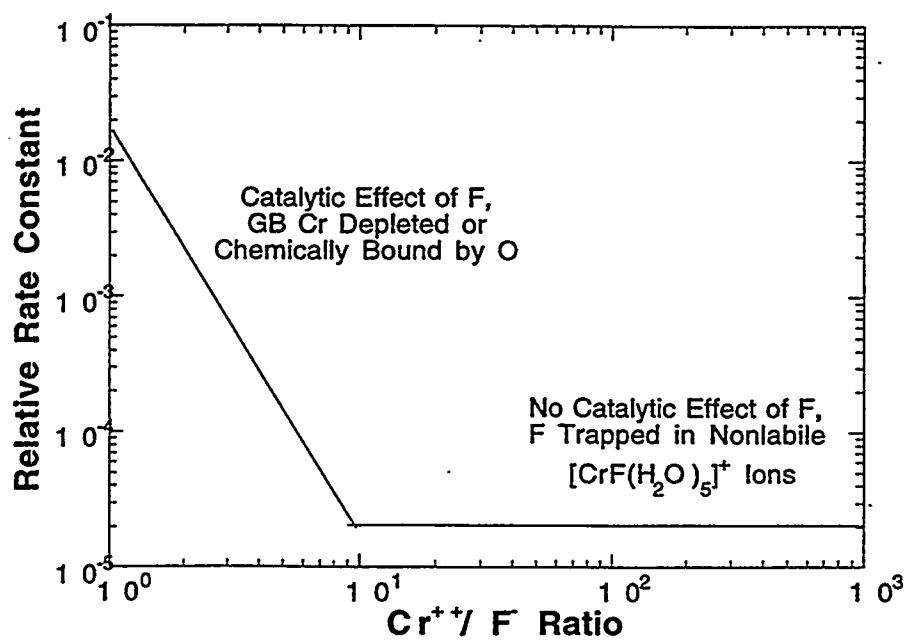
FIGURE 22:
 Schematic illustration of effects of O and F on grain boundaries and Cr ion in crack-tip water on oxyfluorine-assisted SCC

The following model is proposed to explain the mechanism of "oxyfluorine-assisted" SCC, which is based on a synergism among O, Cr, and F. Halide ions, in particular Cl and F, are well known to play catalytic roles in accelerating aqueous corrosion of iron and steels. The catalytic role has been known to be strongly influenced by the concentration of Cr ions in water.¹⁰ The corrosion acceleration has been attributed to the orders-of-magnitude faster rate of formation of a ligand complex between Fe-halide and H₂O than the rate of formation of a similar complex between halide-free Fe and H₂O. A similar effect can be postulated for reaction rates in forming F-containing (fast) and F-free (slow) ligand complexes of [FeF(H₂O)₅]⁺ and [Fe(H₂O)₆]²⁺, respectively. A free F ion is then released from the labile complex FeF(H₂O)₅ in water when H₂O replaces the F atom in the complex. This cycle can be expressed by:
