## A Historical Evaluation of the U15 Complex, Nevada National Security Site, Nye County, Nevada

Cultural Resources Technical Report No. 109  
Division of Earth and Ecosystem Sciences  
Desert Research Institute  
Las Vegas, Nevada

2014

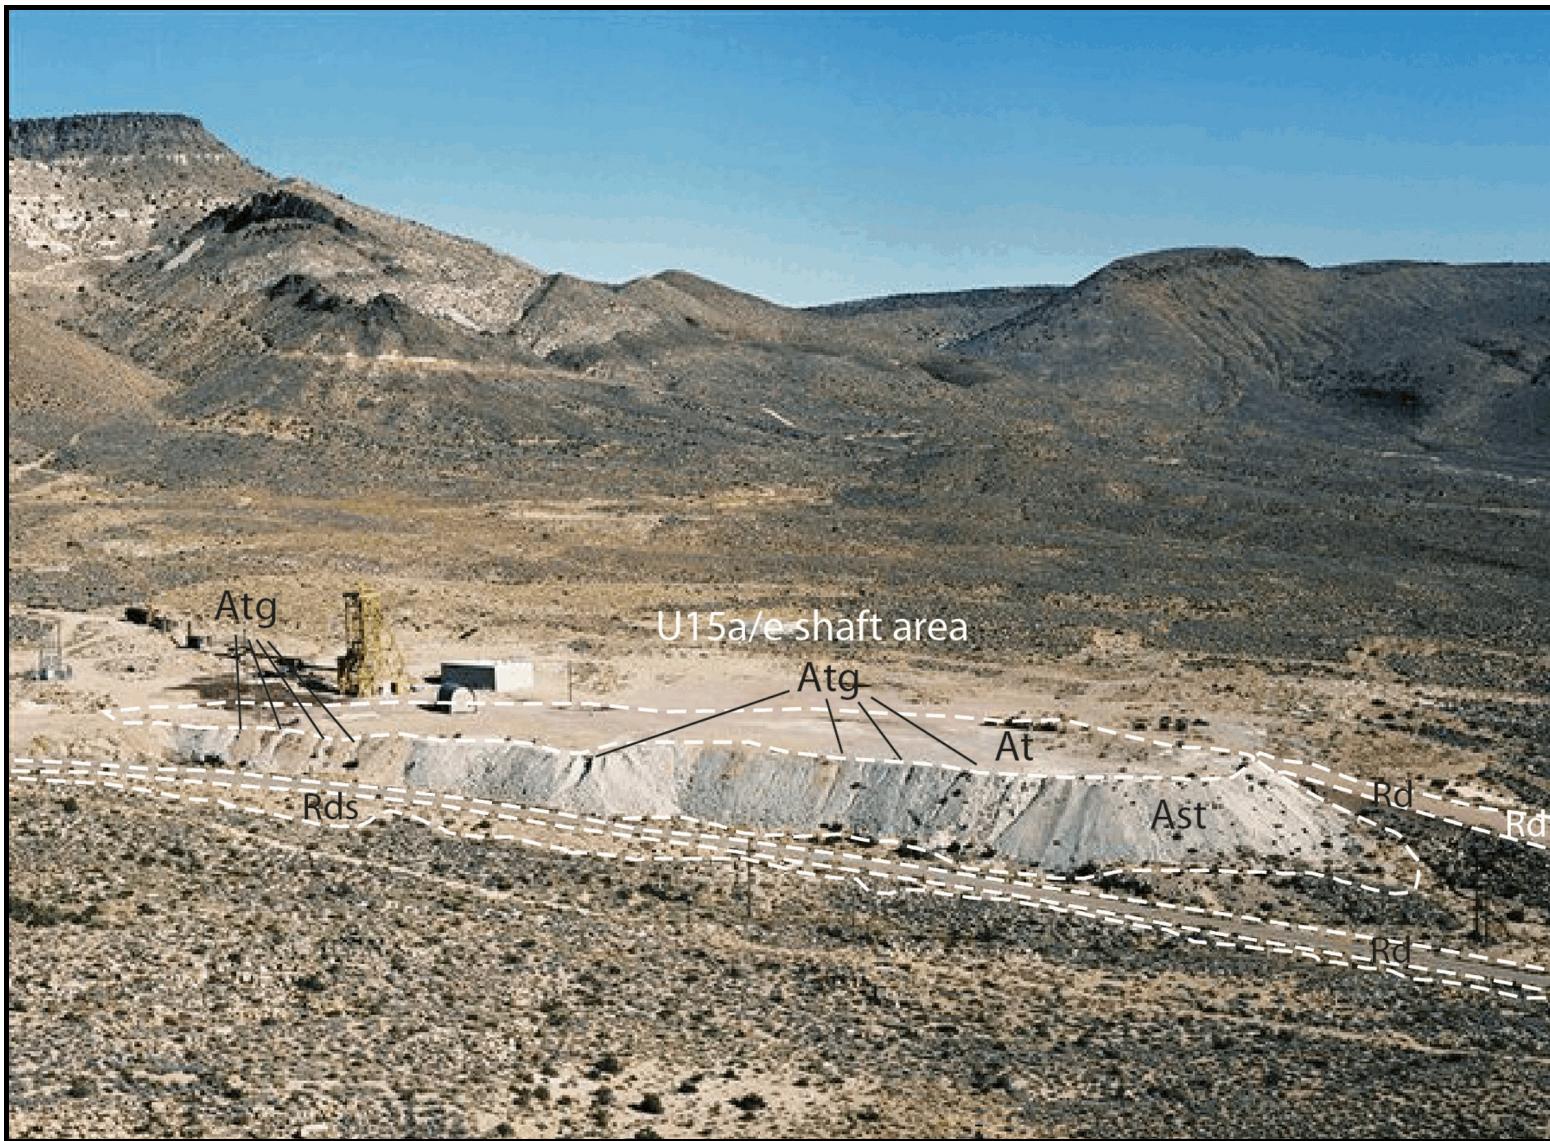
Figure 12. View northeast of the muckpile (At). Shown are rilled and gullied muckpile (Atg) on the muckpile slopes (Ast). Also visible are roads (Rd) and road side-cast (Rds).

vegetation has been destroyed and little vegetation other than grasses and sparse sage and rabbit brush has established in the intervening decades since the last mining activities were undertaken. Small rill networks have developed on the slopes and provide an effective transport linkage between potentially hazardous tailings and the downstream geomorphic and hydrologic systems (see Defense Threat Reduction Agency, 2007). Several large gully systems have formed resulting in the introduction of substantial volumes of sediment onto the lower slopes and into the stream system (Figures 12 and 13).

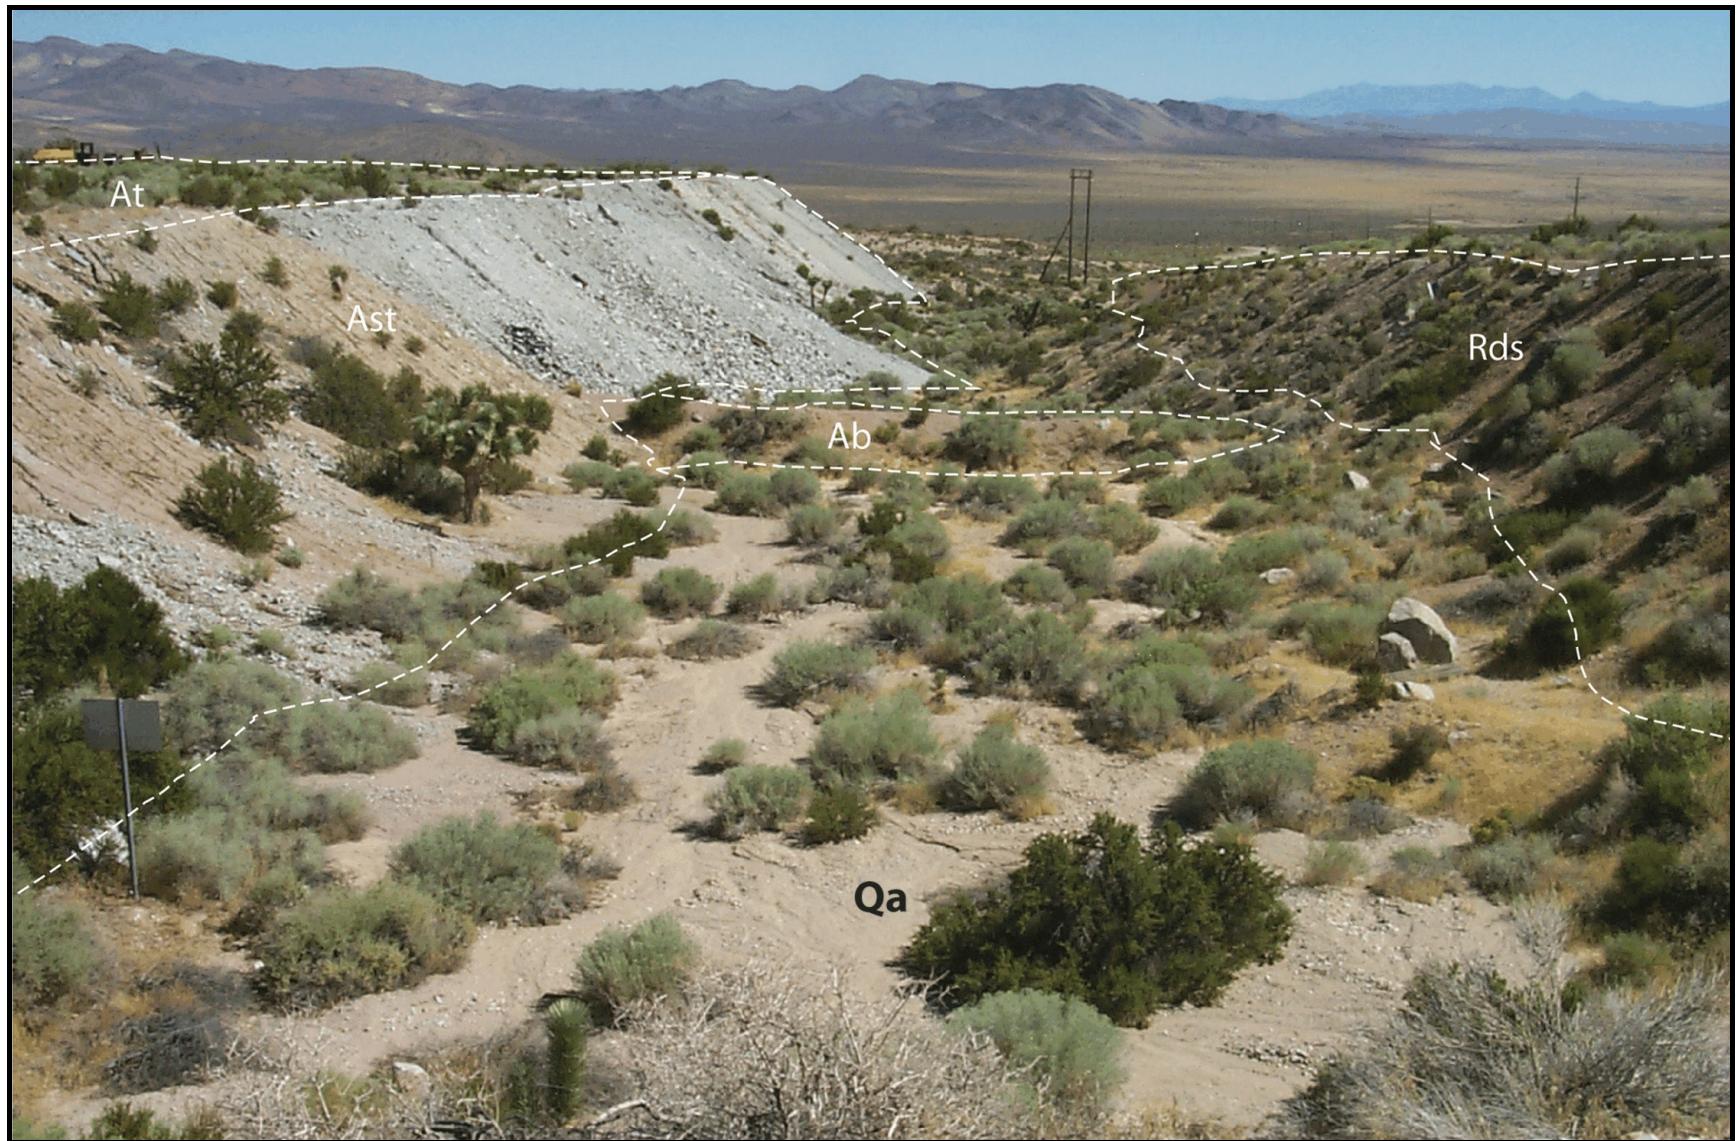
Figure 13. Alluvial valley partially filled with the muckpile (At and Ast) on the left and road side-cast (Rds) on the right. Also visible is active alluvium (Qa) and a prominent berm (Ab) placed across the stream to control runoff.

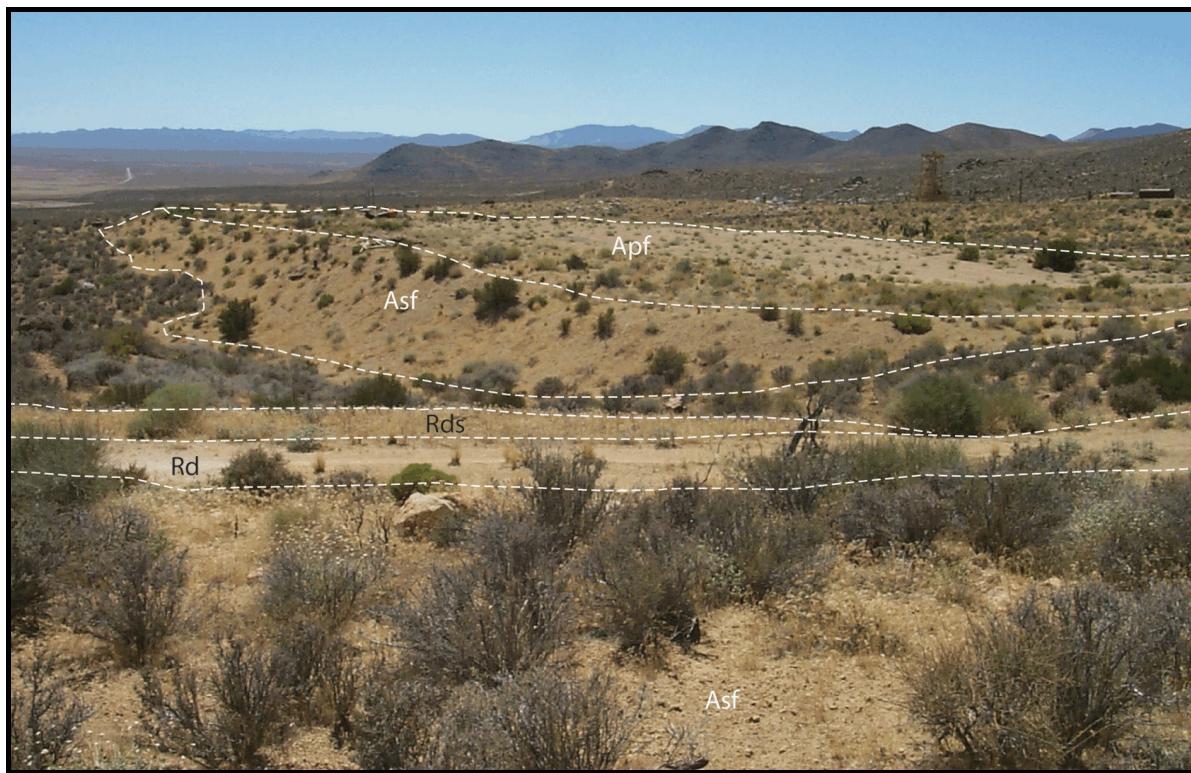
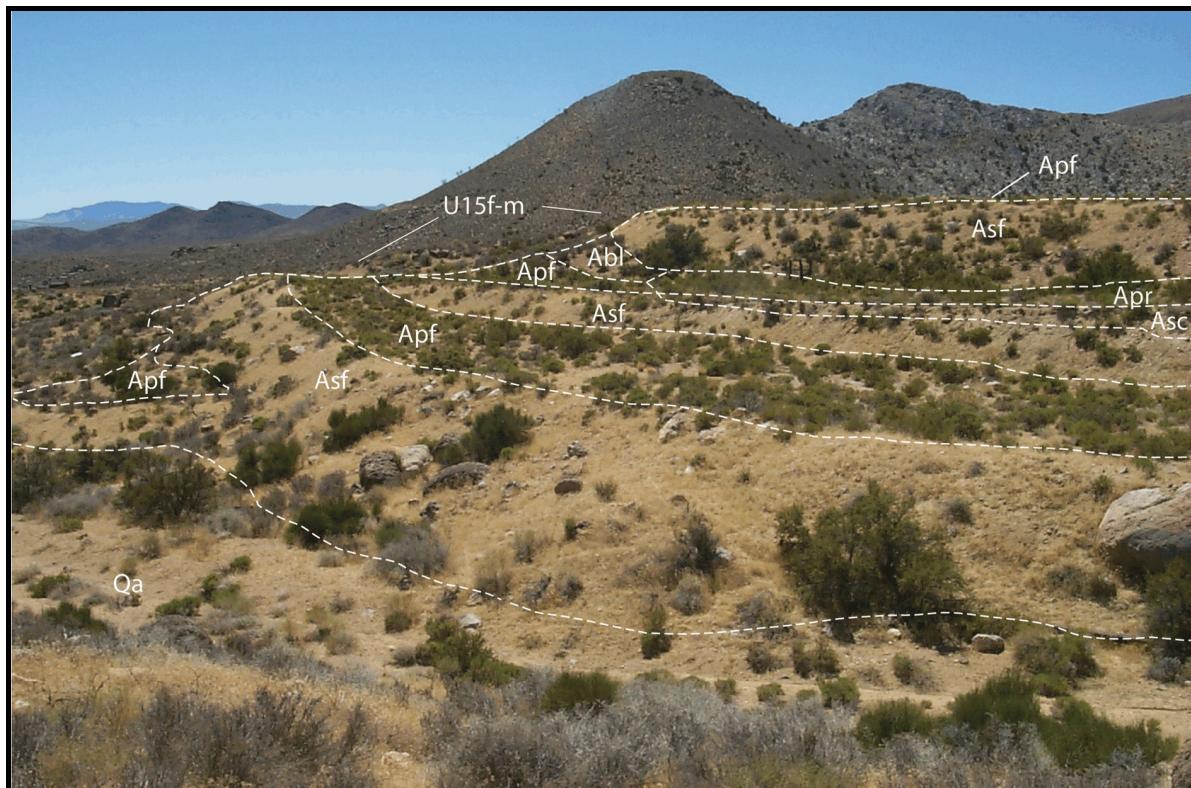
Figure 15. Constructed pad (Apf) and fill slopes (Asf) near the Pile Driver test (top); and fill pads and benches cut in fill (Apf) and pediment surface (Apr) in the U15f-m series area (bottom).

Cut slope (Asc). Cut slopes are formed principally during road construction and maintenance activities, and during excavations and preparations for pads, pits, and buildings (Figures 11 and 15). Cut slopes are commonly associated with small colluvial wedges of loose rock and soil shed from bedrock or fill cut slopes. Cut slopes are associated with access road preparation and are particularly notable on steep slopes. In general, large volumes of friable bedrock and colluvium may be removed depending on road alignment. Road cuts may be many meters tall where road alignment and topography require significant excavation into a hillslope but generally the cut slopes are less than 2 m (6.6 ft) tall. The material excavated from cut slopes is commonly used in road and pad construction activities, especially to fill minor topographic lows, increase the width of road or pad, or raise the road bed or pad elevation. As a pad or roadbed is constructed, material is bladed to the edges of the road or pad and commonly spills onto adjacent hillslopes. In the U15 Complex area, cut slopes occupy about 1.5 hectares (3.8 acres) and comprise 5.5 percent of the mapped disturbed surface area. Cut slopes in colluvium tend to shed sediment into roadside ditches or onto the pad where it can restrict drainage and can result in gullies forming on road surfaces.

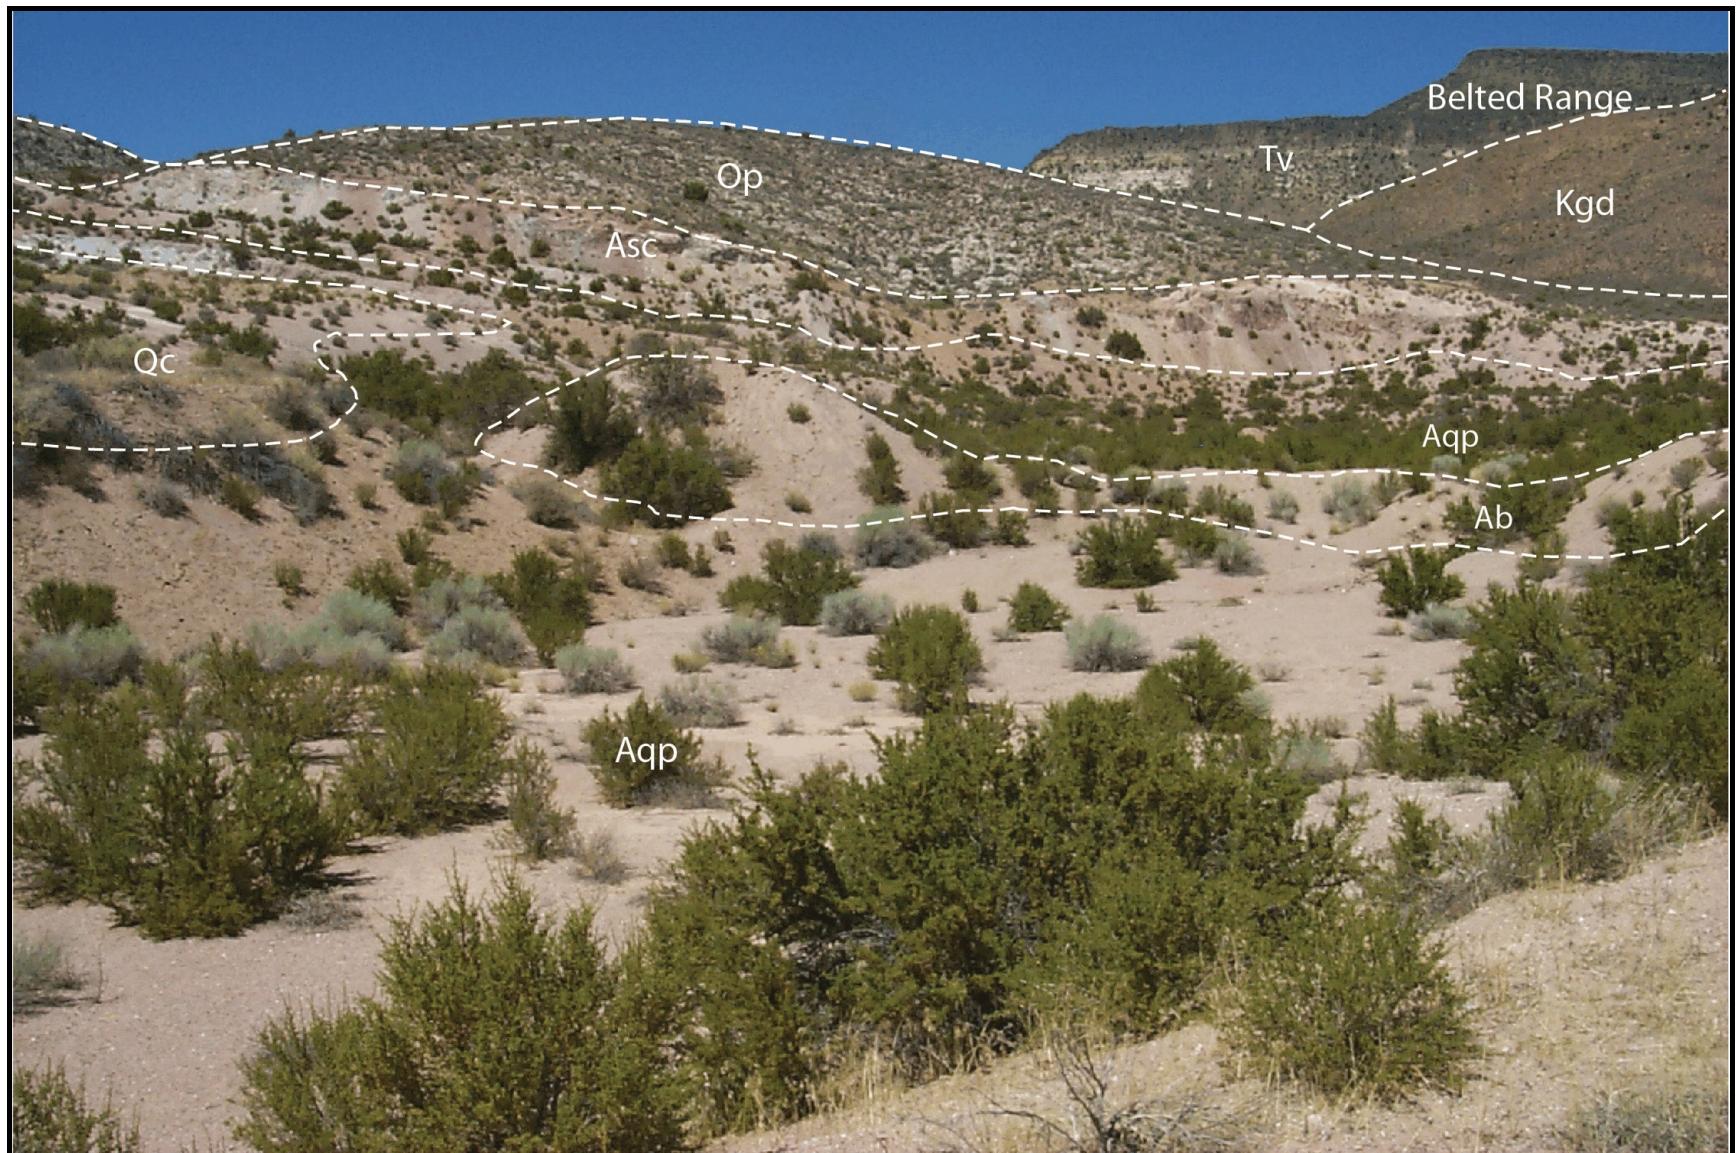
Figure 17. Quarry and borrow pit (Aqp) north of U15a area. Cut slopes (Asc) in Paleozoic bedrock (Op) and colluvium are visible. Prominent berm (Ab) has been pushed into place on borrow pit floor to control runoff.

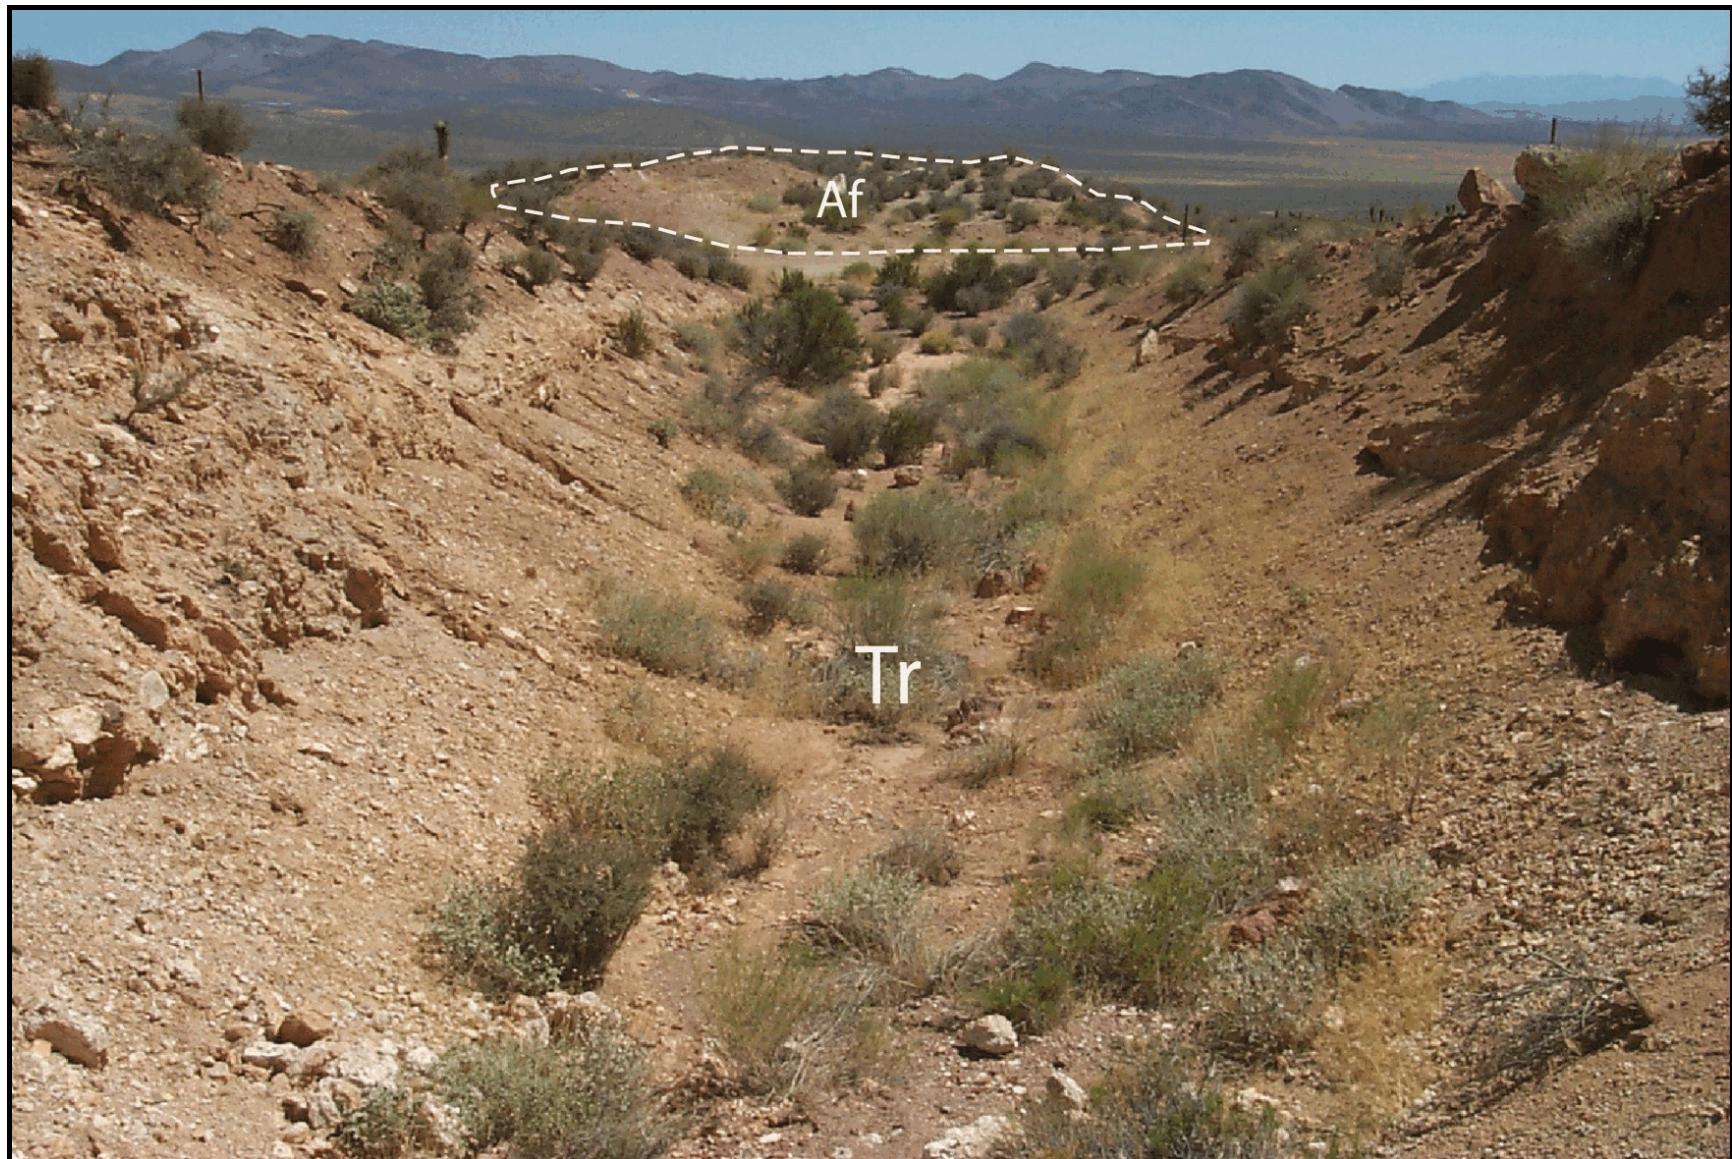
Figure 19. View south toward Yucca Flat of bulldozer trench excavated across the Boundary fault. Trench shows the resistant ledge formed of calcium carbonate, partially filled trench floor, and spoil pile (Af) derived from trench excavation.

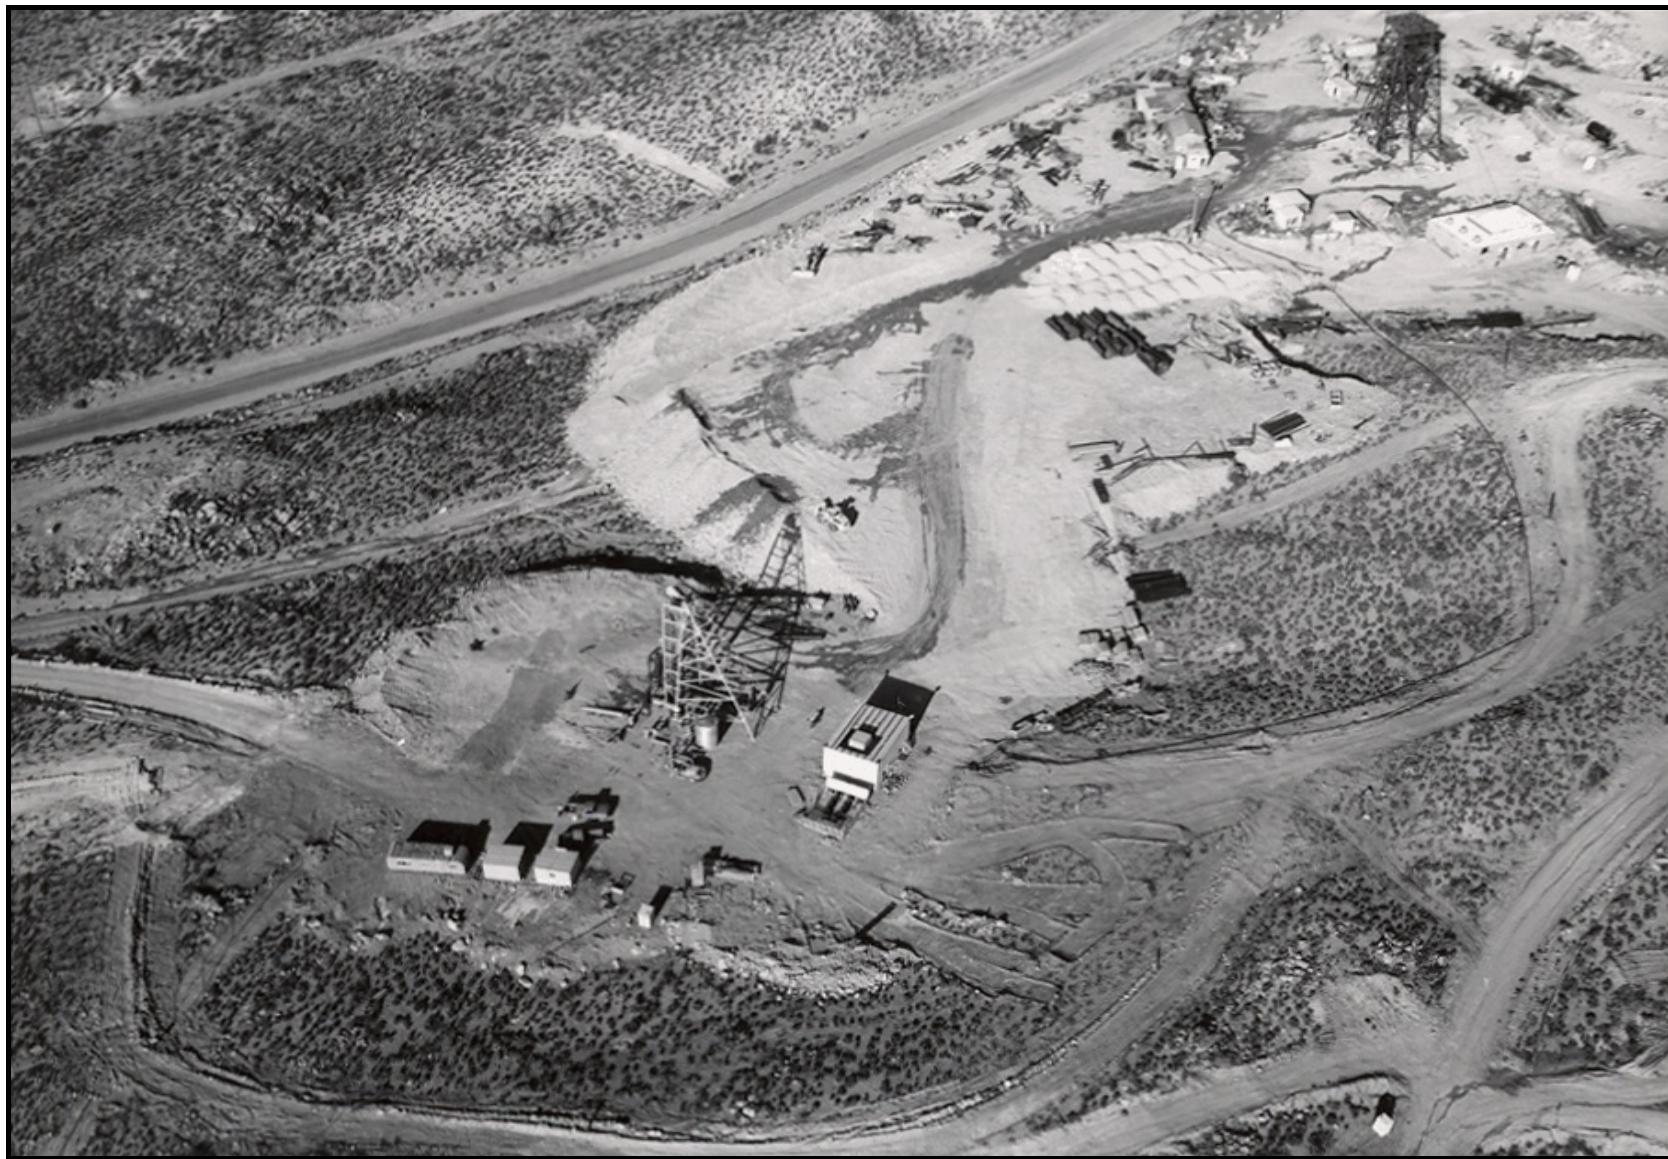
Figure 22. Aerial view northwest of the U15 Complex in 1964. Shown are the head frames and hoist houses for the Tiny Tot access shaft to the lower left and the Pile Driver access shaft to the upper right (REECo photograph 2017-9, dated 1964, on file at the Nuclear Testing Archive, Las Vegas).

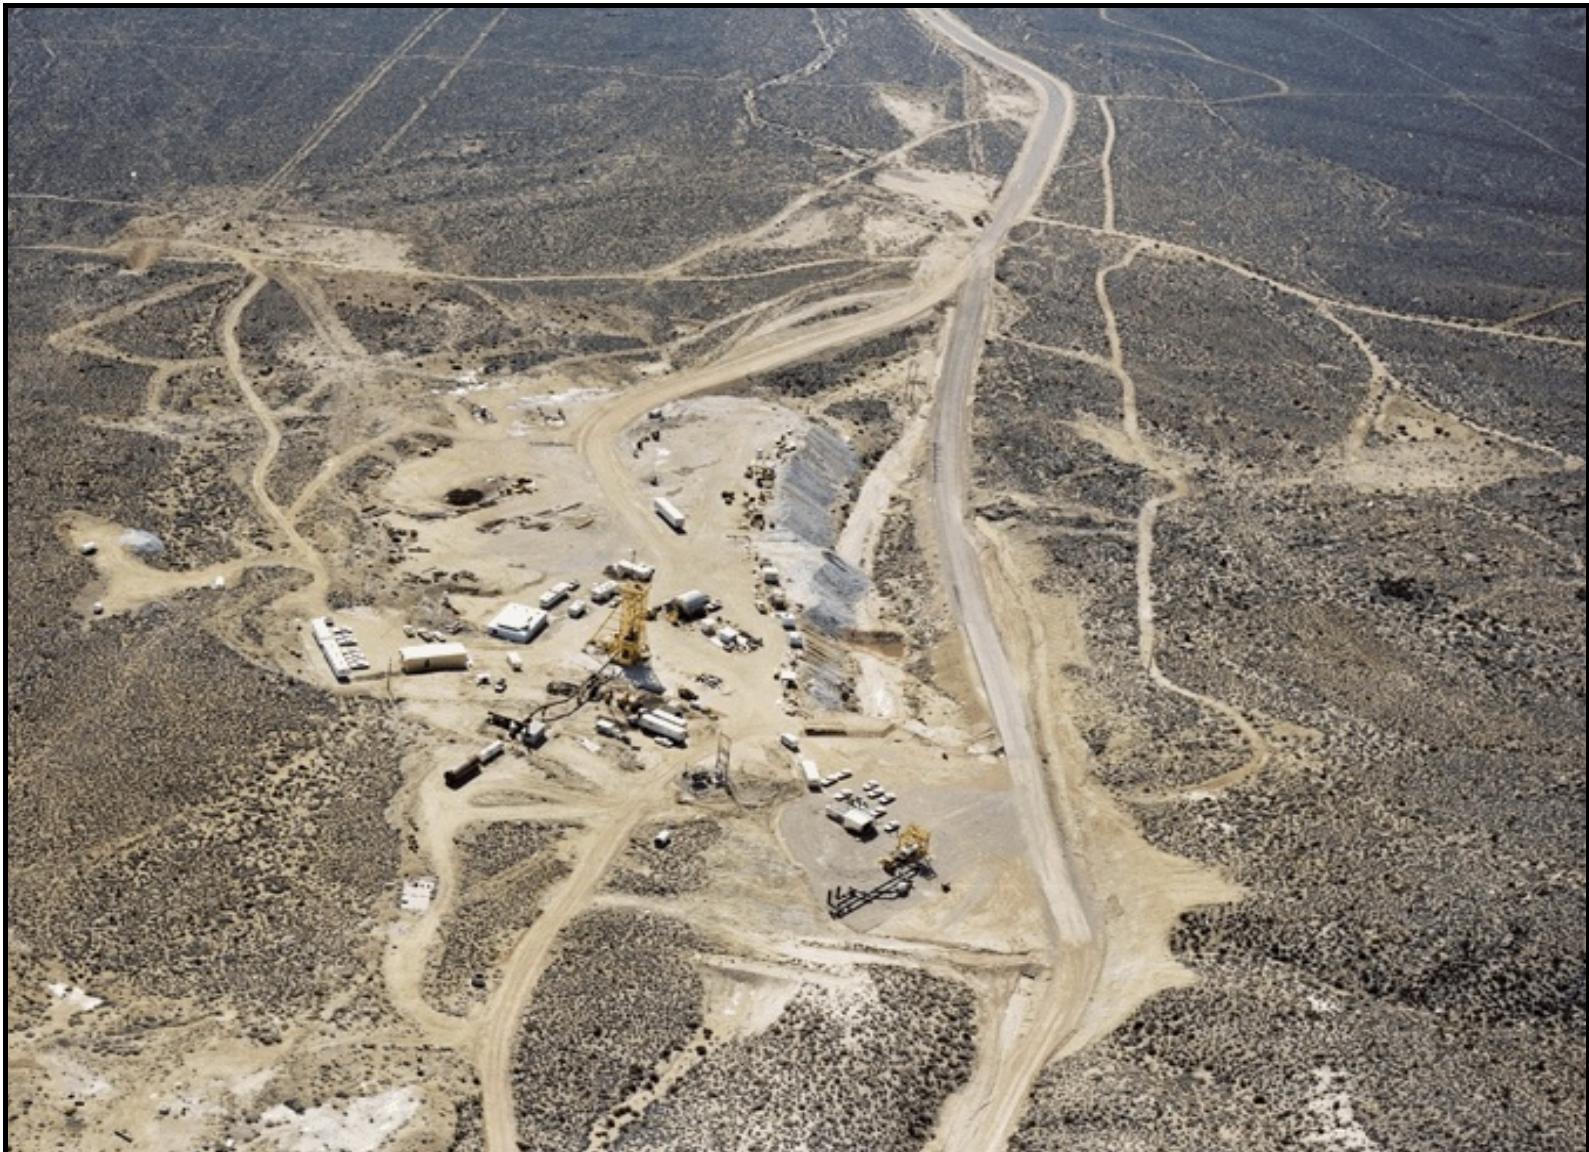
Figure 23. Aerial view south of the U15 Complex in 1980 during the Spent Fuel Test - Climax experiment. Shown are the head frames and hoist houses for the main access shaft in the middle and the canister access hole to the lower right (photograph CL7, dated 1980, on file at the Remote Sensing Laboratory, Las Vegas).

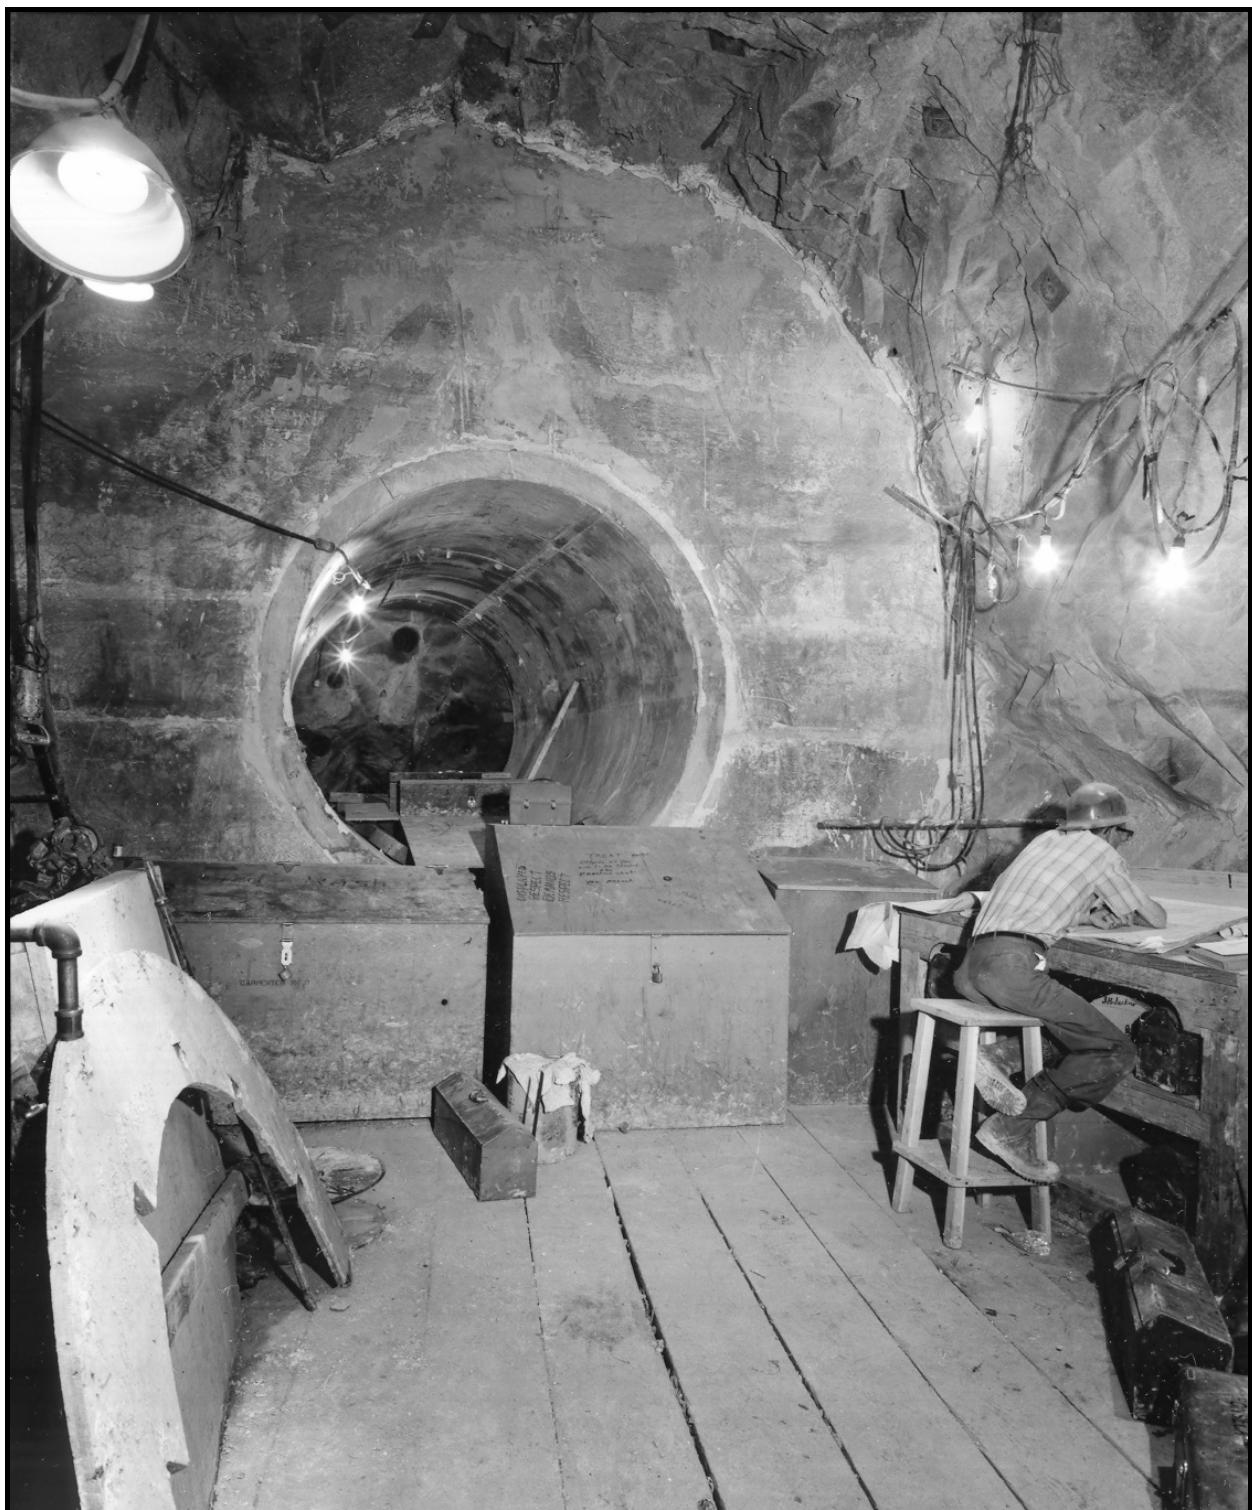
Figure 49. View of concrete experiment section and work station in the Pile Driver nuclear test (REECo photograph 3041-2, dated 1965, on file at the Nuclear Testing Archive, Las Vegas).
