1a. Doc No: RPP-RPT-58498 Rev. 00

Single-Shell Tank Leak Integrity Summary

Abstract: This document summarizes and evaluates the information in the Hanford Tri-Party Agreement Interim Milestone M-045-91F targets, completed between 2010 and 2015, (1) common factors of SST liner failures (M-045-91F-T02), (2) the feasibility of testing for ionic conductivity between the inside and outside of SSTs (M-045-91F-T03), and (3) the causes, locations, and rates of leaks from leaking SSTs (M-045-91F-T04).

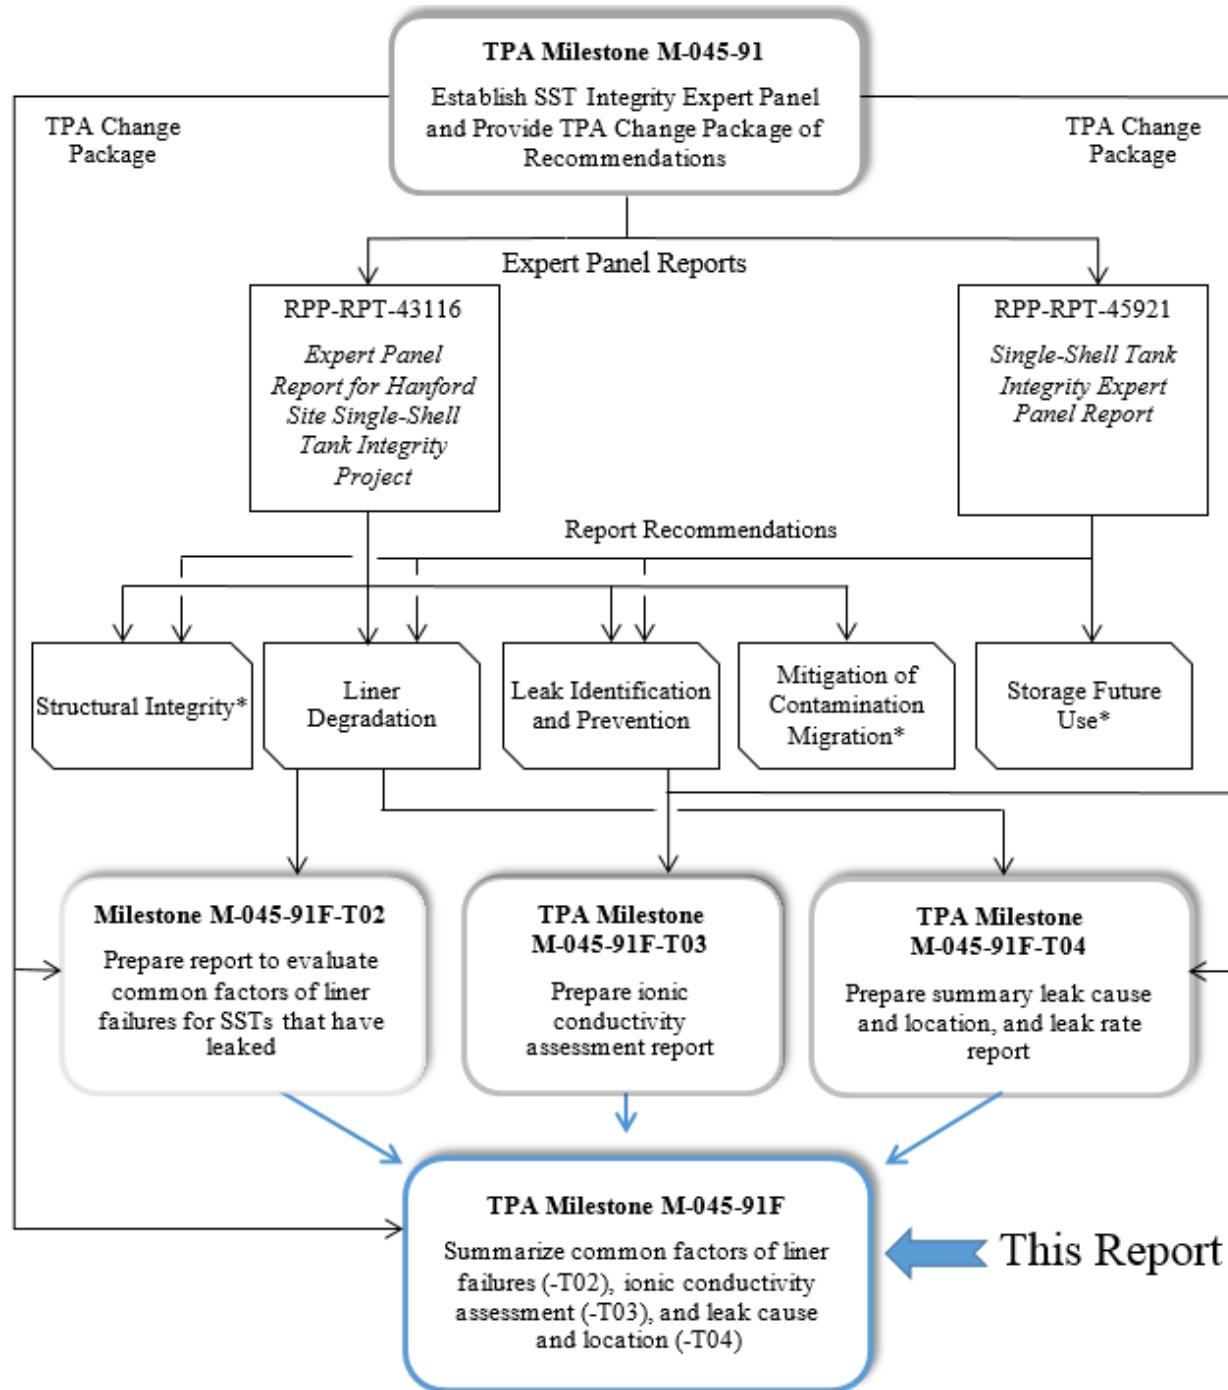
Figure 2-1 graphically indicates the flowdown from milestone M-045-91 to interim milestone M-045-91F.

Figure 2-1. Hanford Tri-Party Agreement Interim Milestone M-045-91F

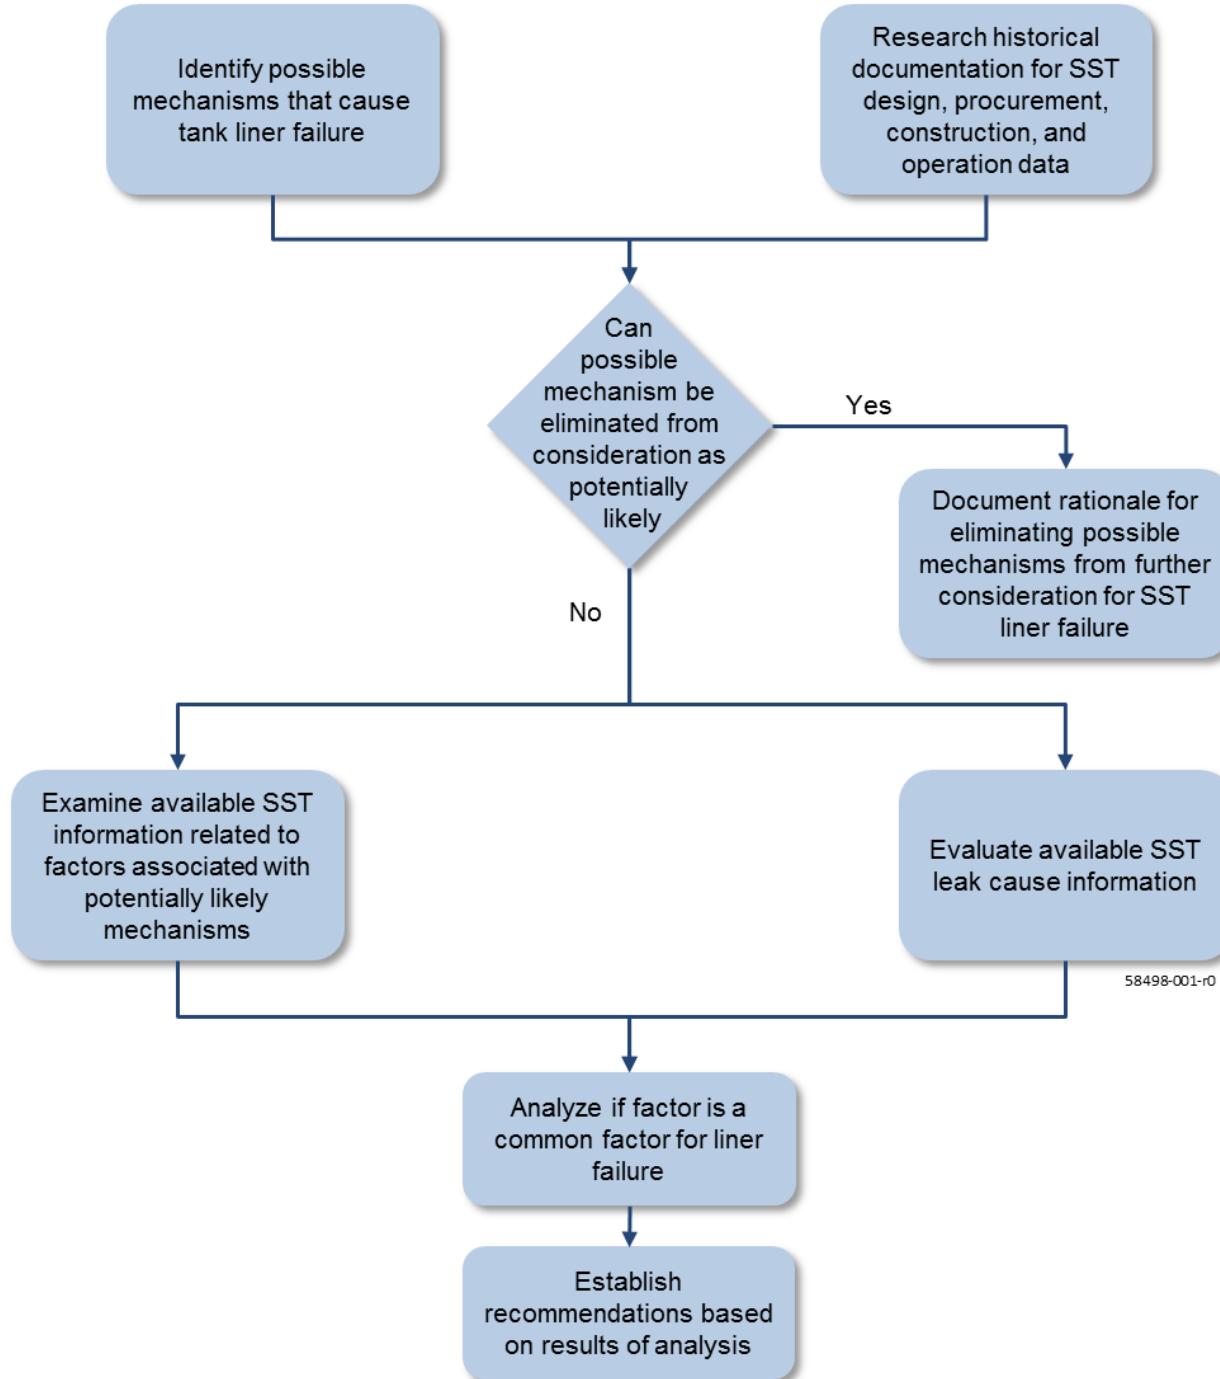
The method used to evaluate common factors of SST liner failures is illustrated in Figure 3-1. The first step in the methodology consisted of identifying the broadest set of mechanisms (i.e., a series of events or processes) that could reasonably cause or play a supportive role in causing liner failure.

Figure 3-1. Methodology for Identifying Common Factors Contributing to Liner Failures

The second step of the process was to evaluate each mechanism against SST historical information to determine if the factors necessary for the mechanism to occur might be present. If known that those factors were not present or were not significant, those mechanisms were eliminated as not being likely. All other remaining mechanisms were considered potentially likely. At this point in the evaluation, the mechanisms are considered potentially likely because they have not been evaluated in detail to determine if the mechanism was a likely factor contributing to liner failure.

The next step of the methodology was to analyze the detailed information to determine if a particular factor was a common factor in tank liner failures. The analysis, where possible, relied on statistical tests for dichotomous categorical data (i.e., liner failure vs. no liner failure). The analysis was hampered by the relatively large number of variables that could not be eliminated from consideration and the relatively small data set available. The analysis was also constrained by the limited availability of historical information.

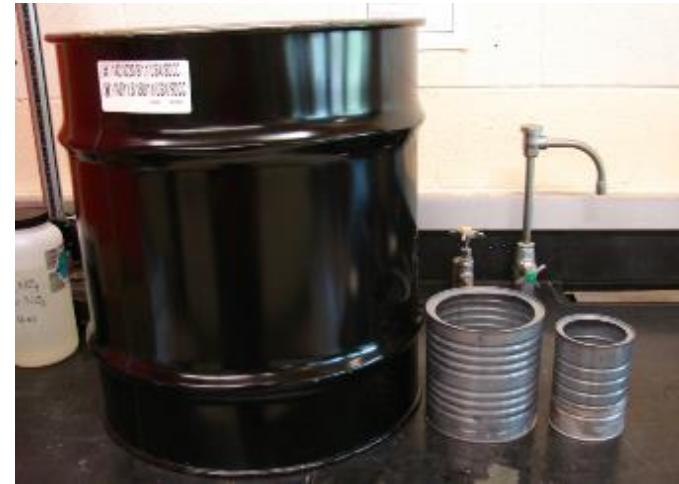
Figure 3-2. Three Test Systems Used in the Ionic Conductivity Feasibility Study (4-in. and 6-in. Diameter Cans and a 26-gal Container)

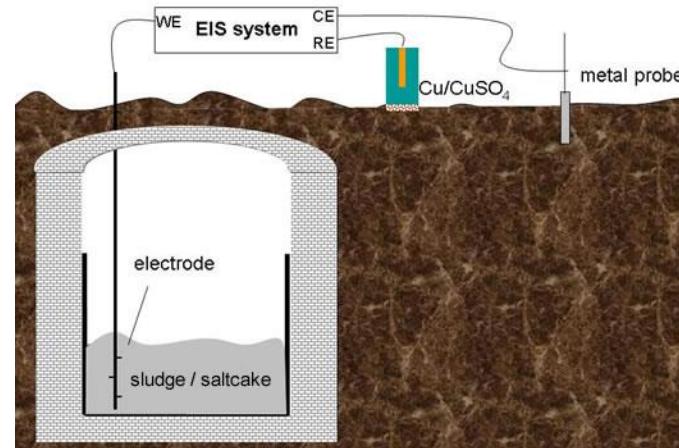
The electrochemical impedance spectroscopy response was similar to that predicted by the equivalent circuit developed in the first task, which validated the parameters used to determine the model circuit element values. The experiments and the simulation modeling predict that the approach would only be able to detect defects such as cracks or holes in the SST steel liner if the area of the defect is relatively large.

Figure 3-3. Schematic of an Electrochemical Impedance Spectroscopy System to Measure Ionic Pathways

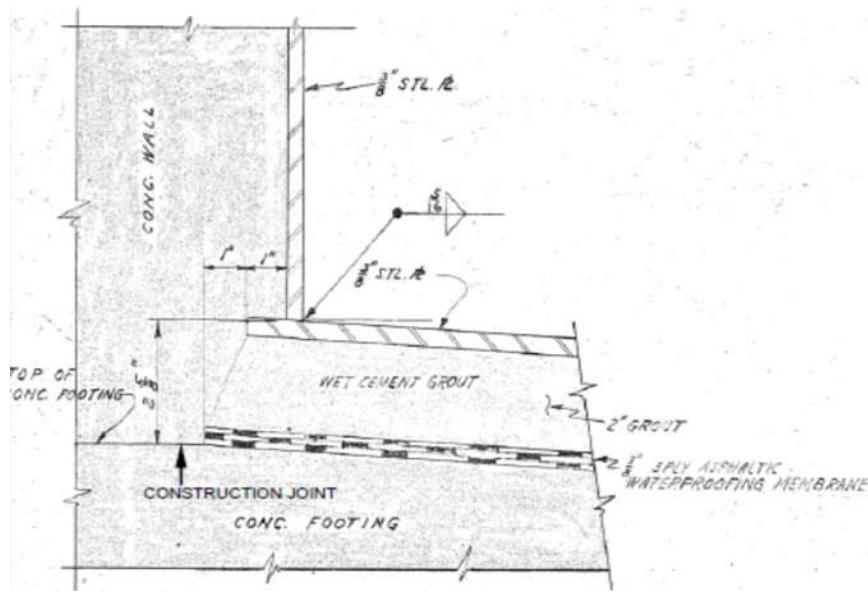
Figure 3-4 shows this orthogonal transition of the SX Farm tanks. A fillet

weld was used to close the seam where the sidewall and tank bottom liners meet versus the butt welding of the knuckle transition of earlier tank designs. A review of the basic differences between fillet and butt welds indicates that the superior butt welds would be preferred for the tank farm waste tanks. Other design specifications changes for A and SX Farms were weld inspection techniques. Welds were inspected using the vacuum soap test at 10 in. of mercury versus the superior full penetration X-ray weld testing. These design changes applied to A and SX Farms were identified as features that could likely cause liner failure.

Figure 3-4. SX Farm Tank Bottom Liner to Sidewall Design Detail

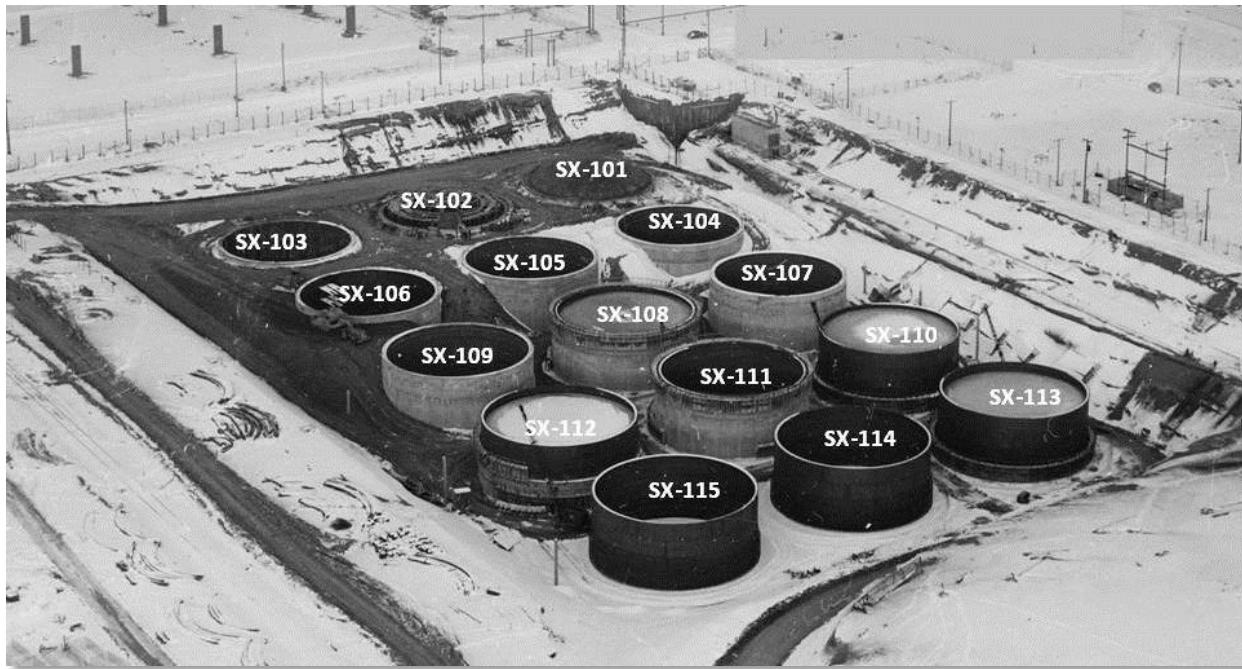
Temperatures during construction of the tank farms were examined to determine if the tank liner fabrication occurred at or below the metal ductile-to-brittle temperature transition. Any low temperatures experienced during construction at or less than the 18°F ductile-to-brittle transition temperature where impact loading (e.g., a dropped tool or piece of equipment from scaffolding) had the potential for creating micro-fissures may have triggered fissures in the steel liner. The most severe temperatures were determined to have occurred during construction of SX Farm (RPP-RPT-54910, *Hanford Single-Shell Tank Leak Causes and Locations – 241-SX Farm*). A photograph of the SX Farm under construction (Figure 3-5), taken January 20, 1954 (high 11°F, low -6°F), shows several of the tanks full of water either undergoing leak testing or for concrete wall pouring. During this cold period, snow-covered ice is seen in the water-filled tanks. Other tank farms experienced less severe temperatures than those recorded during SX Farm construction.

Figure 3-5. SX Farm Construction (January 20, 1954)

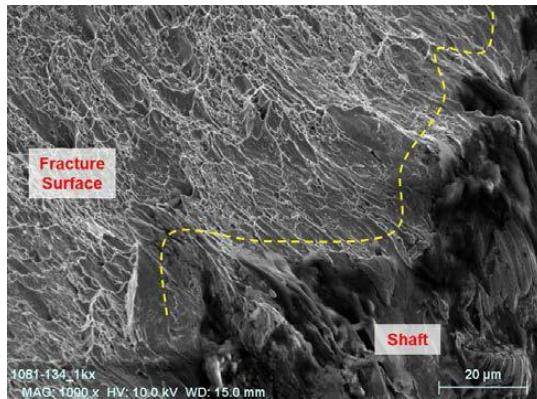
In all tests, there was no evidence of SCC at the specimen fracture surface (as seen by the ductile fracture surface in Figure D-1); however, at positive applied potentials, corrosion was observed for six of the compositions. An example of this corrosion is shown in Figure D-2, and complete results are provided in RPP-RPT-56141, *FY2013 DNV DST and SST Corrosion and Stress Corrosion Cracking Testing Report*. This corrosion phenomenon was investigated using follow-on CPP tests.

Figure D-1. Example of Ductile Fracture Surface from Tank TX-117 Slow Strain Rate Test

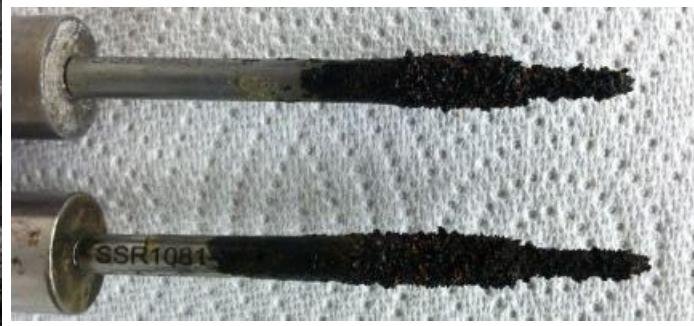
Figure D-2. Severe Corrosion on Tank TX-117 Specimen at +50 mV above Open Circuit Potential

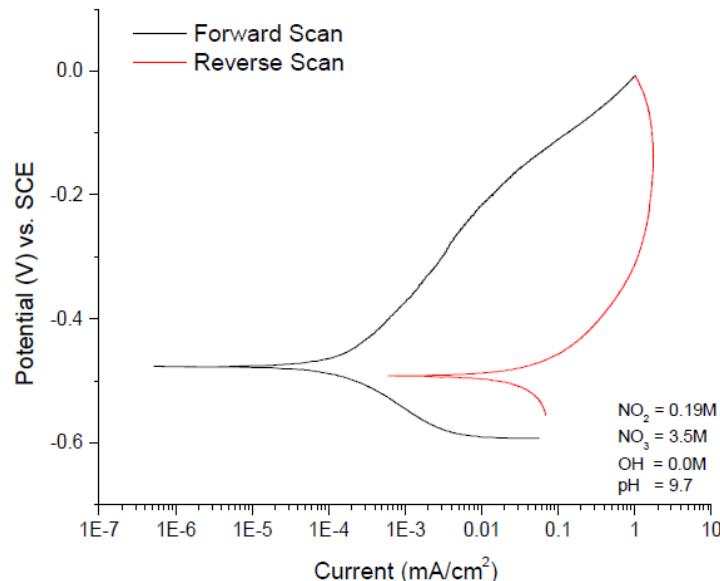
Pitting corrosion and a positive or mixed hysteresis was observed for the tanks that exhibited corrosion during the SSR tests, such as the Tank TX-117 result shown in Figure D-3.

Figure D-3. Cyclic Potentiodynamic Polarization for Tank TX-117 Simulant

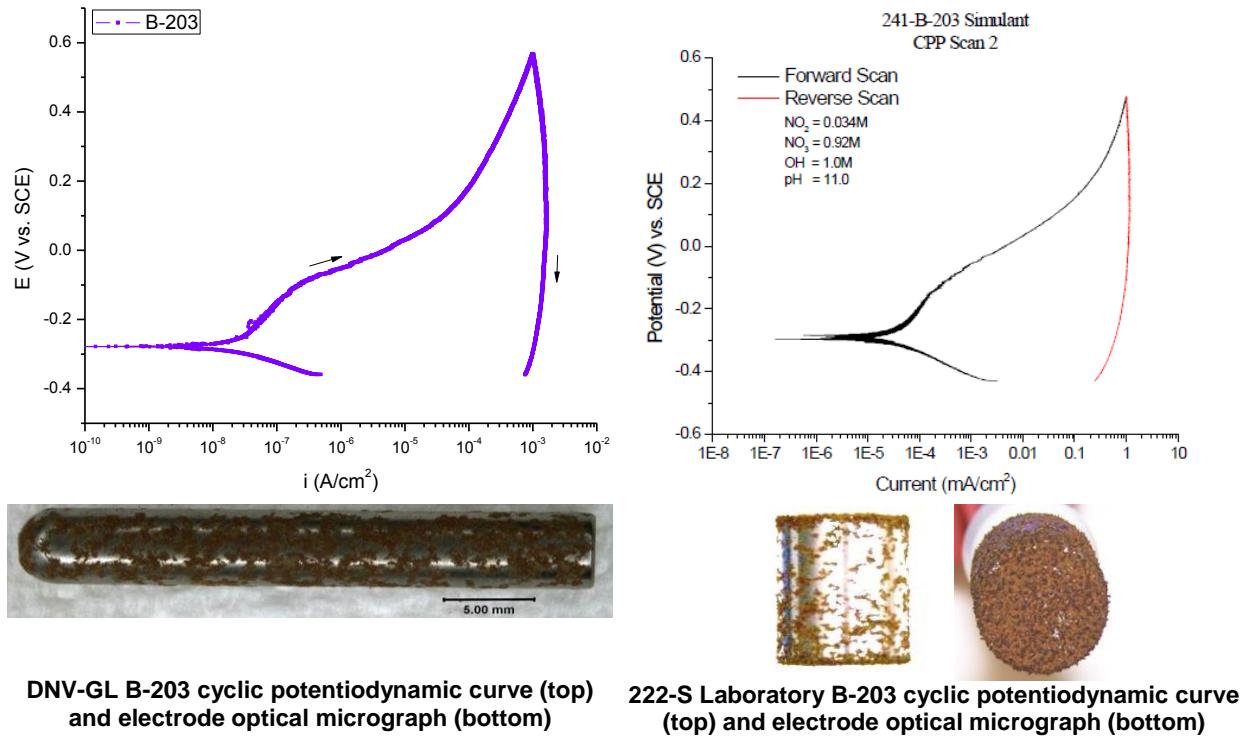
Note that aggressive waste layer CPP testing was conducted at two laboratories: 222-S Laboratory and DNV-GL. The results showed good agreement between the laboratories for the simulants that were tested because they use the same testing protocol. To illustrate this point, Figure D-4 shows the results comparison for the Tank B-203 simulant. Current and future testing can have confidence that the results are reproducible regardless of the laboratory used.

DNV-GL B-203 cyclic potentiodynamic curve (top) and electrode optical micrograph (bottom)

222-S Laboratory B-203 cyclic potentiodynamic curve (top) and electrode optical micrograph (bottom)

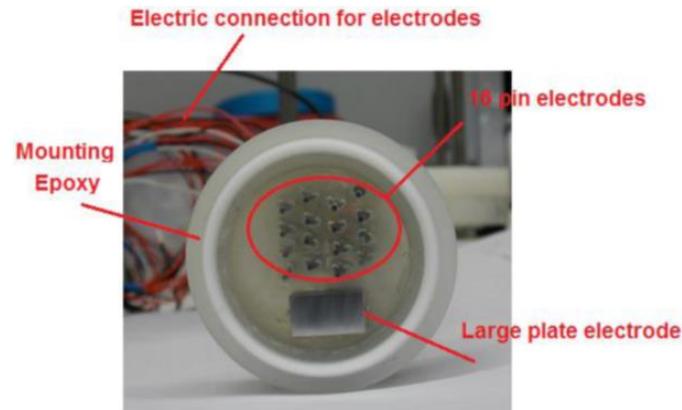
DNV-GL created a multi-electrode array (MEA) that used 16-pin electrodes in a 4×4 array and one large plate electrode (Figure D-5). The MEA was partially submerged and the current was monitored for each of the 16 electrodes. The purpose of this test was to determine the feasibility of using this technique for further LAI and vapor space corrosion testing using ammonia inhibition.

Figure D-5. Multi-Electrode Array for Liquid-Air Interface Corrosion Testing

Corrosion was not initiated at OCP after 48 days, so the MEA was polarized to accelerate the corrosion. Corrosion initiated in the large plate electrode and two-pin electrodes in the bulk solution, but not at the LAI. A 50 ppm and 500 ppm ammonia purge was used similar to the vapor space testing completed at SRNL, and the ammonia appeared to stifle the corrosion that was occurring in the bulk solution.
