SANDIA REPORT

SAND2012-7930

C6 Plate Puncture Testing Report

C6 Plate Puncture Plate Testing Report

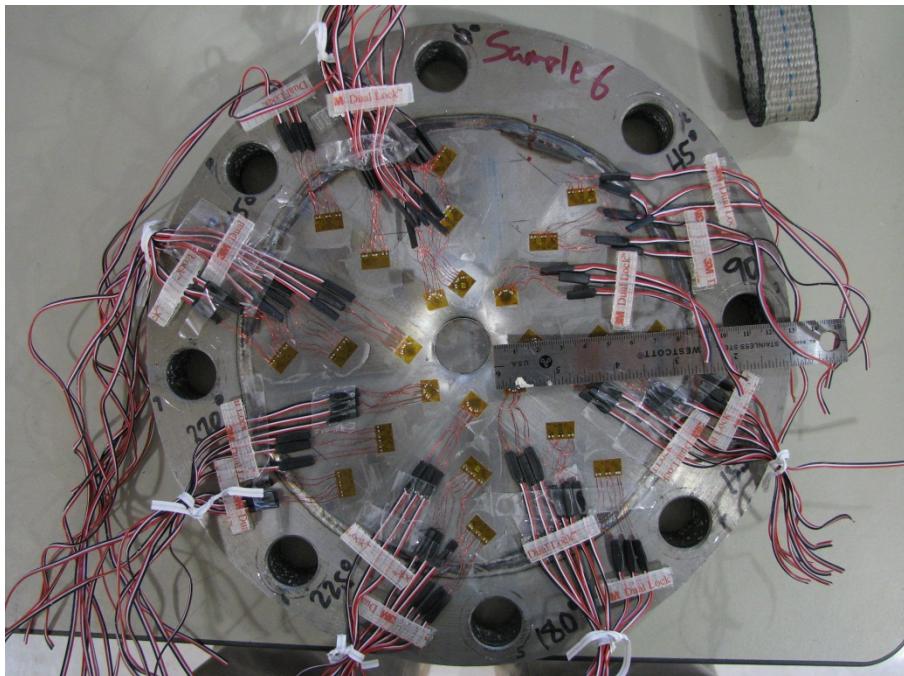
Figure 1. 6-inch diameter plate punched by a 1-inch cylindrical punch

It should be noted from Figure 1 that the orientation of each strain gage changed as the radial angle changed. In addition, the strain gages orientation pattern is not followed for strain gages located along the 0° and 45° radial angles: these gages were rotated 90° counterclockwise from the laid out pattern. Hence interpretation of the measurements shown in Figure 6 after compensating for the variation in strain gage orientations revealed that all principal axes pointed to the center of the plate. The principal angles on the ordinate axis are represented in units of degrees while load on the abscissa is shown in lb_f .

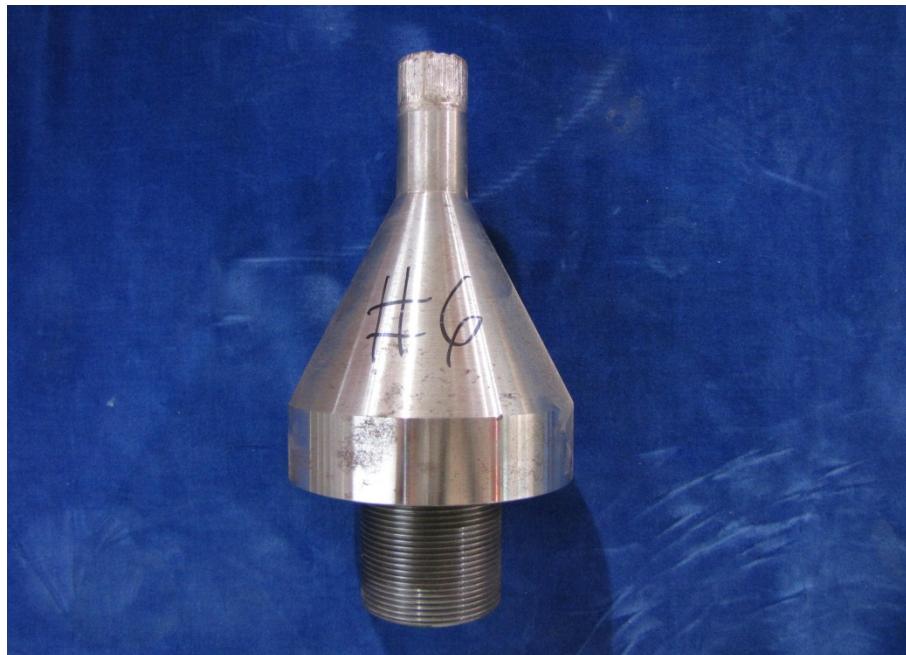
Figure 2. FY07 flat end, 1-inch cylindrical punch

The picture of the punch shown in Figure 2 was taken post-test and shows typical damage incurred by the 1-inch cylindrical punches. The damage at the tip extends approximately one inch in length because the punches used in this test series were allowed to fully pierce the plate. This complete penetration typically dislodged the plate material in contact with the circular end of the punch causing permanent deformation to the plate near the area of contact. The 0.5-inch cylindrical punches were similar in design to the punch shown in Figure 2 but were more susceptible to punch damage during testing as a result of their thin, elongated, cylindrical shape. Common damage to the 0.5-inch cylindrical punches included permanent bending of the smaller diameter punches or complete failure of the punch as shown in Figure 3.

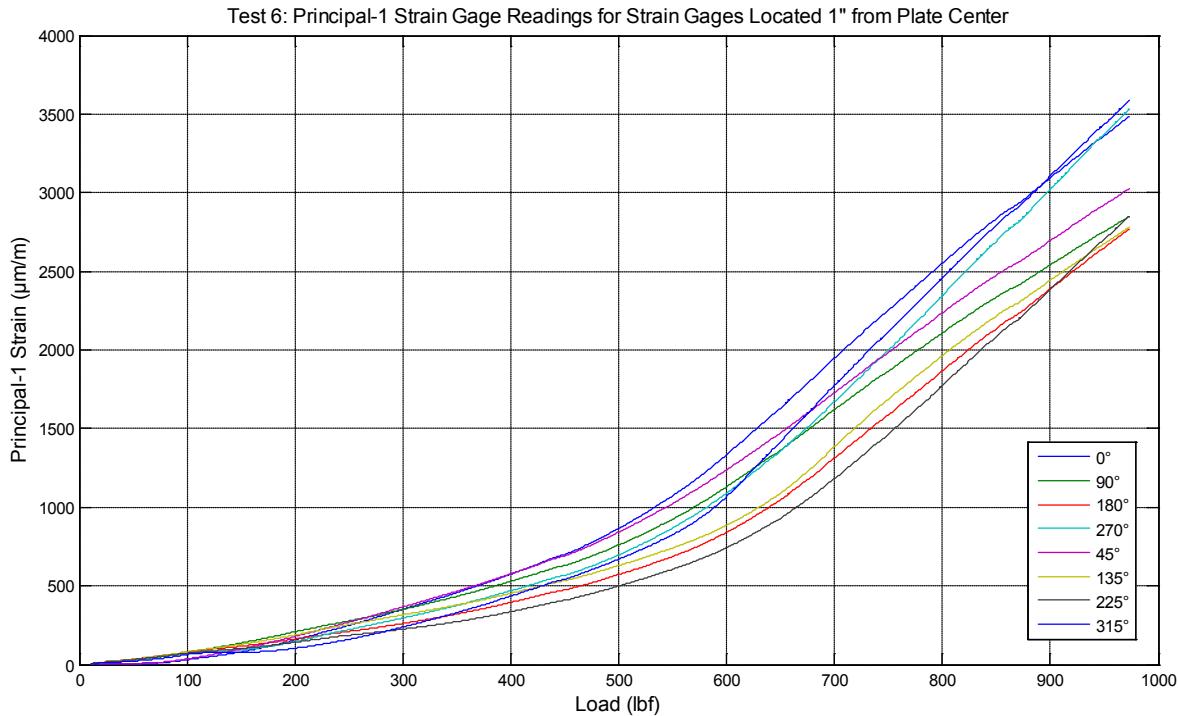
Figure 4. Test 6 principal strain 1

Strain is presented in Figure 4 in units of microstrain ($\mu\text{m}/\text{m}$), and load is represented as lb_f. The calculated strain gage channels for principal strain 1 increased with increasing load and all demonstrated a similar response. The calculated strains located at 0°, 270°, and 315°, exhibited slightly larger strains than any other location on the plate. The signal for the rosette strain gage located one inch from the center at the 0° axis was lost at approximately 1,700 lb_f. Post-test pictures reveal that this gage became delaminated from the plate. A similar loss in signal was observed for the strain gage located one inch from the center along the 315° line.

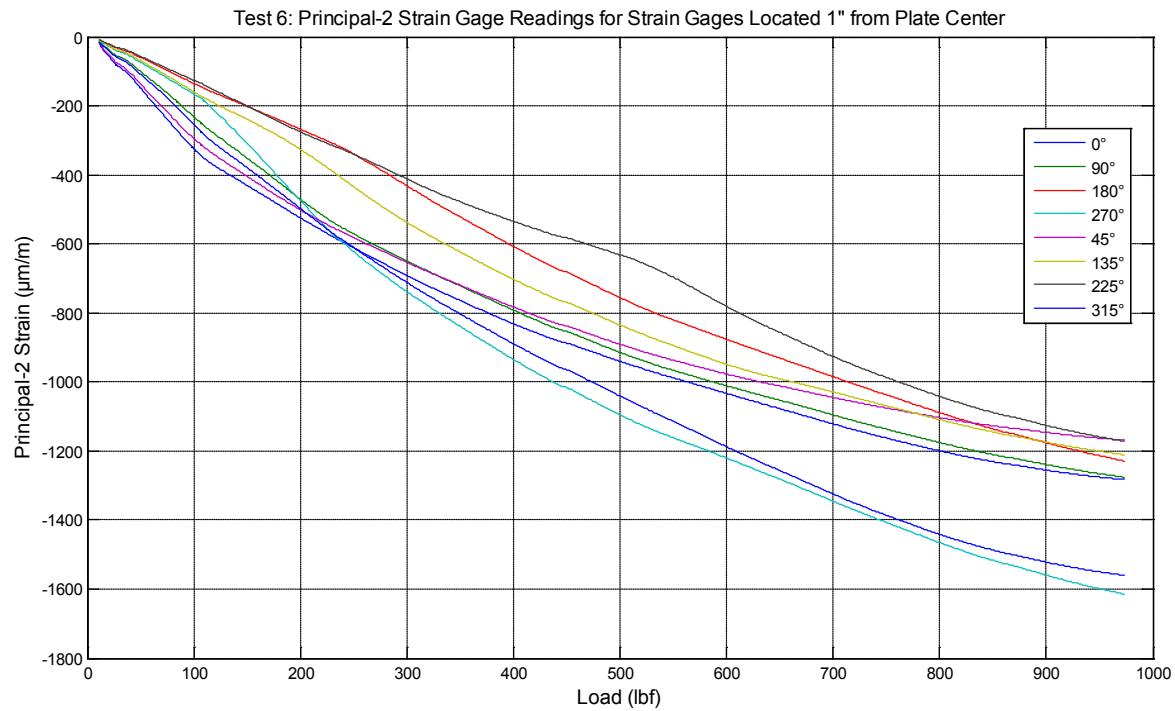
A look at the calculated principal 2 strains in Figure 5 showed a similar trend in data as did the principal-1 strains.

Figure 5. Test 6 principal strain 2

Once again the strains at 0° , 270° , and 315° displayed slightly higher calculated readings than did the other strain gages. Unlike the first principal strains, the second principal strains became increasingly negative as the load was increased.

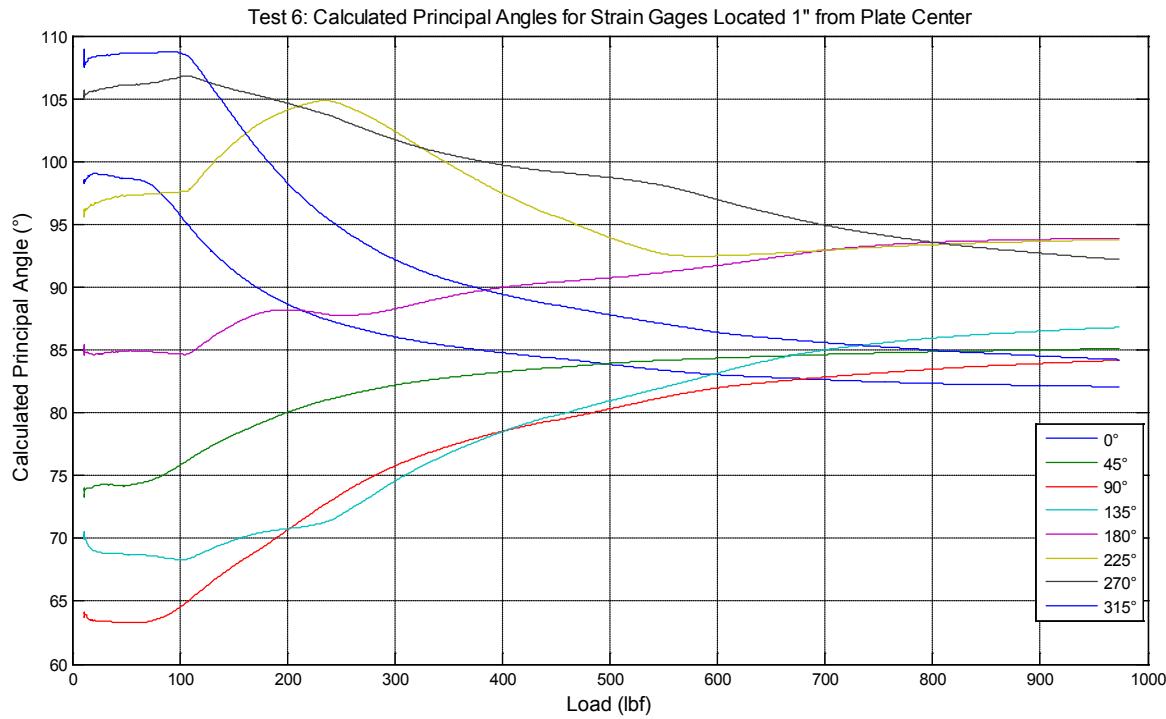
Figure 6. Test 6 principal angle

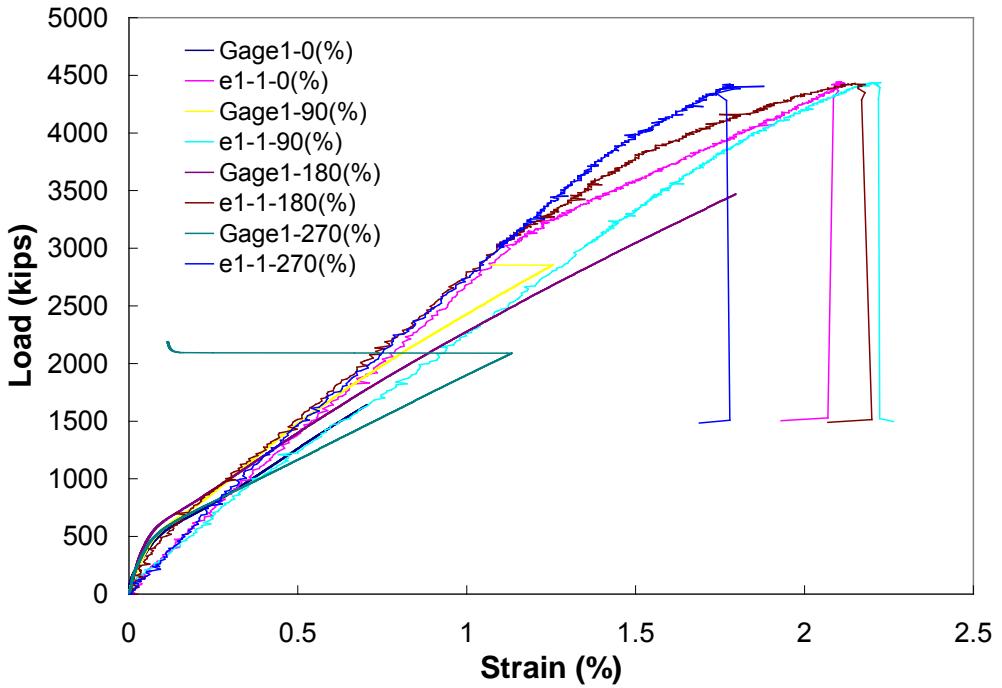
Figure 7 shows data from three sets of rosettes at the 1-inch radius from the center of the plate. The DIC data are indicated by the *e1* label, while the gage data are labeled as *Gage*.

Figure 7. Principal strain data from gages and corresponding DIC results extracted from the data

The DIC data are noisier than the gage data. This is an inherent limitation in DIC in that the strain data are obtained by differentiating the displacement data. This amplifies any noise in the data. Also note that the gages failed between 1% and 2% strain, well before failure of the part. DIC is typically able to achieve a much higher maximum strain measurement (hence the use of Lagrangian strain) than even a perfectly applied strain gage. However, without smoothing or averaging, the strain noise is higher. Data for the 2-inch radius are shown in Figure 8, and data for the 3-inch radius are shown in Figure 9.

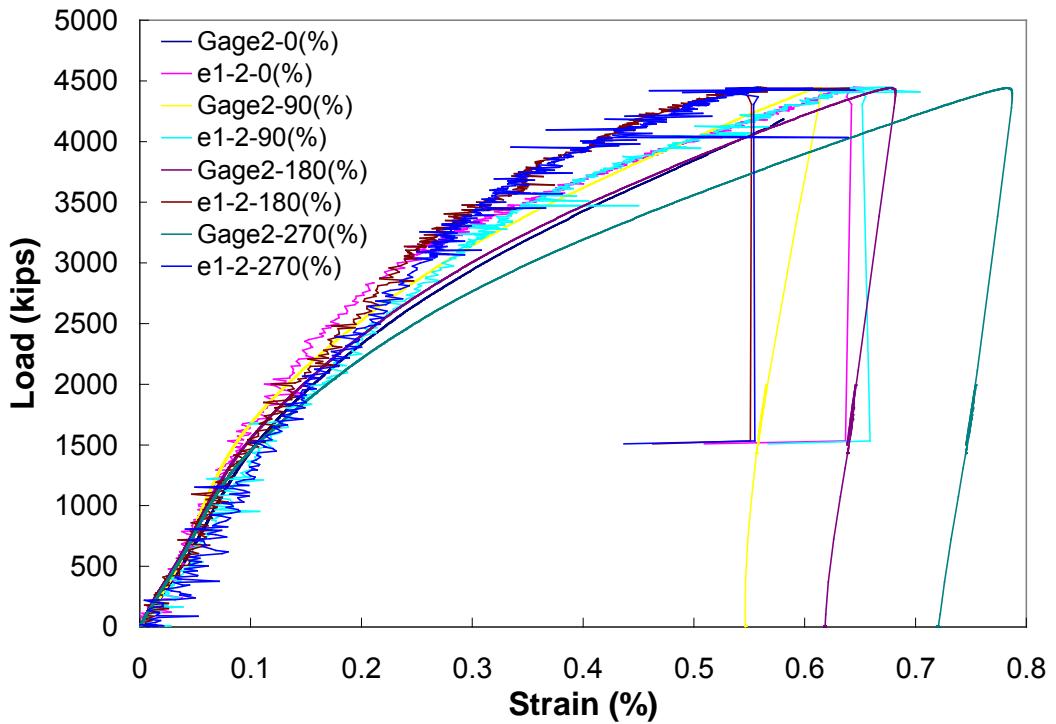
Figure 8. Principal strain data at 2-inch radius

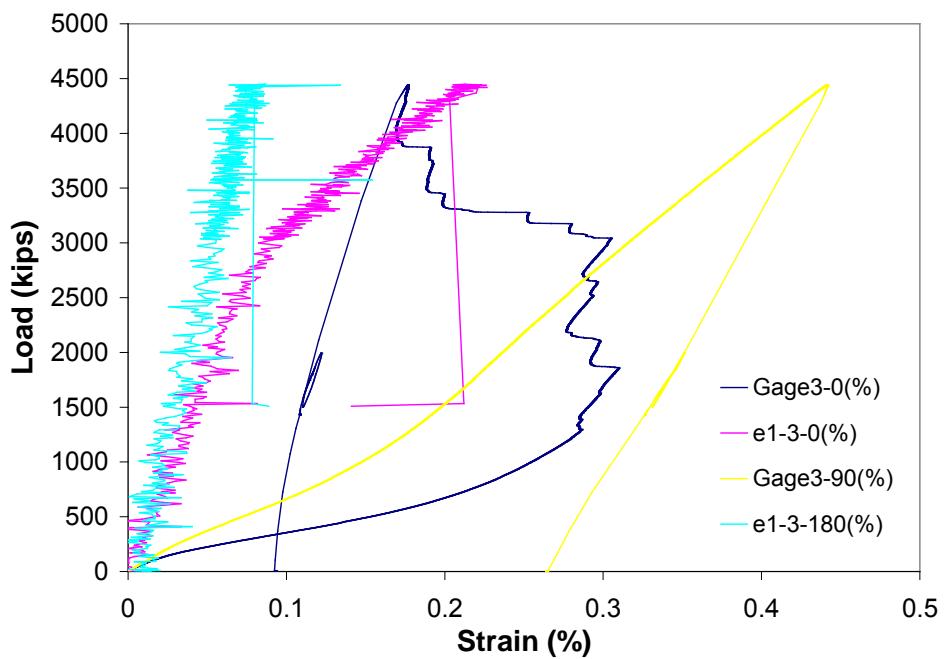
Figure 9. Principal strain data at 3-inch radius (Sample 6)

Comparison of the data at the 3-inch radius suffers mainly because of the low strain levels in that area of the sample: typically DIC can yield results down to 100 microstrain but struggles to achieve better than that. Also, this portion of the sample was not easily imaged with the load frame holding the sample. This did not allow for a data point to be picked as close to the gage location as desired.

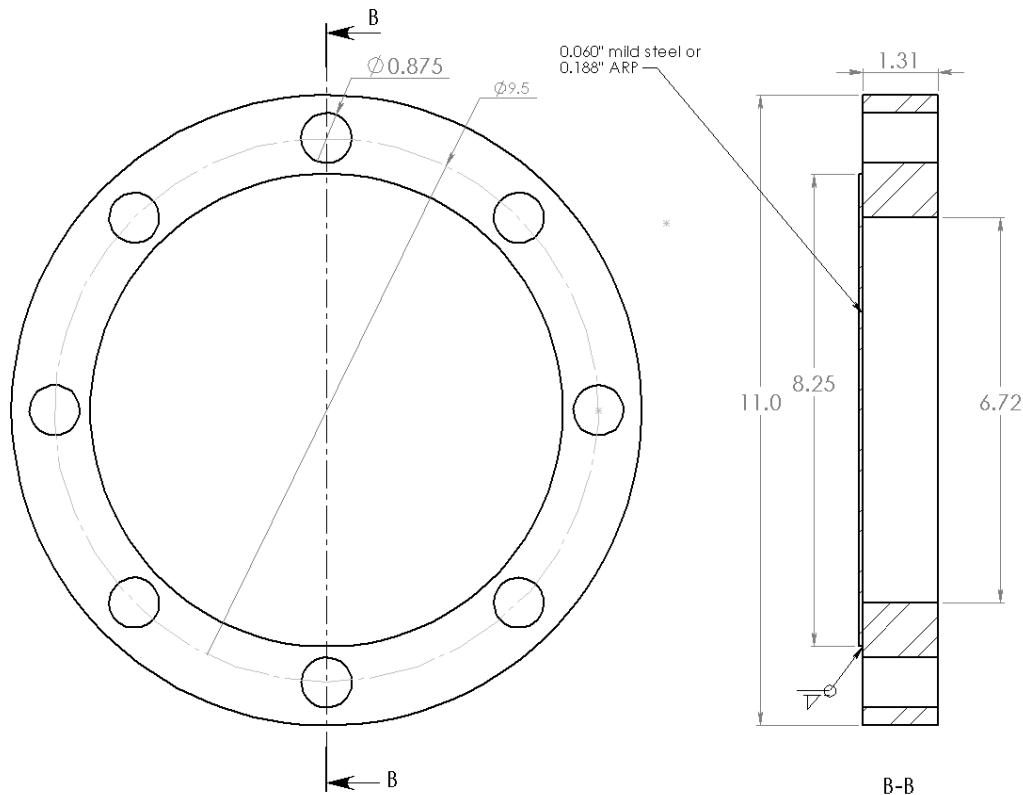
Test specimens were constructed by welding a disk of material to a commercial AWWA C207 Class E pipe flange. The nominal 6-inch size is shown in Figure 10. In FY07 some samples were made using a 12-inch nominal pipe flange; however, it was not possible to accommodate this size in the dynamic test setup. Therefore, all samples tested in FY08 and FY09 were fabricated for the size shown below. This geometry was selected because pipe flanges are an off-the-shelf item. Welding the plate provides a constrained boundary condition. The constrained boundary condition and axisymmetric geometry make it easier to model the tests with a finite element method.

Figure 10. 6-inch (nominal) plate geometry

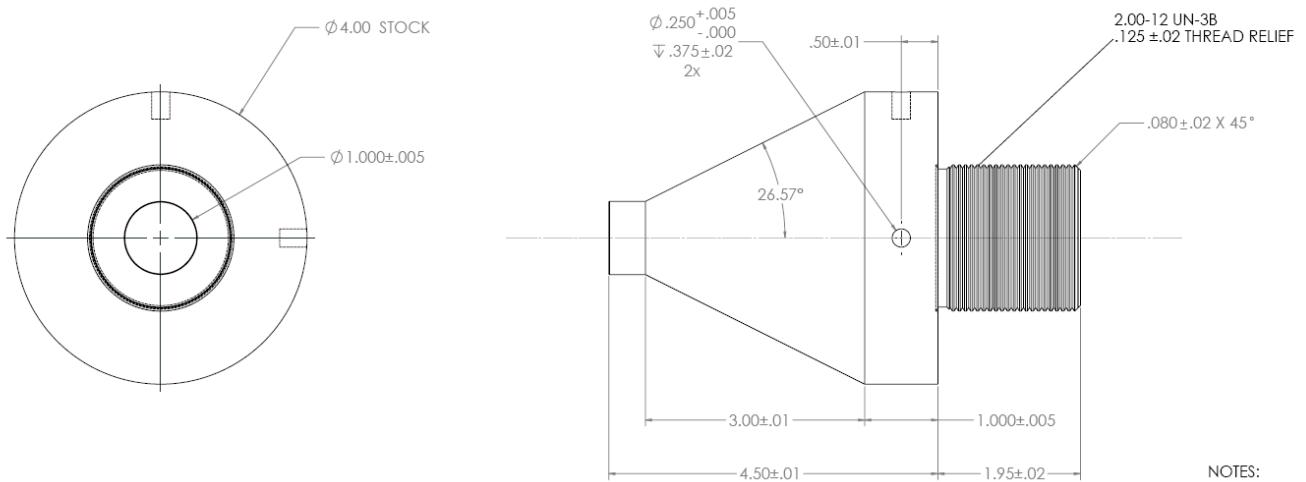
Two punch designs were utilized and are shown in Figure 11 and Figure 12. The cylindrical or flat-end punch is similar to the geometry used in FY07 although, the cylindrical section was shortened to be 0.5 inches long instead of 2 inches. This punch geometry typically loads the plate until a disk of material is punched out of the plate as it fails. The conical punch geometry was added to investigate a different stress field caused by spherical contact. The punches were manufactured of 4340 steel and heat treated to 188 ksi (i.e., 41.5 Rockwell C hardness).

Figure 11. Cylindrical (i.e., flat-end) punch

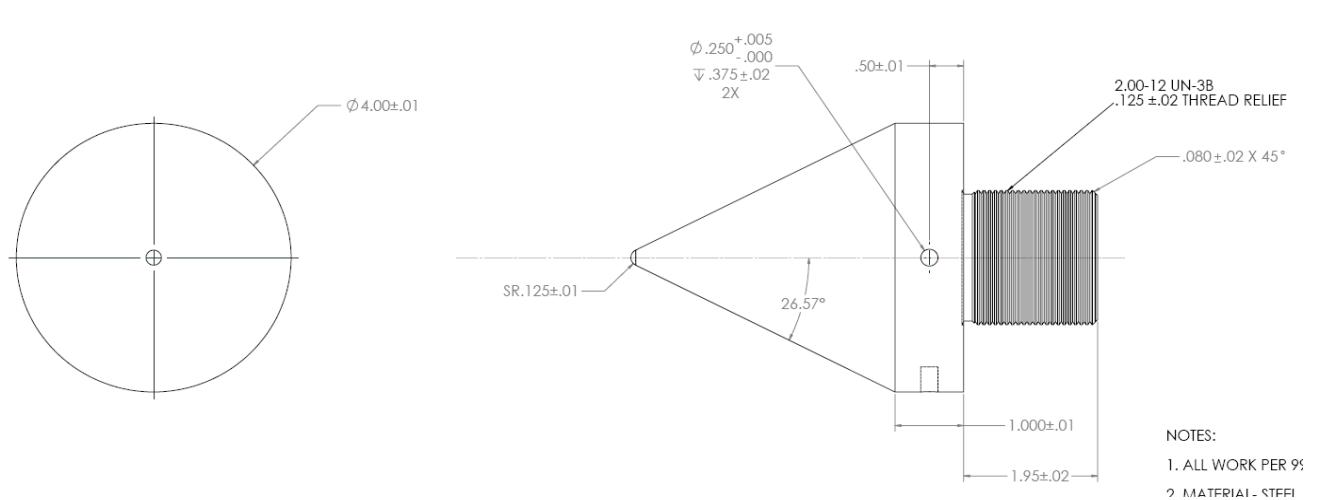
Figure 12. Conical punch

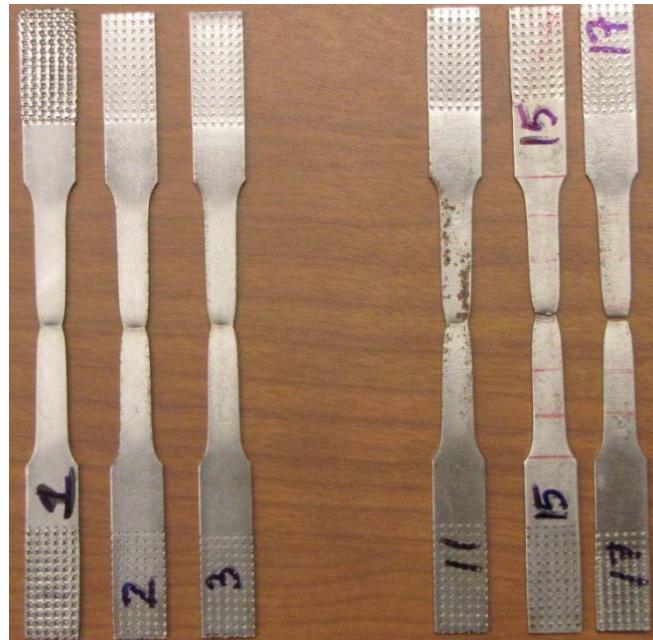
Figure 13 and Figure 14 show the tested samples of mild steel and abrasion-resistant steel, respectively.

Figure 13. Mild steel tensile samples (post-test)

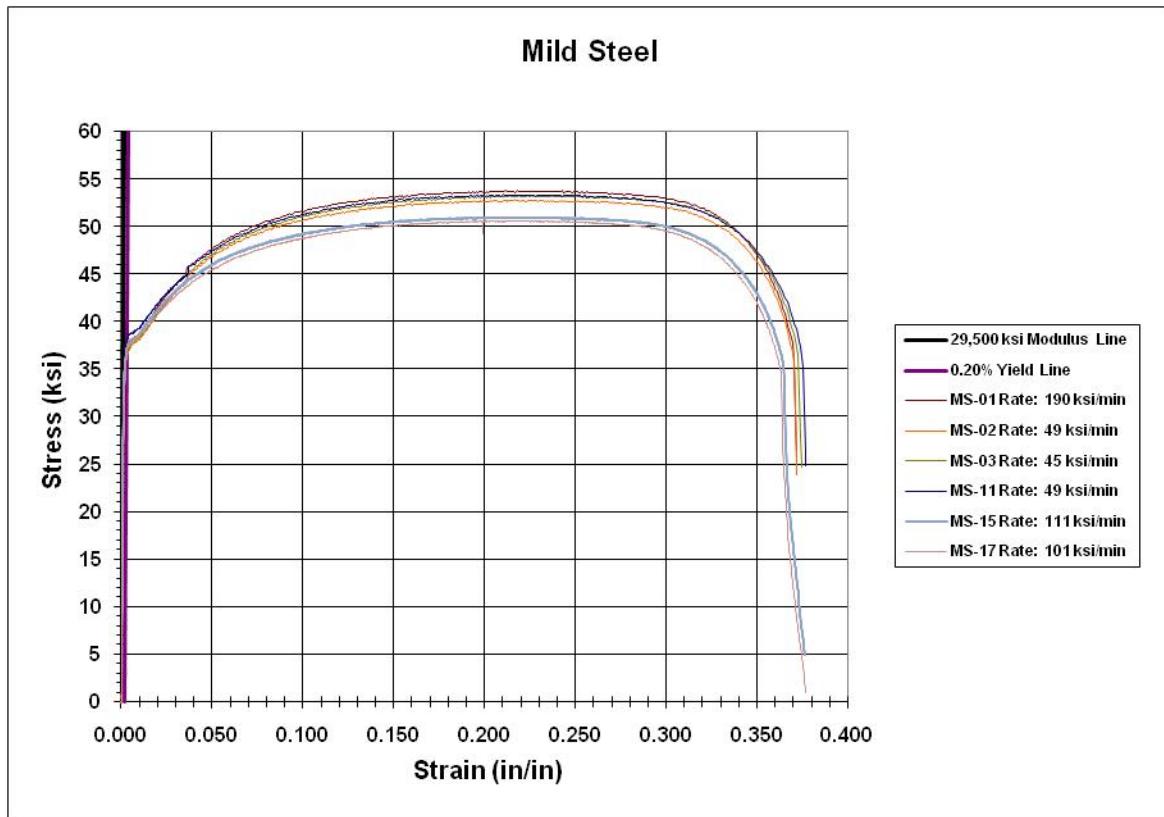
The mild steel is a very ductile material. This is apparent with the load decay rather than abrupt load drop as MS-15 and MS-17 in Figure 15 were pulled to separation. All samples achieved an elongation over 37%. The tensile strengths for the samples were approximately 50.5 ksi for MS-17 and MS-15, and 53 ksi for the other samples.

Figure 15. Engineering stress-strain curve for mild steel

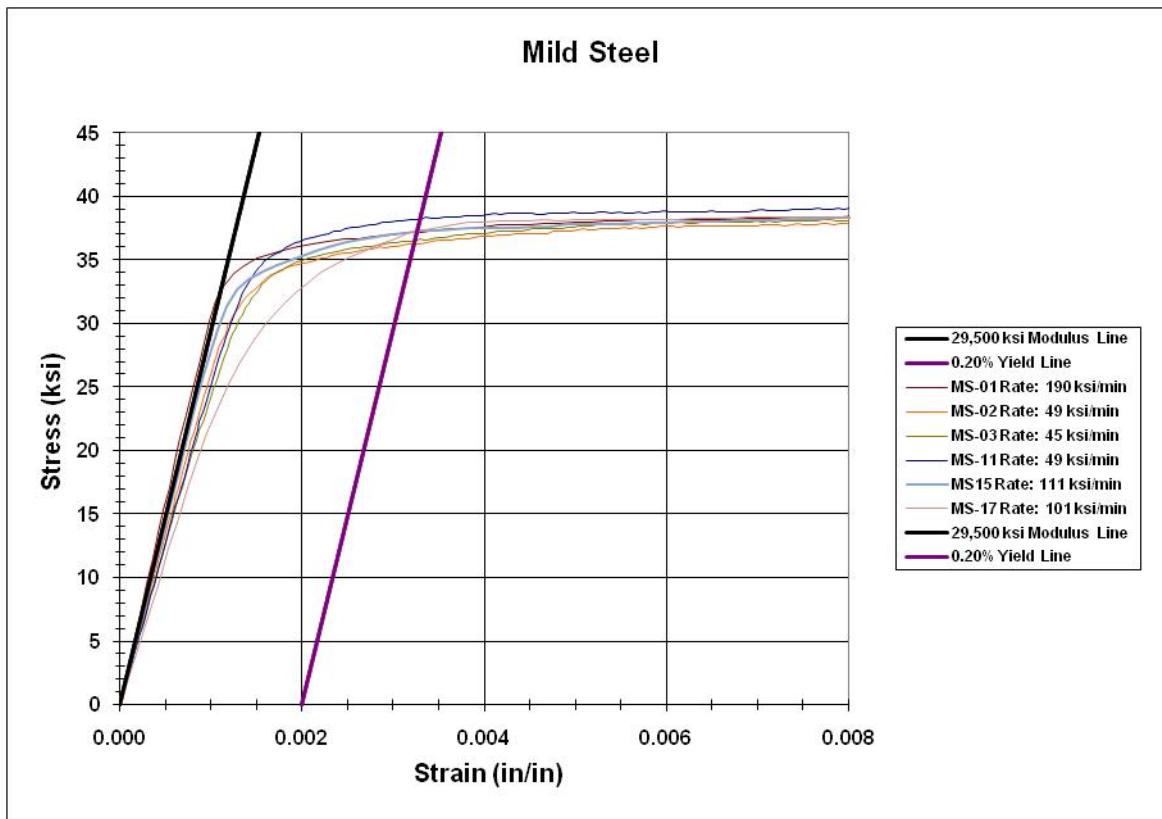
A closer look at the stress-strain curve in Figure 16 reveals information regarding the plastic yielding of the material. In addition to similar yield and ultimate strengths, the mild steel tensile samples exhibit close elastic behaviors. That is, the modulus of elasticity, E, is alike for transverse and longitudinal samples. The modulus of elasticity as well as the 0.2% yield offset are plotted in Figure 16. From the 0.2% offset line, a yield stress of approximately 37 ksi is noted.

Figure 16. Elastic region of the mild steel engineering stress-strain curve

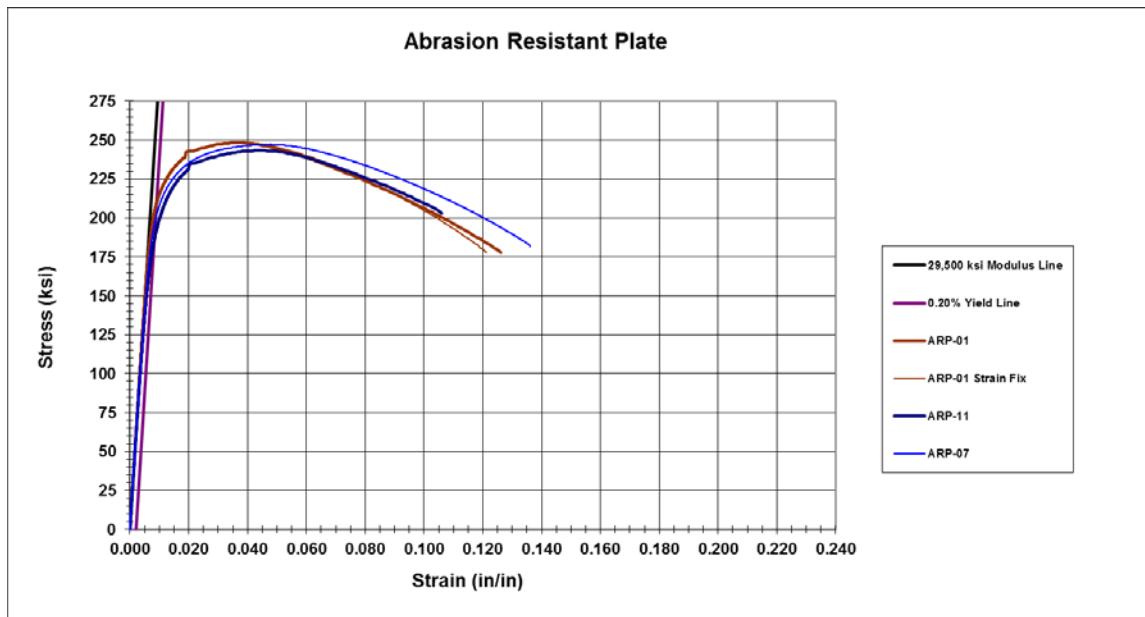
Figure 17. Stress-strain curve for abrasion-resistant plate

One extensometer knife edge for specimen ARP-01 (see Figure 17) was located in the area at which the specimen fractured, so the final elongation displayed for that curve in this graph is incorrect. The ARP-01 Strain Fix curve represents the actuator stroke from the point of ultimate stress and better represents the elongation of the specimen. Including the correction of the strain for ARP-01, the elongation for the specimens tested differed by 3%: it is more ductile in one direction than the other. The ultimate strength is about the same in both directions. According to the supplier, Oregon Steel Mills, a decrease in elongation in the transverse direction as compared to the longitudinal direction is expected. From this information, it was deduced that ARP-01 and ARP-07 represent the longitudinal direction. Without more information from the metal supplier as to the reason for the variance in strain for each direction, it can be assumed that the cause is attributed to the metal forming process of the material.

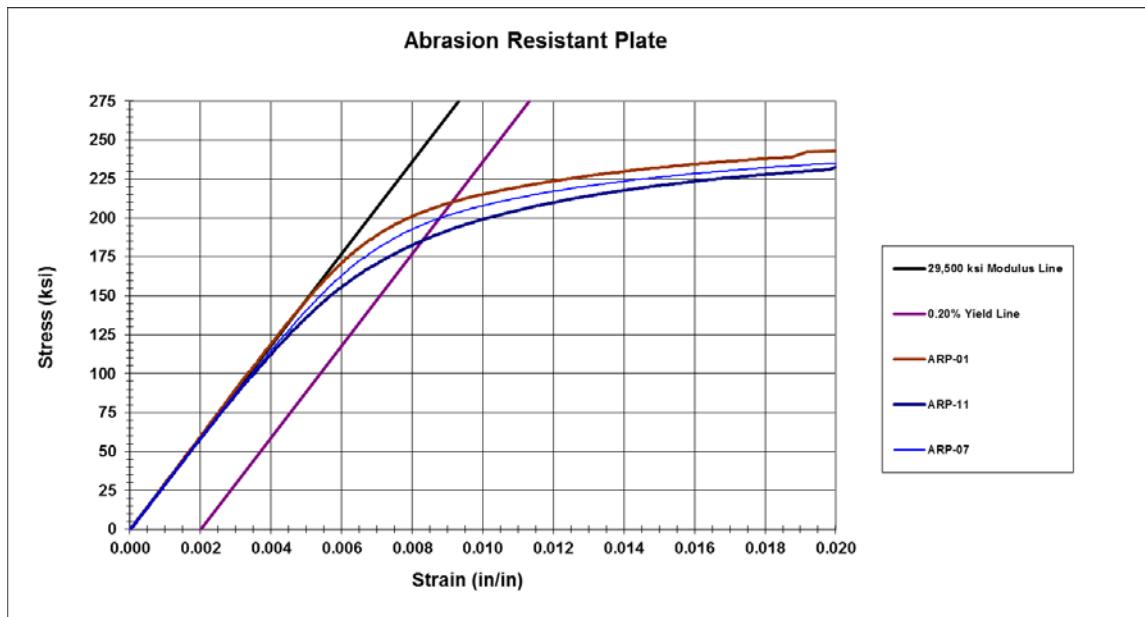
A magnified view of the initial portion of the stress-strain curve of Figure 18 gives information on the measured modulus of elasticity and yield strength of the abrasion-resistant metal.

Figure 18. Elastic-to-plastic engineering stress-strain region of ARP steel

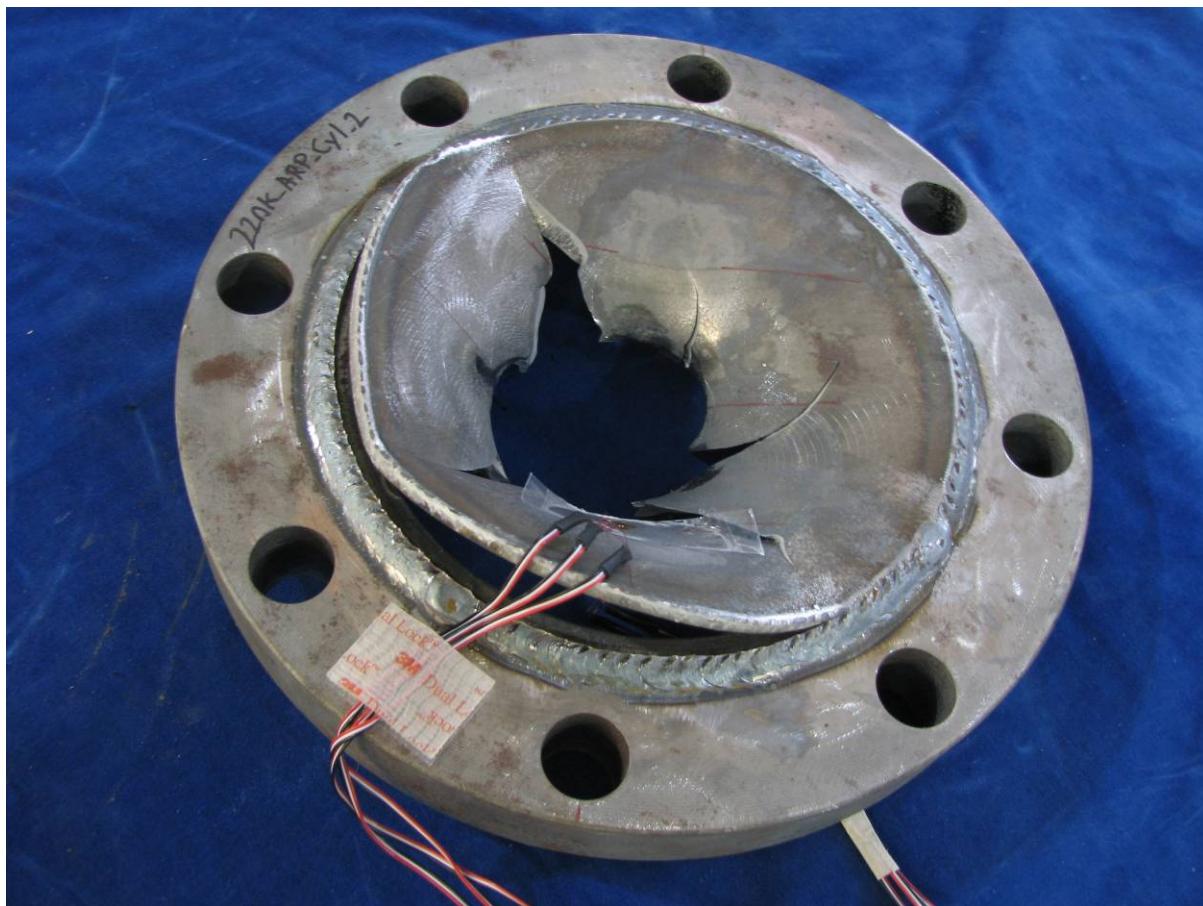
Quasi-static testing was initiated in the 220 kip uni-axial load frame to determine the maximum load achieved for each material. This initial testing required the rewelding of the abrasion-resistant plate to the flange because separation at the union was evident (see Figure 23).

Figure 23. Weld failure for cylindrical punch on ARP

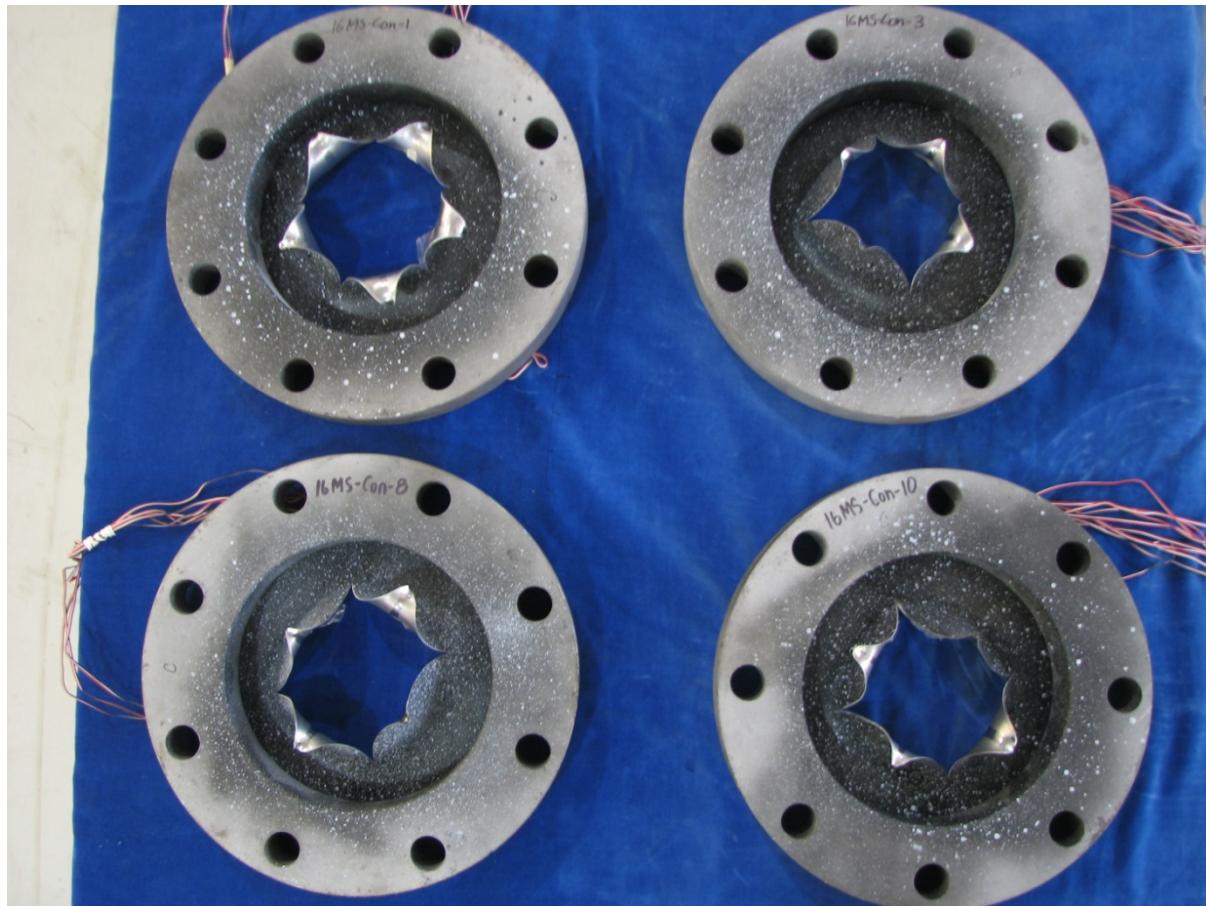
Different failure behaviors were observed between the two dissimilar metals. A petaling pattern was seen with the conical and cylindrical punches for the mild steel material. Figure 24 and Figure 25 display post-test pictures of some of the mild steel plates tested that display this phenomenon.

Figure 24. Mild steel plates punched with conical punch

MS-Con-101 and MS-Con-102 produced similar patterns to those shown in Figure 24. Similar to the plates tested using the conical punch, the cylindrical punch produced a comparable failure pattern as shown in Figure 25.

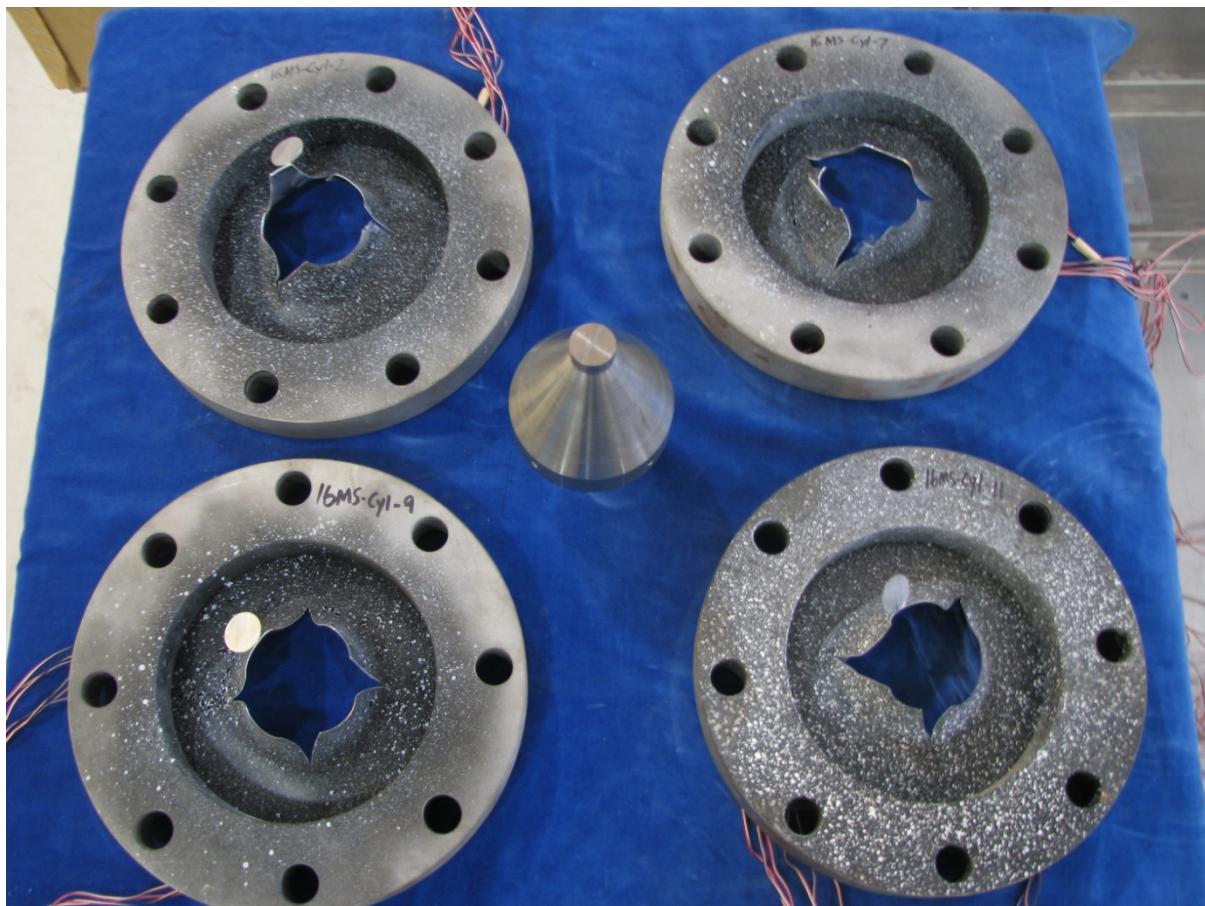
Figure 25. Mild steel plates punched with cylindrical punch

MS-Cyl-103 and MS-Cyl-104, which are not shown in the preceding figures produced patterns similar to the other plates tested with a cylindrical punch. An overall general petaling pattern was noted when the cylindrical punch was used. In all cases, a center circular area matching that of the punch end surface remained attached to the metal. Two of the cylindrical-punched plates (the upper left and lower left images in Figure 25) produced four petals. The other two plates produced three petals. Four petals were produced on MS-Cyl-103 and MS-Cyl-104. The punch used for testing is shown in the center of Figure 25.

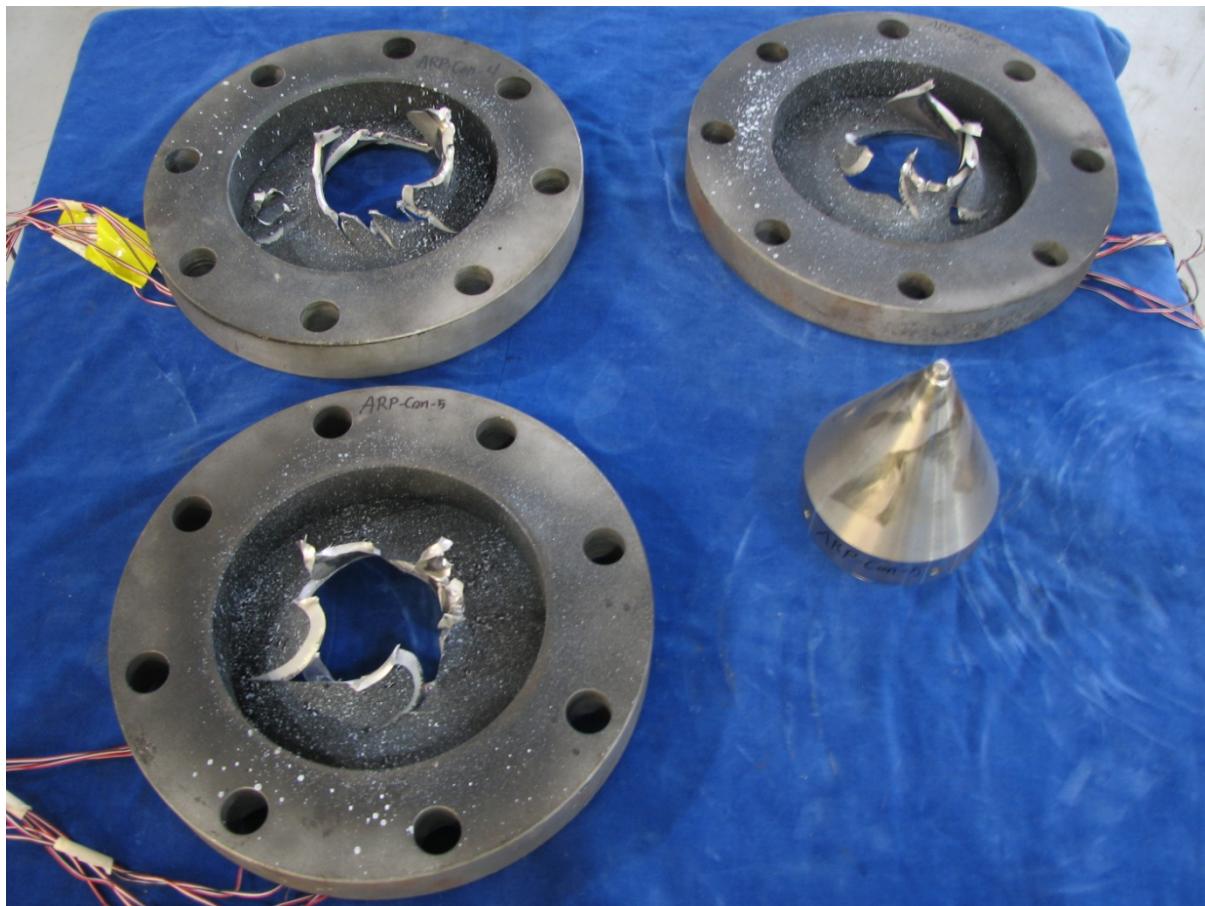
Unlike the mild steel, the abrasion-resistant steel produced vastly different failure patterns as shown in Figure 26. Only the conical punch was used during testing of this material.

Figure 26. Abrasion-resistant steel punched with a conical punch

A punch used for a single test is shown in Figure 26. It is immediately obvious that the punch incurred damage from testing. As a result, a conical punch was only used for one test. It was initially suspected that the punch rotated during contact with the plate, so the other punches used for the final abrasion-resistant plate tests were marked to determine whether the spiraled petaling on the plates was caused by punch rotation. The mark placed on the punch, however, indicated that the punch had not rotated, and the spiral affect could, therefore, not be attributed to the movement of the punch itself. ARP-Con-101 and ARP-Con-102, which are not shown in here, displayed failure patterns similar to those shown in Figure 26.

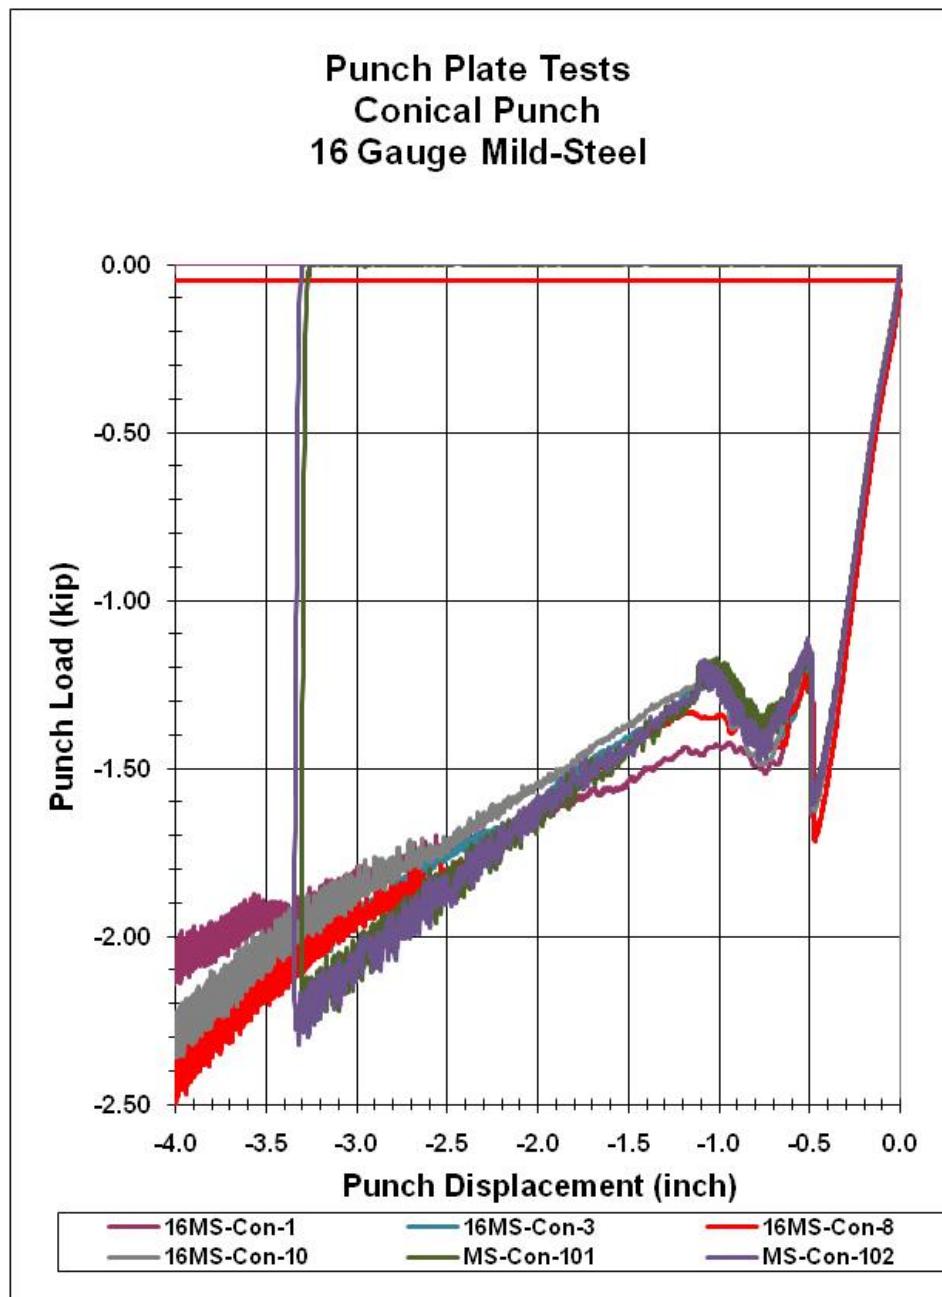
The load versus displacement response for the mild steel plates that were pierced with the conical punches are shown in Figure 27. Although Plate 1 produced the five petals versus the four produced by the other plates, it is not obvious from the data as to the reason for this result.

Figure 27. Load versus displacement response for mild steel plates punched with a conical punch

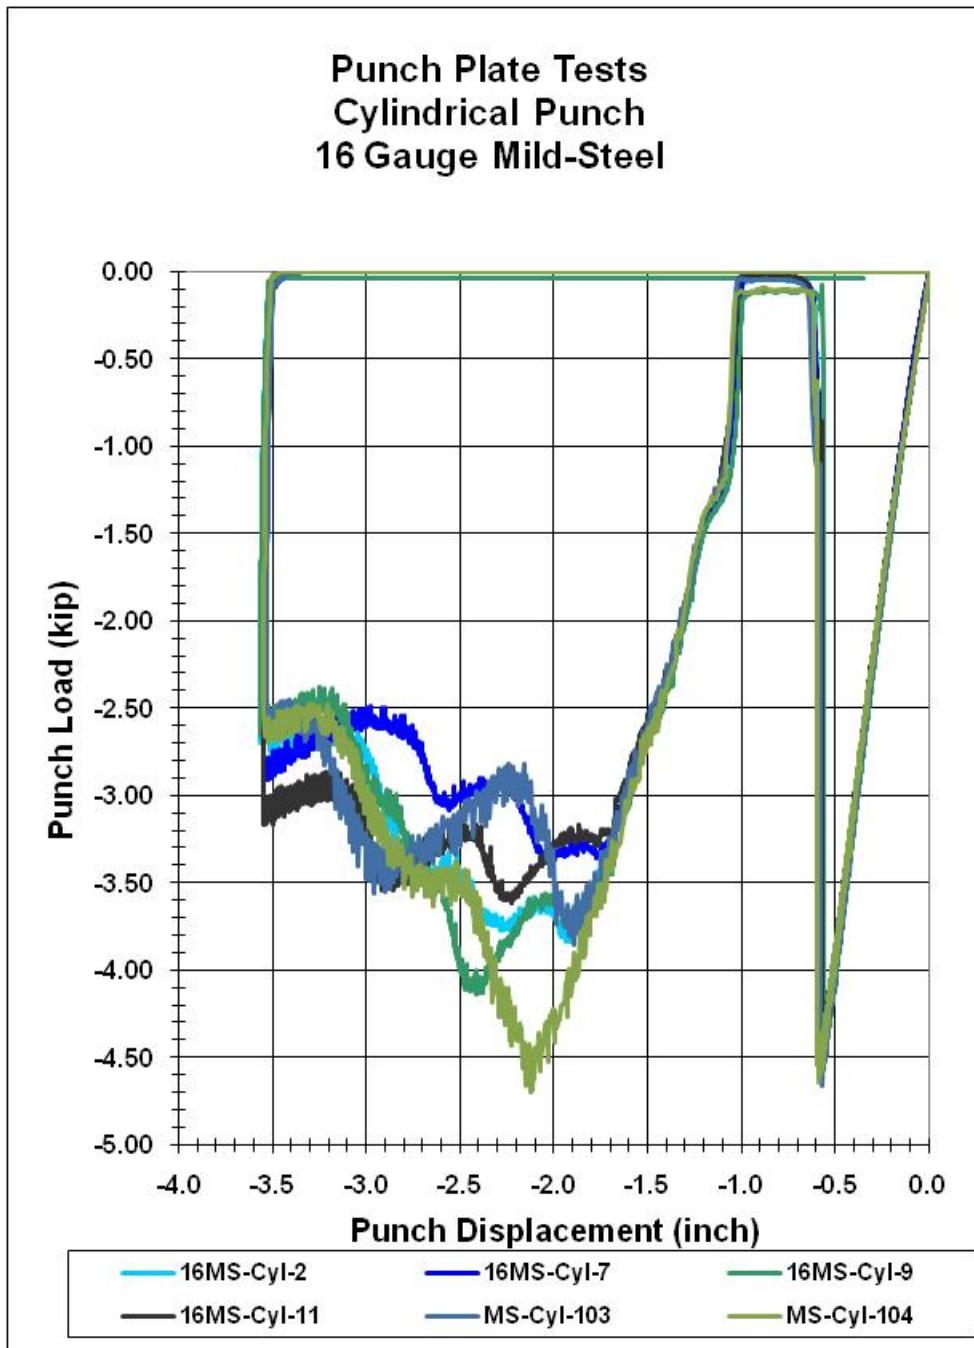
The results from testing of the mild steel plates with cylindrical punches are shown in Figure 28.

Figure 28. Load versus displacement behavior for mild steel plates punched with a cylindrical punch

The cylindrical punch allowed more rebound of the plate because the diameter of the punch was constant along the cylinder, and the plate is allowed to move back to a zero-load condition. Thus the compressive load on the plate is lost. The load remained near zero until the tapered region of the punch began to engage the plate, at which point the compressive load rose again. Once petaling began, variations in the failure behavior are indicated by curve deviations. As shown in Figure 28, all failure patterns closely follow one another until petaling occurred.
