SANDIA REPORT

SAND2012-7930

C6 Plate Puncture Testing Report

C6 Plate Puncture Plate Testing Report

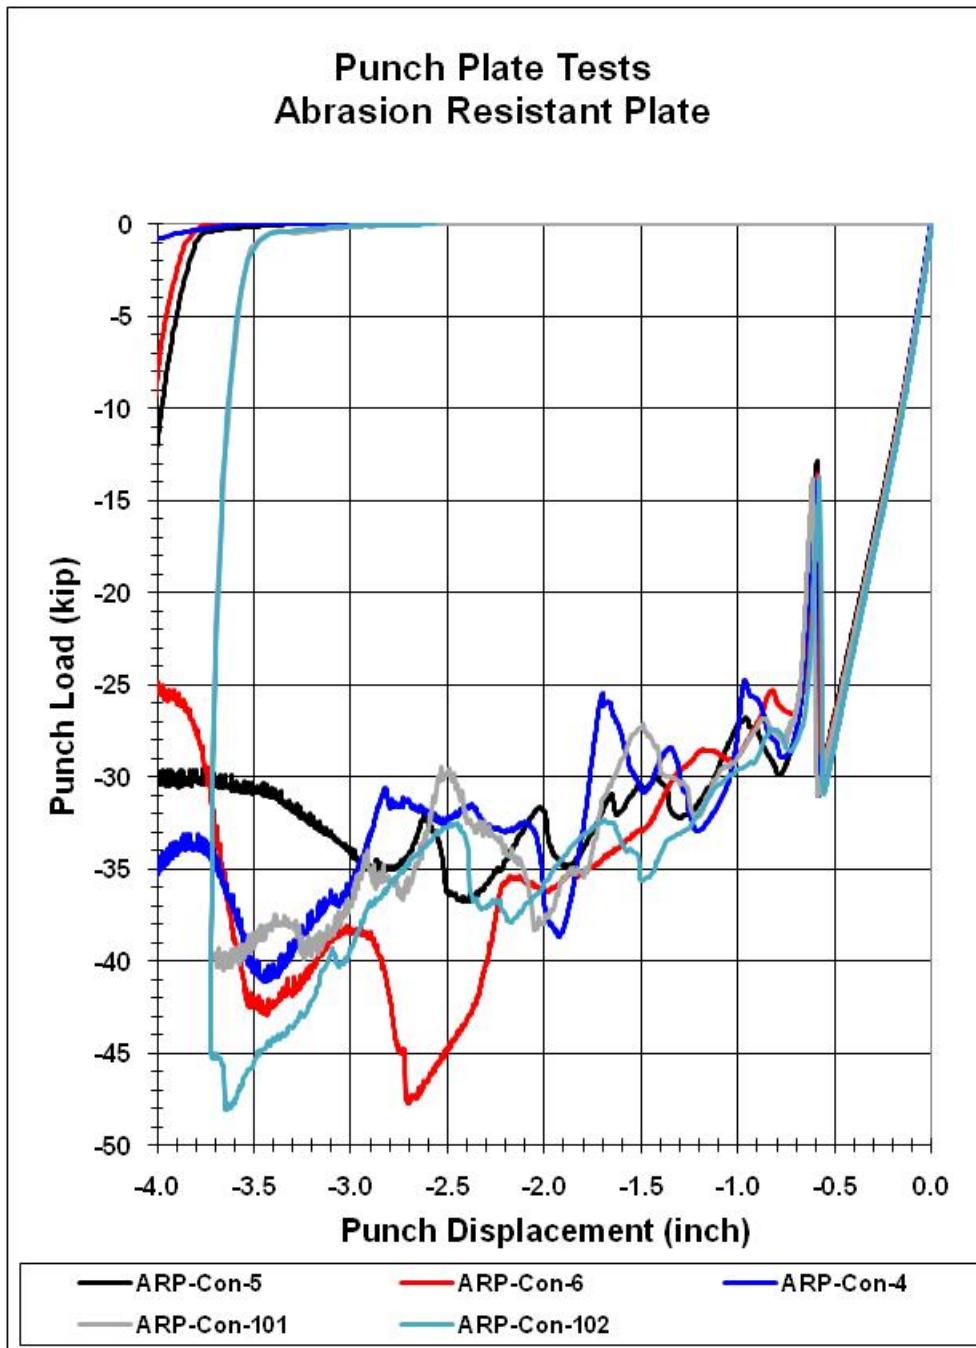
Initially the load versus displacement behavior for the abrasion-resistant plate behaved similarly to the mild steel but with much higher loads achieved (see Figure 29).

Figure 29. Load versus displacement response for abrasion-resistant steel punched with a conical punch

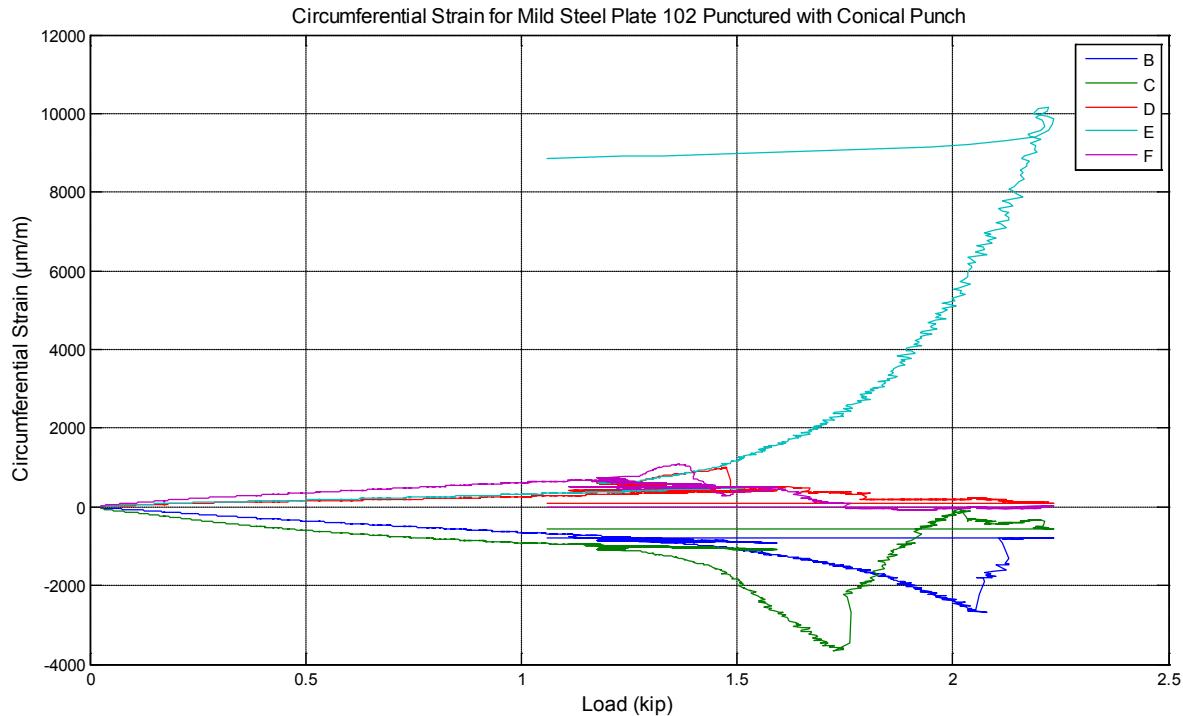
Similar behaviors are noted for the circumferential readings for each side of the plate as presented in Figure 31.

Figure 31. Circumferential strain for mild steel Plate 102 punched with a conical punch

Material in the circumferential orientation on the punch side, denoted by B and C, experienced compression while material on the opposite side of the plate with the same circumferential orientation elongated. Once again, the strain values are slightly higher on the punch side as compared to the DIC side, but the general strain response behaviors observed on one side of the plate appear to be mirrored by those on the opposite side until puncture of the plate.

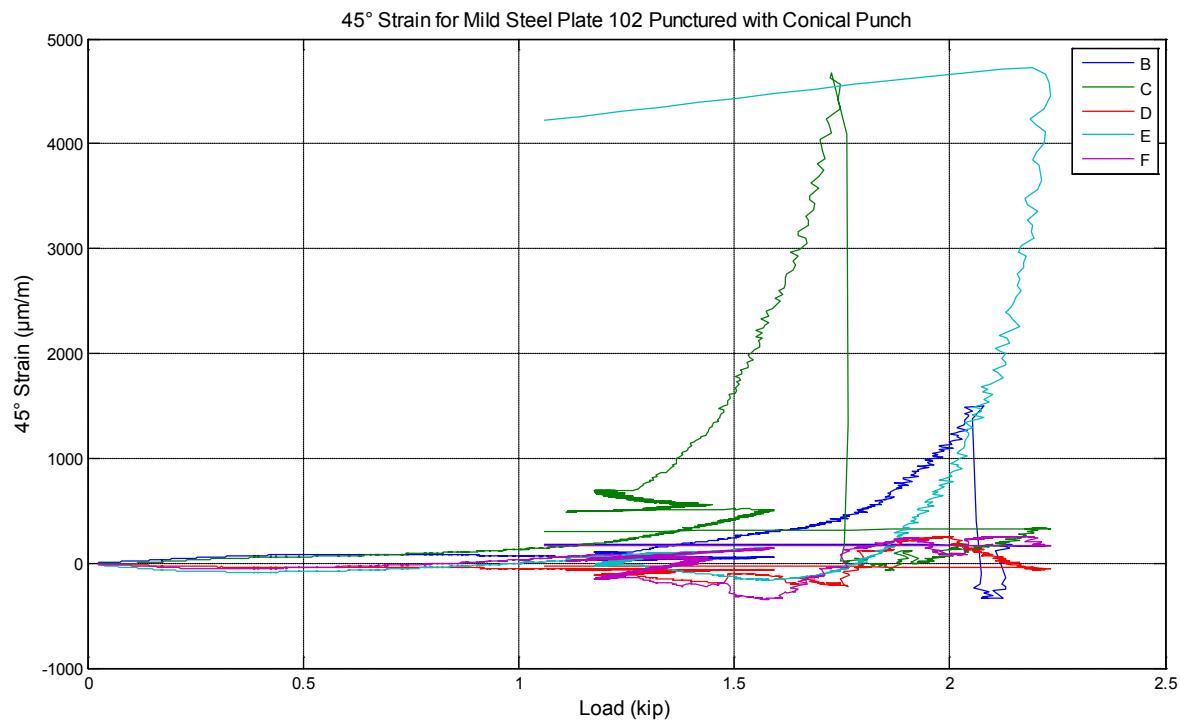
Consistency in the cluttering of strain readings are again obtained for the 45° reading of the rosette gages as shown in Figure 32.

Figure 32. 45° strain for mild steel Plate 102 punched with a conical punch

A similar response observed for the radial and circumferential strain is repeated for the 45° strain reading. The strains on one side of the plate are closely cluttered and mirrored by the readings on the opposite side of the plate. Comparisons of strains along these directions show very little difference in magnitude compared to those observed by the radial and circumferential readings.

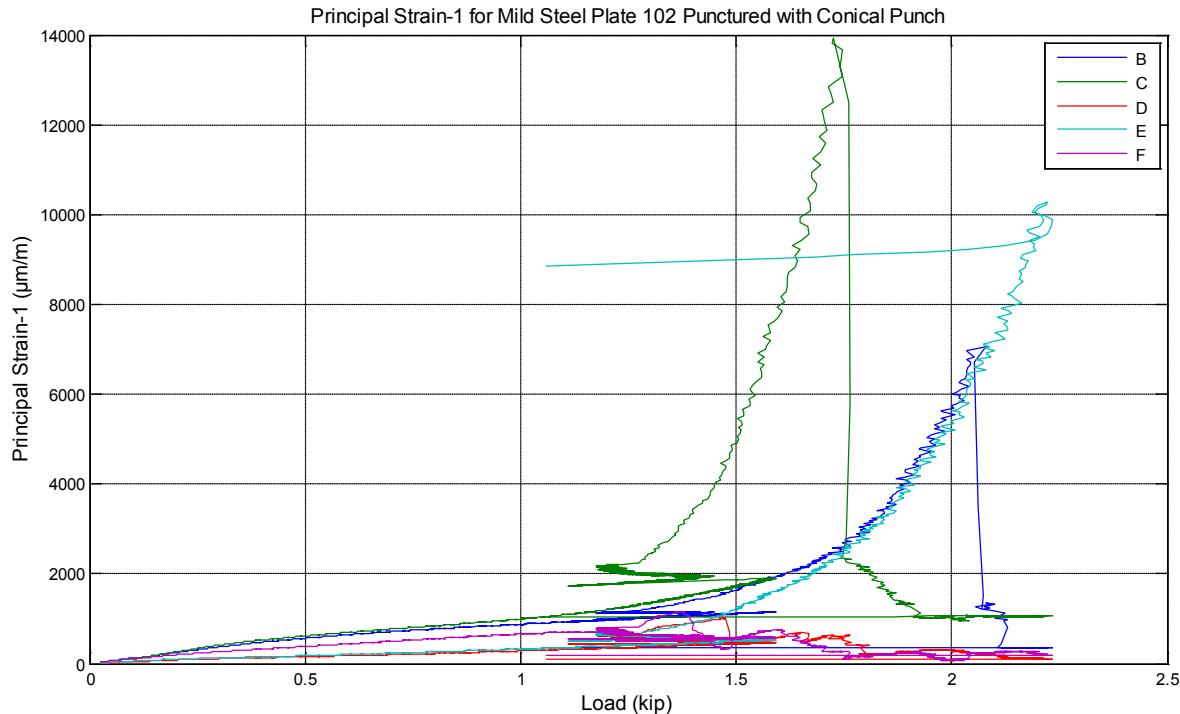
A comparison of the principal strains as shown in Figure 33 and Figure 34 reveal similar response patterns for principal-1 and principal-2 calculated strains.

Figure 33. Principal strain 1 for mild steel Plate 102 punched with a conical punch

It should be noted from Figure 33 that the calculated principal-1 strain until puncture for Gage F differs significantly from Gages D and E. Given the axisymmetric geometry of the setup and the 1.75-inch location from the center of Gages D and F, it was expected that Gages D and F would have closer principal-1 strains than Gages D and E. Gage E was located along the same radial axis as Gage D but 0.75 inches further away from the center.

Again, Gages D and F show slightly different principal strain magnitudes. As with the principal-1 strains, principal-2 strains for Gages E and F are more alike than Gages D and F. After closer examination of the failed MS-Con-102 plate, it was noted that the line of fracture that spread further along the Gage F axis was comparable to the axis of Gages D and E. This may explain the increased strain illustrated in Figure 33 and Figure 34 for Gage F when compared to Gages D and E.

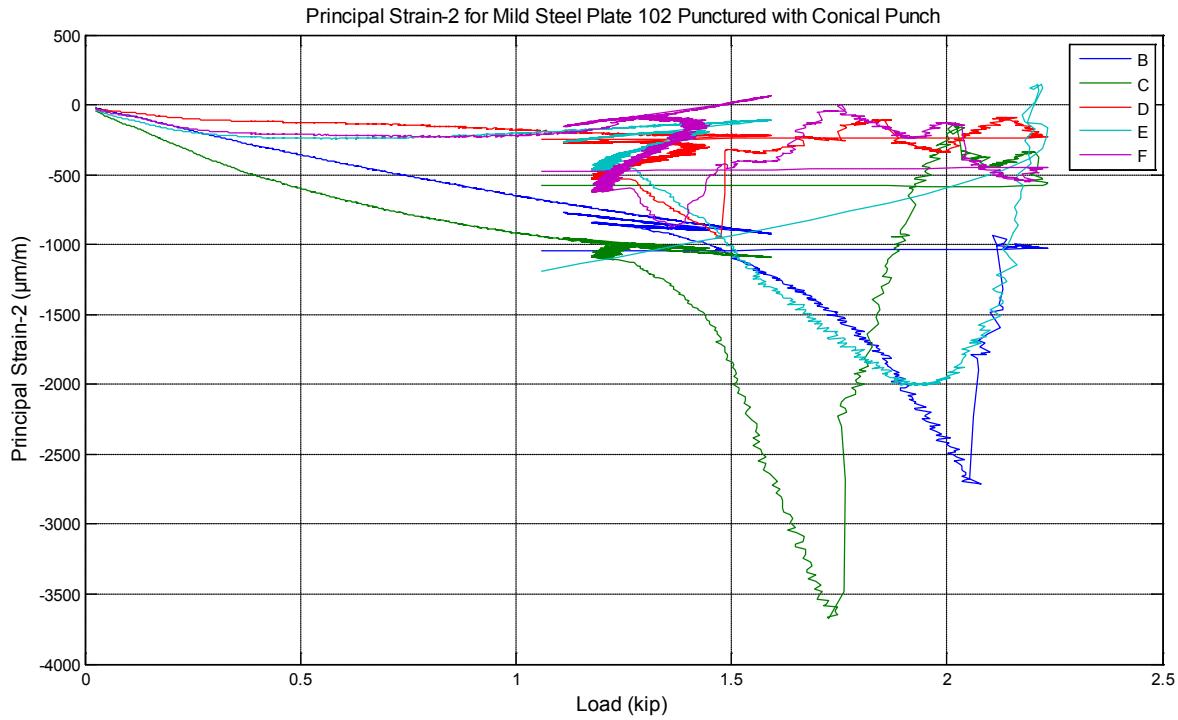
It is not surprising to notice that the calculated principal strain magnitudes are higher for those readings located on the punch side of the plate and, therefore, closer to the point of contact as again demonstrated in Figure 34 for the principal-2 strain.

Figure 34. Principal strain 2 for mild steel Plate 102 punched with a conical punch

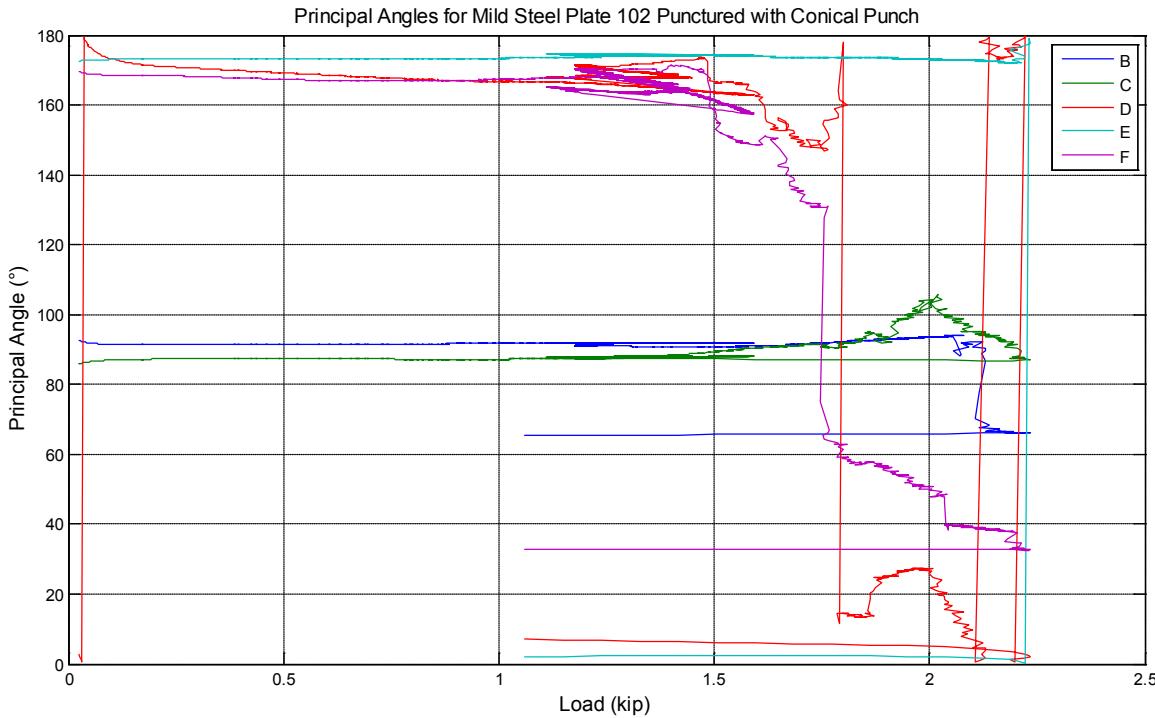
Figure 35. Principal strain angles for mild steel Plate 102 punched with a conical punch

As shown in Figure 35, the two gages located in the punch side of the plate have similar principal angles. The gages on the DIC side of the plate were a mirror image of those on the punch side and would present principal angles 90° off from those on the punch side. Interpretation of Figure 35 indicates that all principal angles point toward the center of the plate, just as was observed in the heavily gaged FY07 plate (see Figure 1).

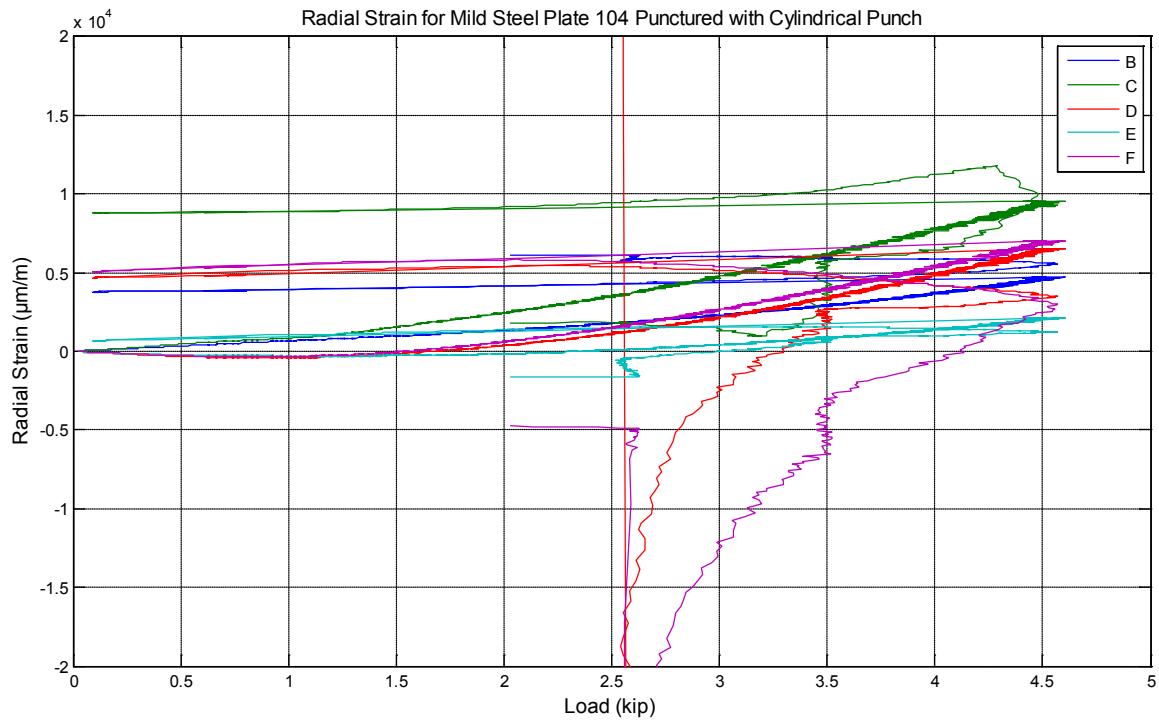
As with the mild steel punched with a conical punch, the mild steel plate punched with a cylindrical punch produced symmetric results. A look at radial and circumferential strains gives a better understanding of the symmetry in failure (see Figure 36 and Figure 37).

Figure 36. Radial strain for mild steel Plate 104 punched with a cylindrical punch

As shown in Figure 36 and Figure 37, strains on the punch side of the plate are again higher than on the DIC side. More symmetry is observed between Gages D and F than when the mild steel was punched with a conical punch. Petaling of this plate did not create cracks along the strain gage axes in this case. Strain gage readings for the axis lying between the circumferential and radial readings are shown in Figure 38.

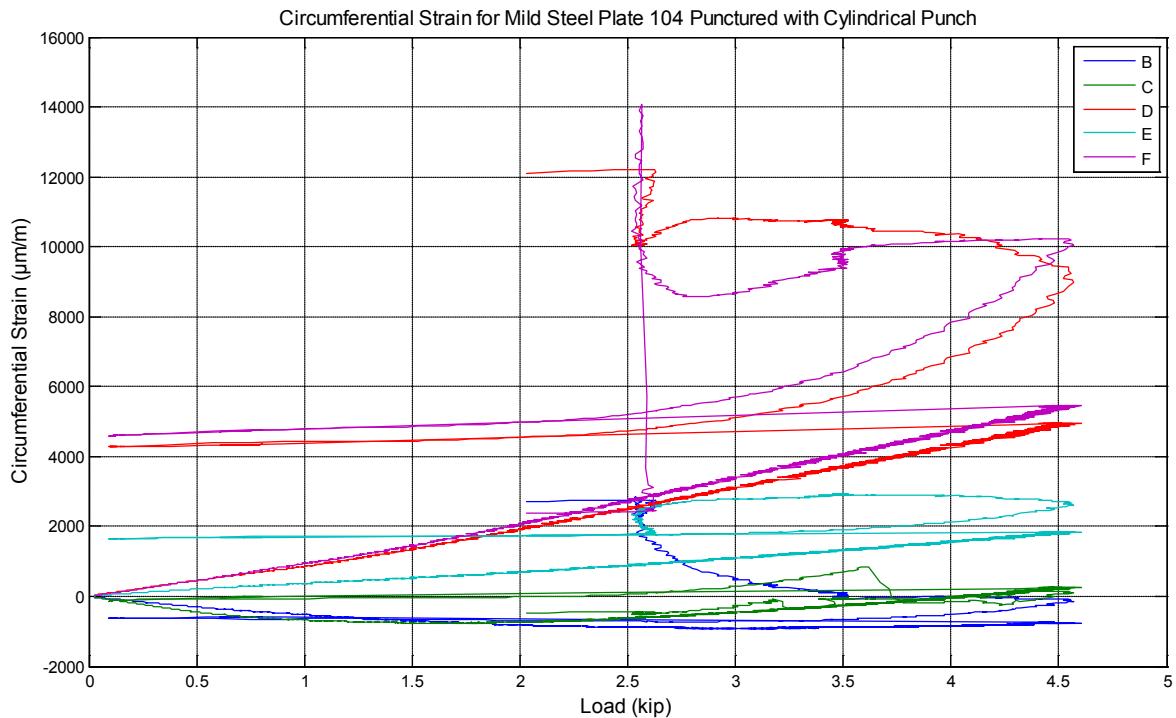
Figure 37. Circumferential strain for mild steel Plate 104 punched with a cylindrical punch

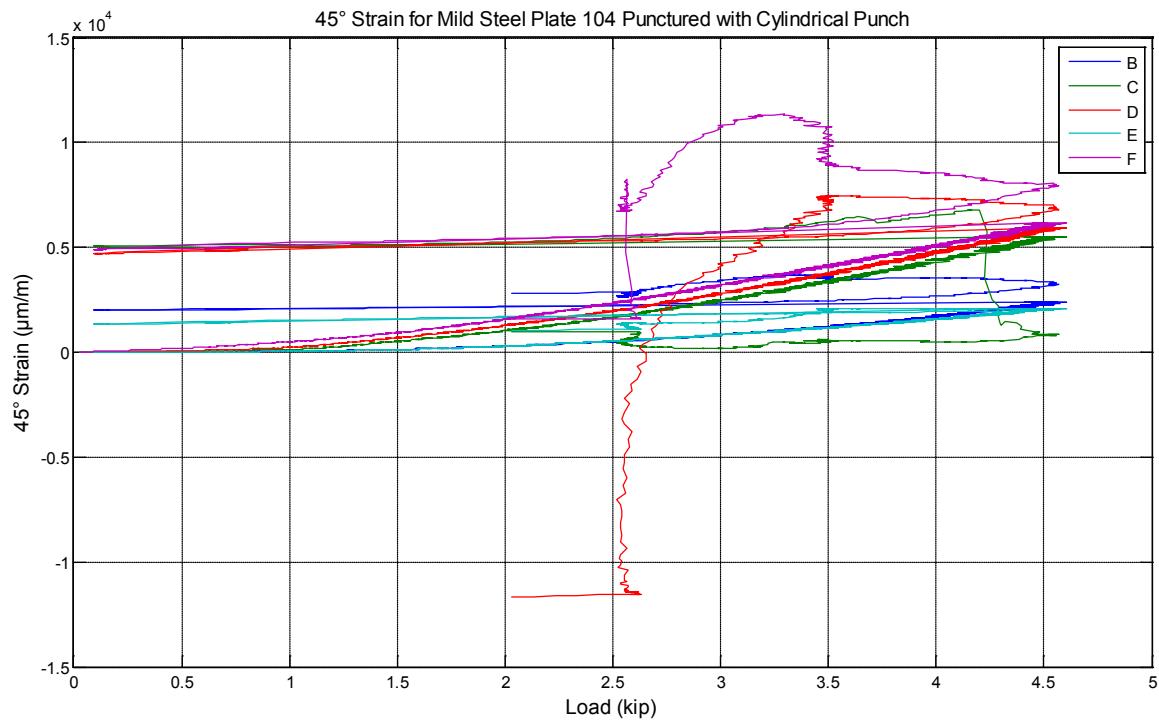
Figure 38. 45° strain for mild steel Plate 104 punched with a cylindrical punch

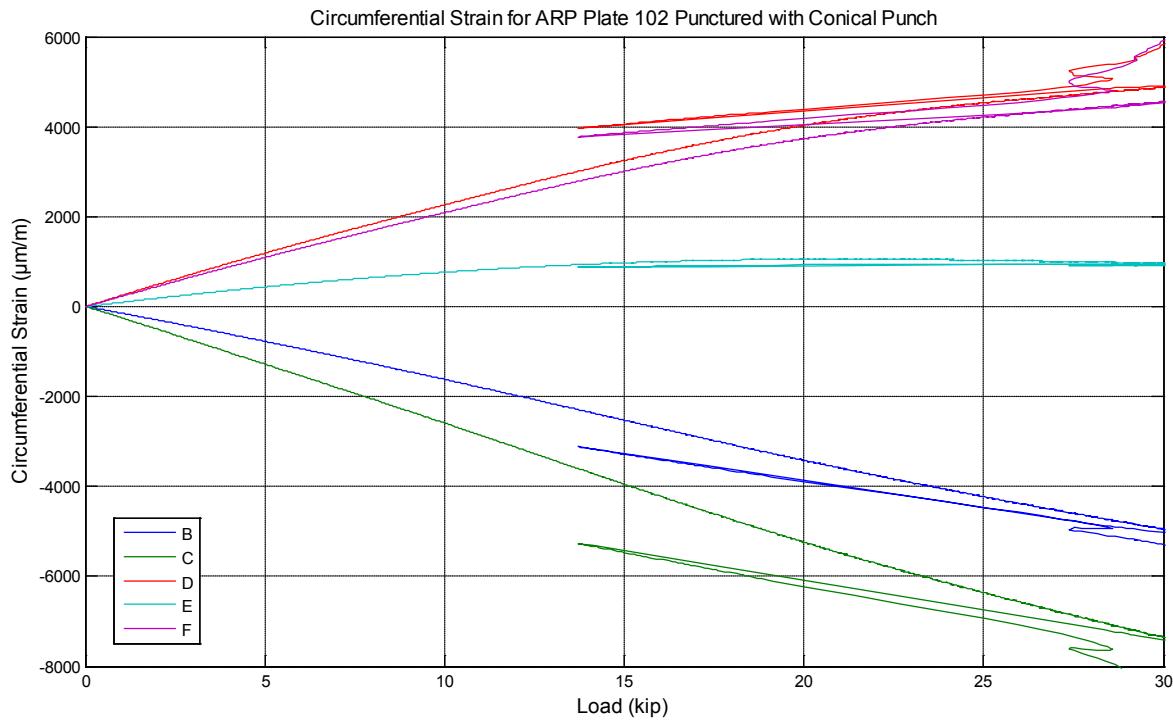
Figure 43. Circumferential strain for abrasion-resistant Plate 102 punched with a conical punch

As shown in Figure 43, the circumferential channel for Gage B was in working condition and followed the same response as Gage C located on the punch side of the plate. Grouping of signals as well as signal sign indicating compression or elongation appear to correlate to plate side. Circumferential readings for the DIC side of the plate are shown as positive strains.

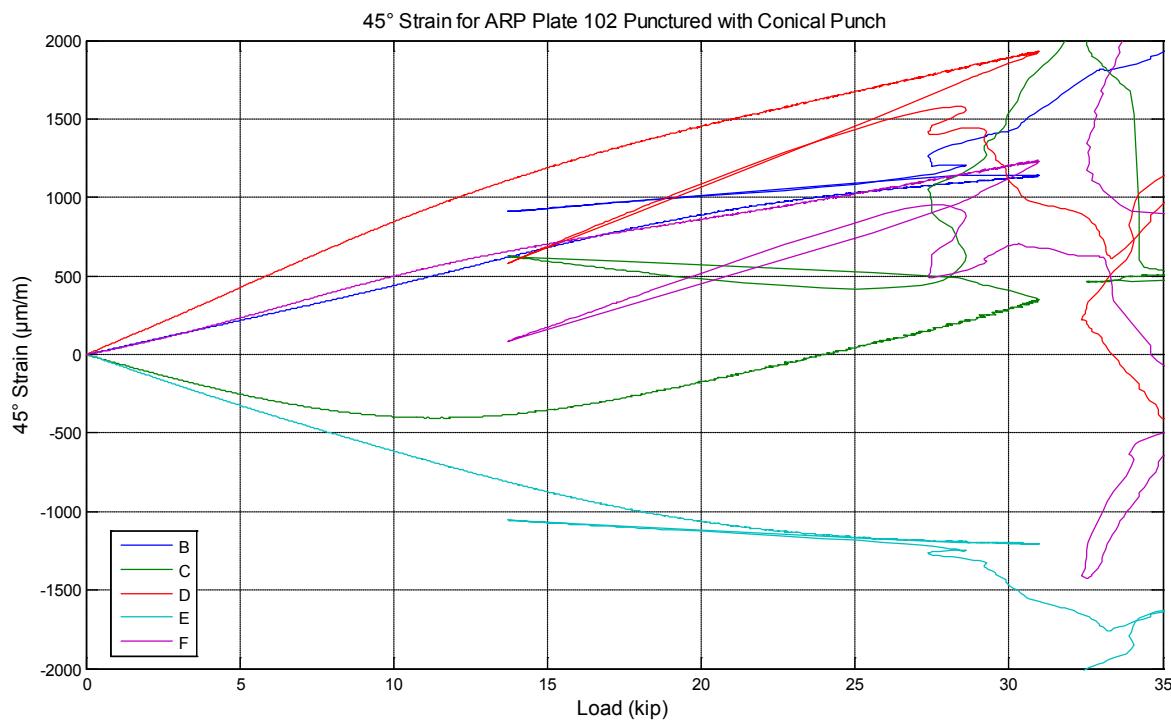
Figure 44. 45° strain for abrasion-resistant Plate 102 punched with a conical punch

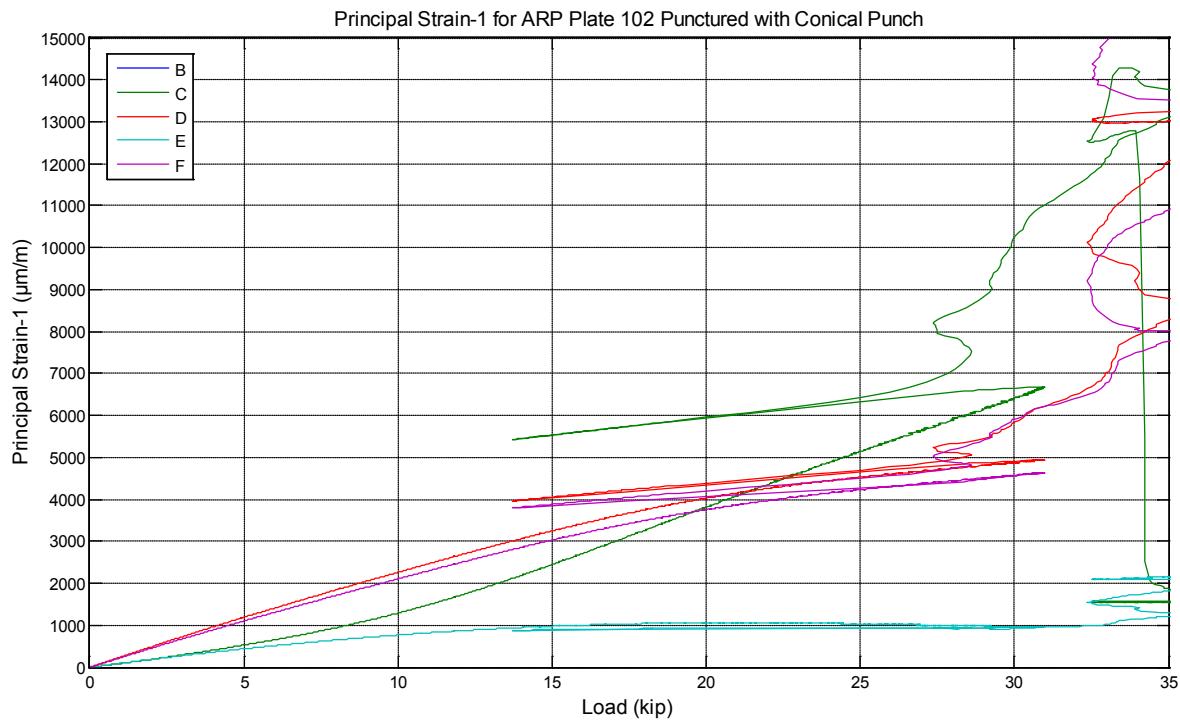
Figure 45. Principal strain 1 for abrasion-resistant Plate 102 punched with a conical punch

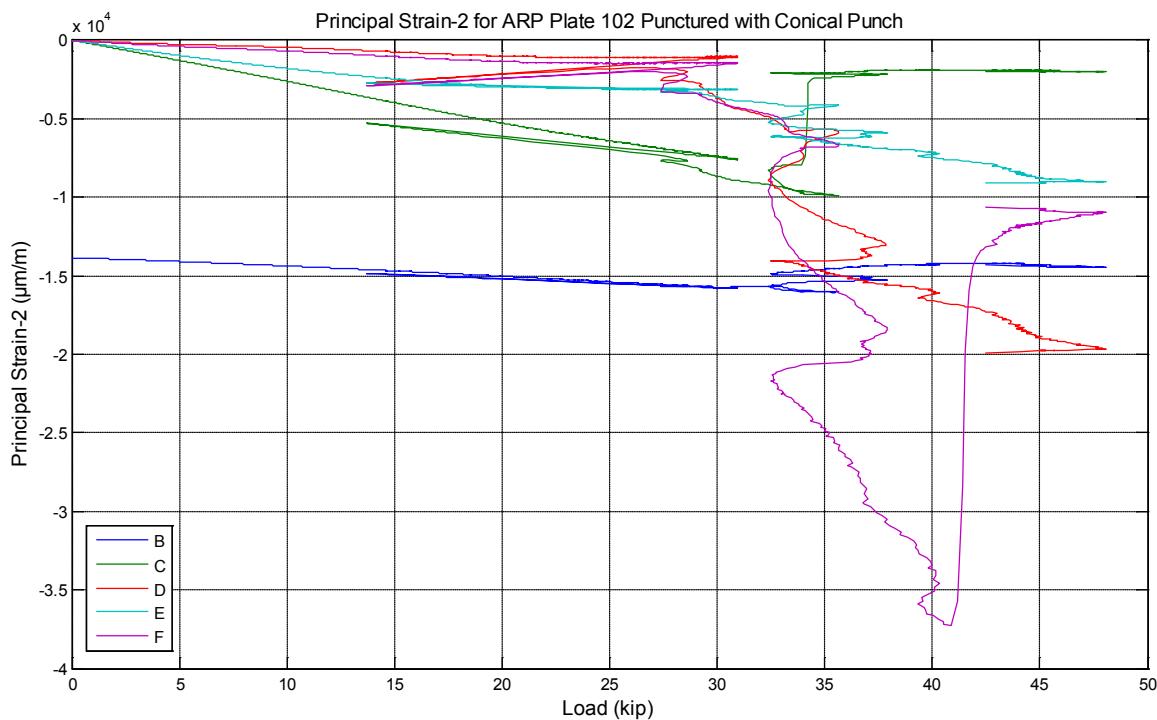
Figure 46. Principal strain 2 for abrasion-resistant Plate 102 punched with a conical punch

As shown in Figure 46, similar behavior is observed for principal-2 strains in that they become increasingly negative as load increases.

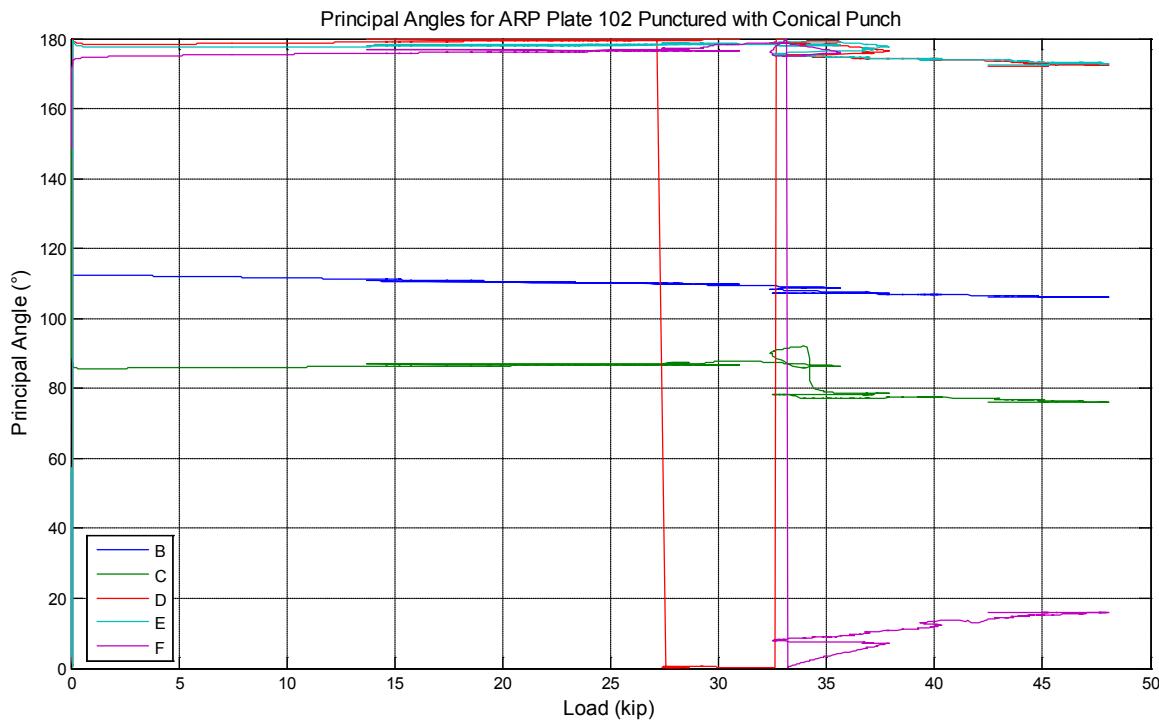
Figure 47. Principal angle for abrasion-resistant Plate 102 punched with a conical punch

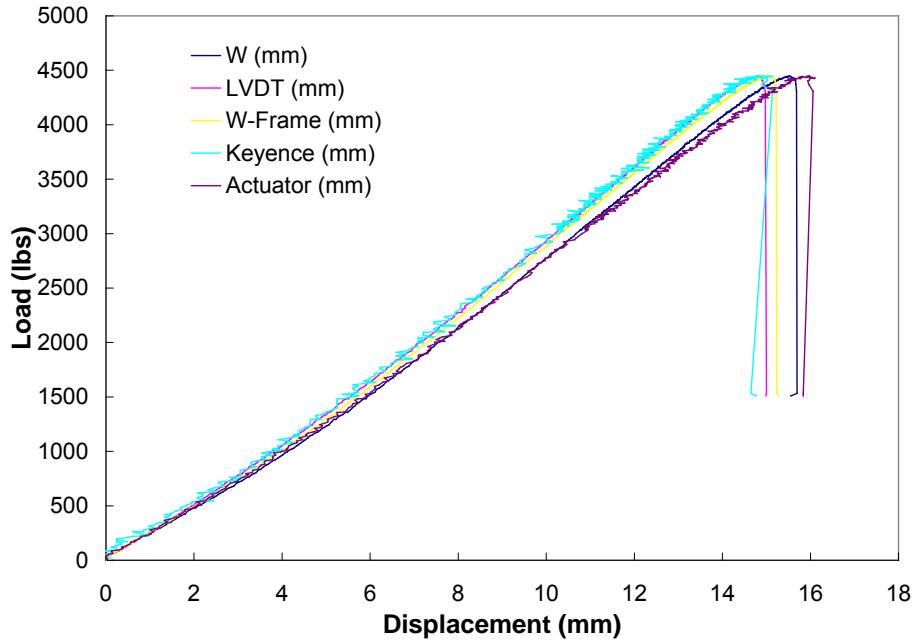
Figure 51. 6-inch plate, 1-inch punch, Sample 6, showing DIC, LVDT, Keyence, and actuator results

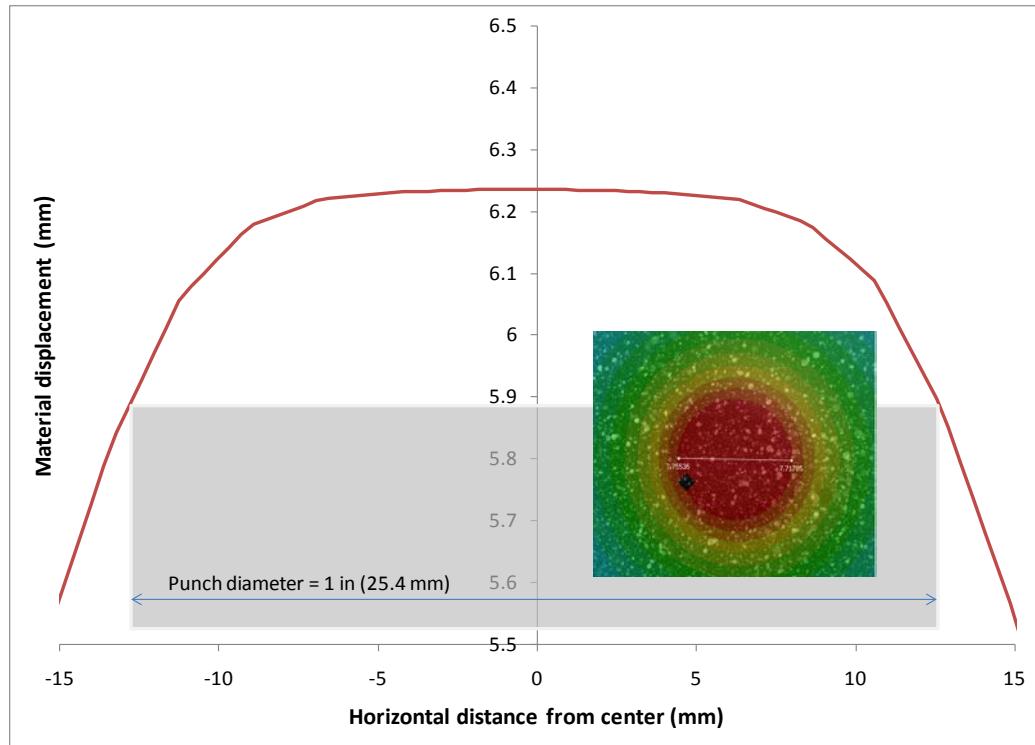
Figure 53. 12-inch sample, 1-inch punch, Sample 2, showing bow around punch tip at around 8 millimeters (mm) of displacement. (The error in Figure 52 is approximately 0.4 mm.)

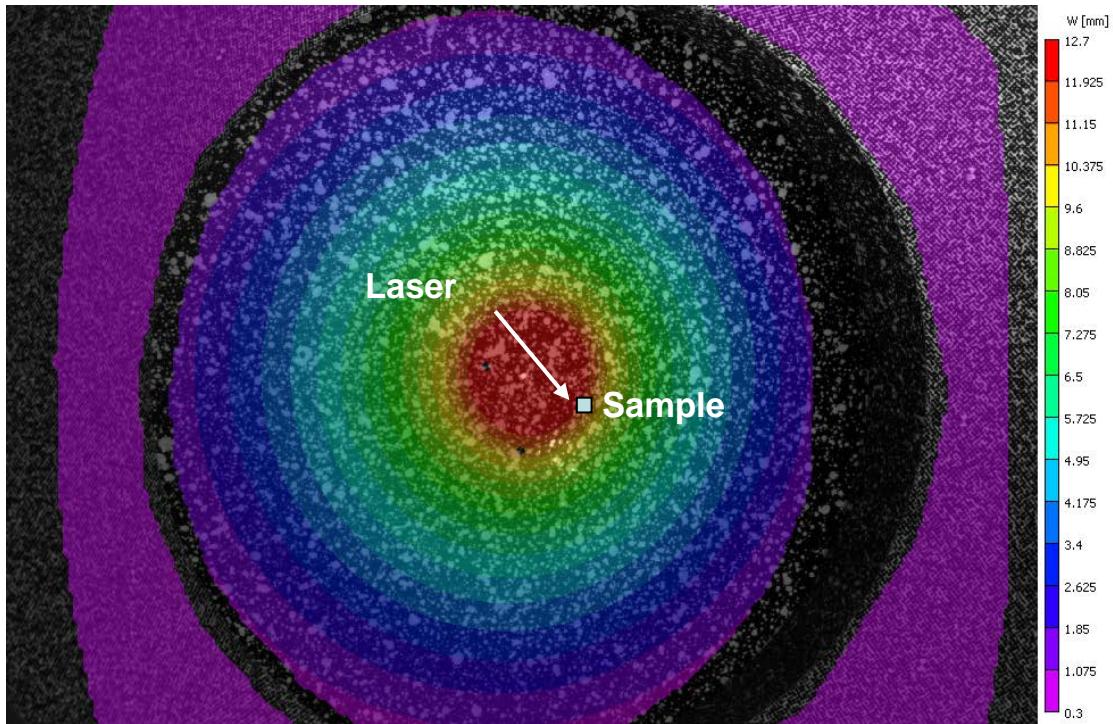
Figure 54. Image of typical extraction location (from 6-inch Sample 6)

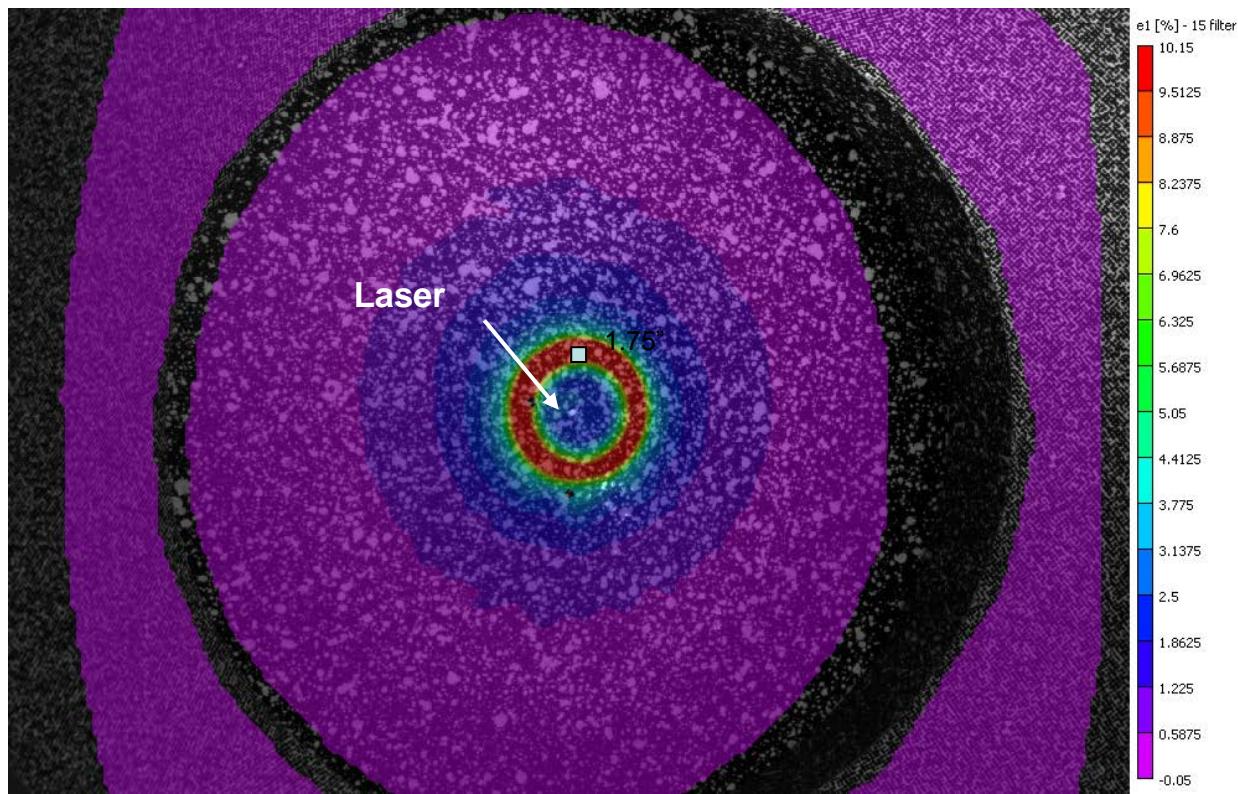
Figure 57. Sample location of extraction of principal strain (from 6-inch Sample 6)

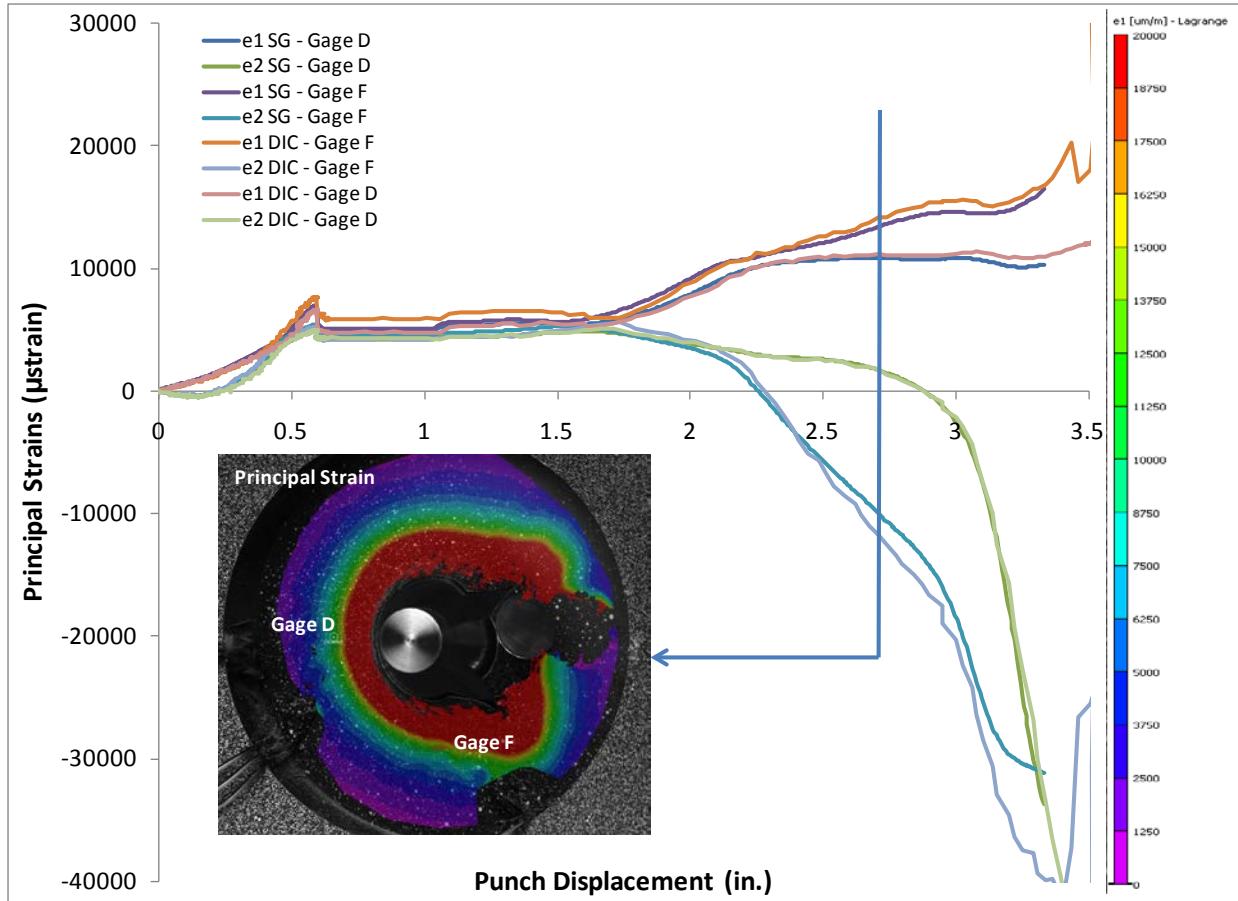
Figure 61. Test 14: mild steel plate punched with a cylindrical punch

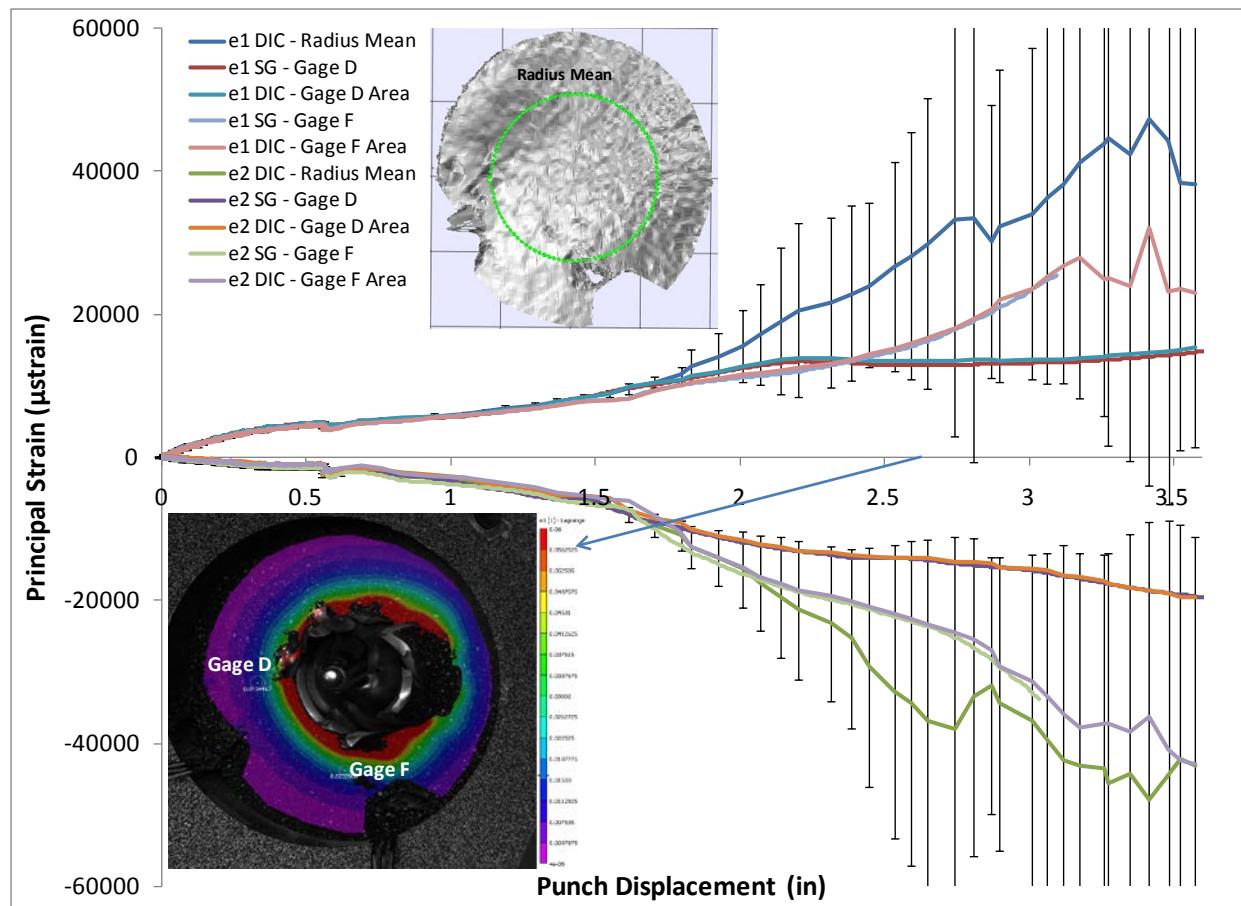
Figure 62. Test 12: abrasion-resistant plate punched with a cylindrical punch

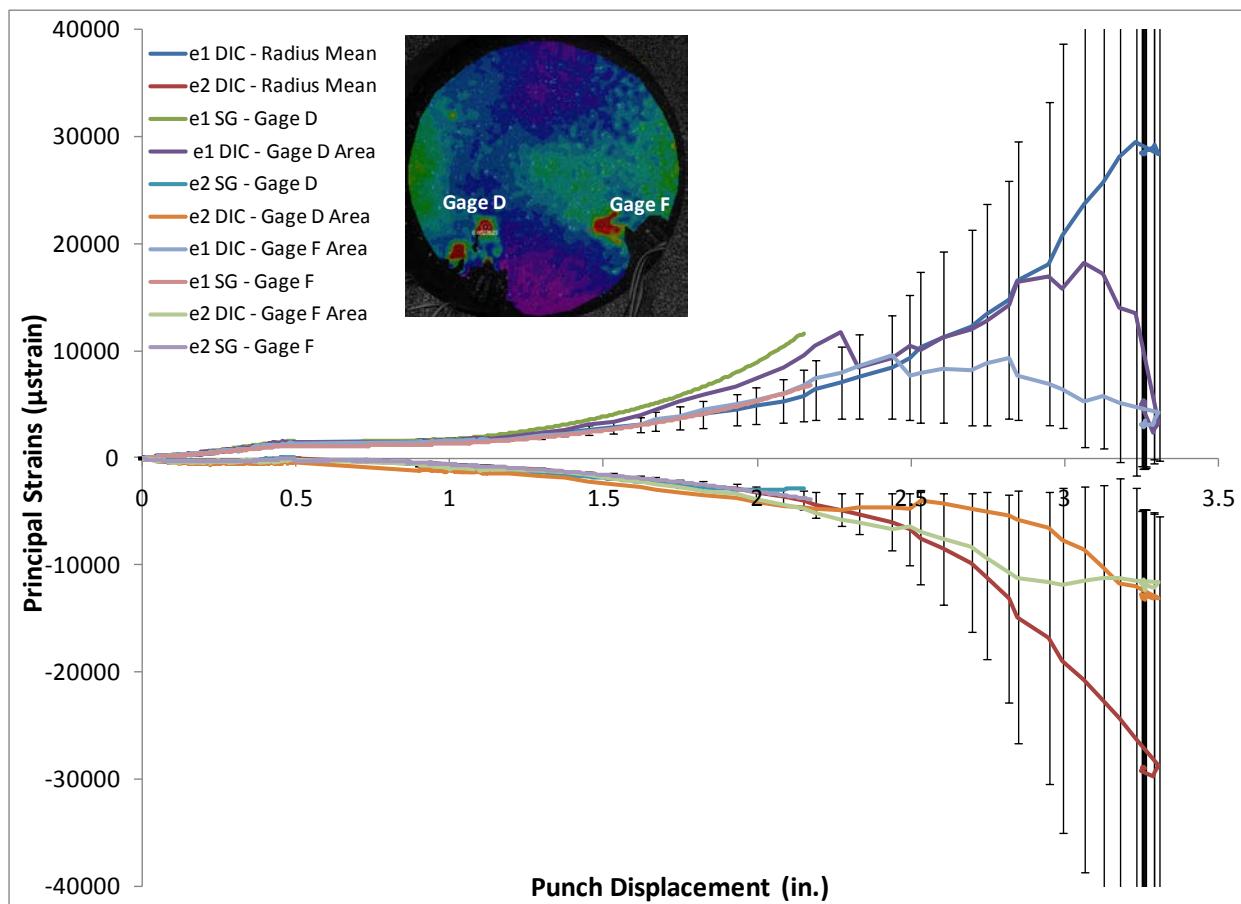
Figure 63. Test 9: mild steel plate punched with a conical punch

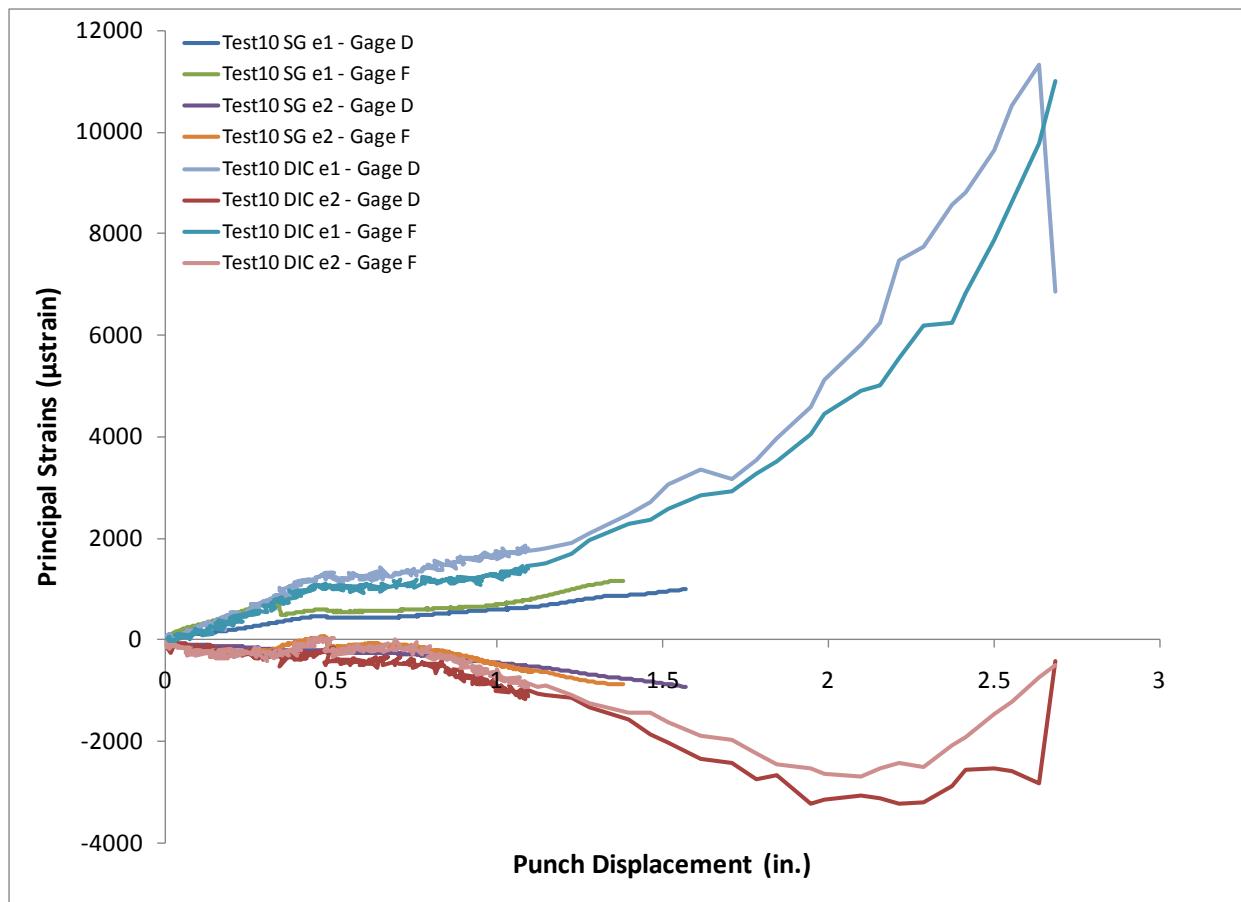
Figure 64. Test 10: mild steel plate punched with a conical punch

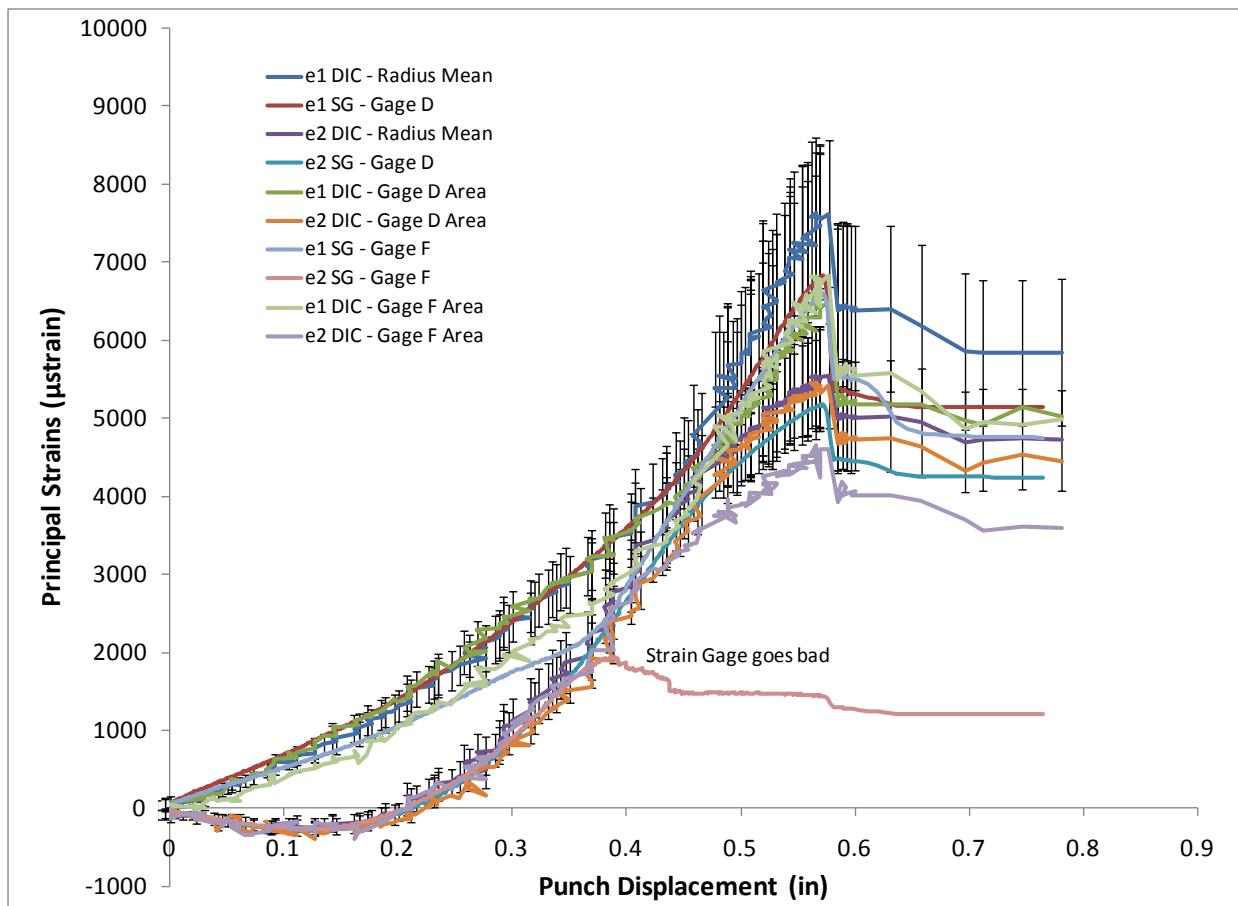
Figure 66. Test 13: mild steel plate punched with a cylindrical punch
