SANDIA REPORT

SAND2012-7930

C6 Plate Puncture Testing Report

C6 Plate Puncture Plate Testing Report

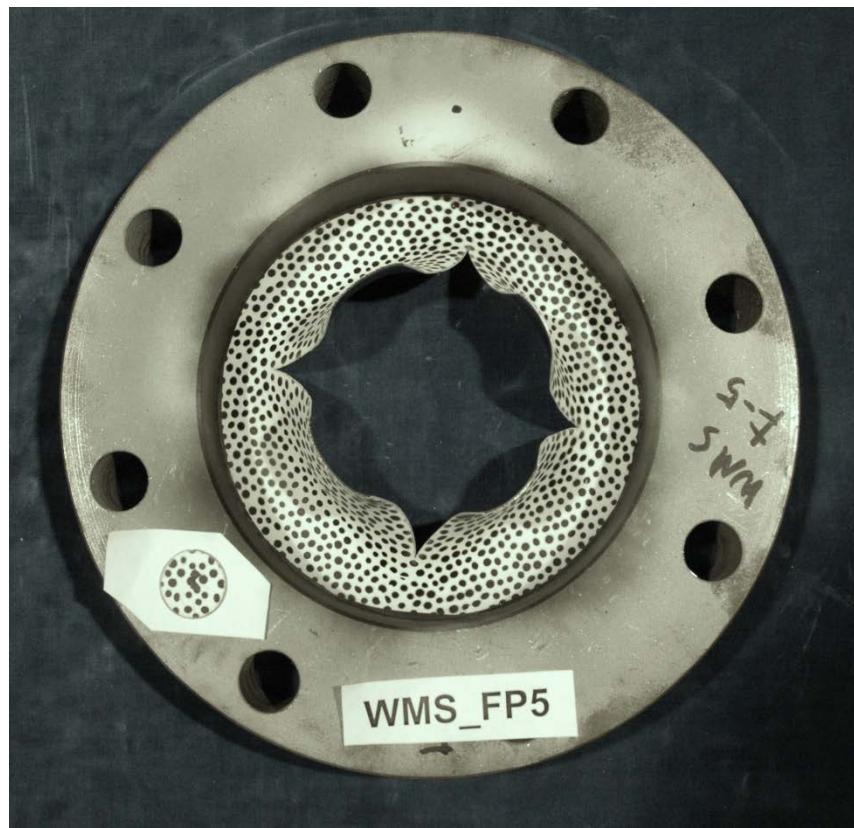
Figure 69. Typical mild steel-flat punch specimen

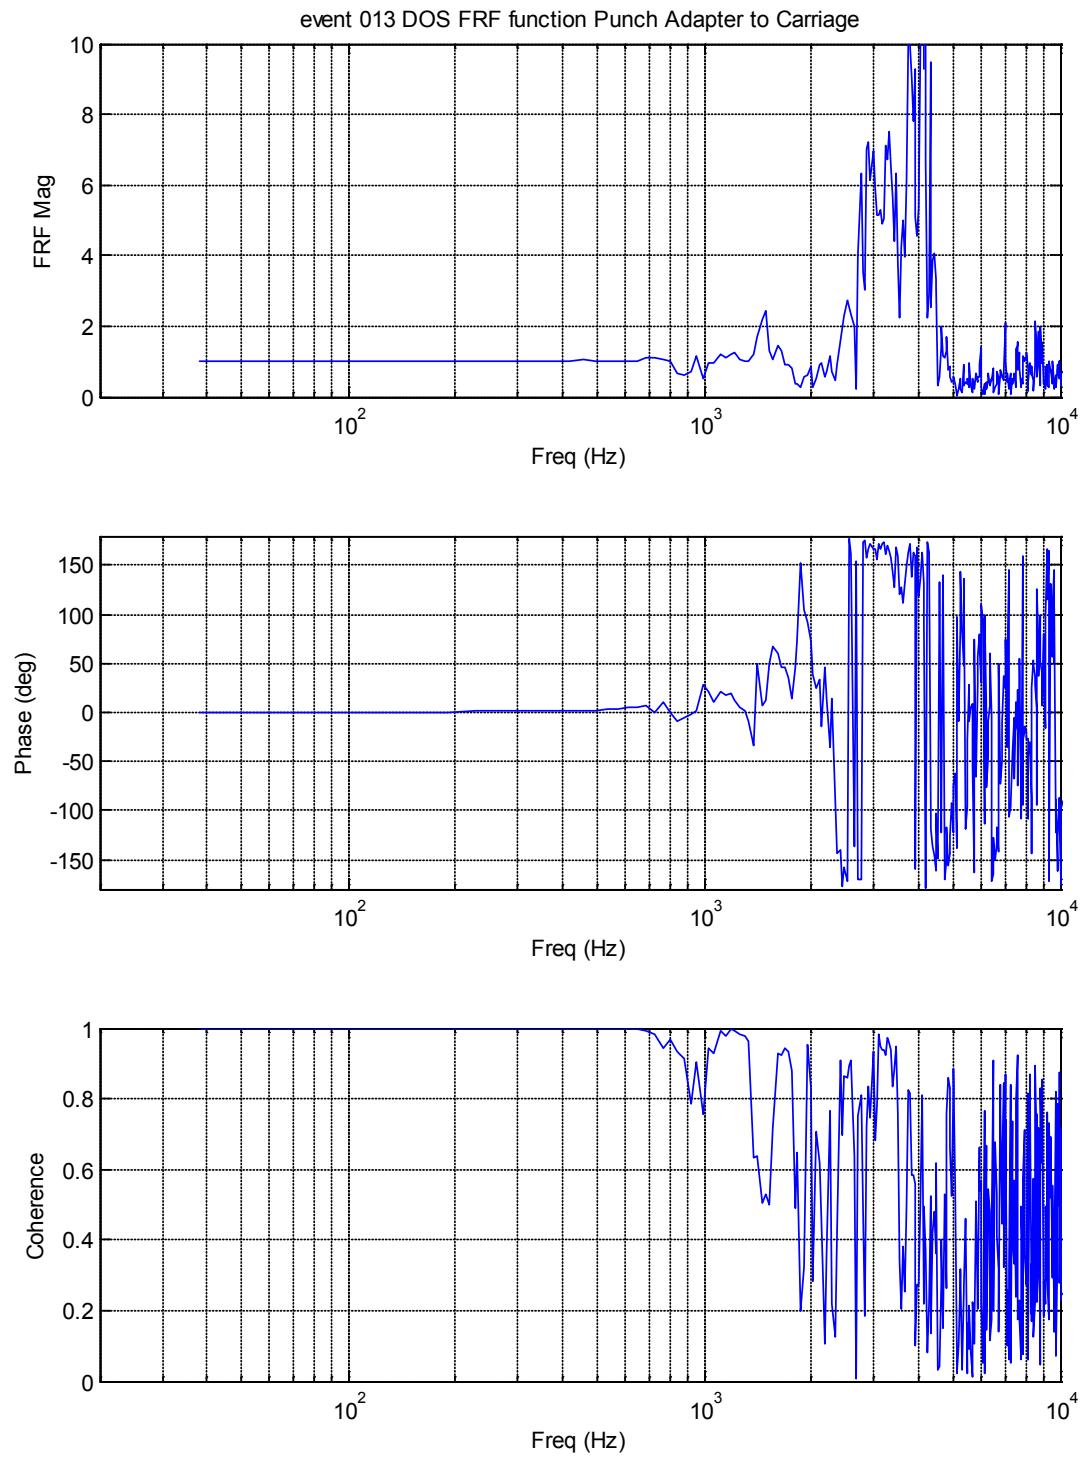
Figure 83. Acceleration frequency response function: punch adapter to carriage

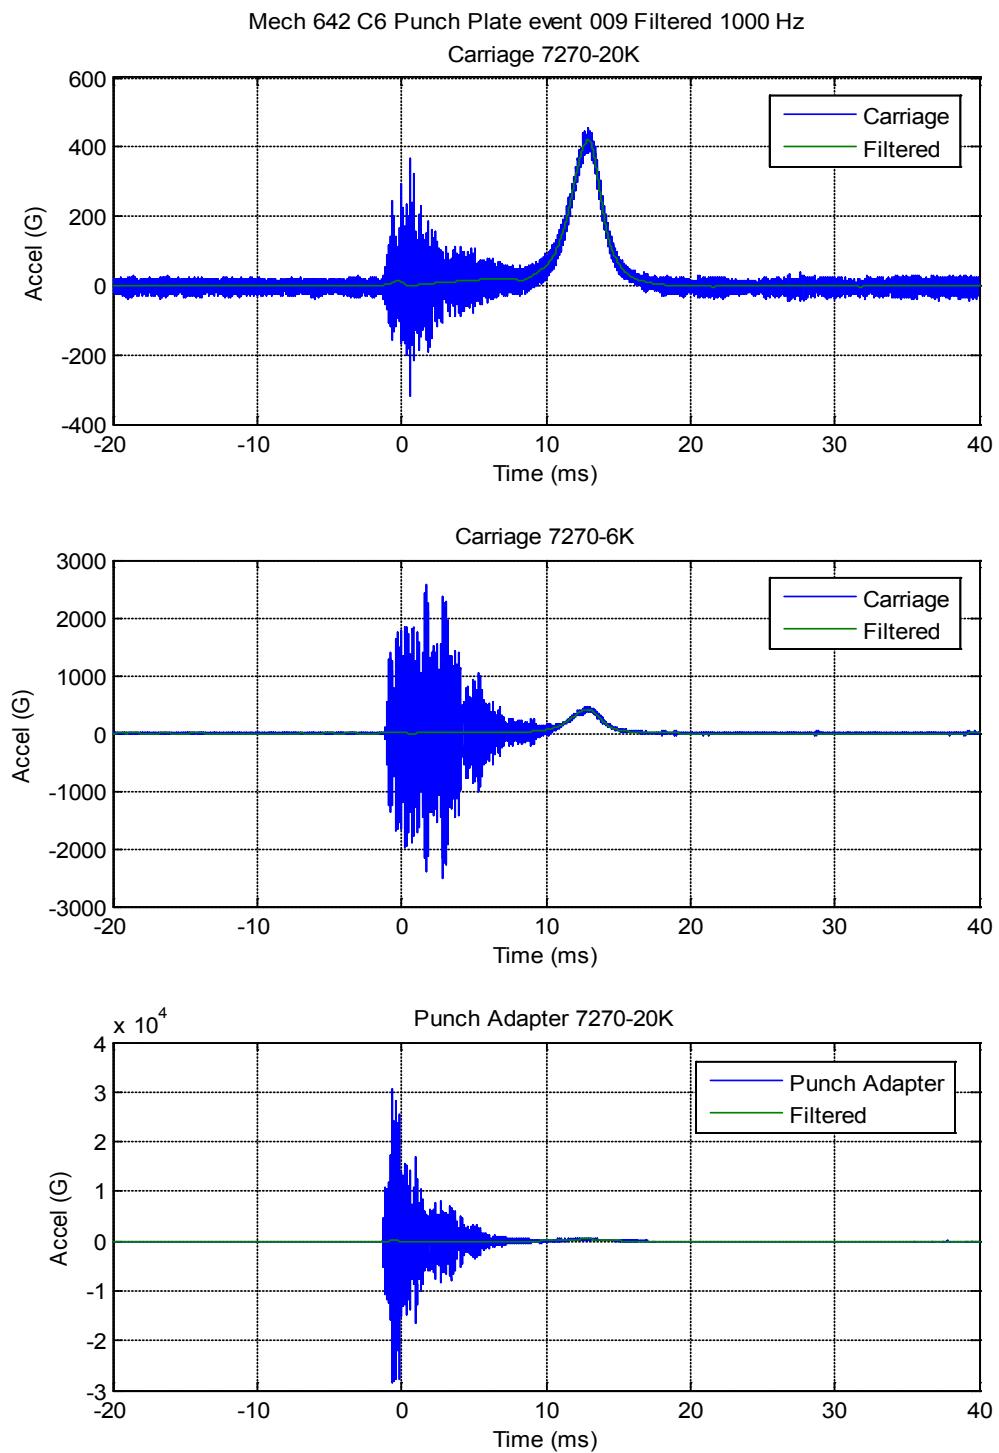
Figure 85. Typical mild steel-flat punch accelerometer data (WMS_FP6)

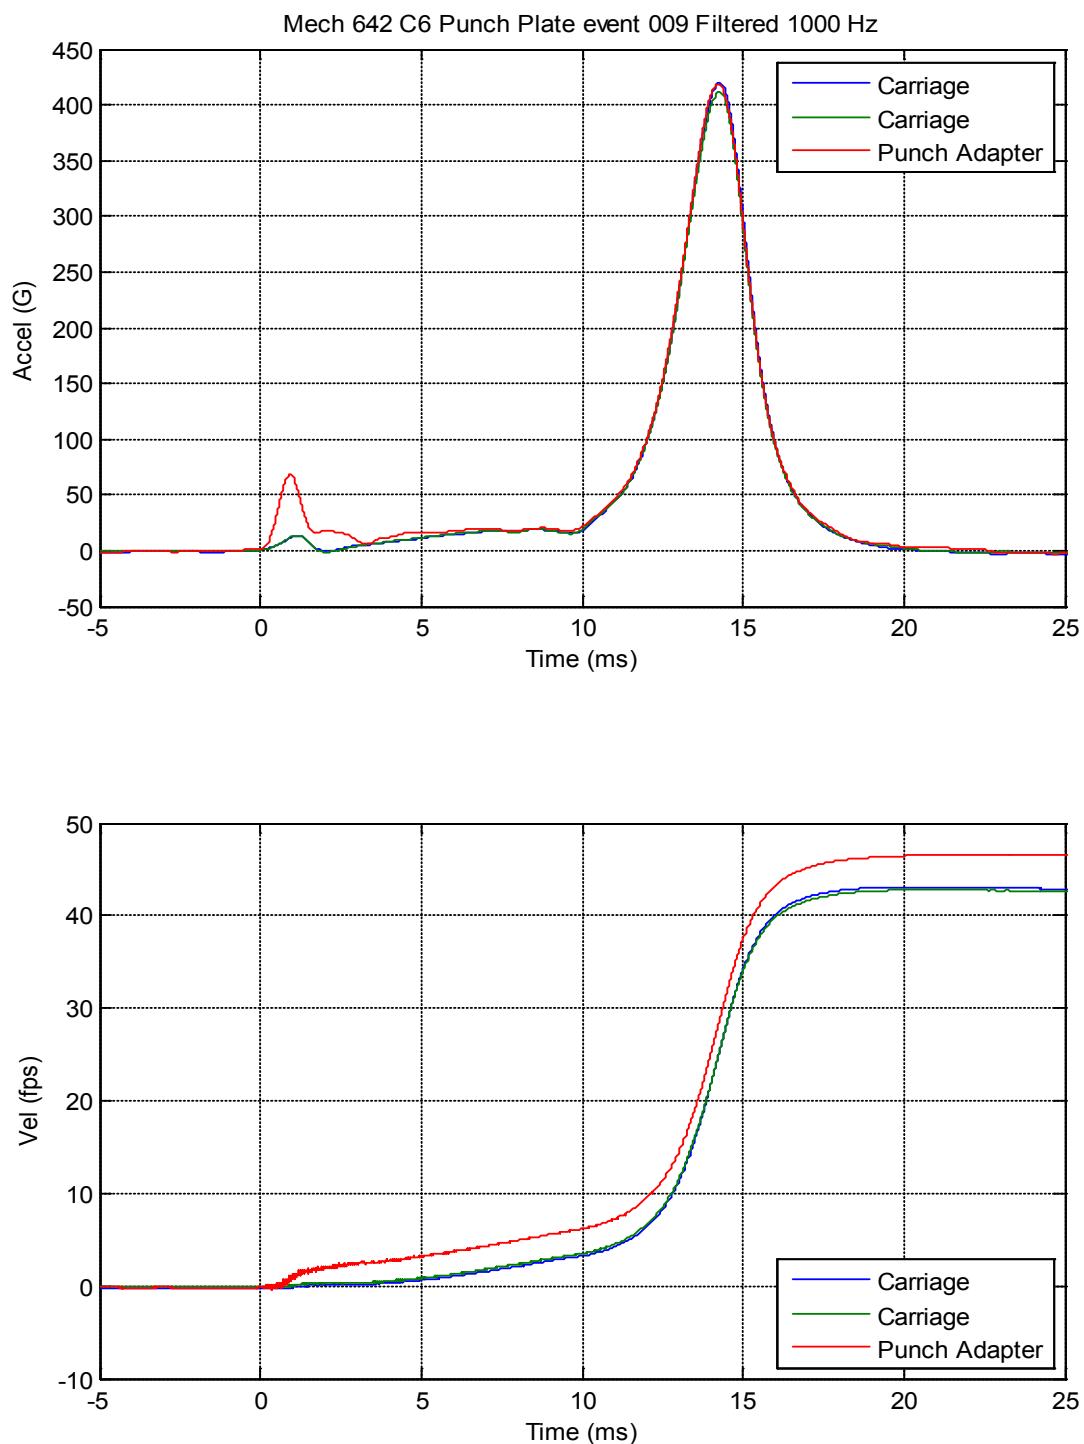
Figure 86. WMS_FP6 accelerometer data filtered and integrated overlay

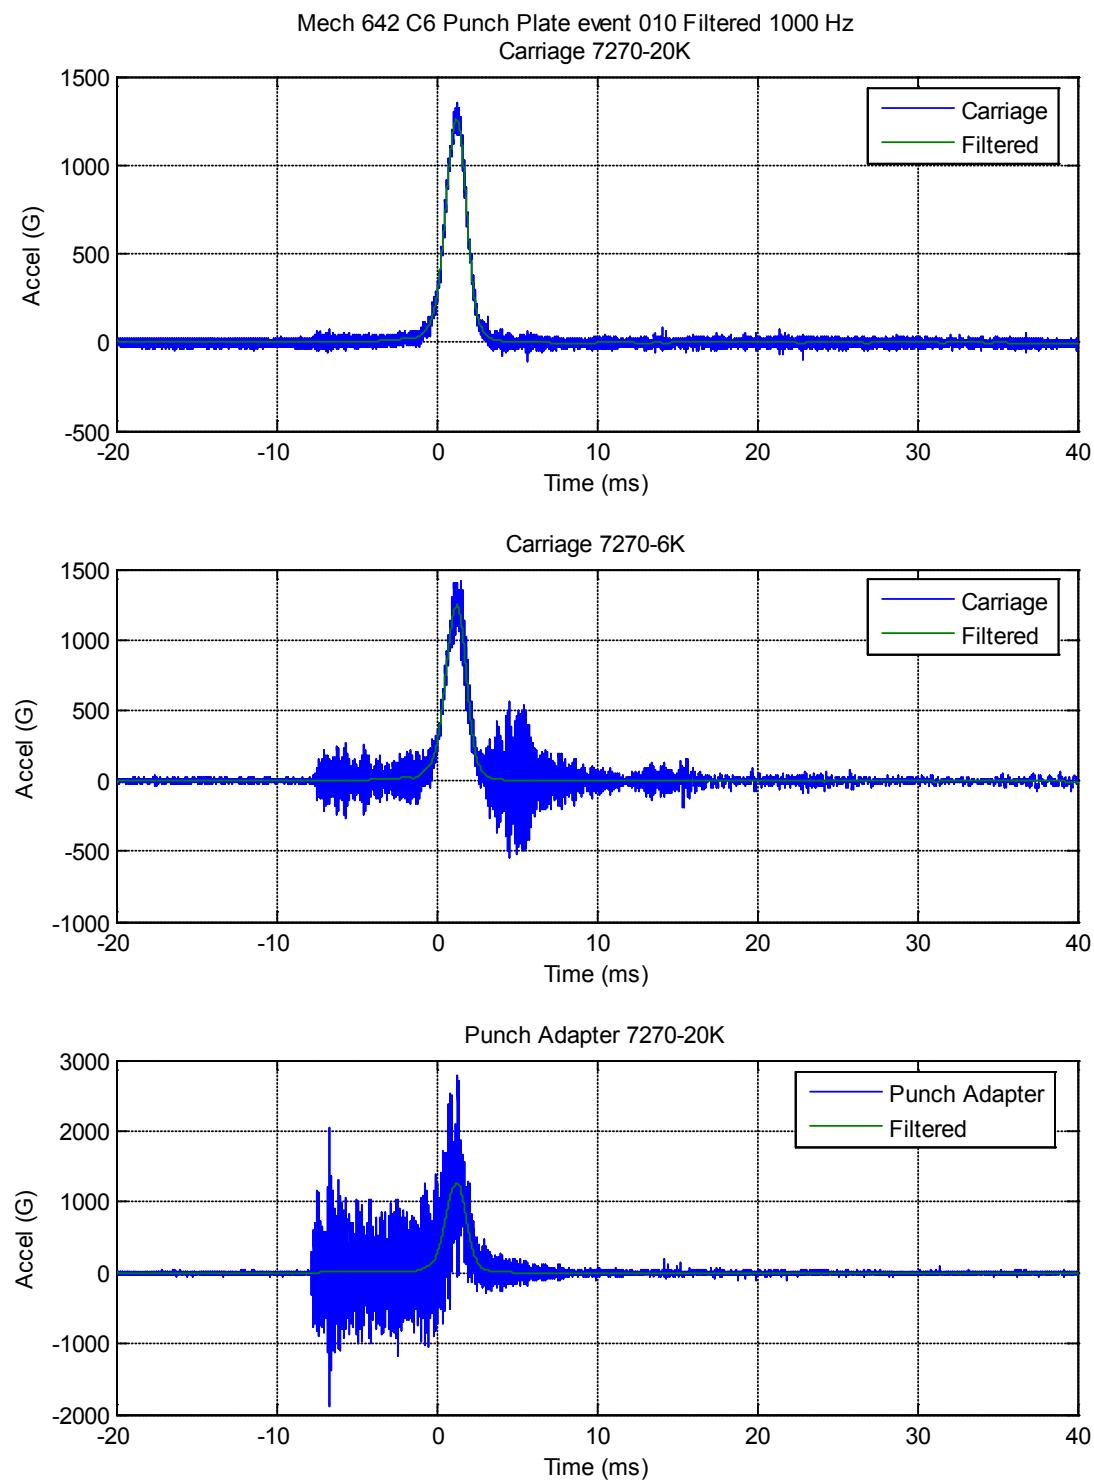
Figure 88. Typical mild steel-conical punch accelerometer data (WMS_CP1)

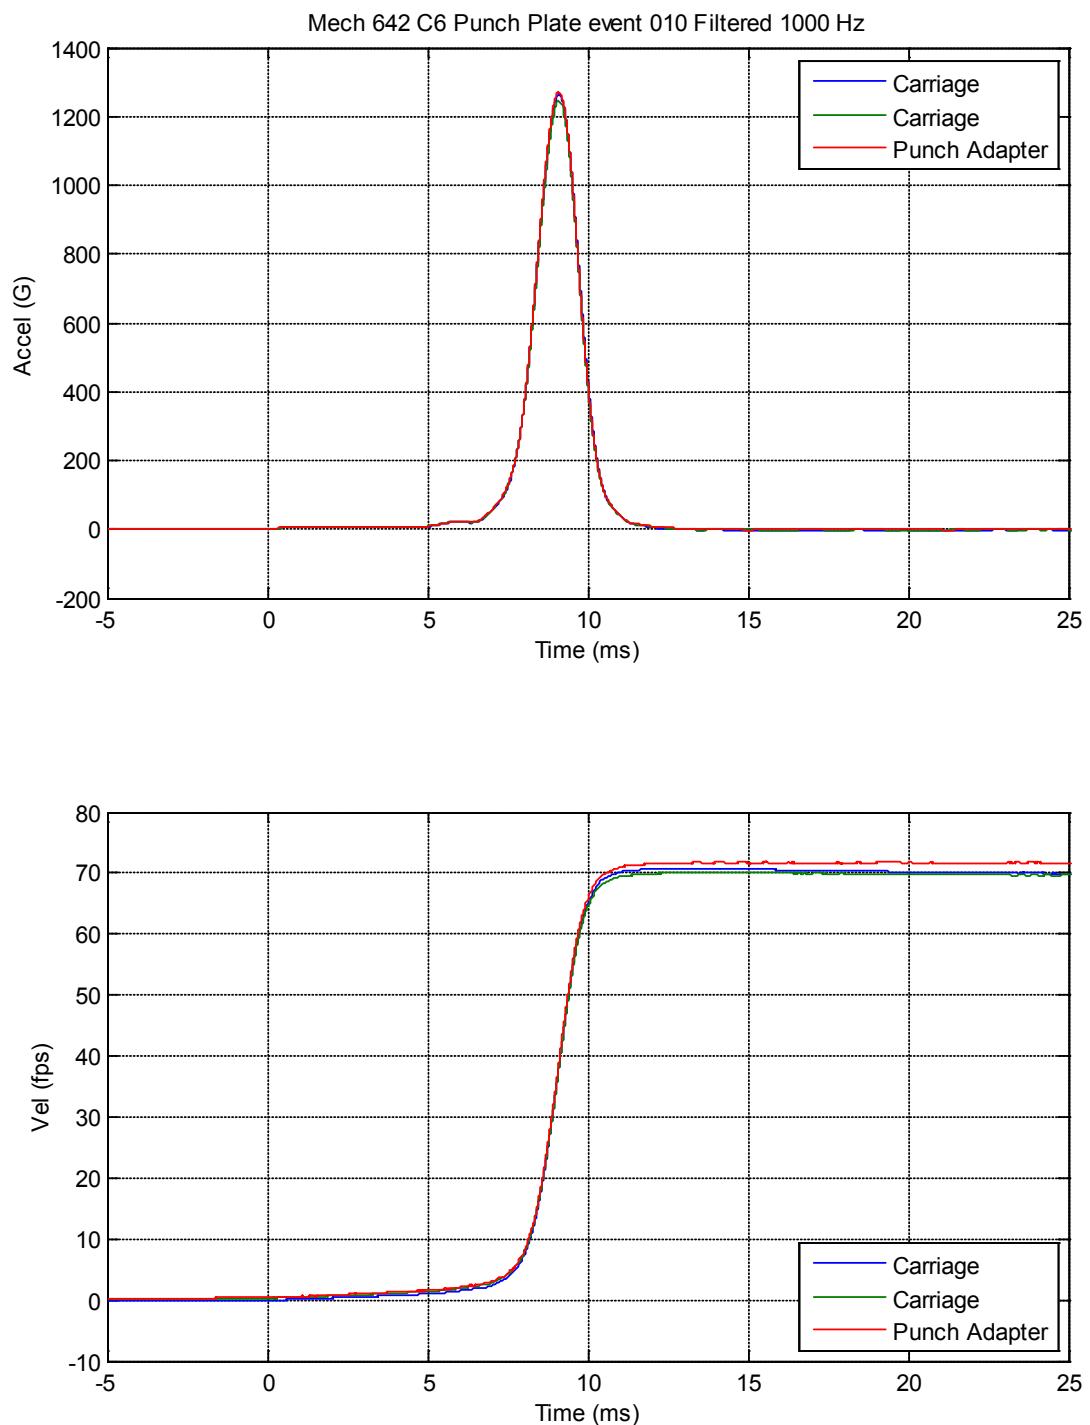
Figure 89. WMS_CP1 accelerometer data filtered and integrated overlay

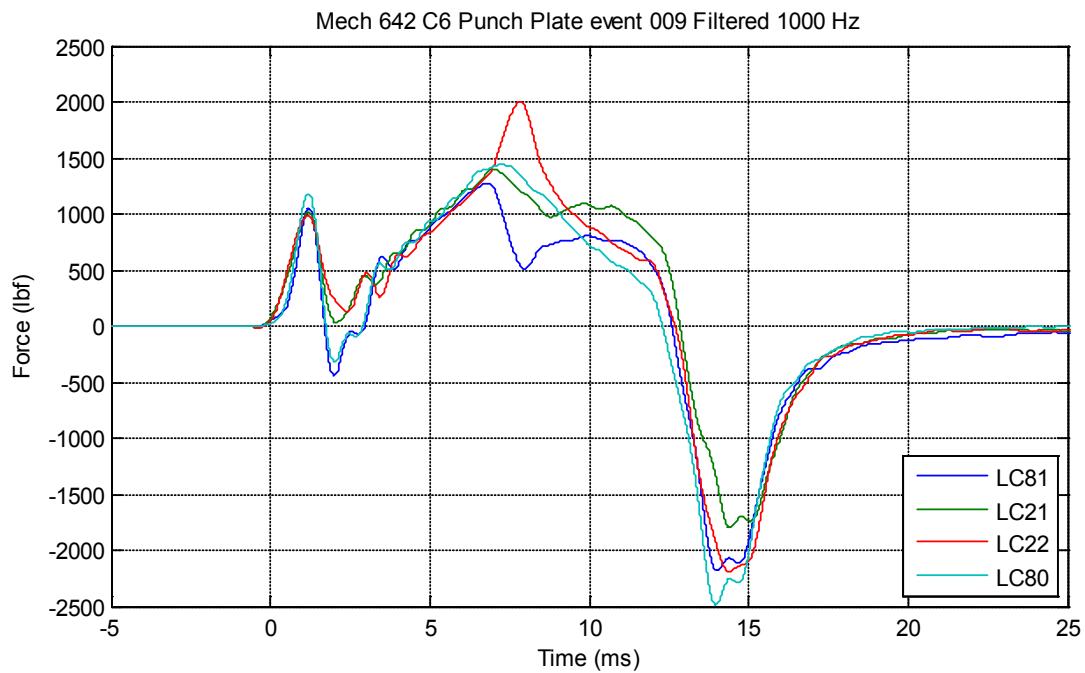
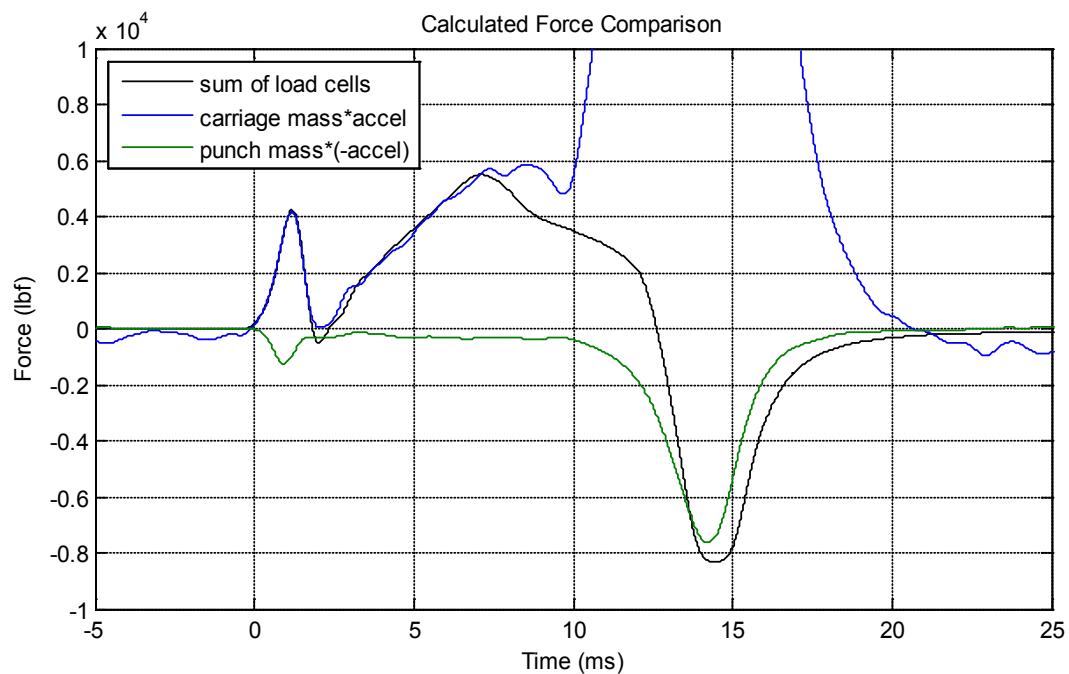
Figure 91. Typical mild steel-flat punch load cell data

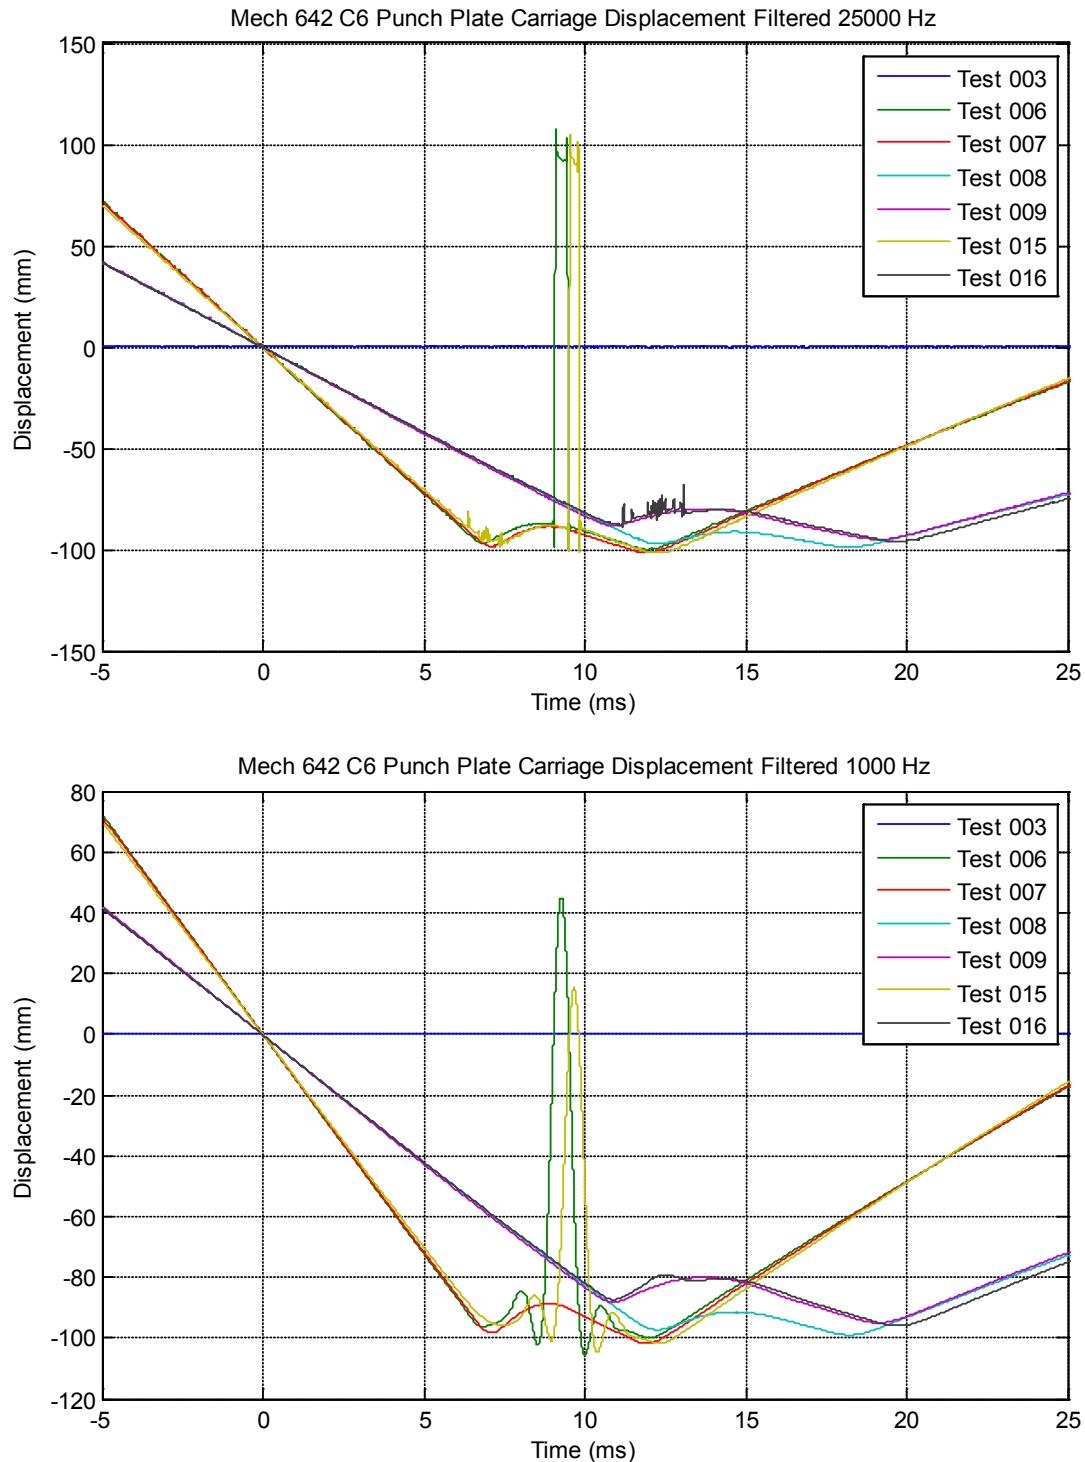
Figure 94. Carriage displacement data curves: 25,000-Hz filter and 1,000-Hz filter

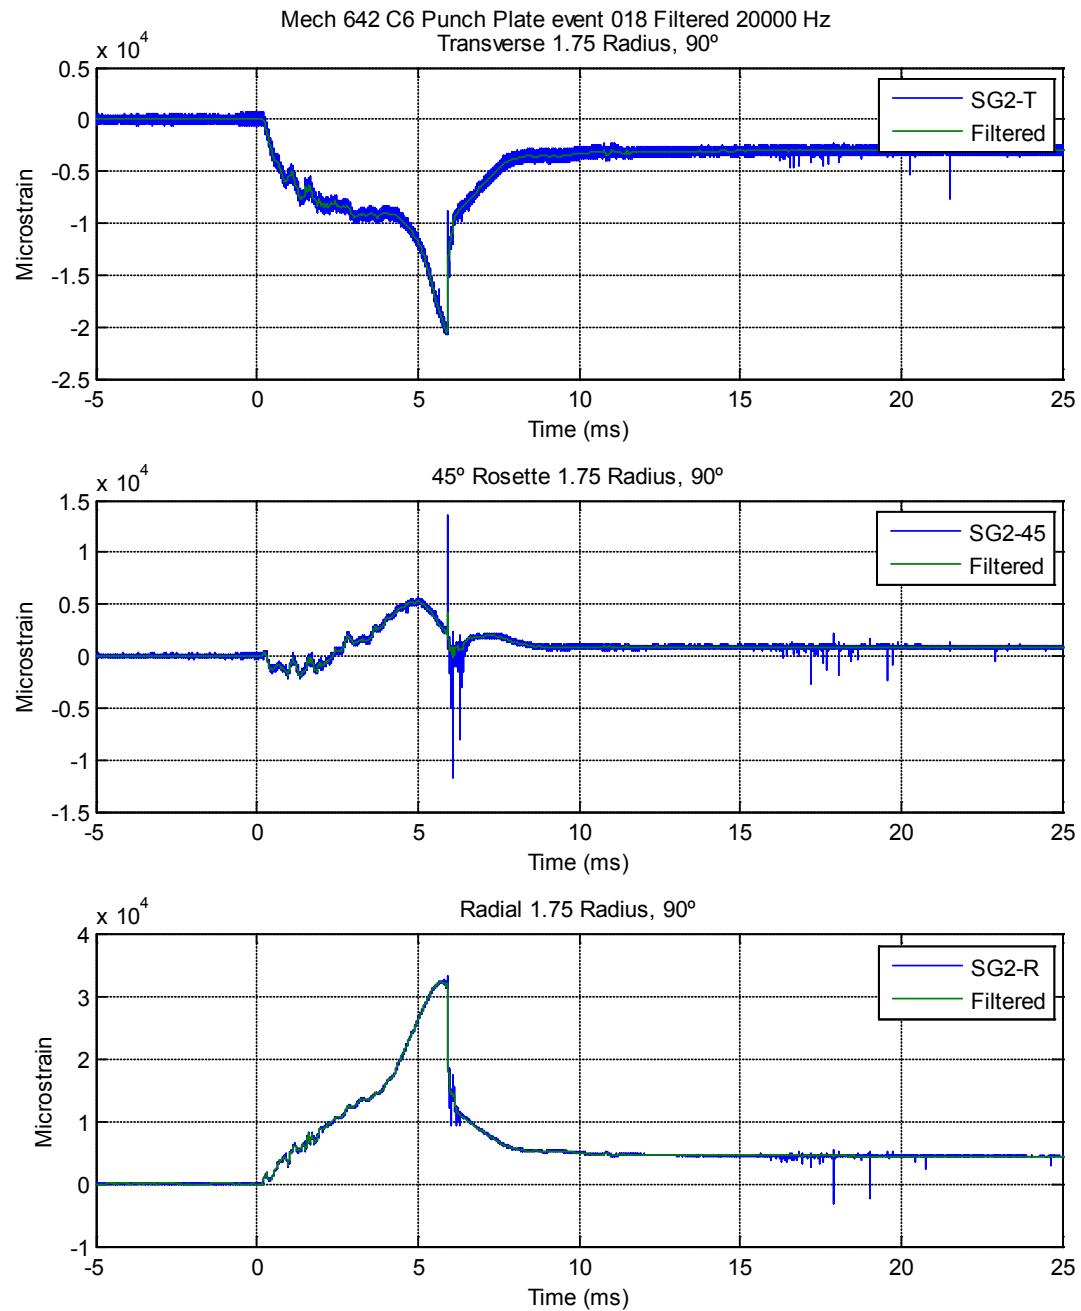
Figure 95. Raw and filtered strain gage data (ARP_CP1)

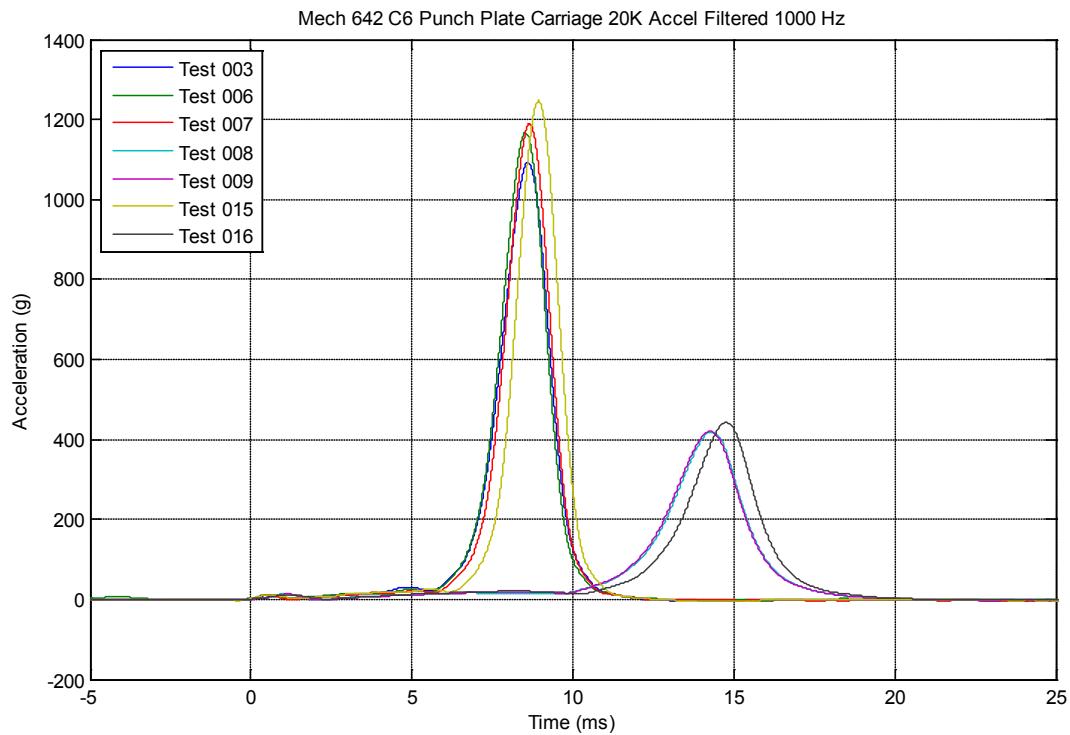
Figure A-1. Mild steel-flat punch acceleration vs. time: Tests 3, 6, 7, 8, 9, 15, 16

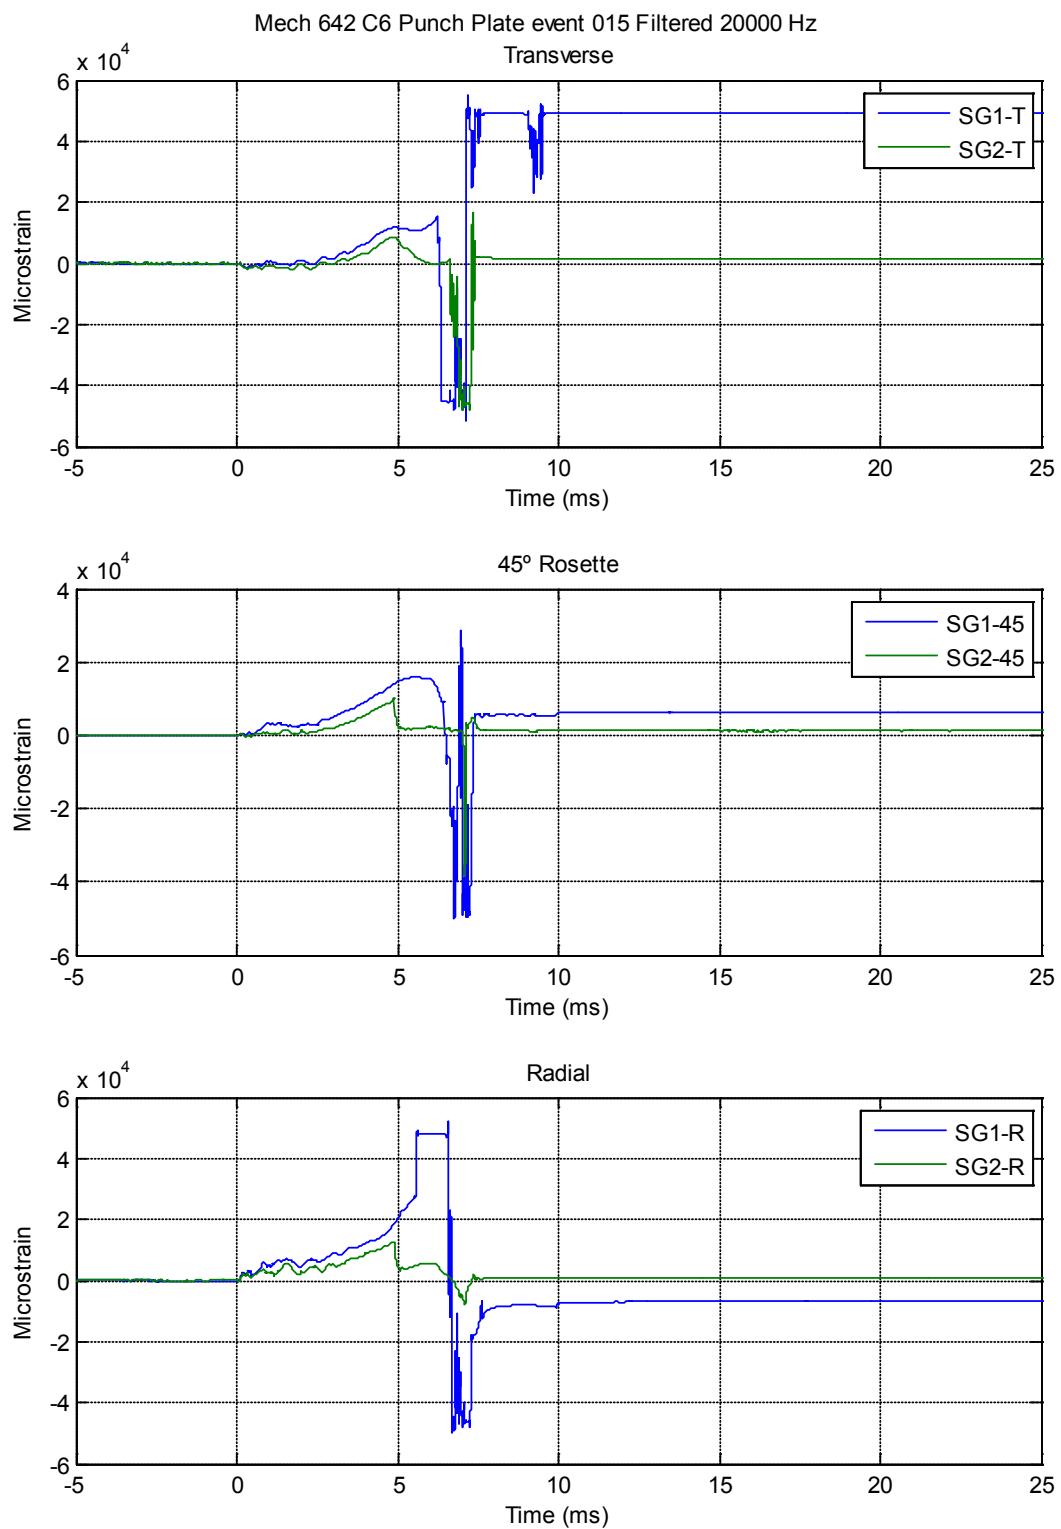
Figure A-5. Mild steel-flat punch microstrain vs. time: Test 15

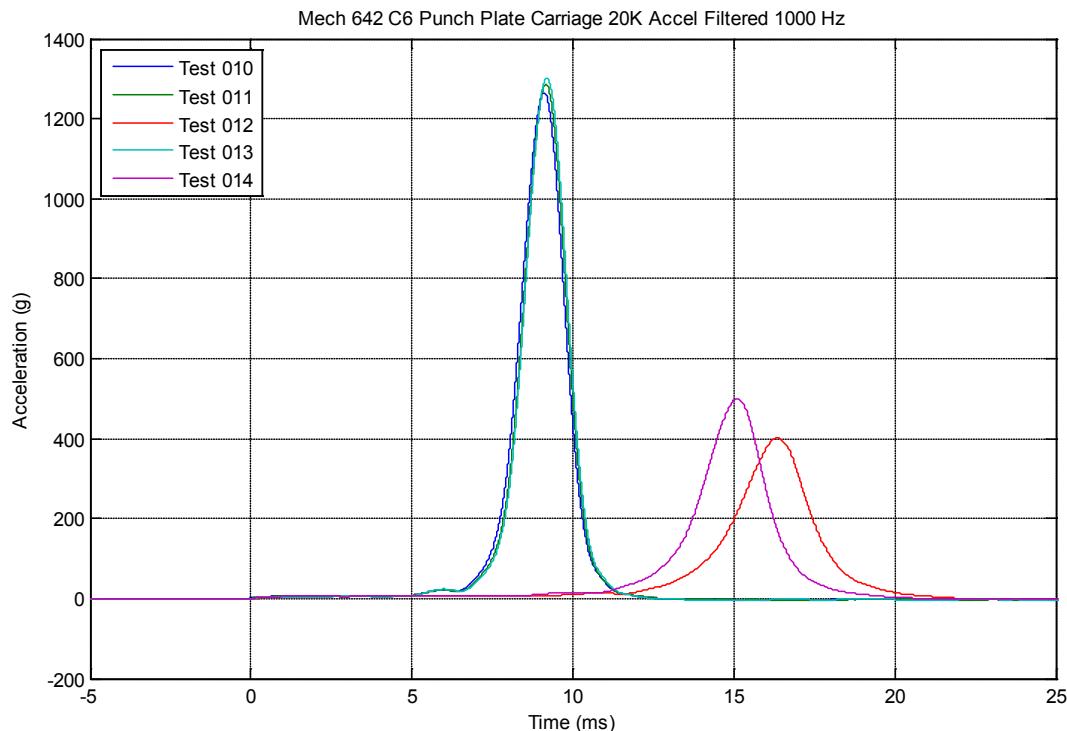
Figure A-6. Mild steel-conical punch acceleration vs. time: Tests 10, 11, 12, 13, 14

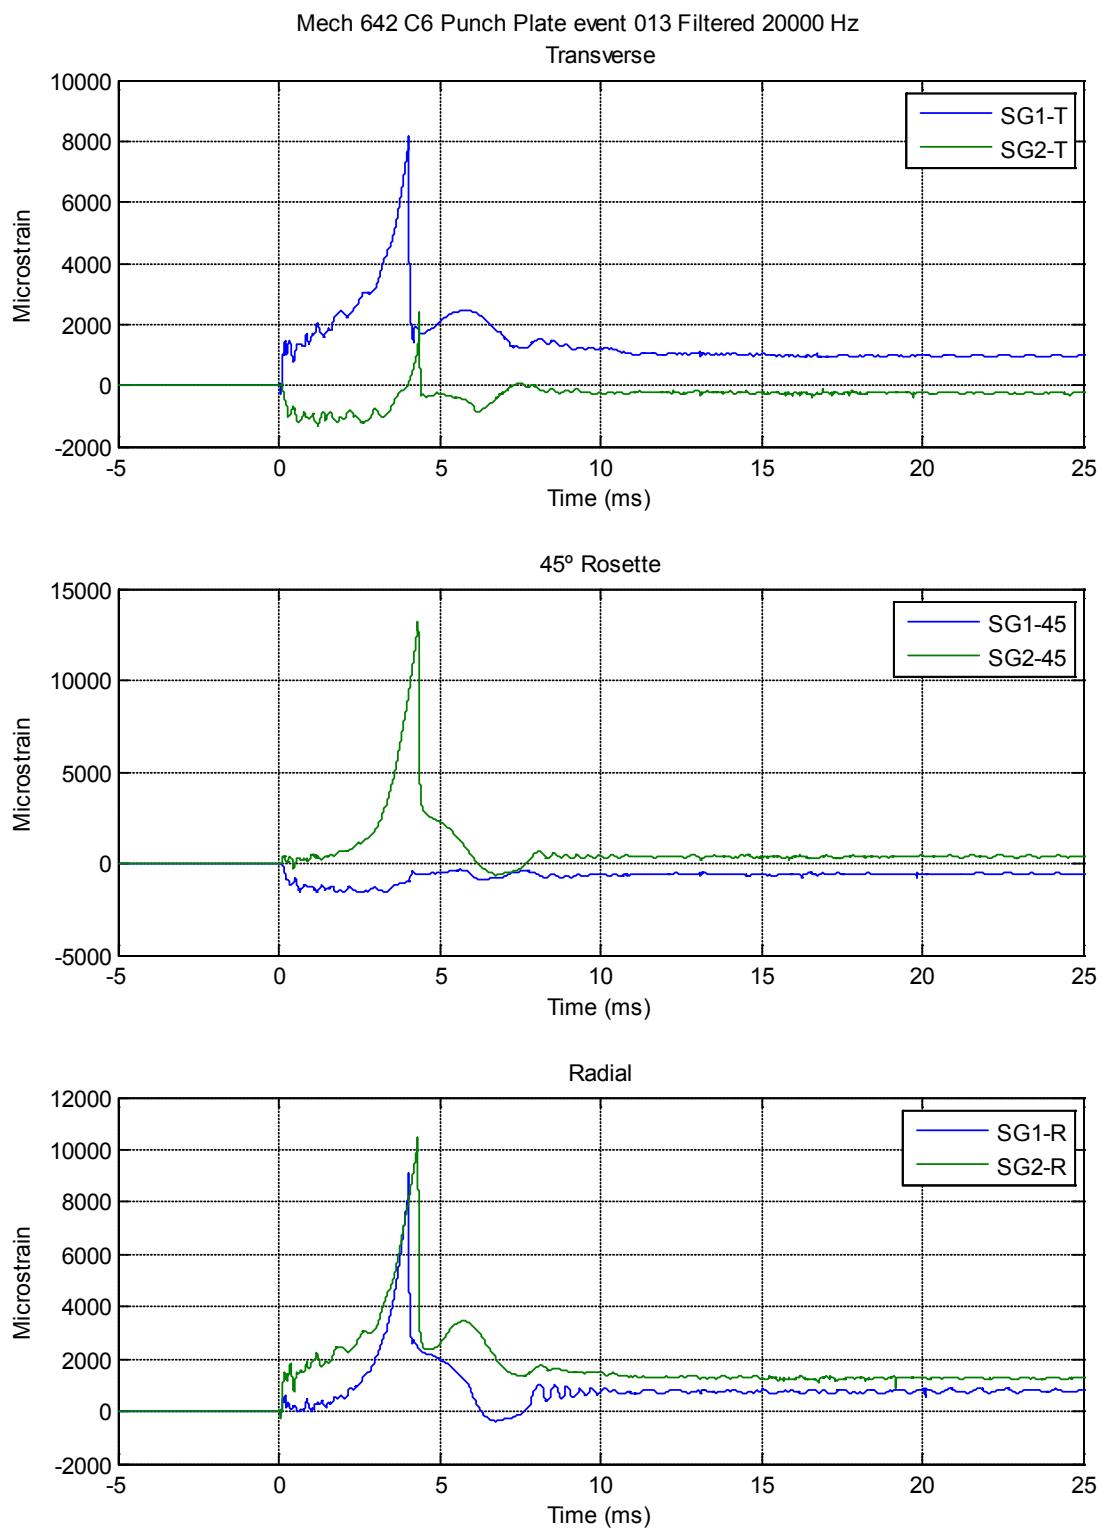
Figure A-10. Mild steel-conical punch microstrain vs. time: Test 13

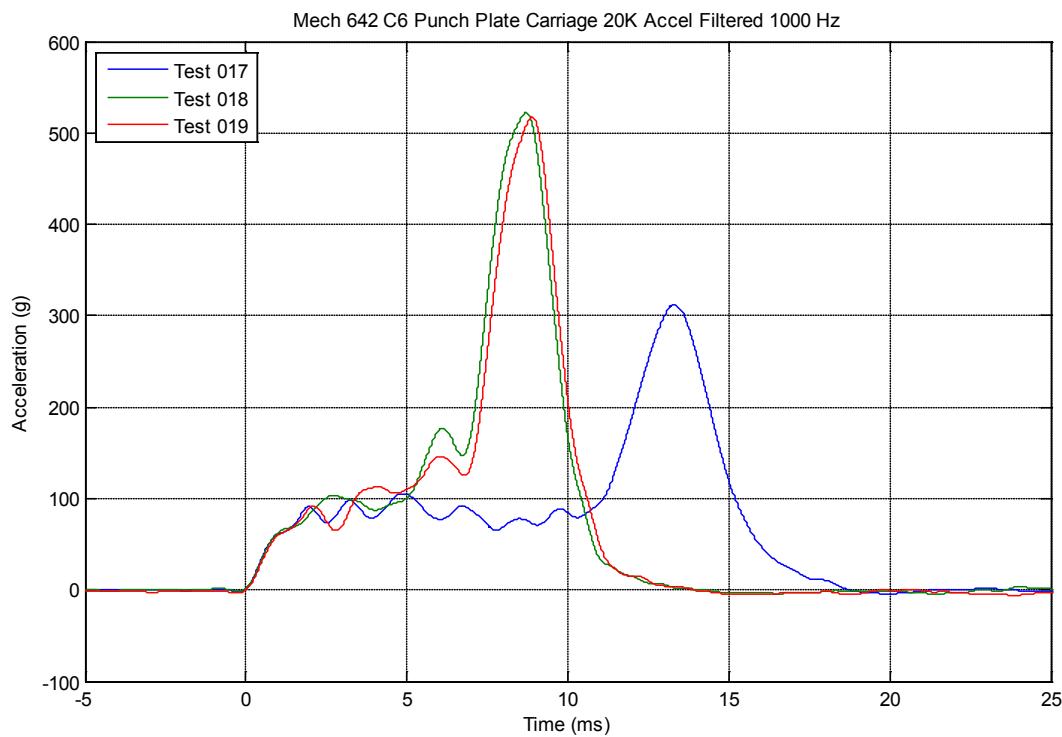
Figure A-11. Abrasion-resistant plate-conical punch acceleration vs. time: Tests 17, 18, 19

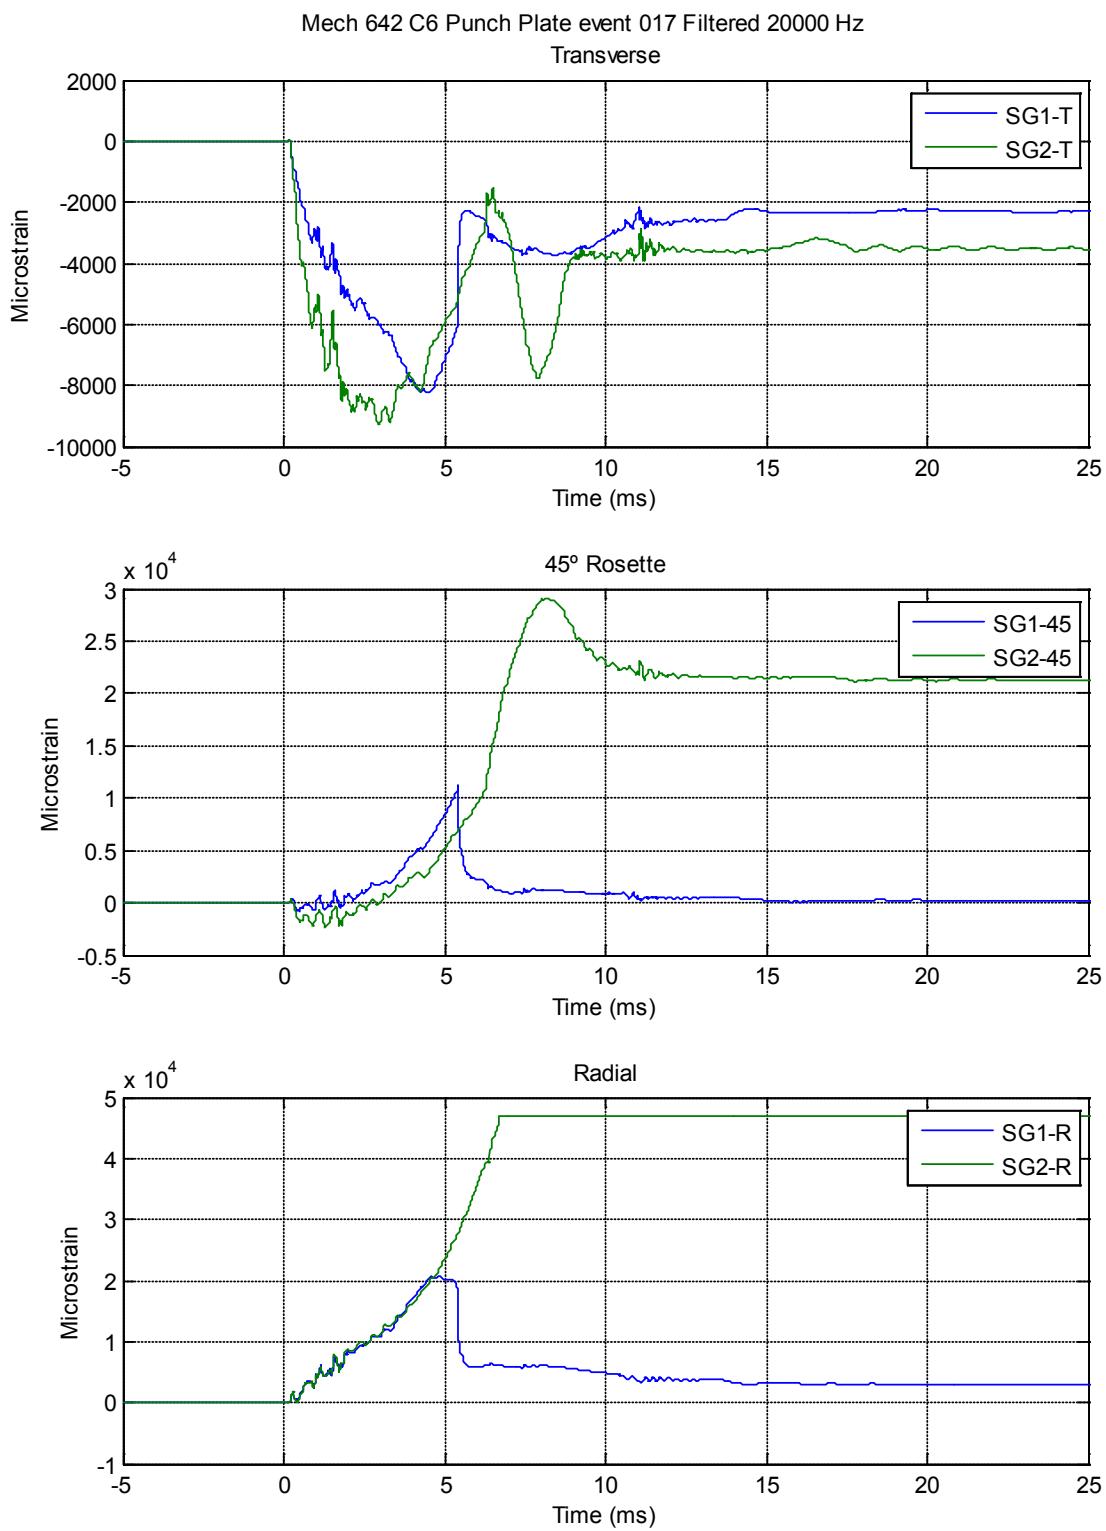
Figure A-15. Abrasion-resistant plate-conical punch microstrain vs. time: Test 17

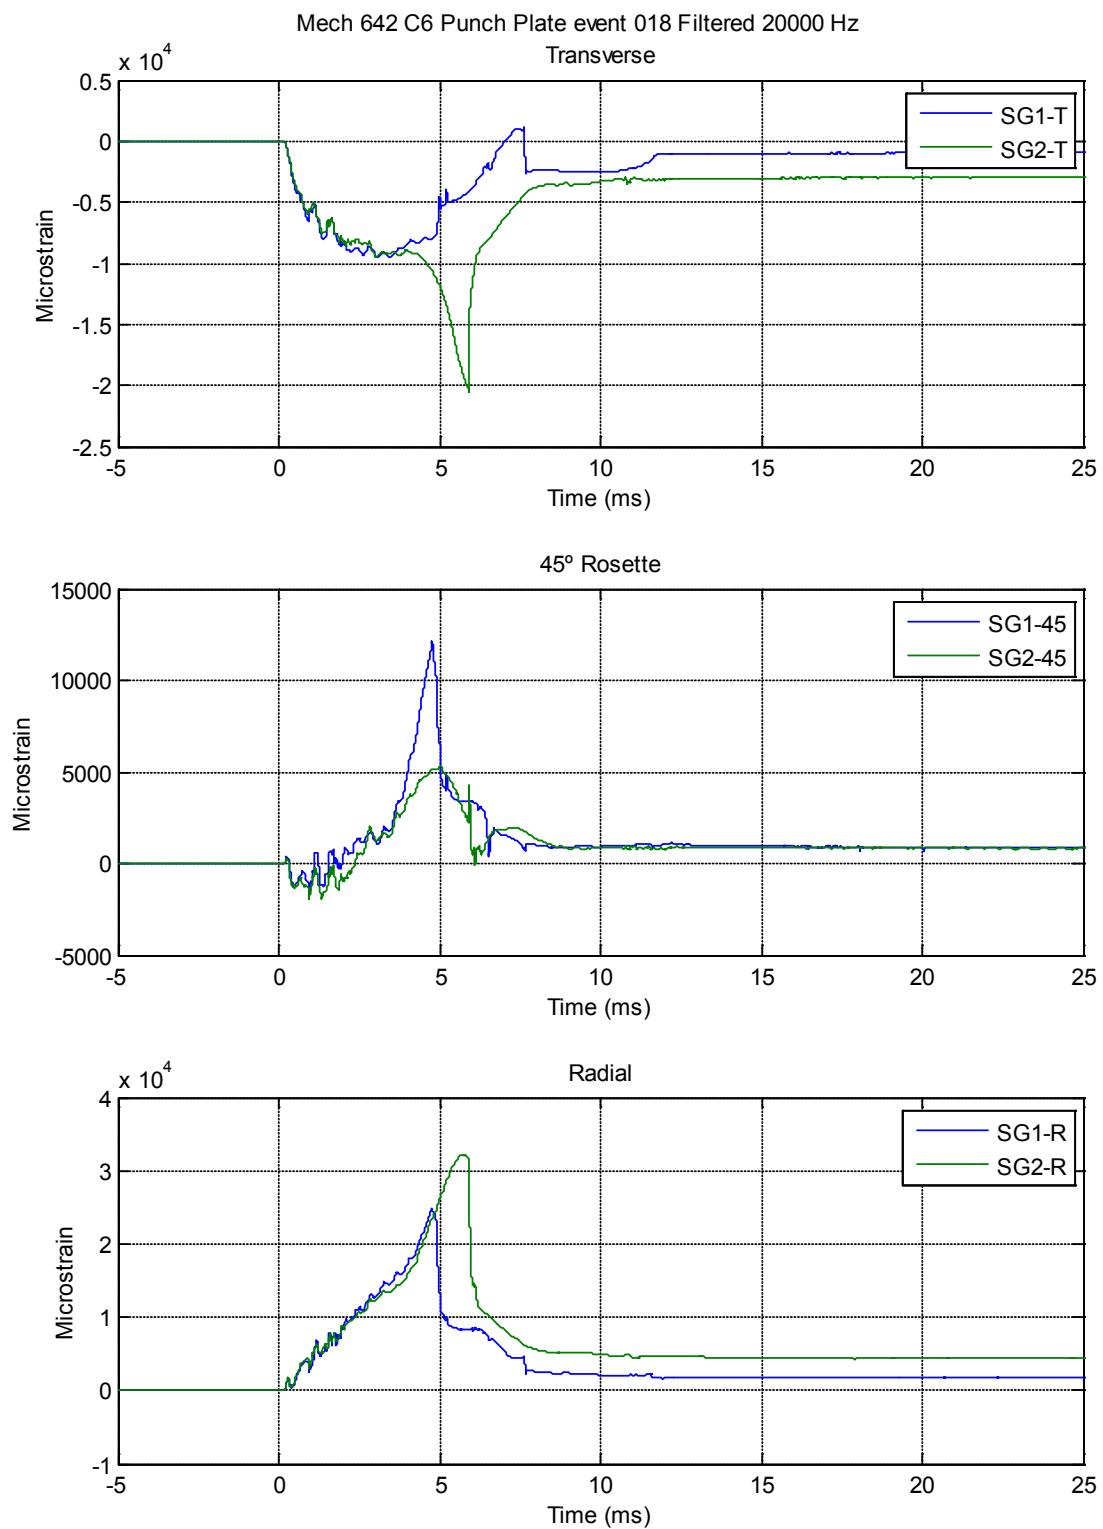
Figure A-16. Abrasion-resistant plate-conical punch microstrain vs. time: Test 18

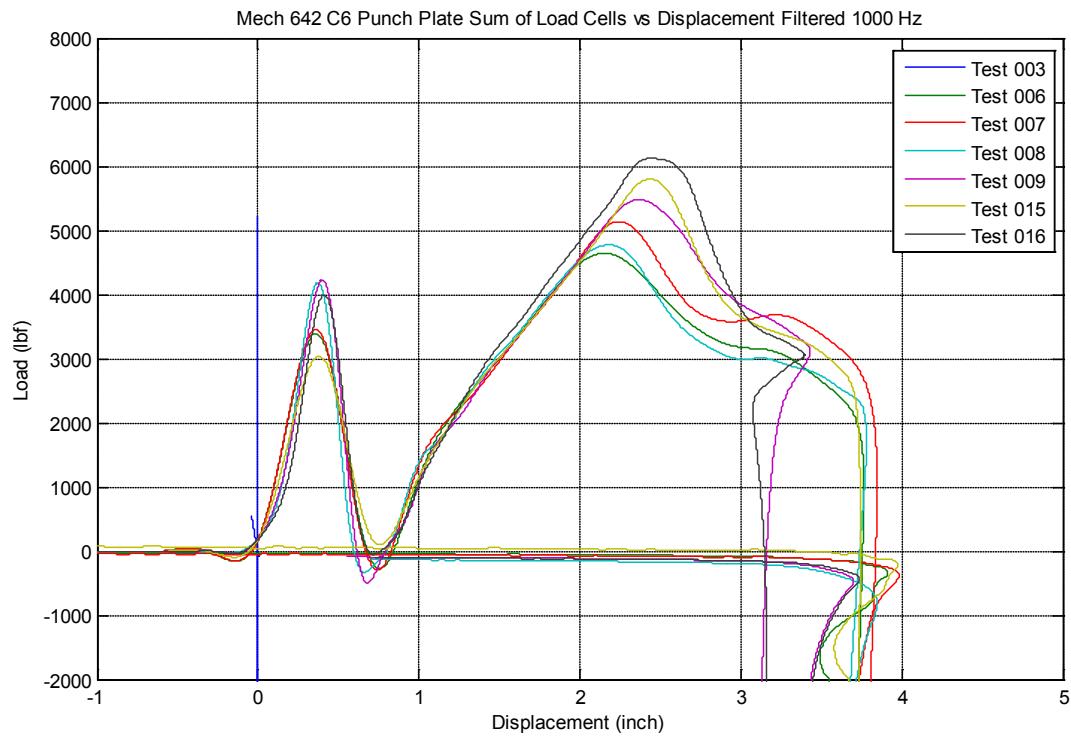
Figure B-1. Mild steel-flat punch load vs. displacement: Tests 3, 6, 7, 8, 9, 15, 16
