SANDIA REPORT

SAND2012-7930

C6 Plate Puncture Testing Report

C6 Plate Puncture Plate Testing Report

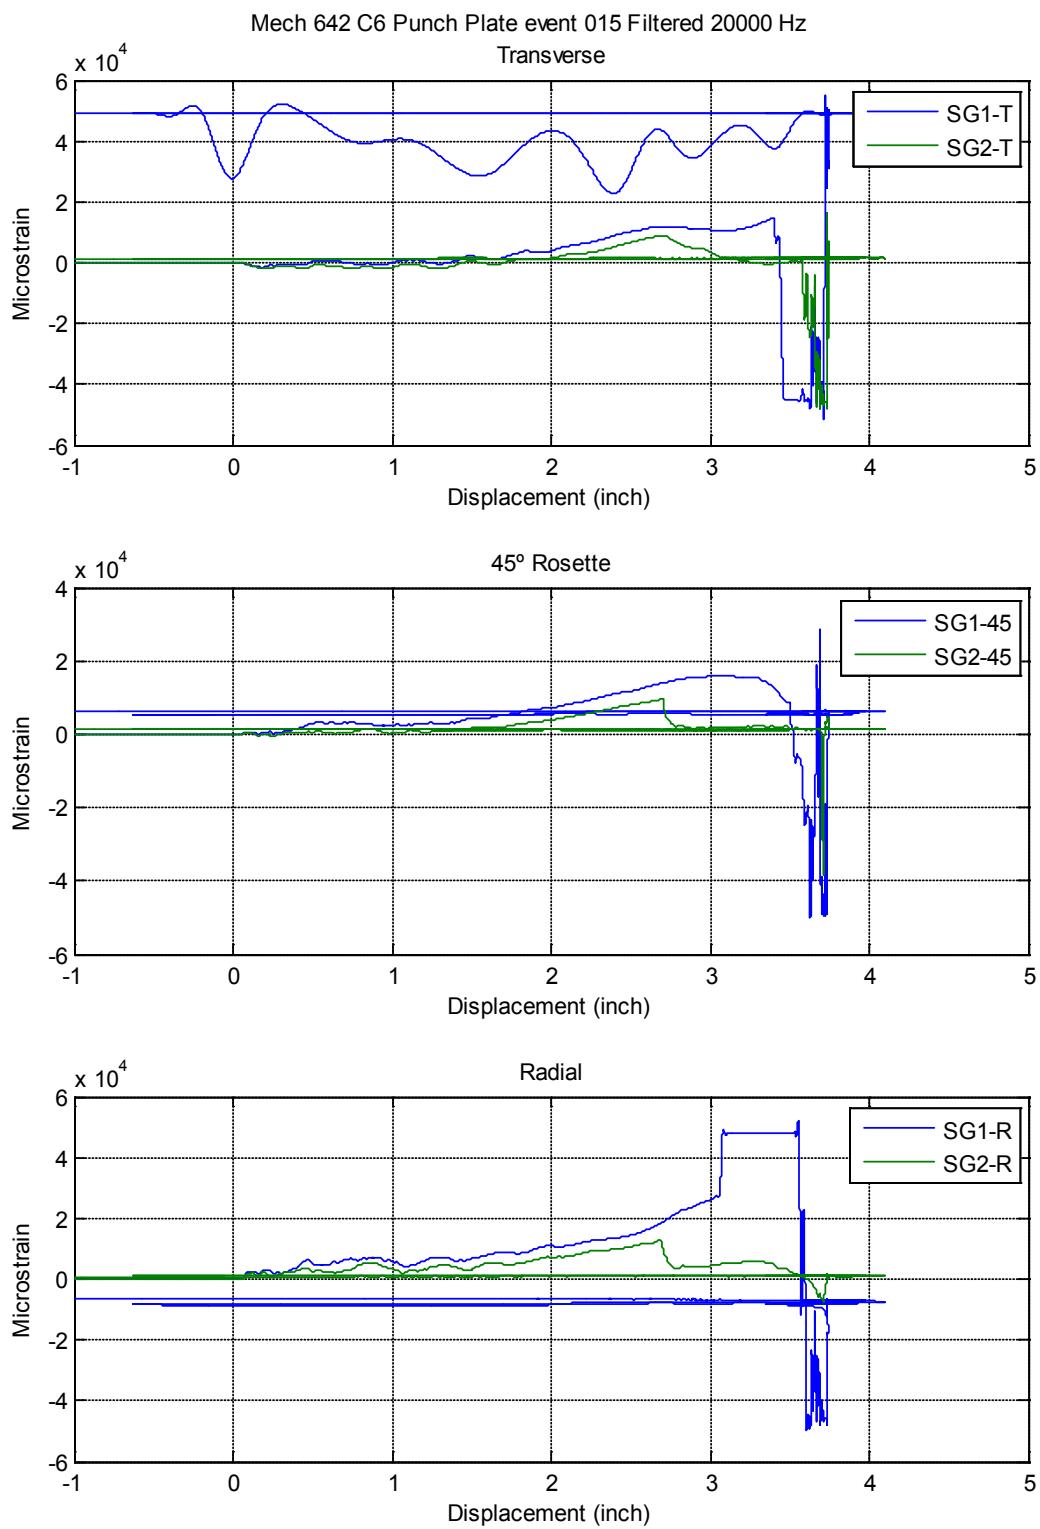
Figure B-2. Mild steel-flat punch microstrain vs. displacement: Test 15

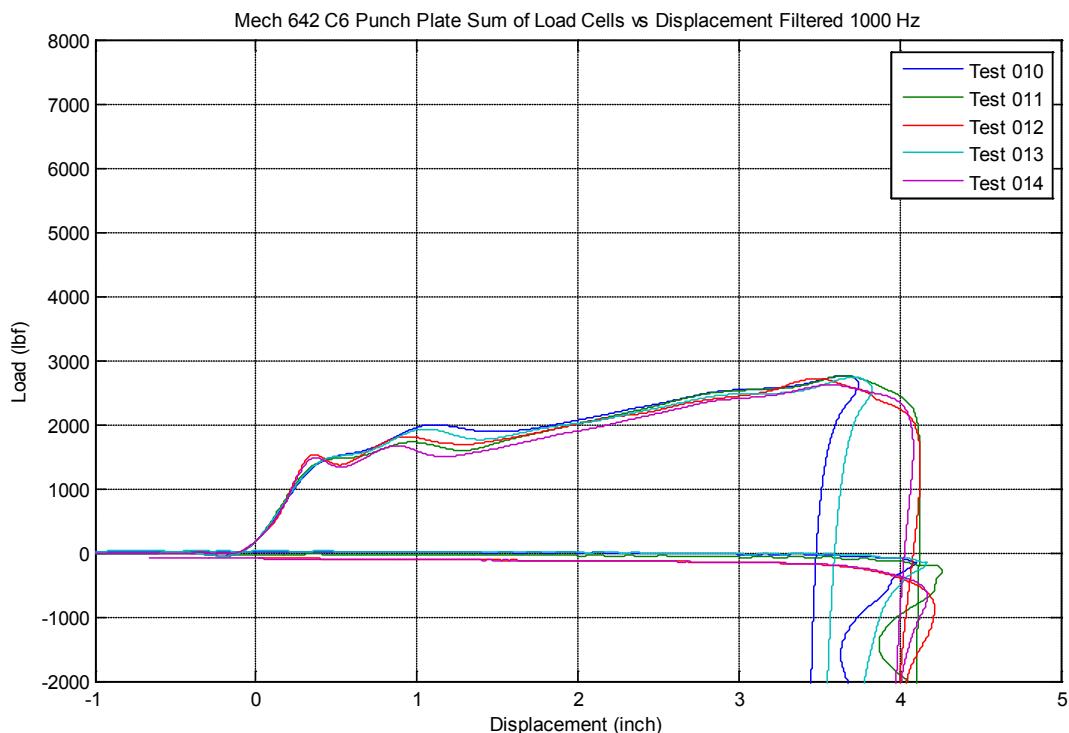
Figure B-3. Mild steel-conical punch load vs. displacement: Tests 10, 11, 12, 13, 14

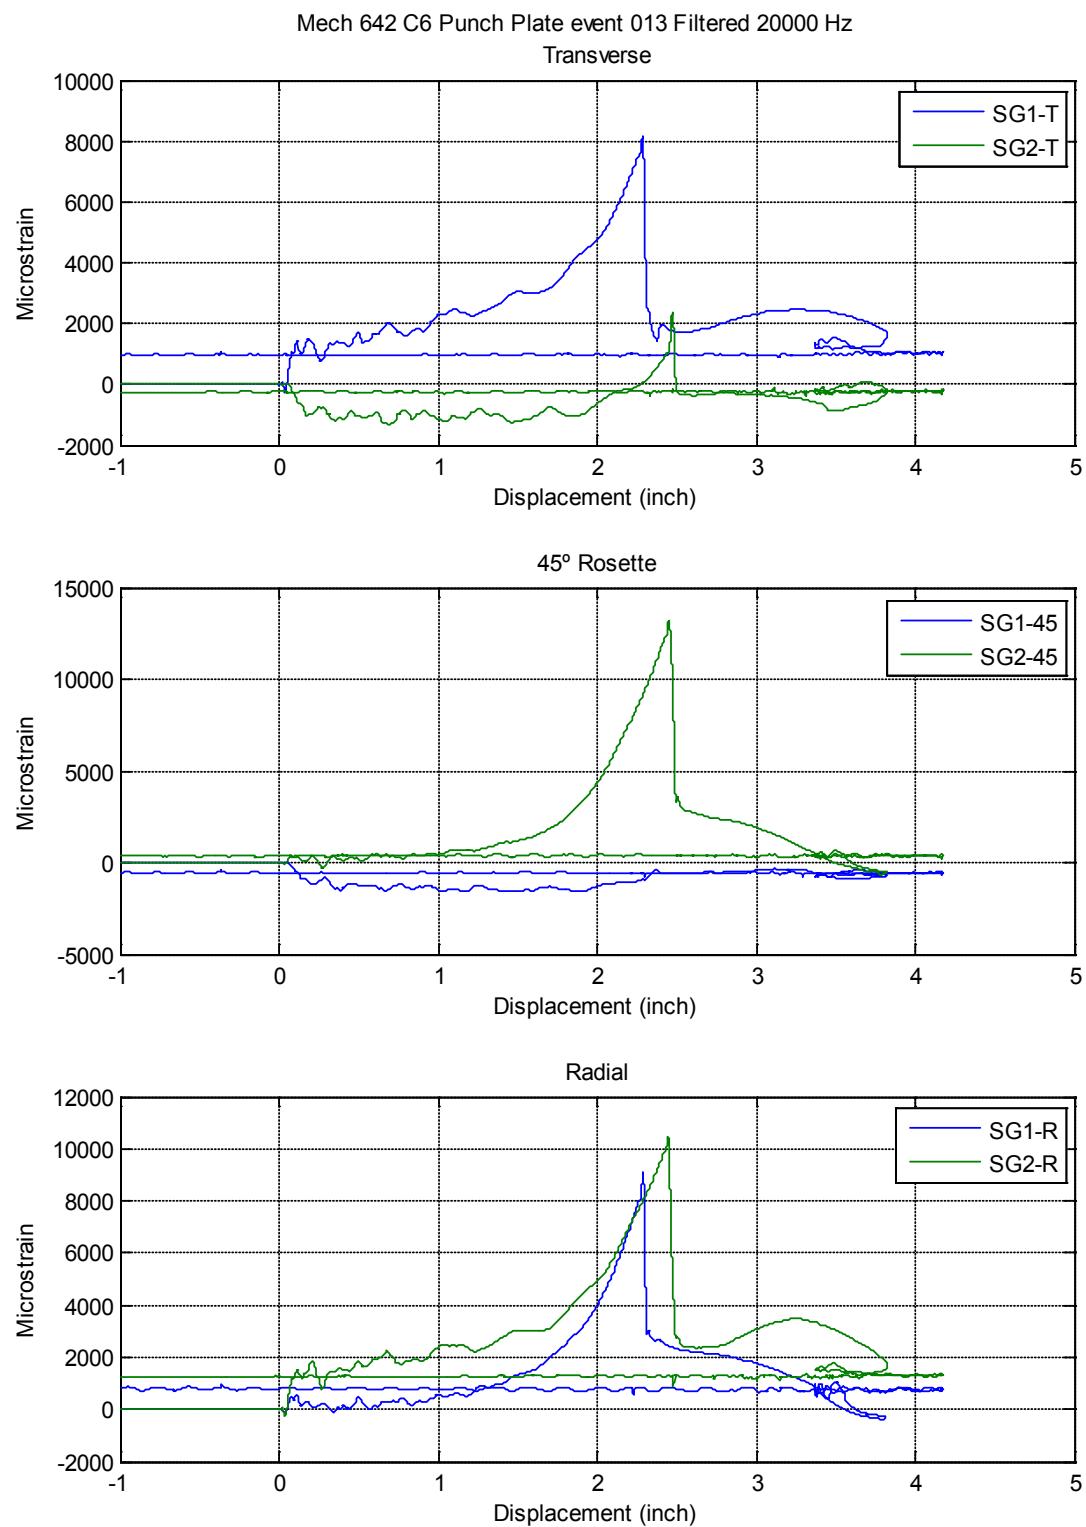
Figure B-4. Mild steel-conical punch microstrain vs. displacement: Test 13

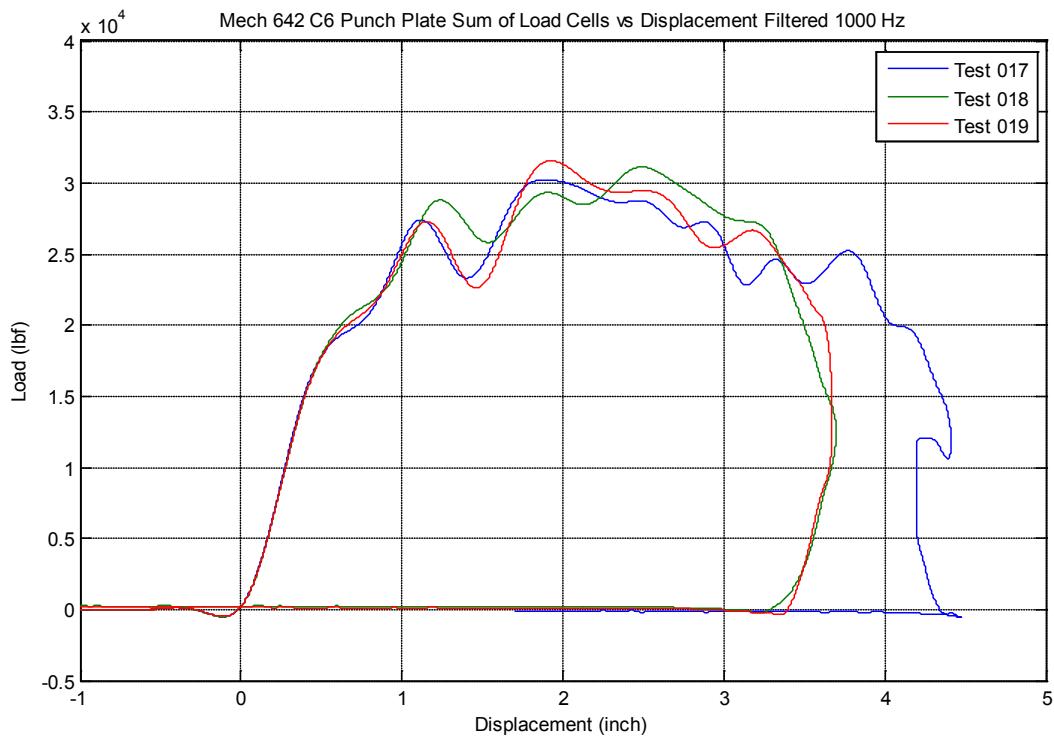
Figure B-5. Abrasion-resistant plate-conical punch load vs. displacement: Tests 17, 18, 19

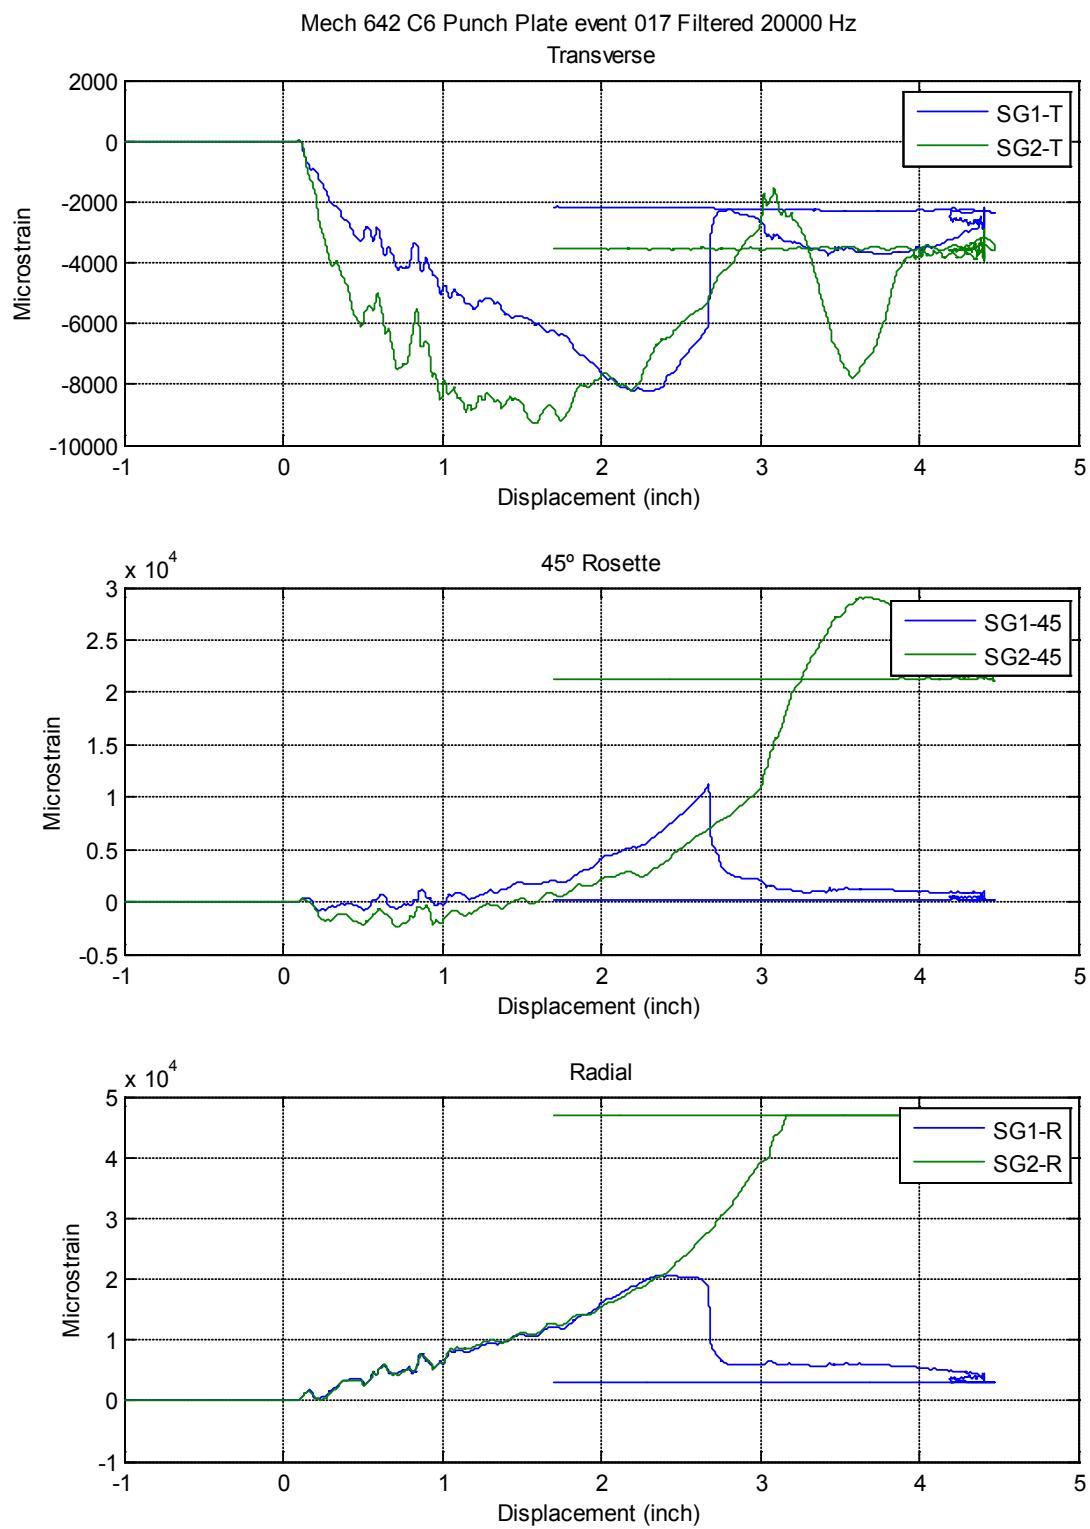
Figure B-9. Abrasion-resistant plate-conical punch microstrain vs. displacement: Test 17

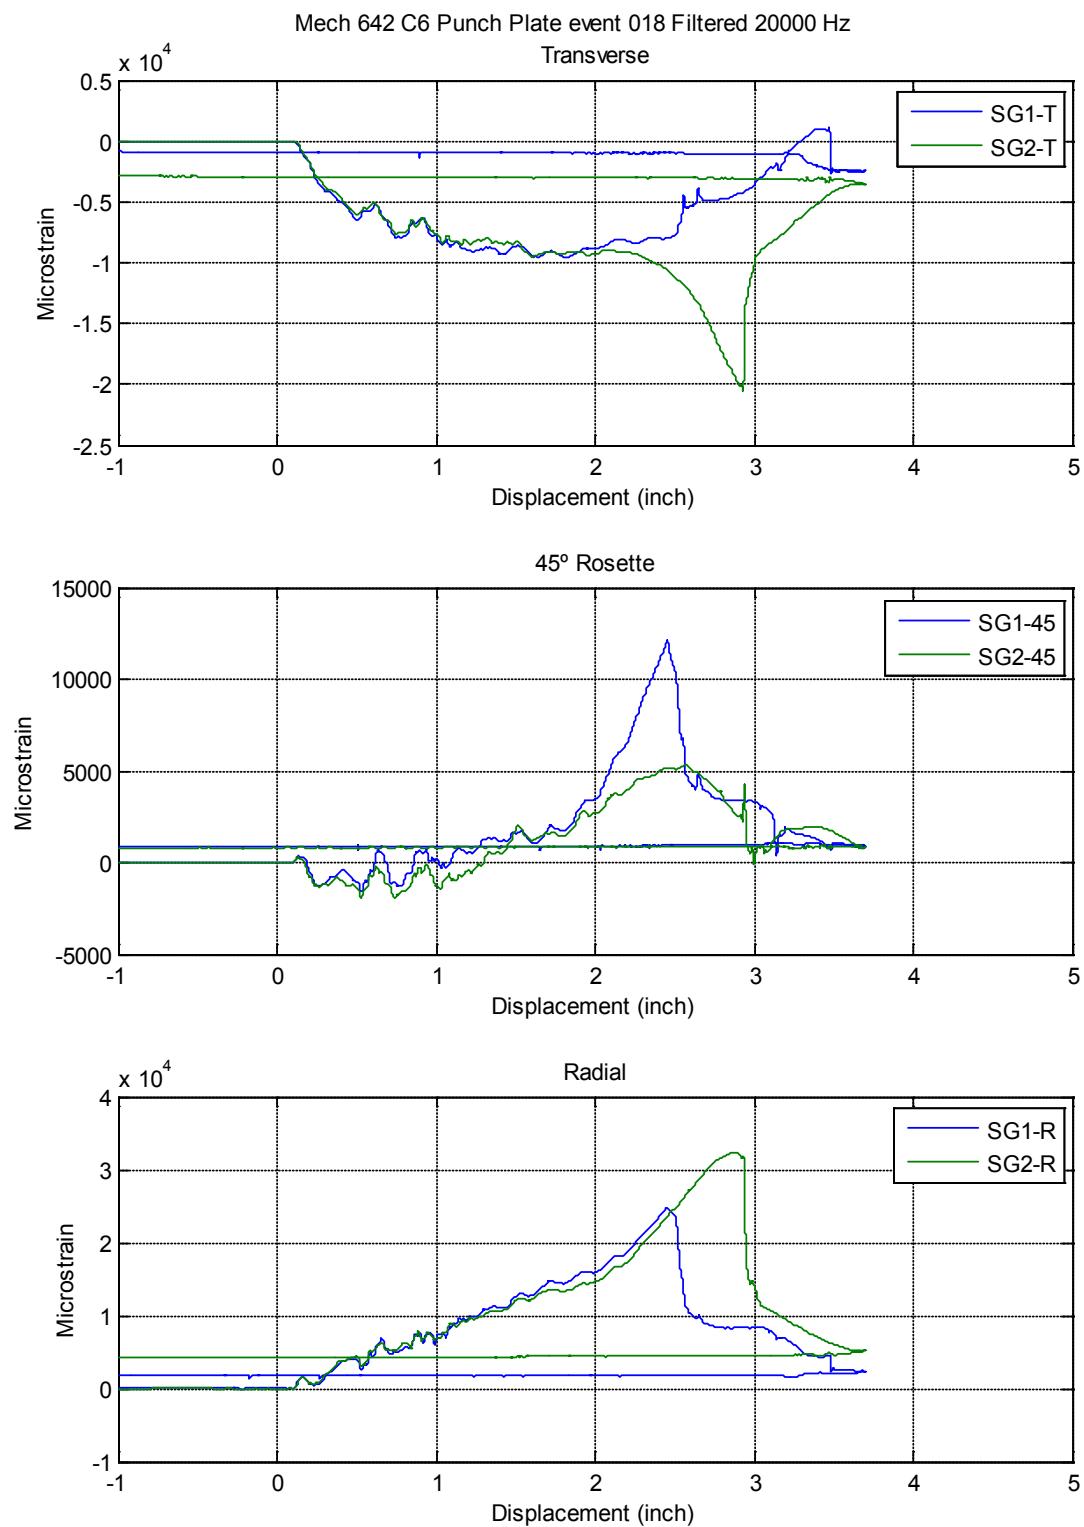
Figure B-10. Abrasion-resistant plate-conical punch microstrain vs. displacement: Test 18
