*subject:* Mechanical Modeling of a WIPP Drum Under Pressure.

## Executive Summary

## Introduction

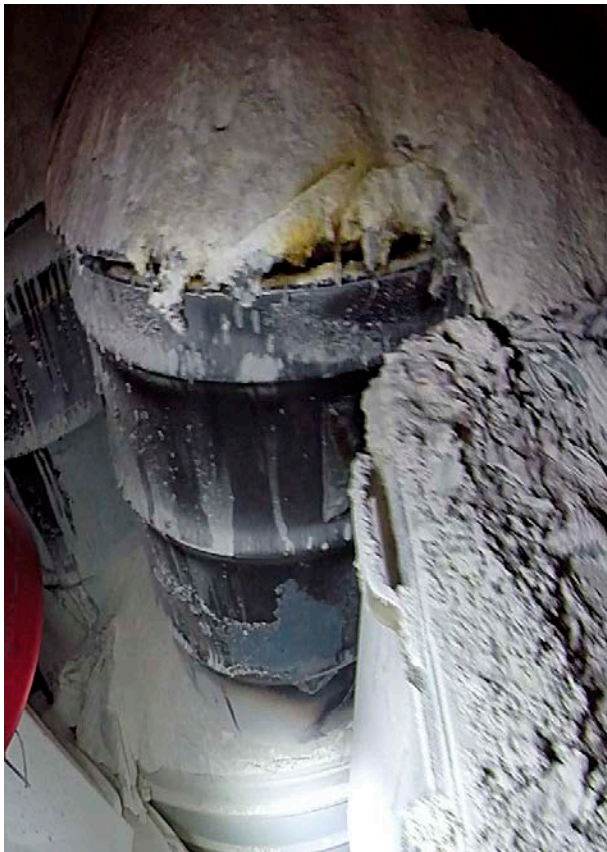
Initial images obtained from within WIPP discovered one drum that appeared open. An image of this drum (drum 68660) is shown in Figure 1.

**Figure 1.** Drum 68660 in WIPP.

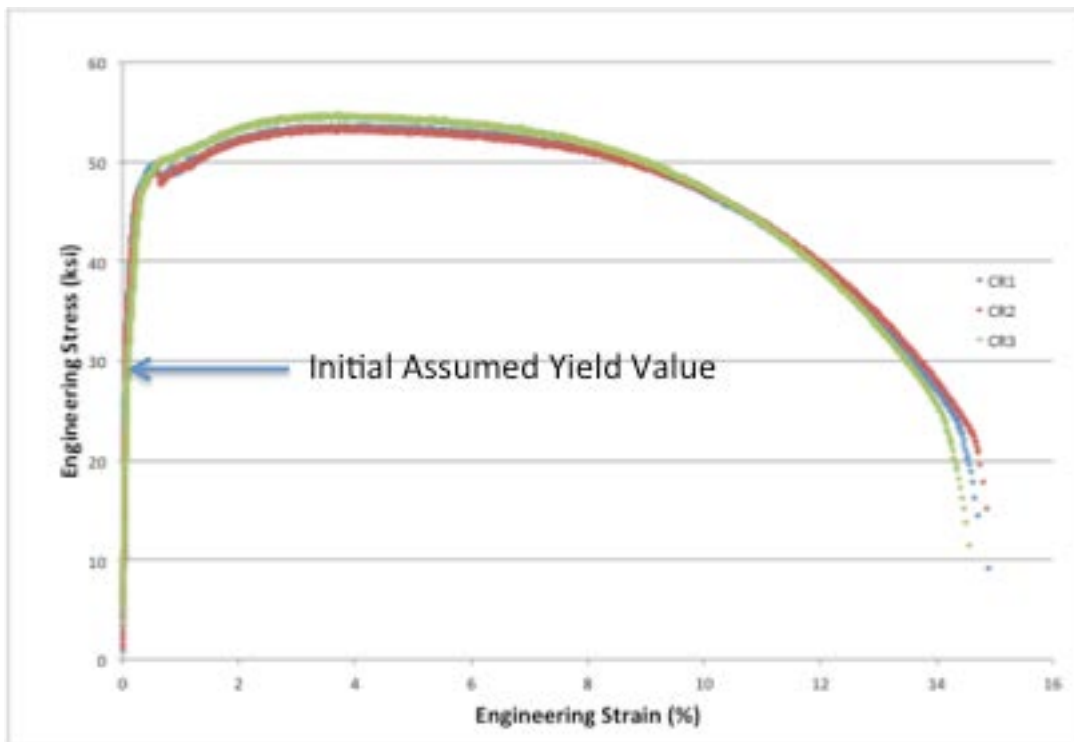
There was not significant variation between each of the three specimens tested for each material. Figures 3 and 4 present the engineering stress-strain plots for the test data. The data for test 2 of each material was used in the analyses. For the closure ring data the material had a yield strength of 30.5e03 psi and for the drum lid material it had a yield strength of 40.0e03 psi. The ELASTIC\_PLASTIC material model in

**Figure 3.** Tested Closure Ring Engineering Stress-Percent Strain Curves for a drum obtained from LANL.

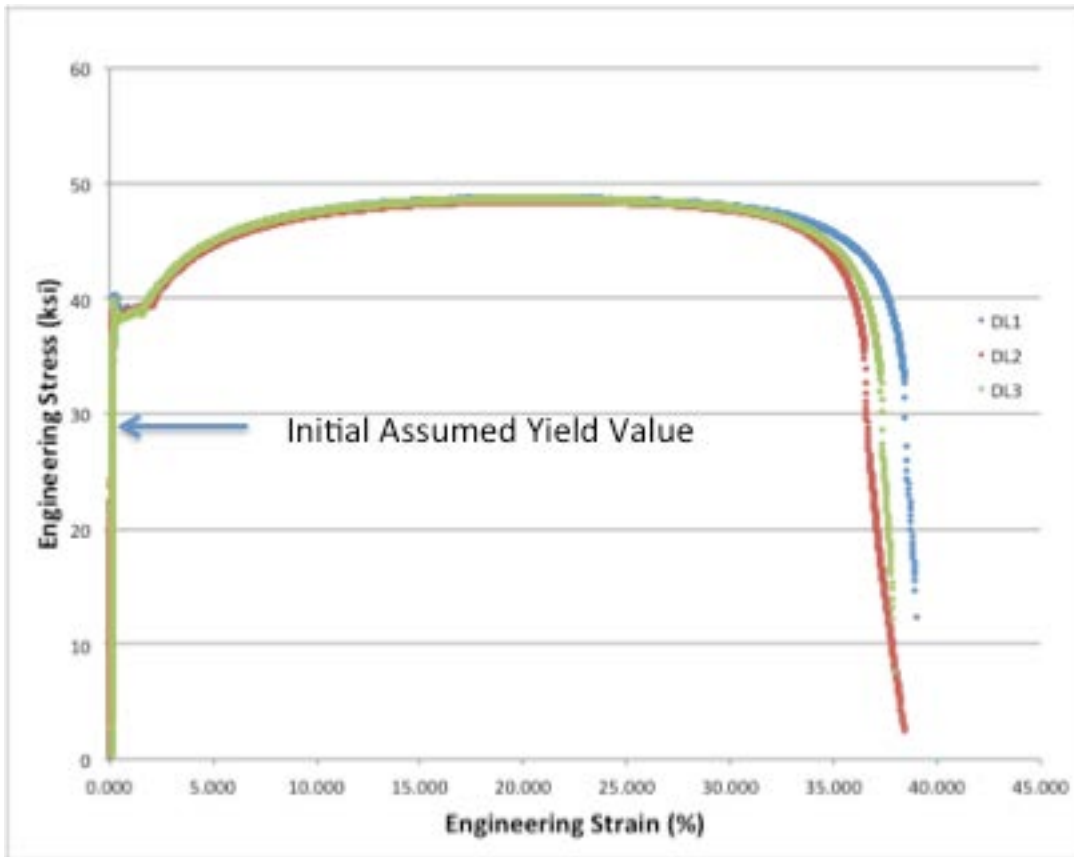
**Figure 4.** Tested Drum Lid Engineering Stress-Percent Strain Curves for a drum obtained from LANL.

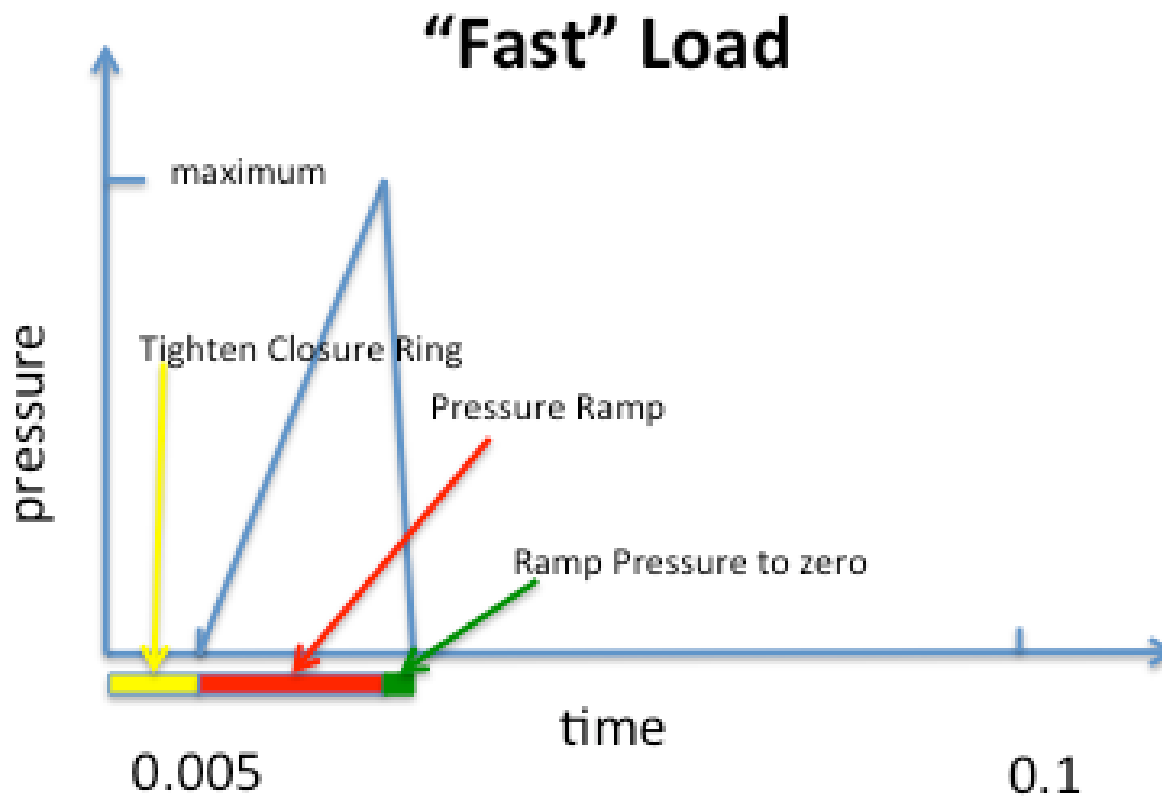
A number of loading cases were explored for the analyses. For the pressurization two main cases were considered. Figures 5 and 6 present schematics of the two basic loading cases. The maximum pressure of the applied loadings varied some, but the shapes of the pressure curves were the same. For the analyses, this pressure was applied to the inside of the drum on the bottom, sidewall, and inside of the lid. When specific cases are discussed below, the maximum pressure will be specified. Figure 5 shows what will be referred to as the “slow” loading case. For these cases the closure ring is closed in 0.005 seconds. Then the pressure is steadily increased until the time has reached 0.1 seconds. The other case (shown in Figure 6), referred to as the “fast” load case the closure ring is closed in 0.005 seconds. Then the pressure is ramped quickly up to a “maximum” pressure at a total time of 0.015 seconds. Then, simulate pressure release, ramped back to zero in another 0.001 seconds (total time of 0.016 seconds). Some cases varying the time to maximum ramp pressure were also performed. Both of these pressure cases are purely hypothesized in nature, i.e. no chemistry effect should be inferred for these cases. They are used to understand structural performance differences that might present themselves from a short burst or a longer term loading.

**Figure 6.** Faster ramped loading form (and unloading) for analyses (referred to as “Fast” load).

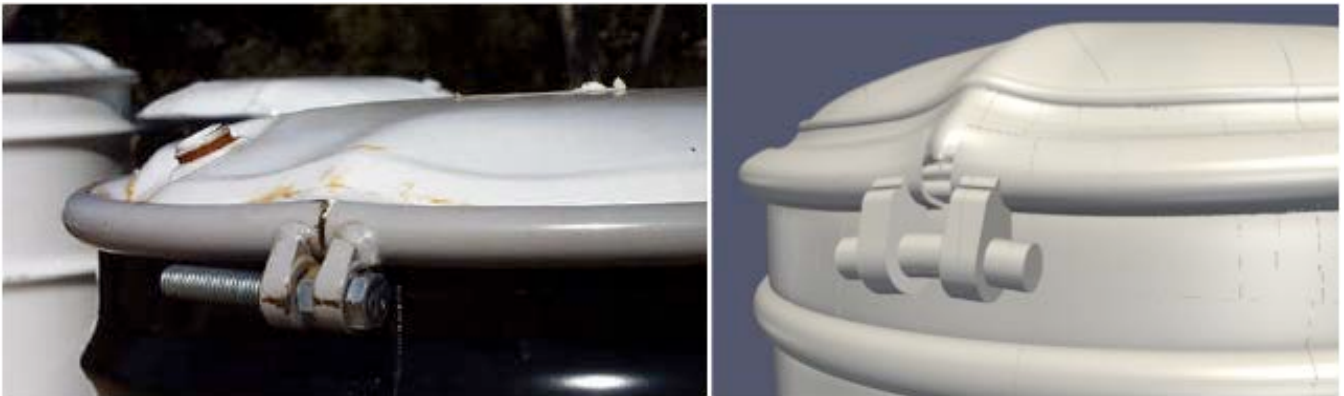
Figure 8 shows a comparison of one of the drums tested at LANL (Larranaga et al., 1999) and the results of the analysis at a similar deformation state. One can see the deformation patterns are similar. In addition, Figure 9 shows a section from the analysis at the same point. There is actually a gap opened between the lid and the drum body lip where the closure ring gap is at the location of the bolt. This is where the drums lost pressure for the drums tested at LANL. In Figure 9, one can see the seal would still be maintained at the opposite side of the lid because the closure ring is in contact with the drum body lip (in a real drum the gasket would protrude out of the closure ring). Also note as pointed out in Figure 9, the discontinuity in the lid deformation pattern near the plug location.

**Figure 8.** Comparison of tested drum at LANL (Larranaga et al., 1999) left, and analysis results, right.

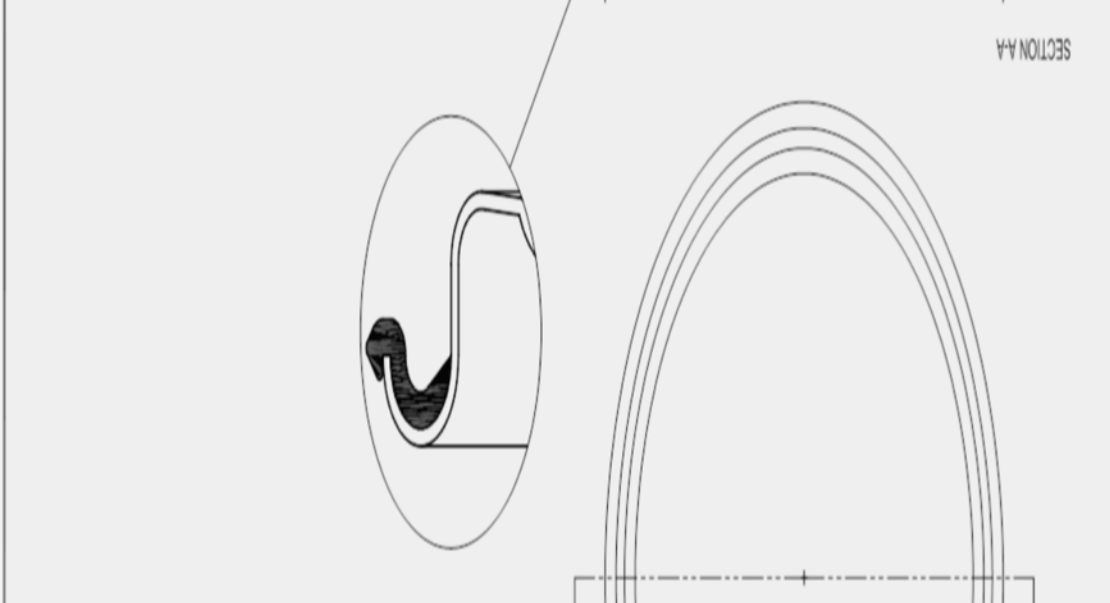
- DRUM COVER EXTERIOR CARBON STEEL PER ASTM A1008 OR ASTM A568 OR EQUIVALENT
- MATERIAL THICKNESS 1.5mm (0.050 - 0.059-16 GAUGE) OR 1.2mm (0.043 - 0.047-18 GAUGE) OR 0.9mm (0.35 - 0.037-20 GAUGE)
- GASKET MAT'L PER ASTM D1068
