Failure Mechanisms and Color Stability in Light-Emitting Diodes during Operation in High-Temperature Environments in Presence of Contamination

Abstract

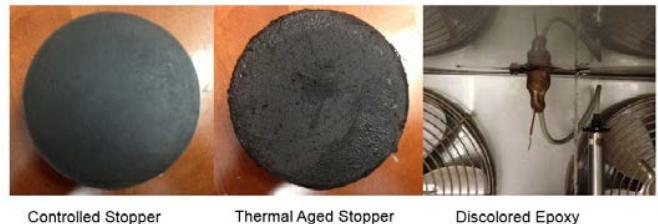
Figure 2. Potential Contamination Sources

In this test two potential contamination sources have been studied. The first is the port stopper of the thermal and humidity chamber and it is made of vulcanized rubber. Sulfur is added to the natural rubber during the vulcanization process. However, sulfur is known to escape from the rubber, although with short chain plasticizing molecules at high temperature. The second potential source of contamination is the adhesive epoxy used in the thermal and humidity chamber. In order to fix the thermal couple and humidity sensor, a lot of adhesive epoxy were used in the chamber during the maintenance. After the test, an obvious discoloration of the adhesive epoxy can be observed. Figure 2 shows the contamination source for this experiment.

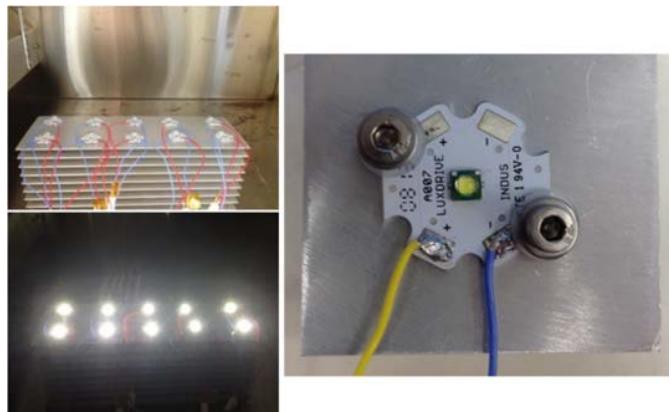
Figure 3. Test Setup

Figure 3 shows the heat sink and fixture used in this work for the environmental chamber. In this setup, a single LED was mounted on the top of a star board that was fixed on the top of the heat sink with screws and nylon insulation. The nylon insulation pad was used to prevent electric connection between the star board and the heat sink. Test samples were subjected to both thermal and relative humidity stress in a contaminated chamber. Figure 4 shows the thermal and humid chamber used in this experiment.
