REPORT TITLE	SOLID OXIDE FUEL CELL POWER SYSTEM DEVELOPMENT
TYPE OF REPORT	FINAL SCIENTIFIC/TECHNICAL
REPORTING PERIOD START DATE	10/01/2013
REPORTING PERIOD END DATE	3/31/2015
PRINCIPAL AUTHORS	RICK KERR – DELPHI MARK WALL – IEPT NEAL SULLIVAN – COLORADO SCHOOL OF MINES
DATE REPORT WAS ISSUED	06/26/2015
DOE AWARD NUMBER	DE-FE-0011769
NAME AND ADDRESS OF SUBMITTING ORGANIZATION	DELPHI AUTOMOTIVE SYSTEMS, LLC 5725 DELPHI DRIVE TROY MI 48098-2815 INDEPENDENT ENERGY PARTNERS TECHNOLOGY, LLC. TEC BUILDING 11479 SOUTH PINE DRIVE PARKER, CO, 80134 COLORADO SCHOOL OF MINES 1610 ILLINOIS STREET GOLDEN, CO 80401

This report summarizes the progress made during this contractual period in achieving the goal of developing the solid oxide fuel cell (SOFC) cell and stack technology to be suitable for use in highly-efficient, economically-competitive, commercially deployed electrical power systems. Progress was made in further understanding cell and stack degradation mechanisms in order to increase stack reliability toward achieving a 4+ year lifetime, in cost reduction developments to meet the SECA stack cost target of \$175/kW (in 2007 dollars), and in operating the SOFC technology in a multi-s

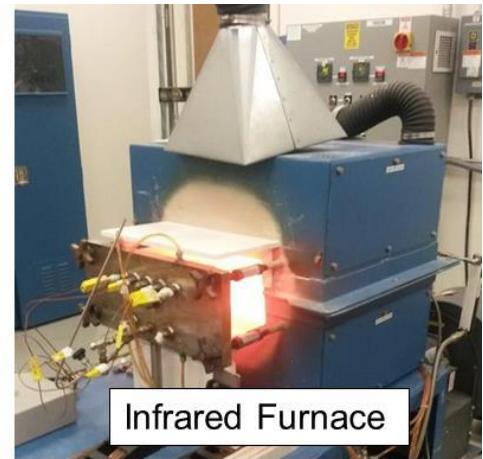
Two-cassette stack samples were made with repeating unit seals from different fabrication processes and compositional additive variations. These were evaluated by first leak testing, after the initial sintering process, then by leak testing again at periodic intervals after thermal cycling exposure in a regular air atmosphere, with no externally applied load, in an infrared furnace. The infrared thermal cycling profile was developed to substantially accelerate the rate of thermal cycling when compared to that of a stack in a typical operating environment. The thermal cycle profile, infrared furnace, and a two-cassette stack specimen are exhibited in Figure 11.

Figure 11: IR thermal cycle profile, furnace, and two-cassette stack sample.

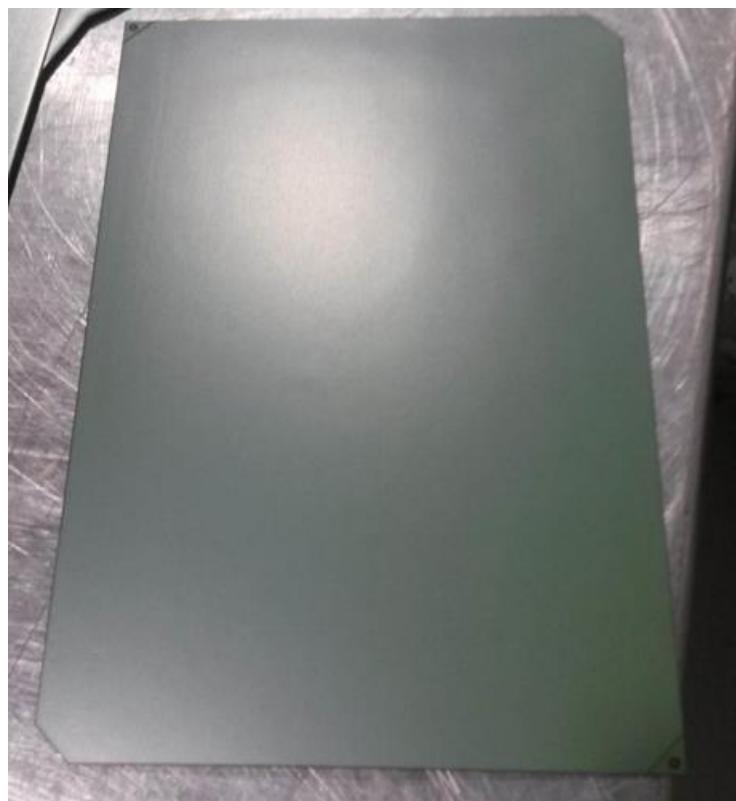
Two alternate suppliers of bilayer tapes have been identified and continue to be developed. A pilot scale run was conducted at Supplier A in late October 2014, which yielded electrolyte and active anode tapes (Figure 24). To date, in-house made slurries have been provided for all Supplier A coating work. Recently, slurries made at a third party have been shipped to Supplier A for the next rounds of work. A later goal will be supplier-site slurry fabrication.

Figure 24: Gen 3 fired bi-layer made with Supplier A process.
