FINAL SCIENTIFIC AND TECHNICAL REPORT

Computational Design and Experimental Validation of New Thermal Barrier Systems

DOE Award Number: DE-FE0004734

Louisiana State University and A & M College
Baton Rouge, LA, 70803-2701

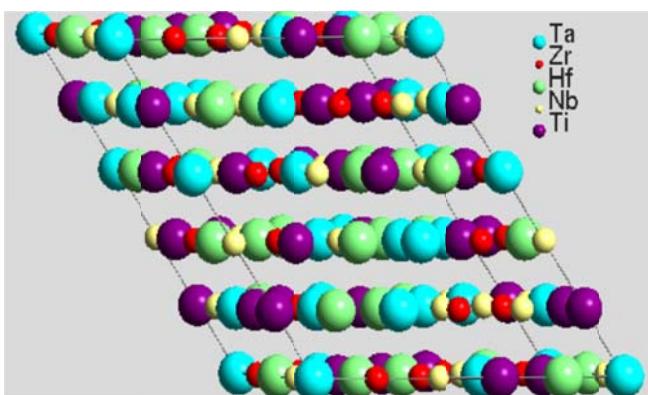
Fig 1.1 The unit cell model used in simulation for $Ta_{20}Nb_{20}Hf_{20}Zr_{20}Ti_{20}$.

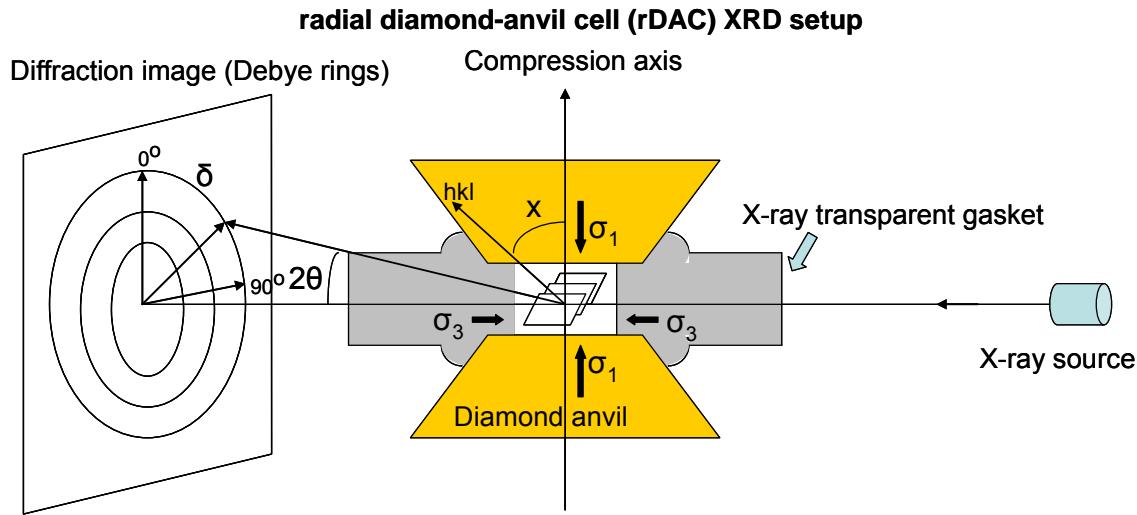
Fig 2.1 The radial synchrotron x-ray diffraction shear stress texture measurement setup.

The dislocation dynamics texture study was conducted at LBNL by adding radial shear stress to the DAC loaded sample. The Fit2D and MAUD software were used to process the texture data. The Figure 2.1 below shows a typical synchrotron high pressure shear stress texture measurement experiment setup.

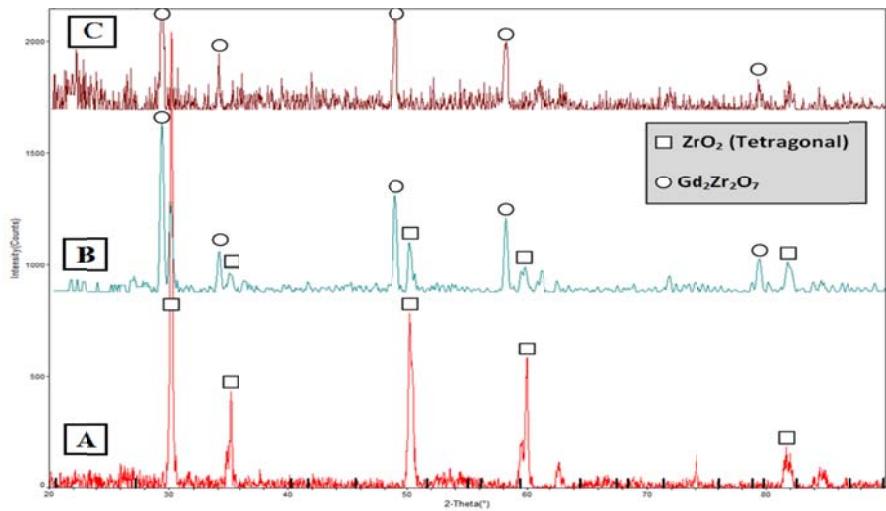
Fig 3.1.1. XRD patterns of as-received A) conventional YSZ, B) $\text{Gd}_2\text{Zr}_2\text{O}_7$ +YSZ, C) $\text{Gd}_2\text{Zr}_2\text{O}_7$

Figure 3.1.1 reveals the X-ray diffraction patterns for the as-received conventional YSZ, $\text{Gd}_2\text{Zr}_2\text{O}_7+\text{YSZ}$, and $\text{Gd}_2\text{Zr}_2\text{O}_7$ coatings. It can be seen that the major phase of the APS coated YSZ is tetragonal zirconia, $\text{Gd}_2\text{Zr}_2\text{O}_7+\text{YSZ}$ coating includes both tetragonal ZrO_2 and $\text{Gd}_2\text{Zr}_2\text{O}_7$ phases, and $\text{Gd}_2\text{Zr}_2\text{O}_7$ has a single phase as expected. The cross-sectional microstructure of APS YSZ, $\text{Gd}_2\text{Zr}_2\text{O}_7+\text{YSZ}$ and $\text{Gd}_2\text{Zr}_2\text{O}_7$ TBC specimens are shown in Fig. 3.1.2. All layers of the as-sprayed specimens have similar microstructures with a noticeable level of porosity without any visible cracks. For the as-sprayed TBC samples, no delamination can be found along the YSZ / $\text{Gd}_2\text{Zr}_2\text{O}_7+\text{YSZ}$ / $\text{Gd}_2\text{Zr}_2\text{O}_7$ top layer and the NiCrAlY bond coat interface. Figure 3.1.3 shows the XRD patterns obtained from the YSZ, $\text{Gd}_2\text{Zr}_2\text{O}_7+\text{YSZ}$, and $\text{Gd}_2\text{Zr}_2\text{O}_7$ coatings after the hot corrosion test with the $\text{Na}_2\text{SO}_4+\text{V}_2\text{O}_5$ salt mixture at 1050°C . Comparing the patterns of the as-sprayed TBC samples, most of the tetragonal zirconia in the YSZ sample has changed to the monoclinic phase and YVO_4 is formed as a hot corrosion product, while for the other two specimens, besides monoclinic ZrO_2 the newly evolved peak is related to GdVO_4 .

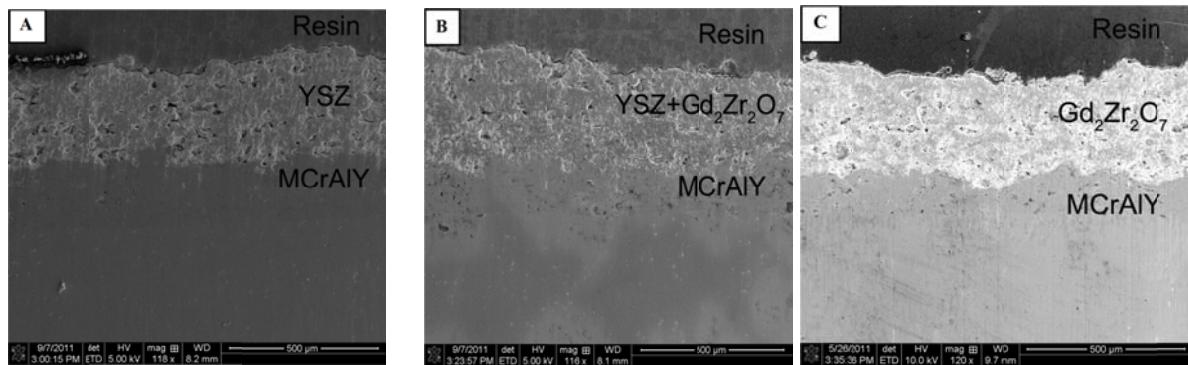
Fig 3.1.2. Cross-section of APS coatings A) conventional YSZ, B) $\text{Gd}_2\text{Zr}_2\text{O}_7$ +YSZ, C) $\text{Gd}_2\text{Zr}_2\text{O}_7$

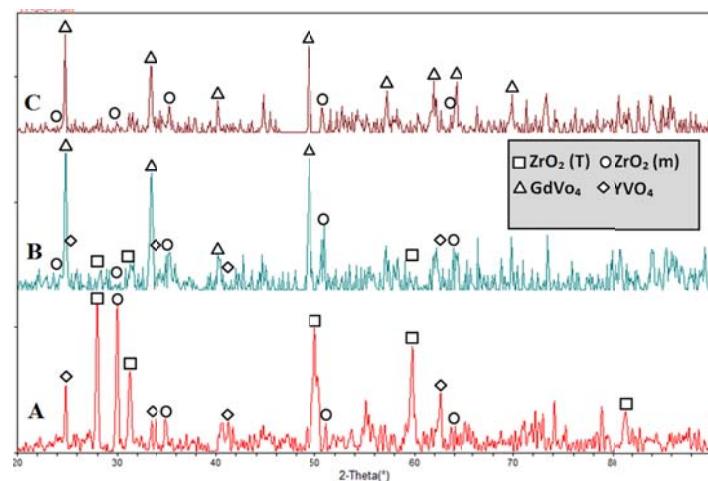
Fig 3.1.3. XRD patterns of A) conventional YSZ, B) $\text{Gd}_2\text{Zr}_2\text{O}_7$ +YSZ, C) $\text{Gd}_2\text{Zr}_2\text{O}_7$ after hot corrosion in $\text{Na}_2\text{SO}_4+\text{V}_2\text{O}_5$ at 1050 °C

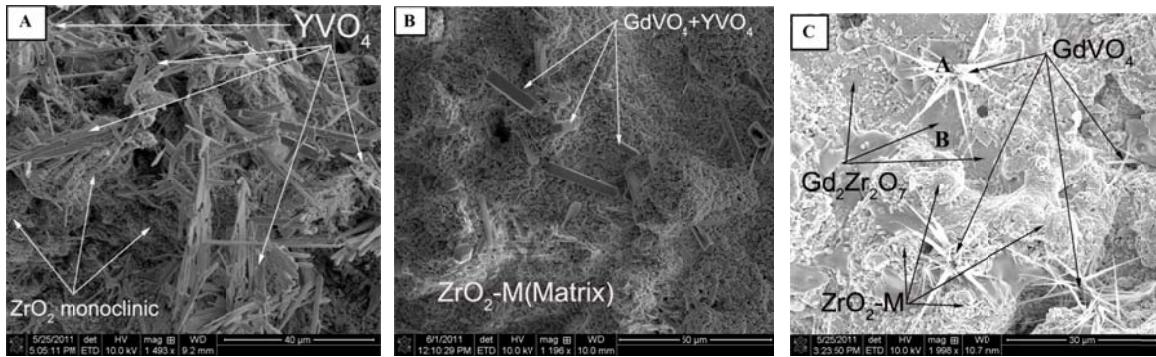
Fig 3.1.4. SEM surface images of A) conventional YSZ, B) $\text{Gd}_2\text{Zr}_2\text{O}_7$ +YSZ, C) $\text{Gd}_2\text{Zr}_2\text{O}_7$ after hot corrosion in $\text{Na}_2\text{SO}_4+\text{V}_2\text{O}_5$ at 1050°C

Typical surface morphologies of YSZ, $\text{Gd}_2\text{Zr}_2\text{O}_7$ +YSZ and $\text{Gd}_2\text{Zr}_2\text{O}_7$ specimens after hot corrosion tests are presented in Fig. 3.1.4, with the apparent formation of new crystals. Apart from XRD analysis, Fig. 3.1.3, Energy Dispersive Spectroscopy (EDS) analysis, Fig. 3.1.5, was performed at different regions of the TBC surfaces to confirm the chemical compositions of the hot corrosion products. EDS analysis from region A on Fig. 3.1.4a demonstrated that the crystals were composed of yttrium, vanadium and oxygen, then they were identified by XRD analysis to be YVO_4 . The EDS spectra obtained at different regions of A and B in Fig. 3.1.4c confirmed the presence of elements consistent with the formation of GdVO_4 (region A) and existence of $\text{Gd}_2\text{Zr}_2\text{O}_7$ (region B). For Gd_2VO_4 specimen, small amount of zirconium coming from the background was also detected (Fig. 3.1.5c).

temperature of 1050°C (five 4-hours cycles), serious degradation and spallation started to occur, Fig. 3.1.4a. Due to the damage by the $\text{Na}_2\text{SO}_4+\text{V}_2\text{O}_5$ corrodents, a porous layer was formed on the YSZ coating. Phase analysis results on these porous areas showed that a large amount of tetragonal zirconia on the surfaces of the conventional YSZ top layer had transformed to monoclinic phase due to the depletion of yttria. In addition, large quantity of rod shaped hot corrosion reaction product, YVO_4 , was detected on the surface of the conventional YSZ coating. Similar findings have been reported by other researchers.

For the $\text{Gd}_2\text{Zr}_2\text{O}_7+\text{YSZ}$ and $\text{Gd}_2\text{Zr}_2\text{O}_7$ coating, the corrosion products are GdVO_4 and YVO_4 as well as monoclinic ZrO_2 . In Fig.3.1.4B, it is obvious that some regions are perfectly intact and the major phase in these areas is $\text{Gd}_2\text{Zr}_2\text{O}_7$. Compare to YVO_4 , the GdVO_4 crystals are much smaller in size and quantity and they have a unique dendrite shape. For the YSZ sample, after hot corrosion tests, large quantity of rod shaped YVO_4 crystals are visible on the coating surfaces.

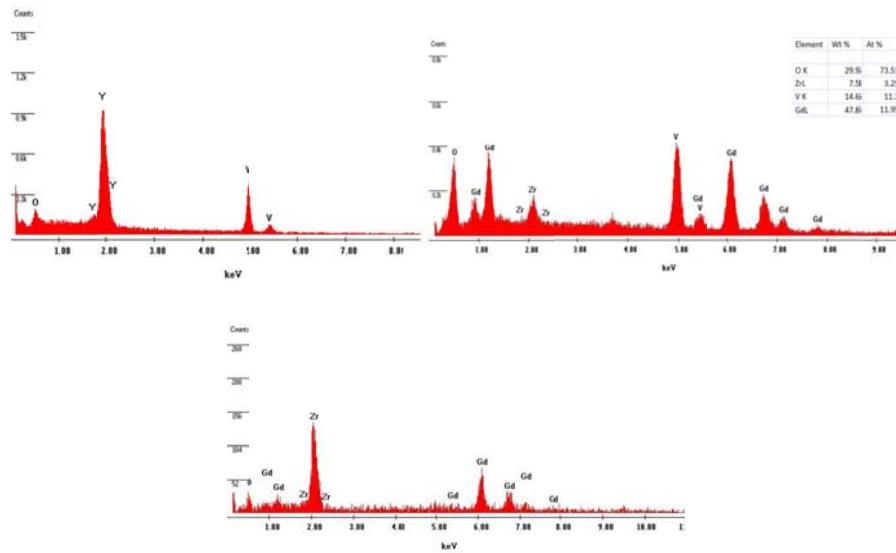
Fig 3.1.5. EDS spectra from the surface of the coatings A) crystal at region A in Fig. 3.1.4a, B) crystal at region A in Fig. 3.1.4c, C) region B in Fig. 3.1.4c

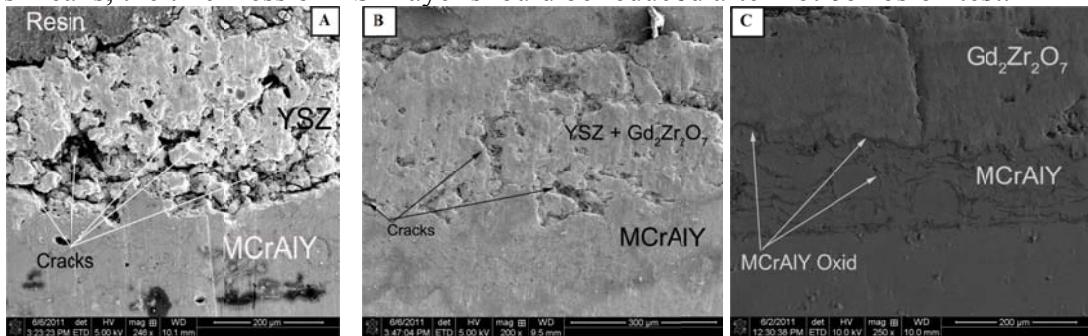
Fig 3.1.6. Cross-section of A) conventional YSZ, B) $\text{Gd}_2\text{Zr}_2\text{O}_7$ +YSZ, C) $\text{Gd}_2\text{Zr}_2\text{O}_7$ after hot corrosion in $\text{Na}_2\text{SO}_4+\text{V}_2\text{O}_5$ at $1050\text{ }^\circ\text{C}$

The representative cross section SEM images of the conventional YSZ, $\text{Gd}_2\text{Zr}_2\text{O}_7$ +YSZ and $\text{Gd}_2\text{Zr}_2\text{O}_7$ coatings after the hot corrosion tests are presented in Fig. 3.1.6. As shown in Fig. 3.1.6(a), the corroded areas near the YSZ/bond coat interface implies a weak coating which can be easily torn off; large harmful horizontal cracks have formed inside the conventional YSZ layer throughout the thickness of coating. Transverse cracks are clearly visible in the YSZ coating, Fig. 3.1.6a. In certain regions, the cracks divided the YSZ layer into several sub-layers, implying the initiation of delamination and spallation of the YSZ coating. Some large cracks have propagated and extended deep into the ceramic coat and even reached the top-coat/bond-coat interface, which would be susceptible to cause the debonding of the ceramic coat from the bond coat. Moreover, comparing Fig. 3.1.2a and Fig. 3.1.6a, the thickness of YSZ layer has been reduced after hot corrosion test. YSZ tetragonal to monoclinic phase transformation initiated from the beginning of hot corrosion test. As it accompanied by volume expansion, it can be torn off easily by small thermal and mechanical shocks during the hot corrosion cycles. So the failure of YSZ coating may occur by gradual loss of YSZ coating from the surface toward bond coat. This means, the thickness of YSZ layer should be reduced after hot corrosion test.

The micro cracks and pores were observed in both conventional YSZ and YSZ+ $\text{Gd}_2\text{Zr}_2\text{O}_7$ coatings. In comparison, the YSZ+ $\text{Gd}_2\text{Zr}_2\text{O}_7$ coating has finer and fewer micro cracks than the conventional YSZ coating. In the case of YSZ+ $\text{Gd}_2\text{Zr}_2\text{O}_7$ composite coatings, only a few visible cracks were observed inside the zirconia layer after the hot corrosion test but without spallation. It can be concluded that molten salts and oxygen penetration were retarded in this specimen thus a better hot corrosion resistance.

Fig. 3.1.6C shows a $\text{Gd}_2\text{Zr}_2\text{O}_7$ coating cross-section, which has no significant degradation and spallation after hot corrosion test. Although one vertical-crack appears from the surface to bond coat, no visible degradation around the tip of the crack is observed. The cross-section image of the $\text{Gd}_2\text{Zr}_2\text{O}_7$ coating shows less porosity than the conventional YSZ which means it's harder for the molten salts and the oxygen to penetrate through the $\text{Gd}_2\text{Zr}_2\text{O}_7$ layer. This further confirms that the $\text{Gd}_2\text{Zr}_2\text{O}_7$ coating exhibits a good hot corrosion resistance and good durability.

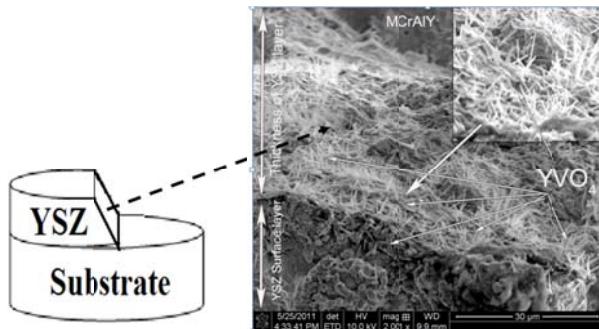
Fig 3.1.7. Cross section along the crack of a delaminated YSZ coating after hot corrosion in $\text{Na}_2\text{SO}_4 + \text{V}_2\text{O}_5$ at 1050 °C

Fig. 3.1.7 shows the crack of a delaminated YSZ coating. The infiltration of molten salt through the entire YSZ coating leads to the formation of dendritic YVO_4 crystals throughout the entire thickness of the crack. The formation of YVO_4 crystals implies the depletion of Y_2O_3 in this region, which leads to the subsequent tetragonal to monoclinic ZrO_2 transformation and thus a large destructive volume changes/stresses within the ceramic coat.

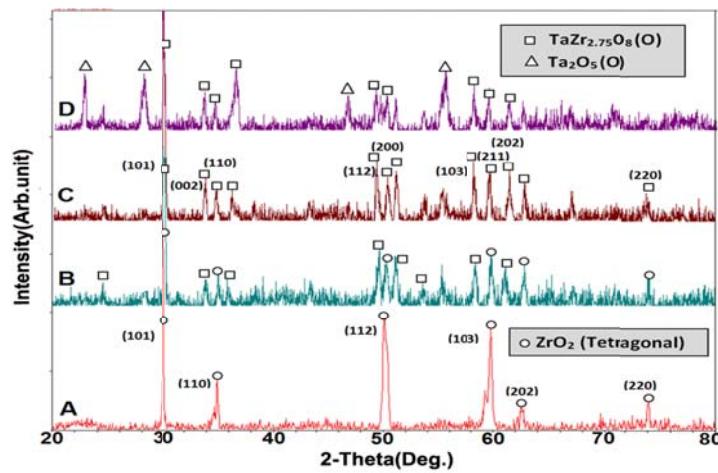
Fig 3.2.1. XRD patterns of as-received A) YSZ, B) 30TaSZ, C) 50TaSZ and D) 70TaSZ

Figure 3.2.1 depicts the X-ray diffraction patterns for the as-received YSZ, 30TaSZ, 50TaSZ and 70TaSZ specimens. In Fig. 3.2.1A, for sintered YSZ, only diffraction peaks corresponding to tetragonal ZrO_2 can be distinguished. In the 30TaSZ, a mixed tetragonal and orthorhombic phases form, and 50TaSZ sample shows a near pure orthorhombic phase of zirconium tantalum oxide. The zirconium tantalum compound in orthorhombic phase is found to be $\text{TaZr}_{2.75}\text{O}_8$, based on the XRD patterns of 30TaSZ and 50TaSZ. For 70TaSZ sample, besides $\text{TaZr}_{2.75}\text{O}_8$, well-defined peaks corresponding to Ta_2O_5 are also observed. Note in Fig. 3.2.1, the more intense peaks of Ta_2O_5 are at $2\theta = 22.8^\circ$ and 28.3° .

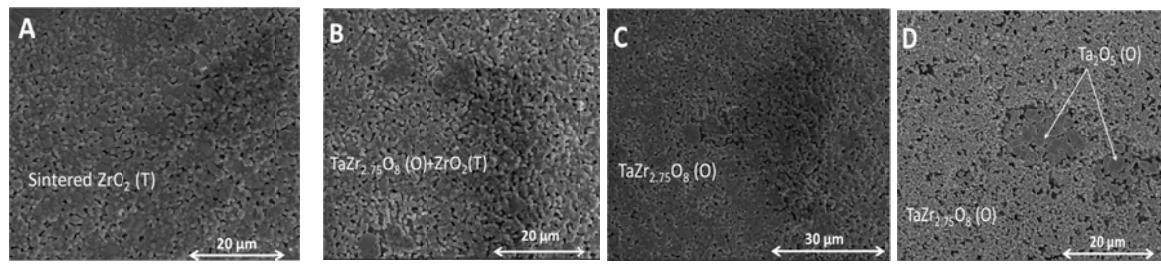
Fig 3.2.2. SEM images of as-received sintered A) YSZ, B) 30TaSZ, C) 50TaSZ and D) 70TaSZ

Figure 3.2.2 shows the as-received SEM image of YSZ, 30TaSZ, 50TaSZ and 70TaSZ. These SEM images show a typical microstructure of pressed and sintered samples with certain amount of porosity, visible on the surface of samples. In Fig. 3.2.2D, for 70TaSZ sample, there are two distinct microstructures, a matrix of orthorhombic $\text{TaZr}_{2.75}\text{O}_8$ and some isolated Ta_2O_5 regions. This sample is made of 30 wt. % of ZrO_2 mixed with 70 wt. % of Ta_2O_5 .

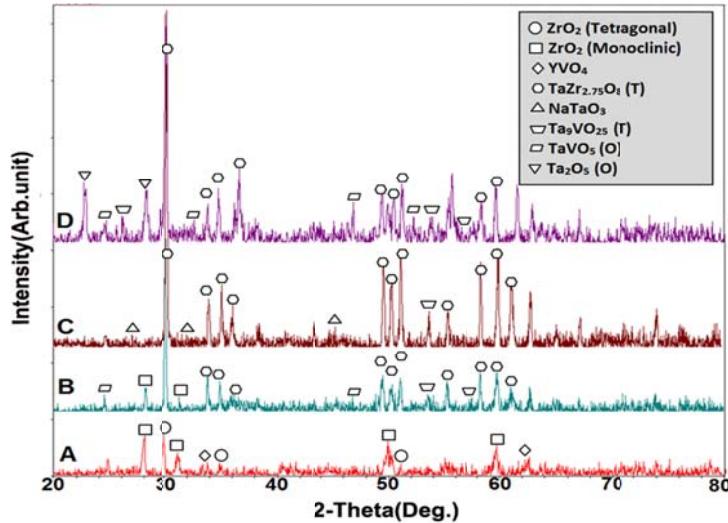
Fig 3.2.3. XRD patterns of A) YSZ, B) 30TaSZ, C) 50TaSZ and D) 70TaSZ after hot corrosion in $\text{Na}_2\text{SO}_4 + \text{V}_2\text{O}_5$ at 1100°C for 40 hours

Figure 3.2.3 illustrates XRD patterns of YSZ, 30TaSZ, 50TaSZ and 70TaSZ specimens after hot corrosion at 1100°C in $\text{Na}_2\text{SO}_4 + \text{V}_2\text{O}_5$ salt for 40 hours (10 cycles). In Fig. 3.2.3A, starting from tetragonal phase, after 40 hours of tests, a large portion of the YSZ sample changed to the monoclinic phase by the $\text{Na}_2\text{SO}_4 + \text{V}_2\text{O}_5$ salt. YVO_4 is formed as the major hot corrosion product.

An examination of XRD pattern of the 30TaSZ sample, besides $TaZr_{2.75}O_8$ and tetragonal zirconia peaks which are present in the original as-received sample, after hot corrosion, some new peaks are identified which can be contributed to monoclinic zirconia, $TaVO_5$ and Ta_9VO_{25} . SEM images of the YSZ, 30TaSZ, 50TaSZ and 70TaSZ specimen after hot corrosion tests are presented in Fig. 3.2.4. Apart from XRD analysis (Fig. 3.2.3), Energy Dispersive Spectroscopy (EDS) analysis was performed at different regions of the samples to confirm the chemical compositions of the hot corrosion products. For crystals in Fig. 3.2.4A, EDS analysis demonstrated that these crystals were composed of yttrium, vanadium, and oxygen. Further analysis confirmed these crystals were YVO_4 . Hot corrosion products of 30TaSZ sample are rod-shape. The extent of the attack is, however, much smaller in comparison to the YSZ sample.

In 70TaSZ sample, besides TaV_9O_{25} , strong peaks contributed to pure Ta_2O_5 and $TaVO_5$ were also detected, Fig. 3.2.3D. The formation of considerable amount of $TaVO_5$ and Ta_9VO_{25} crystals in this sample is due to the large amount of excess Ta_2O_5 , which reacts with the molten salt. Considering the intensity of the XRD peaks and the amount of hot corrosion products, reaction rate of 70TaSZ is higher than the 50TaSZ case. However, exposure to $Na_2SO_4 + V_2O_5$ salt does not cause destabilization of zirconium tantalum oxide to monoclinic phase seen for the YSZ sample.

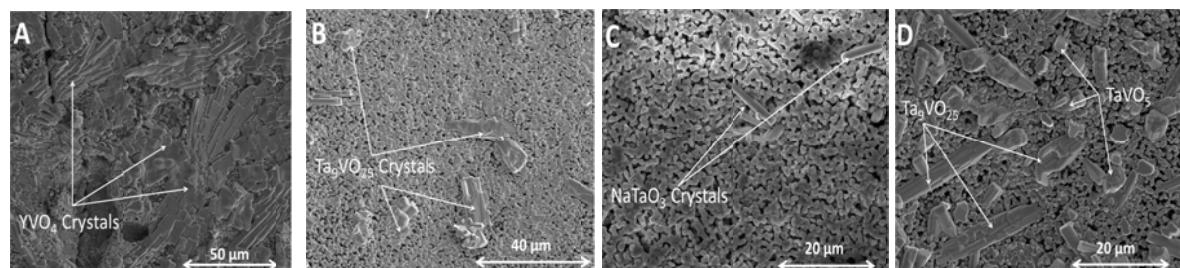
Fig 3.2.4. SEM surface images of A) YSZ, B) 30TaSZ, C) 50TaSZ, D) 70TaSZ after hot corrosion in $Na_2SO_4 + V_2O_5$ at 1100 °C for 40 hours.

In the 50TaSZ case, after hot corrosion, only a small quantity of rod-shaped crystals was formed. According to EDS result, crystals in Fig. 3.2.4C contain sodium, tantalum and oxygen and with considering the XRD pattern, they are found to be $NaTaO_3$. Most of the $TaZr_{2.75}O_8$ surface didn't react with molten salt and it is almost perfectly intact. XRD shows strong peaks of orthorhombic phase of zirconium tantalum oxide.

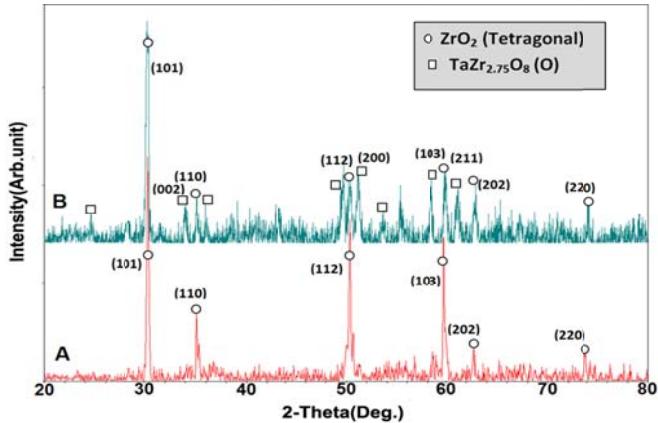
Fig 3.2.5. XRD patterns of as-received A) 30TaYSZ, B) 30TaSZ

It is noteworthy to compare the hot corrosion behavior of 30TaYSZ (30 wt. % Ta_2O_5 +70 wt. % YSZ) with 30TaSZ (30 wt. % Ta_2O_5 +70 wt. % ZrO_2). Figure 3.2-5 shows the XRD patterns of the as-received 30TaYSZ and 30TaSZ. As indicated by the XRD patterns, 30TaYSZ is a pure tetragonal zirconia phase while 30TaSZ is a mixture of tetragonal zirconia and orthorhombic tantalum zirconium oxide ($TaZr_{2.75}O_8$). For 30TaYSZ, the amount of Ta_2O_5 added into YSZ is not high enough to form complex tantalum zirconium oxide. Instead, tetragonal zirconia is found to be the only phase formed, with $Ta_2O_5 - Y_2O_3$ dopants in the ZrO_2 matrix. Similar findings are reported in previous studies.

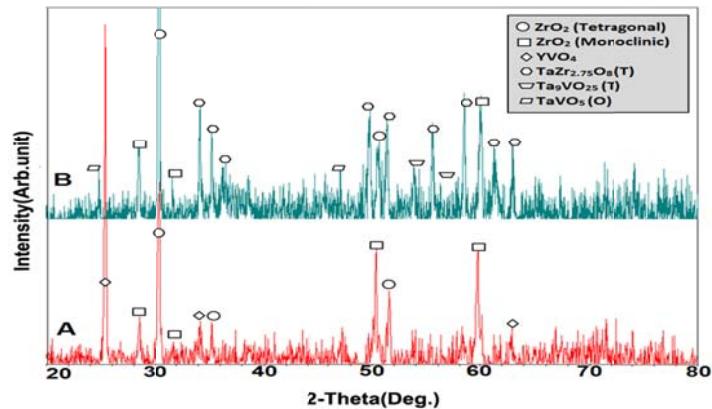
Fig 3.2.6. XRD patterns of A) 30TaYSZ, B) 30TaSZ after hot corrosion in $\text{Na}_2\text{SO}_4 + \text{V}_2\text{O}_5$ at 1100 °C for 40 hours

Figure 3.2.6 shows XRD patterns of 30TaYSZ and 30TaSZ specimens after hot corrosion at 1100°C in $\text{Na}_2\text{SO}_4+\text{V}_2\text{O}_5$ salt for 40 hours. In Fig. 3.2.6A, it is seen that the 30TaYSZ sample, which is pure tetragonal to begin with, has high level of monoclinic phase, in conjunction with the formation of YVO_4 , due to $\text{Na}_2\text{SO}_4+\text{V}_2\text{O}_5$ salt corrosion. Besides orthorhombic $\text{TaZr}_{2.75}\text{O}_8$ and tetragonal zirconia, some new peaks are identified on 30TaSZ sample after hot corrosion, which are monoclinic zirconia, TaVO_5 and $\text{Ta}_9\text{VO}_{25}$. Figure 3.2.7 shows SEM images of 30TaYSZ and 30TaSZ after hot corrosion at 1100°C in $\text{Na}_2\text{SO}_4+\text{V}_2\text{O}_5$ salt for 40 hours. Based on the quantity of corrosion products, 30TaSZ is found to have a better hot corrosion resistance than 30TaYSZ, due to the formation of the highly stable orthorhombic $\text{TaZr}_{2.75}\text{O}_8$ phase.

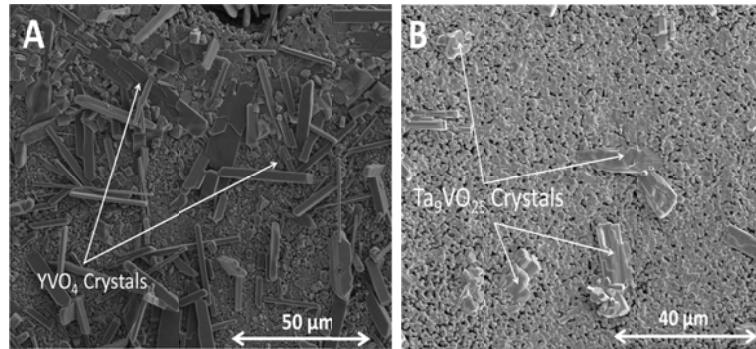
Fig 3.2.7. SEM surface images of A) 30TaYSZ, B) 30TaSZ, after hot corrosion in Na₂SO₄ + V₂O₅ at 1100 °C for 40 hours.

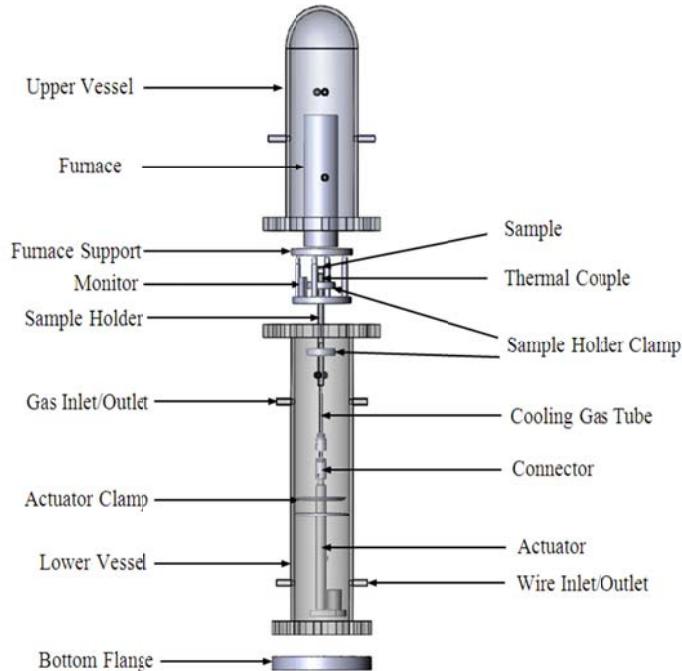
Fig. 4.1.1 Thermal cycling test rig design

According to the above requirement, the design and fabrication work were initially started by a group of senior students in mechanical engineering department of LSU. They built up the steel vessel which can generate a high pressure inside, the support table where the vessel locates, the gas pipeline to introduce different compositions of gases. After that more than two years have been devoted to accomplish the initial requirements of the test rig through design-build-trouble shouting-redesign procedure. Fig.4.1.1 illustrates the final design of the test rig and Fig.4.1.2 shows the fabricated rig.

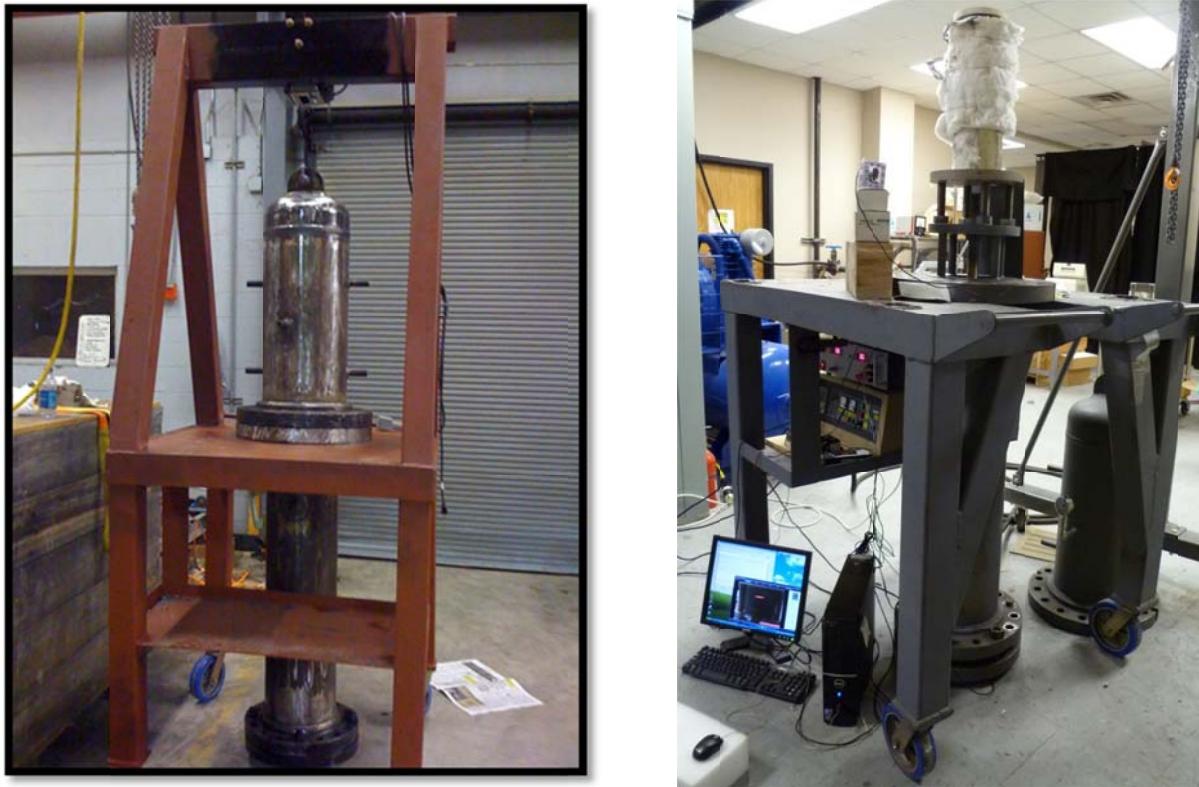
Fig.4.1.2 Thermal cycling test rig under construction (L) and under operation in the lab (R)

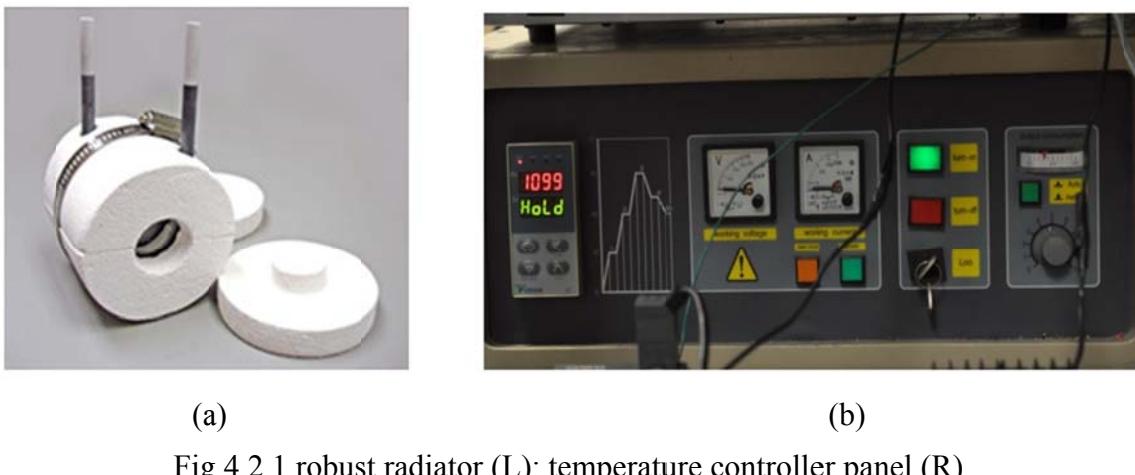
Fig.4.2.1 robust radiator (L); temperature controller panel (R)

To achieve the high temperature, the robust radiator from MHI company was used as the heating element (see Fig.4.2.1). The coil heating element is made of molybdenum disilicide and the maximum core temperature is 1900 °C with a continuous work temperature of 1700 °C. The coil is first insulated by ceramic refractory and then by insulating fiber to reduce the heat dissipation. The programmable silicon controlled rectifier (SCR) temperature controller from MTI Company is used to control the heating temperature.

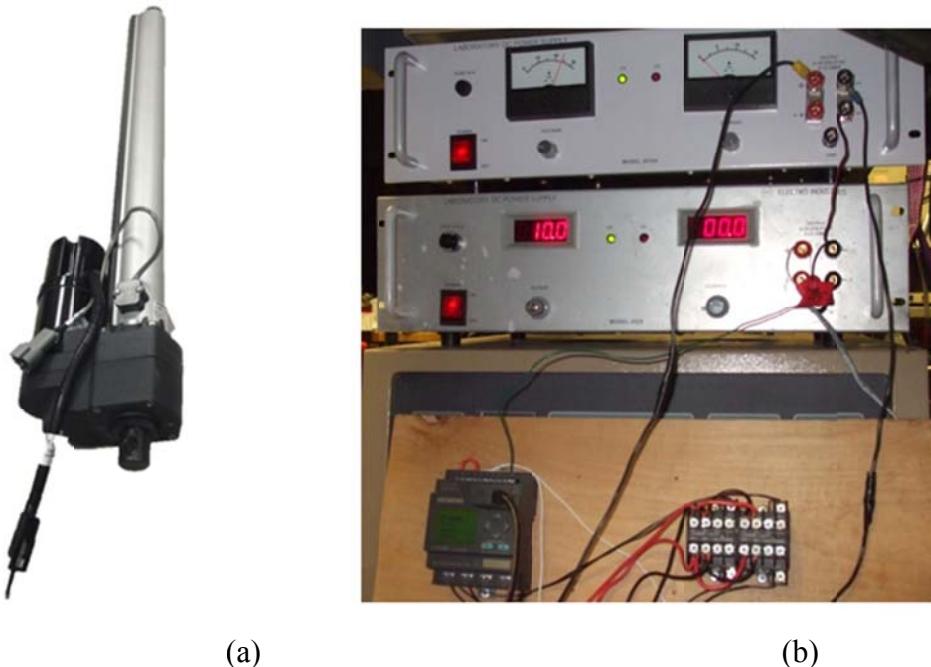
Fig.4.4.1 (a) Actuator; (b) Siemens Program Logic Controller (PLC) and DC power supply

24V DC actuator with potentiometer for position output was used to carry the samples into and out of the furnace (see Fig.4.4.1(a)). The actuator was controlled by a Siemens Program Logic Controller (PLC) (Fig.4.4.1(b)). 24V DC is the main power supply for the PLC and the actuator. A 12V DC power supply was used to transfer the resistance to voltage which is the feedback signal to the PLC.

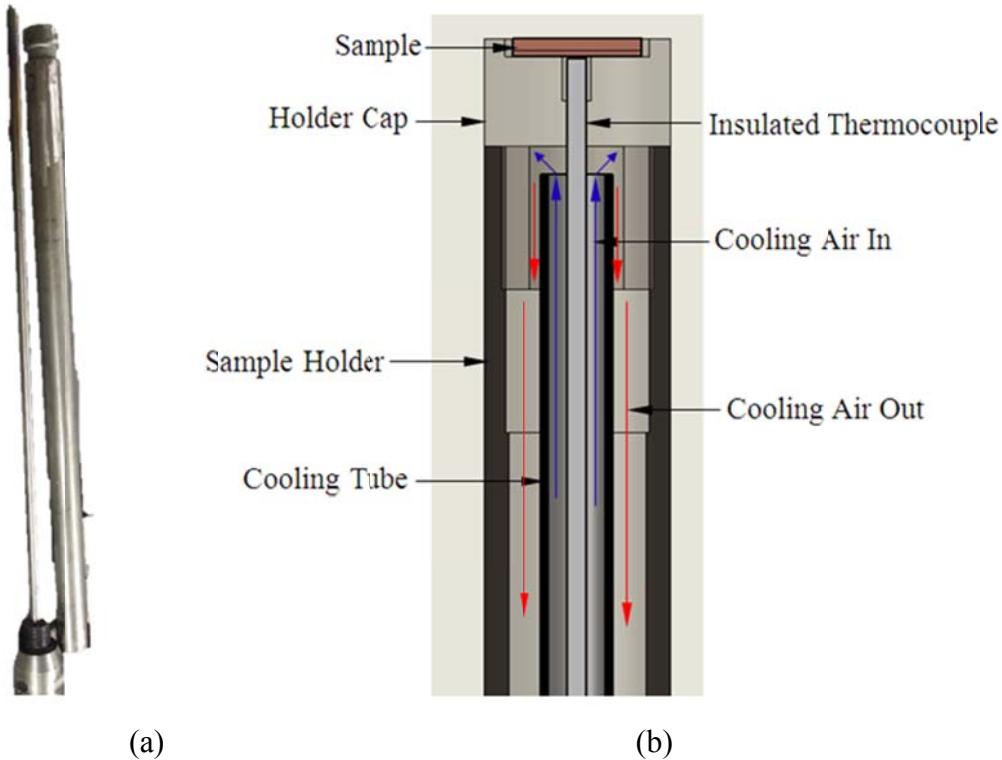
Fig.4.5.1 (a) Assembled sample holder, cooling tube and thermocouple; (b) Illustration of cooling mechanism

To generate thermal gradient, the back of the substrate must be cooled by compressed cooling gas. The magnitude of thermal gradient can be controlled by the cooling air flow rate. The temperature of top surface of the sample is the same as the furnace temperature because when running the test, the sample holder stops at the position where the furnace thermocouple is as close as possible to the top surface of the sample. To calculate the thermal gradient, the back temperature of the substrate needs to be known. This is realized by another thermocouple which is put into the cooling tube, see Fig.4.5.1.

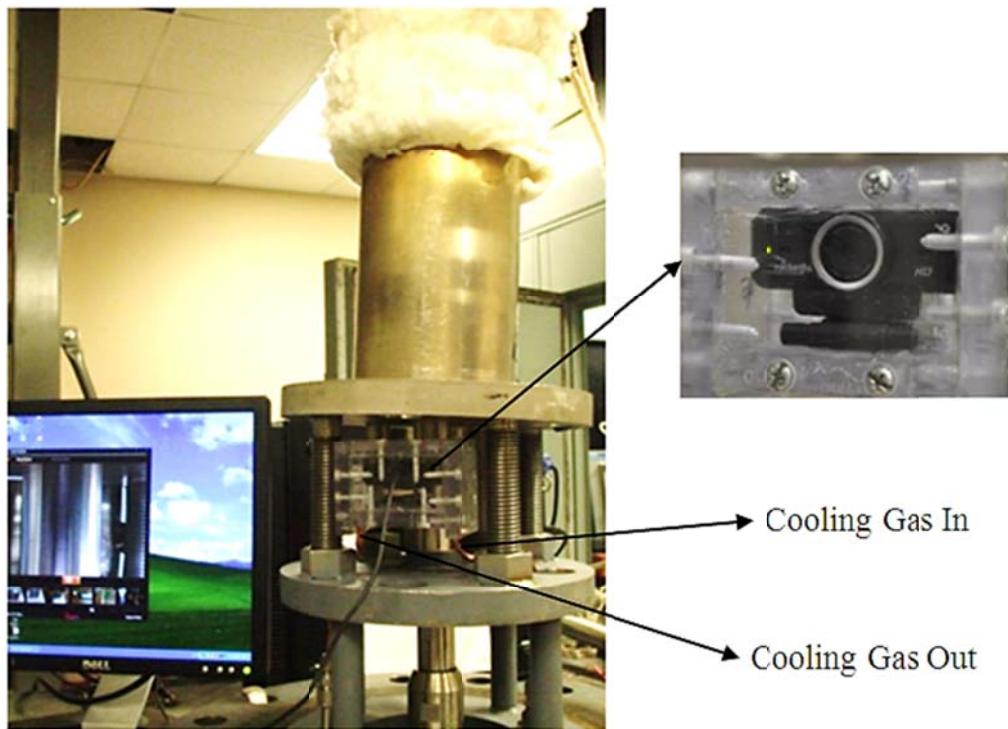
Fig.4.6.1 Camera capturing images while the test in progress

An auto-focus webcam is used to monitor the failure of the sample when the sample gets to the lowest position (see Fig.4.6.1). Because of the strong radiation and convective heat transfer from the high temperature sample, the camera is sealed in a polycarbonate cabin and cooled by the flowing compressed air introduced by the inlet and outlet ports from the bottom of the cabin. Besides the on-line monitor, the camera can record the whole experimental procedure. To save disk space, the camera also can capture and save images according to the set time interval.

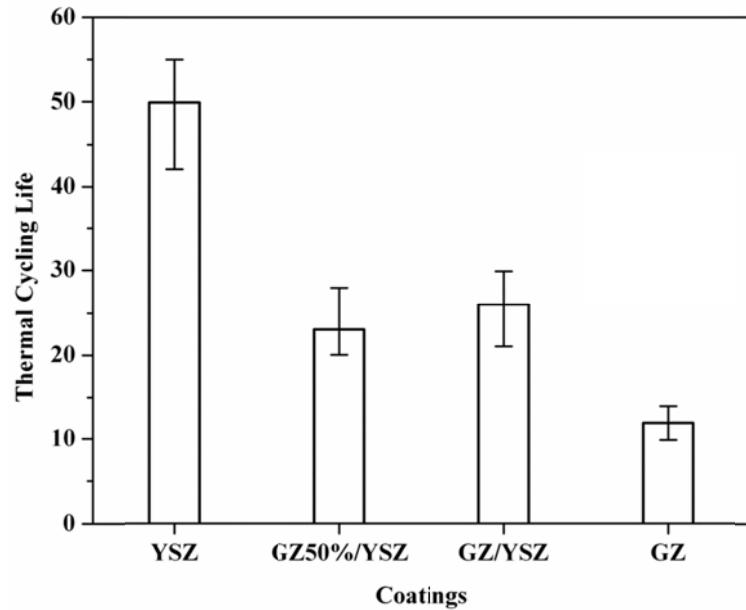
Fig.4.7.1 Thermal cycling life of single and double ceramic-layered coatings at 1150 °C

YSZ has the longest thermal cycling life. The failure happened by delamination at the edge. GZ failed by complete delamination of the whole ceramic layer and it has the shortest thermal cycling life. Although the thermal expansion coefficient of GZ is close to that of YSZ, it is reasonable to assume that the thermal stress in GZ is larger than that in YSZ considering the sintering effect of GZ. What's more, the fracture toughness of GZ is much lower than that of YSZ, implying that the crack initiation and growth will occur even with lower stress levels. Therefore, the single-layer GZ coating has much lower thermal cycling life than YSZ. GZ50%/YSZ coating failed by bucking, which is another typical phenomenon in YSZ coatings.

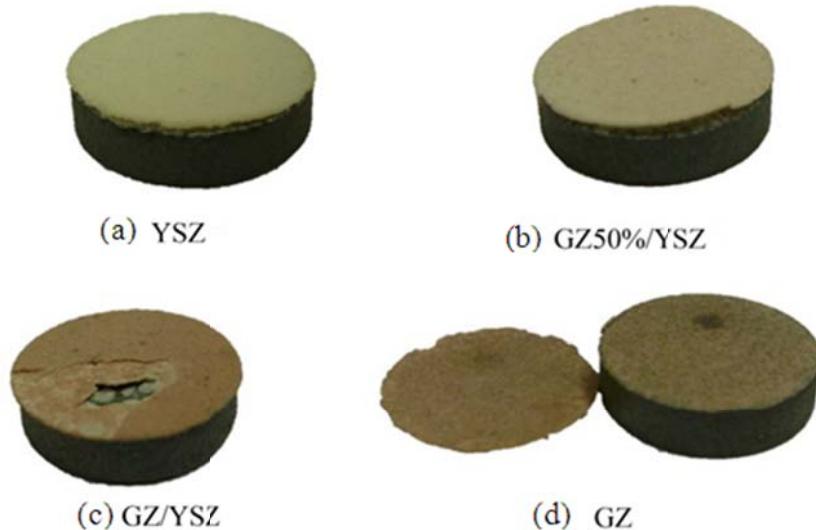
Fig.4.7.2 Photograph of failed single and double ceramic-layered coatings after the thermal cycling test at 1150 °C. (a)YSZ failed after 31 cycles; (b) GZ50%/YSZ failed after 23 cycles; (c) For GZ/YSZ, the GZ layer was spalled after 26 cycles and after 32 cycles the YSZ were also spalled; (d) GZ failed after 12 cycles.

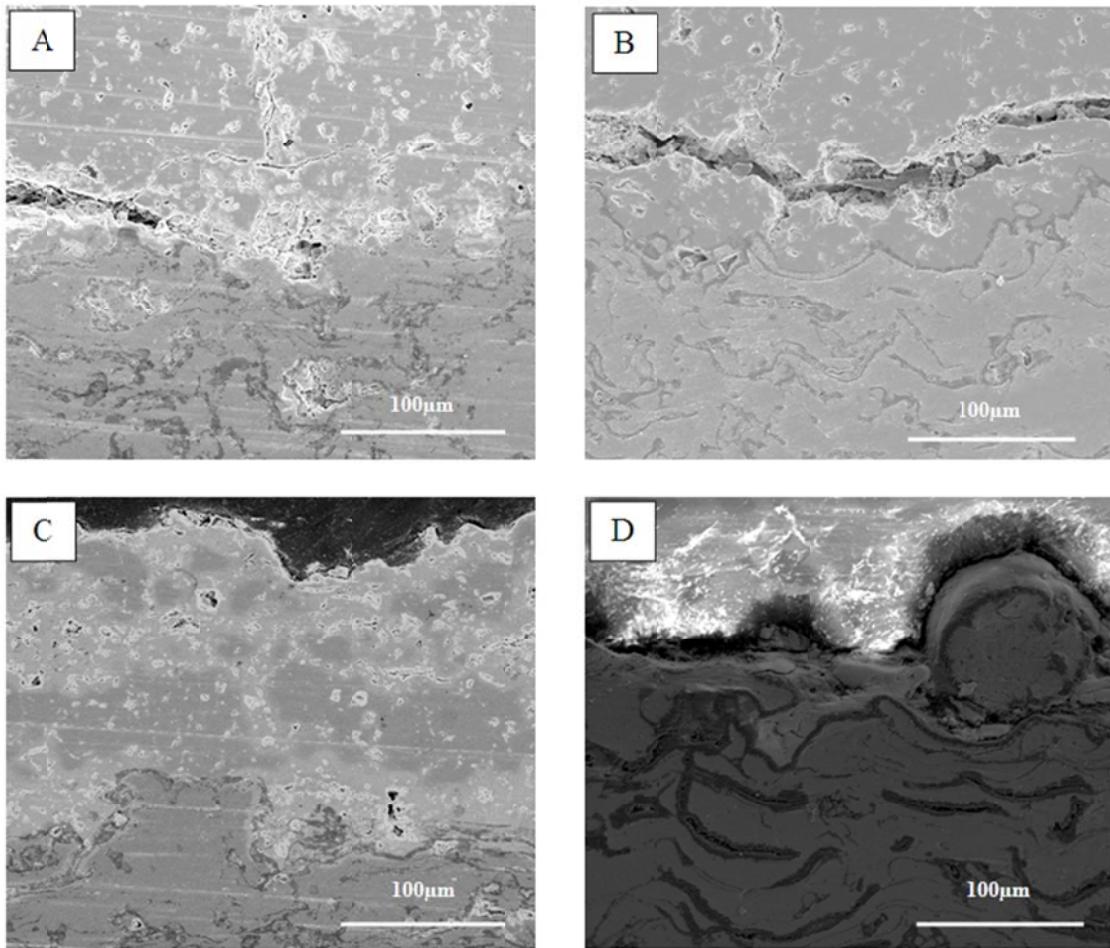
Fig.4.7.3 SEM micrographs of the cross-section of single and double ceramic-layered coatings after thermal cycling tests at 1150 °C (A) YSZ, (B) GZ50%/YSZ, (C) GZ/YSZ, and (D) GZ.

Fig.4.7.3 displays the SEM micrographs of the cross-section of the failed coatings after thermal cycling. All of them failed in the ceramic layer close to the interface of the YSZ layer and TGO except for GZ/YSZ coatings, leaving spots of ceramics on the surface of the bond coat, which is often occurred in the APS coating systems. Another interesting phenomenon should be noticed is that the ceramic layer often came off in a whole piece within one or two cycles, indicating that large horizontal cracks were initiated and developed into large cracks before the vertical cracks became prominent. This is different from many other results and it may be due to the smaller and edge-unbeveled substrate or more uniform temperature gradient in the furnace cycling test than that in the burner-rig test. In the GZ/YSZ coating the delamination first occurred in the GZ layer close to the interface of GZ and YSZ layers, indicating a different failure mechanism from typical YSZ systems.

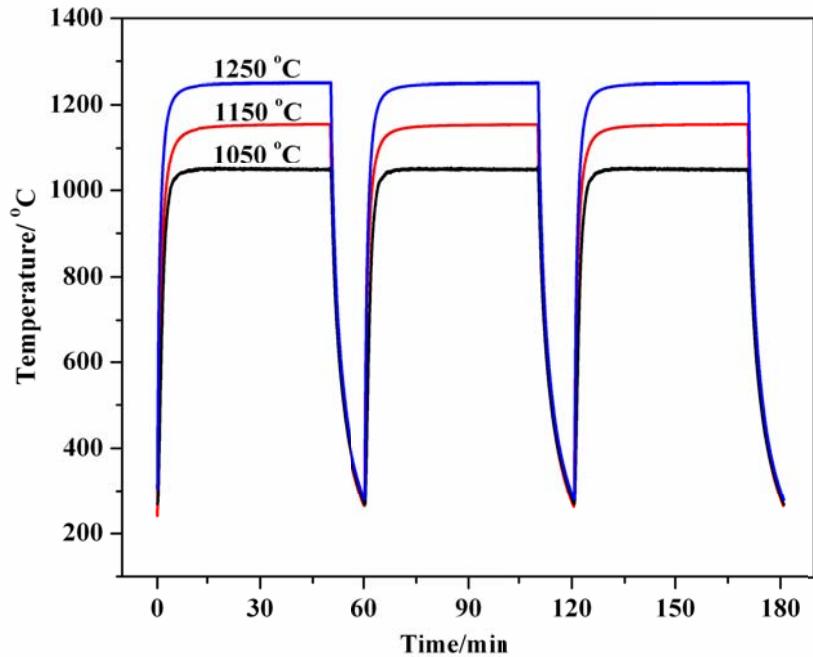
Fig.4.7.4 Measured temperature profile of 1h-thermal cycling test at different temperature using the designed test rig.

Fig.4.7.4 is the measured temperature profile of the 1h-thermal cycling test at 1050 °C, 1150 °C, and 1250 °C. It took around 10 minutes for the specimens to get to the peak temperature. After 10 minutes cooling in the air out of furnace, the temperature was around 260 °C. The temperature of the specimens was quite stable after they reached to the peak temperature, which is an advantage compared to the burner-rig thermal cycling test.

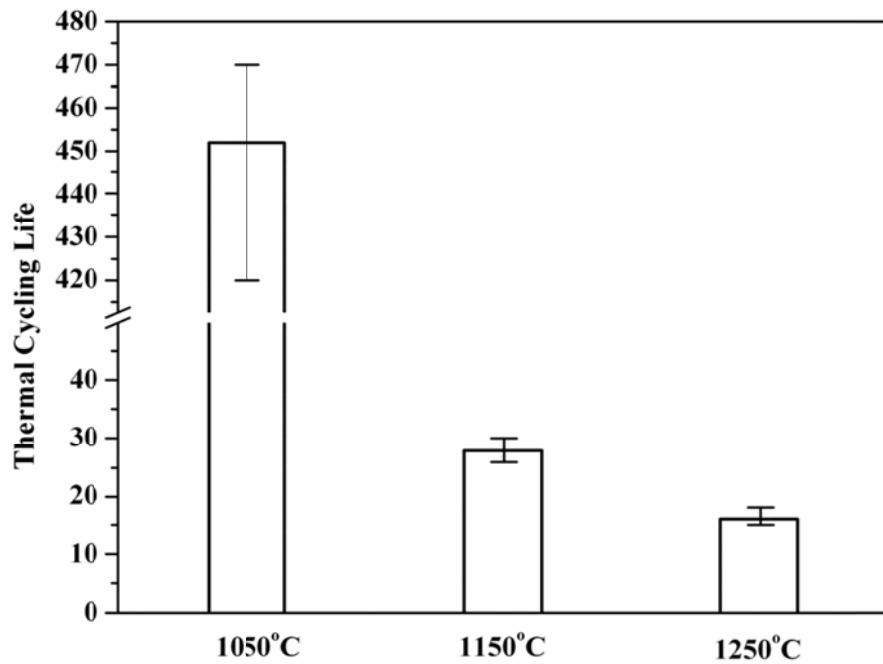
Fig.4.7.5 Thermal cycling life of GZ/GZ50%/YSZ coatings at different temperature with the designed test rig.

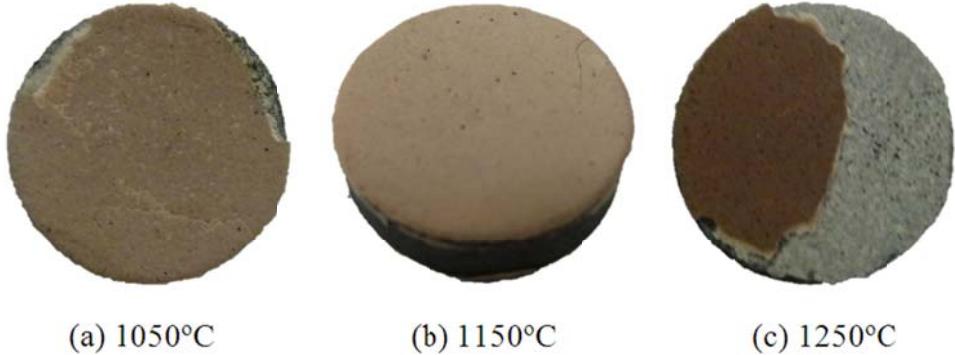
Fig.4.7.6 Photograph of failed GZ/GZ50%/YSZ coatings after the thermal cycling test at different temperature using the designed test rig. (a) Coating failed after 452 cycles at 1050 °C; (b) coating failed after 28 cycles at 1150 °C; and (c) coating failed after 16 cycles at 1250 °C.

appeared on the surface. Coatings at 1150 °C and 1250 °C failed suddenly, usually within one or two cycles. The failure initiated by the delamination at the edge, and then rapidly grew into large areas. If the vertically crack also grew large enough in the growth process of horizontal cracks, large part of coatings could peel off.

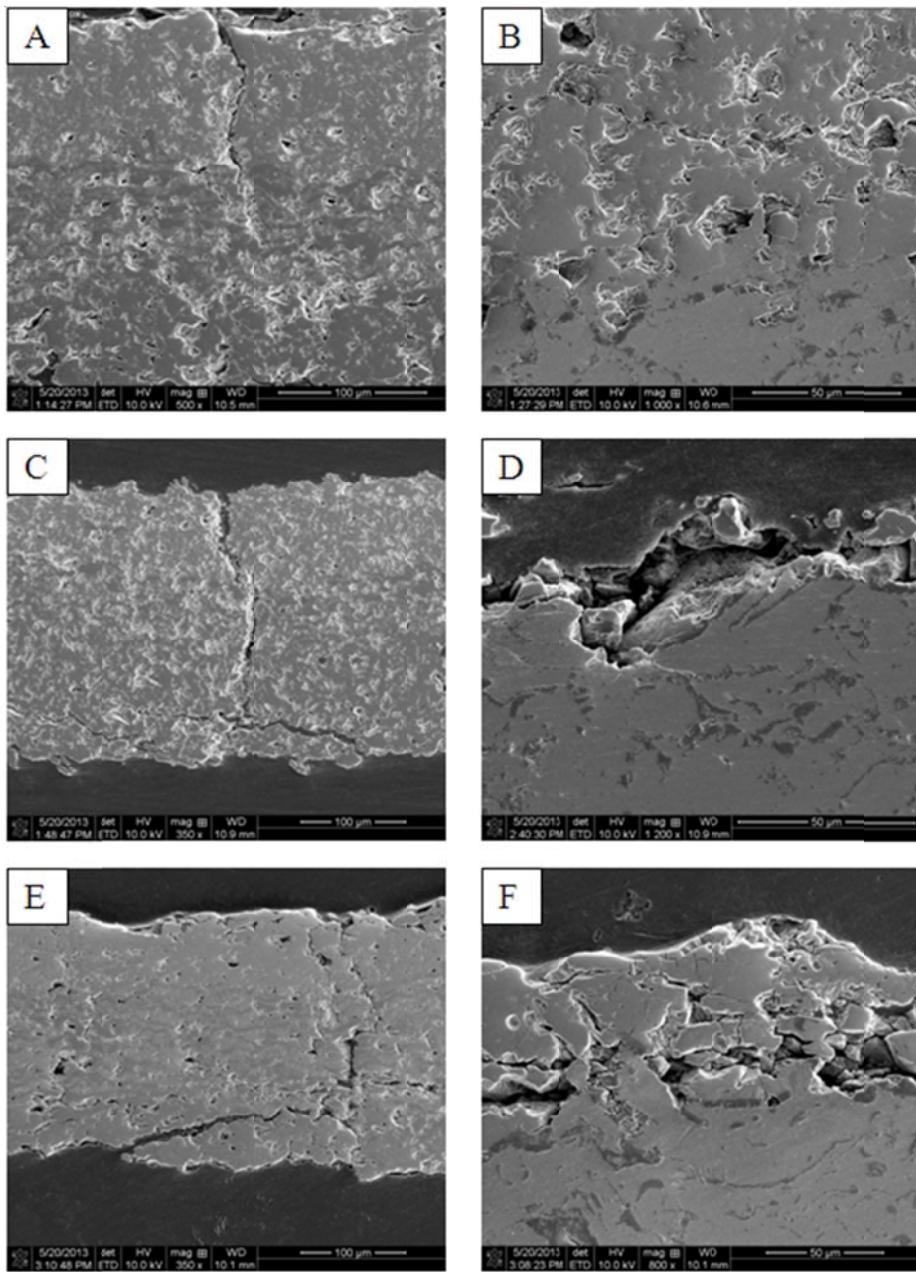
Fig.4.7.7 SEM micrographs of the cross-section of GZ/GZ50%/YSZ coatings after the thermal cycling test at different temperature using the designed test rig. (A) and (B) 1050°C; (C) and (D) 1150°C; (E) and (F) 1250°C.

Fig.4.7.7 exhibits the SEM micrographs of the cross-section of the failed coatings after thermal cycling at different temperature. In this figure, the delaminated ceramic layers were shown in A, C, and E. There were large vertical cracks along with the horizontal delamination/cracks, which initiated from the top GZ layer. These vertical cracks penetrated into the sub-layer after initiation and may stop by the sub-ceramic layer (as shown in A) or penetrate through the whole ceramic layer (as shown in C and E). The delamination areas around the interface of YSZ layer and the bond coat were shown in B, D, and F. All of the delamination occurred in the YSZ layer close to the interface of the YSZ layer and TGO.

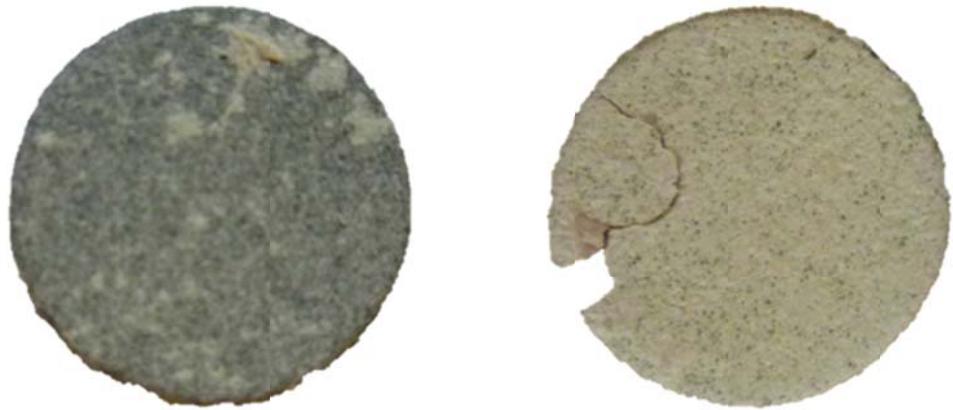
Fig. 4.7.8 Photograph of the failed GZ/GZ50%/YSZ coating after 8 cycles of 10h-thermal-cycling test at 1150 °C.

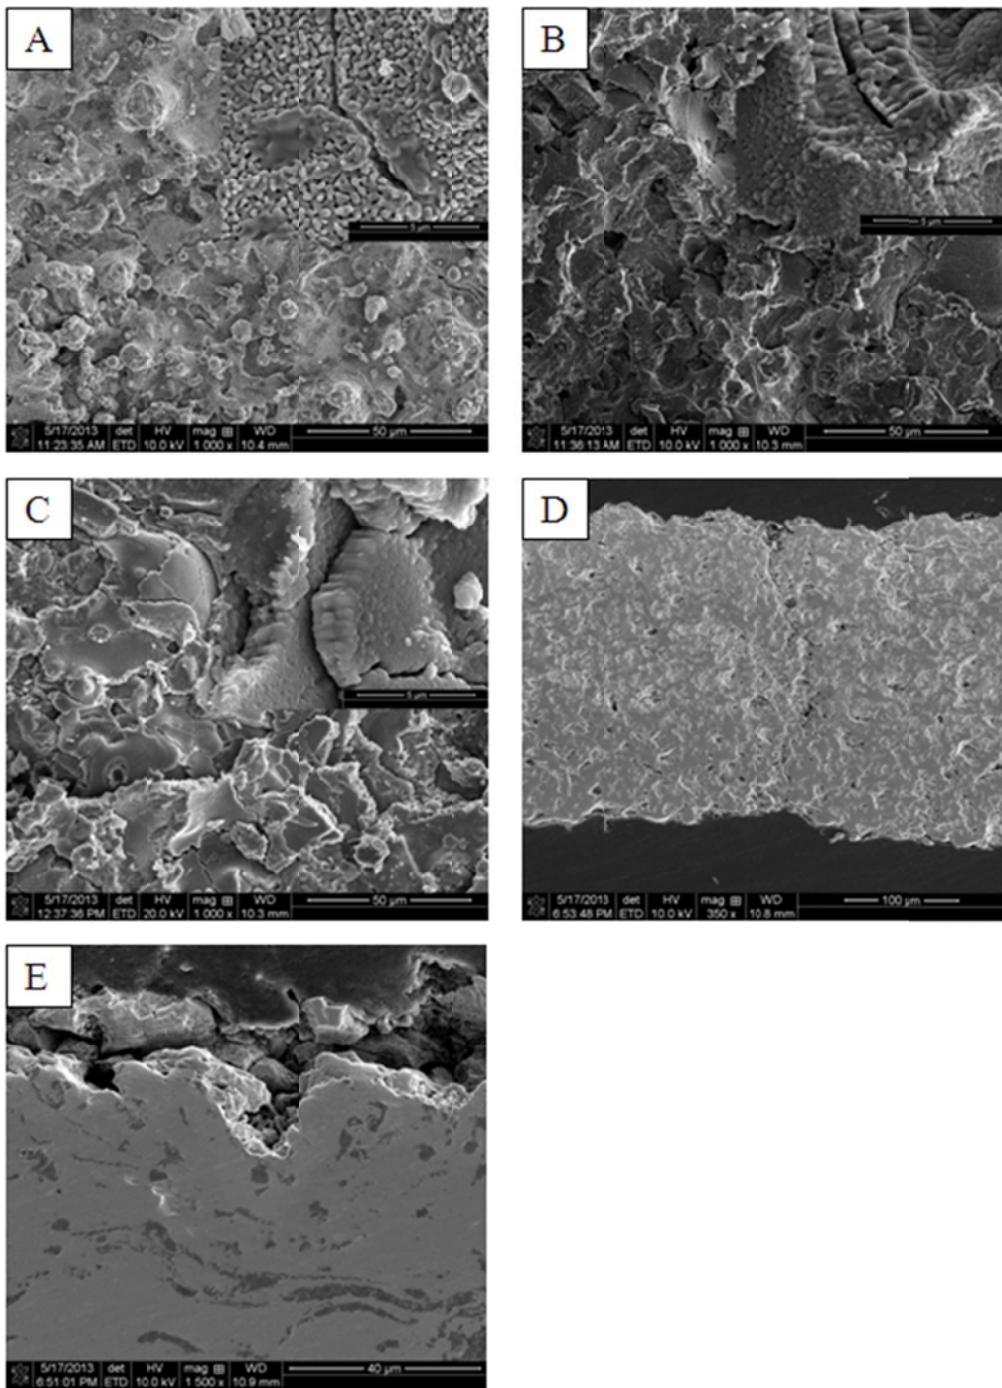
Fig. 4.7.9 SEM micrographs the surface of GZ/GZ50%/YSZ coatings after 8 cycles of the 10h-thermal-cycling test at 1150 °C.

the ceramic coatings. Therefore, few large cracks showed in the ceramic cross-section microstructure in Fig.4.7.9 D. Dense columnar YSZ grains appeared on the back surface of delaminated ceramic layer (Fig.4.7.9 B). Same morphology was observed on the delaminated surface of the substrate in Fig.4.7.9 C. The cross-section microstructure in E showed no TGO layers which may be lost in the sample-cutting process.
