FINAL SCIENTIFIC AND TECHNICAL REPORT

Computational Design and Experimental Validation of New Thermal Barrier Systems

DOE Award Number: DE-FE0004734

Louisiana State University and A & M College
Baton Rouge, LA, 70803-2701

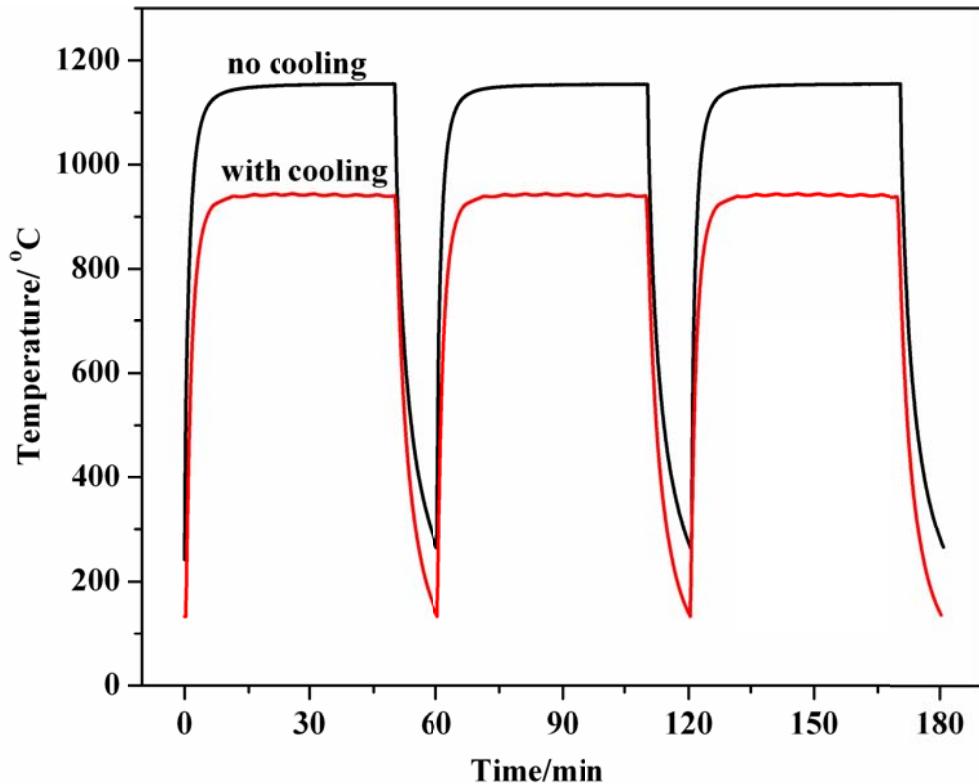
Fig.4.7.10 Measured temperature profile of thermal cycling test at 1150 $^{\circ}\text{C}$ with and without cooling using the designed test rig.

also decreased the minimum temperature from ~ 260 $^{\circ}\text{C}$ to ~ 133 $^{\circ}\text{C}$. The fluctuation of the peak temperature under cooling condition is a litter larger than that without cooling.

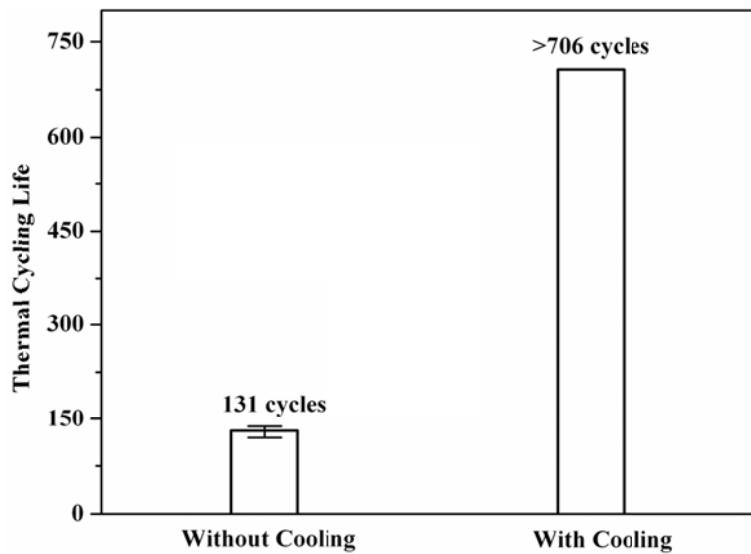
Fig.4.7.11 Thermal cycling life of GZ/YSZ coatings at 1150 °C without and with cooling using the designed test rig.

Fig.4.7.11 indicates the thermal cycling life of GZ/YSZ coatings at 1150 $^{\circ}\text{C}$ without and with cooling. The macroscopic appearances of coatings are shown in Fig.4.7.12. The thermal cycling life of GZ/YSZ coating with cooling was more than 706. The top surface morphology shown in Fig.4.7.12 (b) indicates that the sample still kept integrity expect for the small chips at the edge. It was not considered to be failed because the damaged area was less than 20%. The dramatic increase of the thermal cycling life with cooling was mainly due to the low temperature of the bond coat. Another thing should be pointed out is the sample size effect. At the same temperature, the thermal cycling life of 1/2" GZ/YSZ samples tested by CM furnace was 26. While for the 1" samples tested in designed test rig, the thermal cycling life was 131. Even considering the differences in test condition, the large samples are considered to have longer thermal cycling life than smaller samples.

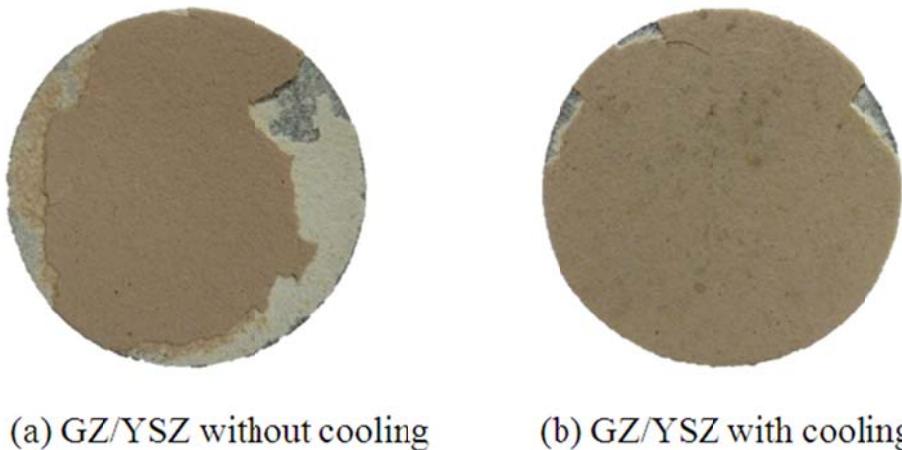
Fig.4.7.12 Photograph of GZ/YSZ coatings after the thermal cycling test at 1150 °C (a) without and (b) with cooling using the designed test rig.

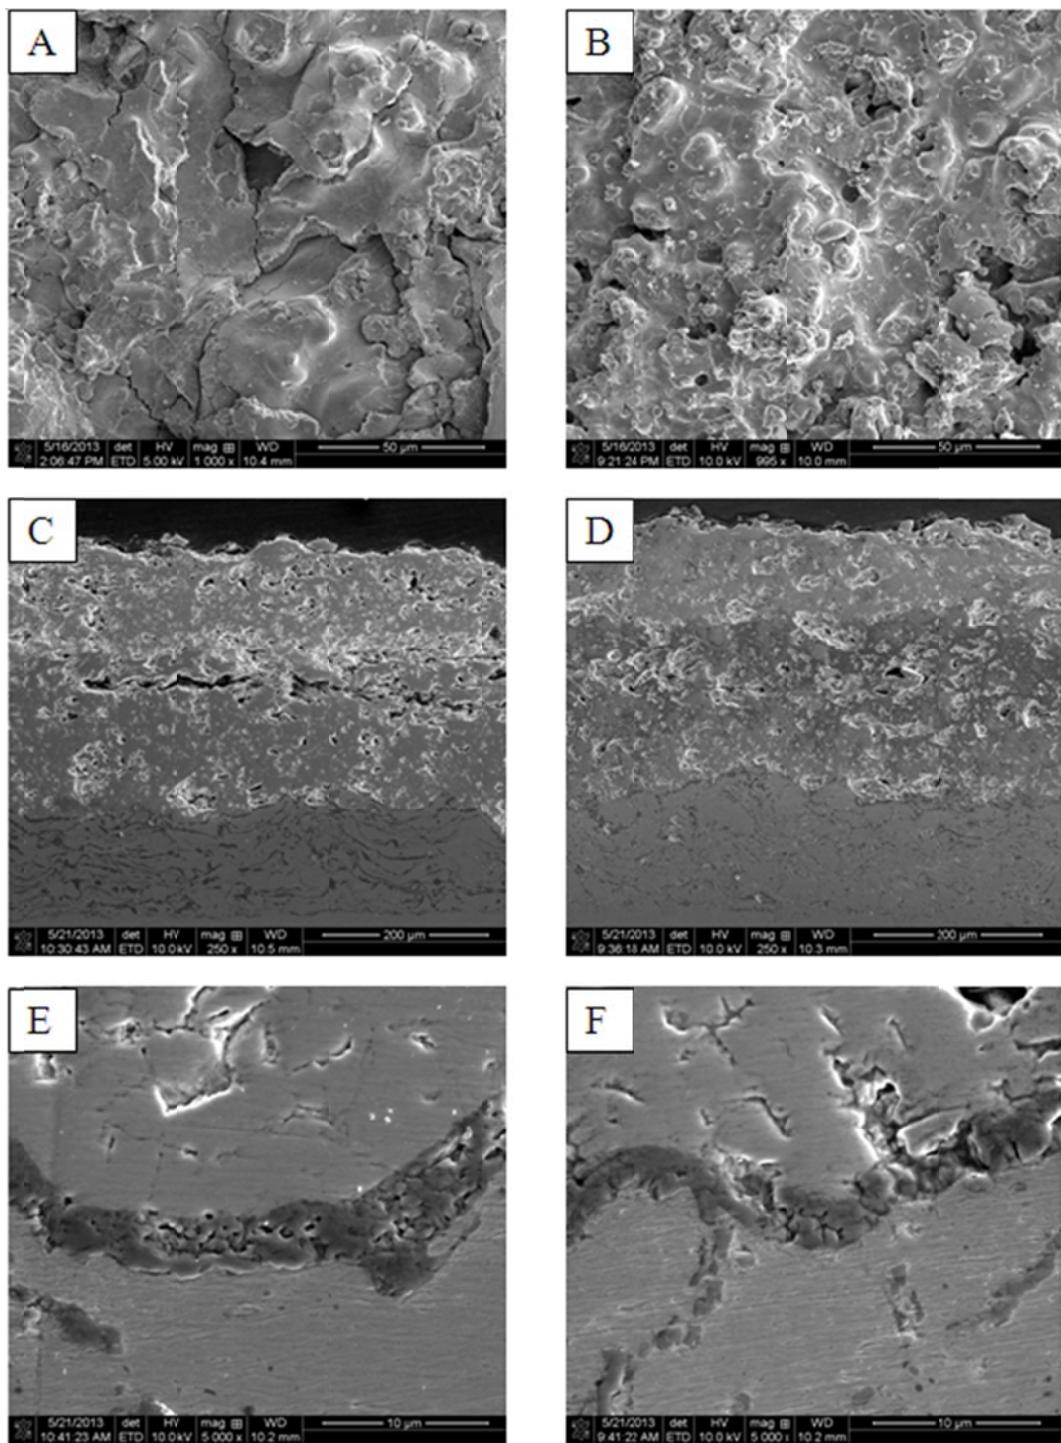
Fig.4.7.13 SEM micrographs of GZ/YSZ coatings at 1150 °C (A, C, E) without cooling and (B, D, F) with cooling after the thermal cycling test at 1150 °C.

Fig.4.7.13 presented the SEM micrographs of the front surface and cross-section of the coatings after thermal cycling. Without cooling the coating showed lots of cracks on the surface (Fig.4.7.13 A) and big horizontal crack in the YSZ layer close to the top GZ layer (Fig.4.7.13 C). The cracks enhanced the oxidation rate by permitting more oxygen penetrated into the ceramic coating and reached the interface of YSZ/TGO and inside of bond coat. As shown in Fig.4.7.13 C and D, the oxidation of the bond coat without cooling is more severe than that with cooling although the oxidation time is shorter. Also the TGO thickness of coating without cooling (~4.4 μm , Fig.4.7.13 E) is much thicker than that with cooling (~3.4 μm , Fig.4.7.13 F).

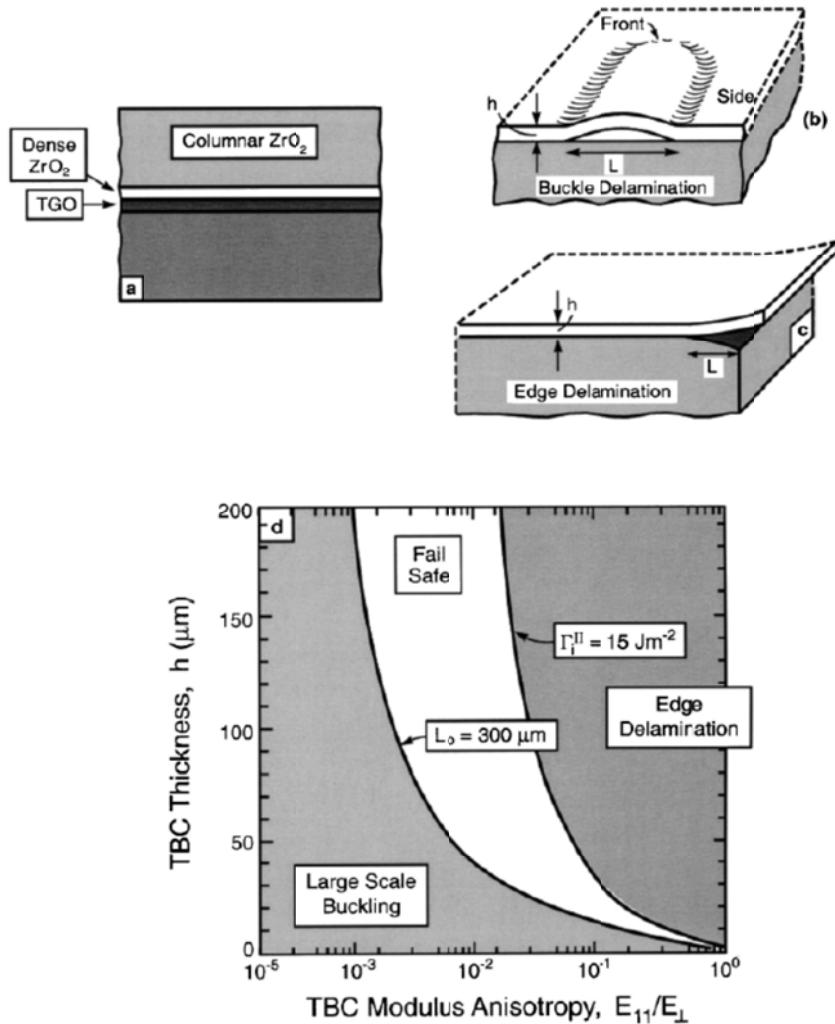
Fig.4.7.14 A schematic of large scale buckling and edge delamination of TBCs with a failure mechanism map.

Edge and buckle-driven delamination were also the two main competing failure mechanisms for conventional YSZ TBCs. The same explanation is supposed to be applied for the current GZ based TBCs. P. K. Wright et al. proposed a failure map representing the basic elements of this competition, as shown in Fig.4.7.14. In the lower left of the map, as the TGO experiences large in-plane compressions upon cooling, the film attempts to alleviate the stress by lengthening itself, through out-of-plane displacements. This can happen by TGO buckling. Because the low in-plane modulus of the TBC does not resist the small scale TGO buckling, the system would fail by TBC buckling. In the upper right, the TBC has relatively high in-plane stiffness and limited strain tolerance, causing the residual stress in the TBC to be large and resulting in a high strain energy density. The TGO growth and the increased amplitude of undulations with thermal cycle enhance this energy density which provides a strong driving force for the edge delamination. The plasma sprayed TBC has splat grain morphology and inter splat boundaries parallel to the interface, which makes the relatively in-plane stiffness high, thus most of the failure occurs by edge delamination.

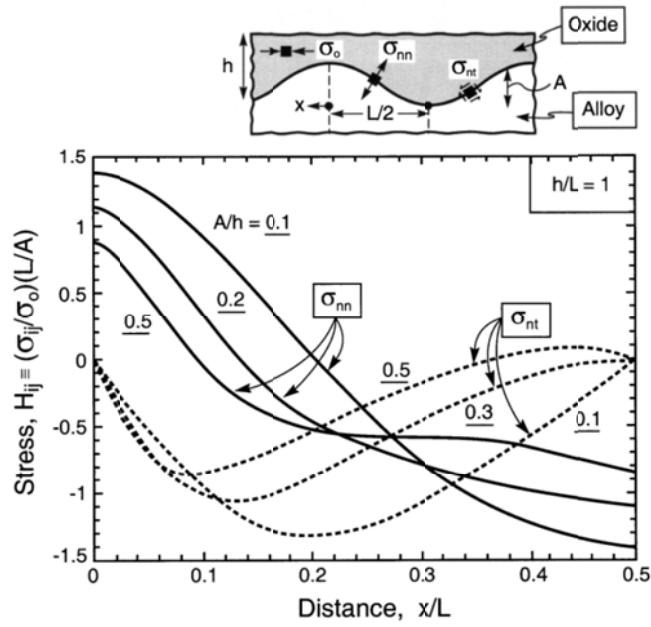
Fig.4.7.15 Distribution of stresses at an undulating TGO interface

Imperfections (especially undulations) cause the thermal expansion misfit stresses to redistribute, as shown in Fig.4.7.15. Normal tensions exist where the TGO is convex and vice versa. Shear stresses exist at inclined section. These stresses depend on the elastic mismatch and the ratio of the amplitude to the wavelength of the undulations.

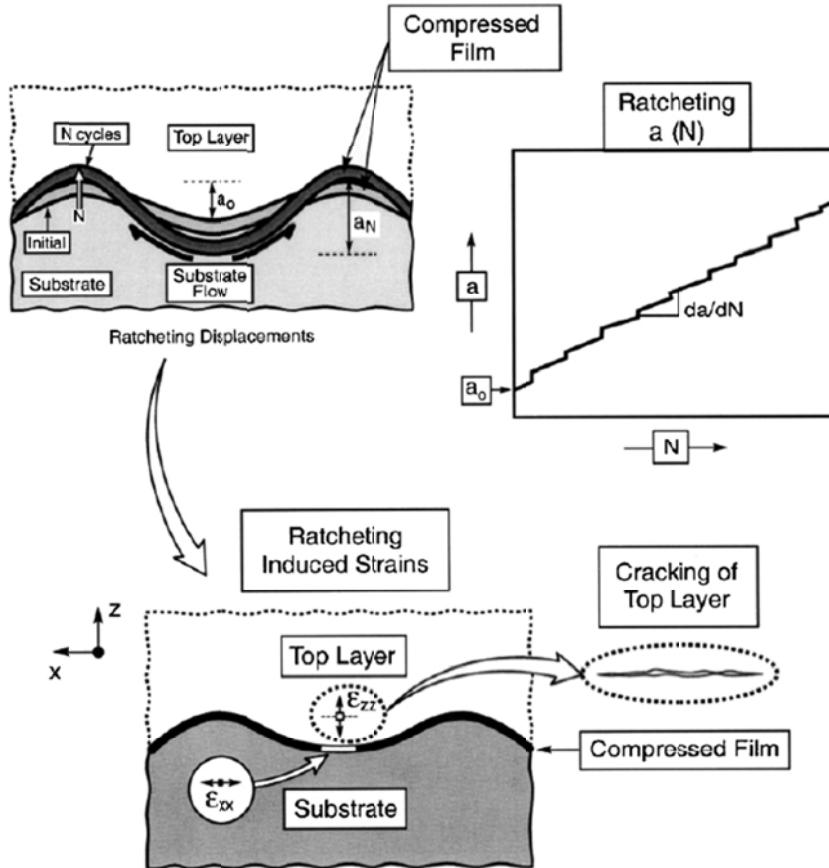
Fig.4.7.16 Schematic indicating the ratcheting phenomenon and its effect
