# Evaluation of Boulder, CO, SmartRegs Ordinance and Better Buildings Program

L. Arena and G. Vijayakumar

*Consortium for Advanced Residential Buildings (CARB)*

April 2012

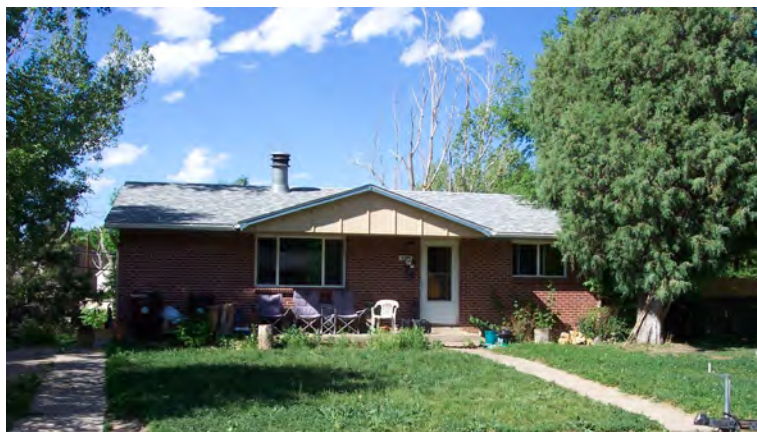
***This rental property passed Boulder's SmartRegs requirements upon initial inspection.***

Because of the owner's commitment to energy conservation, he had already made several energy improvements to the property before the new regulations were put in place. The attic had been air sealed and insulated to approximately R-38. The exterior walls (2x4) were dense-packed with cellulose insulation, and all windows were upgraded to double-pane, low-e, vinyl units with U-values of 0.30. The crawlspace ceiling had been insulated and air sealed from the house and the existing ductwork located in the crawl had been insulated.

Air leakage and pressure testing confirmed that both the attic and the crawlspace were well isolated from the main living area. Based on the blower door result of 986 cfm@50 pascals, the estimated infiltration rate of this home is approximately 0.44 air changes per hour under natural conditions (ACHn) or 8 ACH@50 pascals.

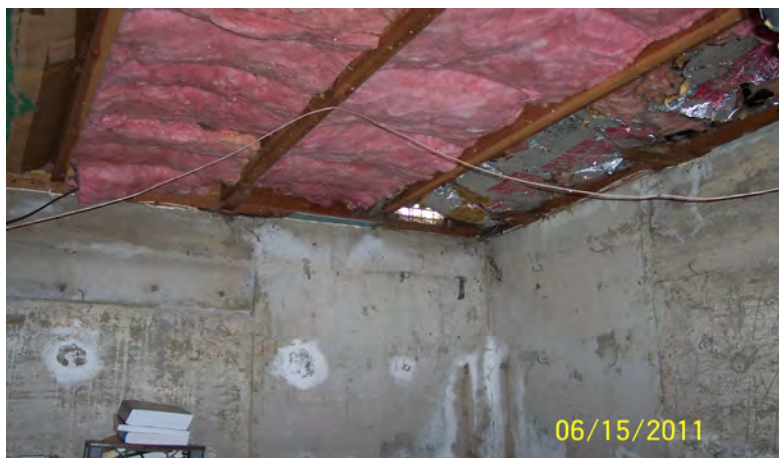
***This home receives no credit for the crawlspace ceiling insulation because the majority of the ductwork is located here.***

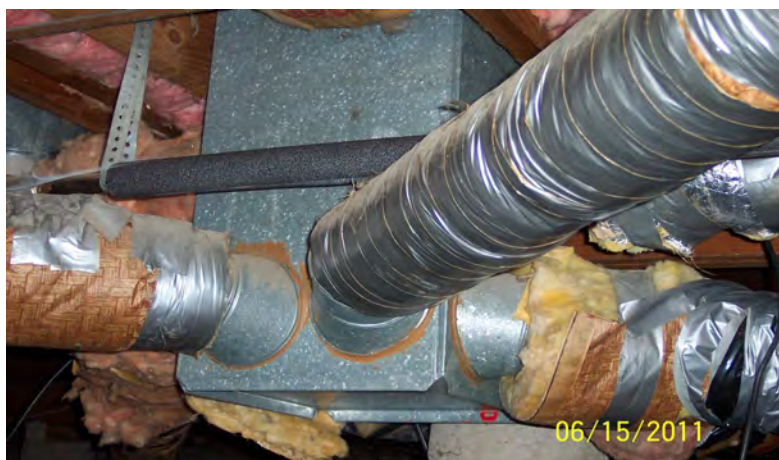
***Main supply plenum from down flow furnace with supply branch takeoffs. 99% of the supplies are located in this crawl.***

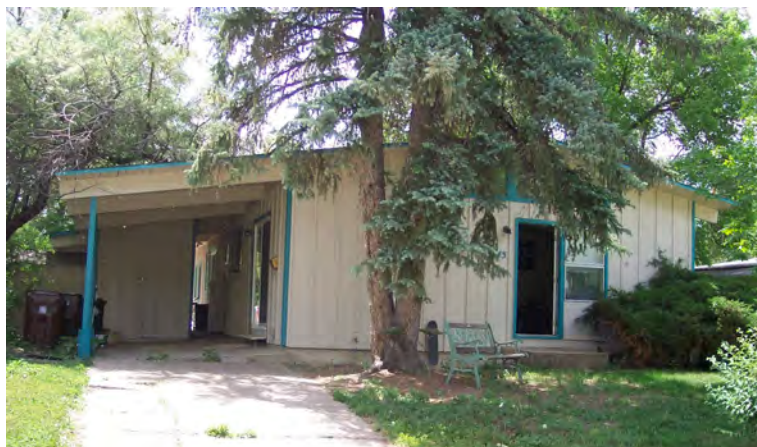
***With an initial score of only 89 points on the SmartRegs checklist, this property owner must make some energy efficiency improvements to comply with Boulder's new ordinance.***

Efficiency levels in this property were consistent with its year of construction (see table at right). Other than a couple of window replacements, no energy improvements appear to have been made to date. All ductwork and the heating system are located in the vented, unconditioned crawlspace. The addition at the back of the home has slightly higher wall and ceiling R-values than the original structure, but are not to the levels required by current codes.

Based on the blower door result of 2711 cfm@50 pascals, the estimated infiltration rate of this home is approximately 0.59 air changes per hour under natural conditions (ACHn) or 10.5 ACH@50 pascals.

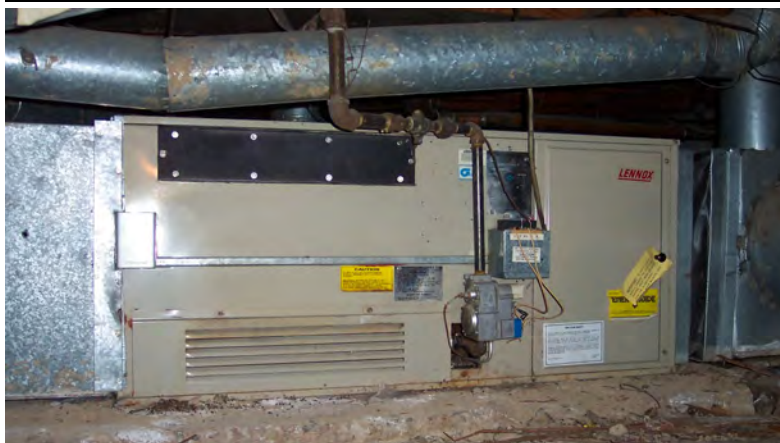
***All ductwork and the heating system were located in the vented, uninsulated crawlspace.***

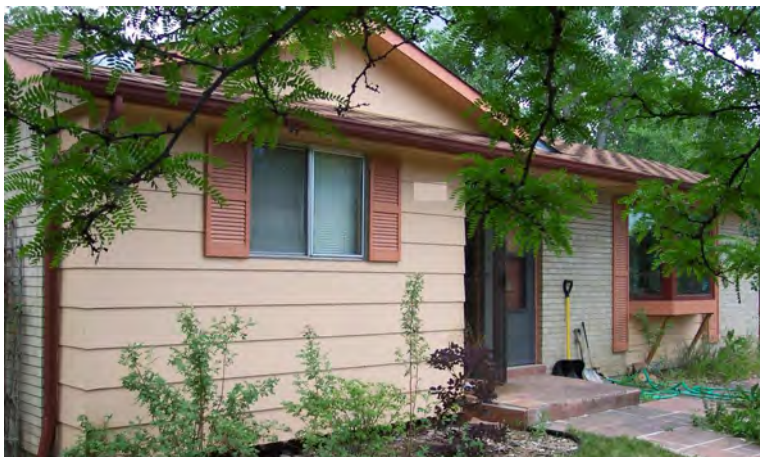
***This home's initial score was 62 points on the SmartRegs checklist. This property owner must make some energy efficiency improvements to comply with Boulder's new ordinance.***

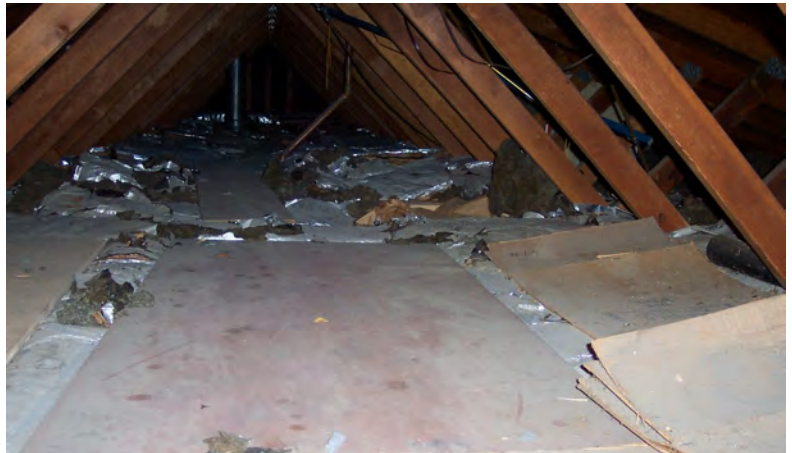
**Attic is only insulated to R-11.**

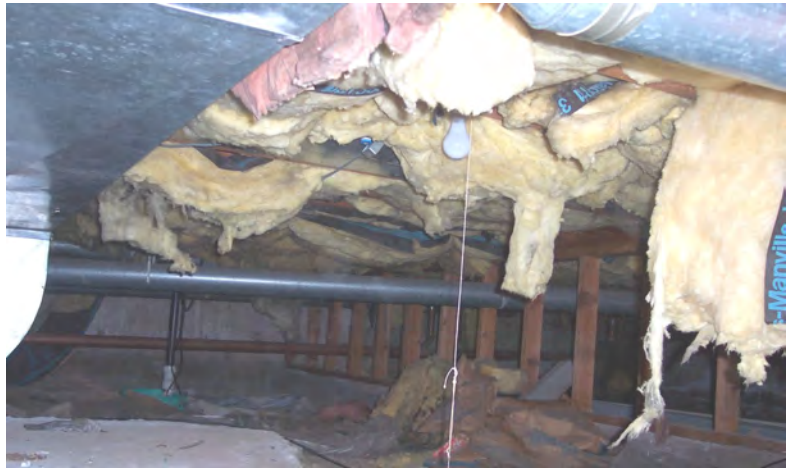
**All ductwork and the heating system were located in the vented crawl-space. Insulation was falling down in multiple locations.**

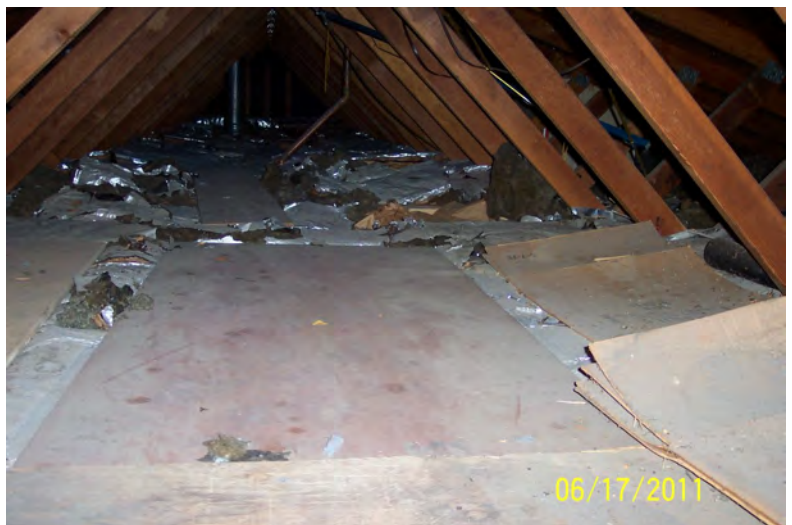
**Attic is only insulated to R-11.**

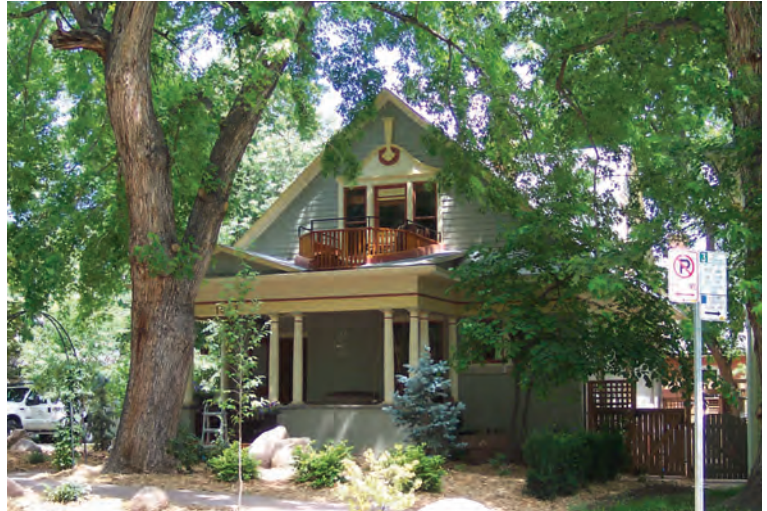
***This historic home scored 87 points on the SmartRegs checklist. The property owner must make some energy efficiency improvements to comply with Boulder's new ordinance.***

Efficiency levels of the building shell—walls, attic and foundation—were consistent with its year of construction (see table at right), but the heating and cooling systems have been upgraded with high efficiency equipment and the ductwork, where accessible, has been sealed. At the time of the inspection for this case study, the owner was employing a carpenter, who specializes in historic properties, to perform extensive air sealing for her.

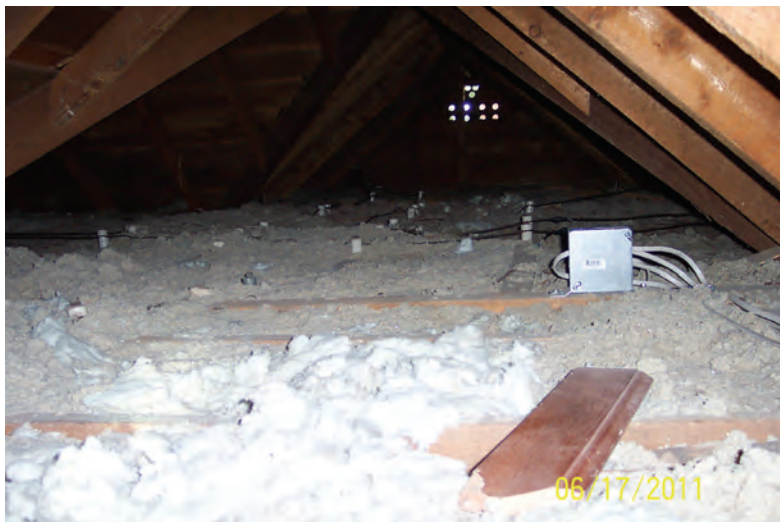
**Attic is only insulated to R-10 and contains knob and tube wiring.**

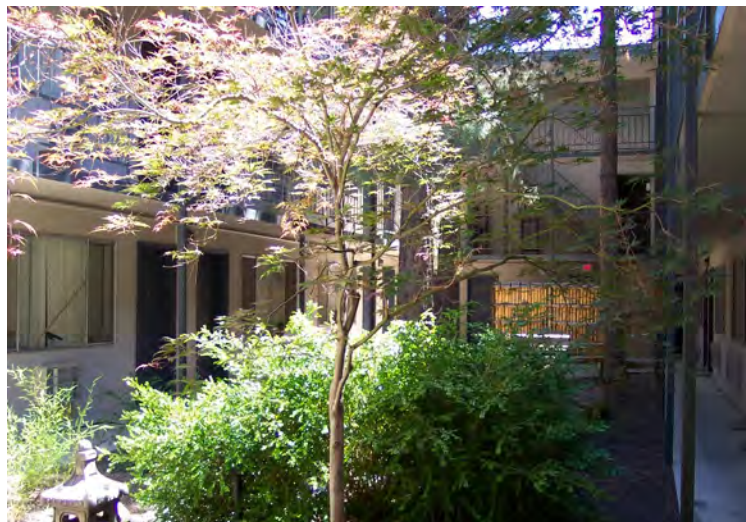
***This 3-story, multi-family apartment building in Boulder, CO offers a central courtyard for tenant use.***

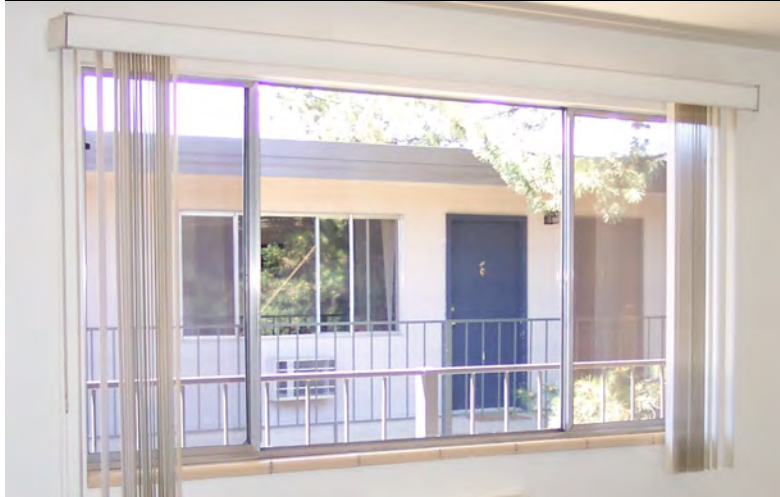
**All the windows in this apartment complex are single pane metal windows.**

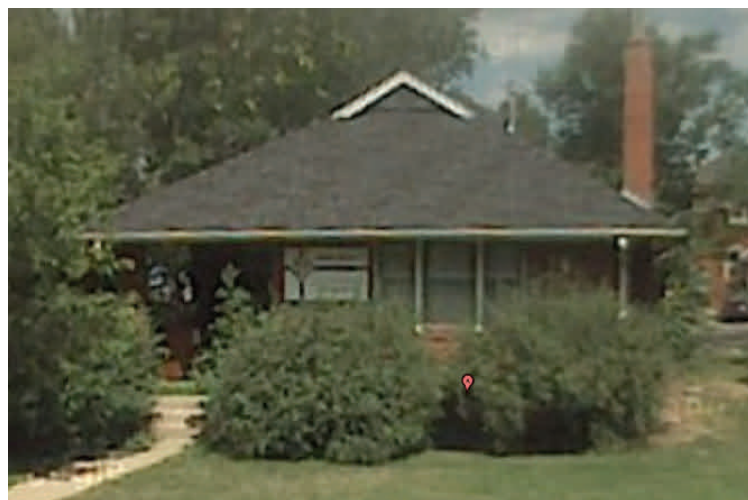
*This home has been divided into two rental units. While the lower unit complies with Boulder's SmartRegs ordinance, improvements must be made to the upper unit .*

The lower unit in this building, being partially below grade and substantially bordered by conditioned space of the upper unit (entire ceiling and 50% of the walls) scores much higher on the SmartRegs checklist than the upper unit. Of the 51 point difference between the two units, 43 points come from the fact that the lower unit's ceiling and 50% of its walls border the upper unit.

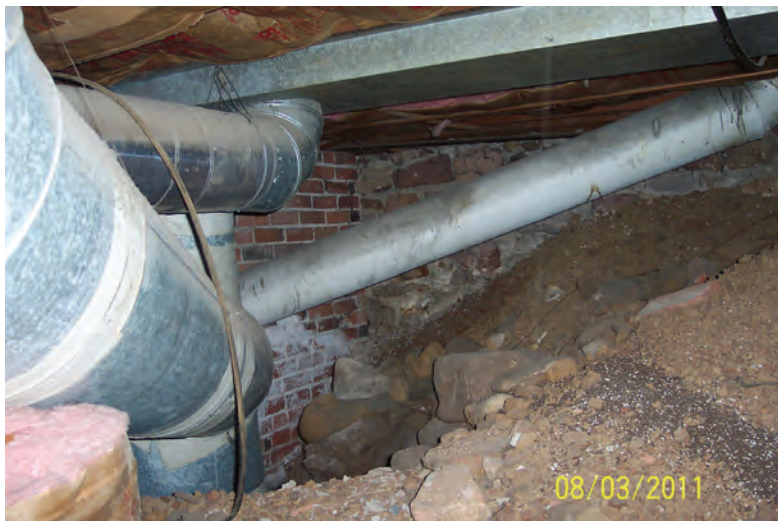
**R-19 insulation is installed between the floor joists in the ceiling of this crawlspace but gets no credit on the SmartRegs checklist because heating ducts are present.**

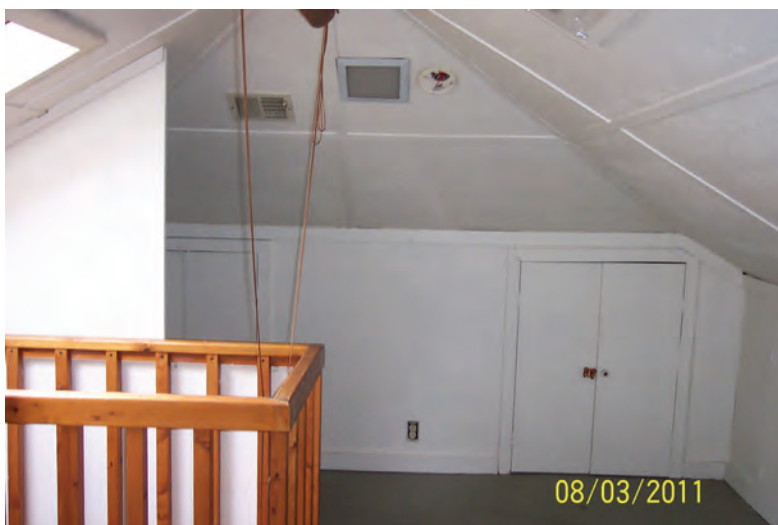
**Attic is only insulated to R-11. Kneewall access hatches are extremely leaky.**

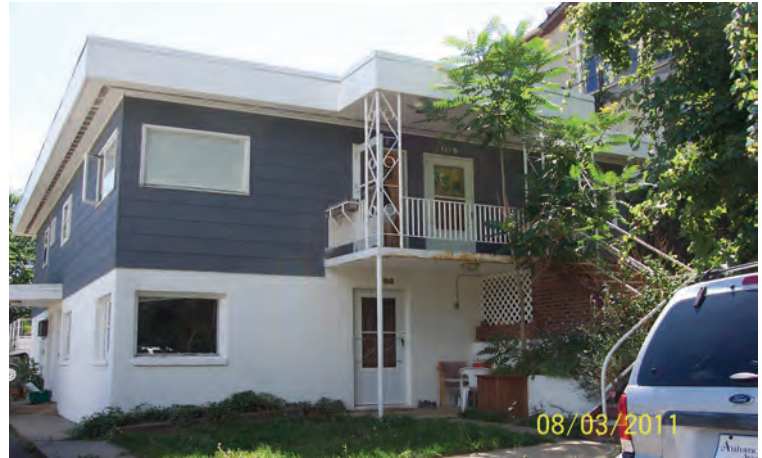
***This apartment (upper left) initially scored 85 points on the SmartRegs checklist. At the time of this audit, the score was reduced to 74 points due to the addition of a window air-conditioning unit by the occupants.***

During the initial SmartRegs inspection, the upper left apartment scored 85 points, but since that first inspection, a window air-conditioner (A/C) was installed by the occupant. Because the A/C was poorly installed, this measure also increased the air leakage of the unit. Finally, it appears that several compact fluorescent bulbs (CFL's) were replaced with incandescent bulbs. All of these measures resulted in a loss of points on the SmartRegs checklist.

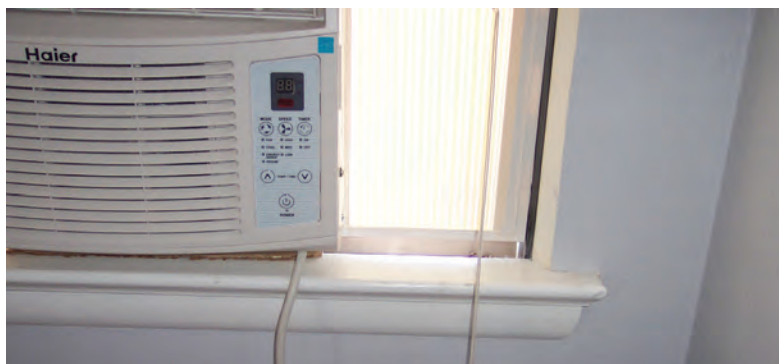
**A window air-conditioner was installed after the initial SmartRegs inspection. A large air-gap around the A/C resulted in a significant increase in the overall infiltration rate of the apartment.**

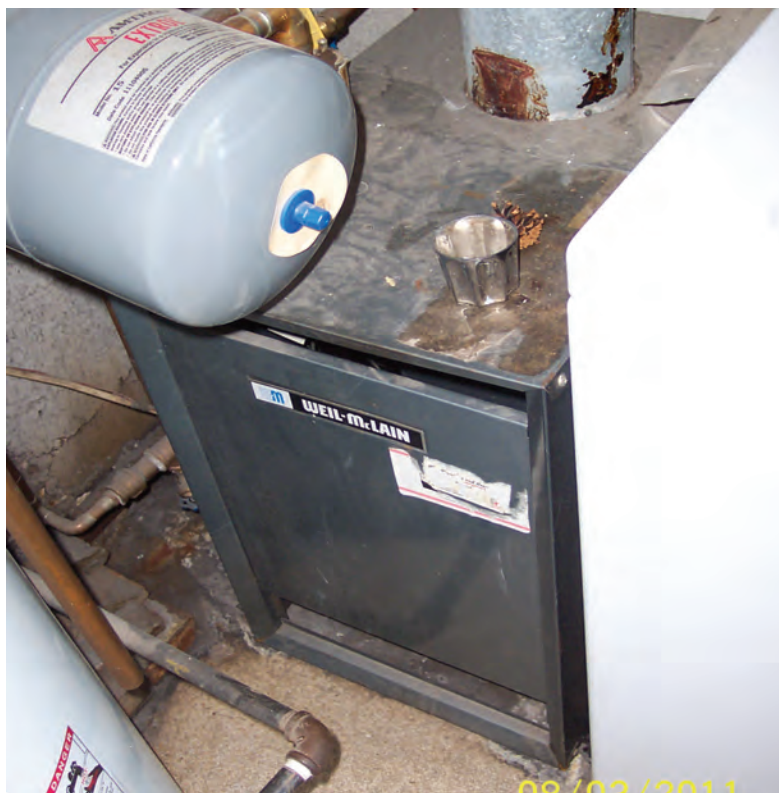
**Replacing this 60% efficient gas boiler with a 90% efficient unit gains 17 points on the SmartRegs checklist. Installing 1 kW of PV is awarded 44 points.**

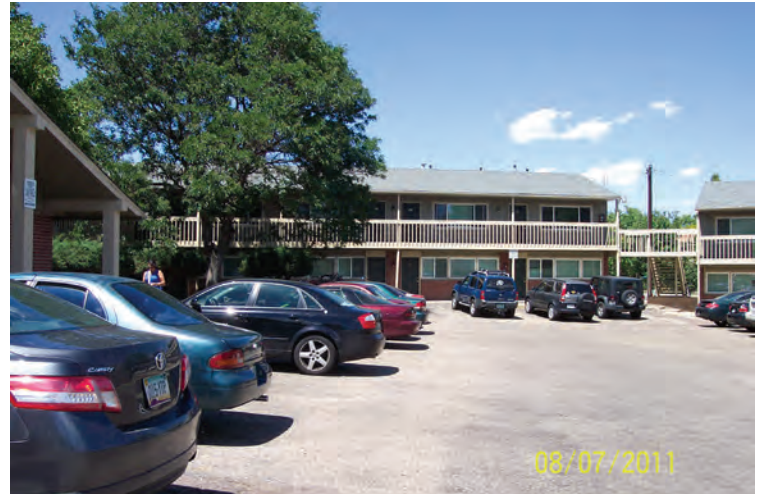
**This 2-story, multi-family apartment building in Boulder, CO underwent extensive retrofits to all its 37 units.**

In order to demonstrate compliance with SmartRegs, the property owner of these 37 rental units opted to use the Prescriptive Checklist. Prior to upgrades, these units were well below the 100 point threshold. The complex was constructed in the 1950's, with minimal attic insulation, no wall insulation, and single pane windows. Heating is provided by ductless in-unit natural gas heaters and hot water is provided by 6 centrally located gas storage water heaters. No cooling or mechanical ventilation is provided, although some tenants install window air conditioners on their own. Actual annual bills per unit range from \$200-\$600 for electricity and \$250-\$550 for natural gas, with almost \$210 in just monthly service charges.

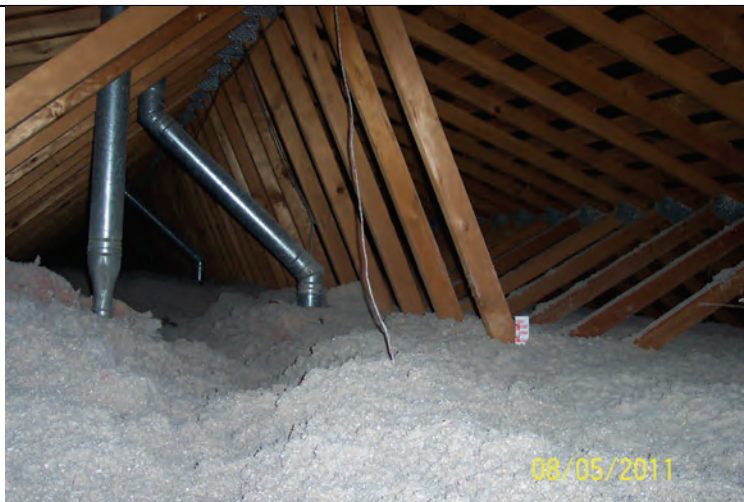
*The attics are now insulated with approximately 13" of R-50 cellulose loose-fill insulation*

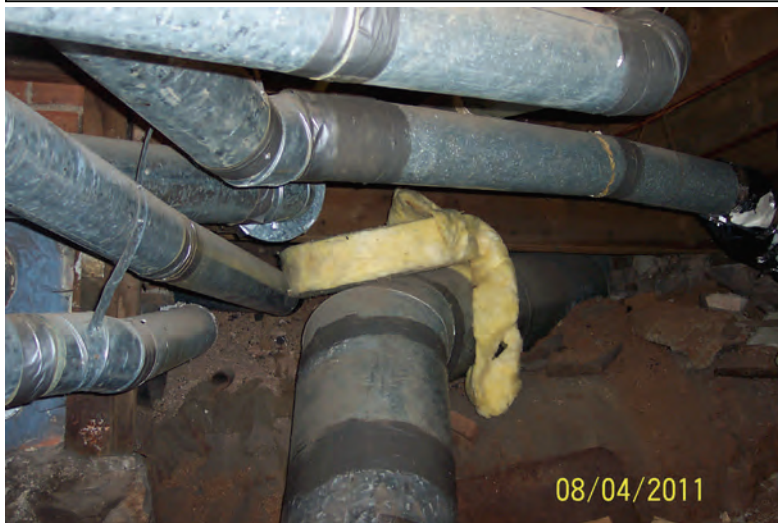
**Uninsulated, partially sealed ductwork in the uninsulated basement/crawlspace**

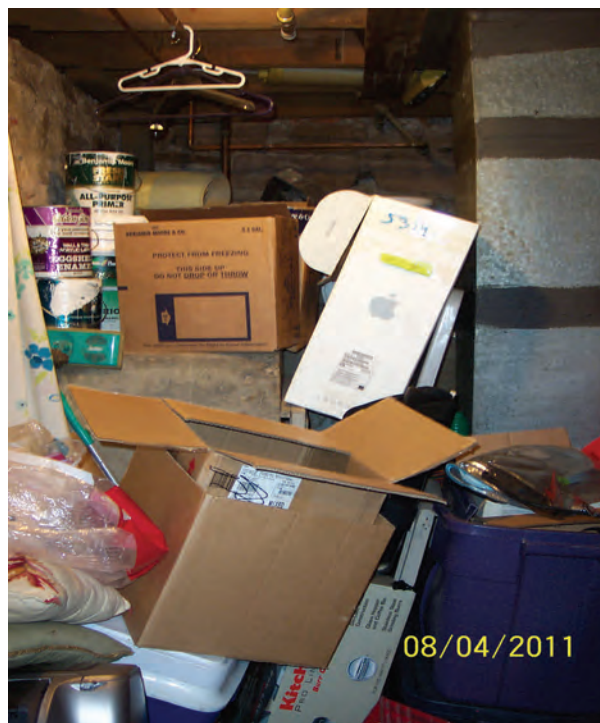
**Basement and crawlspace are being used as storage making any retrofits in this area difficult and more costly.**
