Case Study of Envelope Sealing in Existing Multiunit Structures

Jordan Dentz, Francis Conlin,
and David Podorson
ARIES Collaborative

October 2012

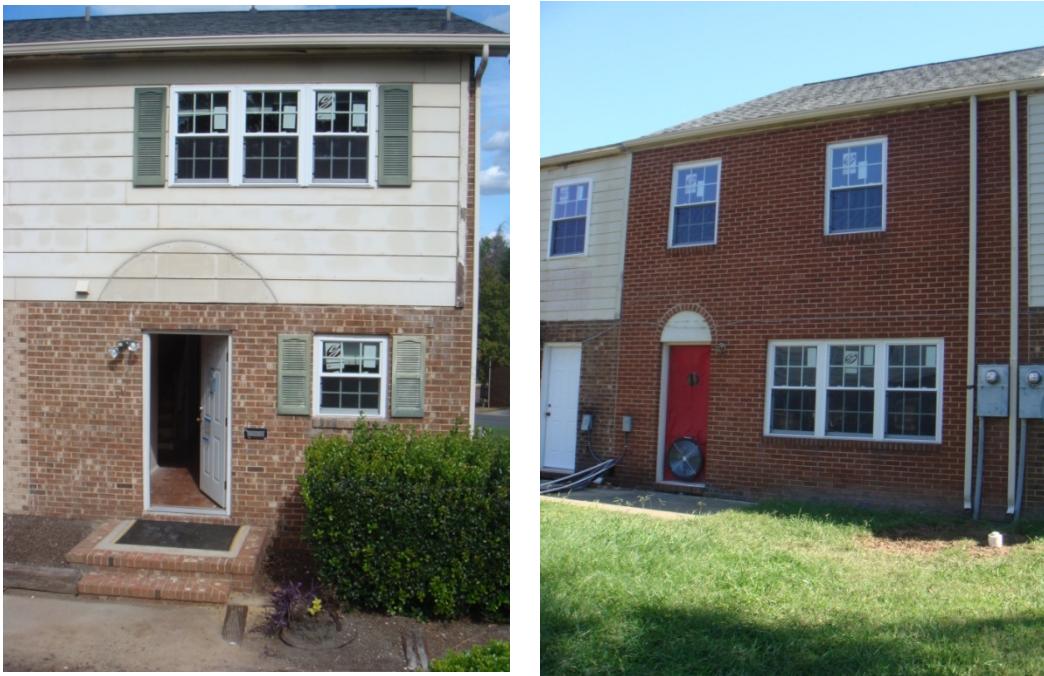
Figure 1. Townhome units

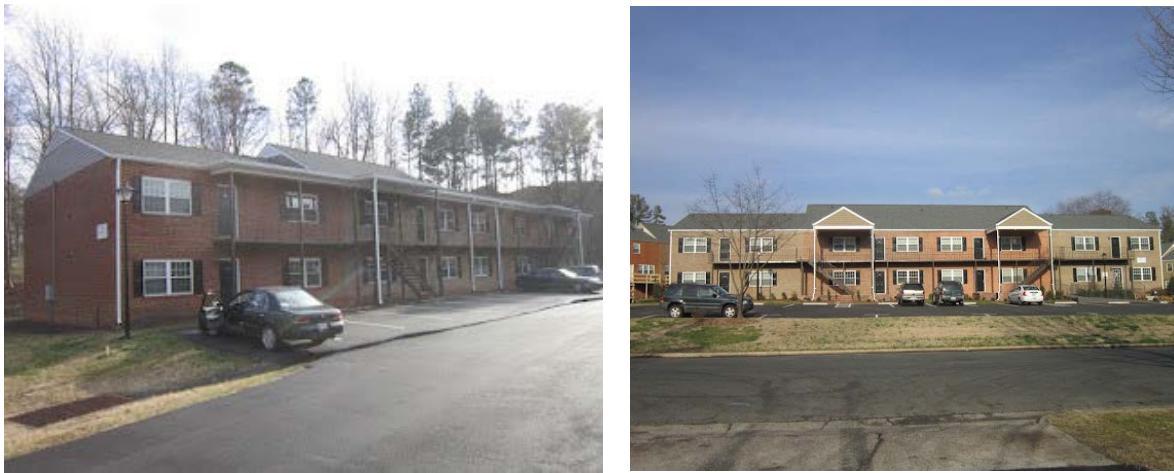
Figure 2. Apartment units

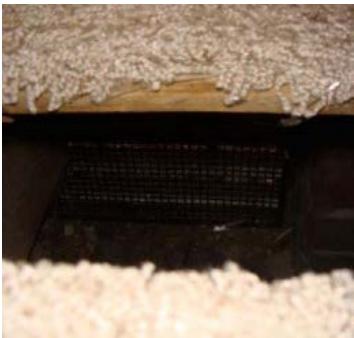
Figure 5. Before: Disconnected duct boot behind floor register

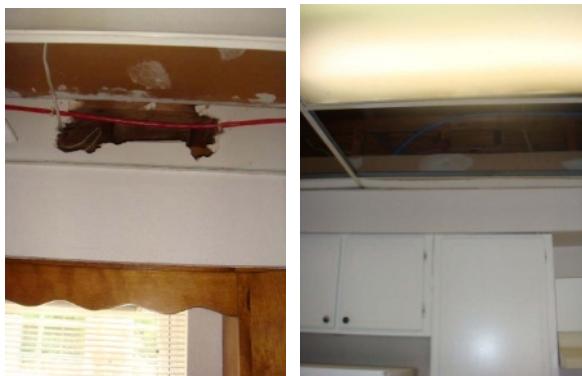
Figure 7. Before: Openings in walls above dropped ceiling in kitchen

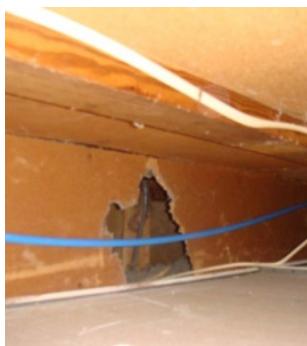
Figure 9. Before: Opening in wall above dropped ceiling

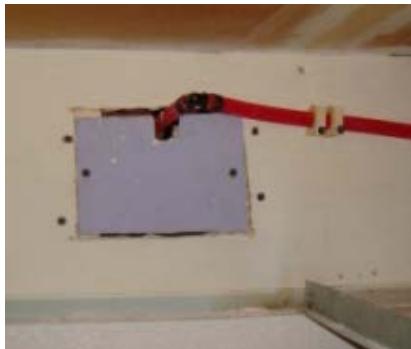
Figure 11. Before: Poorly patched plumbing opening in wall above dropped ceiling

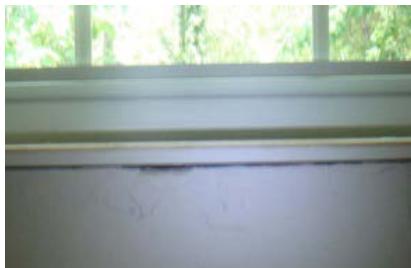
Figure 13. Before: Gaps around window sill resulting from poor installation of windows

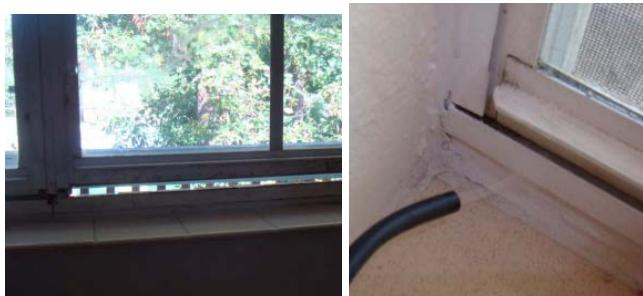
Figure 15. Before: Old windows not closing tightly

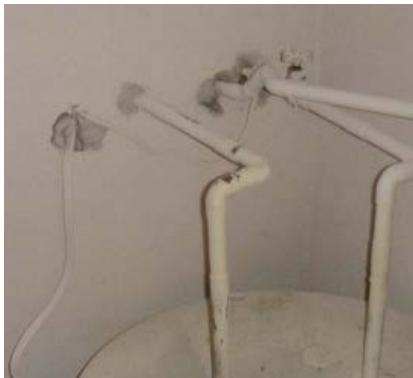
Figure 19. Before: Openings around water heater pipe penetrations

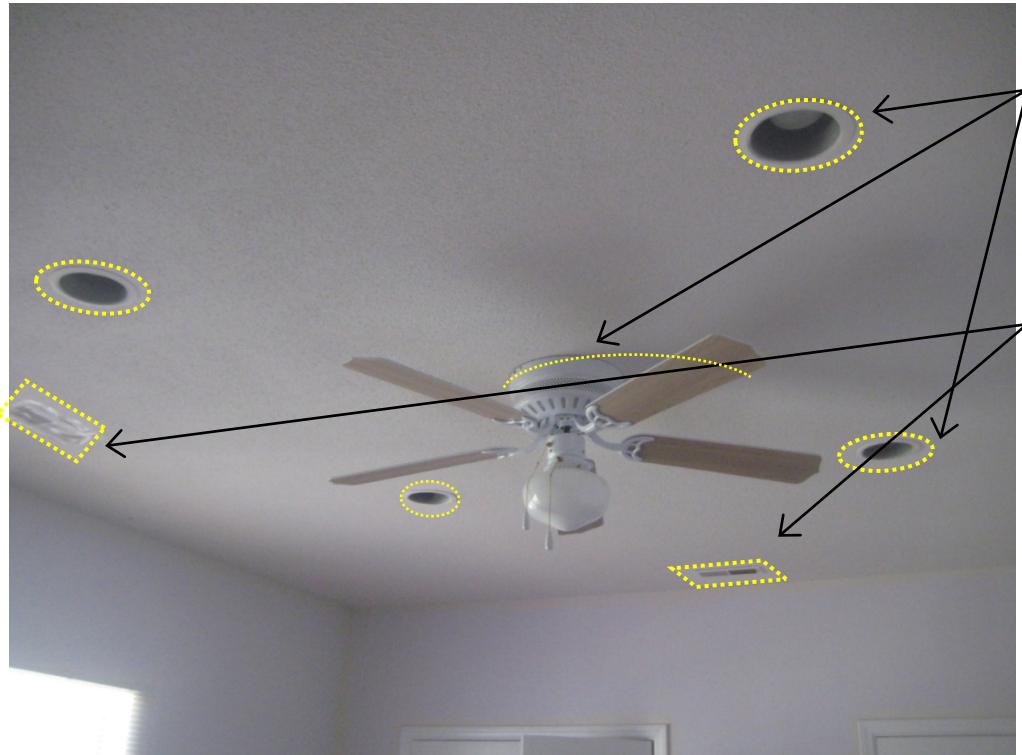
**Typical electrical fixture penetration**

1. Seal can lights and ceiling fan to air barrier or remove completely and repair air barrier. Seal entire perimeter of fan. Air leakage within the fixture assemblies might require installing airtight enclosures on the attic side, and then sealing them to the ceiling air barrier with foam, caulk, or gaskets depending on air barrier and enclosure material.
2. Seal intersection of HVAC supply duct with ceiling air barrier.

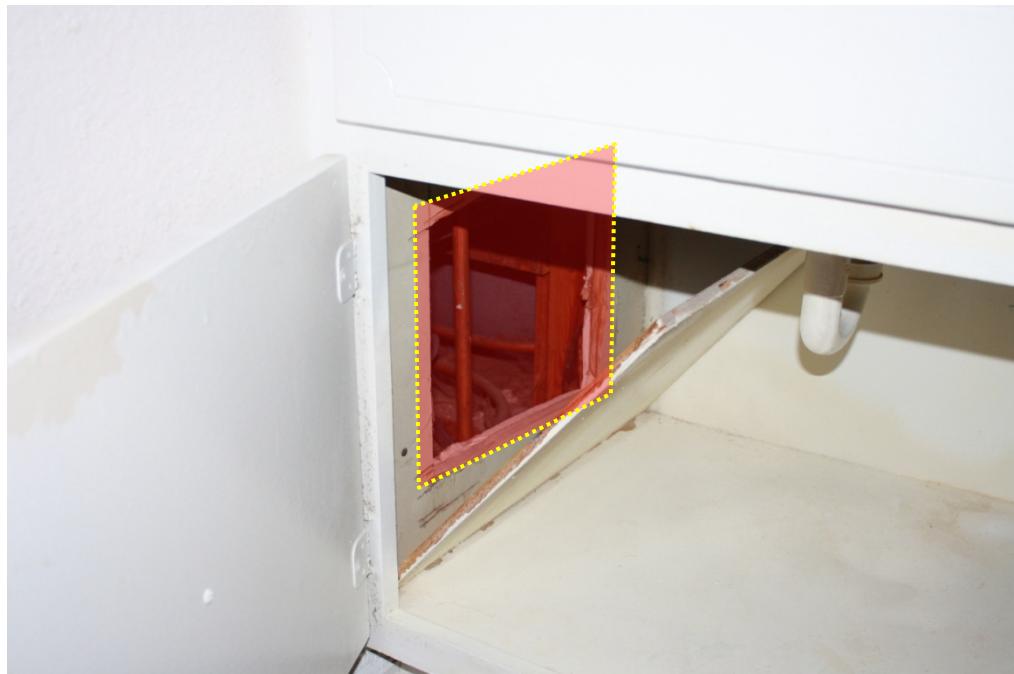
**Typical access void behind tub in bathroom**

Install patch or plug and mechanically fasten to substrate, then make airtight with sealant or fluid-applied membrane around perimeter.

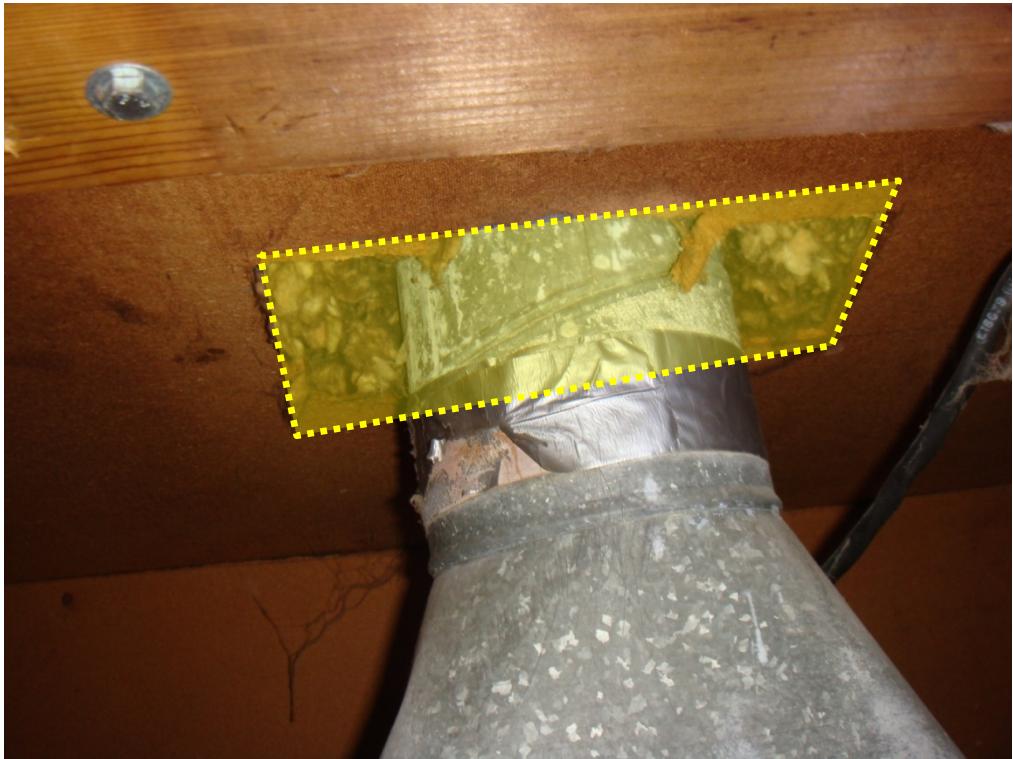
**Typical unsealed duct penetration**

Apply spray foam or sealant/membrane with transition strips around HVAC penetration to make airtight.

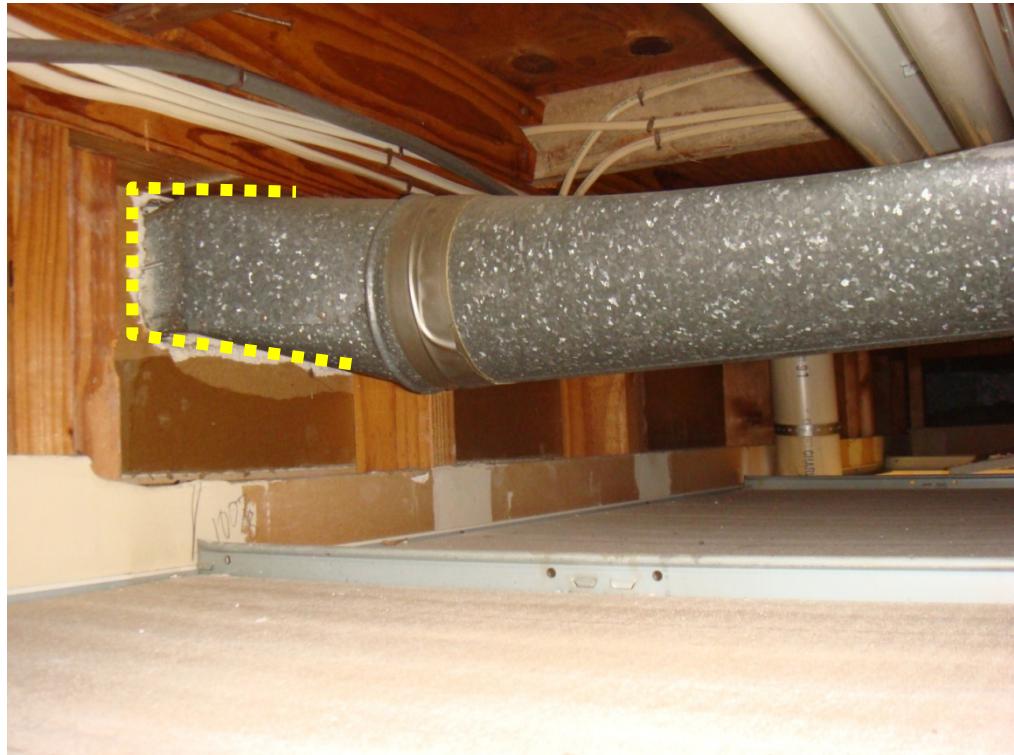
**HVAC duct penetration through air barrier**

Install sealants or membranes with backer rod or transition strips as necessary to make duct penetration airtight.

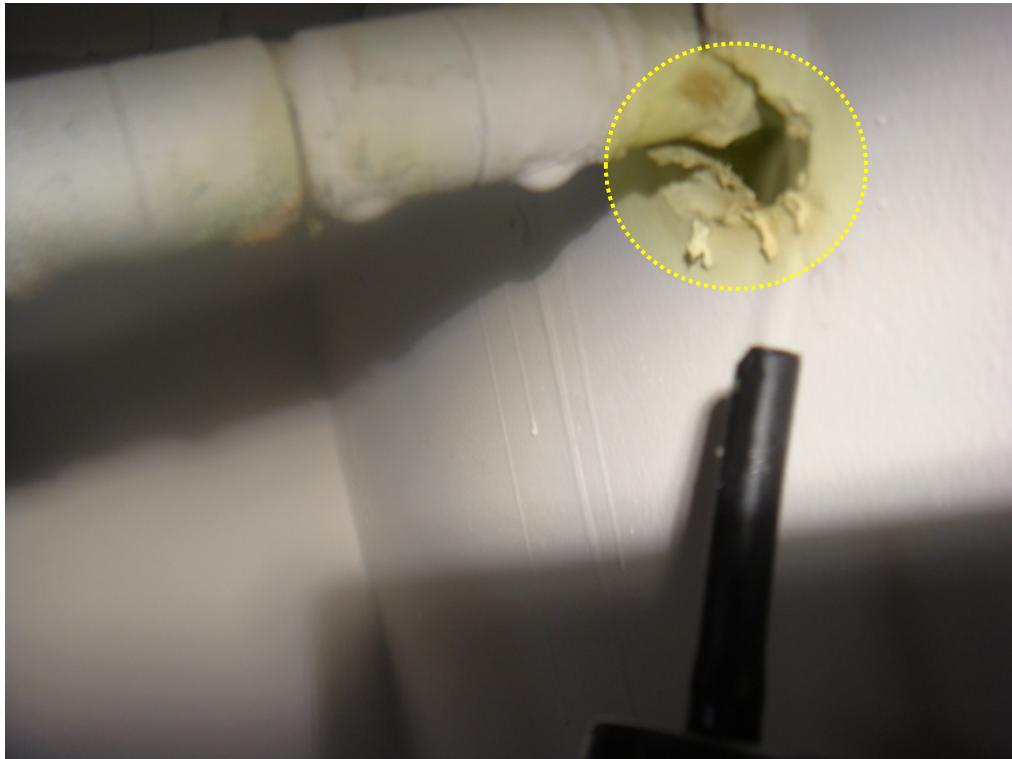
**Typical unsealed plumbing penetration under sink**

Air seal between the plumbing penetration and the GWB air barrier using continuous beads of spray foams or fluid membrane with transition strips.

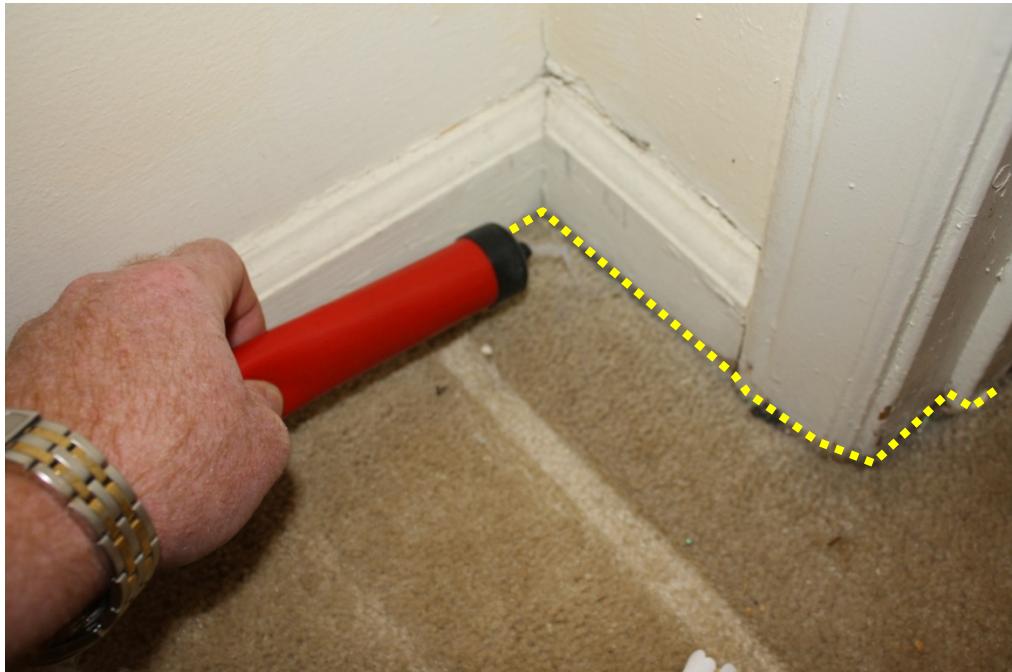
Floor to wall transition

Pull carpeting away from wall. Clean area to ensure sealant adhesion and install a continuous bead of sealant to make floor-to-wall intersection airtight. Use backer rod to support sealant at openings greater than $\frac{1}{4}$ in., or the distance described in the sealant manufacturer's installation instructions.

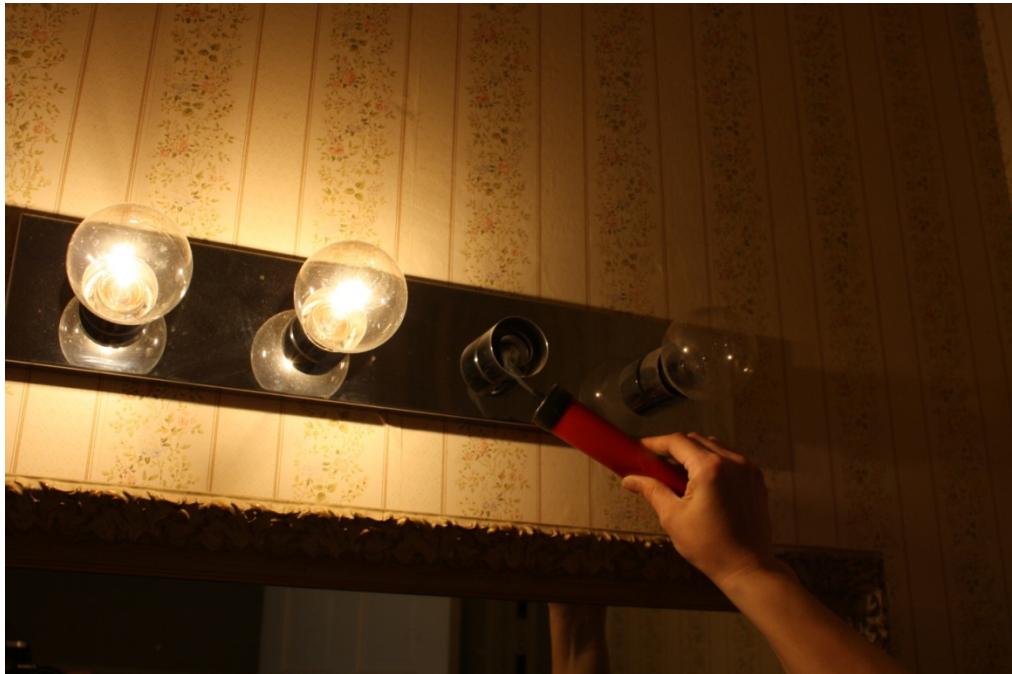
**Typical bathroom electrical fixture penetration**

Make fixture airtight by installing an airtight enclosure on the inside-wall side of the air barrier and sealing the enclosure to the inside-wall side of the air barrier. Alternatively, remove the fixture, install “Air Barrier Rated” lighting fixture, and caulk rated fixture to GWB air barrier to ensure airtight seal.
