# Greenbelt Homes Pilot Energy Efficiency Program Phase 1 Summary: Existing Conditions and Baseline Energy Use

J. Wiehagen, M. Del Bianco, and A. Wood  
*NAHB Research Center*

February 2013

On behalf of the U.S. Department of Energy's Building America Program

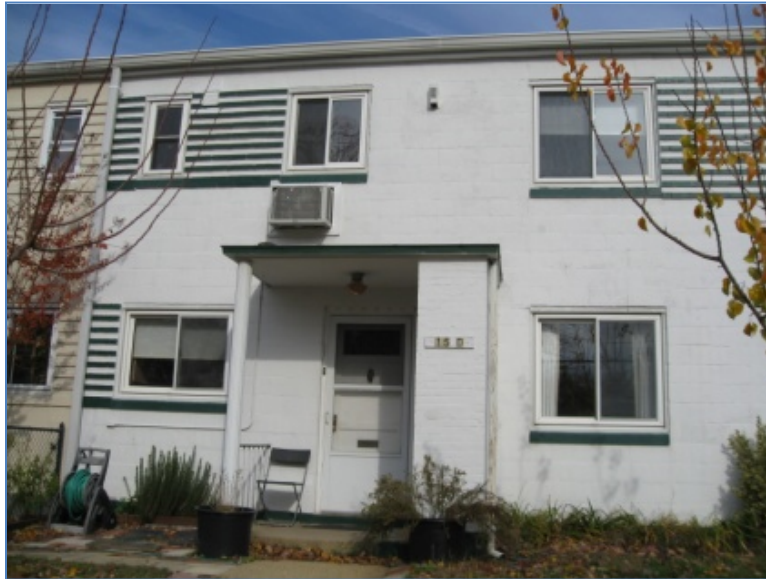
**Figure 1. Block building, one end unit, front.**

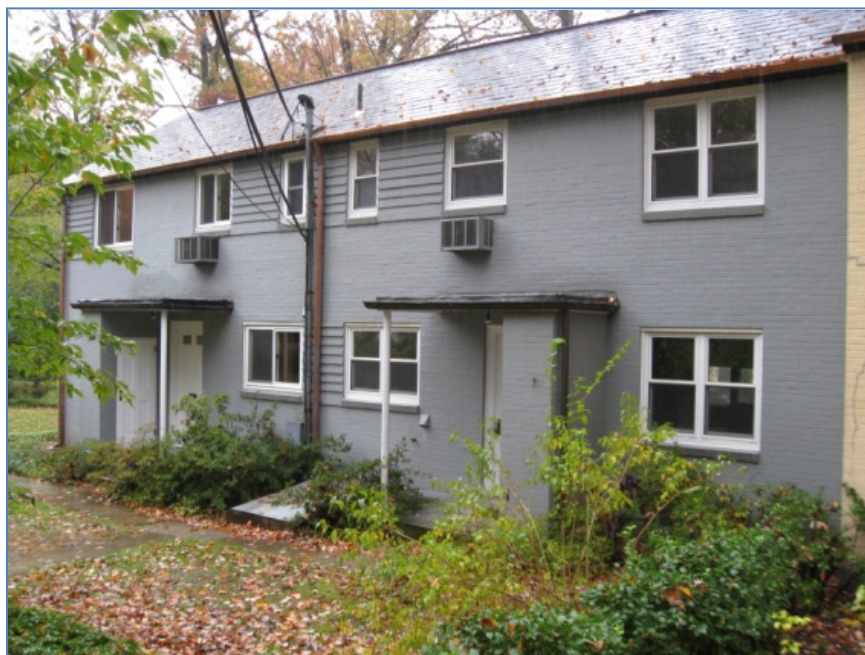
**Figure 4. Wood frame brick building, front elevation, two units.**

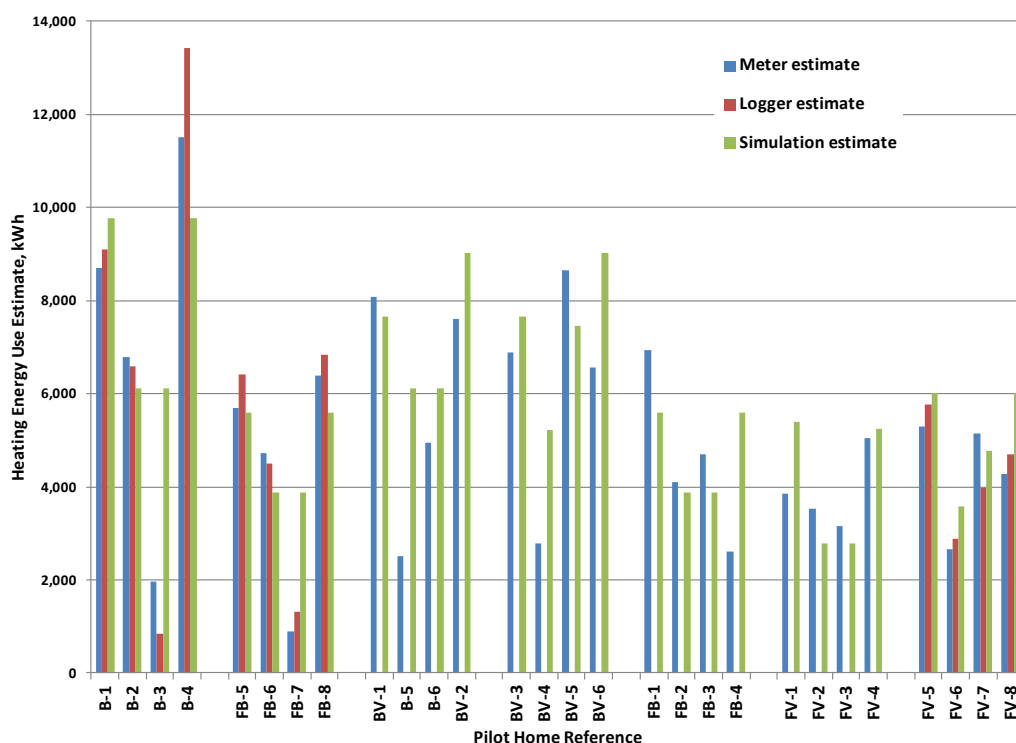
**Figure 8. Summary comparison of heating energy use estimates for the heating period November 2010 – March 2011.**

4. When comparing the simulation data estimates to the utility meter readings, the results are more varied with an average ratio of 148% for across all of the homes and a standard deviation of 109%. When removing the three outlier homes from the data set, the average ratio of simulated to meter energy use is 106% with a standard deviation of 21%, indicating a somewhat good approximation of energy use by the homes from the simulation estimates.

Figure 8 charts the data as described in the four summary points above.

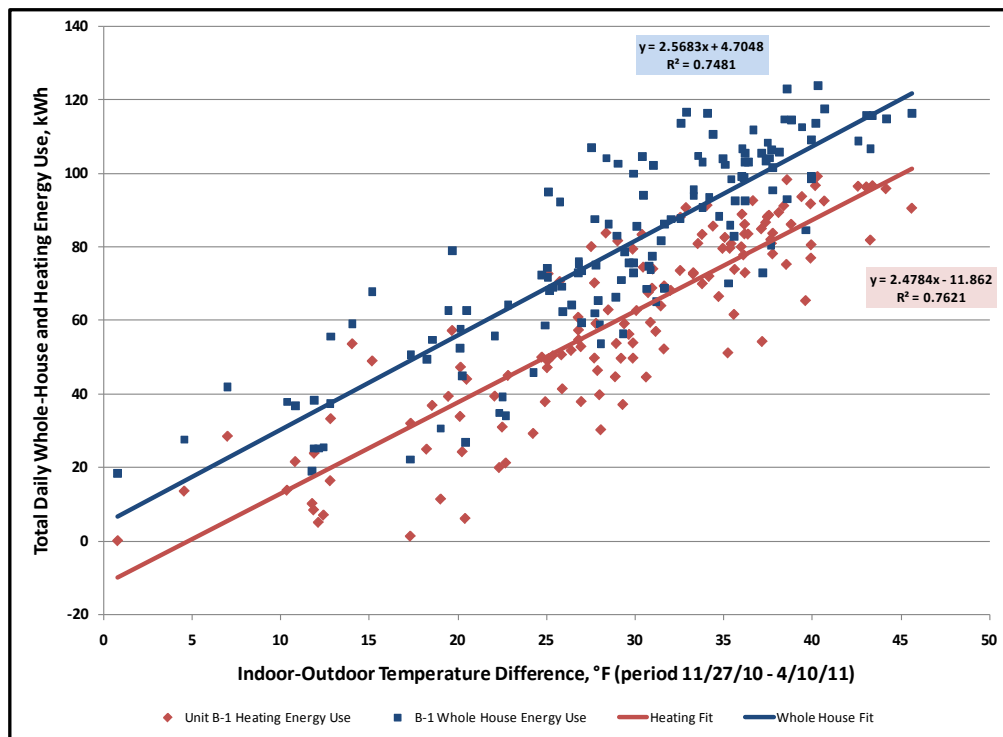
Figure 9. B-1 Whole house and heating electric use analysis.

Figure 9, Figure 10, and Figure 12 indicate similar performance because the whole house and heating energy use are consistent as evidenced by the whole house and heating energy fit lines being parallel, or having a similar slope. The area between the fit lines is generally indicative of energy use for appliances, lights, water heating and miscellaneous. When the area is consistent, as shown by these graphs, it indicates that usage is more or less routine from day to day.

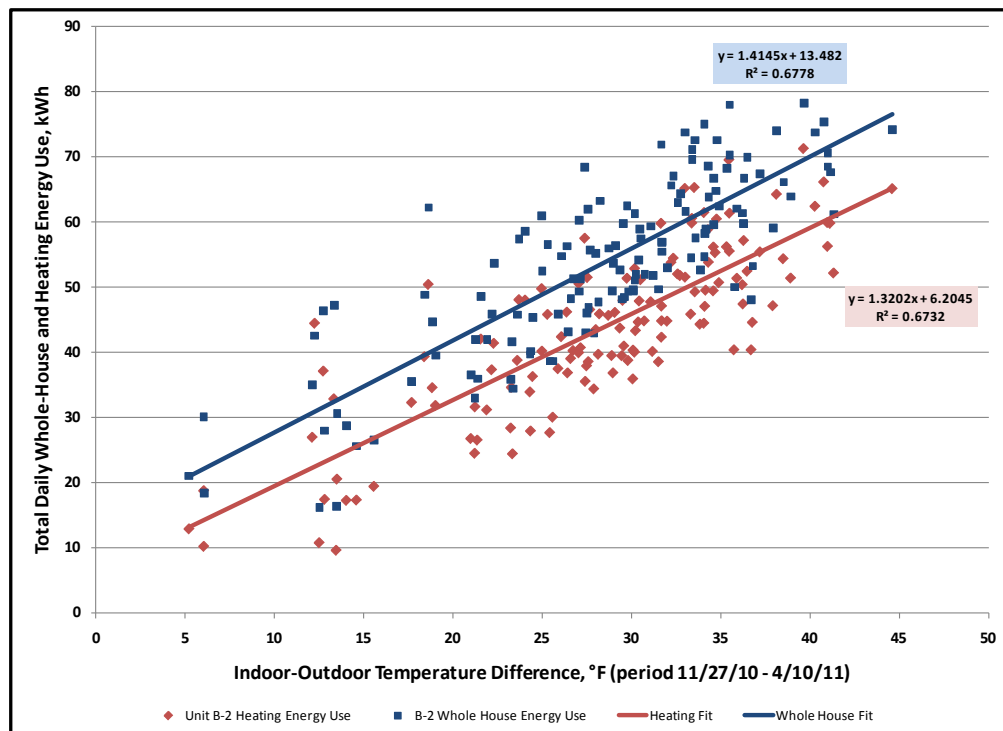
Figure 10. B-2 Whole house and heating electric use analysis.

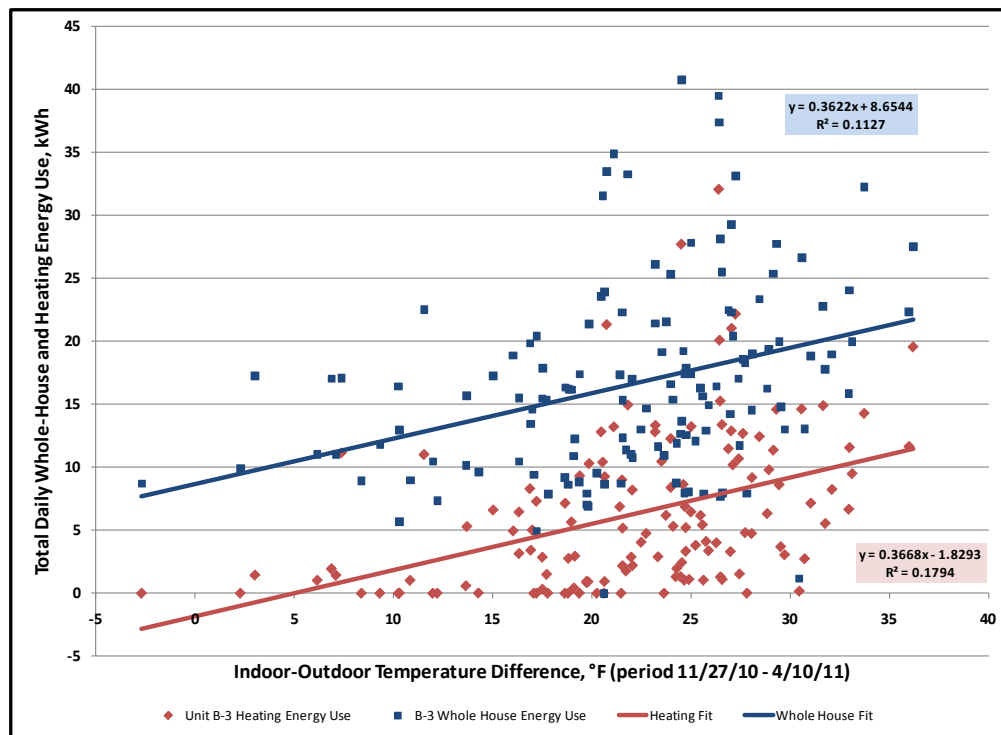
Figure 11. B-3 Whole house and heating electric use analysis.

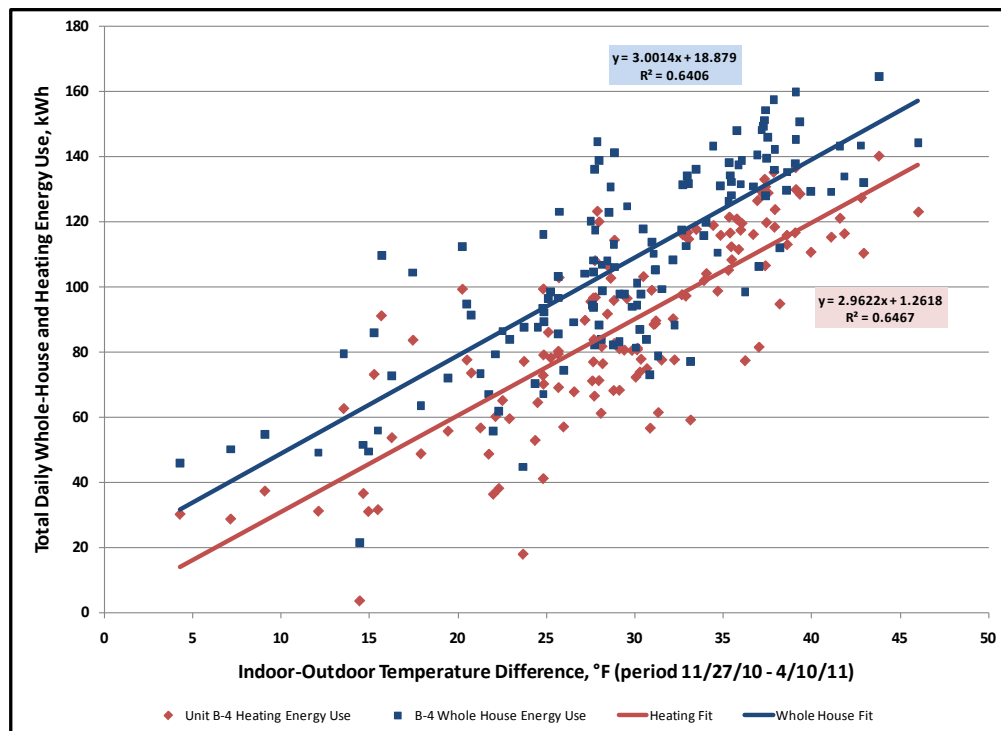
Figure 12. B-4 Whole house and heating electric use analysis.

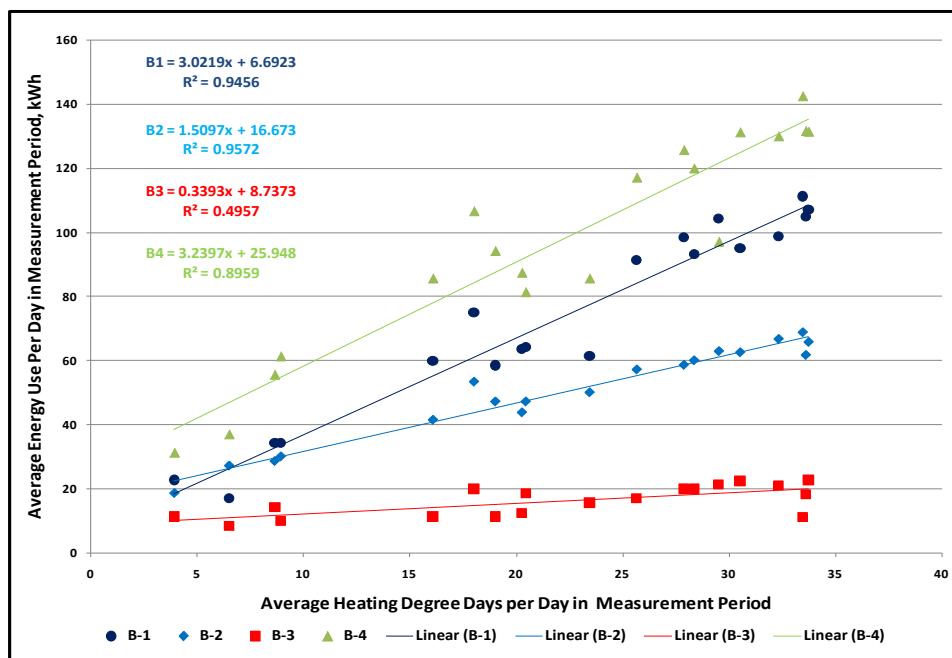
Figure 13. B-1 through B-4 average daily electricity use based on HDDs in the period.

Units B-4 and B-1 demonstrate the highest daily energy usage during the heating period. These are end units with approximately 25% more exterior wall surface, nearly 50% more roof surface area, and 28% more heated area than B-2 and B-3, thus higher energy usage for space conditioning is expected.

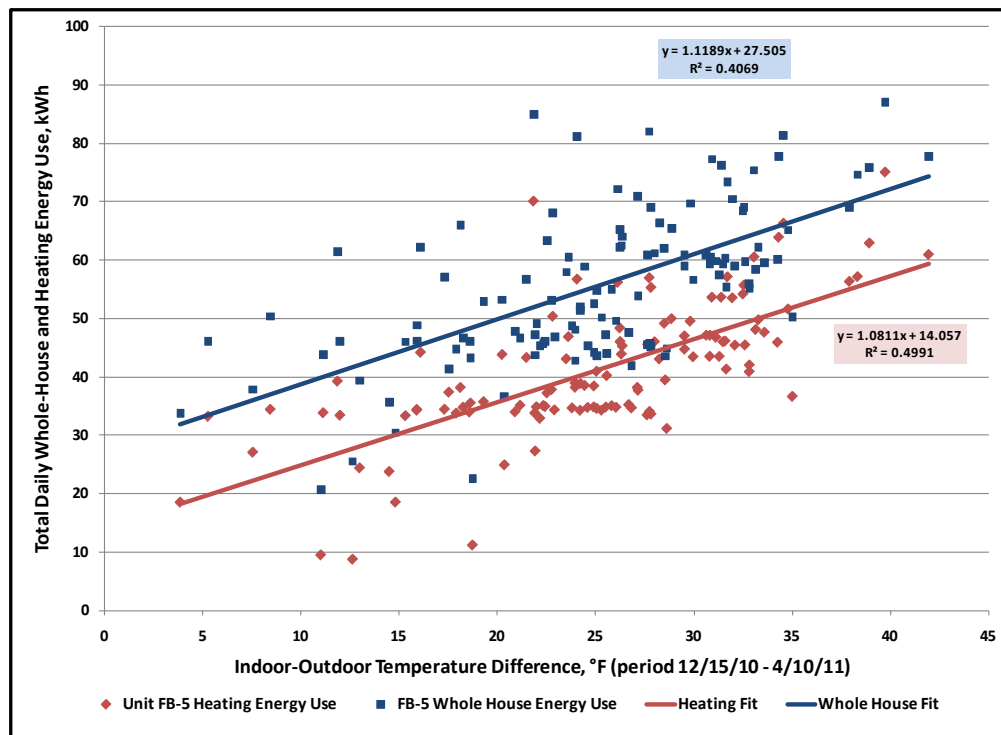
Figure 14. FB-5 Whole house and heating electric usage.

The daily energy usage range for the occupied homes is not large—90 to 115 kWh per day—and homes are of similar area. The maximum energy for space heating is, as would be expected, higher for the exterior units (75 to 85 kWh maximum daily usage) than the interior occupied unit

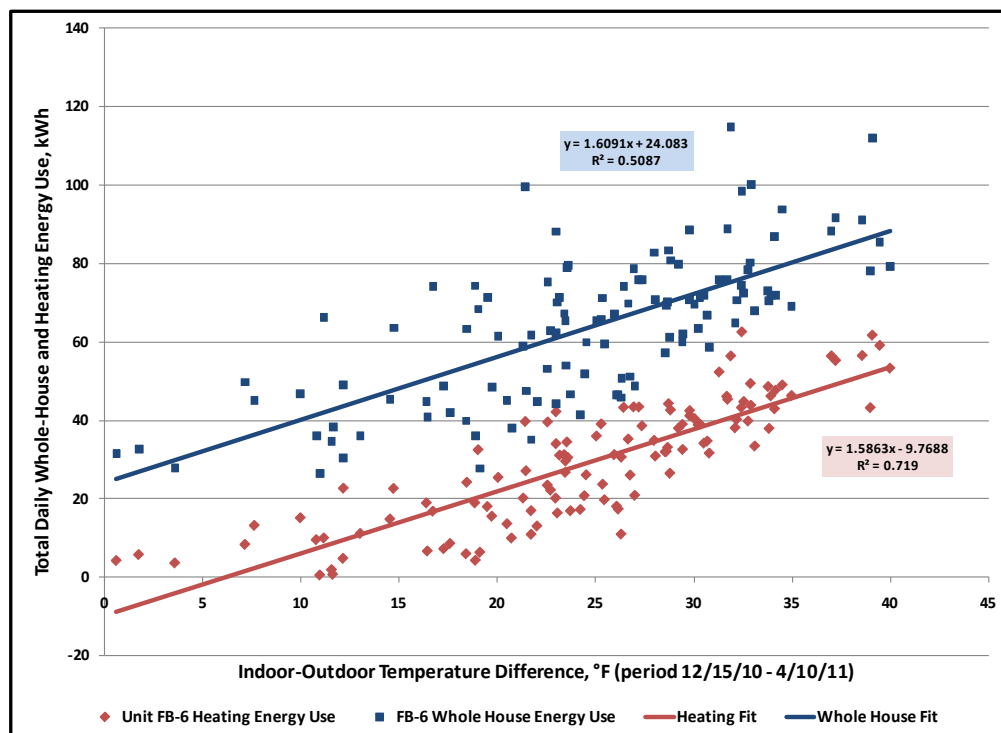
Figure 15. FB-6 Whole house and heating electric usage.

(65 kWh). The larger-than-normal difference between the whole house and heating energy use (more than 20 kWh usage per day) for unit FB-6 (Figure 15) is generated by heating hot water.

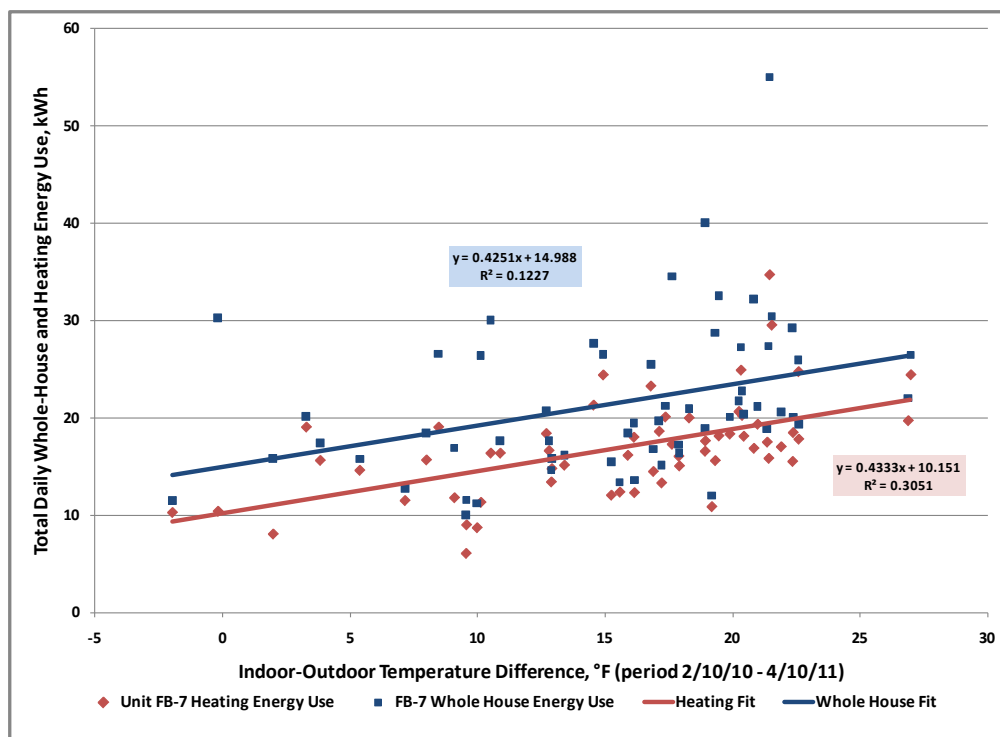
Figure 16. FB-7 Whole house and heating electric usage.

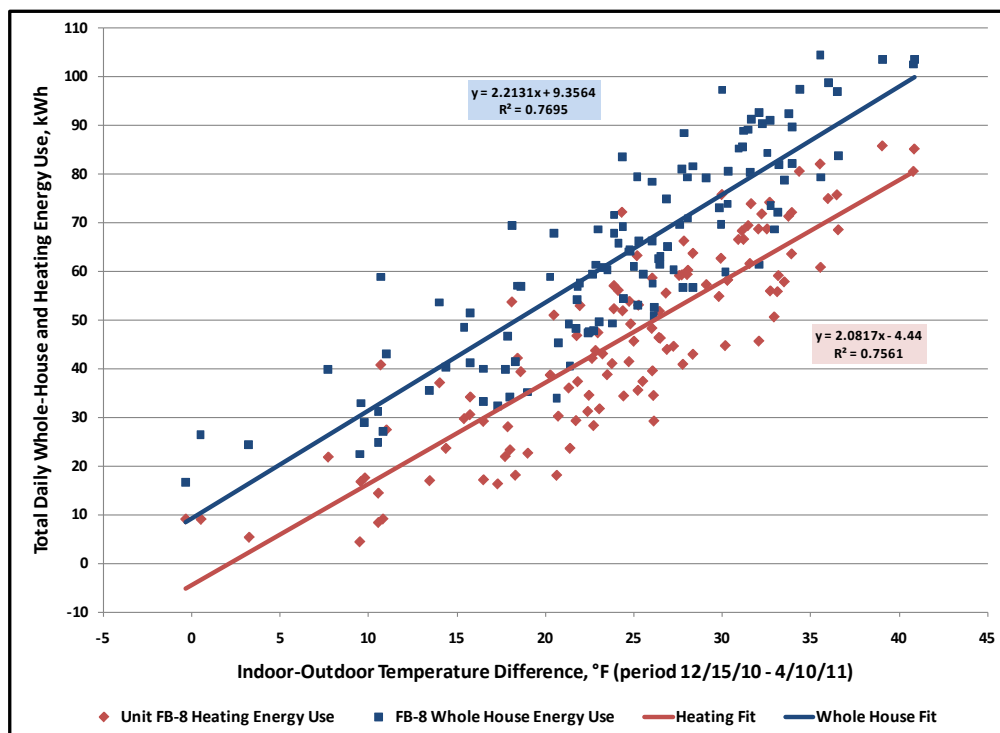
Figure 17. FB-8 Whole house and heating electric usage.

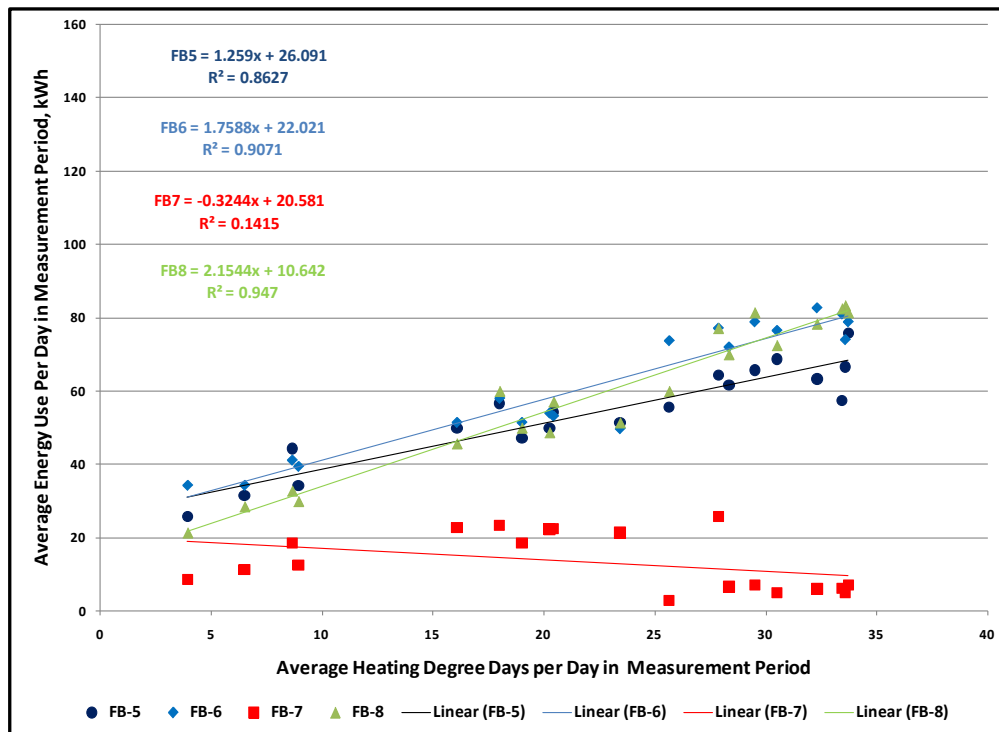
**Figure 18. FB-5 through FB-8 average daily usage and HDD during the period.**

Figure 18 compares the energy use recorded at the meter with the HDD for the period. The data correlates well with that presented in the previous graphs (Figure 14-Figure 17).

The energy used in these wood frame brick (FB) units is significantly lower than for the block (B) units (Figure 9 through Figure 12) due to the former having wall insulation. FB-5 and FB-8 are the end units with approximately 340 more square feet of exterior wall surface than interior units; however, all of the homes in this building have similar conditioned area (Table 3).

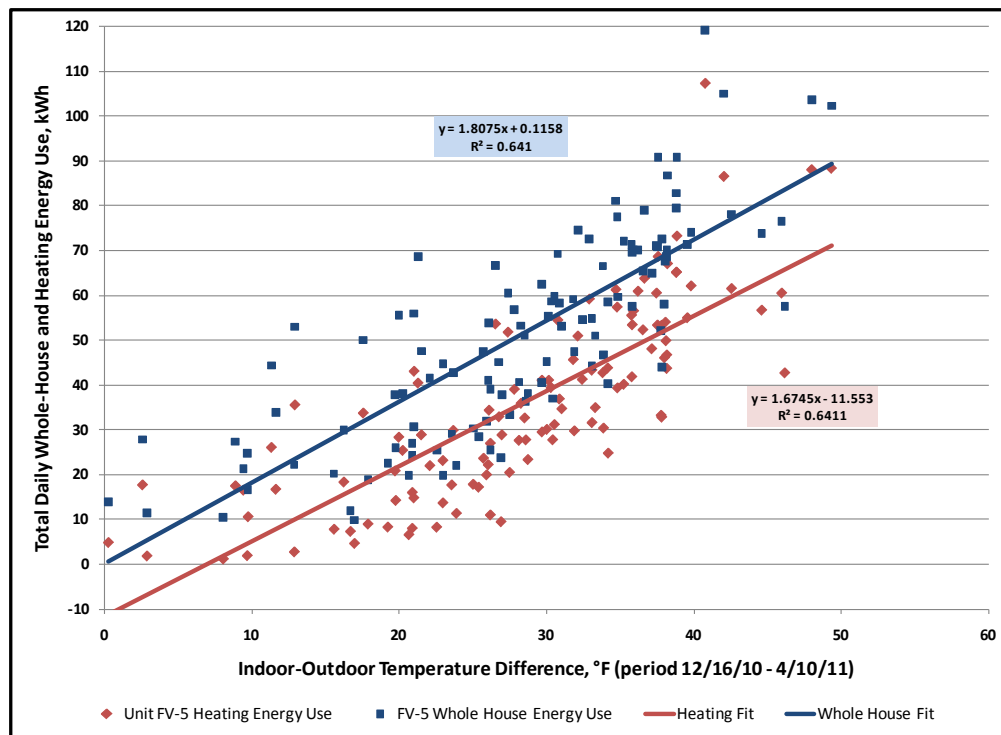
Figure 19. FV-5 Whole house and heating electric usage.

Figure 19 through Figure 22 indicate the detailed daily data for whole house and heating energy use. The maximum energy use recorded for any day is similar to that of the wood frame brick building but, the range for these wood frame vinyl homes is not as great as those of the other building types. The range of maximum daily use was 74–119 kWh per day (used in FV-6, and FV-5, respectively). The two other homes in the building recorded maximum daily energy use of 75 and 104 kWh. The maximum heating energy use, however, was as would be expected, higher for the exterior units (108 and 63 kWh), than the interior units (47 to 52 kWh). The difference in heating energy use in the end homes can be attributed to the 6°F difference in average indoor heating set point.

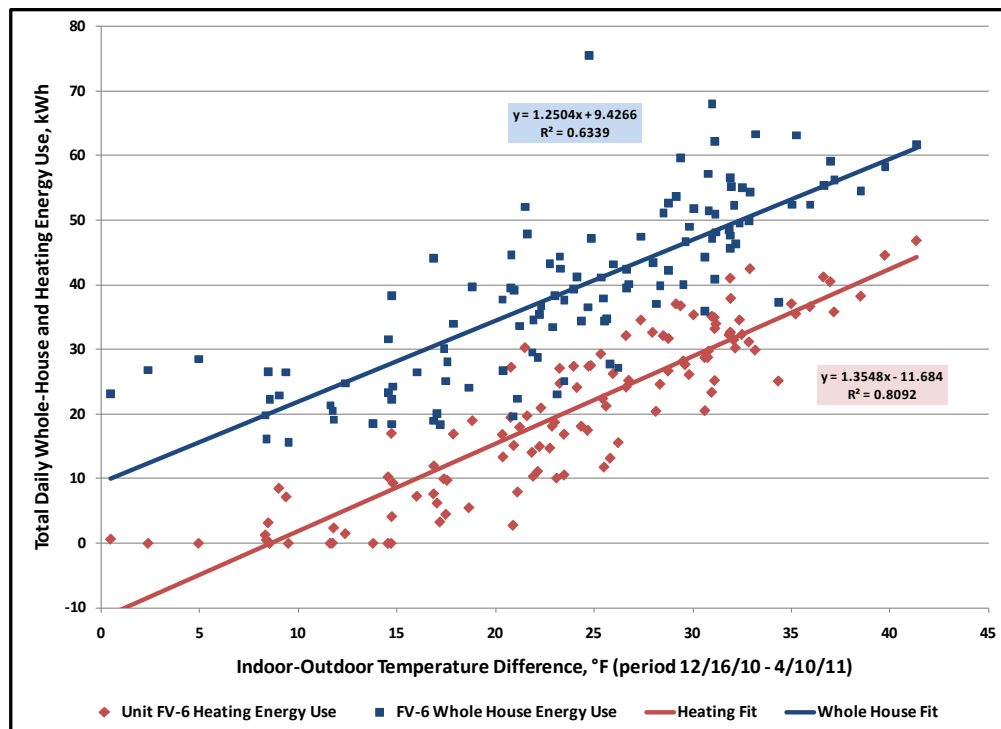
Figure 20. FV-6 Whole house and heating electric usage.

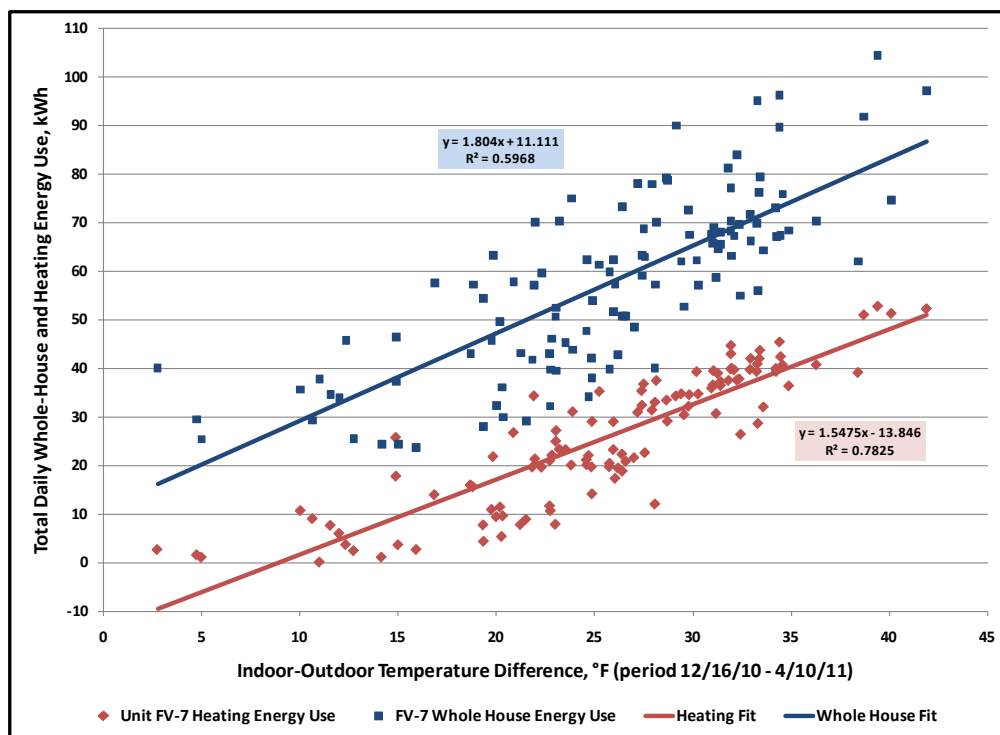
Figure 21. FV-7 Whole house and heating electric usage.

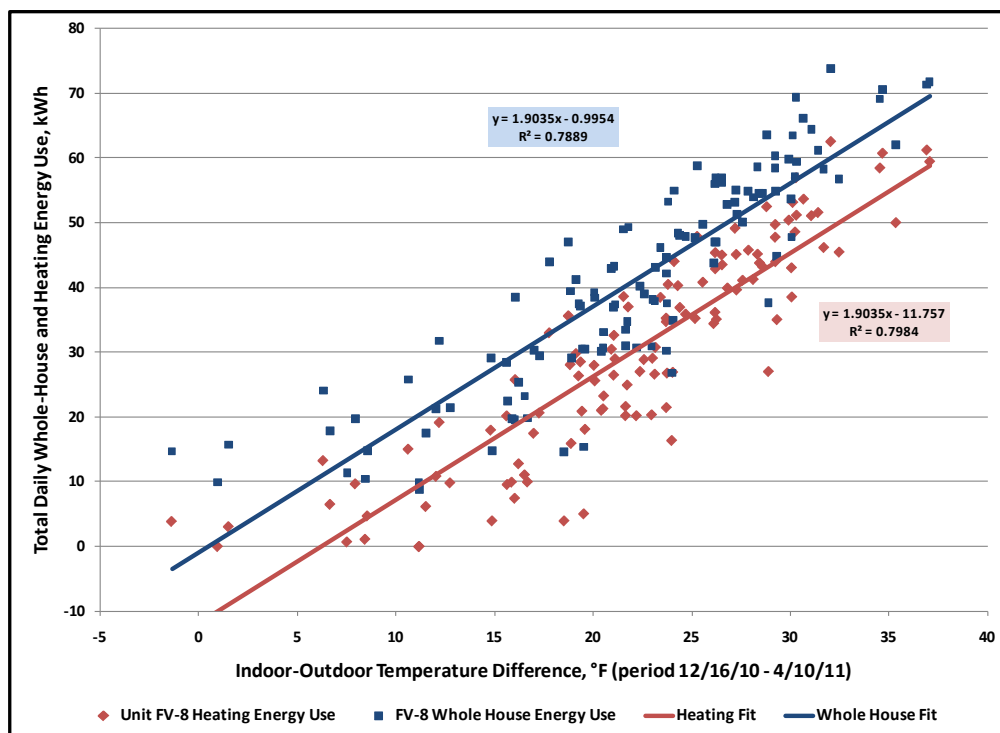
Figure 22. FV-8 Whole house and heating electric usage.

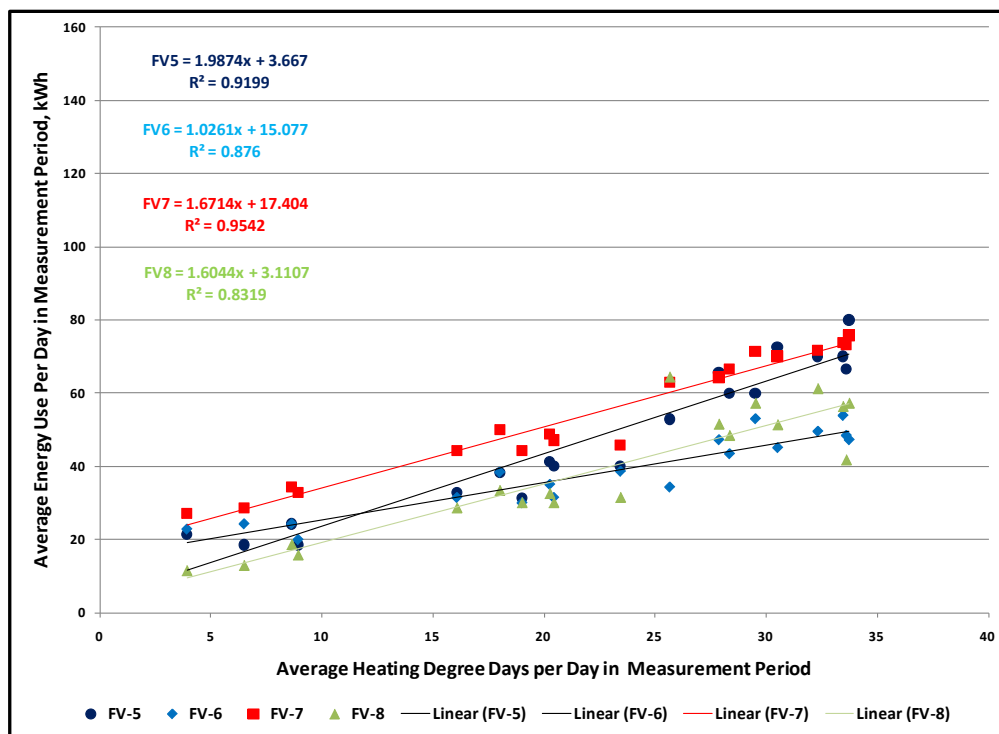
Figure 23. Average daily usage and HDD during the period; FV-5 through FV-8.

Comparison between the daily energy data recorded by the transducers (Figure 19 through Figure 22) to the utility meter records (Figure 23) indicates the agreement between the two methods. Figure 23 is a graph of the relationship between periodic utility meter records and the

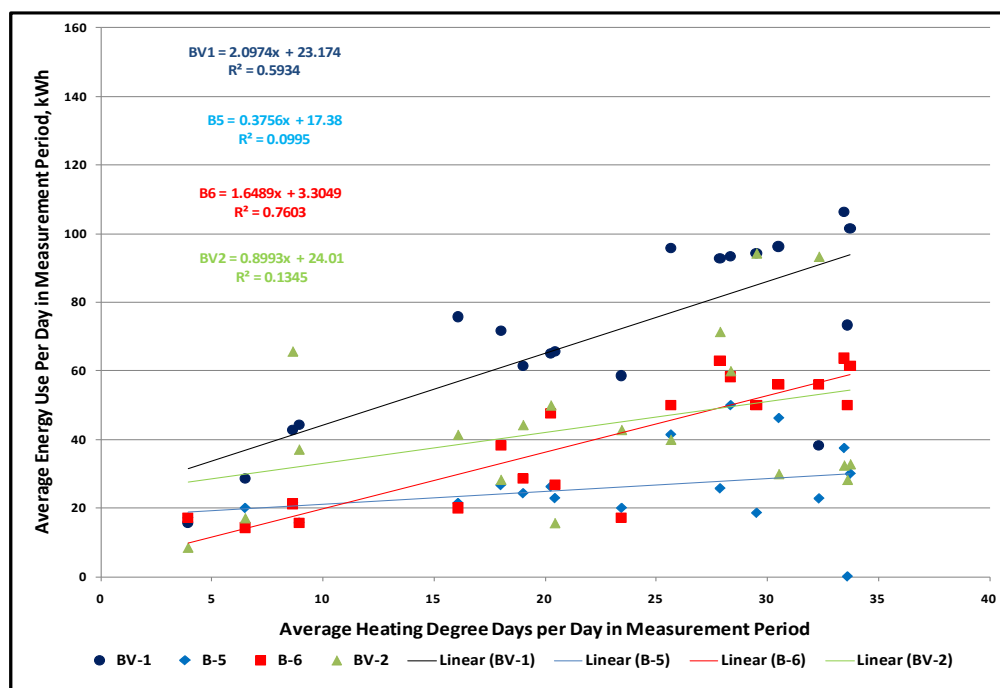
Figure 24. BV-1, B-5, B-6 and BV-2 average daily usage and HDD for the heating period.

The end units, BV-1 and BV-2, indicate the highest maximum daily energy usage during the period; however B-6, an interior unit, is a close third in energy usage. These three units have considerably different conditioned areas of 1,528, 1,245, and 921, respectively. Like the other block end units, the two in this building have more than twice as much exterior wall surface area as the interior units.

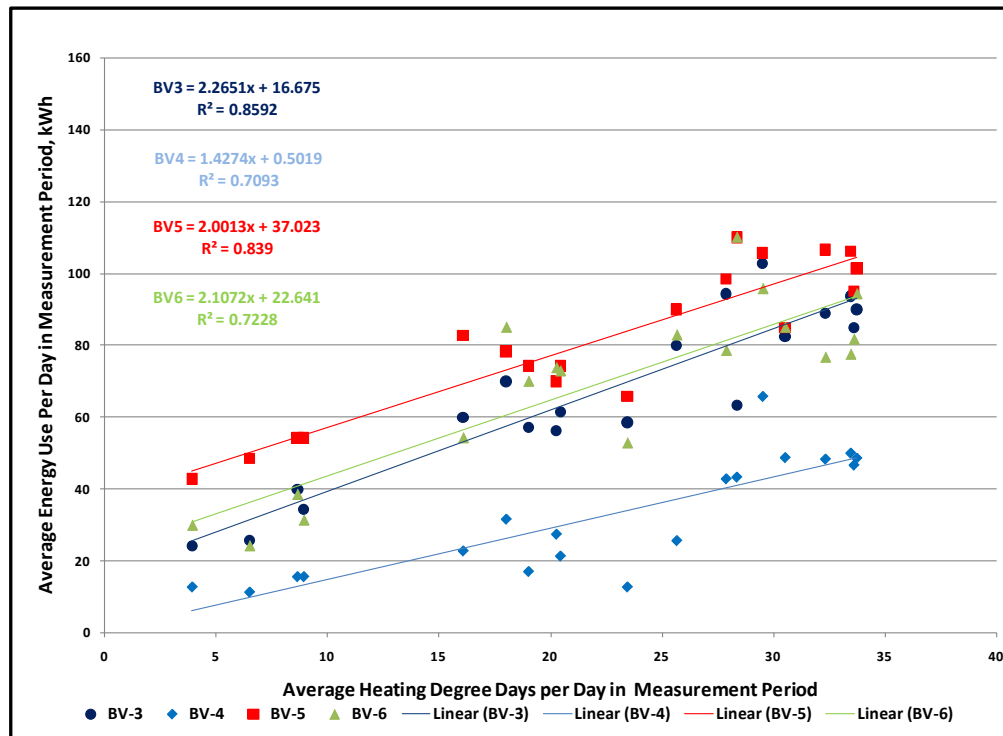
Figure 25. BV-3 through BV-6 average daily usage and HDD for the heating period.

Temperature sensors were installed in each unit of the masonry block vinyl-sided building for part of the heating season (February through April 2011). Energy use data was obtained via periodic utility meter readings, as energy transducers were installed in May 2011; after the heating season ended. The average indoor temperatures in these units were closest of any of the buildings to those used in the energy simulations—69°F, 64°F, 70°F, and 66°F. Figure 25 charts the electricity used during utility meter measurement period normalized to the number of HDDs in that period.

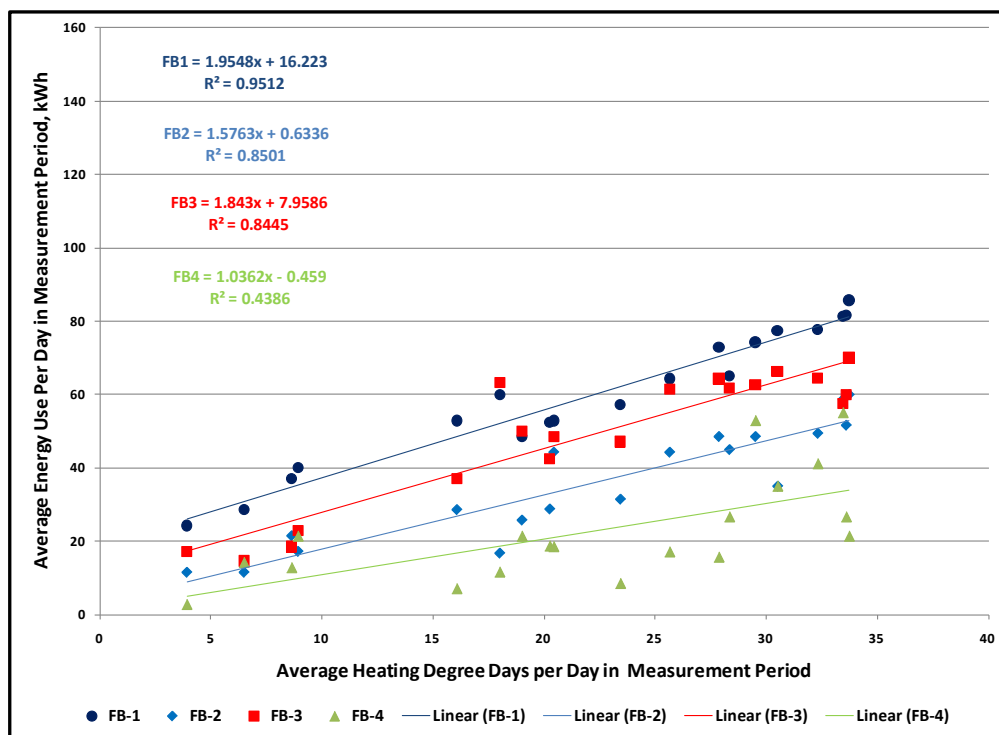
Figure 26. FB-1 through FB-4 average daily usage and HDD during the period.

Temperature sensors were installed in each unit of this wood frame brick-veneered building for part of the heating season (February through April 2011). Energy use data was obtained via periodic utility meter readings, as energy transducers were installed in May 2011; after the end of the heating season. The average indoor temperatures vary considerably—70°F, 65°F, 66°F and 58°F. Each of the homes in this building contains the same conditioned area, 1,080 ft<sup>2</sup>. Figure 26 charts the electricity used during each utility meter measurement period normalized to the number of HDDs in that period. The FB-4 unit appears to be an anomaly both as an exterior unit and lower slope of energy use with reference to the weather severity.

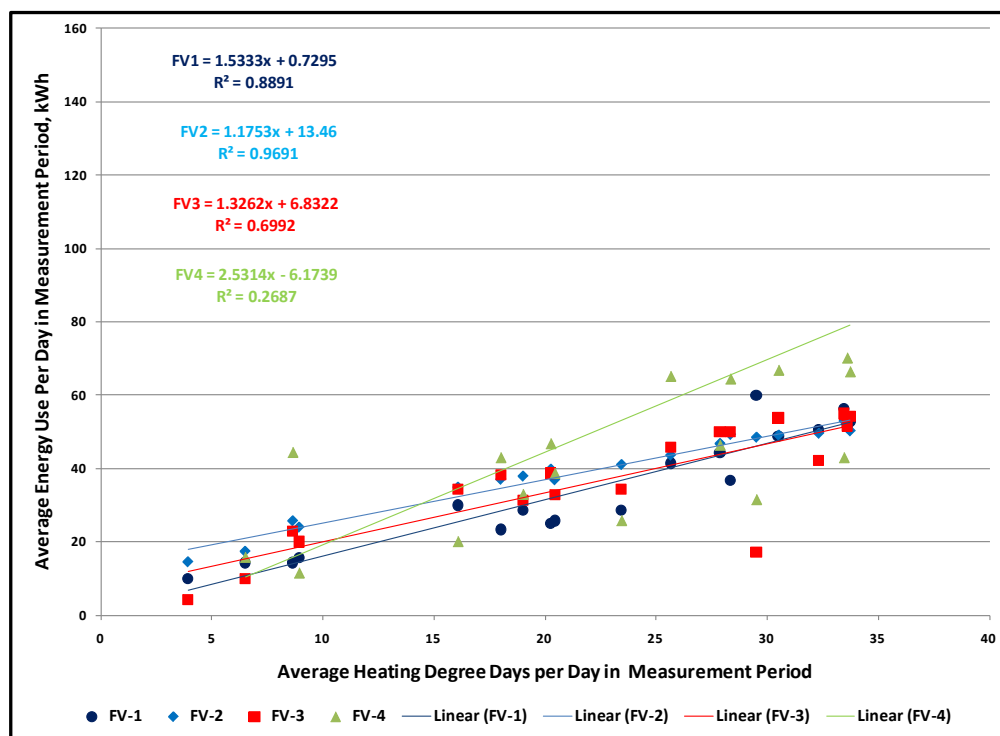
Figure 27. FV-1 through FV-4 average daily usage and HDD for the heating period.

Temperature sensors were installed in each unit of this wood frame vinyl-sided building for part of the heating season (February through April 2011). Energy use data was obtained via periodic utility meter readings, as energy transducers were not installed until May 2011 after the end of the heating season. Average indoor temperatures were 63°F, 69°F, 68°F, and 68°F. Whole house energy use is plotted against the HDDs in the period in Figure 27.

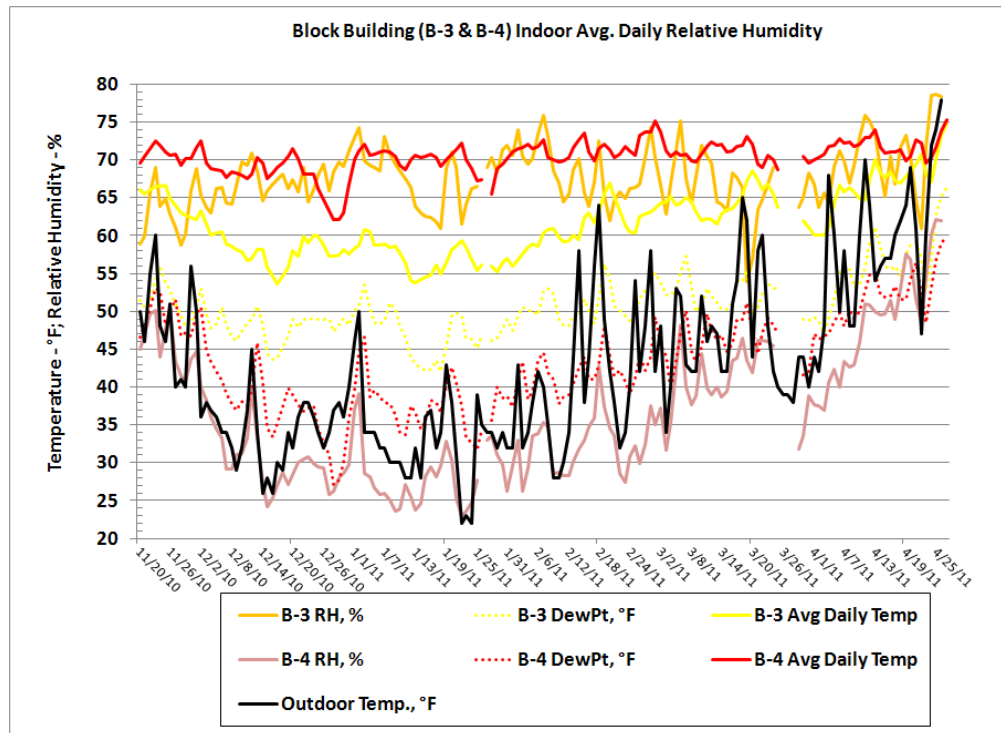
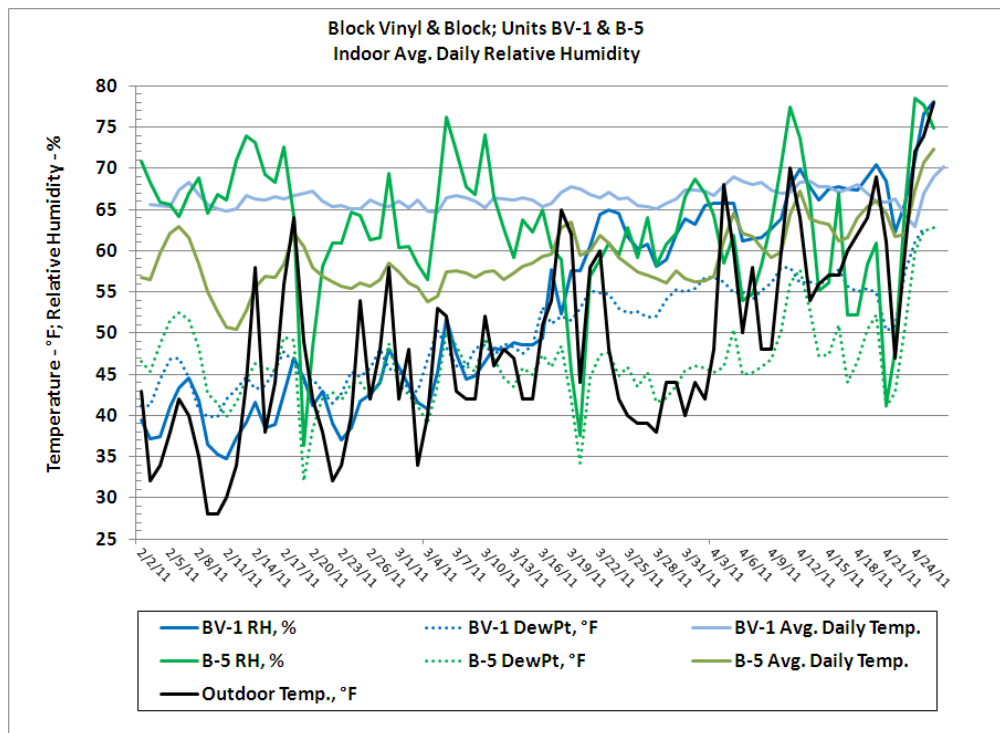
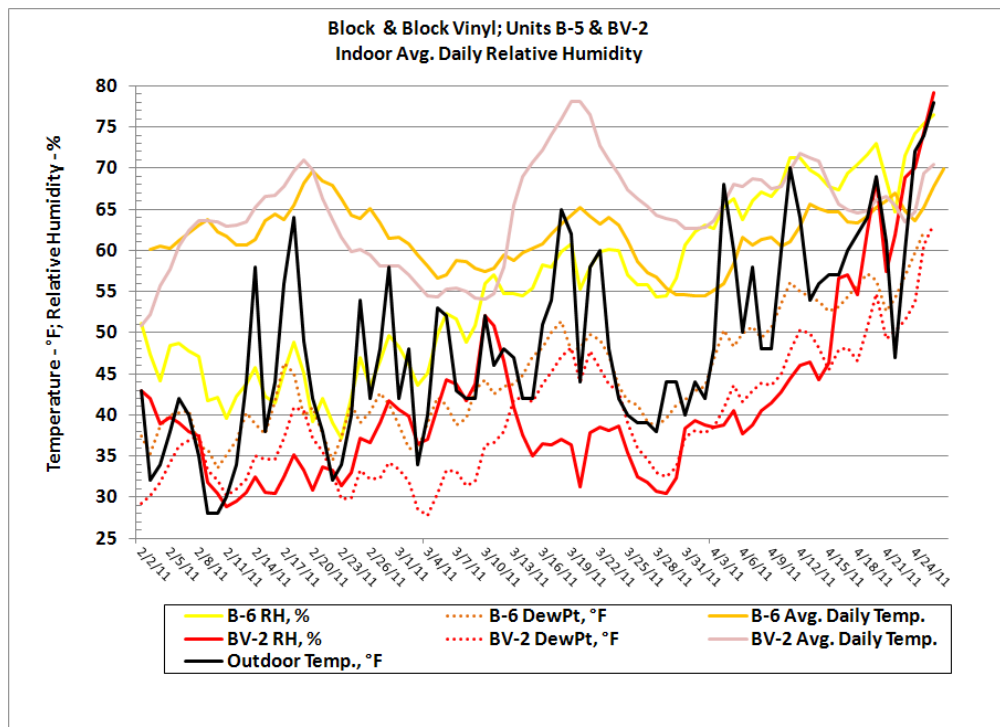
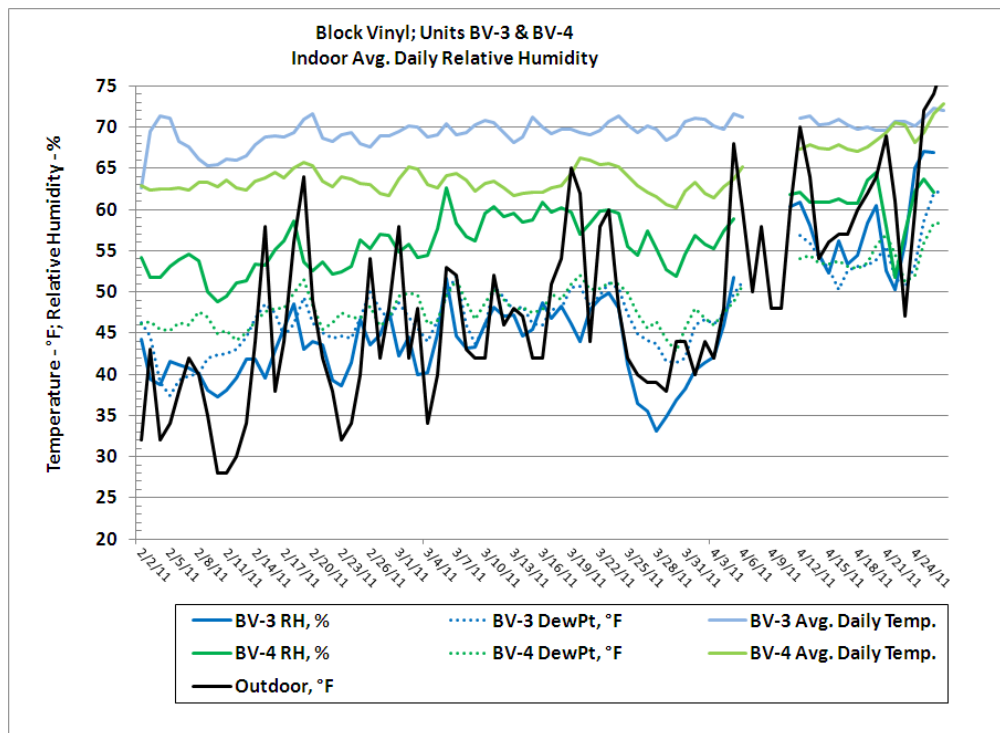
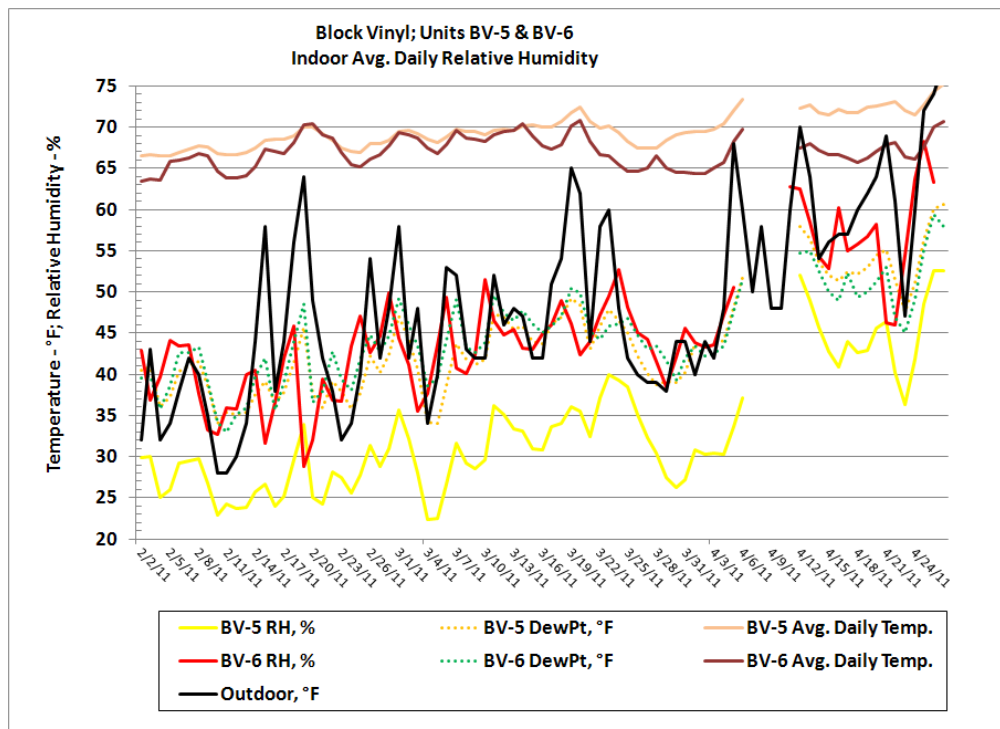
**Figure 28. Indoor relative humidity B-3 and B-4.**

Figure 29. Indoor relative humidity BV-1 and B-5.

Figure 30. Indoor relative humidity B-6 and BV-2.

Figure 31. Indoor relative humidity BV-3 and BV-4.

Figure 32. Indoor relative humidity BV-5 and BV-6.

Homes in the pilot study tended to show average indoor RH within the ASHRAE recommendation range, however, a majority of the units showed average household RH higher than the more recently recommended limit of 40%; 14 of 26 homes recorded in Table 11 showed average heat season RH above 40%. Two of the block houses had RH levels over 60% (B-3 and B-5) for some duration of the heat season. Both of these units indicate significantly cooler indoor average temperatures than the pilot group of homes—62°F and 64°F. The GHI Report 1, Phase 1<sup>11</sup> proposed exhaust fans with timers as a method of diluting the humid indoor air by exhaust ventilation. (RH sensors in units B-1 and B-2 were not available for this measurement period.) Figure 28 through Figure 38 show the available RH data for each home.
