# Greenbelt Homes Pilot Energy Efficiency Program Phase 1 Summary: Existing Conditions and Baseline Energy Use

J. Wiehagen, M. Del Bianco, and A. Wood  
*NAHB Research Center*

February 2013

On behalf of the U.S. Department of Energy's Building America Program

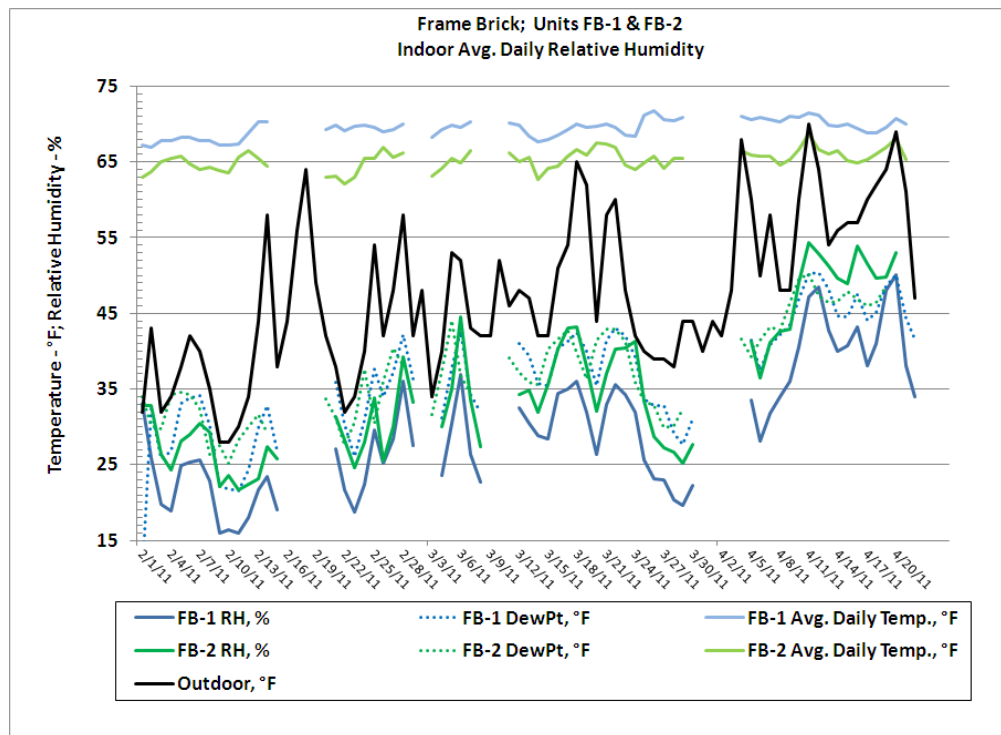
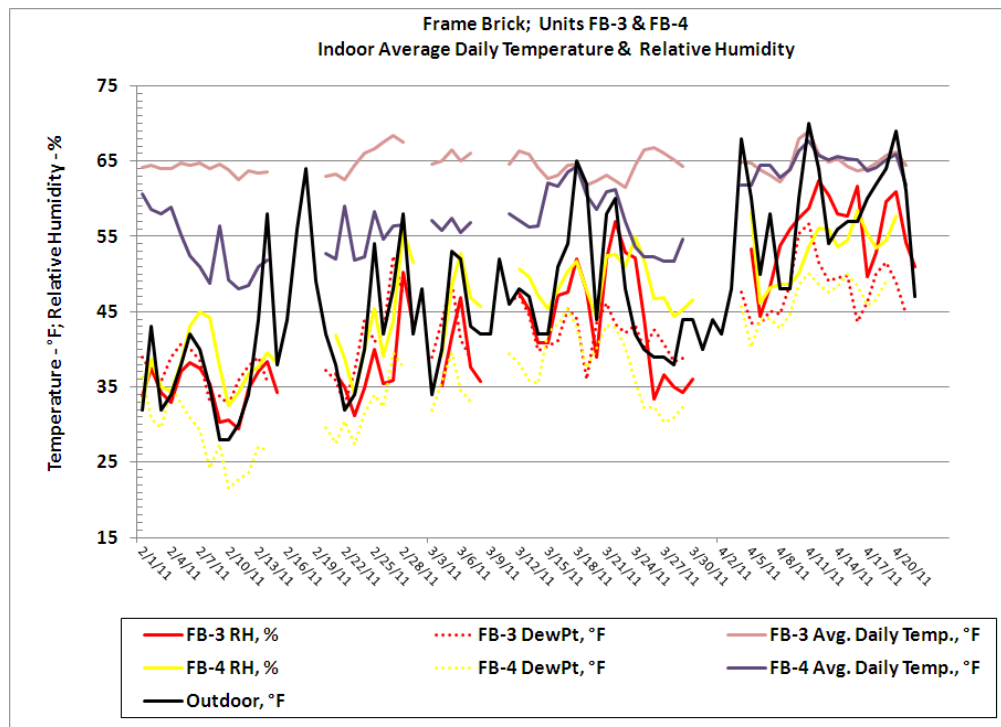
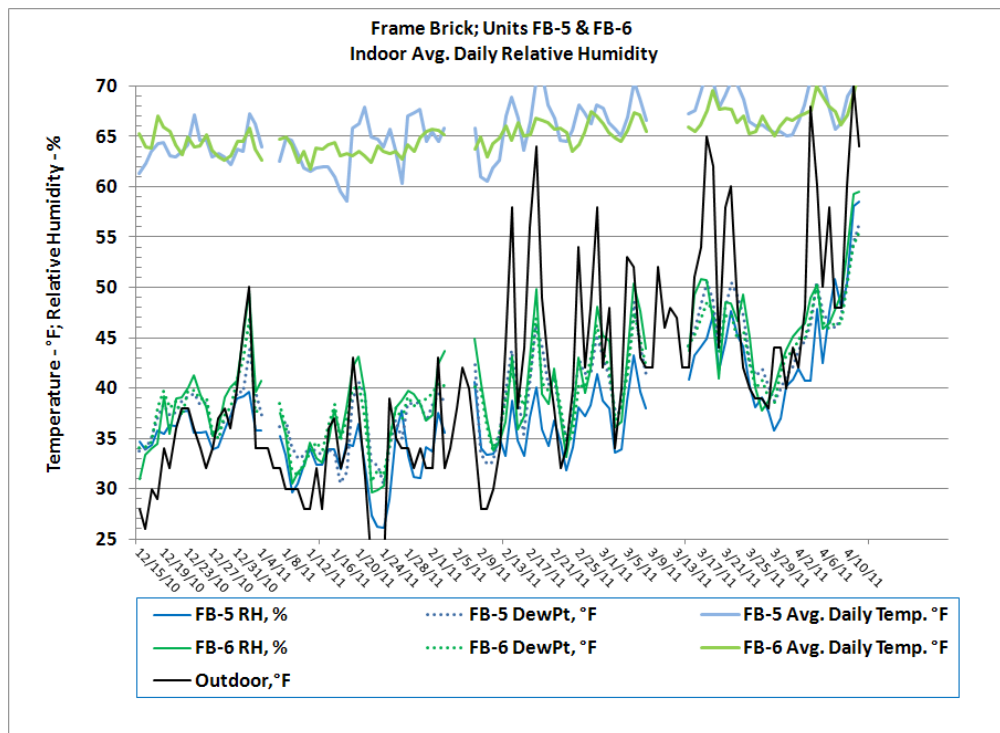
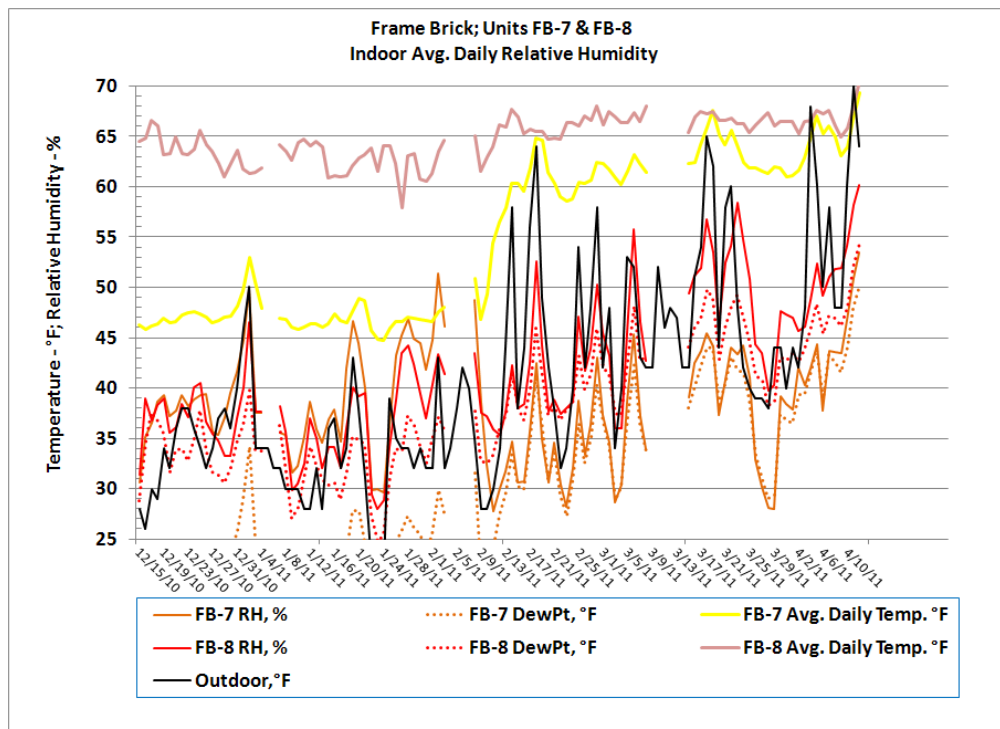
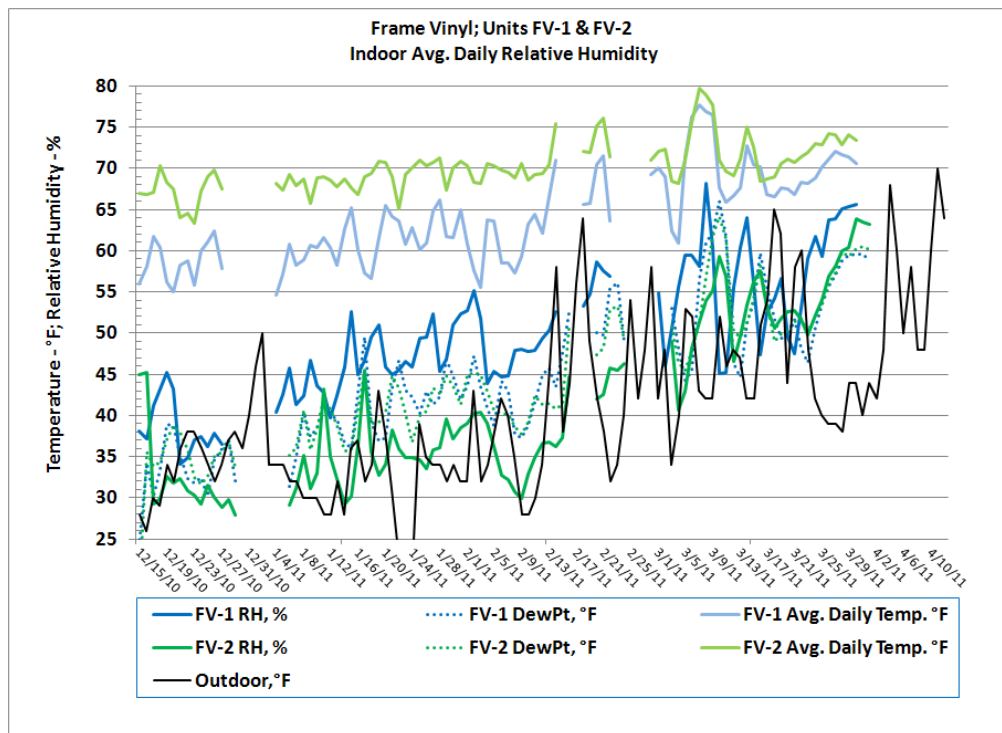
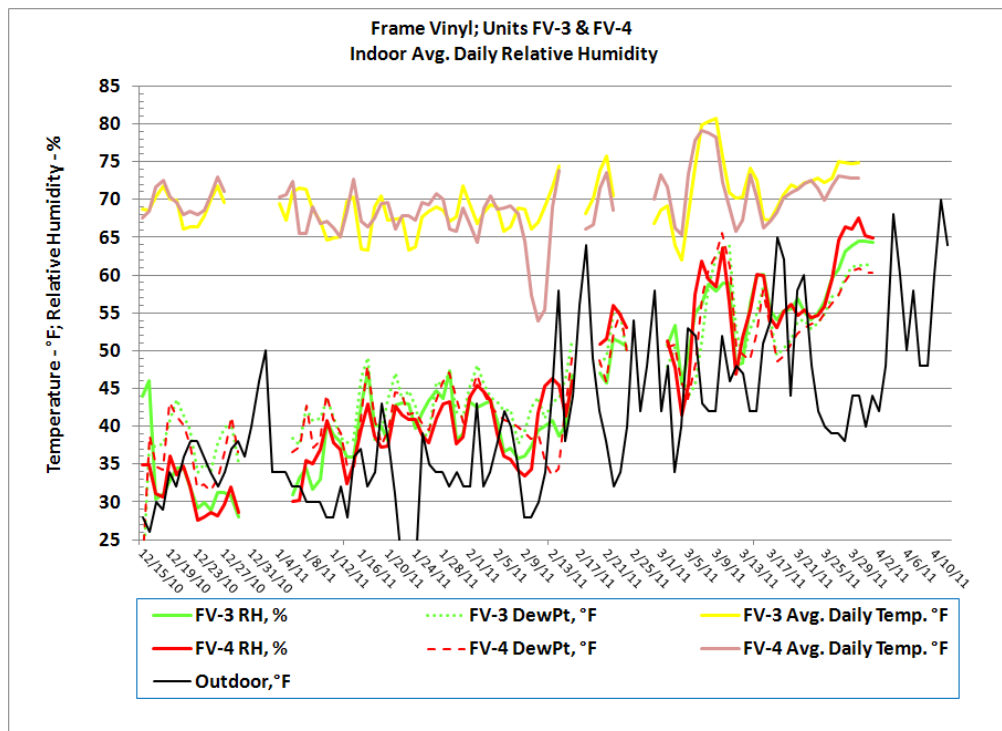
Figure 33. Indoor relative humidity FB-1 and FB-2.

Figure 34. Indoor relative humidity FB-3 and FB-4.

**Figure 35. Indoor relative humidity FB-5 and FB-6.**

**Figure 36. Indoor relative humidity FB-7 and FB-8.**

Figure 37. Indoor relative humidity FV-1 and FV-2.

Figure 38. Indoor relative humidity FV-3 and FV-4.

The indoor RH of the wood frame brick and wood frame vinyl buildings for the heating period are detailed in Figure 33 through Figure 38.

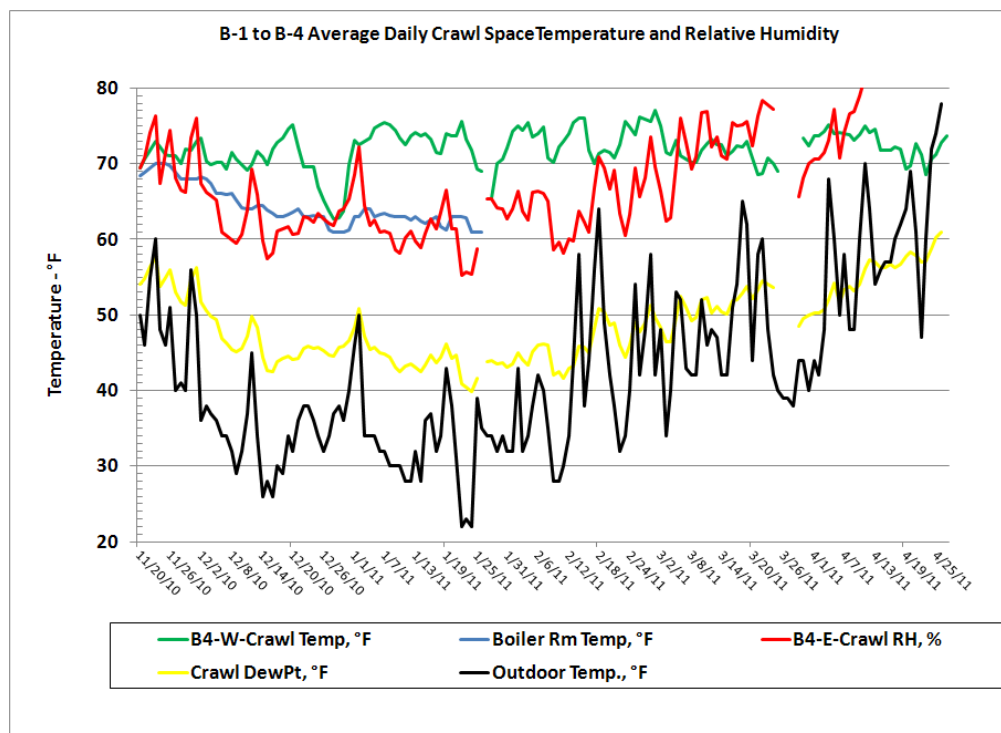
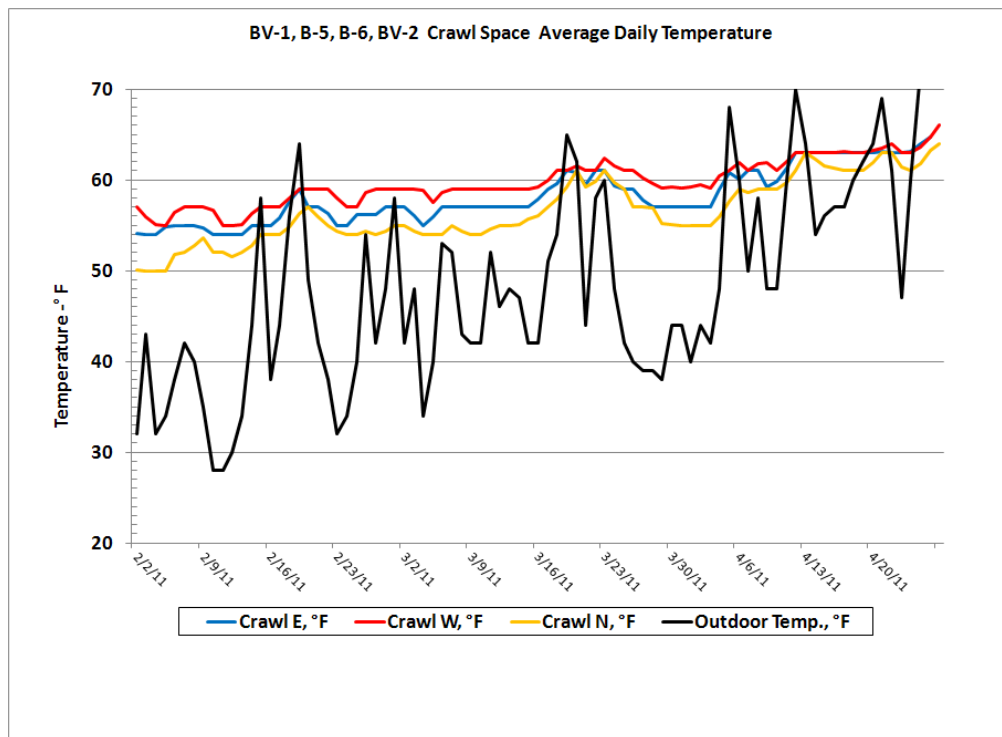
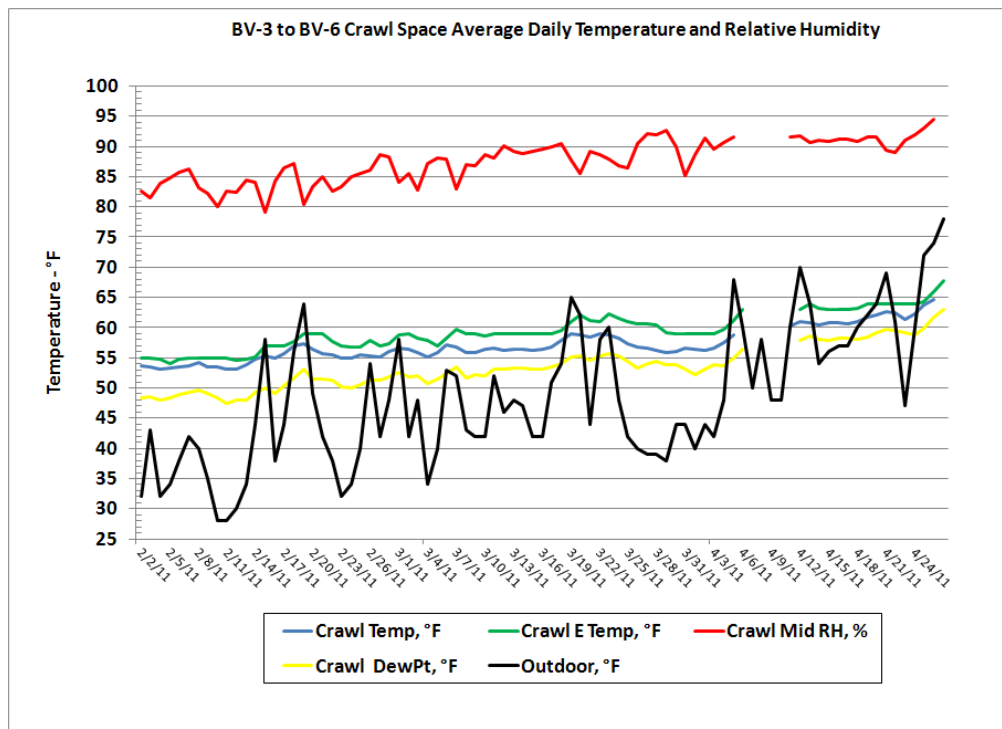
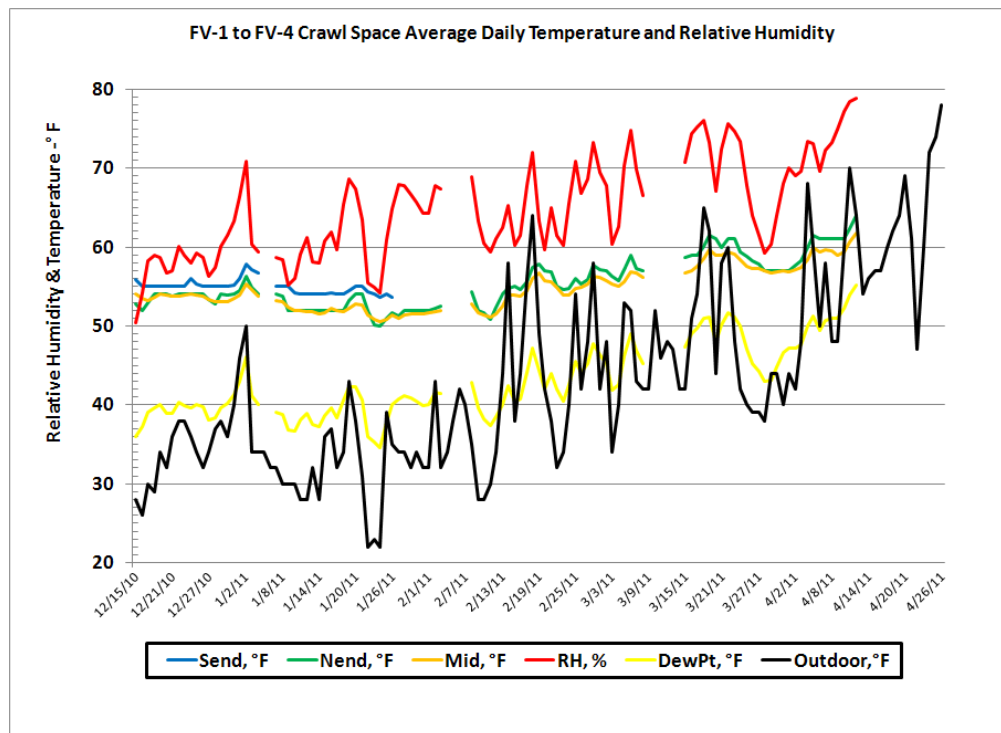
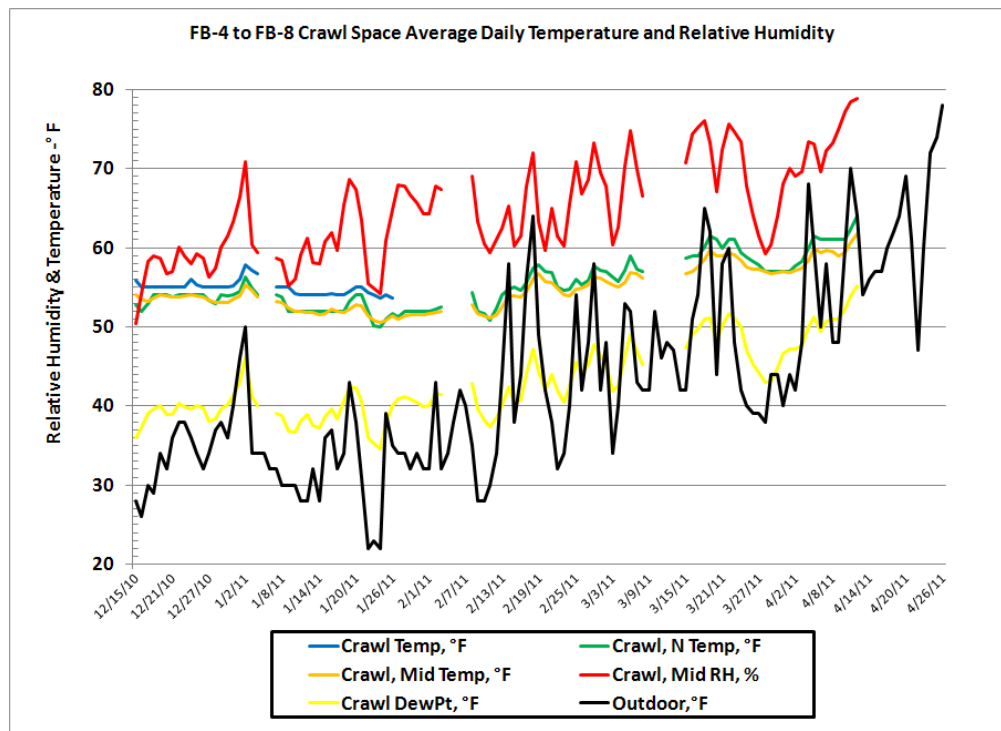
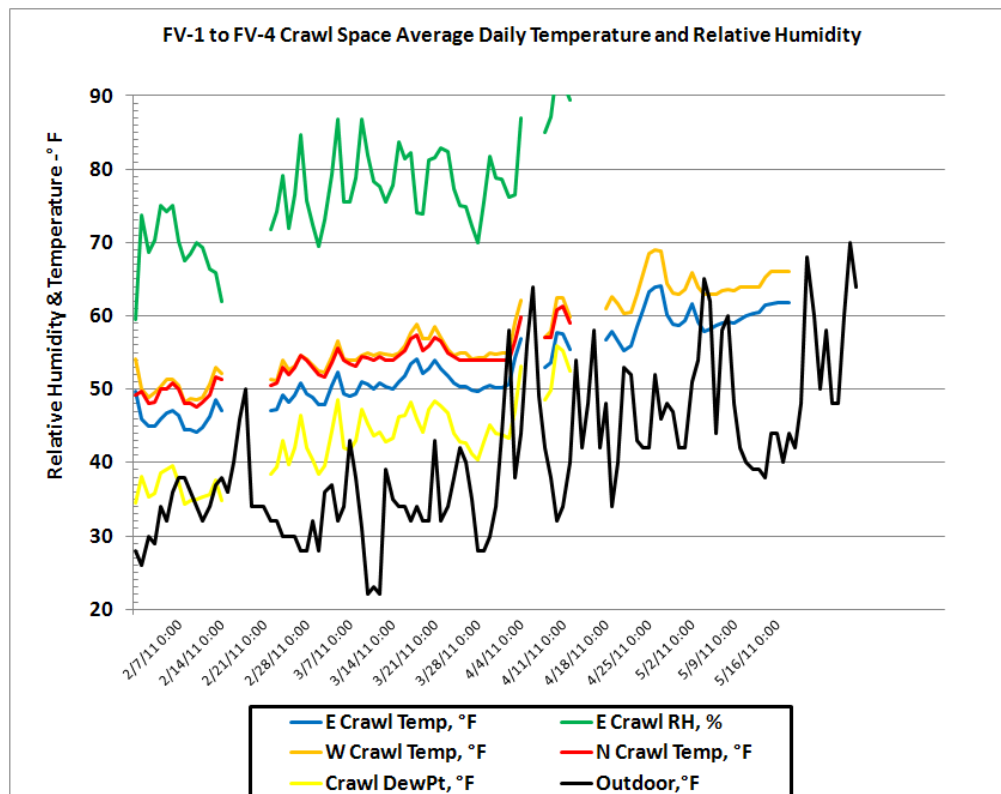
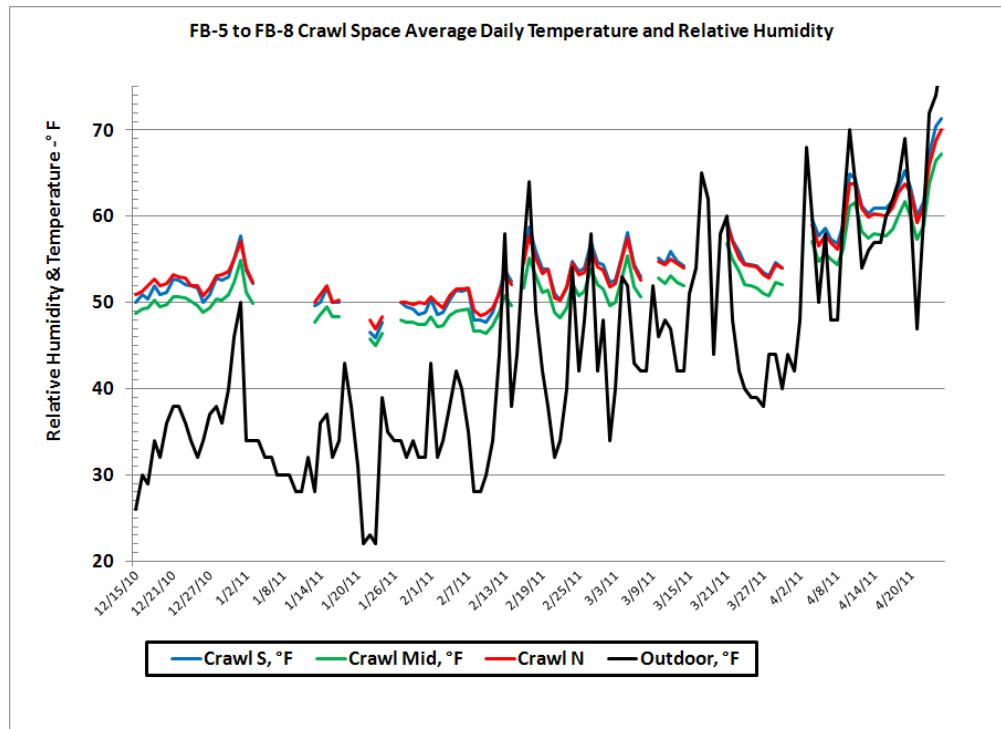
**Figure 39. Crawlspace relative humidity; Units B-1 through B-4.**

**Figure 40. Crawlspace temperature; BV-1, B-5, B-6 and BV-2.**

**Figure 41. Crawlspace temperature and relative humidity BV-3 through BV-6s.**

**Figure 42. Crawlspace temperature and relative humidity FB-1 through FB-4.**

**Figure 43. Crawlspace temperature and relative humidity FB-5 through FB-8.**

**Figure 44. Crawlspace temperature and relative humidity FV-1 through FV-4.**

**Figure 45. Crawlspace temperature and relative humidity FV-5 through FV-8.**

The data indicates that the dew point in the crawlspaces remains below the temperature in the crawlspaces, generally resulting in little condensation potential on surfaces. One group of block building, units BV-1 through BV-2, did not report the RH due to a sensor malfunction. Average daily temperatures for the crawlspace are reported.
