## **FINAL REPORT**

**Project Title:** Development of Advanced Manufacturing Technologies for Low Cost Hydrogen Storage Vessels

**Recipient:** Quantum Fuel Systems Technologies Worldwide, Inc.

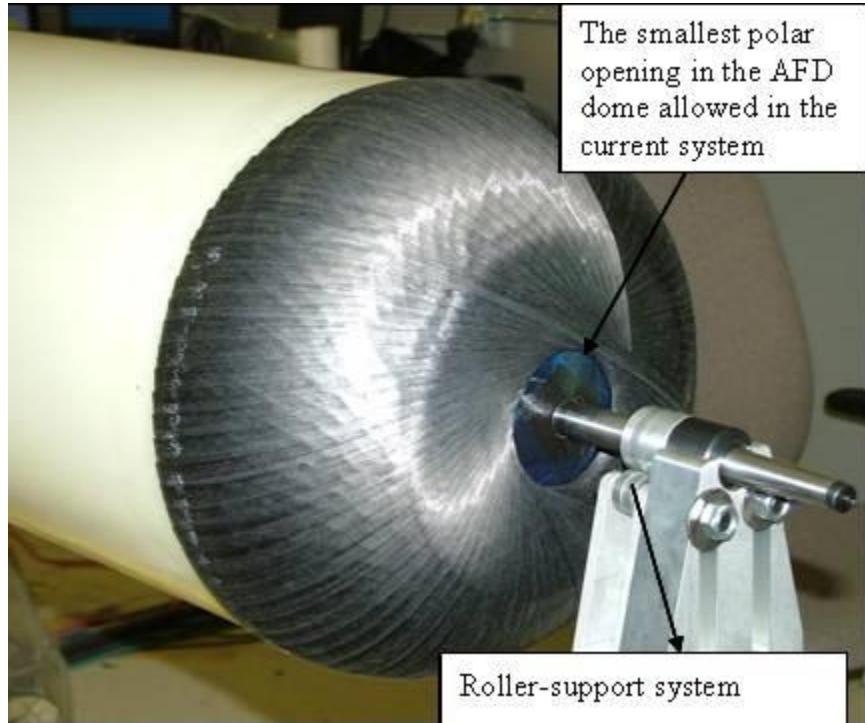
**Figure 5. Finished aft dome**

The placement process is shown in Figure 5 to Figure 7 below. When the robot is laying down the material on the dome, a slight amount of heat is required to generate the right tackiness and soften the material to conform it to the curvature. The heat is generated from a heat gun. A little practice is required since too much heat pre-cures the material and produces possible delamination. The temperature on the dome surface is checked from time to time through an infrared (IR) detector to make sure it is well below the material cure temperature. As shown in Figure 5, the aft dome of the liner assembly is mounted on the so-called "Roller-support System", instead of being mounted on the rotation chuck, in order to increase the clearance between the robot head and supporting system, and decrease the polar opening as much as possible, since it is inferred from design that the smaller the polar opening the more material can be saved. The finished forward dome is shown in Figure 6. Since the forward dome is different from the aft dome, the composite design, mounting system and process development for both domes are different and have to be done separately, resulting in different final appearance. Figure 7 shows the material compaction force is from the rubber roller, approximately 80 psi. To

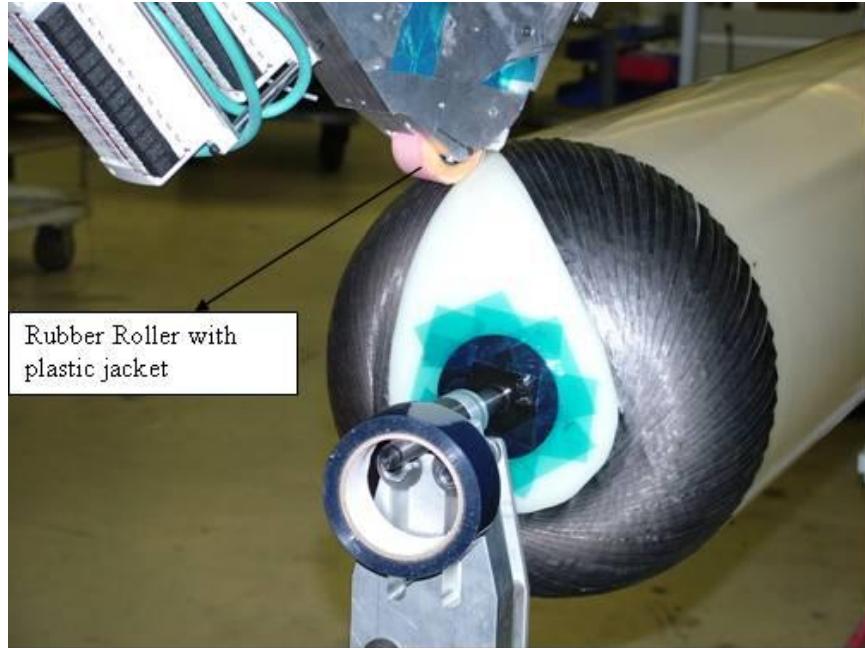
**Figure 7. Material compaction from the rubber roller**

counter the compaction force of the rubber roller, about 5 psi of air pressure is inside the liner to make the liner surface sufficiently rigid.

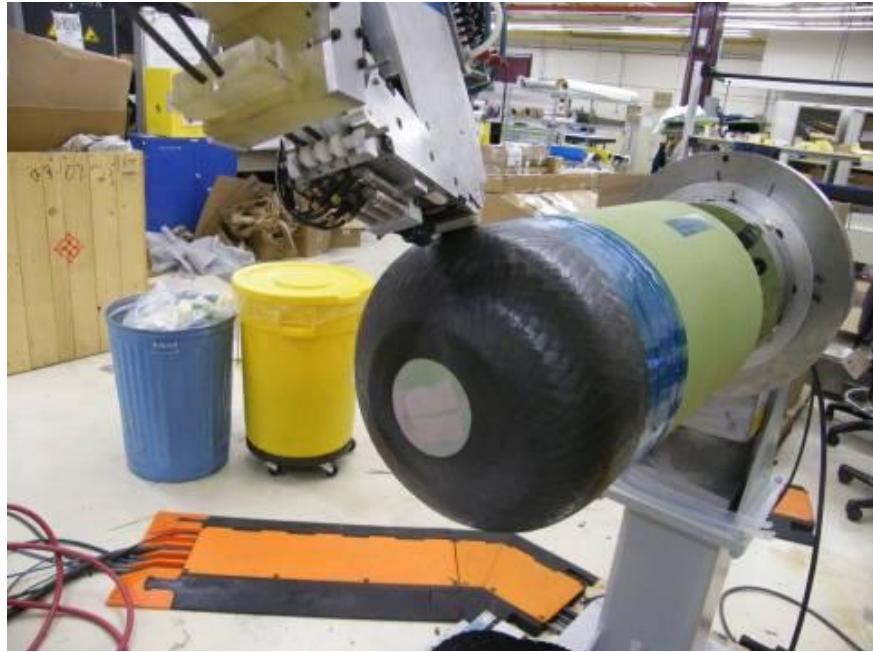
**Figure 8. Semi-rigid foam tooling**

The forward and aft end caps were manufactured at Boeing using the semi rigid tooling as shown in Figure 8, and the end caps were then removed from the tooling and shipped to Quantum. To maintain the shape of the parts during shipment, the parts were packed in dry ice to increase the stiffness. Quantum placed the AFP end caps on the vessel and overwrapped with the first layers of FW material. An initial low temperature cure was conducted prior to shipping the partial wound vessel back to Boeing to ensure the FW layers would not be damaged during shipment. Upon arrival at Boeing, the second layer of AFP fibers were put on top of the FW layers. The vessel was then returned to Quantum for the final layers of FW over the previous layers.

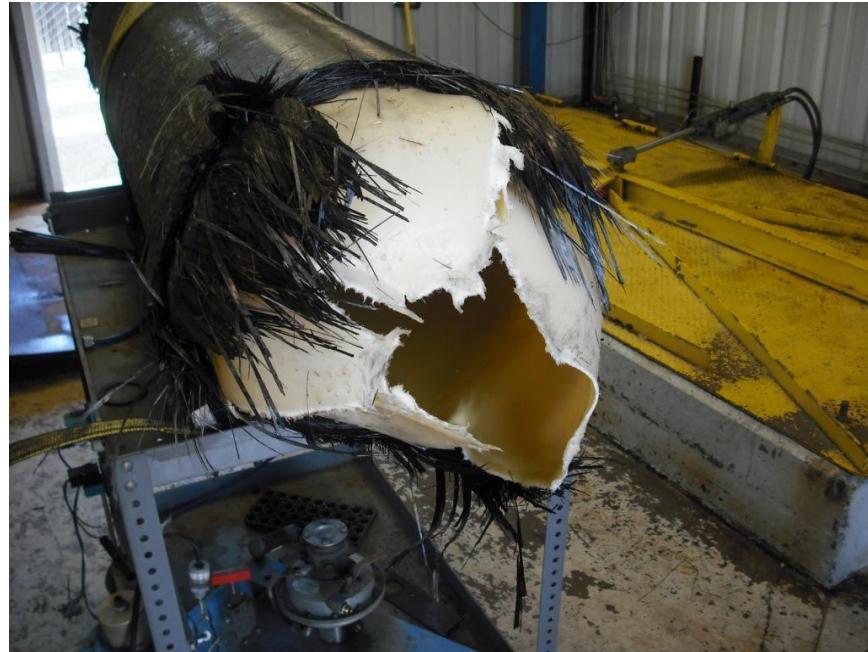
**Figure 9. Vessel failure on the aft end**

Upon completion of the vessel with FW, it was burst tested and achieved a burst pressure of 20,500 psi (141.3 MPa) or 90% of the minimum requirement, which was lower than that of Vessel 4 but had a fiber reduction of 10.6 kg or 16.3% lower than Vessel 4. The burst location was at the aft end blind boss (see Figure 9), which was different from the previous failure modes.

With failure at the blind boss, the vessel was propelled like a rocket during the burst test, destroying both ends of the vessel and losing its usage for any analysis work.

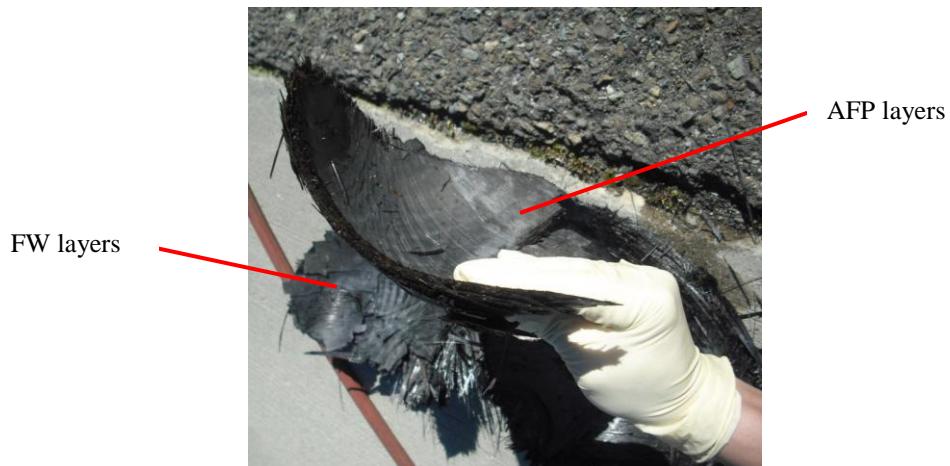
**Figure 10. Composites from the aft end showing dryness between FW and AFP layers**

The composite pieces from the aft end revealed that the surfaces of the AFP layers detached from the FW layers were rather dry (see Figure 10), which is a sign of insufficient resin between the two layers. Prior to FW, the AFP end caps were not wetted out. The amount of resin on the end caps was depended on FW only, which could have contributed to this shear failure.

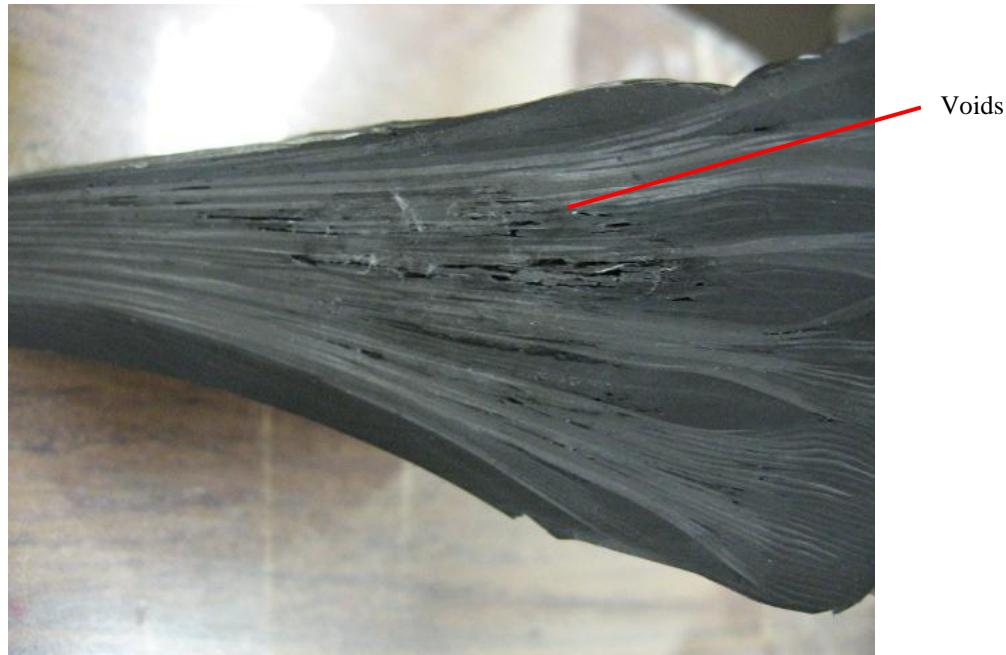
**Figure 11. Voids shown in the sectioned aft dome**

After polishing up half of the domes at Quantum, excessive voids were found in the aft end due to fiber bridging, as shown in Figure 11. The bridging was caused by incorrect assumption of the “necking factor” value used in the design input file. Necking factor is defined as the ratio of fiber width at the turn around next to the boss vs. bandwidth in the cylinder section.

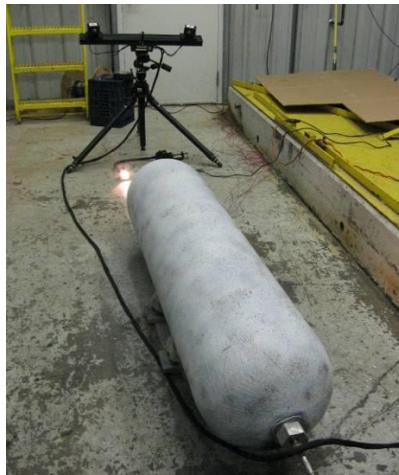
**Figure 12. ARAMIS measures the displacement of dots on vessels and evaluates the strains**

Prior to conducting burst test on Vessel 7, eight strain gages were attached on the aft end of the vessel to measure the strains vs. pressure between 0 psi and 1.5X service pressure (15,000 psi). In addition, Boeing has offered to measure vessel strain optically with digital image correlations – ARAMIS®. It essentially measured strains of the entire vessel by optically measuring displacement of the exterior surface. The vessel first had to be painted white to cover up the natural black color of carbon fiber. Then black dots were sprayed on top of the white paint. ARAMIS measures the displacement of these black dots to evaluate the strains, as shown in Figure 12. The vessel was pressurized 14 times between 0 to 15,000 psi to take pictures of all vessel surfaces (8 on the cylinder section, and 6 on the domes). Images generated from the measurements are shown in Figure 13. In each case, the physical strain gages were used to compare with the values measured by ARAMIS and showed good correlations.

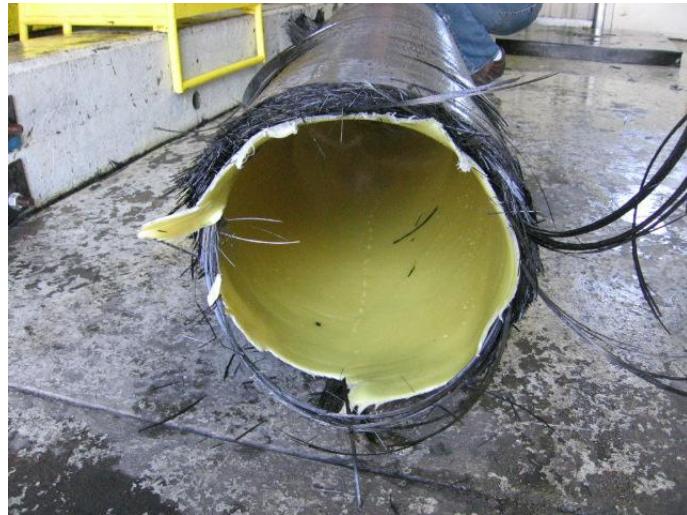
**Figure 15. The aft end cap failed at edge of AFP layers**

Vessel 9 was 760 psi (5.2 MPa) short of the burst requirement. This translates to achieving 97% of the minimum requirement. Figure 15 shows the failure location was at the tangent between the cylinder section and aft dome. Since the result was very close to the requirement and the vessel was wound over two days (due to winding pattern development time), it was determined to build Vessel 10 in one day with design identical to Vessel 9.

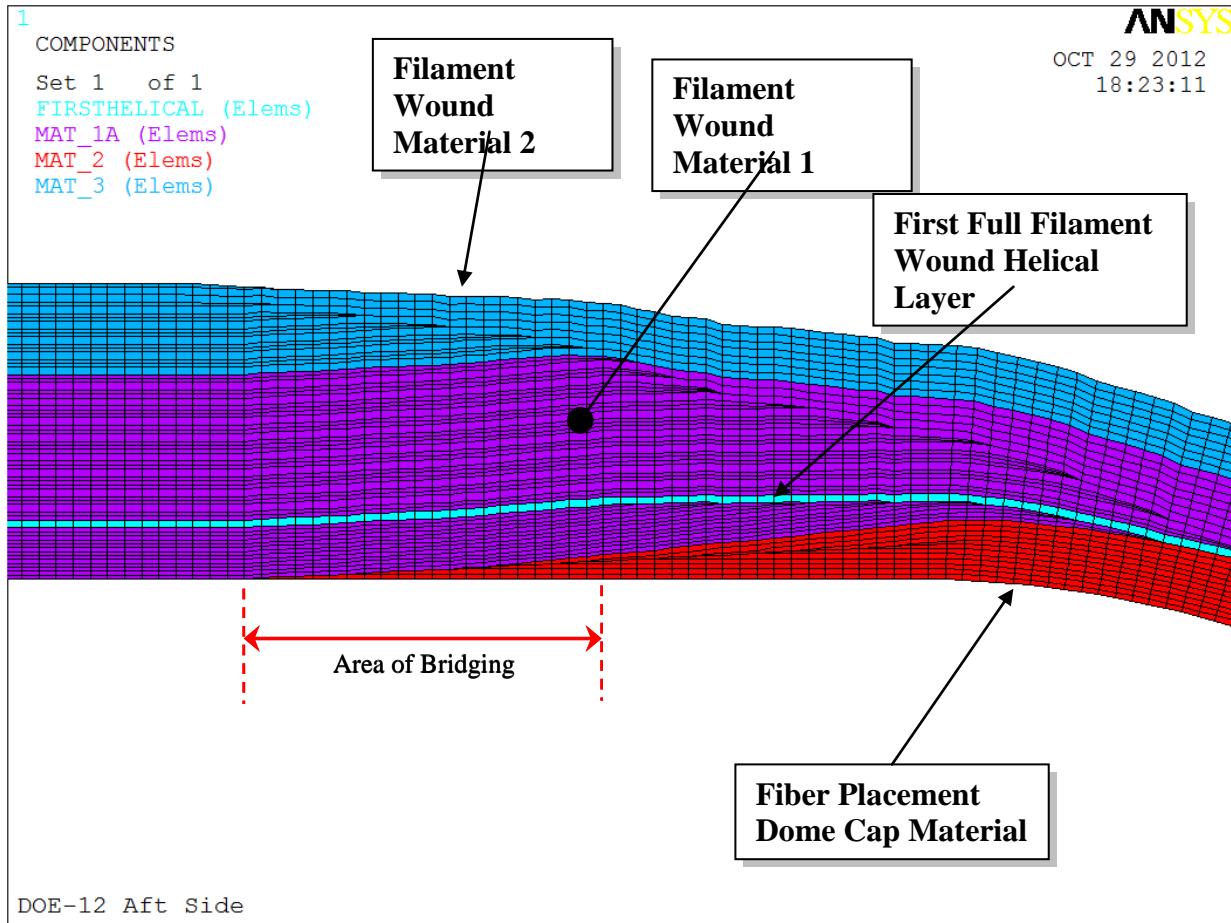
**Figure 17. Vessel 12 finite element model for aft end near tangent location using mWind**

The analysis results of Vessel 12 using mWind showed the fiber strains near the tangent line were low and the maximum fiber strain was in the first hoop layer near the mid section of the cylinder. Figure 16 shows the fiber strain results of Vessel 12 for the aft end.

During winding of Vessel 12, bridging was observed in the mid cylinder for the first full helical layer. A review of the finite element model showed that the first hoop layers did not fill the cylinder section enough to match the end cap maximum height in the cylinder section. Figure 17 shows the finite element model near the tangent line. This bridging likely caused Vessel 12 to not meet the required burst strength.

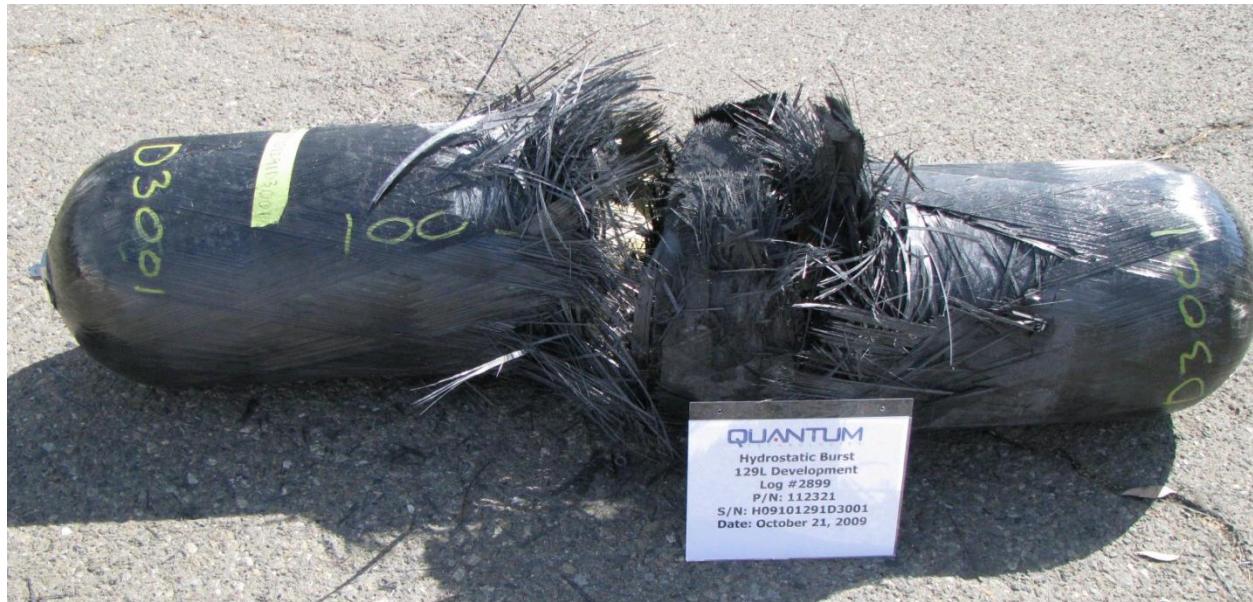
Figure 18. Vessel 1 shown after burst test

An in-depth review of past designs was completed to assess any trends or commonality between each design. The one common result was that all fabricated pressure vessels that were burst tested failed in the aft dome at the cylinder to dome tangent line (at a minimum) except Vessel 1. Vessel 1’s burst location was in mid cylinder with the helical fibers failing first, then the vessel split into two sections. Figure 18 shows a photo of Vessel 1 after the burst test.

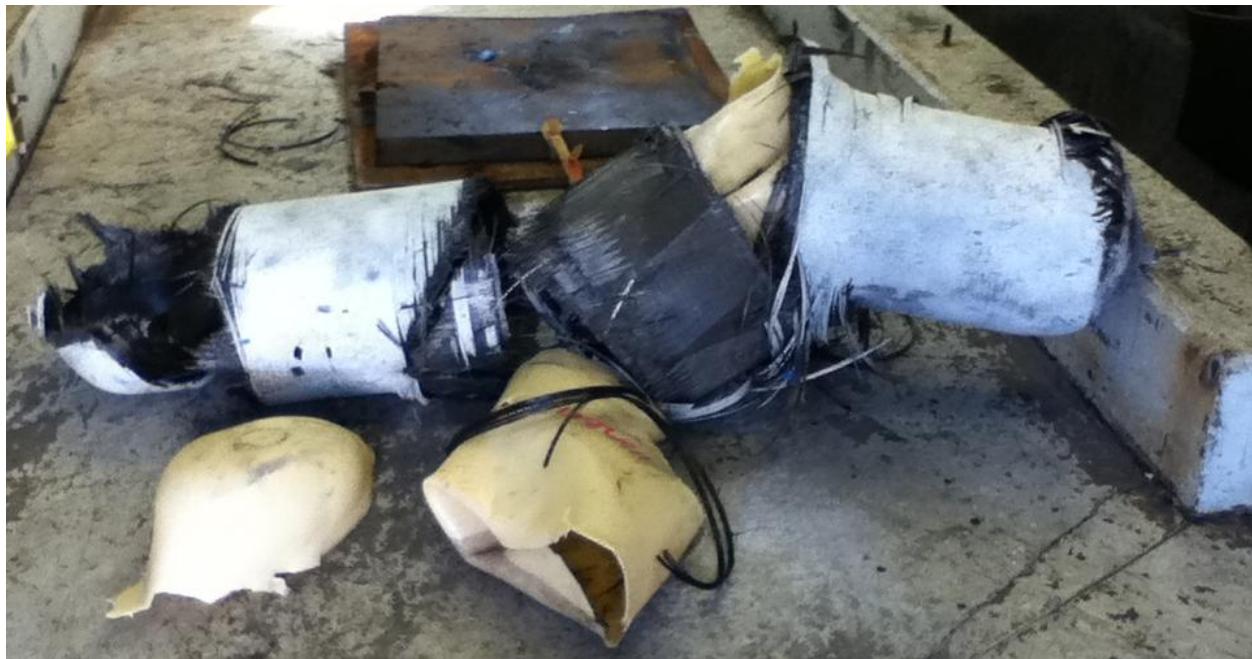
**Figure 22. Vessel7 after burst test**

The results of KWind and mWind versions of Vessel 7 design show that the vessel would have different burst modes. KWInd predicts a cylinder failure, while mWind predicts an aft dome failure. The burst test conducted on Vessel 7 shows a mid cylinder burst and an aft dome burst at the tangent line. At the time of testing Vessel 7, it was thought the aft dome damage was caused by the mid cylinder burst. Figure 22 and Figure 23 show photos of the burst test on Vessel 7. These pictures revealed that the rupture could have occurred at both the mid cylinder section and at the tangent line of the aft dome, which is consistent with the results of both the KWInd and mWind models. However, mWind predicts a worse failure mode of the two. For design purposes, it is preferred to use a tool that predicts the worst case.

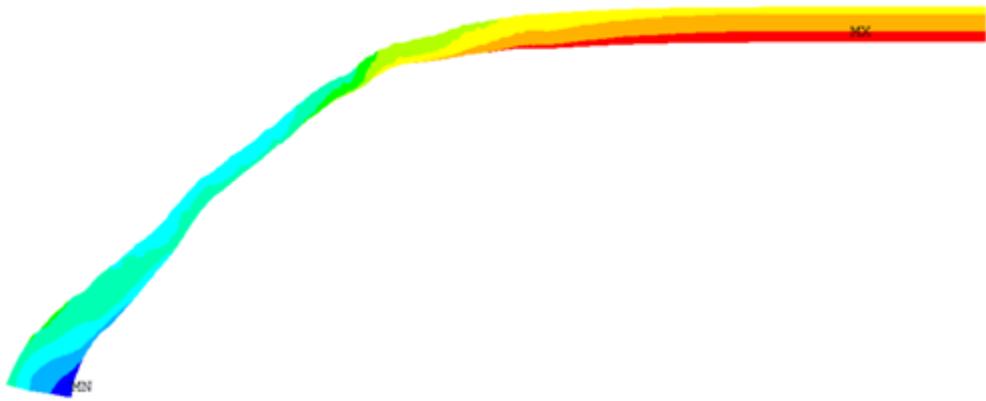
**Figure 27. Hoop strain contour plot of Vessel 13 forward end**

Figure 24 and Figure 26 show the fiber strain results for Vessel 13 aft and forward ends respectively. Figure 25 and Figure 27 show hoop contour plots of the finite element model results for the aft and forward ends, respectively. The displacements of the model are magnified by 20 times to assess if any excessive bending exists in the dome.

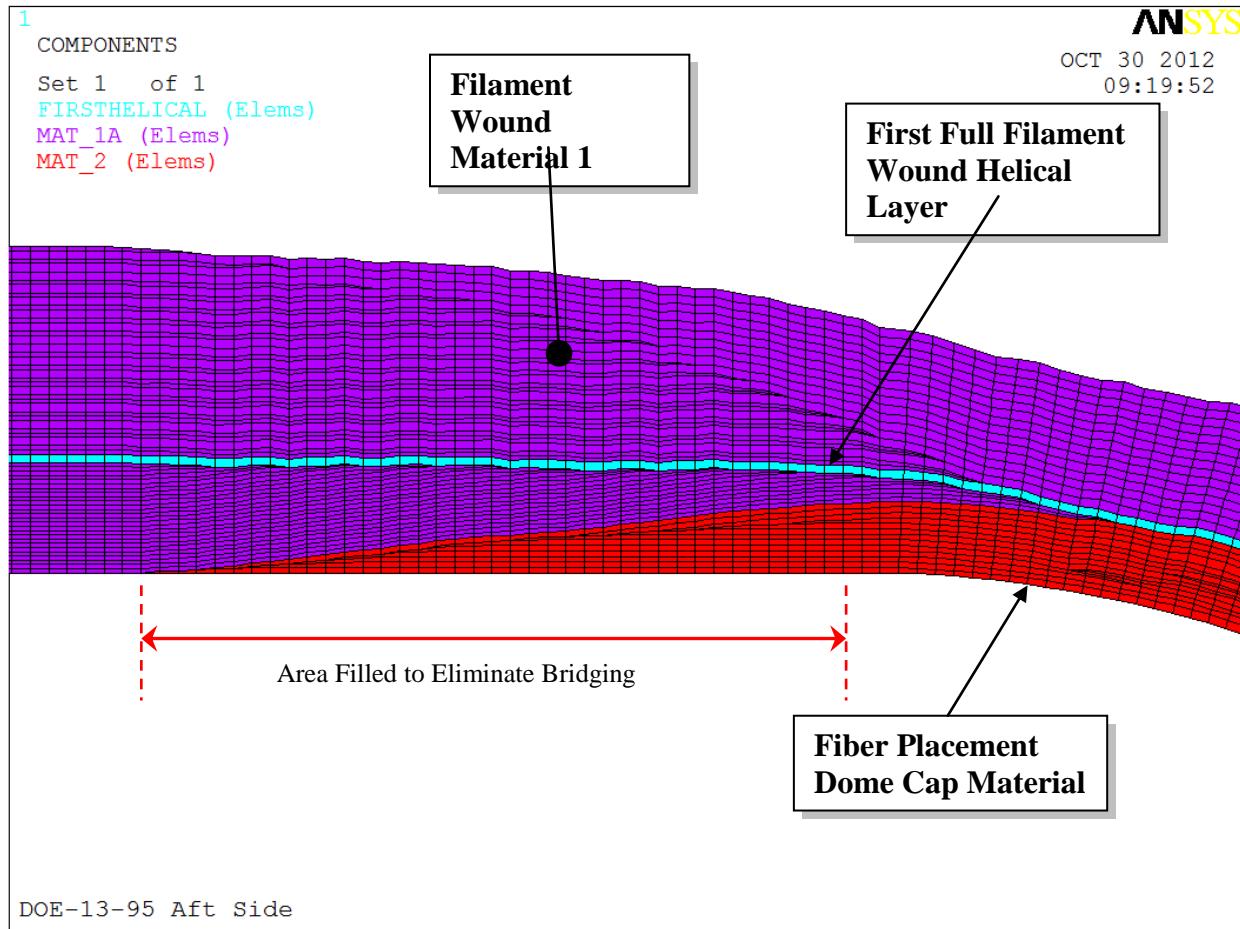
**Figure 28. Vessel 13 composite layup near tangent line**

Figure 28 reveals the composite build up near the tangent line from the model generated from mWind. This shows how extra hoops are used to fill the cylindrical section to the height of the AFP end cap material and should eliminate any bridging in the cylinder section.

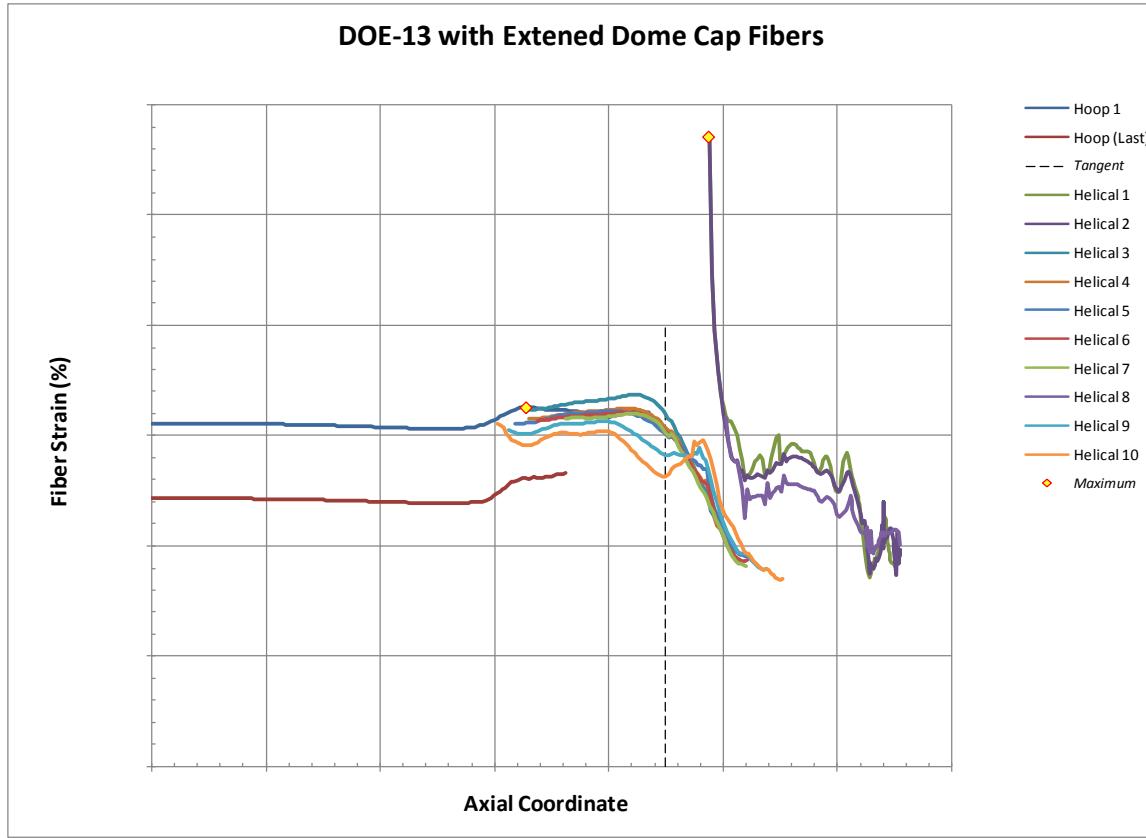
**Figure 31. Vessel 13 aft end fiber strains with extended end cap**

Discussions with Boeing revealed the tangent point defined by Boeing was 0.9" different from that of Quantum. Boeing defined the tangent point of each dome by measuring the liner with a CMM, while Quantum based the tangent point on geometry of the tooling used to make the liner. This places the tangent one inch outward from parting lines of the tooling. This "extended" configuration was analyzed on the aft end, and it showed the extra length on the dome cap would increase the fiber strains in the end caps by 90% at the termination of fiber on the cylinder side, which is shown in Figure 31.

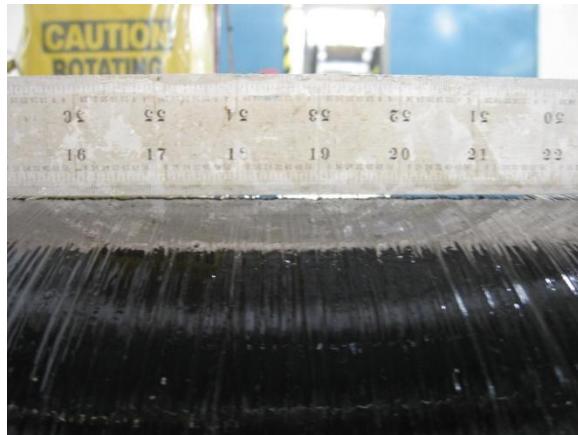
**Figure 33. Initial hoop layers with gap**

The vessel winding layup was adjusted during fabrication to avoid fiber bridging in the dome-cylinder transition area seen on Vessel 12. The original number of hoop layers per design of Vessel 13 that was laid down between the end caps did not provide sufficient material to match the thickness of the end caps at the tangent points. **Figure 33** shows a photo of a straight edge and the gap that existed in the cylinder section of the vessel. The winding layup was adjusted to relocate some hoop layers from the outer layers to the inner layers. Figure 34 shows the layup with the relocated hoop layers needed to fill the gap.

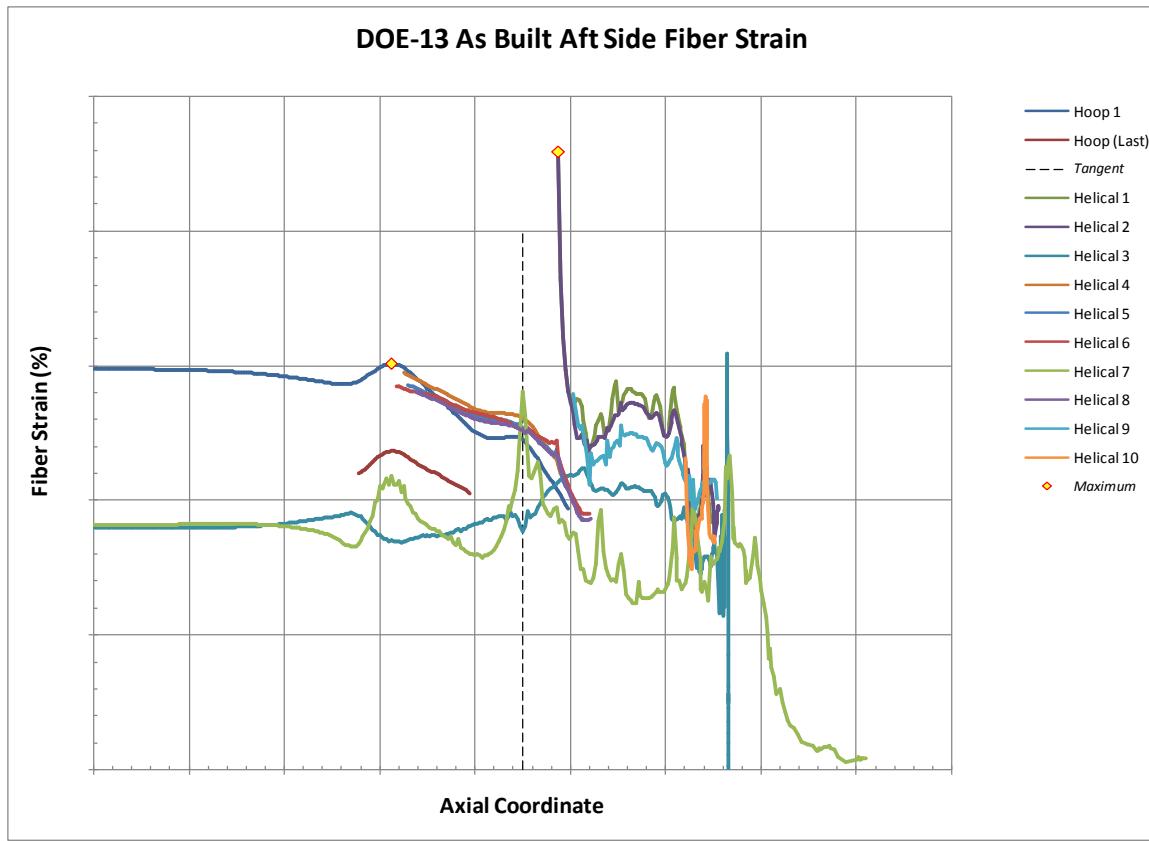
**Figure 35. Final and as built fiber strains of Vessel 13 aft end**

The final helical and reduced hoops on the outer layers were adjusted to provide the most desirable predicted fiber strains for Vessel 13. Figure 35 shows the as-built aft end fiber strains of Vessel 13.

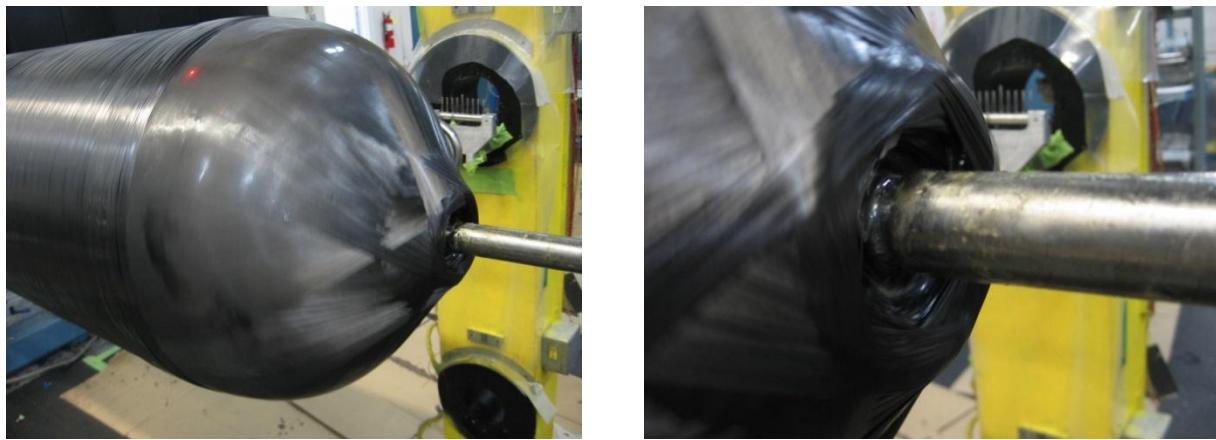
**Figure 36. Vessel 13 aft end composite buildup**

When Vessel 13 was completed with FW, the aft dome appeared to have a larger buildup at the aft polar boss than expected. Figure 36 shows two views of the composite buildup at the aft end. Bridging between layers was also observed in the aft end buildup during the winding operations. This type of buildup has been known to cause a reduction in burst strength in other vessels and was a concern for Vessel 13.

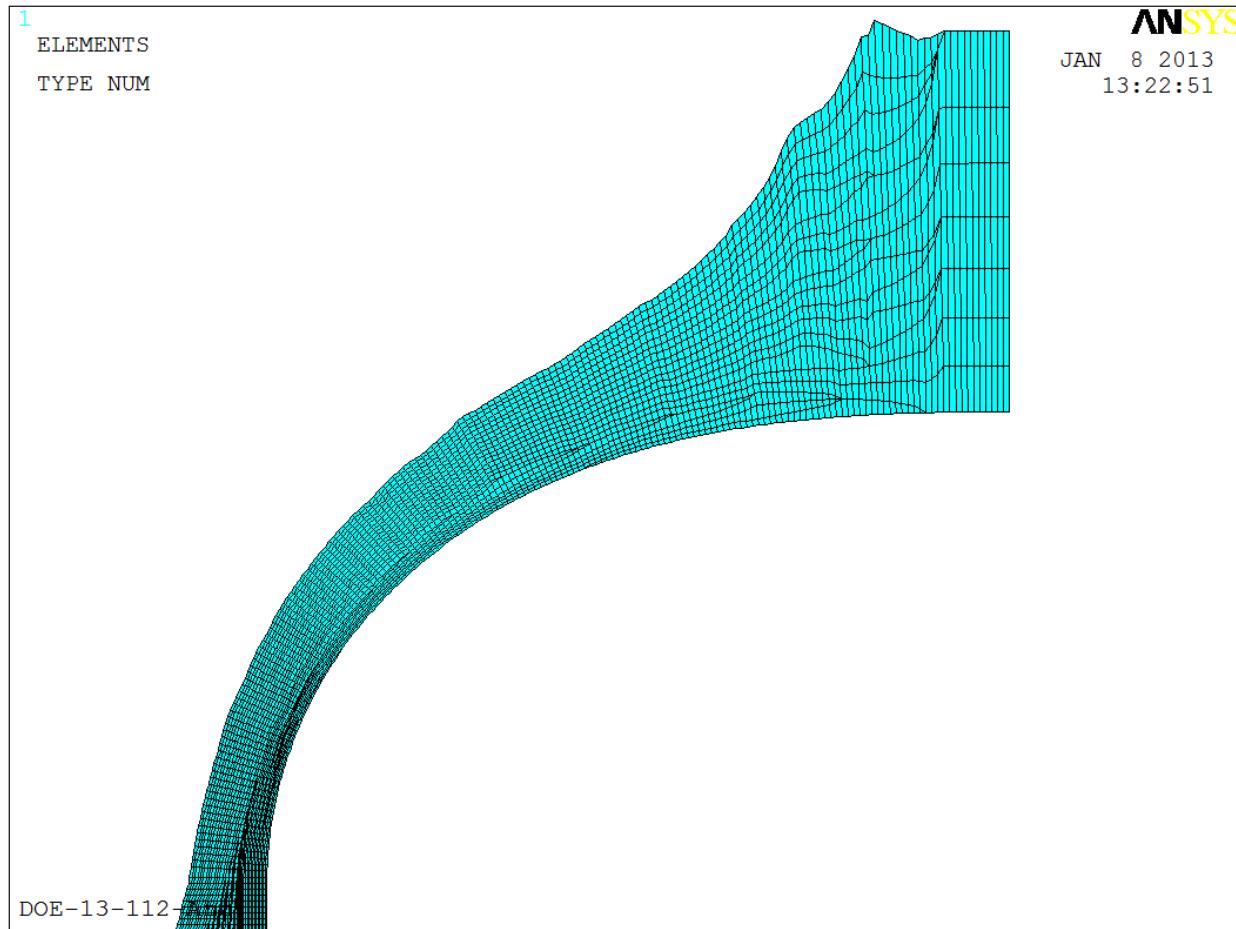
**Figure 38. Aft dome finite element model buildup of Vessel 13**

Figure 38 shows the final design layup for Vessel 13 in the same orientation as the CT scan image. The buildup near the aft polar boss is similar. Small adjustments to the buildup thickness will be made in mWind to better correlate the predicted and actual fiber buildup.

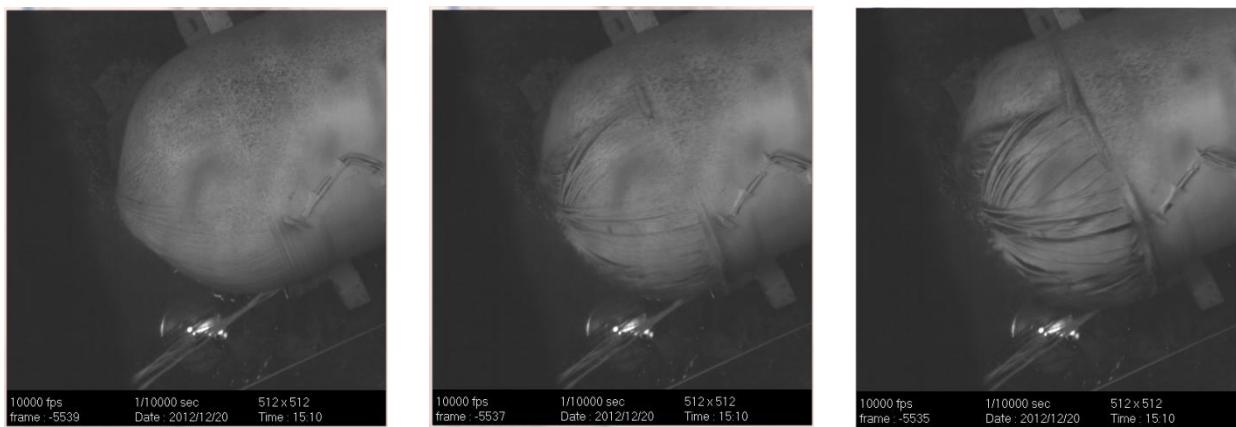
**Figure 39. Vessel 13 burst test high speed video frames**

High speed camera was utilized to capture the burst location of Vessel 13. This valuable information would help design the subsequent vessel if necessary. The vessel ruptured with an internal pressure of 20,679 psi (142.57 MPa), achieving 91% of the burst requirement. Rupture occurred in the aft dome polar boss. Figure 39 shows three frames of the burst test high speed video.

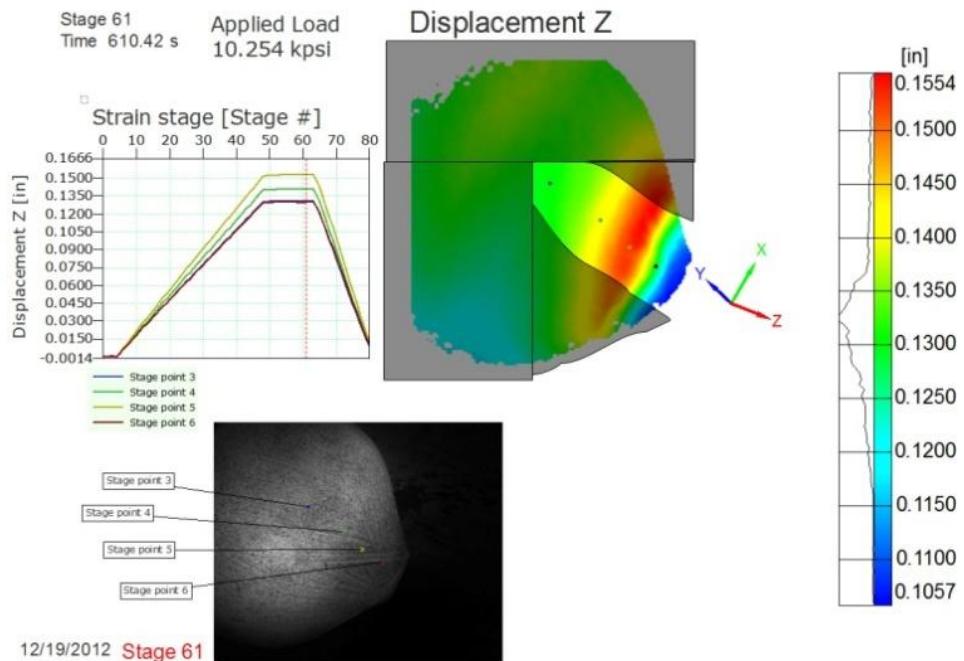
**Figure 43. Optical displacement measurement with ARAMIS on Vessel 13 aft dome by Boeing**

The displacements of four points on the aft dome surface (Figure 43) were measured and compared to the results of the FEA results of Vessel 13 with the correct dome end buildup. Figure 44 shows a plot of the measured axial displacements at the four points and the predicted axial displacements. These results show a good correlation between the displacements except at the aft boss area. Two factors may affect the measurements at the aft boss: 1) The voids affected the stiffness of the material in this area and caused a larger discrepancy between the measured and predicted values and 2) the dome curvature affected the visual view of the optical measurement tool and obscured the measurement.

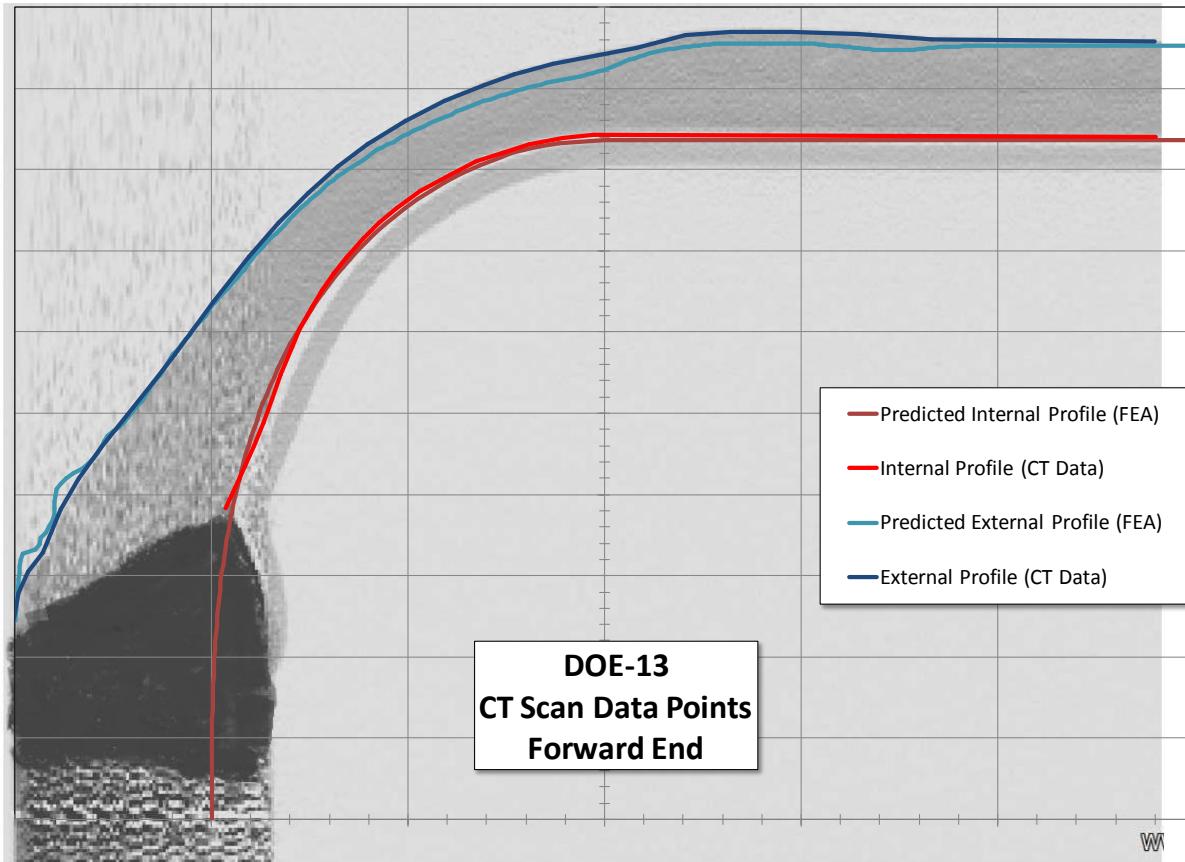
**Figure 48. CT scan of Vessel 13 forward dome with predicted and measured profiles**

The CT scan measurements on Vessel 13 were used to assess and adjust the predicted material buildup of mWind at the polar bosses. Figure 48 shows the CT scan of the forward dome with the measured and predicted profiles.

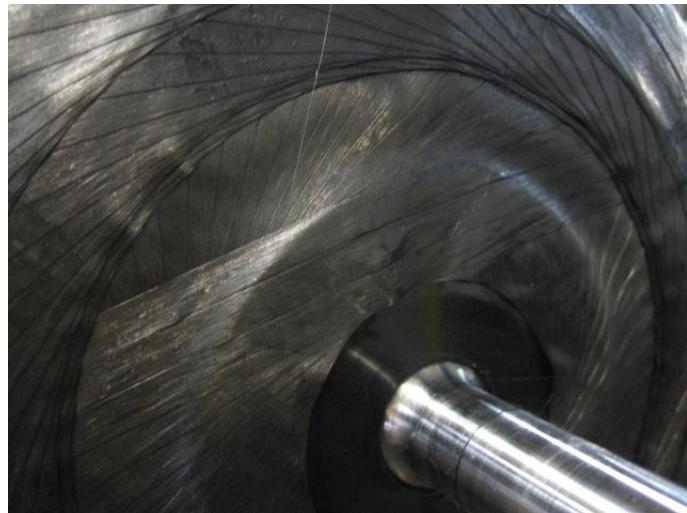
**Figure 56. Bridging was observed after a partial helical layer was applied to pull the end caps tight onto the liner**

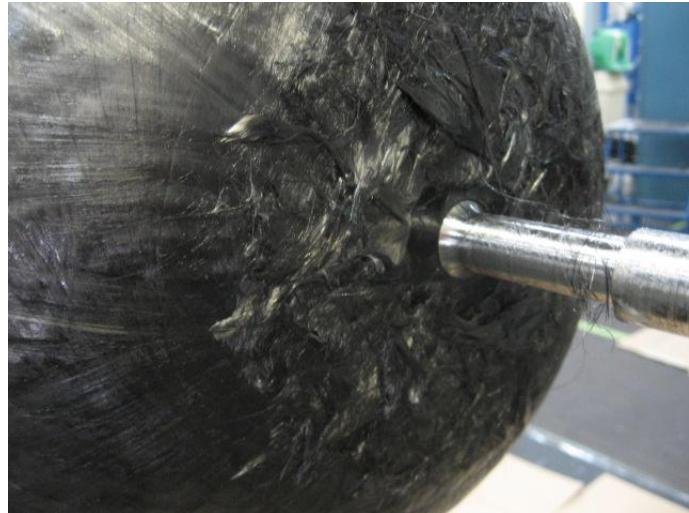
**Figure 57. Chopped fiber was used to fill the dip between two end cap layers**

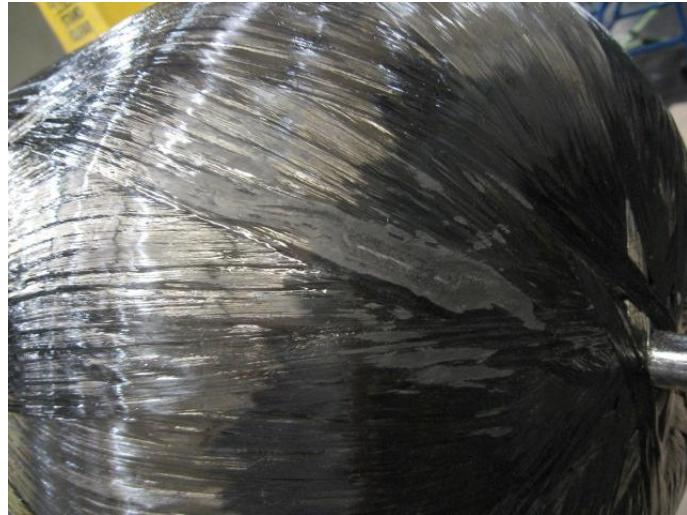
**Figure 58. Ridge formed on the filament winding layer was filed away to avoid bridging for subsequent fiber layers**

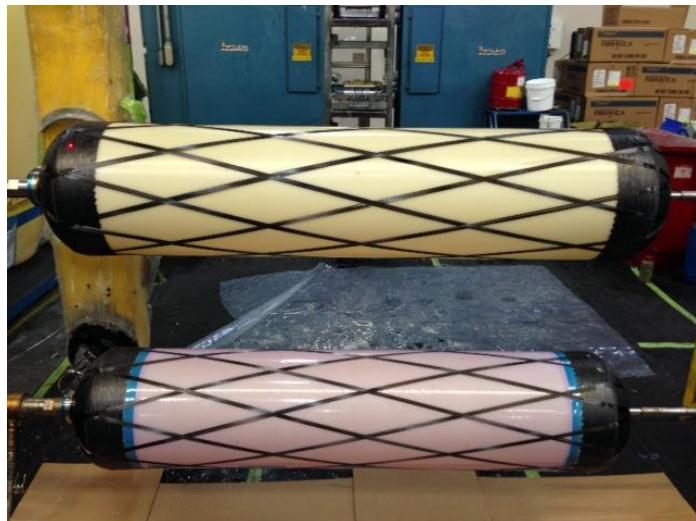
**Figure 60. Released film installed for the bottom vessel planned for cycle test**

As seen in Figure 60, the bottom vessel had the release film while the top vessel was a bare liner. With the convention to serialize vessels from the bottom up on the winding machine, Vessel 15 was sent to cycle test, and Vessel 16 was sent to burst test.

On Vessel 8 that was built for cycle test in 2011, a release film was missed to be installed between the liner and composite to prevent mechanical bonding from happening due to the higher curing temperature of the Boeing resin system. That particular vessel did not pass the minimum cycle count of 15,000 due to excessive strain at the bonded location. For complete description of applying this release film on the vessels for the latest tests, please refer to the Boeing section 4.3.9 below under “Lessons Learned during Placement of Released Film on Liner”.

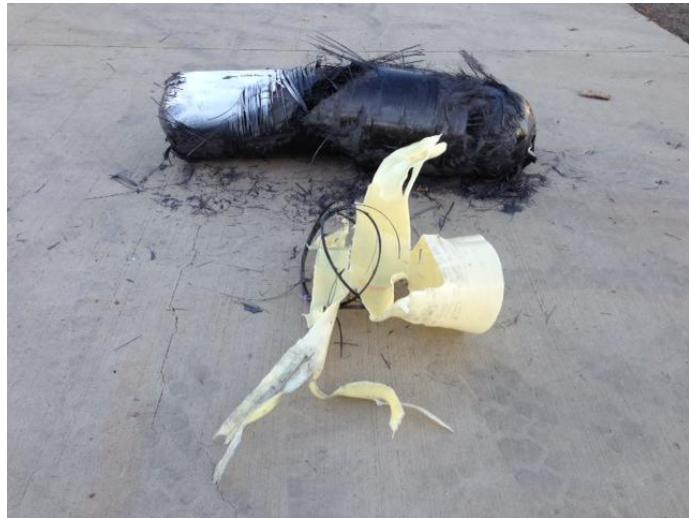
**Figure 61. Vessel 16 burst mode was mid cylinder per design**

A high speed camera was again utilized to capture the burst mode. Based on previous experience, the camera focused on the aft end in anticipation of a dome failure. The vessel achieved a burst pressure of 23,572 psi (162.5 MPa), exceeding the minimum burst requirement by more than 3%. The high speed video did not show the failure location on the aft end; the vessel simply traveled across the frame. Upon examining the vessel after burst test, it was determined that the burst location was mid cylinder, as shown in Figure 61. At the same time, the released film was discovered in the burst pit. The vessels had been serialized incorrectly and swapped as a result. The incorrectly serialized vessel weight was 62 kg, which translated to a 18.4% weight savings from the baseline vessel that weighted 76 kg. This vessel was 3.9 kg heavier than that of Vessel 7, which passed burst test previously. However, Vessel 7 only exceeded the minimum requirement by merely 0.4%. The vessel originally built for burst test was put in for the cycle test, hoping any bonding would not cause detrimental effects on the vessel during cycle testing.

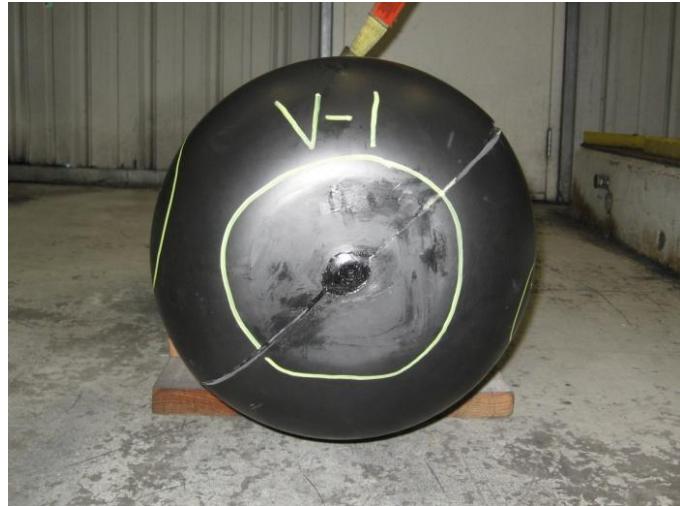
**Figure 64. The foam dome was cut to remove material to fit onto composite dome**

The foam domes and foam rings designed for the baseline (all FW) vessel were used on this particular vessel to prepare for the impact damage test. Since the hybrid design reduced the vessel diameter significantly, the foam domes had to be modified to fit onto the vessel. Foam dome material was removed to fit them over the smaller composite domes, as shown in Figure 64. In addition, the inside curvatures of the two halves had to be forced to conform to the composite dome profile. However, a perfect conformance was not possible due to the foam dome stiffness. Some air gaps were present as a result. In addition to the less-than-ideal foam domes, the composite domes were much thinner as a result of the hybrid design. This would further affect the outcome of the impact damage test.

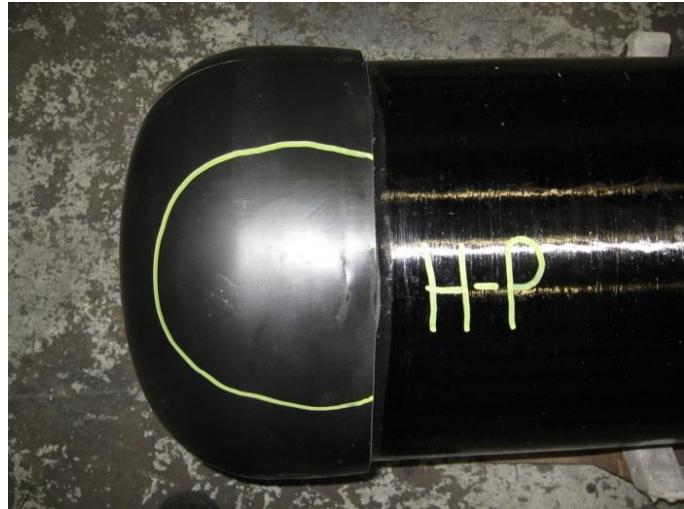
**Figure 65. Foam dome deformation after impact**

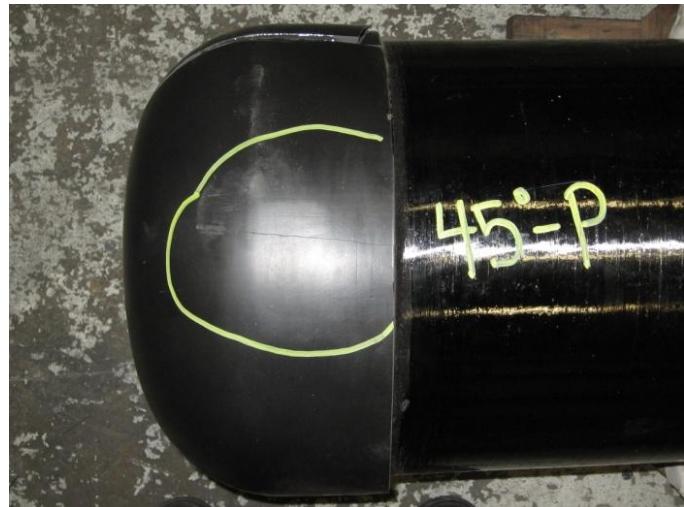
**Figure 66. Foam dome cracked after impact**

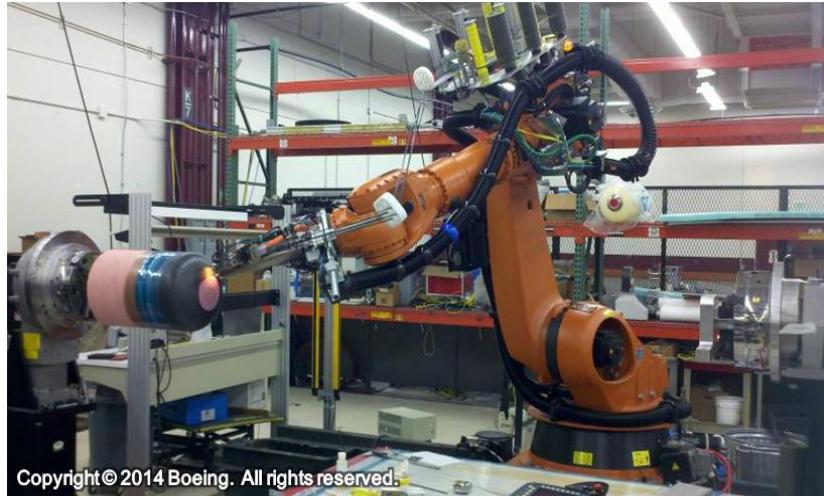
**Figure 71. New AFP cell fully integrated**

The new head was developed to meet the requirements of fiber placing material onto dome ends either as a separate layup on simplified tooling, on the vessel, or on the liner itself. The completed head was integrated into the AFP KUKA KR240 long arm robotic cell, whereby our first tests were conducted shortly after. Figure 71 illustrates the fully completed and integrated robotic cell. The integration included all installation of components, plumbing, wiring of motors and heater system, and calibration of head unit.
