## **FINAL REPORT**

**Project Title:** Development of Advanced Manufacturing Technologies for Low Cost Hydrogen Storage Vessels

**Recipient:** Quantum Fuel Systems Technologies Worldwide, Inc.

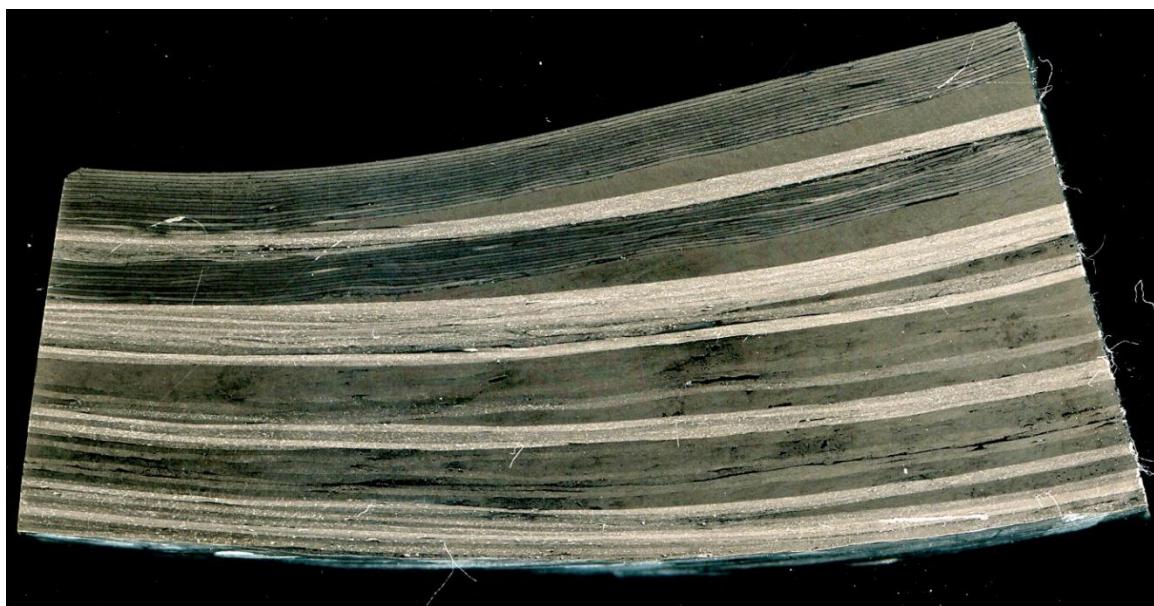
**Figure 74. Polished cross-section photomicrograph showing tow-placed material in two regions near the top, and filament wound material elsewhere. The layup is in the proximity of region “C” in Figure 72 above.**

The cross-section photomicrographs correspond to regions C and A (as indicated in Figure 72). In Figure 74, porosity was seen common to the filament wound regions, whereas the tow placed regions were mostly void free. The pressure generated from the FW was sufficient to completely compact and consolidate the tow placed material. Figure 75 shows a small amount of fiber waviness in the second layer of tow-placed material. Fiber-waviness can degrade the strength properties of the composite material.

Efforts continued by exploring the use of a CT scan to evaluate quality. Key interest was in evaluating porosity and fiber waviness. Figure 73 reproduced one section from the CT scan results. Dark indications were probably porosity, as suggested by photomicrographs of adjacent regions, shown in Figure 74 and Figure 75. However, the dark indications could also be fiber rich areas or other anomalies. Further work was needed to determine which one was indeed the case. The scans were too coarse to determine the extent of any fiber waviness. Thus, the method provided useful information, but it was not effective in quantifying porosity or fiber waviness.

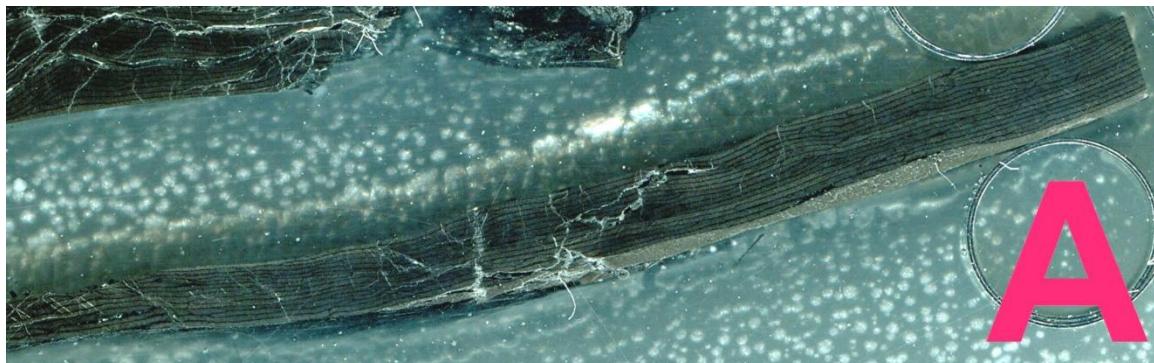
**Figure 75. Photomicrograph of region “A” indicated in Figure 72. This particular region is from the second layer of tow-placed material extracted from the damaged area of the dome. Some fiber waviness is apparent.**

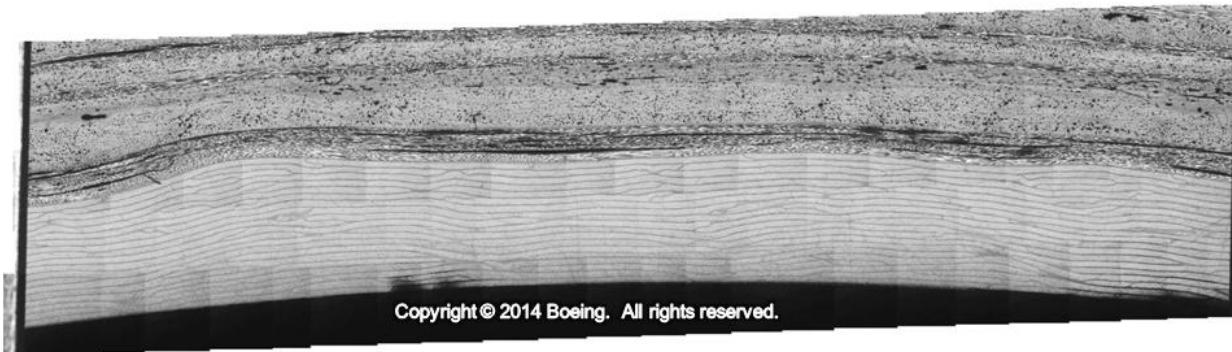
The AFP material was clearly identifiable in these cross-section photomicrographs in Figure 77 and Figure 78. The AFP material had near-zero porosity and little cracking. Significant cracking was clearly visible in Vessel 1 immediately above the AFP layer, creating a delamination. It could not be determined if this crack was due to the burst test or was pre-existing.

**Figure 77.** Cross sectional photomicrograph of Vessel 1. Top image was taken from the longitudinal direction. Bottom image was taken from the circumferential direction.

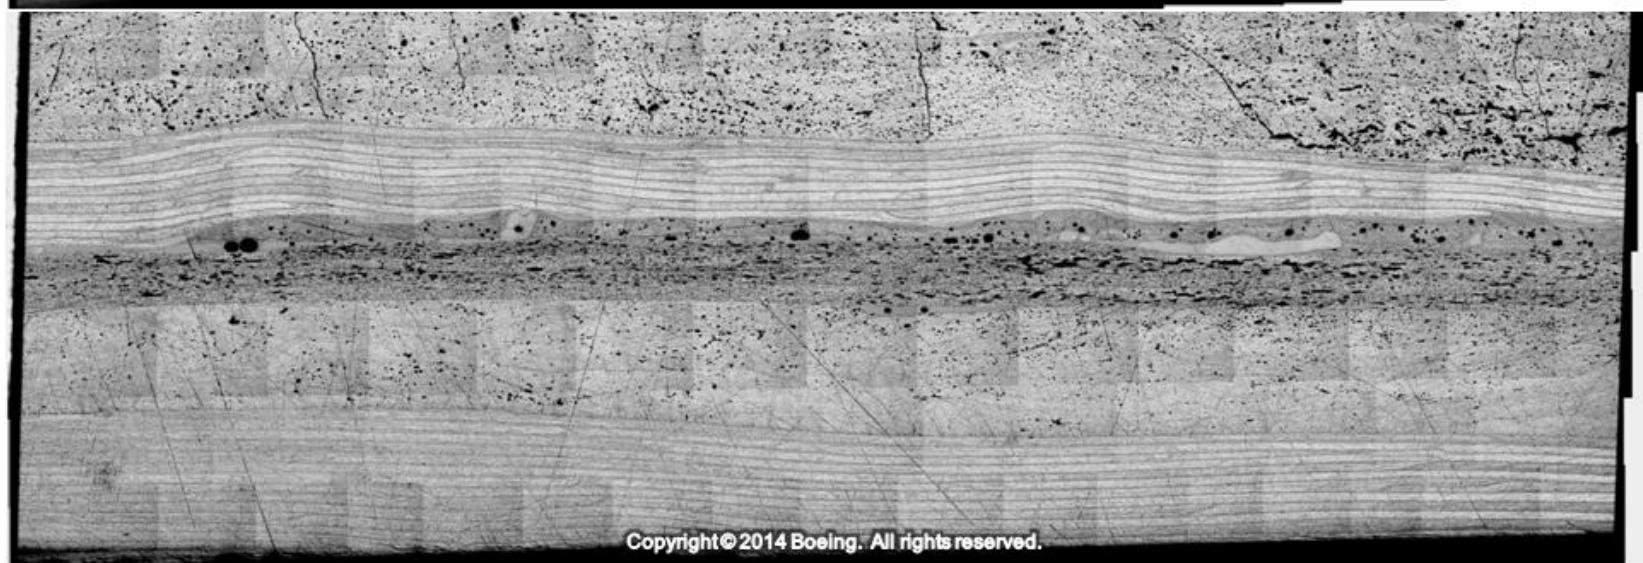
Figure 78. Cross sectional photomicrograph of Vessel 4. Left image was taken from the longitudinal direction. Right image was taken from the circumferential direction.

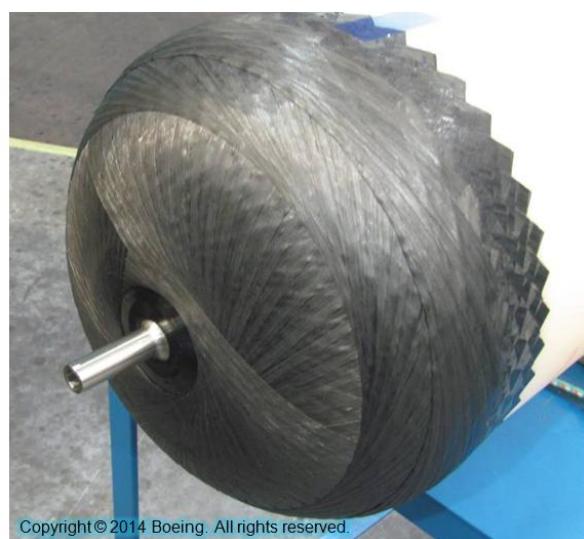
**Figure 87. Aft end fit of AFP end cap on liner with thermoformed shear protector**

These new AFP end caps were provided to Quantum for FW and structural testing. The fit of the AFP end caps with thermoformed shear protectors was superior to anything attained previously. No wrinkling was noticed during FW. Figure 85 to Figure 88 show additional pictures of the fit between liner and AFP end caps with the thermoformed shear protectors. With the new tooling and processes in place, end caps were shipped to Quantum to continue vessel fabrication and testing.

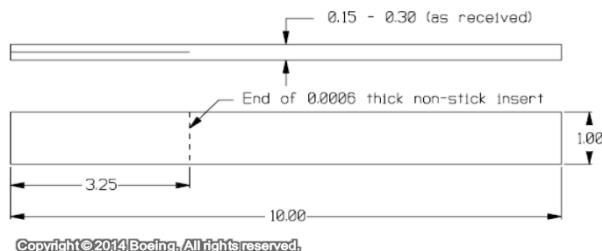
**Figure 89.  $G_{IIC}$ , Edge Notch Flexure (ENF) type specimen used in the experiments. This measures shear type fracture toughness.**

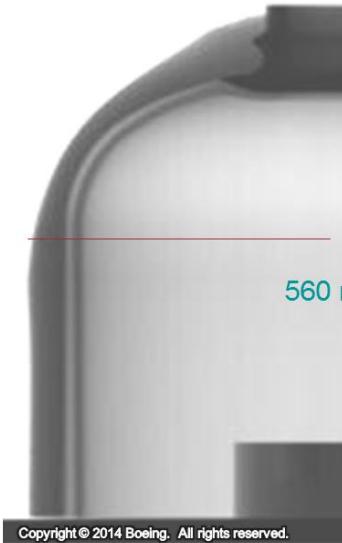
**Figure 90. X-ray of the forward half-dome of Vessel 6**

Vessel 6 was built specifically to be destructively-evaluated, using the current design and processes. Half-dome regions of the forward and aft ends of the vessel were sent to Boeing for detailed analysis. An X-ray of the forward dome is shown in Figure 90. The X-ray shows the internal structure, including the boss, liner, and composite shell, but does not show any high resolution details such as voids.

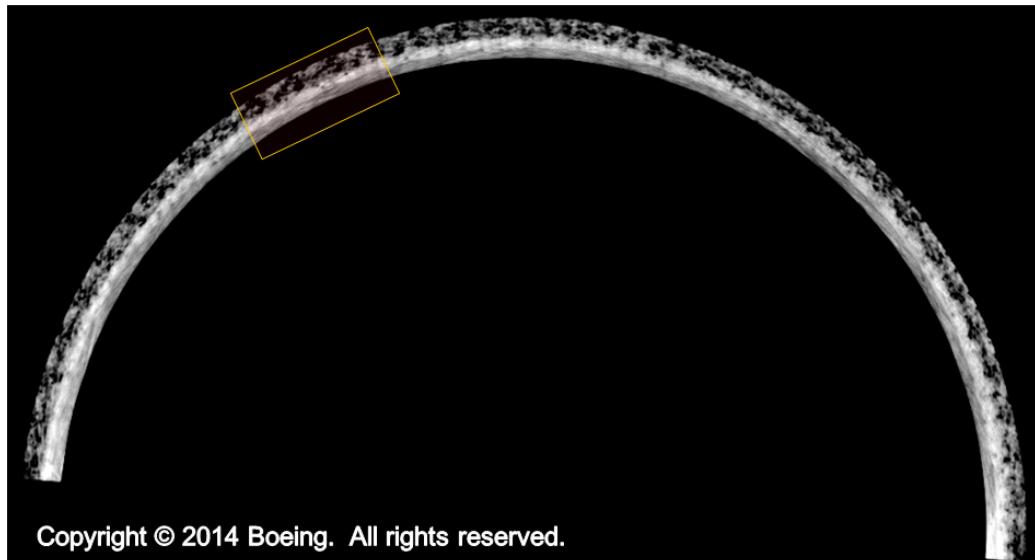
Higher detail of the composite was achieved by performing CT scan of the structure (Figure 91). The CT scan shows three-layer regions in the laminate, which are going from the inner radius to the outer radius: (1) fiber placed plies; (2) hoop filament wound layers, and (3) helically-wound layers. The CT scans were studied for regions suspected of having high porosity, cracking or delamination, or fiber wrinkling.

**Figure 91.** CT scan section taken from the forward dome region, showing suspected porosity in the helically wound material.

One region suspected of having cracks, as identified by the CT scan, was later observed to be a resin-rich layer when observed through a microscope. Because the differences between resin and voids cannot be easily discriminated, the CT scan does not provide sufficient information to determine porosity or cracking directly.

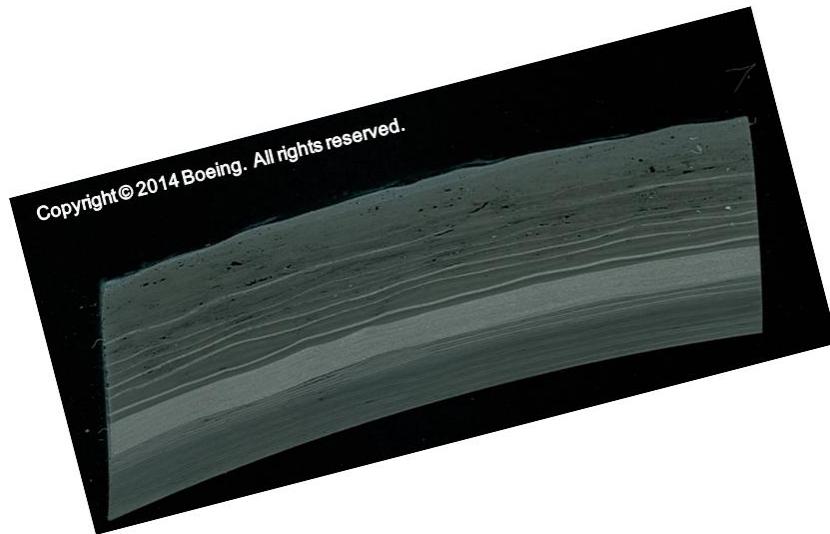
Several regions were sectioned for polished cross-section photomicroscopy at these suspected areas. One example is shown in Figure 92, again showing the three distinct regions identified in the CT scans. Porosity is observed in the outer, helically-wound layers, although not to the extent suggested by the CT scans. In this region, resin-pooling or a less-uniform resin distribution may be contributing to the CT scan response. However, significant porosity was identified in the tip of dome regions; a problem which was later addressed in the fabrication of Vessel 7.

**Figure 92.** Cross section taken from region identified in Figure 91, showing the microstructure of the dome region.

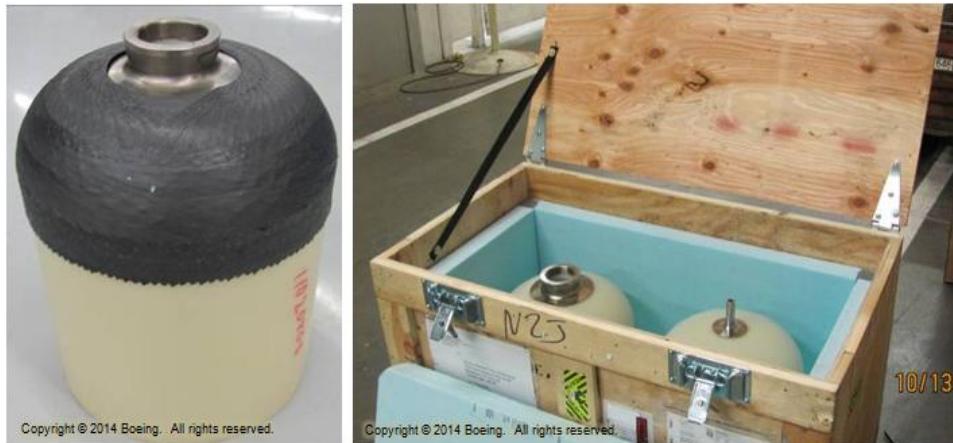
**Figure 94. Forward cap new packaging (left), new reusable shipping container (right).**

A new method of shipment was developed to eliminate the damage. The method uses actual liner to support the forward and aft end caps. The caps are placed onto the reusable dome liners on top of FEP film. More FEP is placed over the composite end caps, and then a bag is placed over the entire layup to keep the dry ice from contacting the caps. This new method allows for a tight fit on the liners with no visible distortion created. Figure 94 shows the forward end cap placed on a reusable shipping liner and the reusable crate that both the forward and aft end caps are placed in for shipping back and forth between Boeing and Quantum. This method showed with no visible damage or distortion to the dome caps. There is a closer tolerance fit from the end caps to the liner, reducing any effects that would have been caused by the constant cylinder section mismatch.

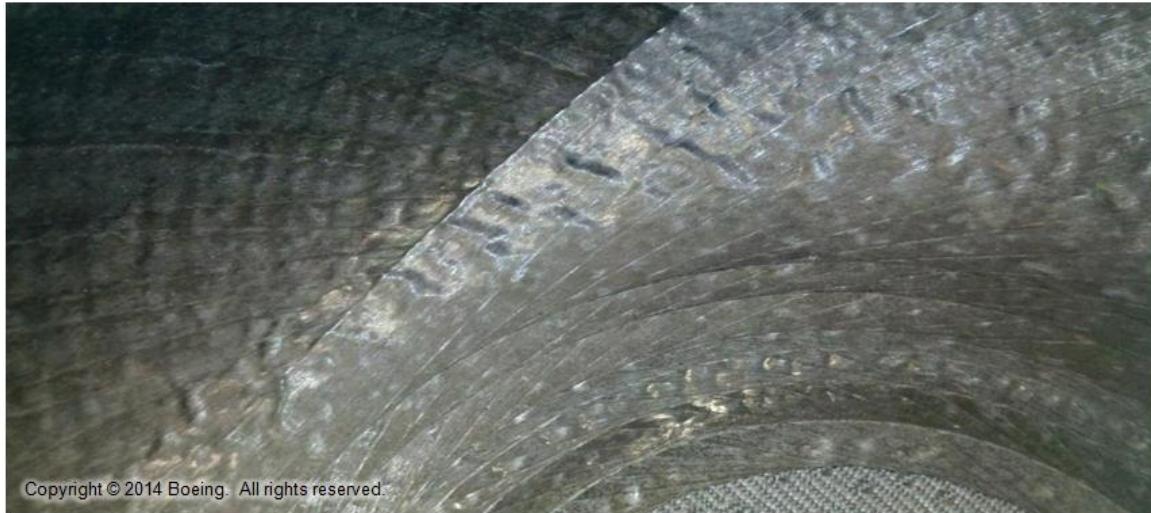
**Figure 95. Picture showing wrinkles in layup of Vessel 9**

During the initial build and rebuild of Vessel 9 AFP end caps, it became evident that small amounts of wrinkling were being induced by the AFP process in the last several sets shipped to Quantum. This slight wrinkling or "marcelling" is a new phenomenon that was not previously observed, when end caps were fabricated on the original equipment. The wrinkling is limited to certain locations, which do not correspond to any failure locations during tank bursts. Nevertheless, the wrinkling is not acceptable for quality parts, and a significant amount of resources were tasked with resolving the causes for the formation of the wrinkling. An example of the visible marcelling can be seen in Figure 95 below. From the observation during layup, it is evident that the wrinkling is being induced on the first couple of plies of the lay-up on the inverted side of the polar opening. The wrinkles tend to be oriented around the polar opening of the first ply.

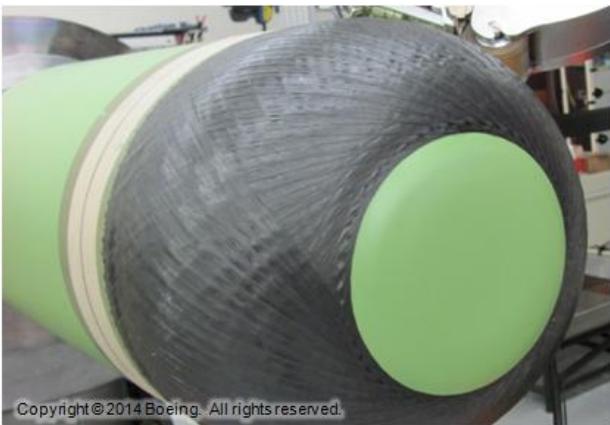
**Figure 96. Picture showing unsealed and sealed foam tools**

The process for all end caps fabricated previously was to stretch a 0.002-inch thick FEP film over the dome wrinkle free, secure it with tape, and layup onto the film. Once the dome was complete, it could be removed from the tool by cutting the FEP film and sliding it off. With the last re-machining of the foam tools to better match the liner contour, the foam was left unsealed which caused the foam to be more susceptible to damage during handling and layup of end caps. Previous end caps were built on sealed foam tools and did not show any signs of wrinkling. To be consistent and protect from wear and tear on the tools, both the forward and aft foam tools were sealed. Figure 96 shows the foam tool unsealed on the left and sealed on the right.

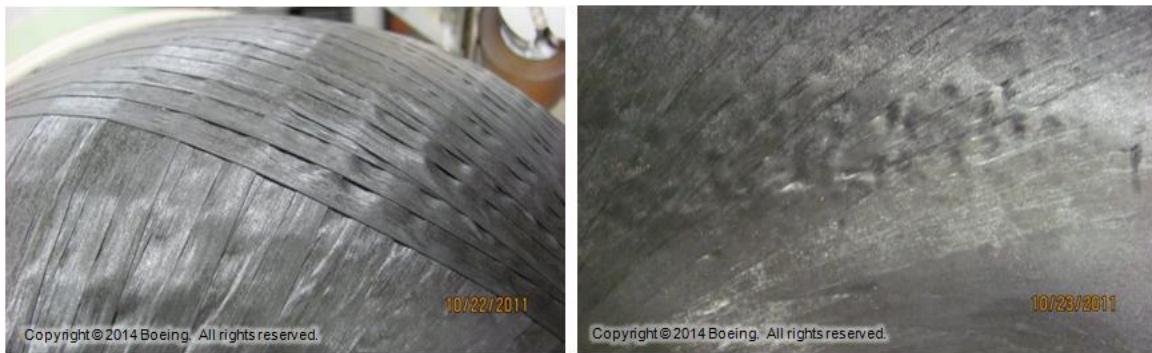
**Figure 97. Pictures showing wrinkles in layup after use of sealed foam tool and FEP film**

Initial observations and speculation was that the thin layer of FEP was slipping against the foam tool and was the cause of wrinkles seen in the first couple of AFP plies. After observing multiple plies and layups, it was noticed that there was evidence of slipping between the FEP film that is stretched over the foam tool and the end cap itself. This problem became more

pronounced when the foam tools were sealed. The newly sealed surface made the interface between the tool and the stretched FEP slippery, aggravating the problem. The unsealed foam mandrel acted as a gripping surface holding the stretched FEP film in place. Figure 97 shows how the material slipped against the newly sealed foam tool and the resulting wrinkling.

The wrinkling shown in Figure 98 was much less pronounced than what was displayed in Figure 97 from the first set of caps sent to Quantum. This demonstrated that the use of a more rigid surface could indeed help reduce the wrinkling effects that were noticed with earlier composite layups.

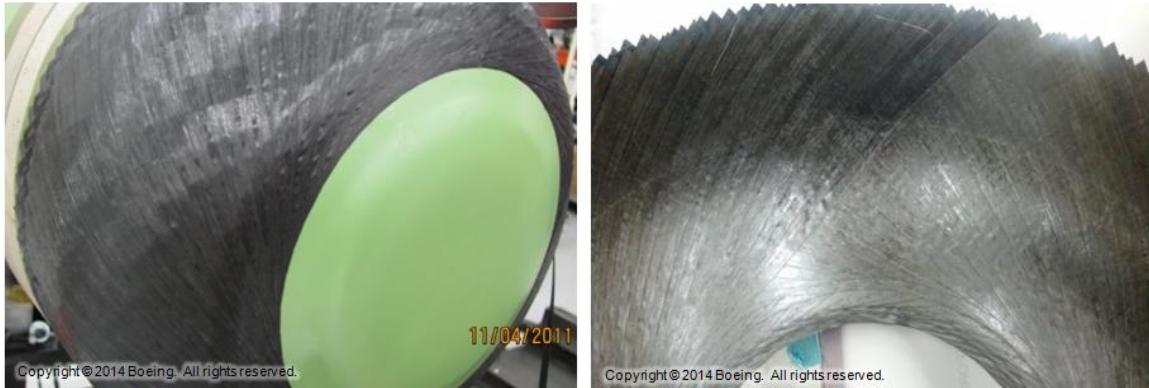
**Figure 98. Picture showing wrinkles from first test with sealed foam tool and no FEP film**

After the layup was completed, wrinkling was still observed on both the outside and the inside surfaces of the end cap, concentrating around the area close to the polar opening of the first few plies. Removal of the part was done by placing the entire foam tool in the freezer until both composite layup and foam tool were frozen. At this point the foam shrunk enough to allow the composite to release or “pop” off the foam tool with little work or stress to the composite layup.

Figure 99 shows the first ply with the use of these parameters. Comparing this with those in Figure 98, it can be seen that there is no wrinkling around the polar opening. Extraction of the part from the tool without the parting FEP film, however complicates the process. The part and tool had to be cooled in the freezer long enough to eliminate the tack of the material and facilitate extraction. The part is then bagged and removed from the freezer in order to allow it to warm to ambient conditions, prior to removing it from the bag. A better means of removing the part from the tool is needed that does not unnecessarily encumber the production process.

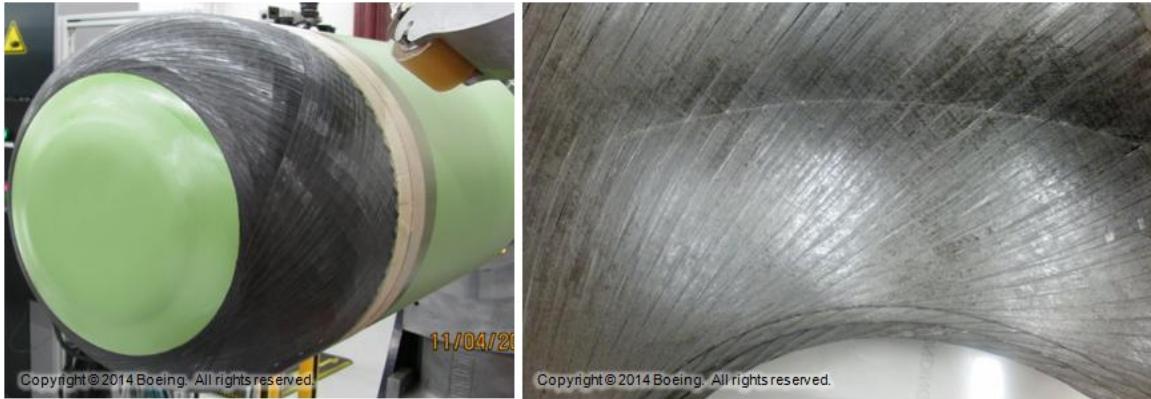
**Figure 99. Picture showing the layup with minimal steering and two tows**

To study the effects of no steering, the polar opening was kept the same and the angle varied to the ideal isotensoid angle. The Vessel 9 design called for a 42-degree fiber angle and a 9.10 polar opening diameter. To eliminate steering, that angle was changed to 44-degrees with the same polar opening. Some wrinkling still occurred. Next, the programs were changed to only two tows, instead of three tows per course, in order to minimize the effects of parallel paths offset from the nominal path. The result of this trial was that the entire lay-up was virtually wrinkle free.

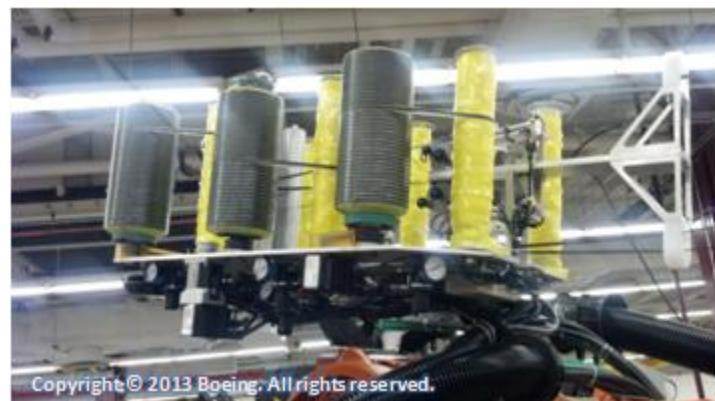
**Figure 104. Upgraded closed loop tension control**

Figure 104 shows the creel system with the installed smart motors and integrated dancer mechanism. The dancer system has linear actuators that are used to control tension. Linear potentiometers are installed to send feedback information to the smart motors for closed-loop control of tension. This allows the tension to be consistent regardless of spool diameter, speed, and direction of fiber movement.

The final control logic was integrated into the upgraded creel system. This controller allows the linear potentiometers that are associated with each individual dancer arm to send information back to the motor that it is affixed to, creating a more-refined tension control system. Each motor controls an individual tow; thus, each of the six tows is controlled independently of each other. Each motor will output the correct torque for its particular lane so that tension across all six tows is consistent, regardless of differences in drag from lane to lane.

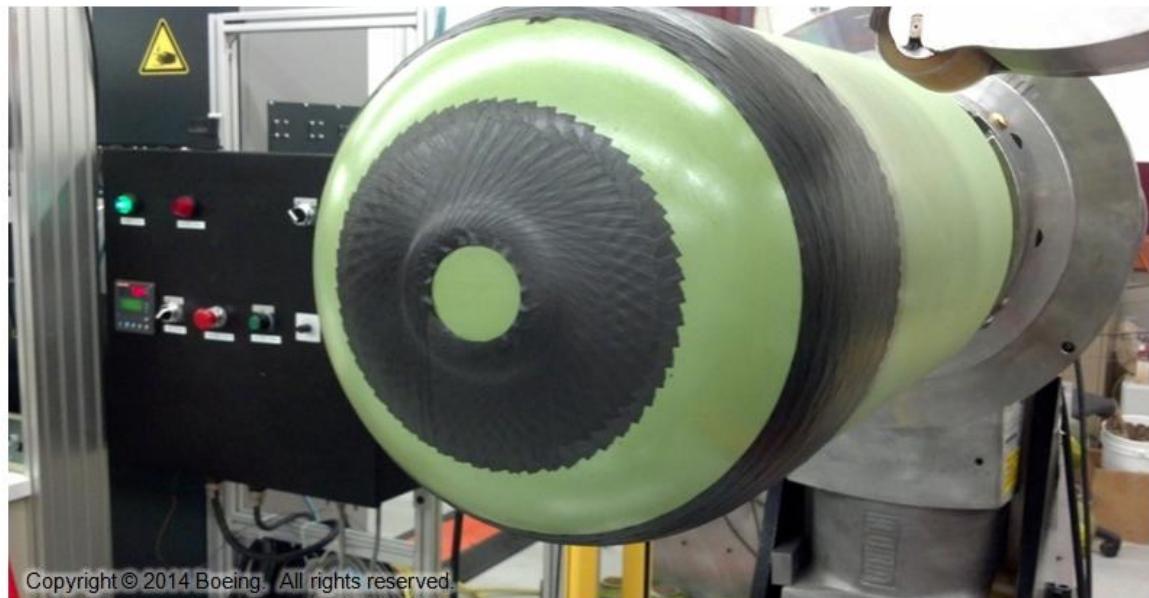
**Figure 105. Layup of aft dome cap**

Figure 105 shows the in-process layup of the aft dome cap on the sealed foam tool. This layup shows a ply placement that will be AFP'd over in a few later plies.

Vessel 13 end caps were built using the new process utilizing the sealed foam tools and method for extracting the dome caps from the foam tool. The new dome caps differed from previous caps in that the transition point where the dome caps merge with the FW process was extended an extra 2 inches. The end caps were also thicker by doubling the plies from 10 to approximately 20 for both the forward and aft. The layup process was successfully completed with no visible wrinkles or defects.

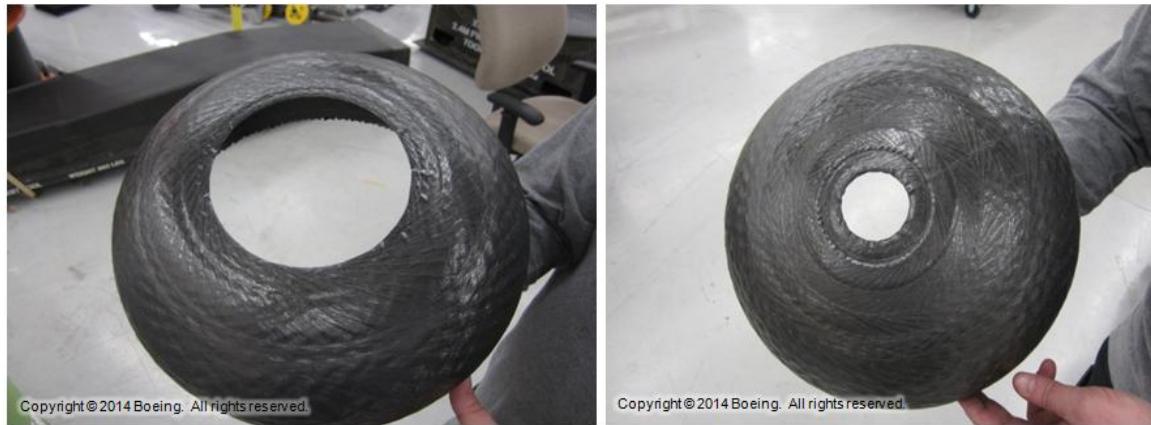
**Figure 106. Pictures of forward and aft end caps external surfaces (after vacuum bagged)**

Figure 106 and Figure 107 show the pictures of the exterior and internal surfaces of both forward and aft AFP end caps after they were vacuum bagged, respectively. The end caps were vacuum bagged to the foam tool to de-bulk the composite and allow for a more accurate CMM

comparison to the software prediction by Quantum. CMM data was also taken from both forward and aft end caps for validation from Quantum's software to the actual.

No visible wrinkles in the dome region of the forward and aft end caps were seen. Slight wrinkling around the most extreme polar opening was seen. This was primarily caused by steering violations exceeding the  $\frac{1}{4}$ -in tow's capabilities.

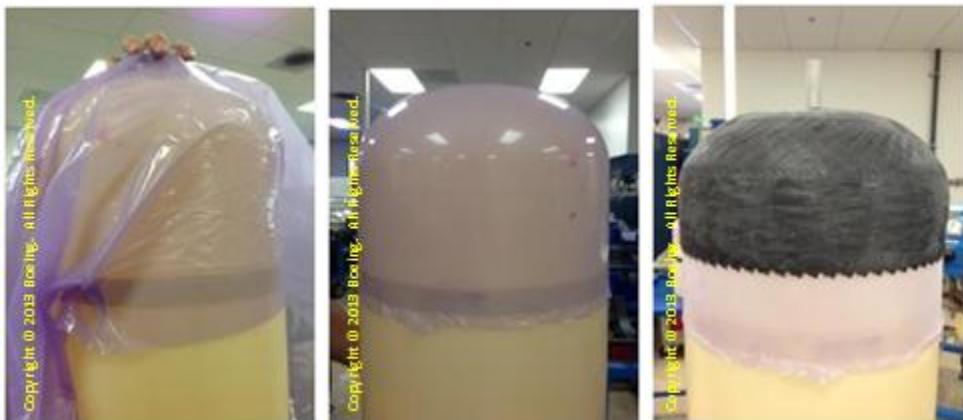
**Figure 109. Process for stretching release film onto liner**

Figure 109 shows the process for stretching the release film onto the dome ends. First double back tape is placed all the way around the constant cylinder section, approximately 18" from the end of the dome. The film is slowly worked around the dome region, being stretched as it's worked. This process takes a bit of work to finesse the film and stretch it around the dome without tearing it. Once stretched, the excess is cut off, and the liner with the stretched FEP film is placed into the freezer for a couple of minutes to shrink the liner for installation of end cap.

Once the end caps are placed over the stretched film, more work is needed to wrap the film over the constant cylinder section. This is done by first cutting away the excess stretched film and then removing the double back tape. New film is then place over the constant cylinder section and taped to the stretched film with blue Mylar tape. This process is difficult and time consuming, and it still creates wrinkles in the film.

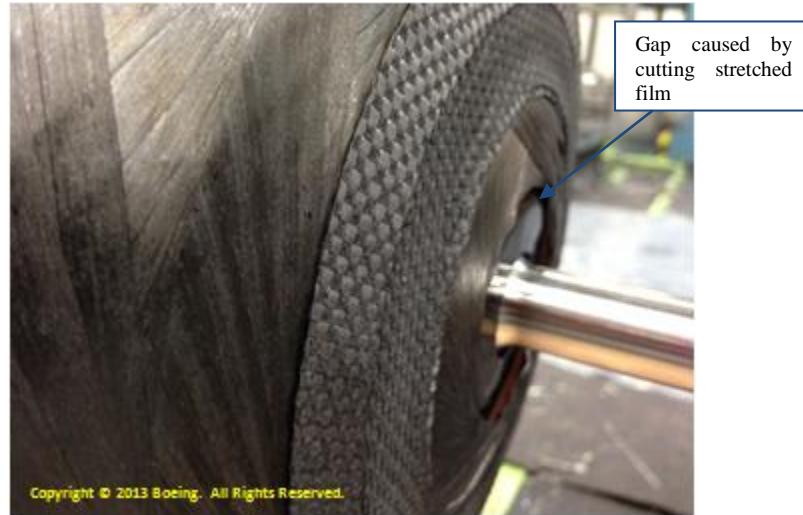
**Figure 110. Picture of gap caused by cutting stretched film**

Since the film is stretched over the dome region, stresses are introduced into the film. Once the film is cut away from the double back tape, it pulls away relaxing these stresses, moving the end cap and causing a separation (gap) between the liner and the cap. Figure 110 shows this separation. This was fixed by reworking each end through the freezer process in order to re-seat the caps back to their proper locations. This added an extra step in the process of placing the film and then locating the end caps.

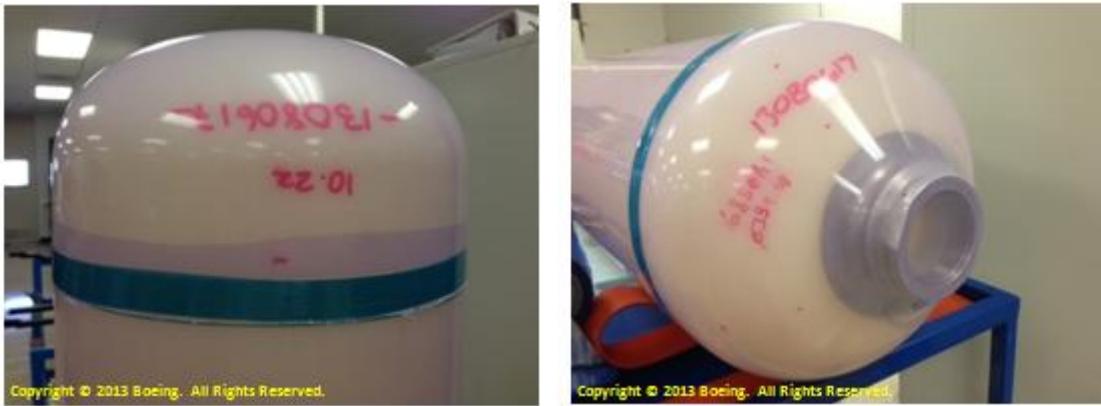
**Figure 111. Picture of domes with stretch film by new method**

A new method for placing the film onto the liner was developed to eliminate the extra steps and the problems associated with the composite cap separating from the dome region on the liner. This method starts by placing the film on the constant cylinder section first, followed by taping one end with Mylar tape, so that the film won't move when stretched over the opposite dome region. On the end that the film is stretched over first, double back tape is placed on top of the film, so that the tape doesn't come in direct contact with the liner. The film is next stretched over the dome region as before, but this time there is no need to cut the film and retrieve the double back tape since it is not touching the liner directly. After the excess film is removed from the stretching process a strip of blue Mylar tape is used to secure the stretched film in place. This is repeated for the other side leaving a nicely stretched taught film over the liner. Figure 111 shows both ends of the liner with stretch film. Figure 112 below shows the completed process with stretched film onto the liner.

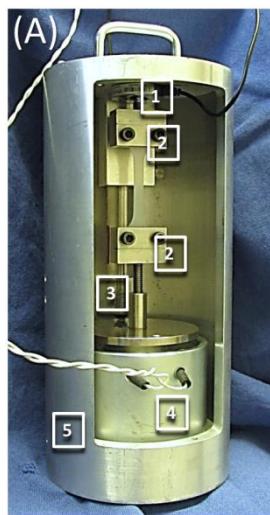
**Figure 117. Photograph of the in-situ tensile test rig showing the various components: (1) load cell, (2) grips, (3) LVDT, (4) solenoid, and (5) frame.**

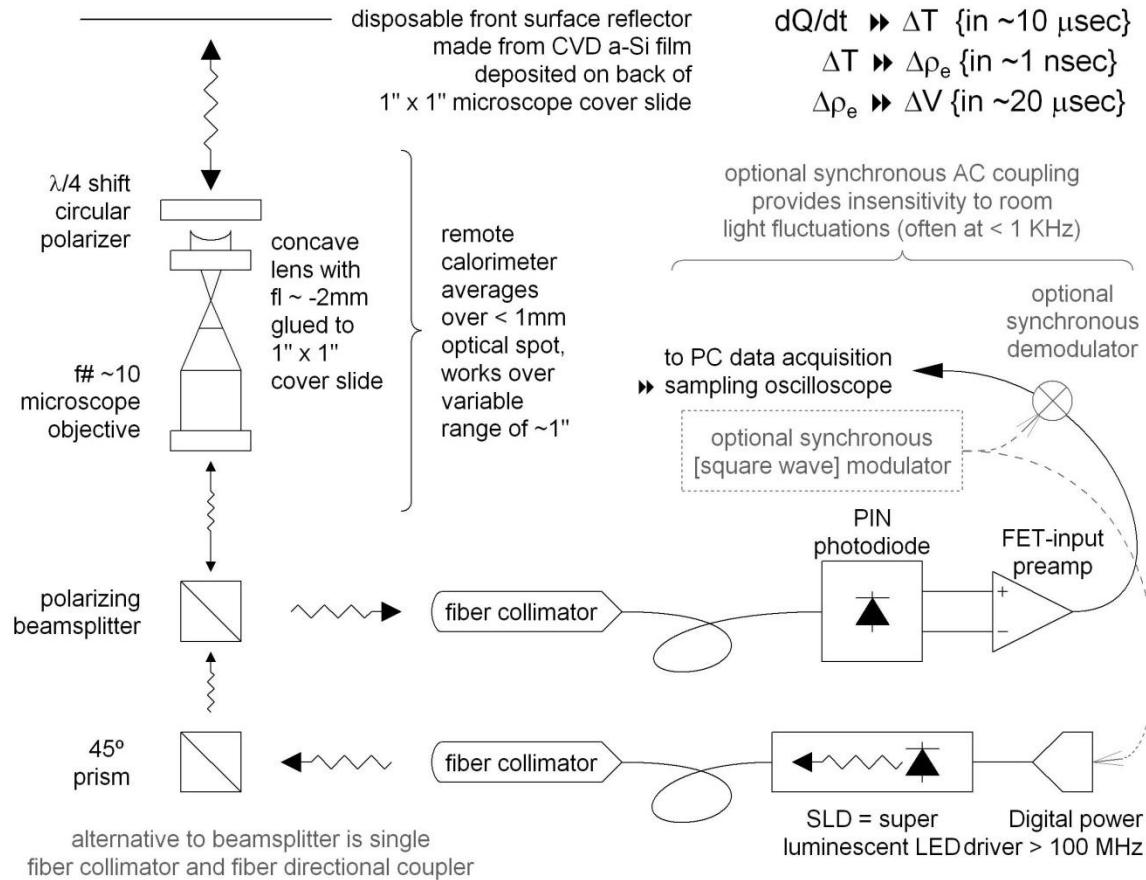
**Figure 124. Schematic diagram of calorimeter to determine tape bonding speed by capturing temperature rise due to bonding with a digital oscilloscope. This hardware diagram mixes physical components, optical beam paths including captured photons in fibers, and electronics.**
